NATIONAL TRANSPORTATION SAFETY BOARD

**ACCIDENT SITE, AIRFRAME, AND ENGINE
EXAMINATION SUMMARY**

ANC13FA084

Location: Anchorage, Alaska
Date: August 24, 2013
Aircraft: Cessna 150L, N18699
NTSB Investigator-in-Charge: Joshua Cawthra

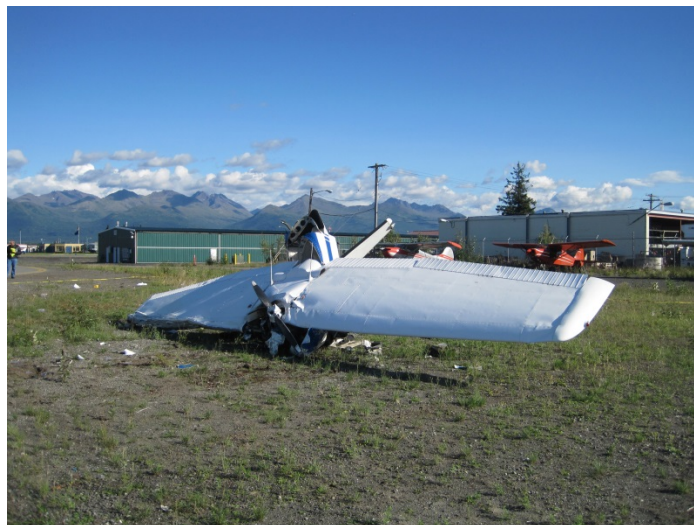
Examination of the accident site revealed that the airplane came to rest in a nose low position about 398 feet west of the departure end of runway 25, oriented on a heading of about 344 degrees magnetic. Wreckage debris remained within about 50 feet of the main wreckage. About five feet directly in front of the main wreckage was a ground scar about 2 feet in width, 6 inches long and about 5 inches deep. Extending from the ground scar in an easterly direction was a swath of paint chips, white in color. At the end of the swath of paint chips, was a portion of the right wing green navigation lens.

Photo 1: View of the accident site and wreckage.

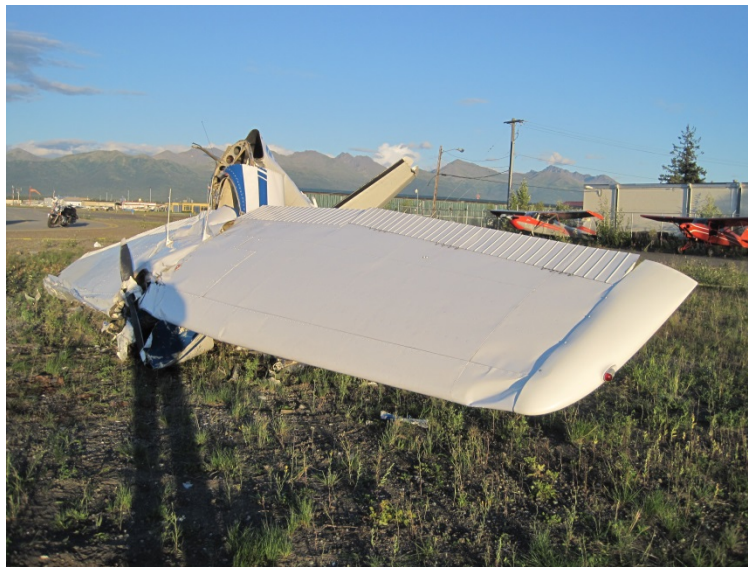
The right wing was intact and remained attached to the fuselage via its mounts, and came to rest in a leading edge, wing tip low position with the inboard portion of the wing elevated. The right aileron and flap remained attached to the wing via their respective mounts. The right flap appeared to be in the “up” position. The flap actuator was observed in a position consistent with the flaps being full up. The leading edge of the wing from the wing tip inboard to the flap aileron junction was crushed aft to the forward wing spar. The leading edge was crushed aft and decreased in damage towards the wing root from the flap aileron junction. The wing lift strut remained attached to the wing and fuselage attach point. The fuel cap was secured in place. Trace amounts of fuel was observed within the fuel tank. The fuel tank was removed from the wing structure and approximately 1.8 gallons of fuel was removed from the tank. Water finding paste was used to test the fuel for water with negative results for water.

Photo 2: View of the Right Wing

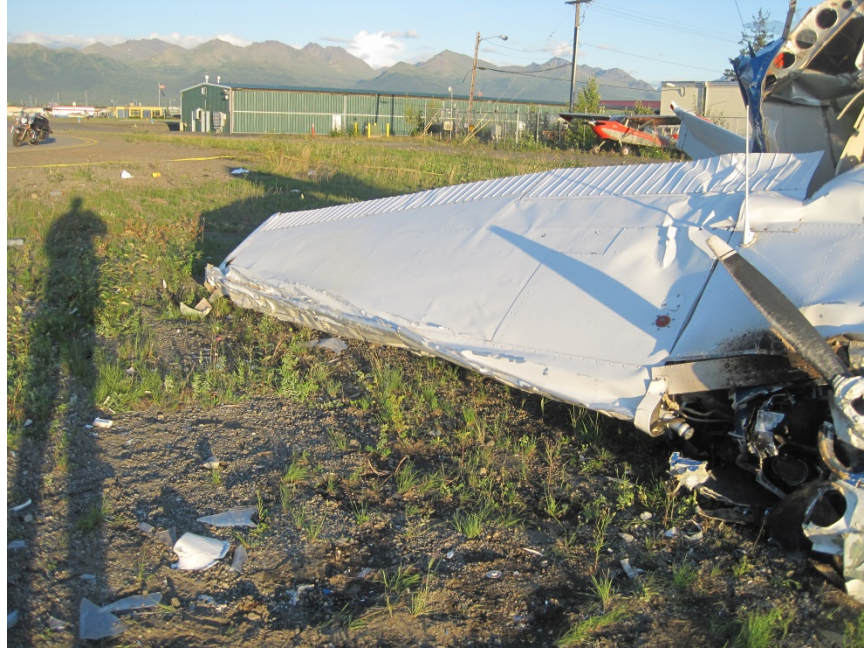
The left wing remained attached to the fuselage via its mounts, and came to rest in a leading edge, wing tip low position with the inboard portion of the wing elevated. The left aileron and flap remained attached via their respective mounts. The left flap appeared to be in the “up” position. The leading edge and wing structure was bent/wrinkled about 14 to 15 inches inboard from the wing tip. The left wing was bent downward slightly just inboard from the flap aileron junction. The fuel cap was secured in place. Fuel was observed leaking from the area of the fuel vent. The lift strut remained attached to the wing and fuselage attach points. The left wing fuel tank was removed from the wing and appeared to be intact and not breached. Approximately 1 quart of fuel was removed from the wing tank. The left wing fuel tank is equipped with a vent line drain on the forward outboard area of the tank. Water finding paste was used to test the fuel for water with negative results.

Photo 3: View of the left wing.

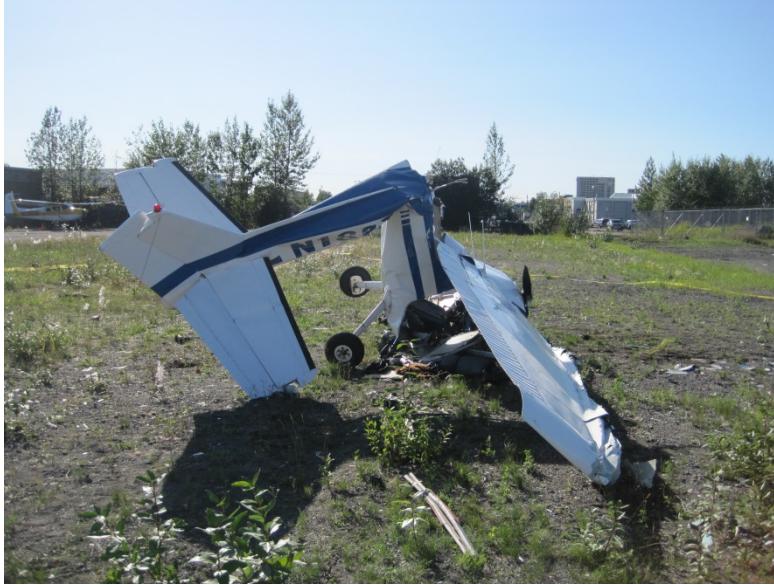
The left and right forward doorposts were damaged. The right seat was removed by first responders and the left seat remained attached to the seat rails. The fuselage structure aft of the baggage compartment was distorted, twisted in a right direction, and bent downwards.

Photo 4: View of the fuselage and accident site area.

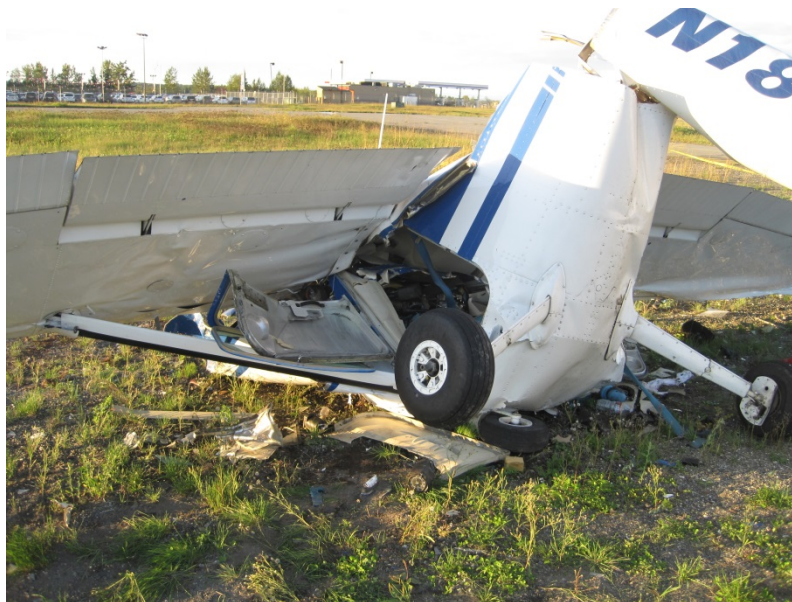
The forward portion of the fuselage was crushed aft. The engine was displaced aft and upward into the instrument panel and windshield. A circular impression on the cabin roof structure just aft of the upper area the windshield was observed, which was consistent with impact from the engine crankcase was observed. Evidence of a postaccident fire was observed near the front part of the engine and cowling area. No soot pattern was observed in the surrounding area of the fuselage or wings.

Photo 5: View of the forward portion of the fuselage.

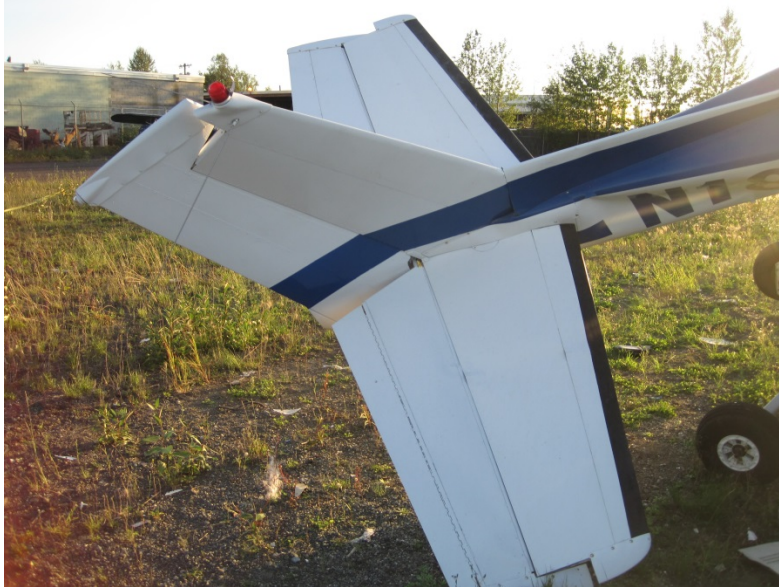
The empennage was intact and appeared to be undamaged with the exception of the right horizontal stabilizer and elevator, which were bent upward slightly about mid span. The rudder remained attached to the vertical stabilizer via its respective mounts. The left and right elevator remained attached to the left and right horizontal stabilizer via their respective mounts. The trim tab remained attached to the right elevator via its respective mount. The trim tab actuator was measured at 1.6 inches and found to be in a position consistent with 3 degrees tab up.

Photo 6: View of the Empennage.

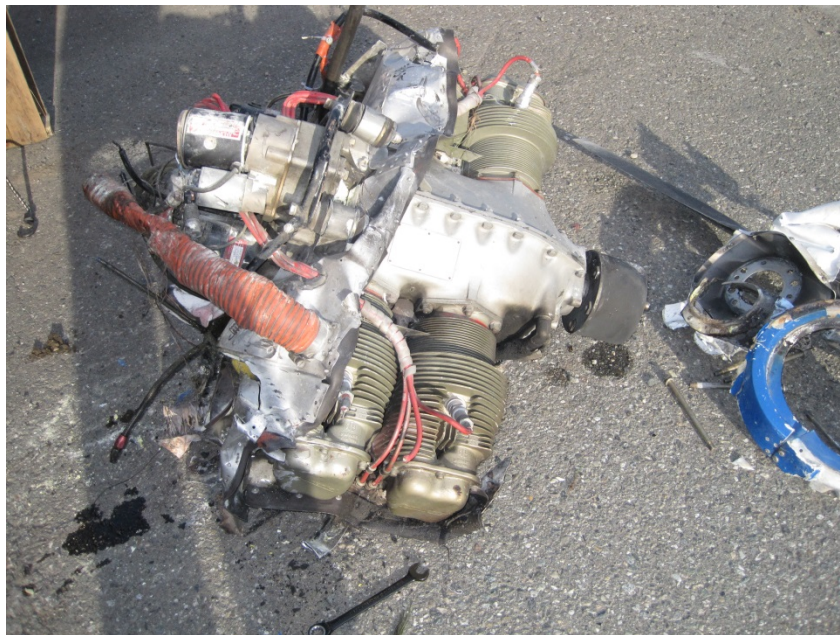
The engine was removed from the airframe and subsequently further examined at a local engine repair facility. The examination of the engine, a Continental Motors O-200-A, revealed that the vacuum pump was separated from its mount pad, two of the four engine mounts were damaged, and the carburetor was separated from the induction intake spider. The oil sump was compressed upwards and breeched. All four cylinders remained attached to the engine. Evidence of fire damage was observed on the carburetor and the cylinder 1 and 3 (right) side of the engine.

Photo 7: View of the recovered engine.

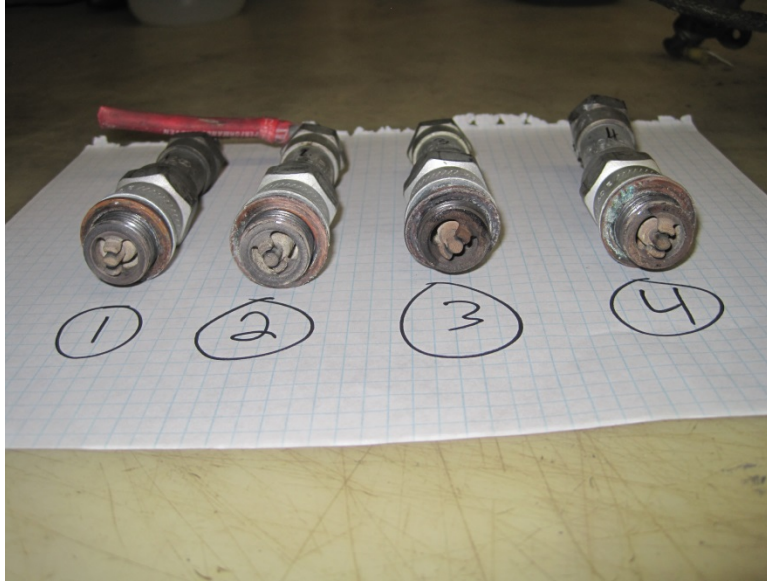
The top sparkplugs, Champion REM 38E's were removed. The number one and two spark plugs exhibited light gray deposits within the electrode area. Number three and four exhibited a brownish color deposit within the electrode area. The number one spark plug exhibited worn out normal signatures and the number two, three, and four exhibited normal wear signatures.

Photo 8: Top Spark Plugs

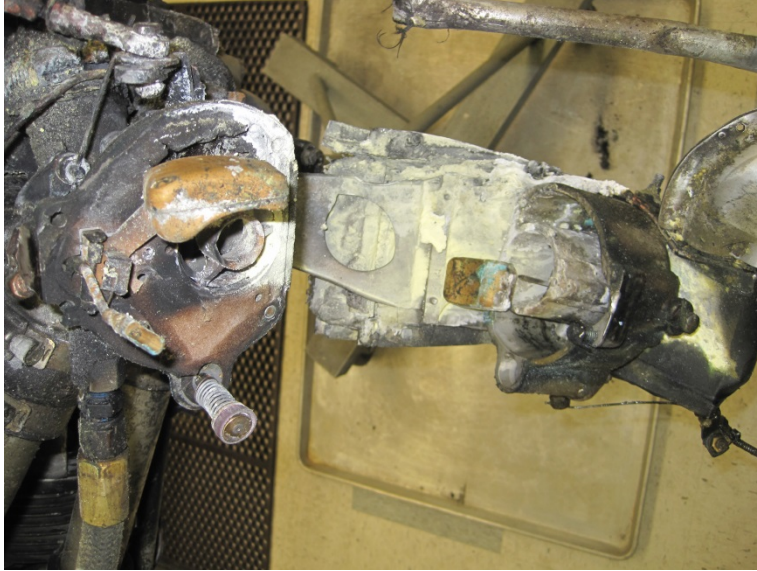
The carburetor was displaced from its mount and exhibited extensive fire damage. The carburetor bowl was separated. The venturi was intact and in place. The mixture arm was impact damaged and moved slightly by hand. The throttle arm was impact damaged and moved slightly by hand. The metal floats were intact, however, one was separated. A significant amount of a foreign substance, consistent with fire extinguishing material, was observed throughout the carburetor bowl, intake filter mount, and brackets. The carburetor heat lever moved partially by hand and remained connected to the air box. The fuel screen was removed and was free of debris.

Photo 9: View of the Carburetor

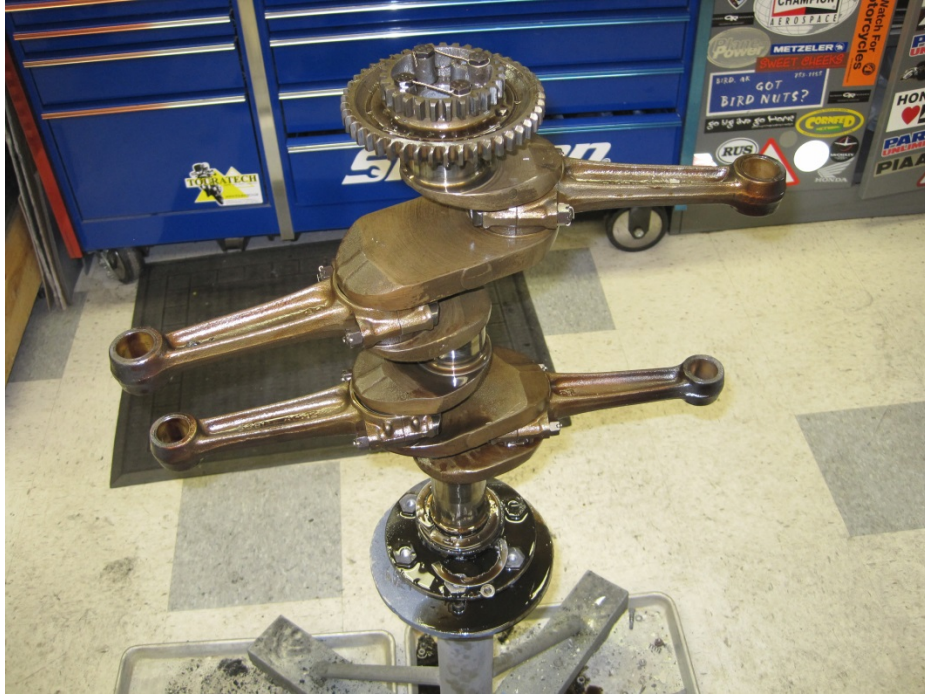
The crankshaft was intact; however, the oil slinger ring was separated throughout its circumference. All four connecting rods remained attached to the crankshaft and moved freely.

Photo 10: View of the crankshaft.

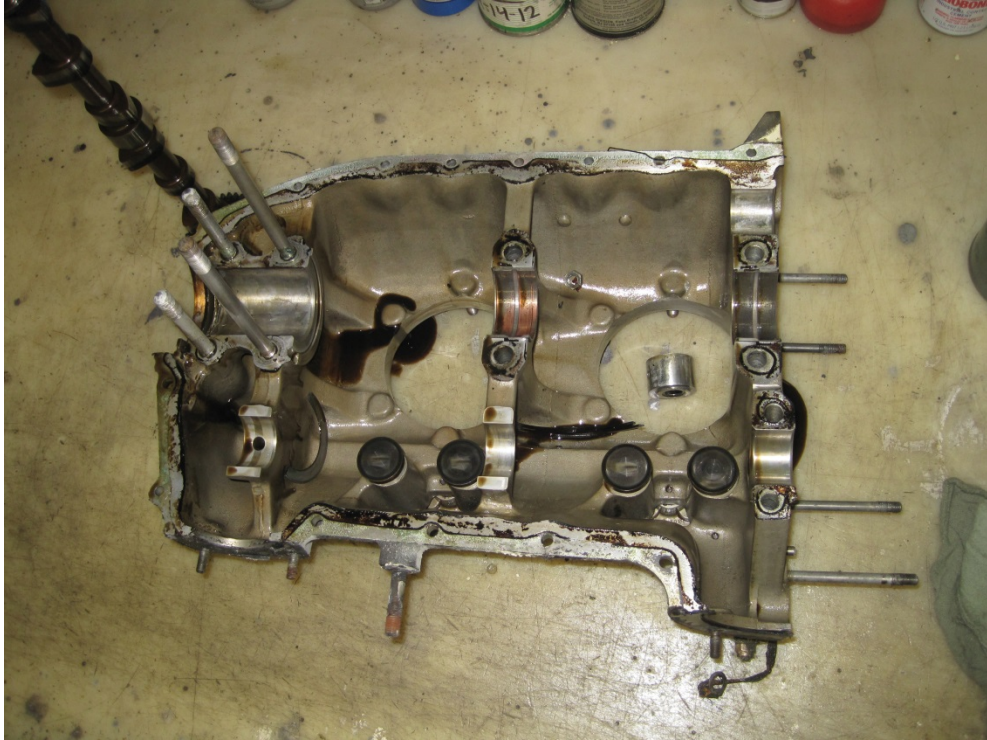
The cylinder 1 and 3 side crankcase halve was intact. The front, middle, and aft bearings appeared to be slightly shifted aft. The forward thrust bearing saddle exhibited impact damage with forward to aft oriented striations. The cylinder 2 and 4 side crankcase halve was intact. The forward, middle, and aft bearings were intact and shifted slightly aft. Damage was observed to the forward bearing saddle and thrust bearing saddle.

Photo 11: Cylinder 1/3 Side of the Crankcase

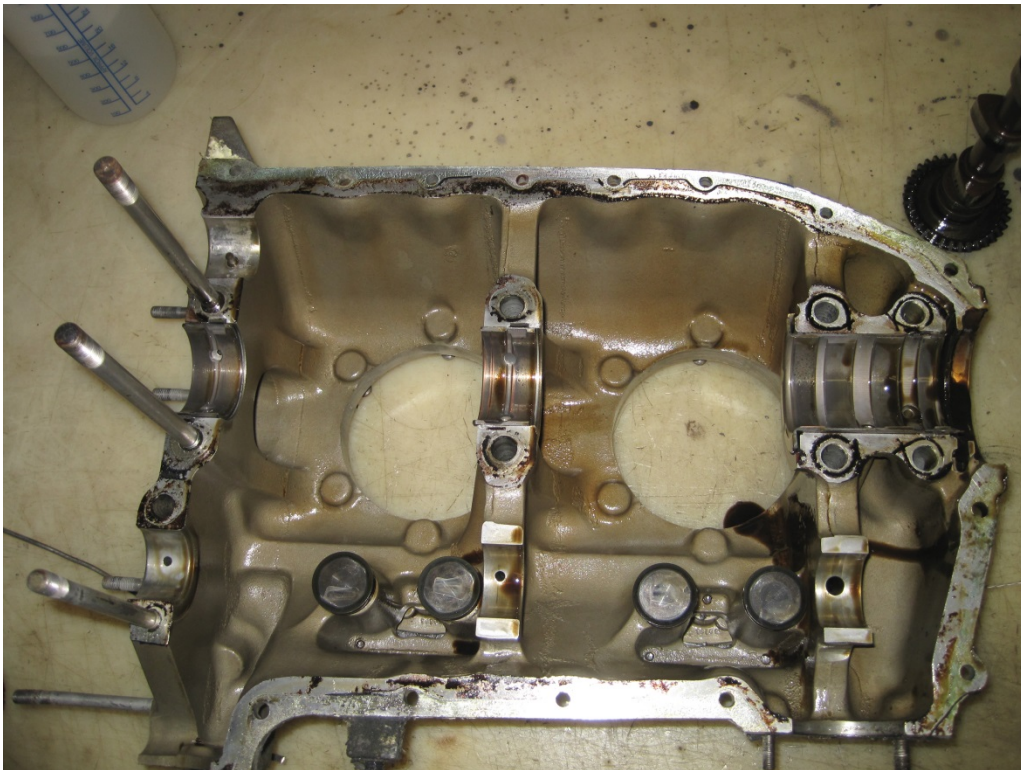
Photo 12: Cylinder 2/4 side of the Crankcase

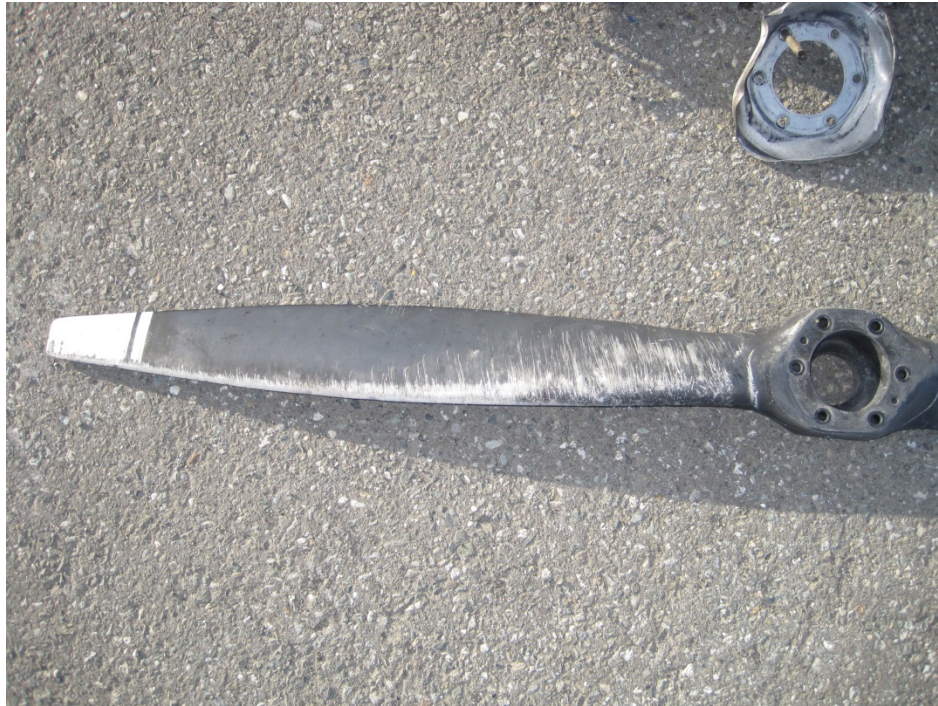
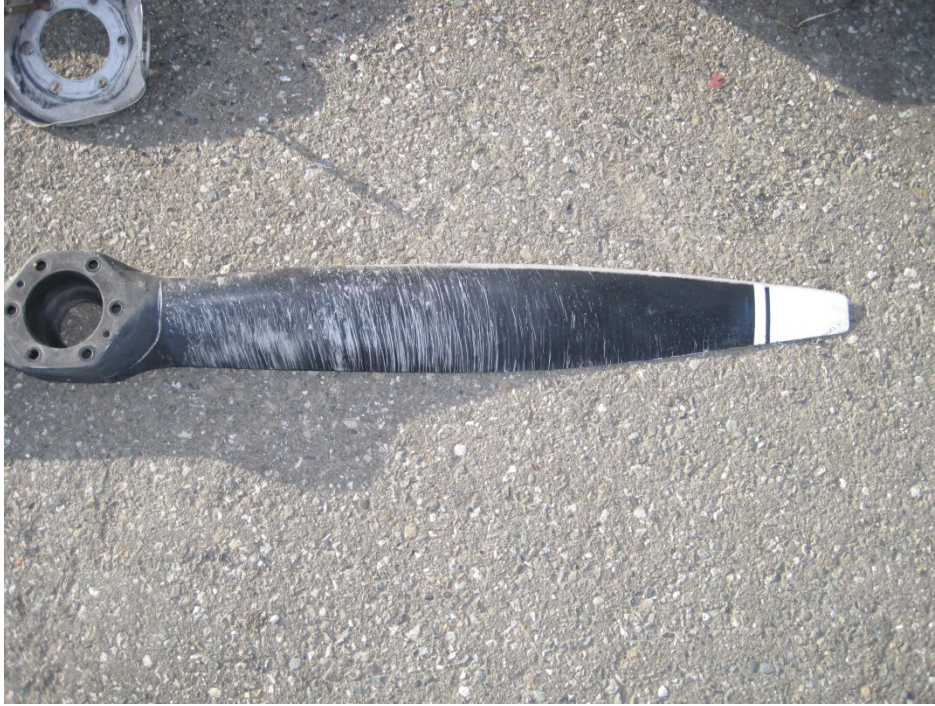
The propeller remained attached to the engine crankshaft propeller flange. Chordwise striations were observed on the inner half of each blade. Both propeller blades were slightly bent aft.

Photo 13: View of the propeller.

Photo 14: View of the propeller.
