## **NATIONAL TRANSPORTATION SAFETY BOARD**

# **ACCIDENT SITE EXAMINATION SUMMARY**

**WPR13FA370**

Location: Paradise, California  
Date: August 13, 2013  
Aircraft: Champion 7GCAA, N9607S  
NTSB Investigator-in-Charge: Andrew Swick

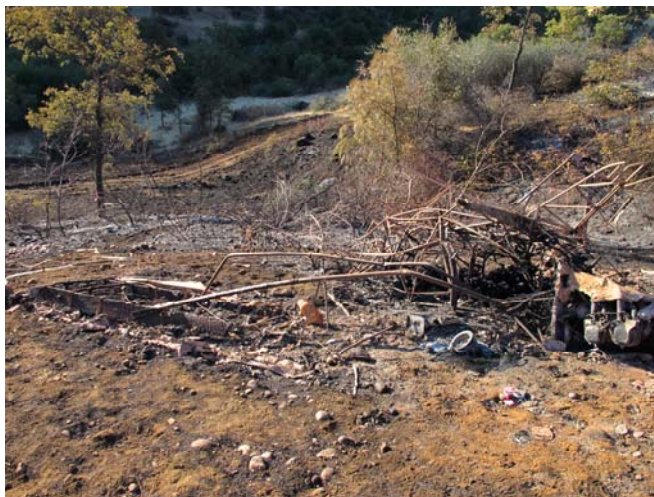
The first identified point of contact (FIPC) was a rocky surface about 10 feet uphill from the main wreckage. The direction of the wreckage debris path was oriented a heading of about 120 degrees magnetic from the FIPC to the main wreckage.

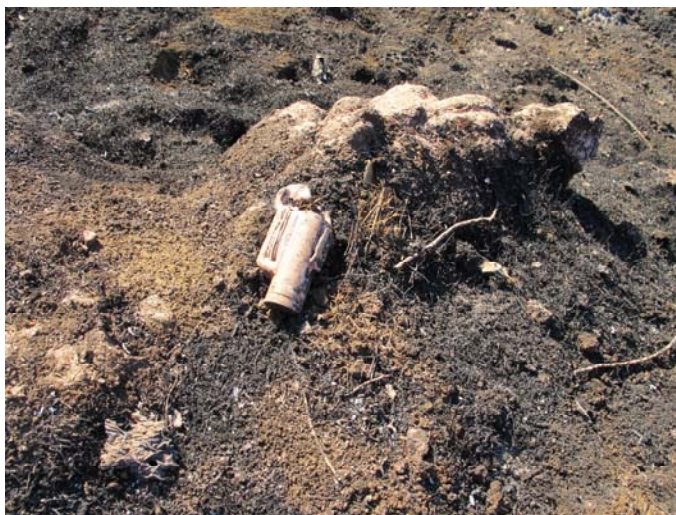
The main wreckage was found inverted with the nose section on a heading of about 300 degrees magnetic. The aft fuselage and tail section structure was intact and was partially separated at the aft fuselage cabin area and was found on top of the main cabin area and right wing. Both wings had excessive thermal damage. The fuel tanks were partially consumed by fire. The forward and aft wood spars had excessive fire damage. Flight control cable continuity was obtained from all flight controls to the cabin area. The forward and aft seat structures had impact damage and remained partially attached to the fuselage. The forward control stick separated from the control linkage assembly. The forward control linkage assembly had thermal deformation. The aileron cable attachments on the control stick assemblies separated.
