NATIONAL TRANSPORTATION SAFETY BOARD

AIRFRAME AND ENGINE EXAMINATION

WPR15LA014

Location: Big Bear City, CA
Date: October 16, 2014
Aircraft: Cessna 172S, Registration Number: N612SP, Serial #: 172S8594
NTSB IIC: Howard Plagens

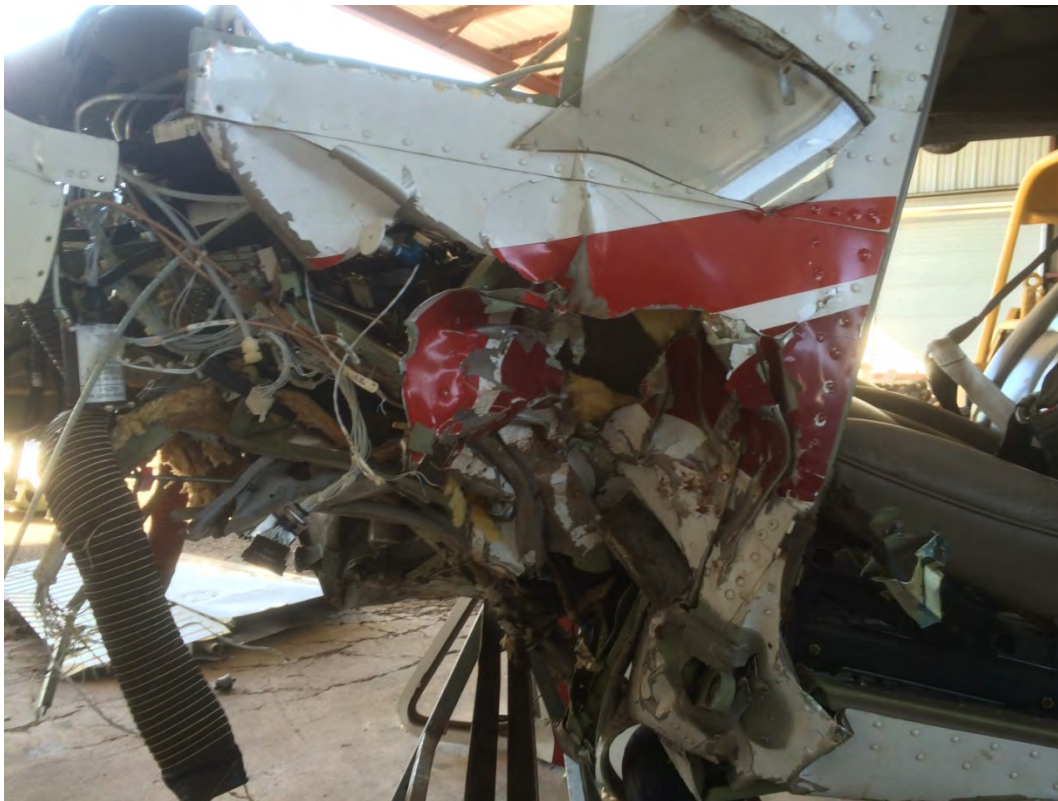
Photo 2 Left Side of Front Cabin

The cabin exhibited circular inward crush damage in the lower left side by the pilot's leg area.

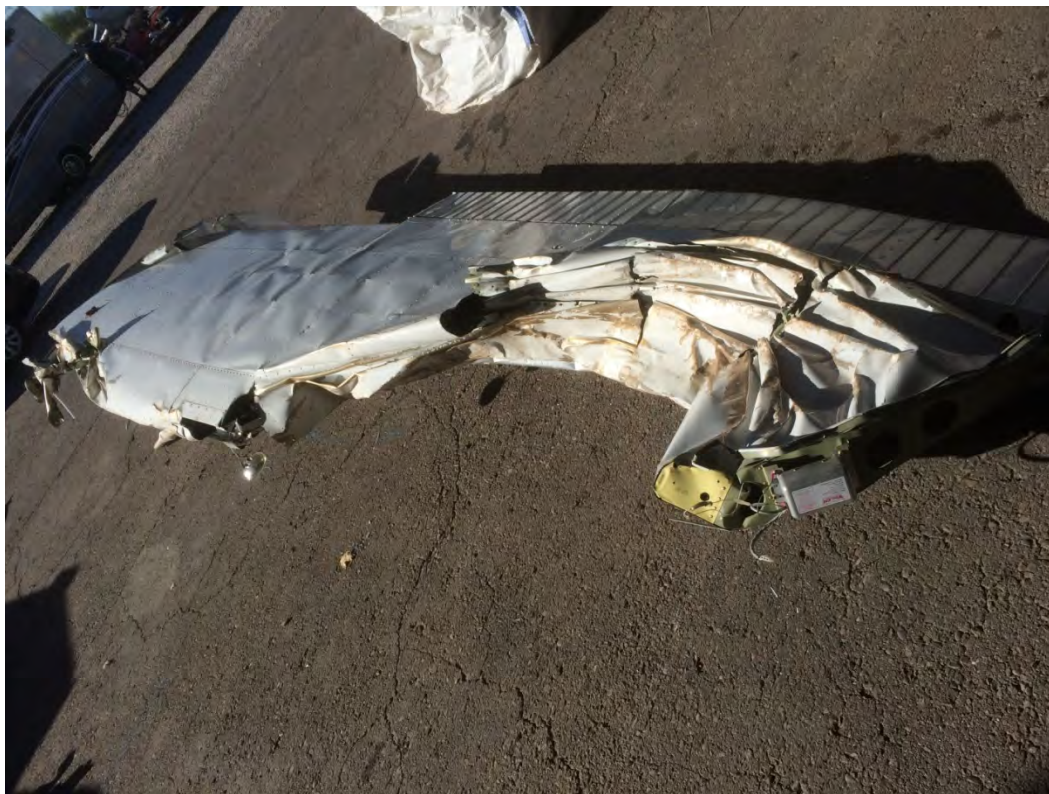
Photo 3 Left Wing

The wings were removed from the fuselage. The rear attach points on each wing were separated at the structure, and the forward spar attach points were removed for recovery. The wing struts remained attached to the wings, and were removed from the fuselage. The outboard half of the left wing had semicircular crush damage aft past the spar. The right wing had leading edge crush damage, and skin torn away. The right wing was buckled in several places. The fuel tanks did not contain a significant amount of fuel. The tank caps were in place with pliable rubber seals.

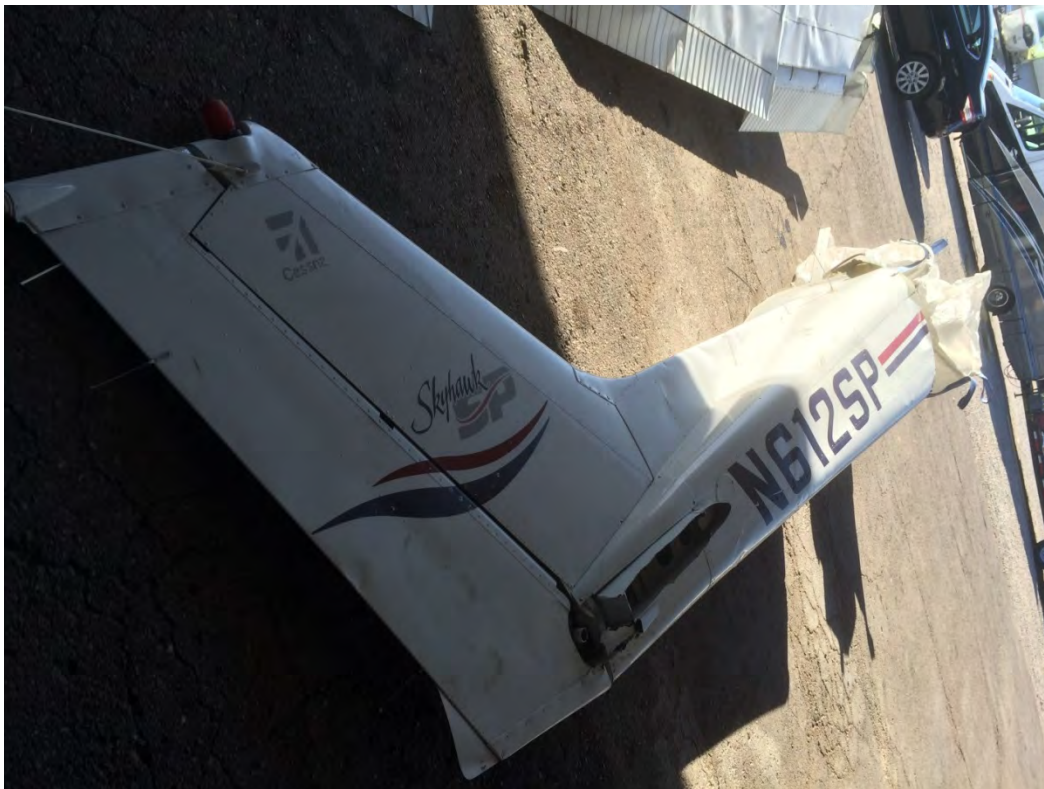
Photo 5 Vertical Stabilizer and Rudder

The horizontal stabilizers were removed near the root for recovery. The elevators remained attached to the horizontals at the hinge points. The stabilizer trim actuator measured 9/10", equating to an approximate 10-degree tab down position. The cockpit trim wheel assembly was impact damaged. The vertical stabilizer remained attached to the tailcone. The rudder remained attached to the vertical stabilizer. The aft fuselage separated from the forward fuselage at the aft end of the cargo compartment.

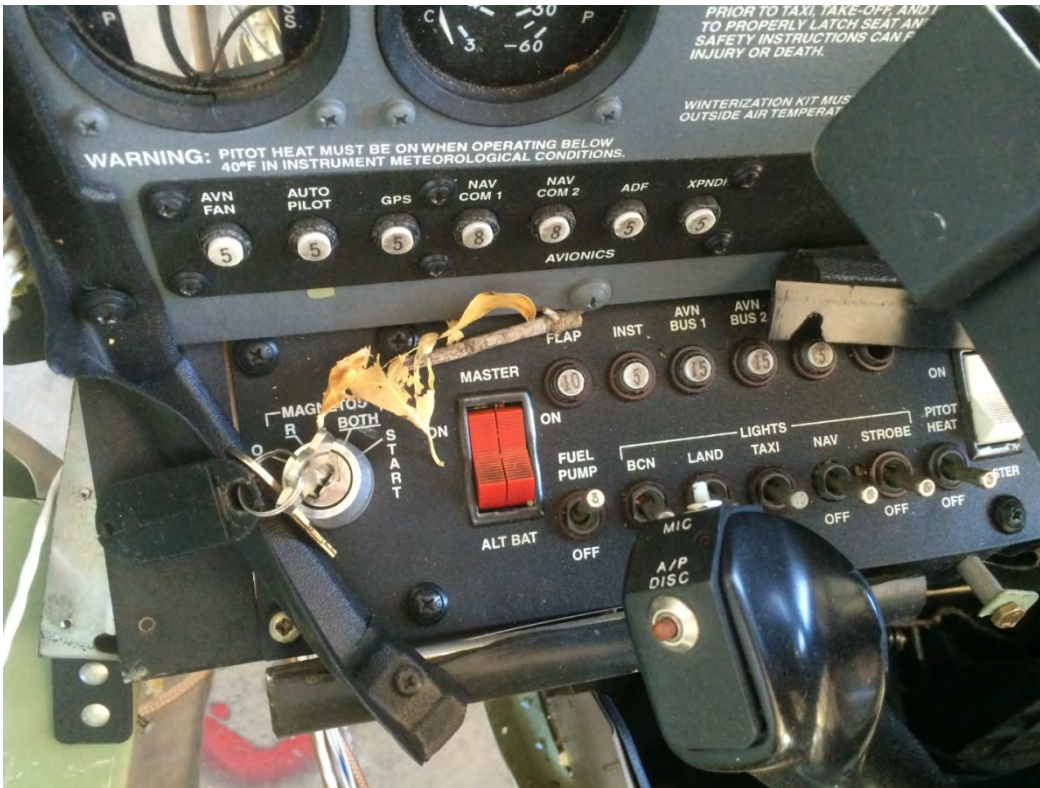
Photo 6 Lower Left Portion of Instrument Panel

The electrical master switch was in the ON position. The ignition switch was in the BOTH position with the key in the switch. The auxiliary fuel pump switch was in the ON position.

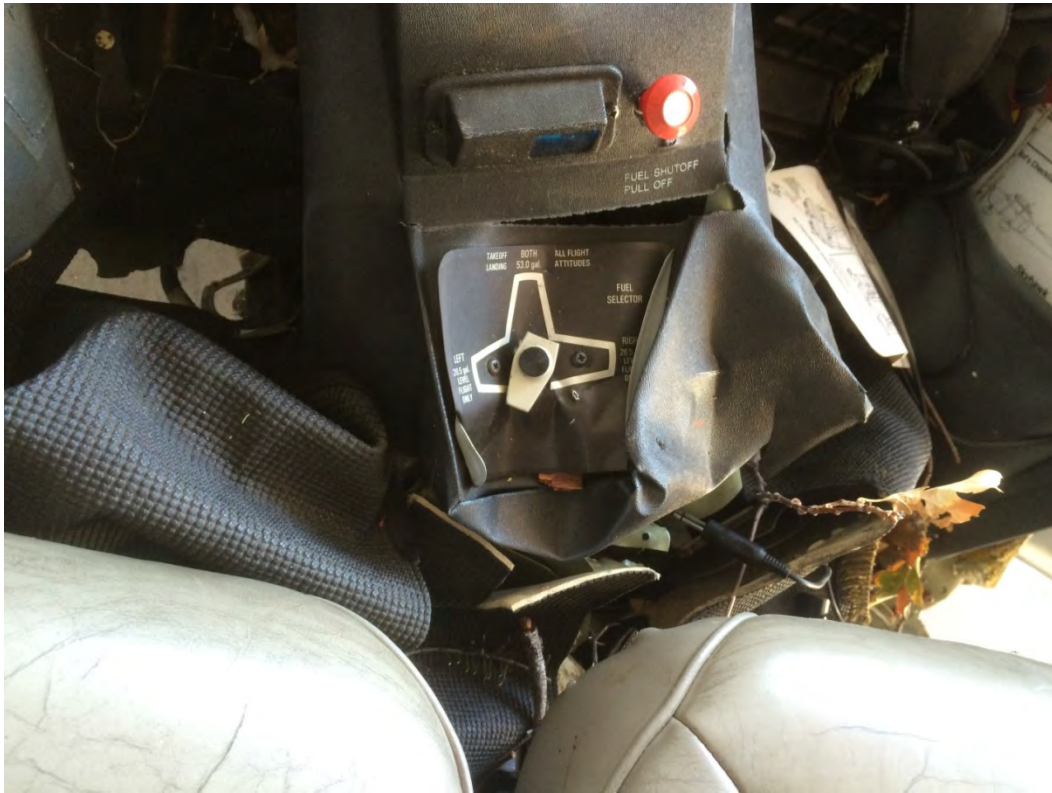
Photo 8 Fuel Selector Valve

There was a fuel shutoff valve on the center portion of the instrument panel that was in the forward position, which was OPEN. The fuel selector valve had three positions that were 90 degrees apart; left was LEFT, forward was BOTH, and right was RIGHT. The selector lever had partially broken off, and was pointing was to the 1-o'clock position. Investigators removed the valve, and determined that it was in the BOTH position. The mixture cockpit control was in the full forward position.

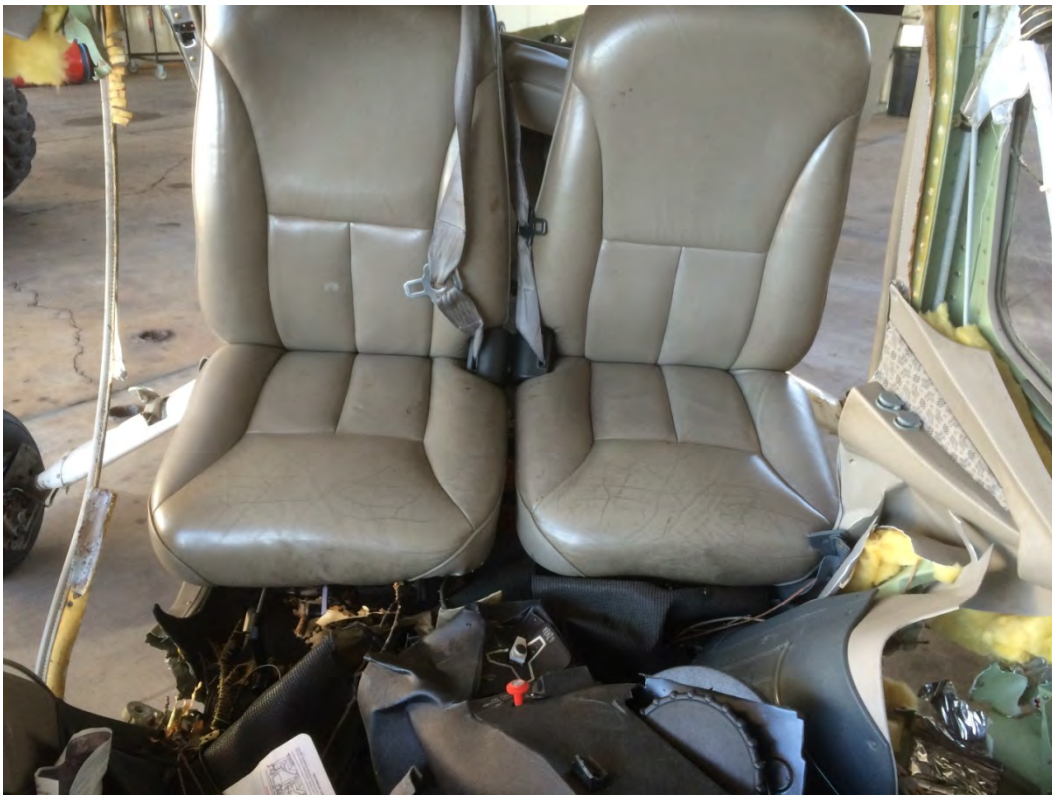
Photo 9 Front Seats

The front seats remained secured to the seat rails with the adjustment pins engaged in the 2nd holes back from the front of the track. The front seats were intact. The front seat belts were functional. The back seat belts were functional. The back seat back was pushed forward, and would not return to the normal upright position due to crushing damage. The rear seat base was intact.

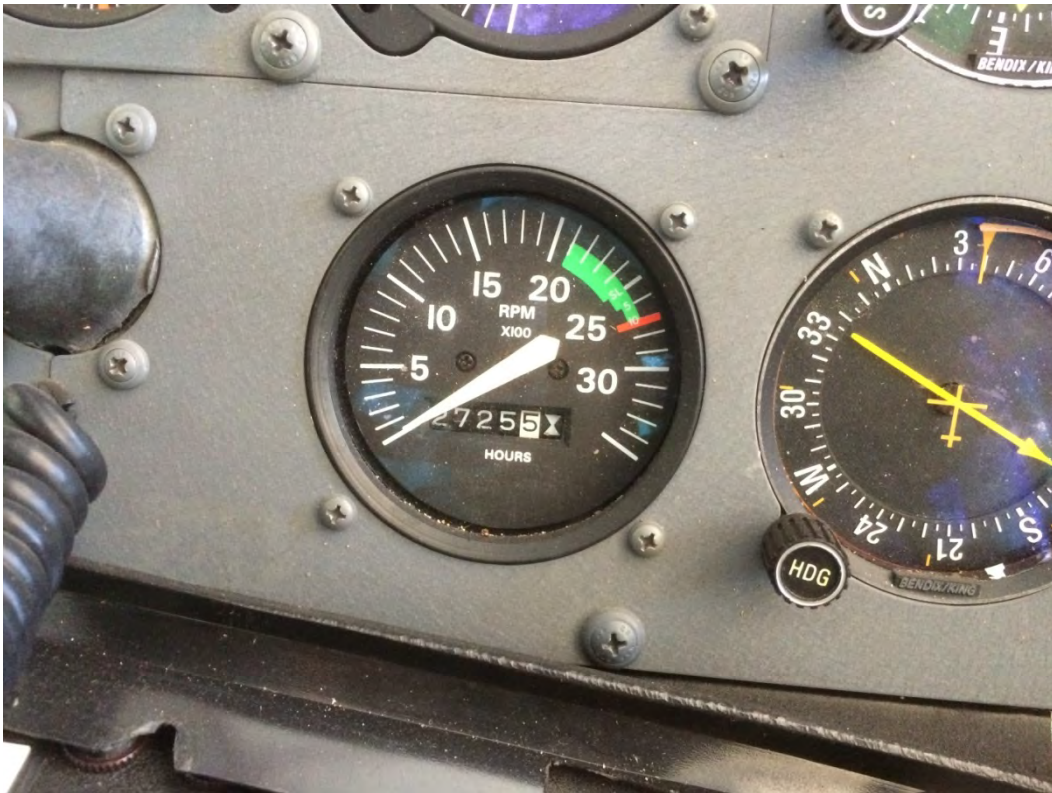
Photo 11 Tachometer

The tachometer read 2,725.5; the Hobbs hour meter read 3,509.6.

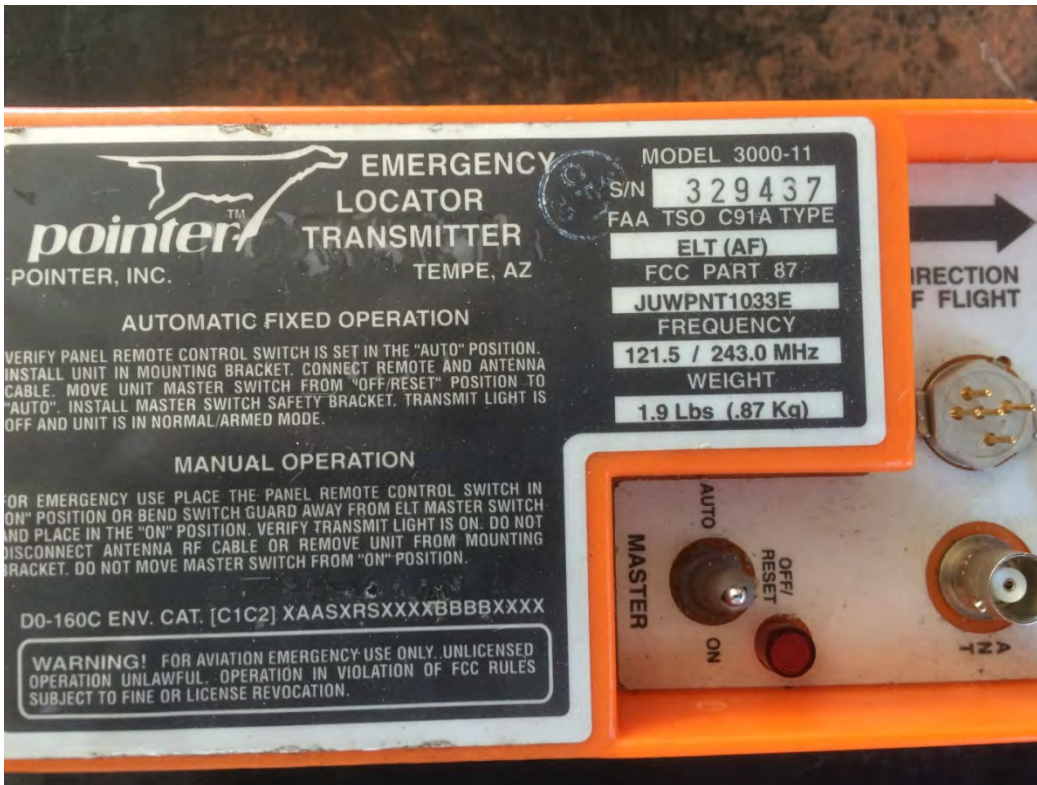
Photo 12 Emergency Locator Transmitter

The emergency locator transmitter (ELT) was a Pointer 3000-11, serial number 329437, TSO C-91a. The ELT was in the ARMED position.

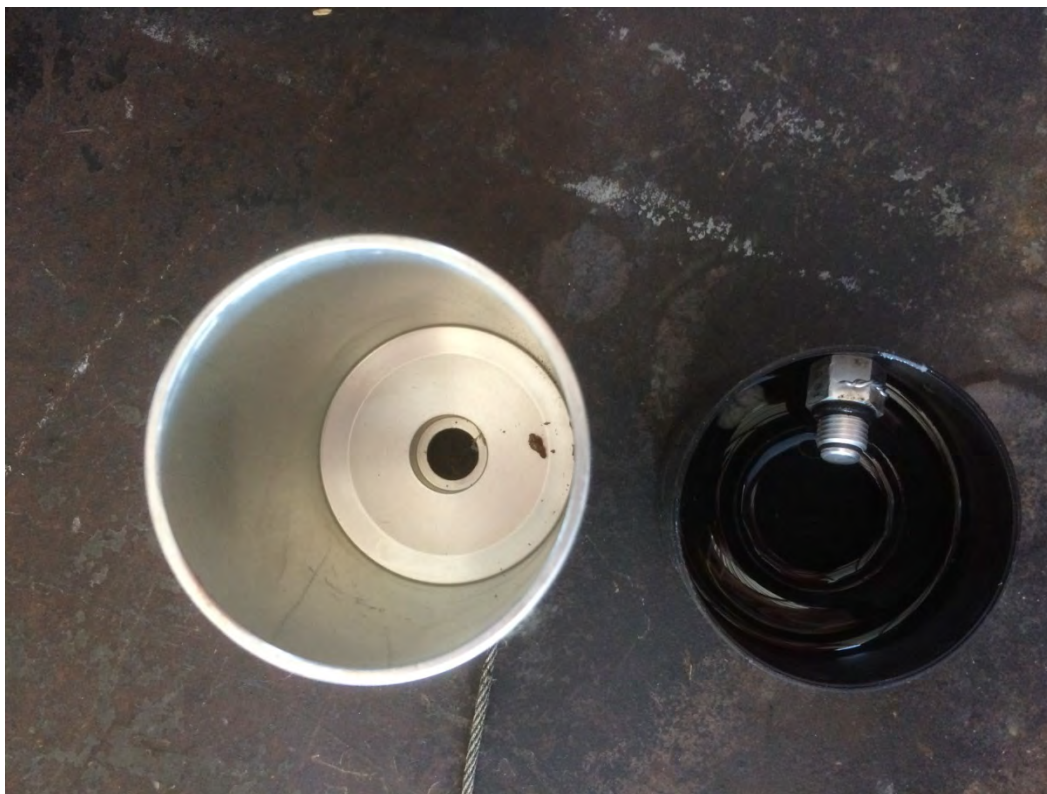
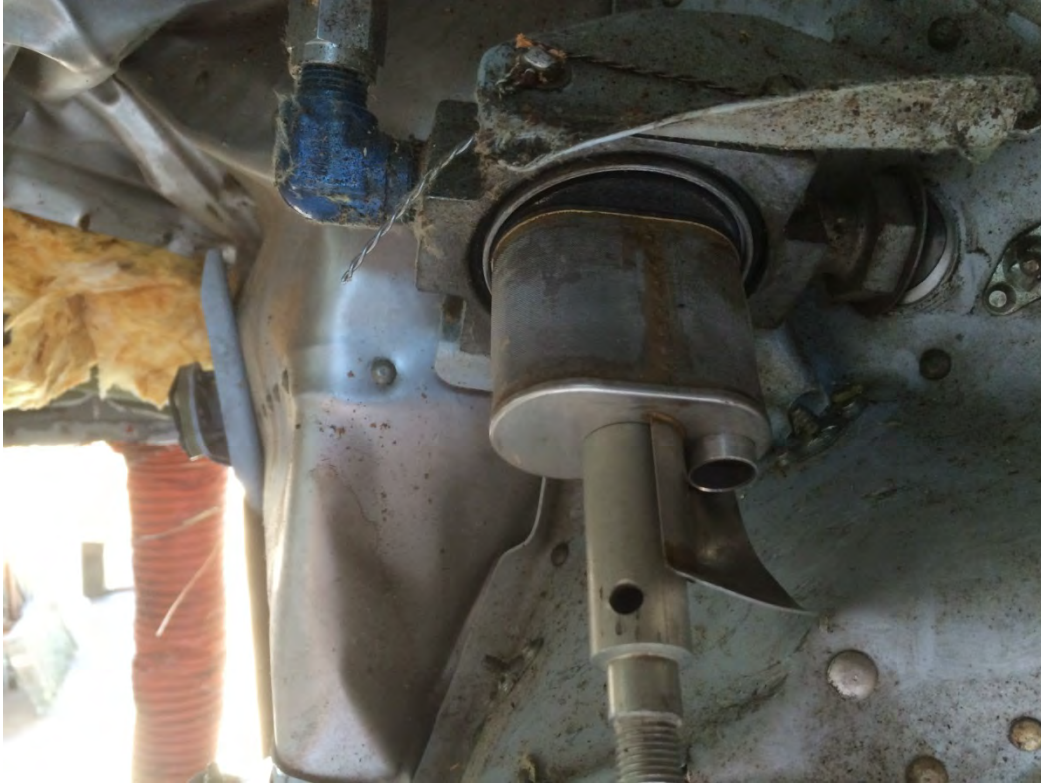
The gascolator contained a clear blue fluid that smelled like aviation gasoline; a water paste test had no response indicating that there was no water contamination. The screen was clean.

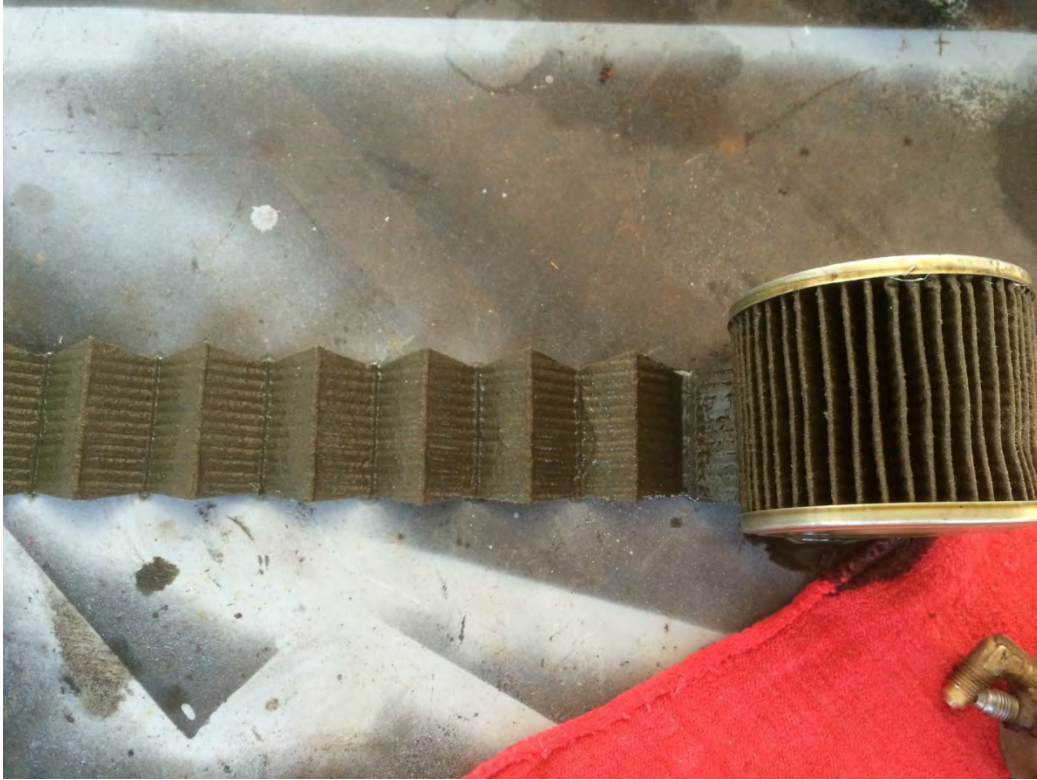
Photo 22 Oil Filter Element

The oil filter was disassembled, and the paper element was clean.

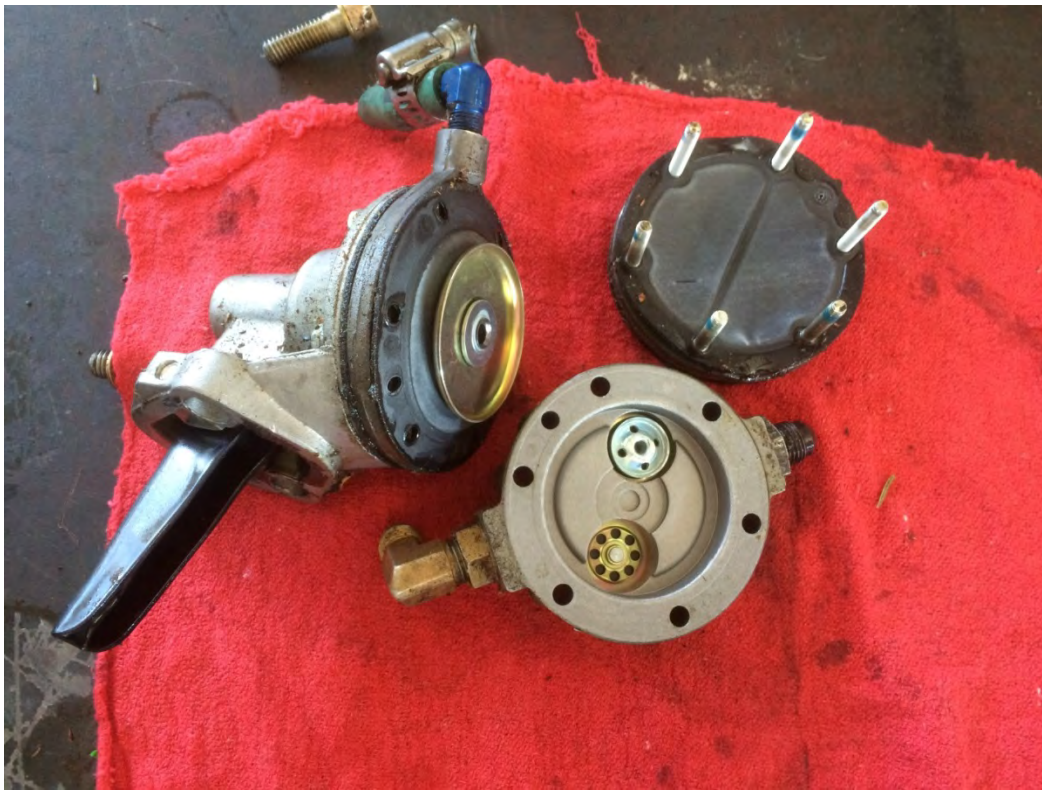
Photo 23 Fuel Pump

The fuel pump's rubber diaphragm was unbroken.

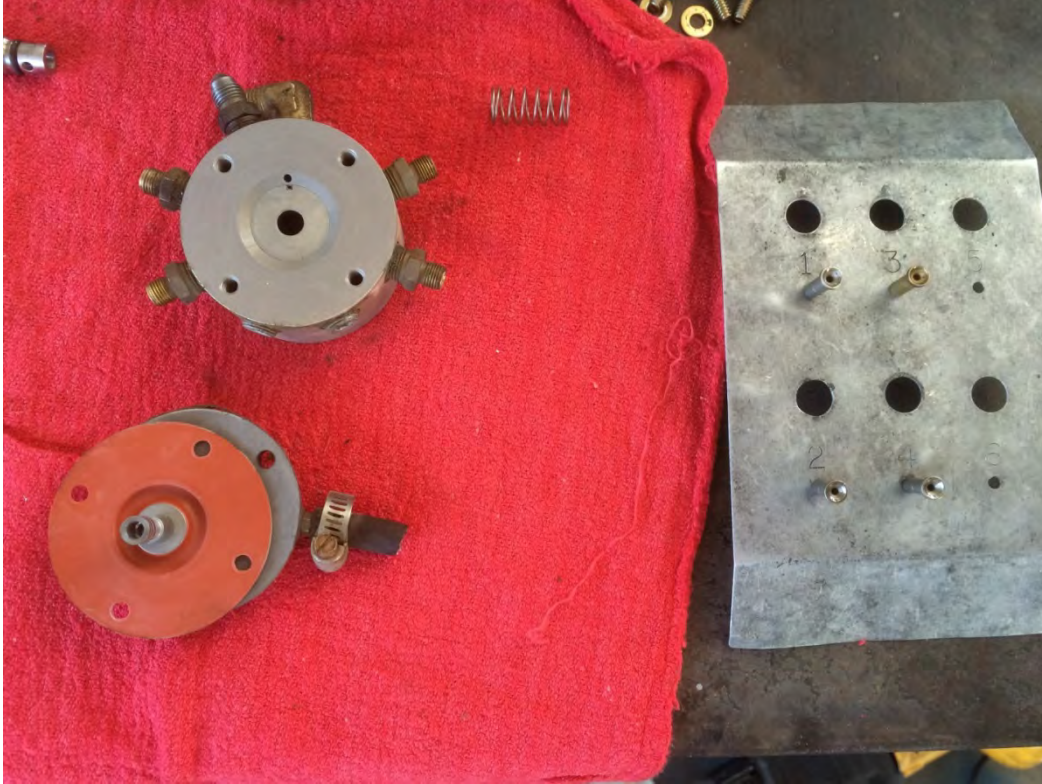
Photo 24 Fuel Distribution Valve

The flow divider's rubber diaphragm was flexible and not cracked; the nozzles were clear.

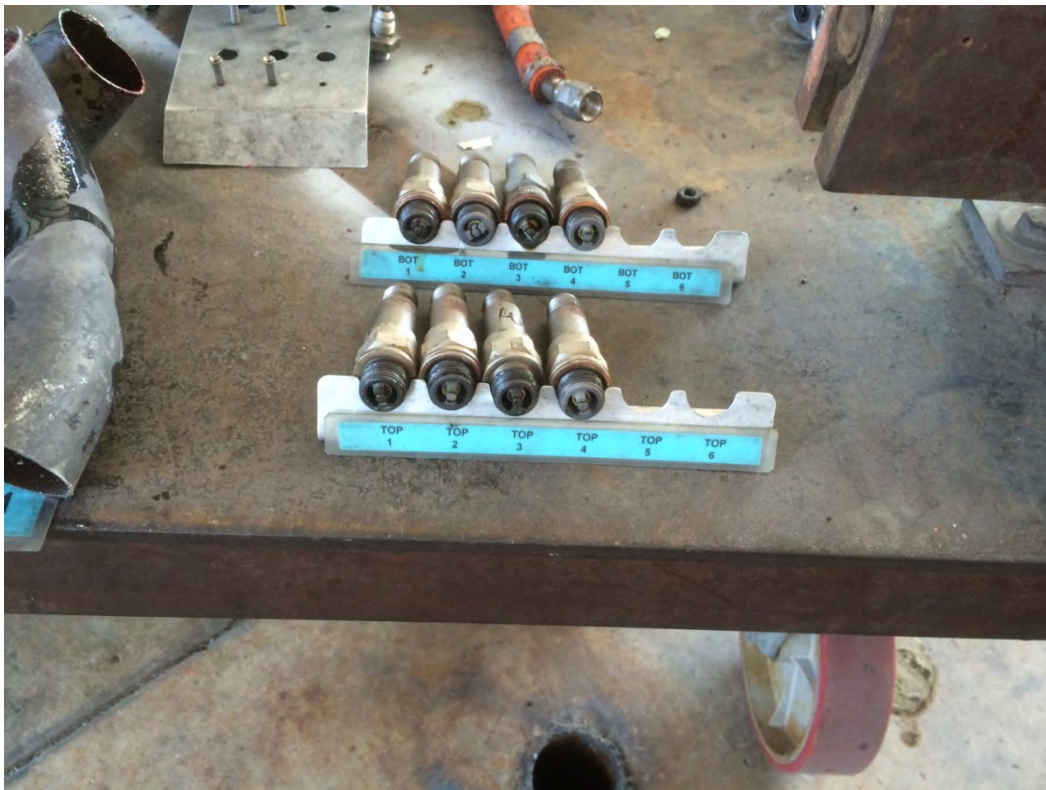
Photo 25 Spark Plugs

Investigators removed the spark plugs. The center electrodes were circular for the top and bottom of cylinder number one and top number three; they were elliptical in the remaining positions. The plugs for cylinders number one and three were oil soaked; the airplane was on its right side for several days prior to recovery. The plugs for cylinders number two and four were clean and gray, which corresponded to normal operation according to the Champion Aviation Check-A-Plug AV-27 Chart. None of the electrodes exhibited mechanical deformation.

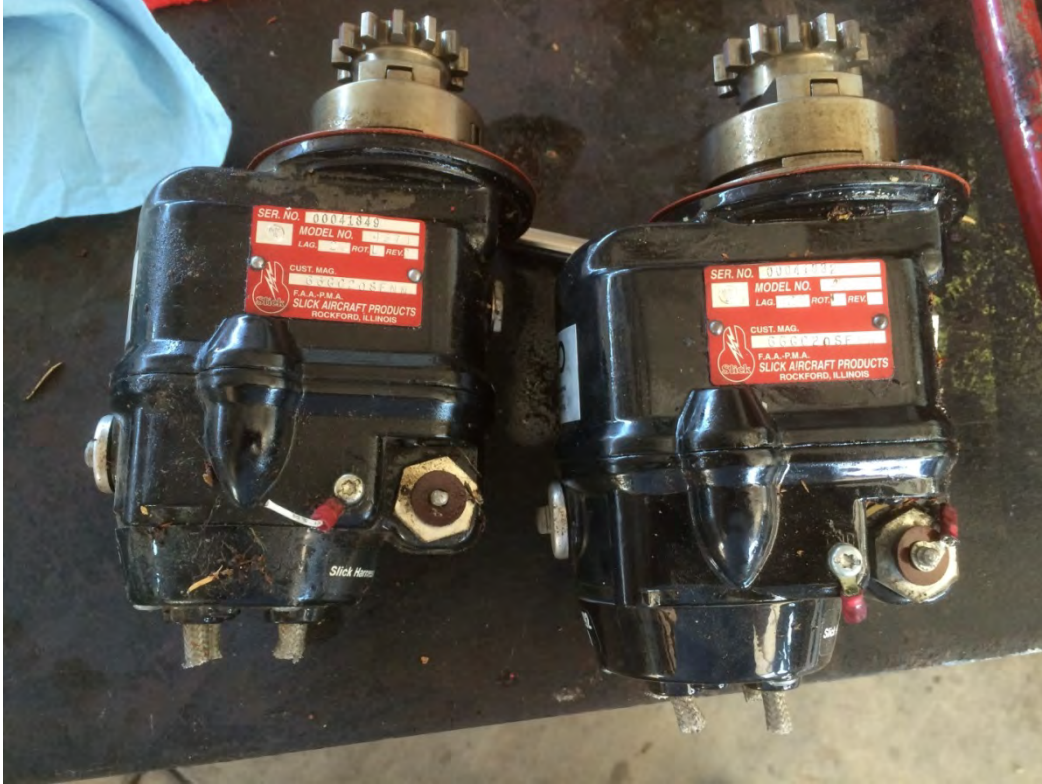
Photo 26 Magnetos

The right magneto was a Slick 4371, serial number 00041849; the left magneto was a Slick 4371, serial number 00041832. The engine to magneto timing was 25 degrees before top dead center. Investigators manually rotated the magnetos, and both magnetos produced spark at all posts.

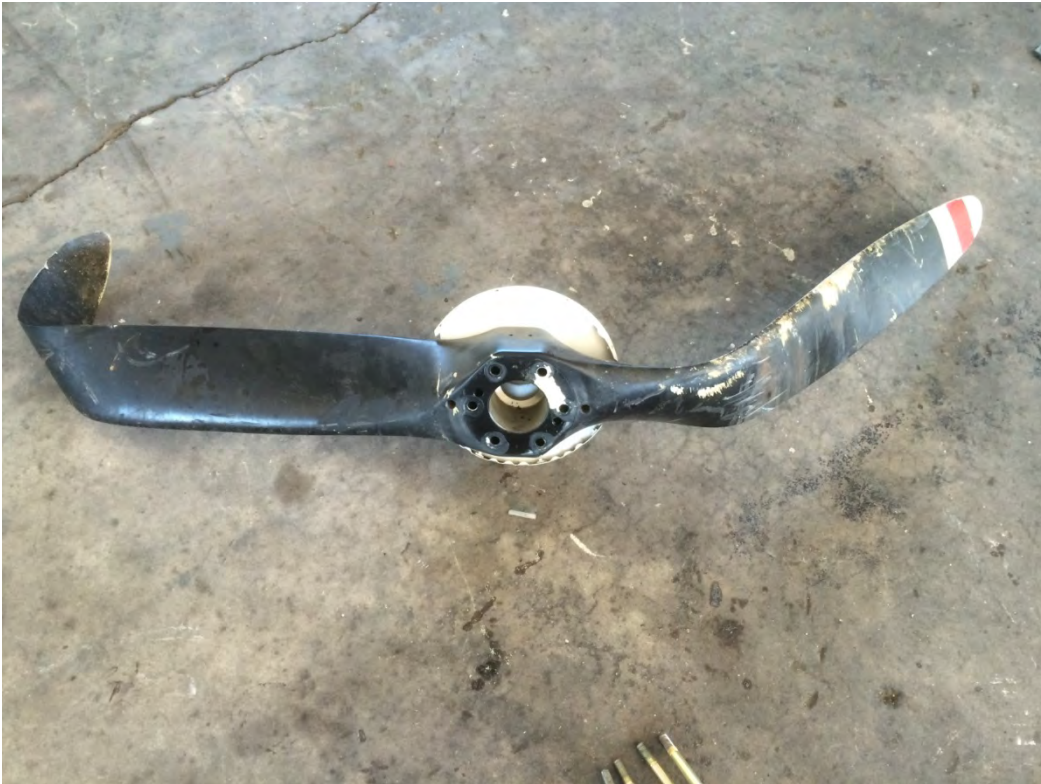
Photo 27 Propeller

The blades were bent and twisted. Both blades exhibited leading edge gouges and chordwise striations.
