NATIONAL TRANSPORTATION SAFETY BOARD

AIRFRAME AND ENGINE EXAM REPORT

WPR16LA078

Aircraft: Boeing A75N1 (PT17), Registration Number: N63555, Serial #: 75-8914

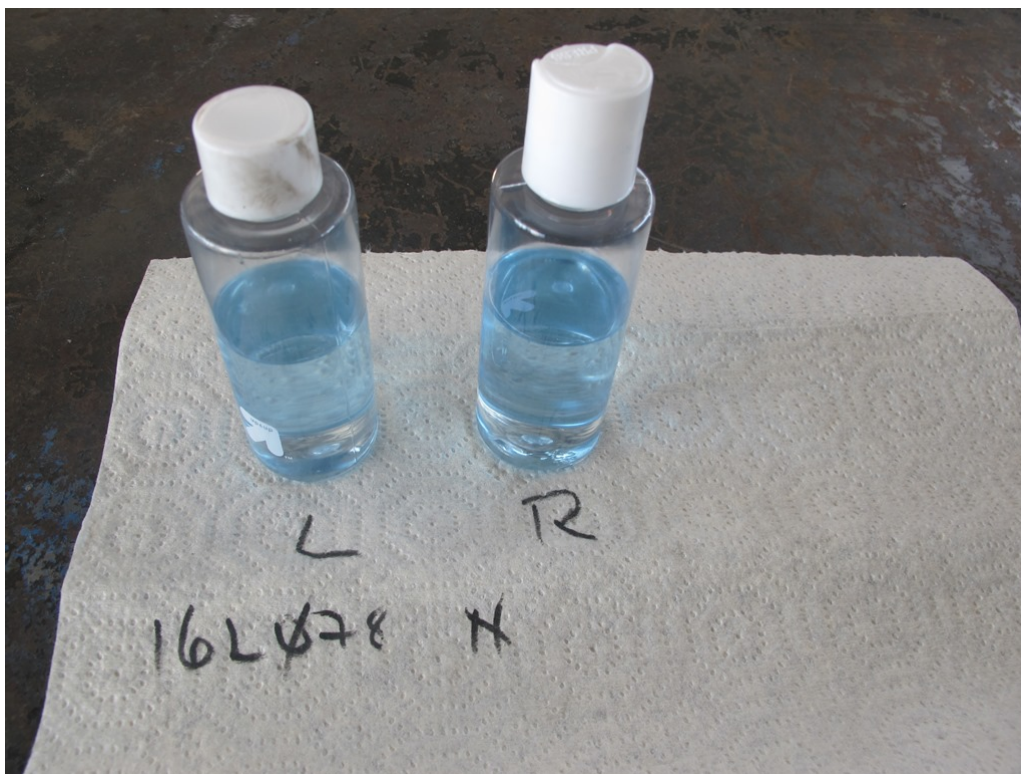
Photo 1 Samples from Fuel Drains

Blue fluid that smelled like aviation gasoline was drained from the left and right fuel drains from the wing fuel tank. There was no visible contamination.

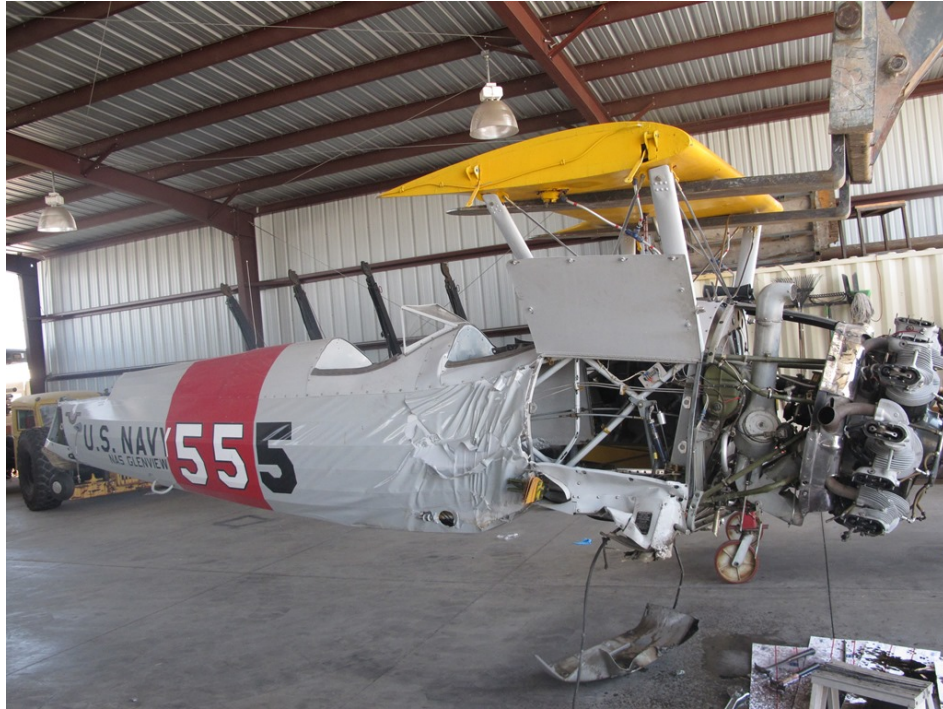
Photo 2 Right Side of Fuselage

The forward end of the fuselage sustained crush damage around the front cockpit. The throttle lever in the cockpit would not move due to the damage; all linkages were connected from the cockpit to the carburetor. The mixture lever in the cockpit would not move due to the damage; all linkages were connected from the cockpit to the carburetor.

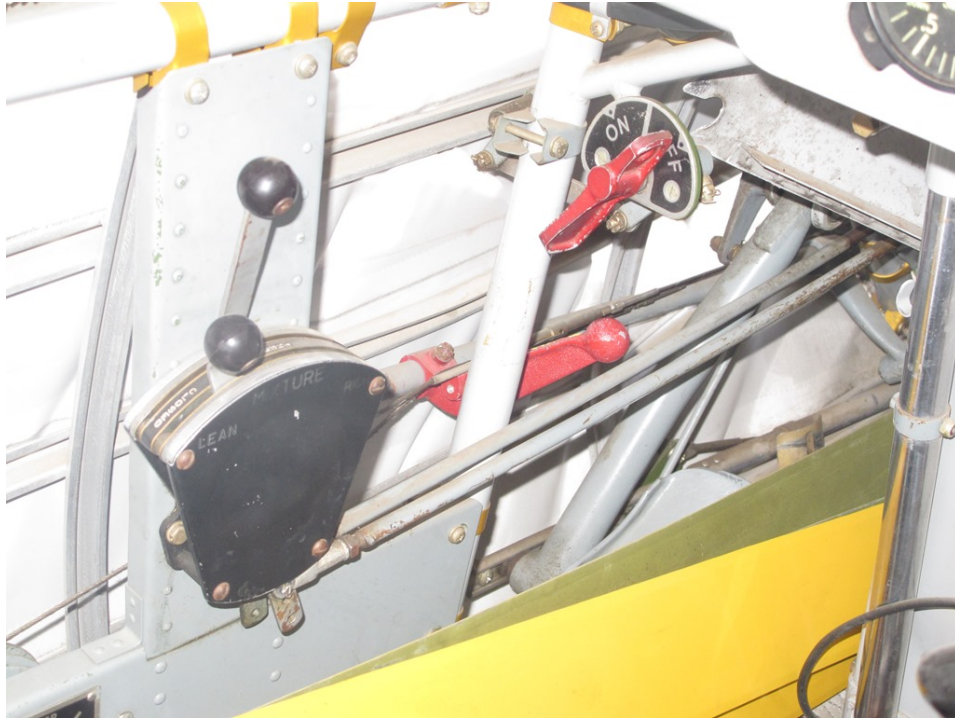
Photo 4 Throttle Quadrant and Fuel Selector Valve

The fuel selector valve was very stiff due to damage in the cockpit area, but could be moved.

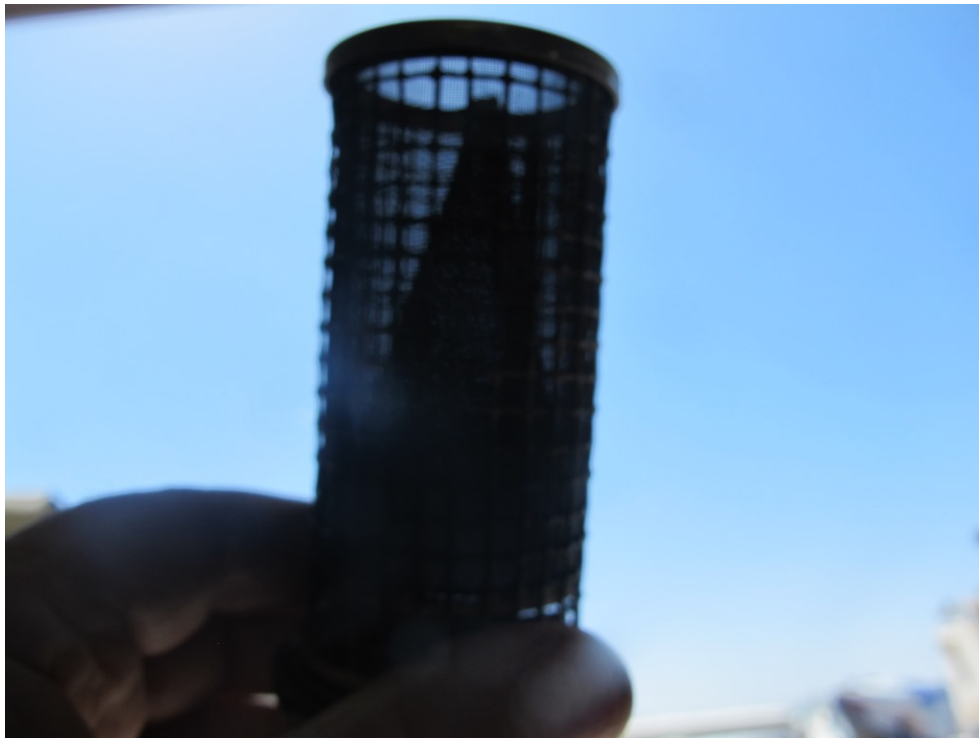
Photo 5 Gascolator Screen

The gascolator was removed and disassembled; it contained a clear blue fluid that smelled like aviation fuel. The screen was clear.

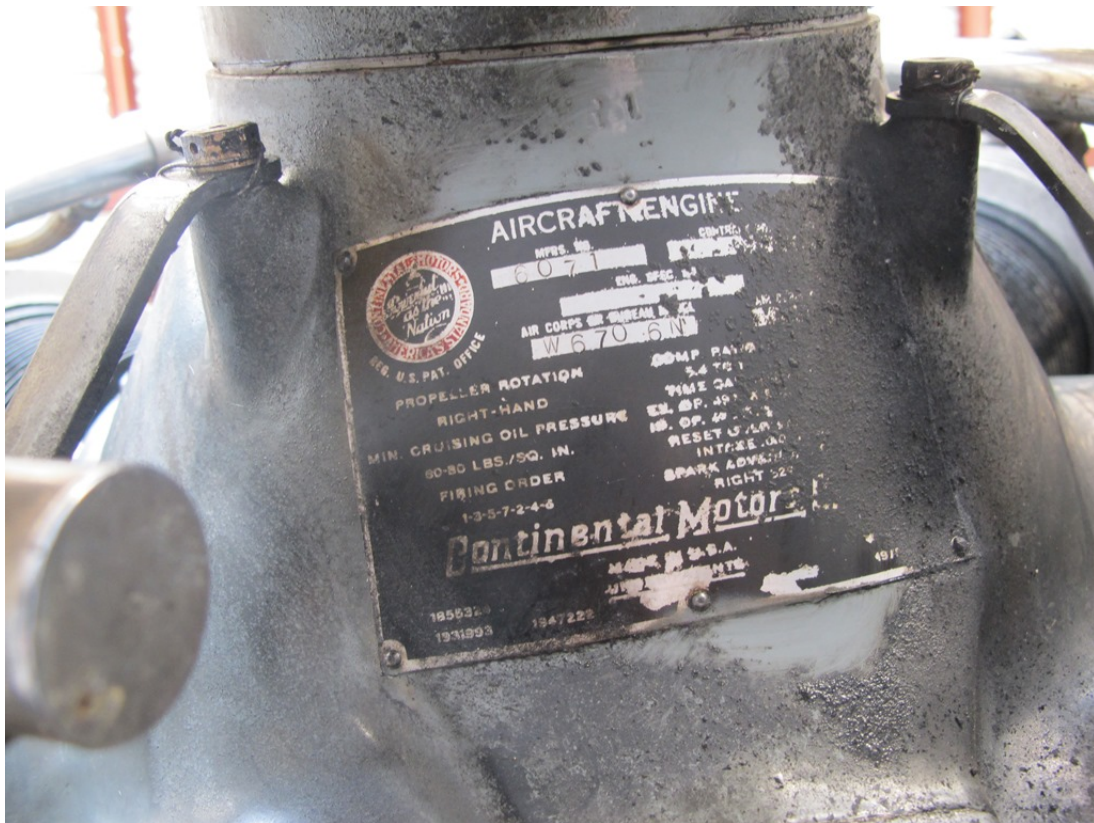
Photo 6 Engine Dataplate

The engine was a Continental Motors W670 6N, serial number 6071.

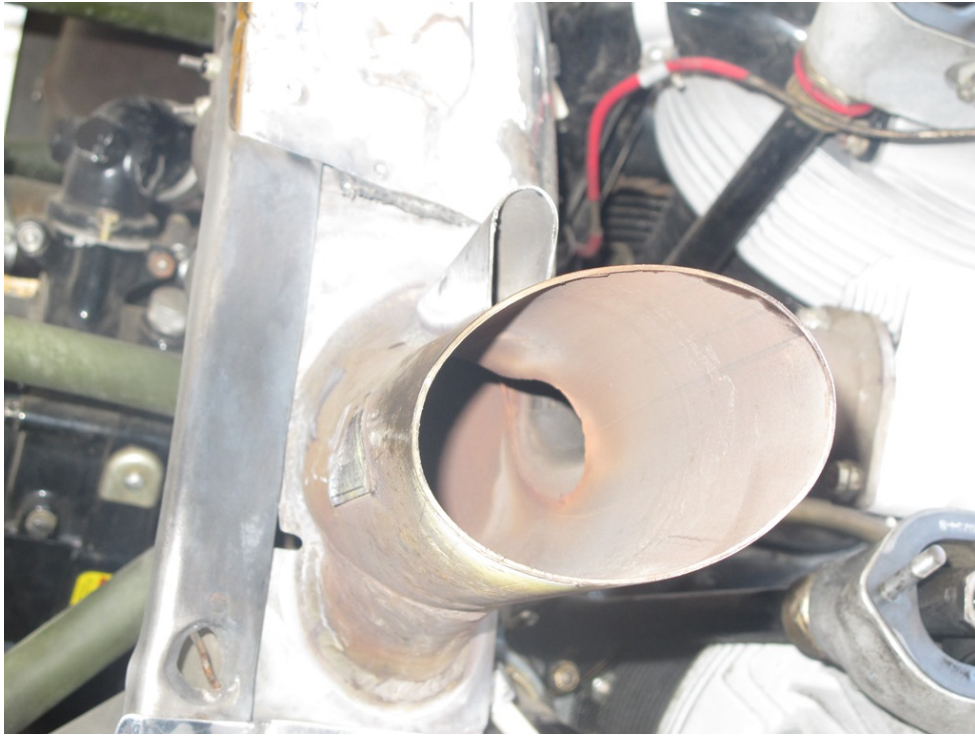
Photo 7 Exhaust Tube

The exhaust tube coloration was light brown.

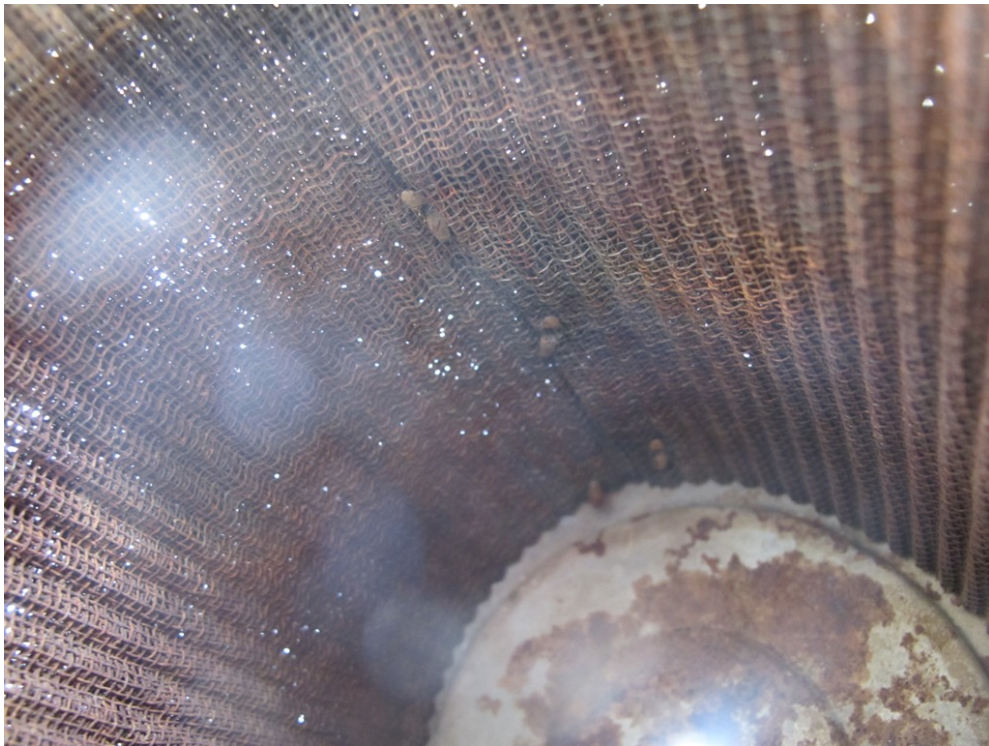
Photo 8 Air Filter

The air filter was clean. There was no discoloration in the intake tube at the filter.

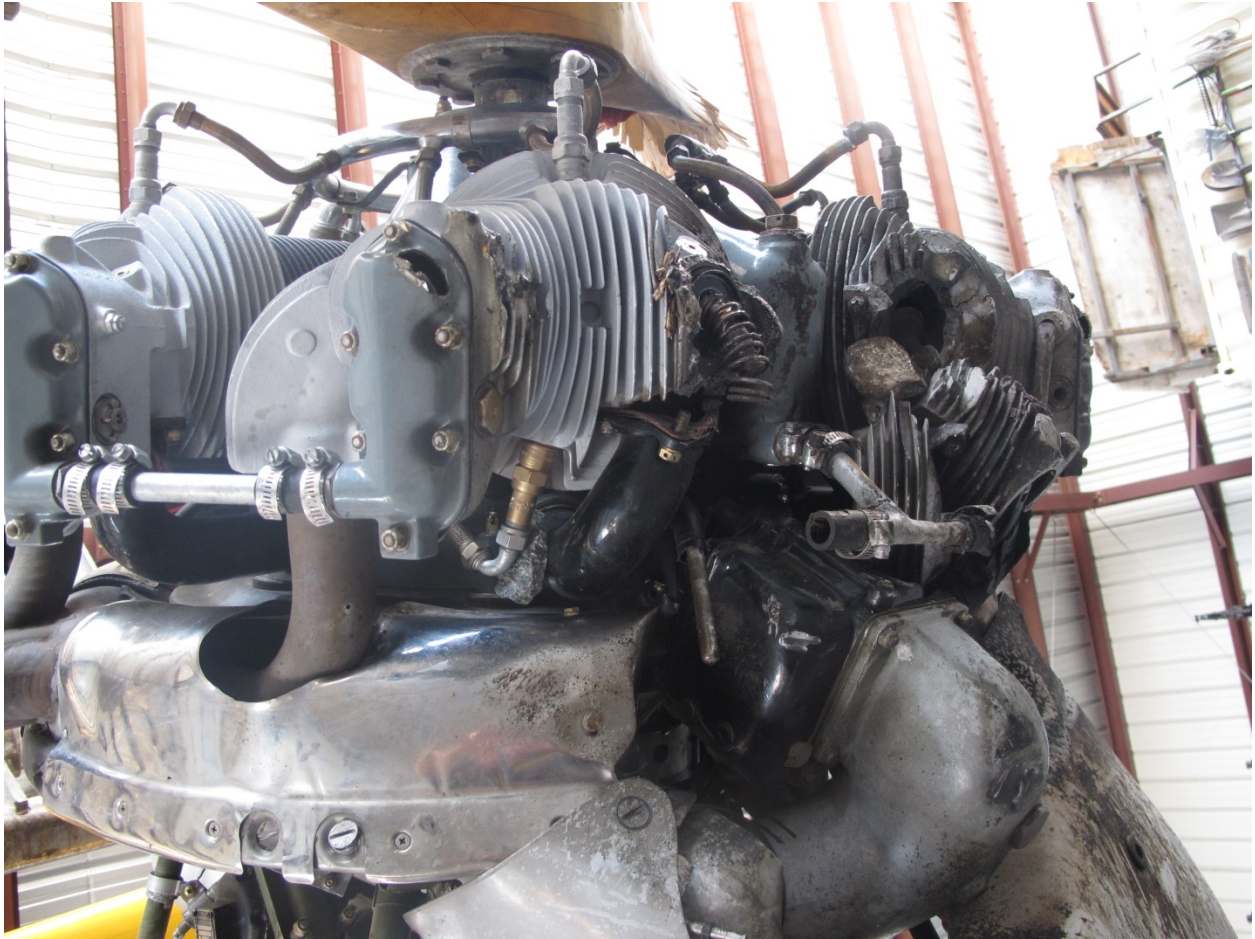
Photo 9 Bottom of the Engine

The bottom two cylinders (four and five) sustained aft crush damage. The exhaust head for cylinder number four sustained crush damage, and fractured and separated; the exhaust push rod for was bent and displaced. The head for cylinder number five was crushed aft and separated.

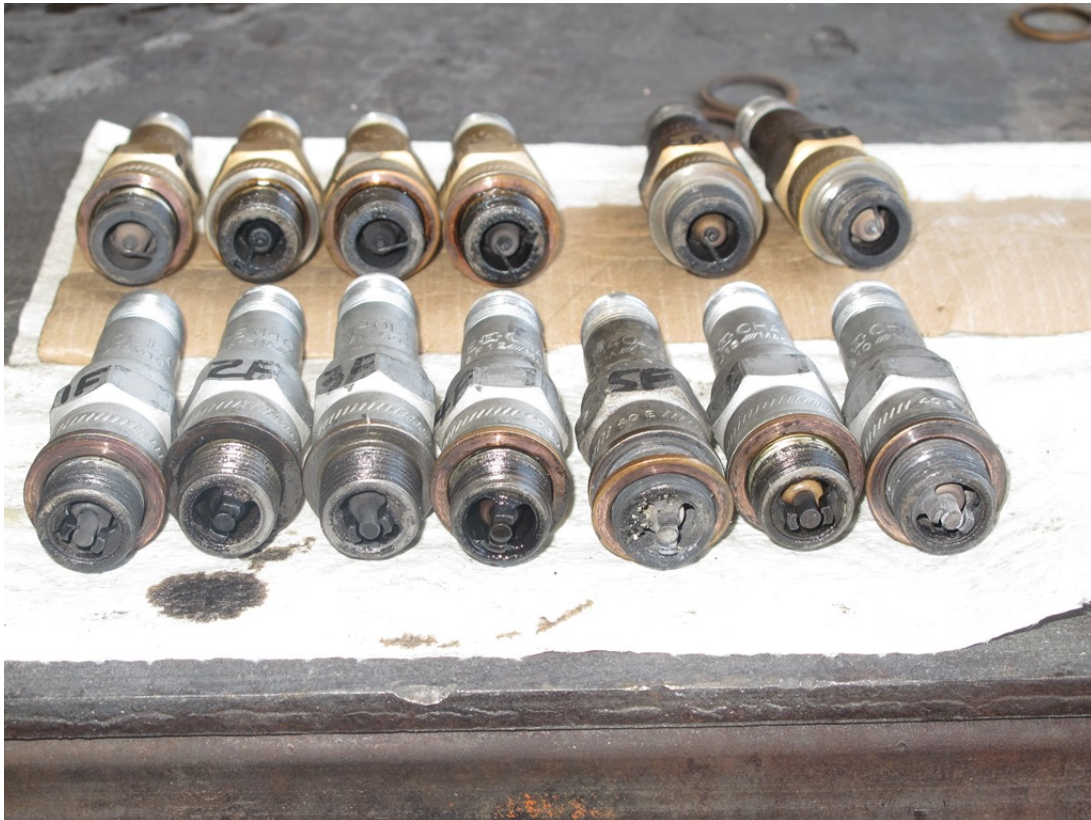
Photo 10 Spark Plugs

The front spark plugs were Champion REM 40-E. All center electrodes were circular with no mechanical deformation. Number four (on bottom of engine) was oily. Number five (on bottom) contained gravel; the cylinder had been breached, and dragged on the ground. The remaining spark plug electrodes were gray, which corresponded to normal operation according to the Champion Aviation Check-A-Plug AV-27 Chart.

The back spark plugs were Champion fine wire REM 38-E. All center electrodes exhibited similar wear with no mechanical deformation. The spark plug electrodes were gray, which corresponded to normal operation according to the Champion Aviation Check-A-Plug AV-27 Chart.

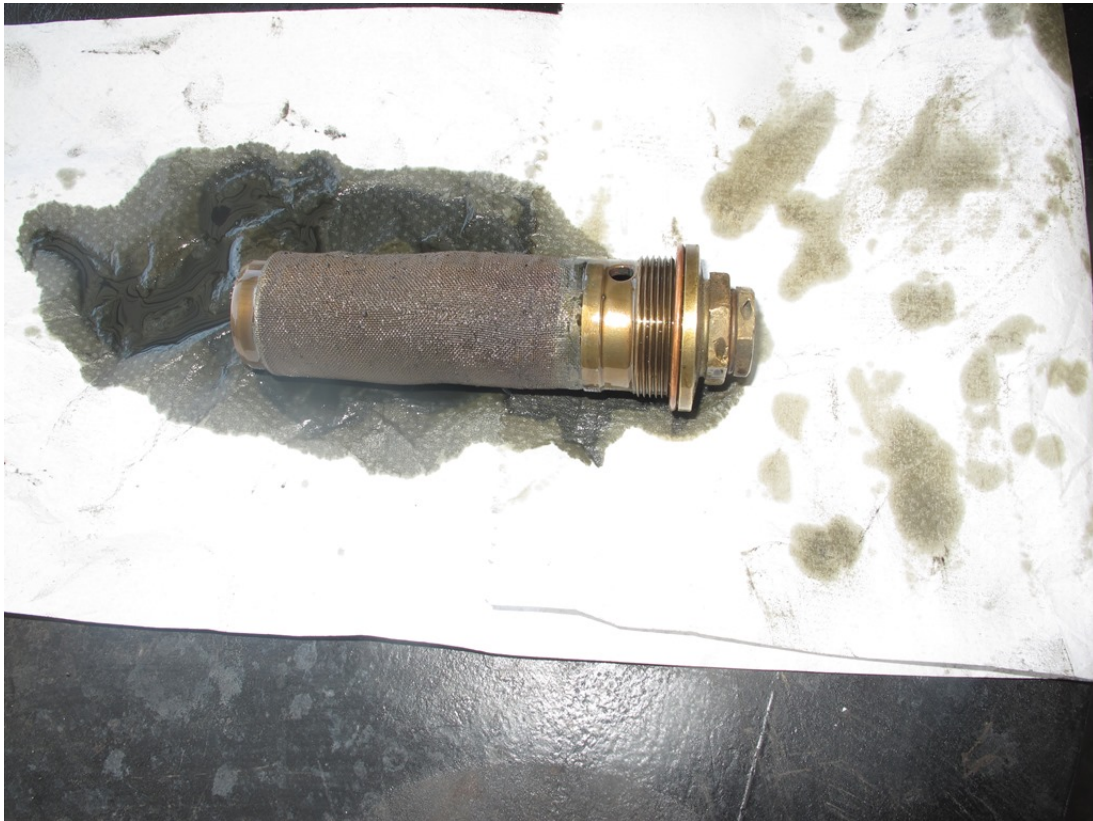
Photo 11 Oil Screen

The oil screen was clean.

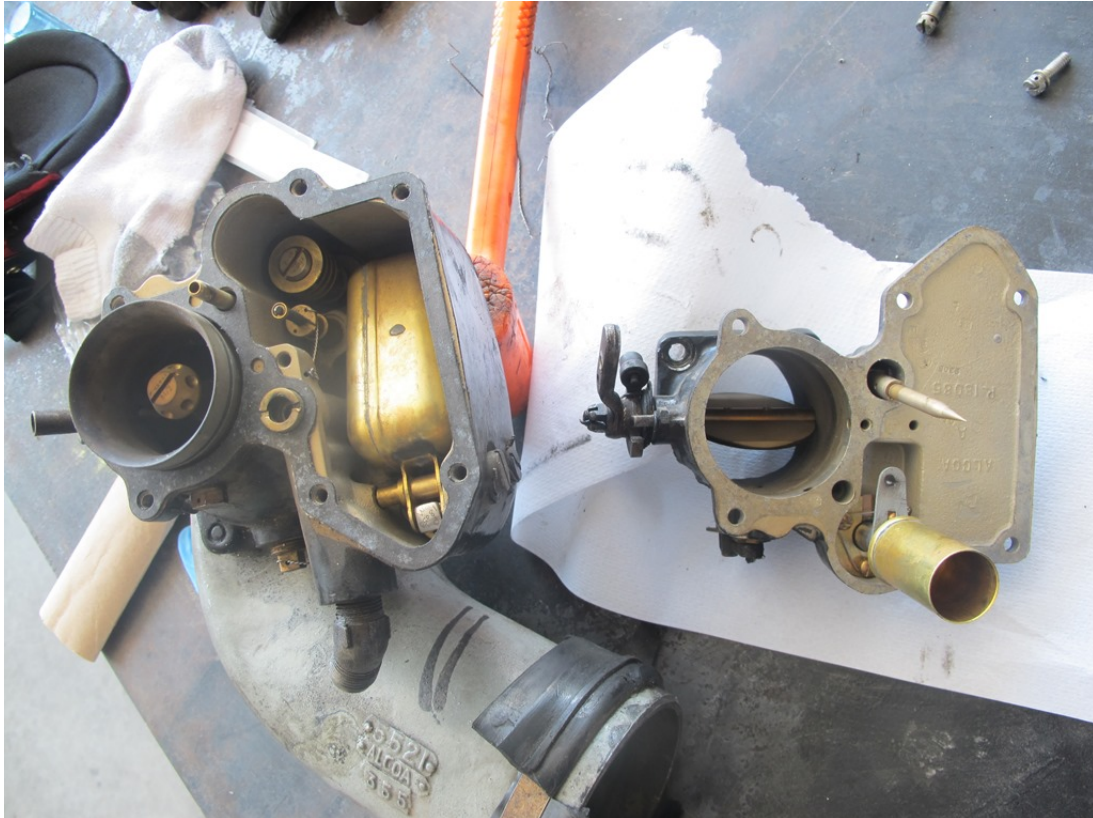
Photo 12 Carburetor

Investigators removed and disassembled the carburetor. The floats were metal; the bowl contained no fluid. The accelerator pump operated without resistance. The throttle lever would not move; the housing was crushed; the butterfly valve was almost vertical (fully open). The mixture lever moved freely from stop to stop.

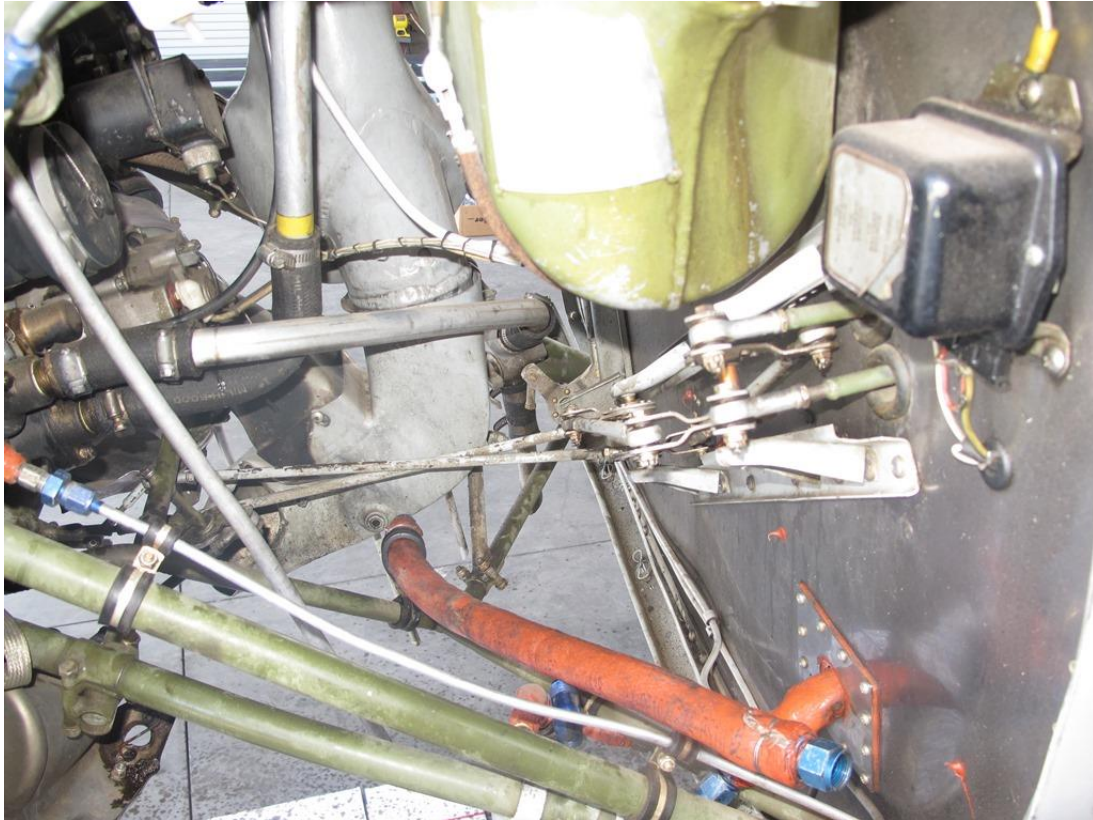
Photo 13 Fuel Line from Gascolator to Carburetor

Investigators removed the fuel line from the gascolator to the carburetor, and nothing drained out from the line. Investigators then connected the line back to the gascolator, and turned the fuel selector valve on. Blue fluid came out of the line. Investigators removed the line again to look through it, and observed an obstruction near one end of the line. They removed the firesleeve on the hose, and observed that the hose went into the fitting at a slight angle that was not visible with the firesleeve in place. Investigators cut the line close to the obstruction. The inner surface of the hose appeared cut, and curled into the hose at the fitting.

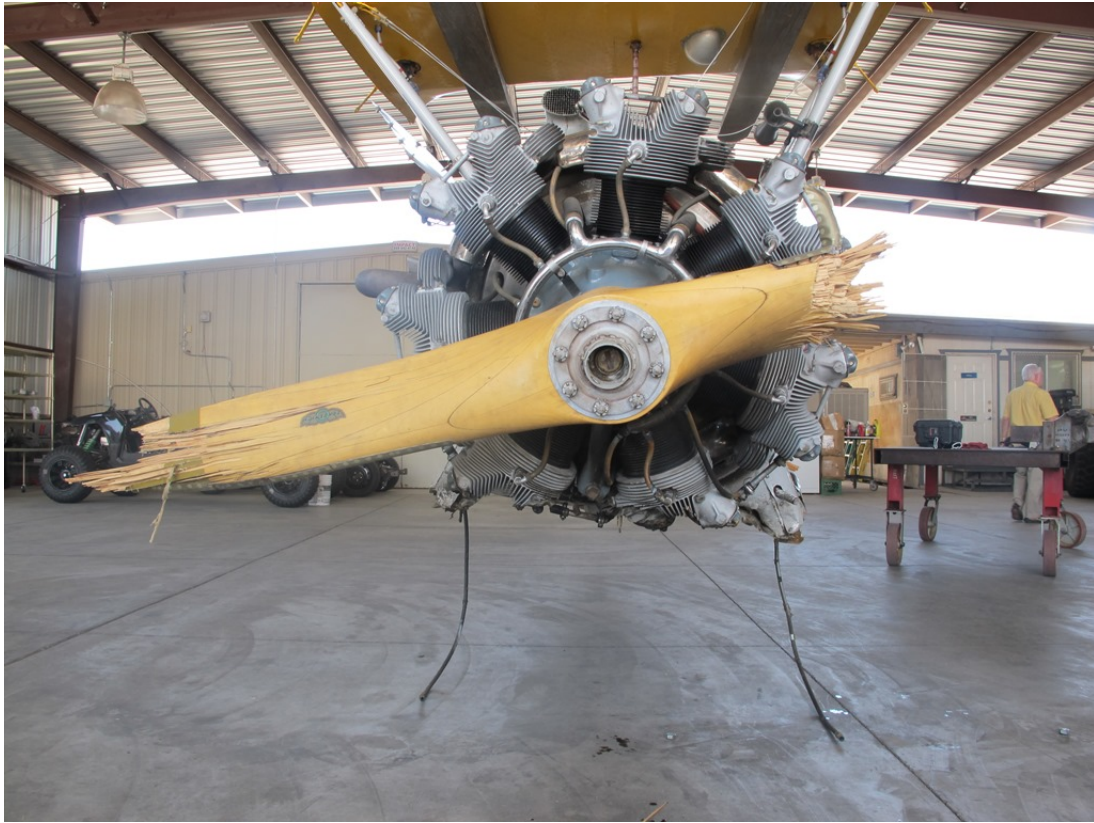
Photo 18 Propeller

The propeller was a two-bladed wooden Sensenich W98AB-66. Both blades fractured along jagged angular planes.
