NATIONAL TRANSPORTATION SAFETY BOARD

AIRFRAME AND ENGINE EXAMINATION

WPR16FA002

Location: Cedar City, Utah
Date: October 3, 2016
Aircraft: Cessna 152, Registration Number: N6449M, Serial #: 15284733
NTSB IIC: Patrick H. Jones

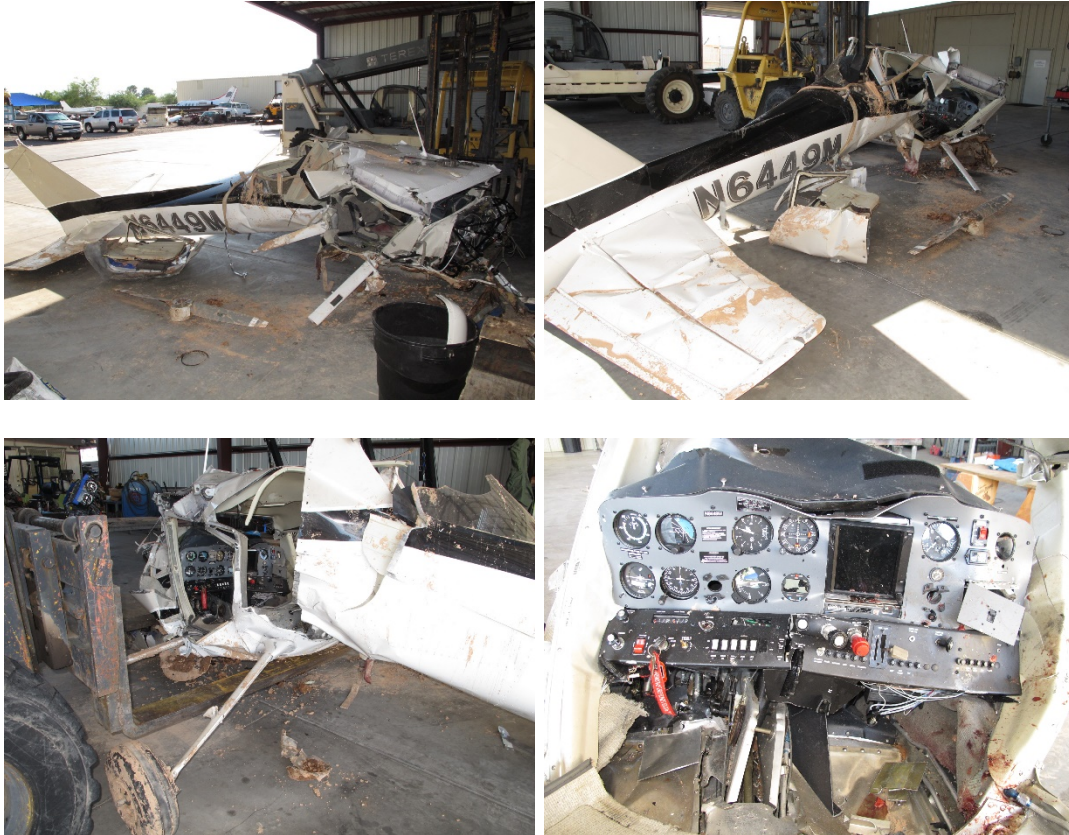
1.1 Airframe Exam Photos

The aircraft impacted the ground with the belly and came to rest upright. There were no ground impact marks around the aircraft to indicate any forward momentum. The outboard right wing leading edge exhibited tapering compression damage. The left wing was canted forward and the right wing was canted aft.

All primary flight control surfaces and major system components were identified and located at the wreckage site prior to the wreckage being recovered. The aileron and flap cables were cut by recovery personnel at the wing roots.

The aircraft was equipped with standard fuel tanks (26 gallon capacity) and it was fueled with 14 gallons of 100LL before the flight the operator calculated based on previous flight records that the airplane departed with a total of 23 gallons. The left and right fuel tanks punctured the bottom of the wings. Both fuel tanks exhibited hydraulic deformation in a downward direction and were breached. First responders reported fuel dripping from both wings at the site.

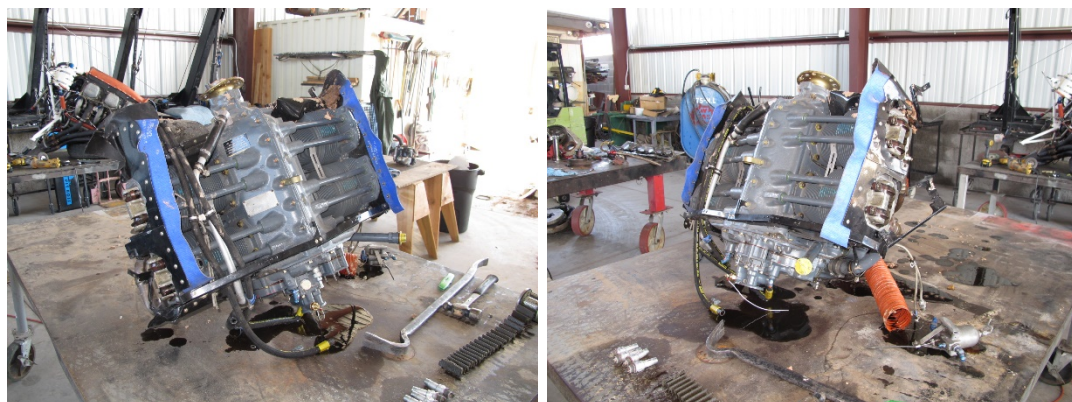
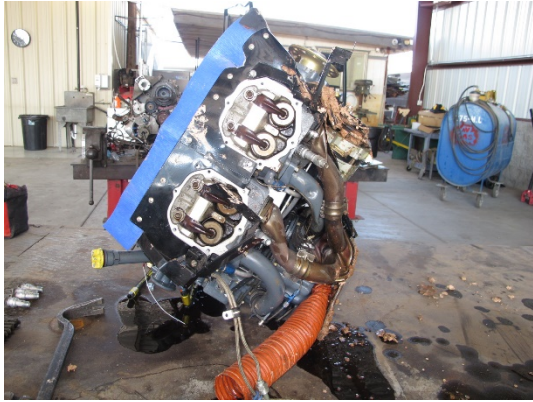
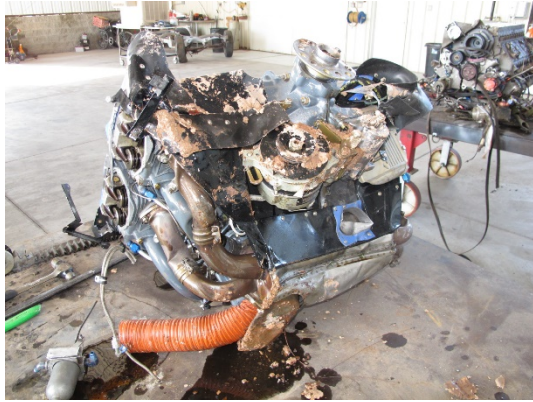
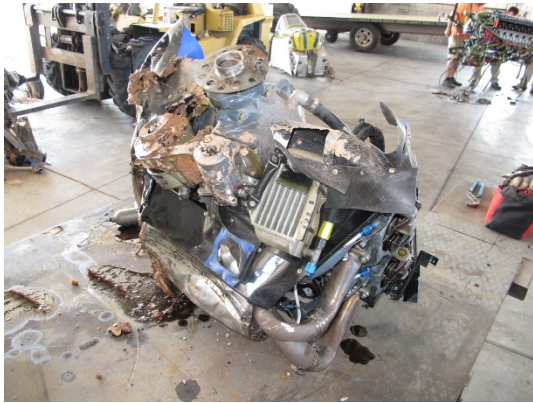
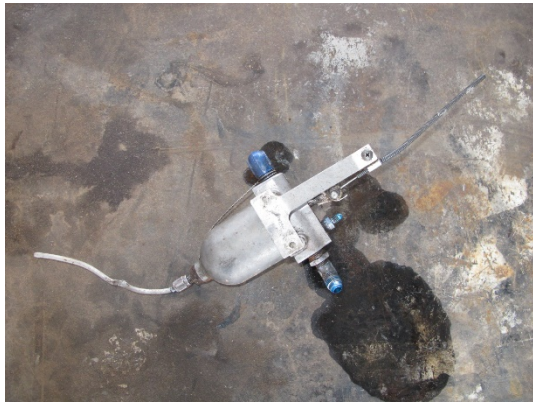
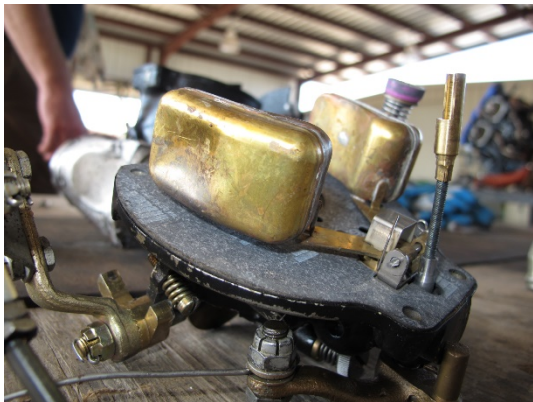
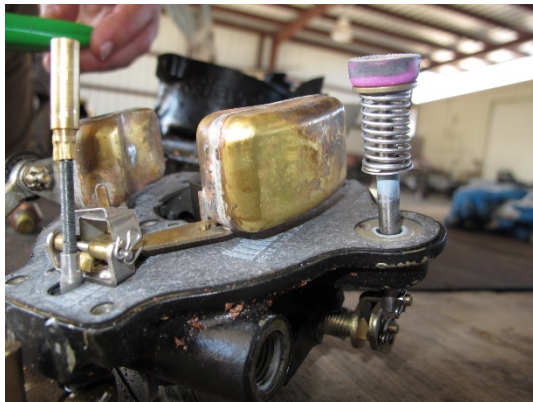
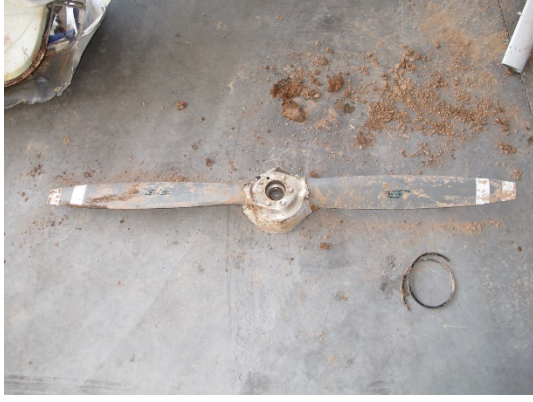
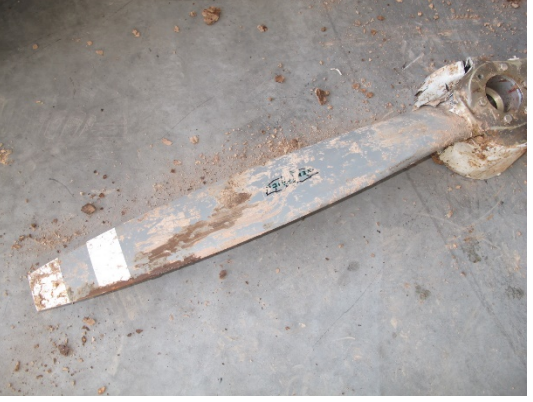
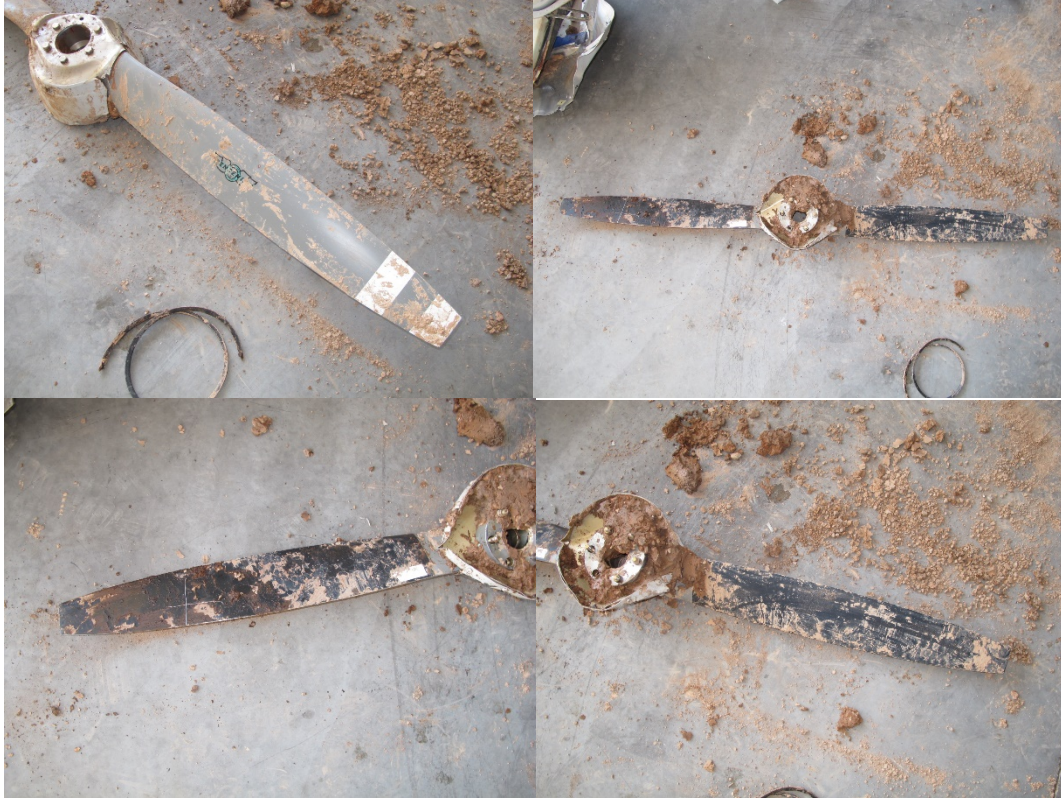
2.1 Engine Exam Photos

Engine compression and valve train continuity were established. The magnetos produced spark at all leads. The top spark plugs appeared new. The carburetor was disassembled and a trace amount of fuel was observed which tested negative for water. One float exhibited hydraulic deformation. The fuel strainer bowl was full of fuel which also tested negative for water and the strainer screen was clean.

The carburetor was impact displaced and was imbedded in the left side lower firewall. It was removed and examined. It was observed fractured radially at the throttle plate. The float bowl was removed and approximately 10 drops of fuel was observed, it was tested using Kolor Kut water disclosing paste, with negative results.

Hydraulic deformation was observed on one of the floats. All fuel lines were empty of any liquid.

The gascolator was secure on its mount. It was removed and examined, fuel was observed, it was tested using Kolor Kut water disclosing paste, with negative results.

The inlet fuel screen was removed and was observed free of contaminants.

Both magnetos were secure on their respective mounts. The engine was rotated by hand using a turning tool inserted into the vacuum pump drive pad, both magnetos sparked at all outlet points as required.

The top spark plugs were removed and examined, they displayed a color consistent with normal combustion when compared to the Champion Check a plug chart.

The lower spark plugs could not be removed due to impact deformation of the exhaust system.

Both propeller blades remained straight and exhibited no damage to indicate rotation at the time of impact.
