## **NATIONAL TRANSPORTATION SAFETY BOARD**

# **AIRFRAME AND ENGINE EXAMINATION**

**WPR14LA272**

Location: Dietrich, ID  
Date: June 29, 2014  
Aircraft: Aerospatiale AS350B2, Registration Number: N3540CL, Serial #: 232  
NTSB IIC: Howard Plagens

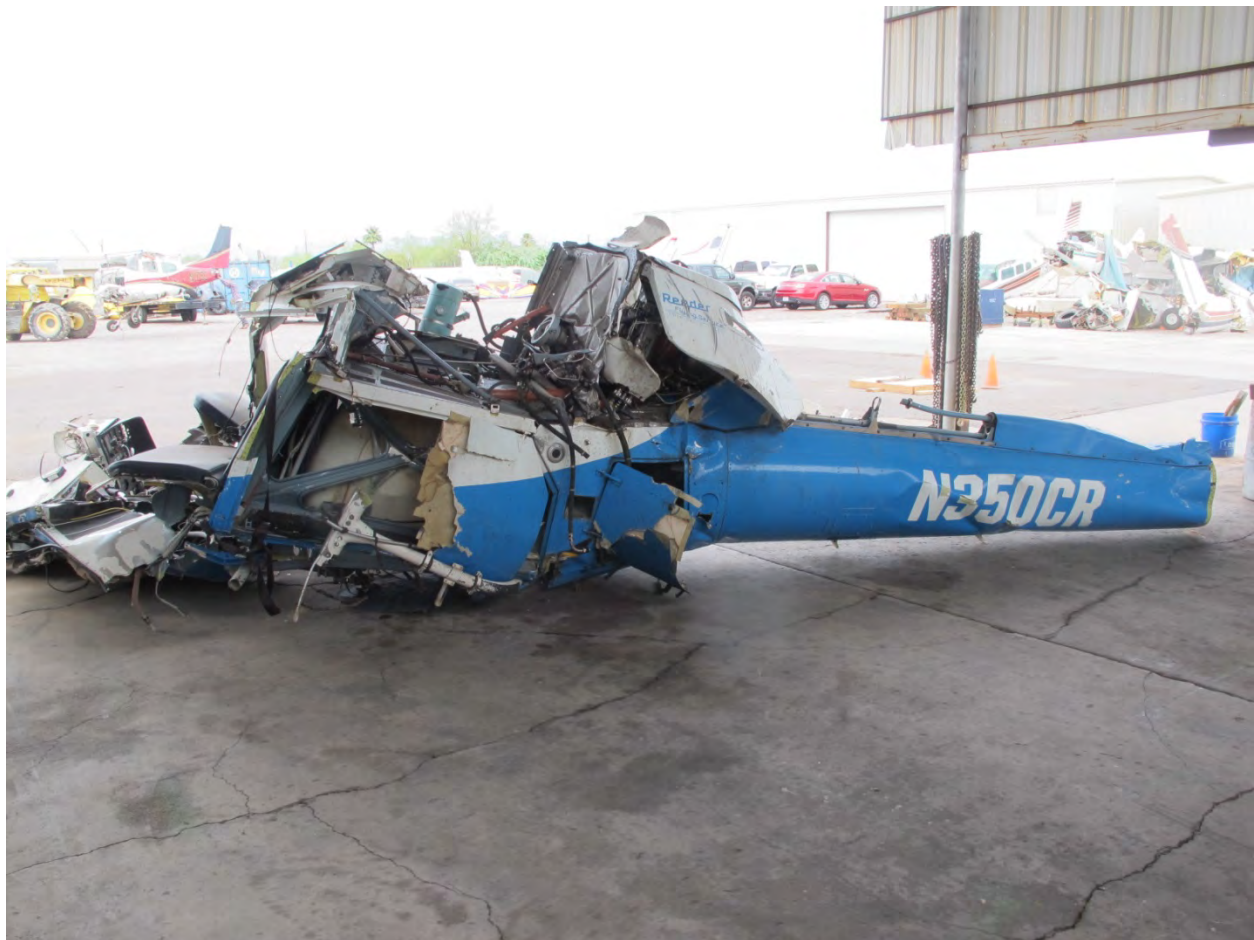
The nose and cabin area were severely crushed and deformed. The windows separated in multiple pieces above the floorboard.

Photo 2 Left Side of Airframe

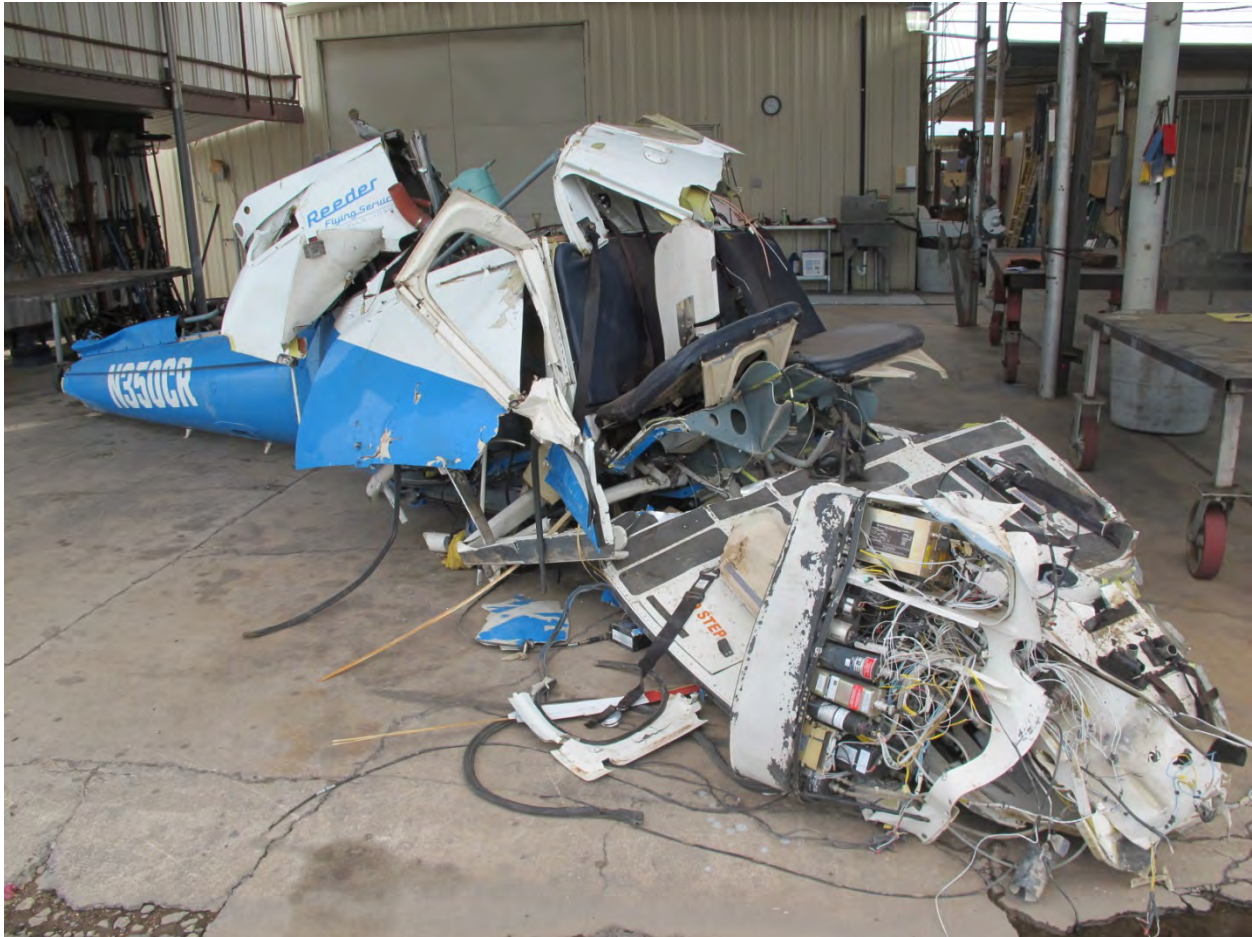
The forward two cabin seats separated from the floorboards at their composite foot structure. The rear seats remained attached to the aft wall and floor. The restraint system was four-point harnesses.

Photo 3 Front View of Cabin Area

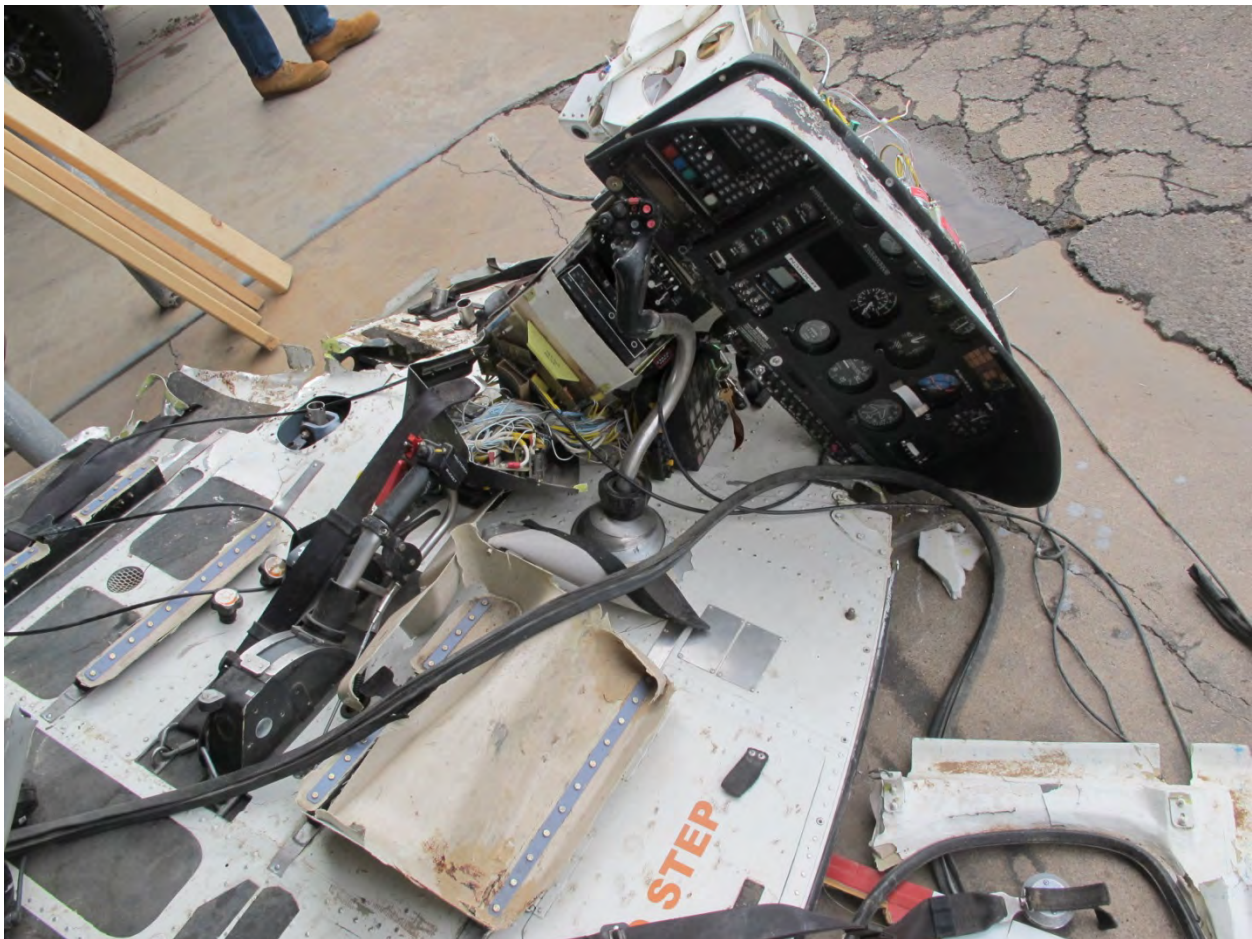
Only single pilot controls were installed, and were on the right side. The pilot's pedals were jammed under the floorboard, and could not be moved; the left pedal was bent down and forward.

**Photo 4 Flight Controls and Instrument Panel**

The cyclic control moved, but was tight. The friction level was not marked, but (assuming an arbitrary scale of 1-5, least to most) the friction level was estimated at a level 4.

The collective was tightened down to an estimated level 3 (assuming an arbitrary scale of 1-5, least to most)

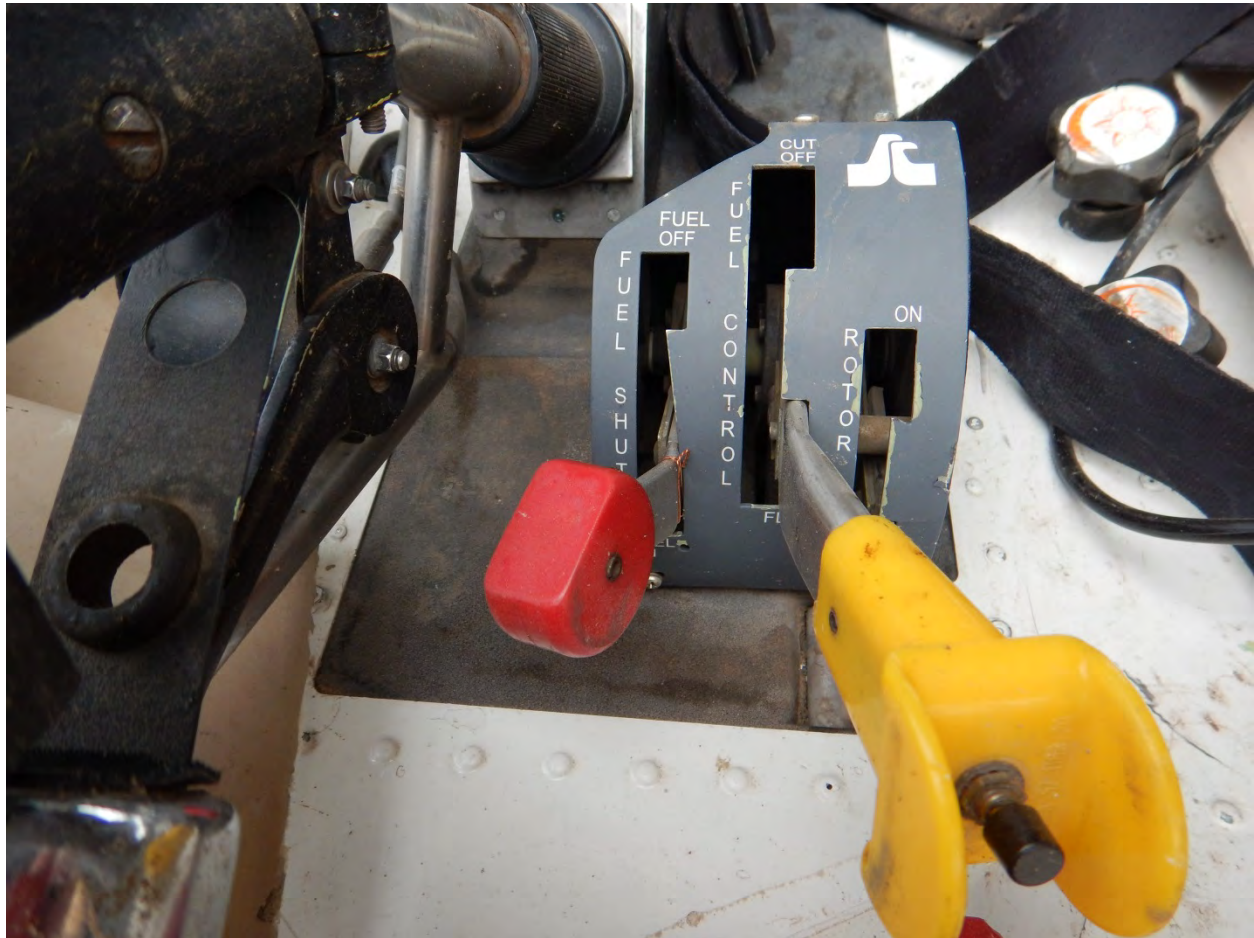
The fuel control lever in the cockpit was in the FLT position. The fuel shutoff lever located in the cockpit was in the FUEL ON position. HONEYWELL PHOTO

Photo 5 Honeywell Photos of Fuel Control and Fuel Shutoff Levers

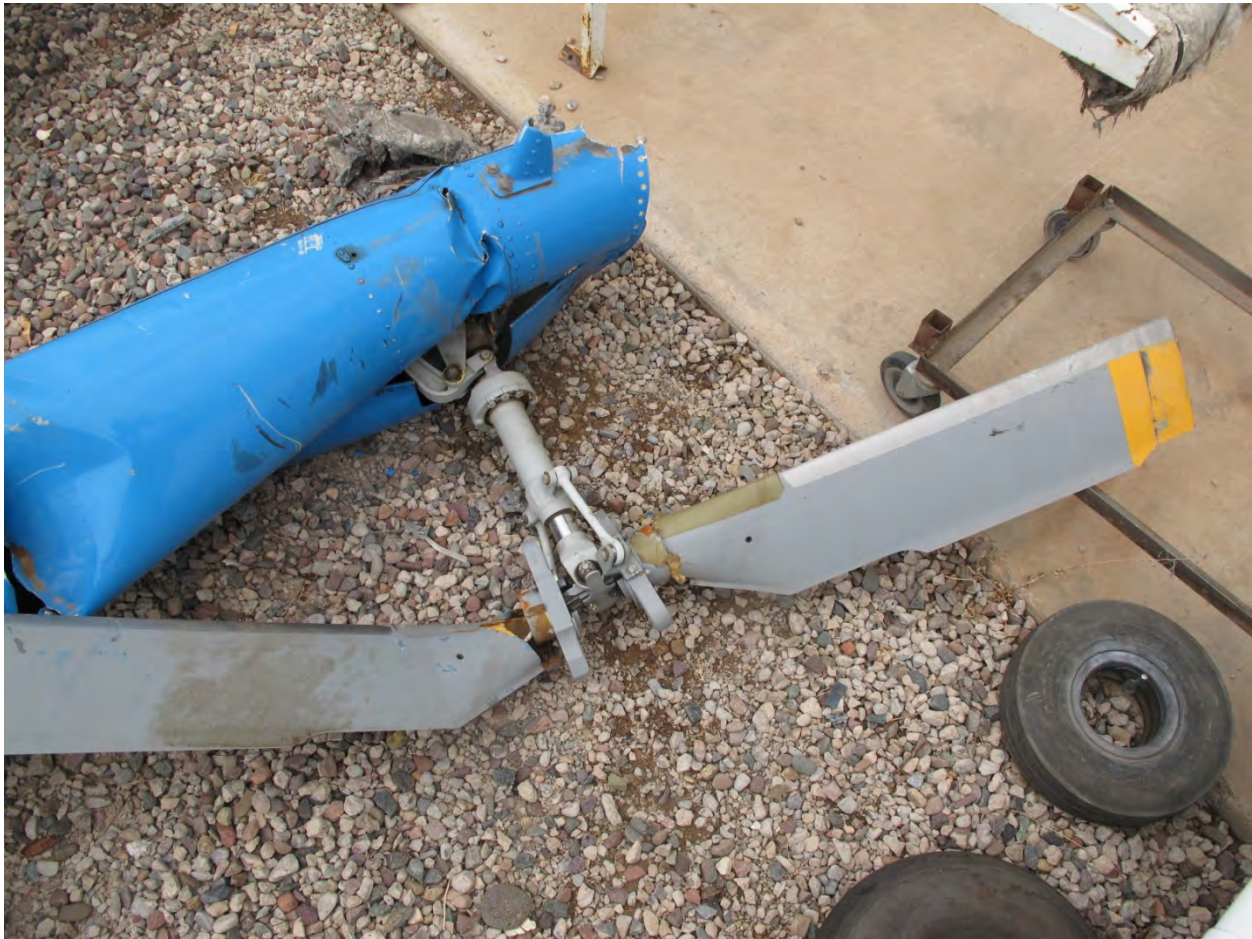
The forward portion of the tail rotor drive shaft at the forward engine coupling separated at the flange coupling internal bore with jagged, angular signatures. The forward Thomas coupling was still attached with its spline fitting. One foot aft, the tail rotor drive shaft separated with a blunt impact signature. The aft 3 feet of the tail rotor drive shaft separated with a blunt impact

signature, and remained attached to the tail rotor gearbox. The tail rotor blades remained attached to the hub; but they had fractured, and were loose at the composite hub.

Photo 6 Tail Rotor

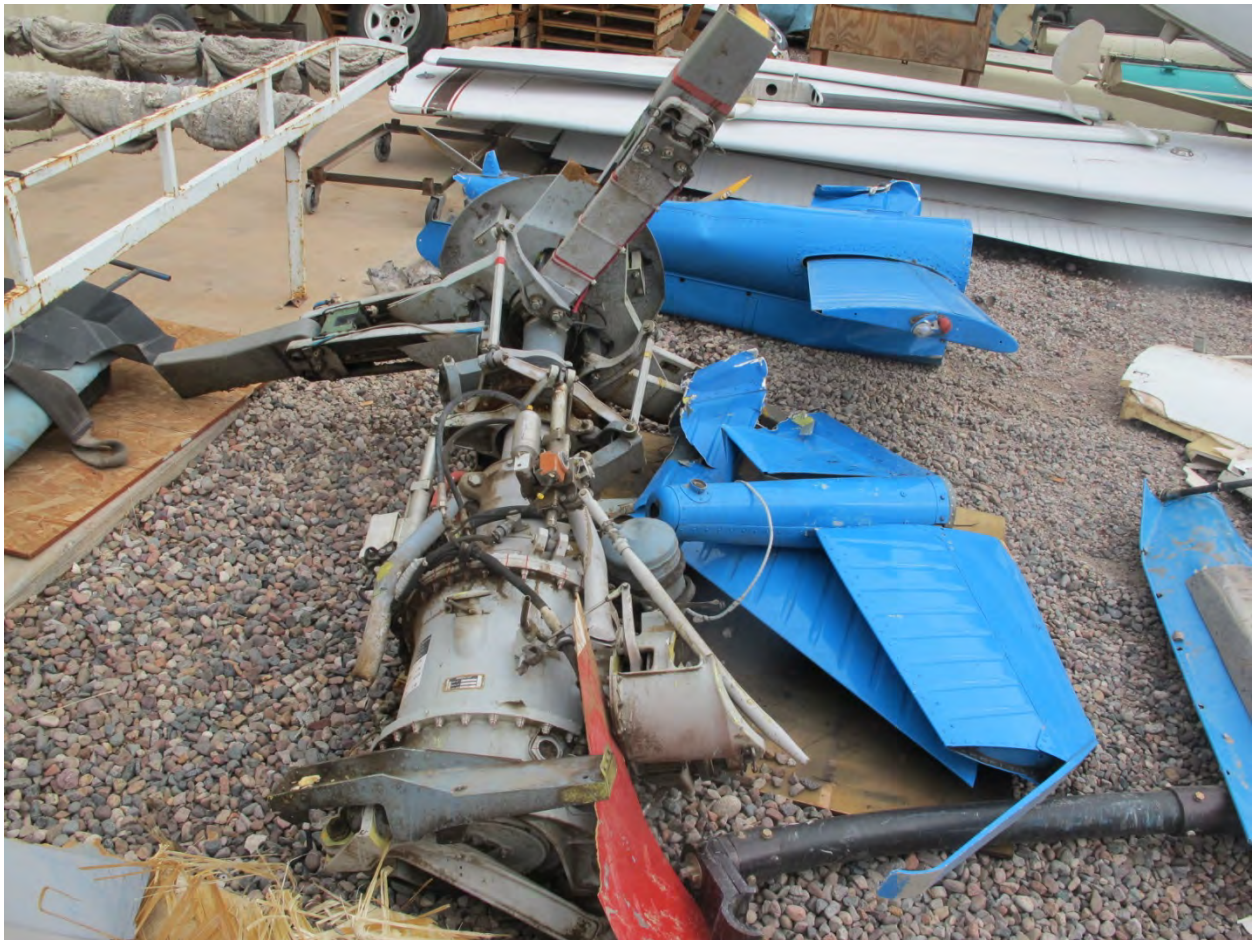
All three blades remained attached to the main rotor hub. All three Starflex arms were broken midspan. Two of the main rotor blade outboard sections had impact damage and trailing edge separation.

Photo 7 Main Rotor Hub Starflex

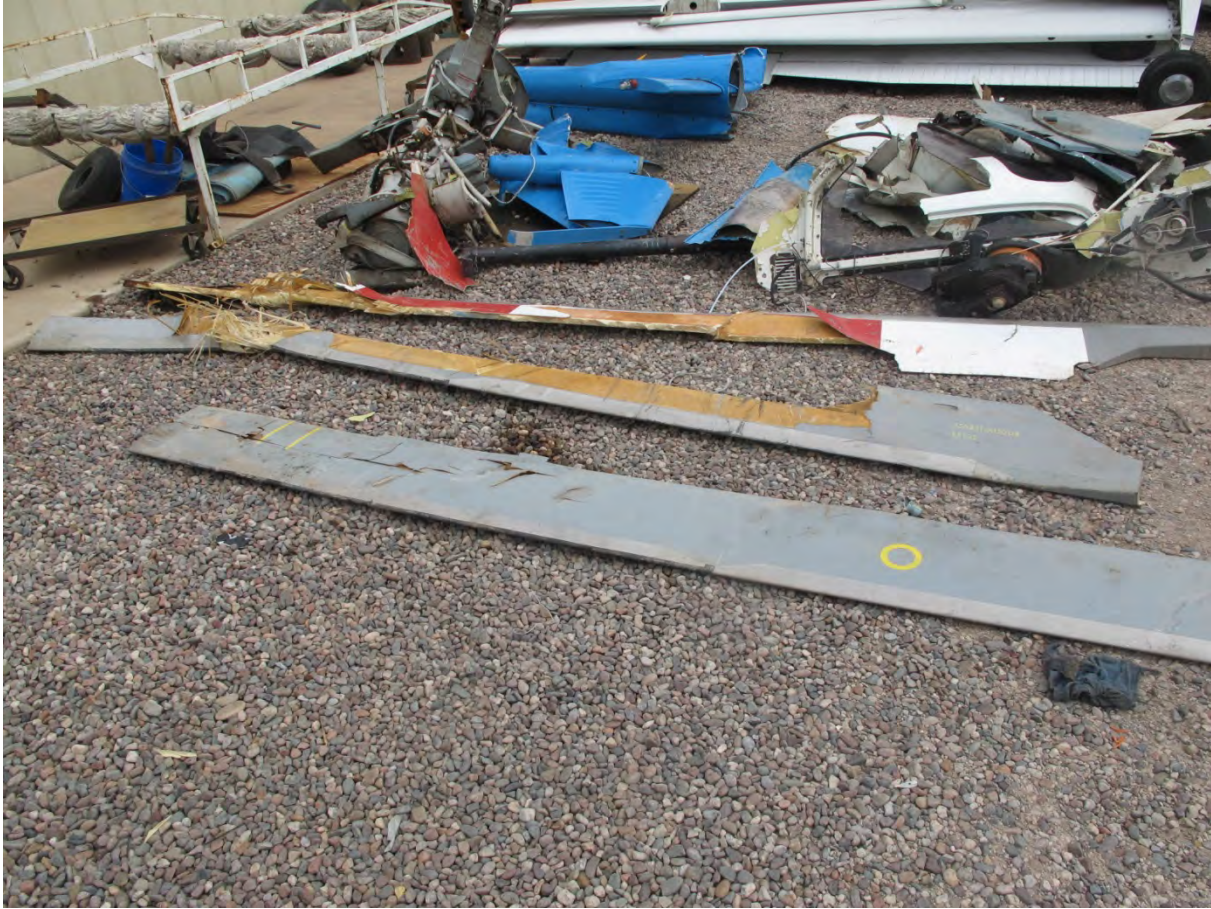
Photo 8 Main Rotor Blades

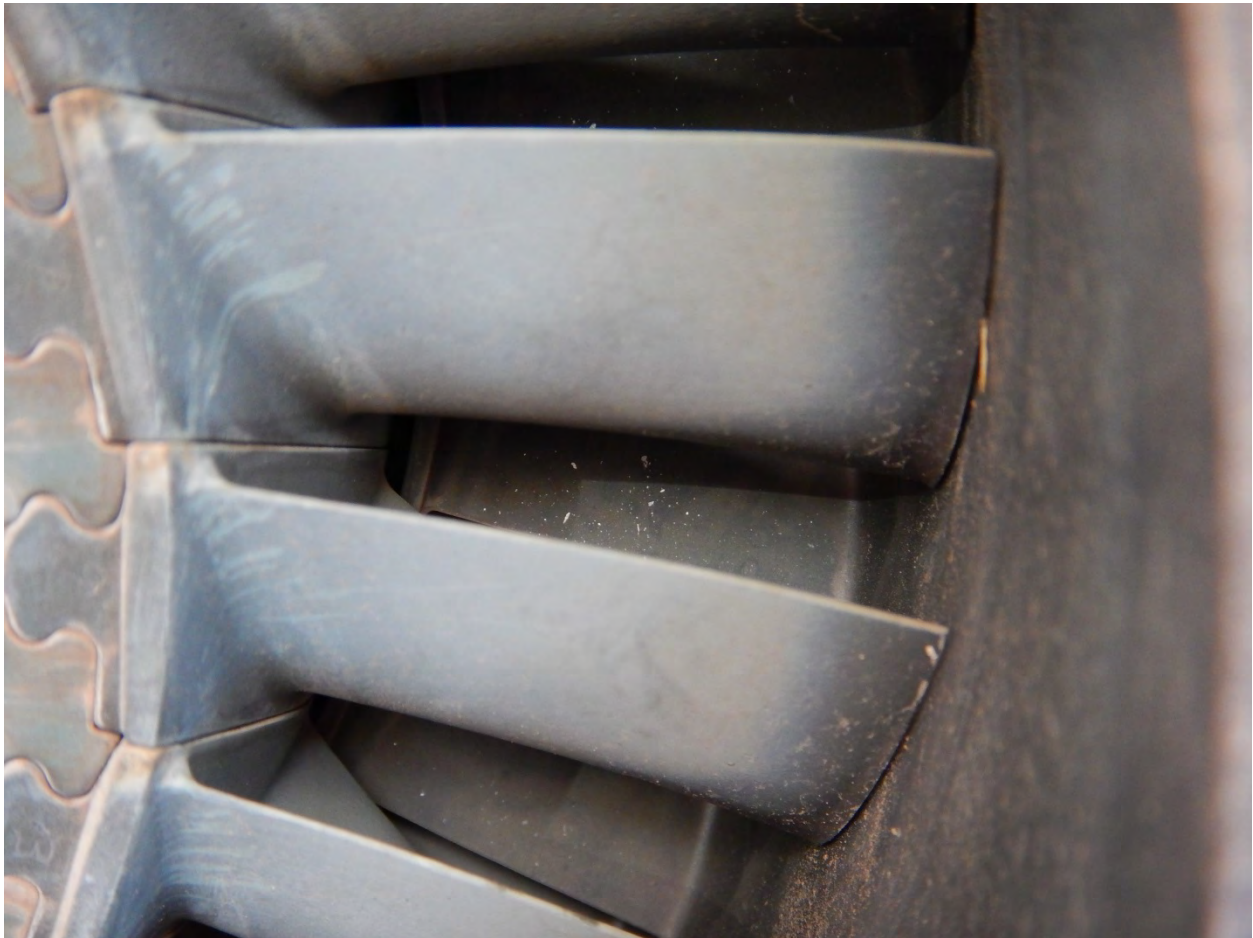
There was metal spray on the aft side of the power turbine nozzle.

Photo 10 Honeywell Photo of Metal Spray

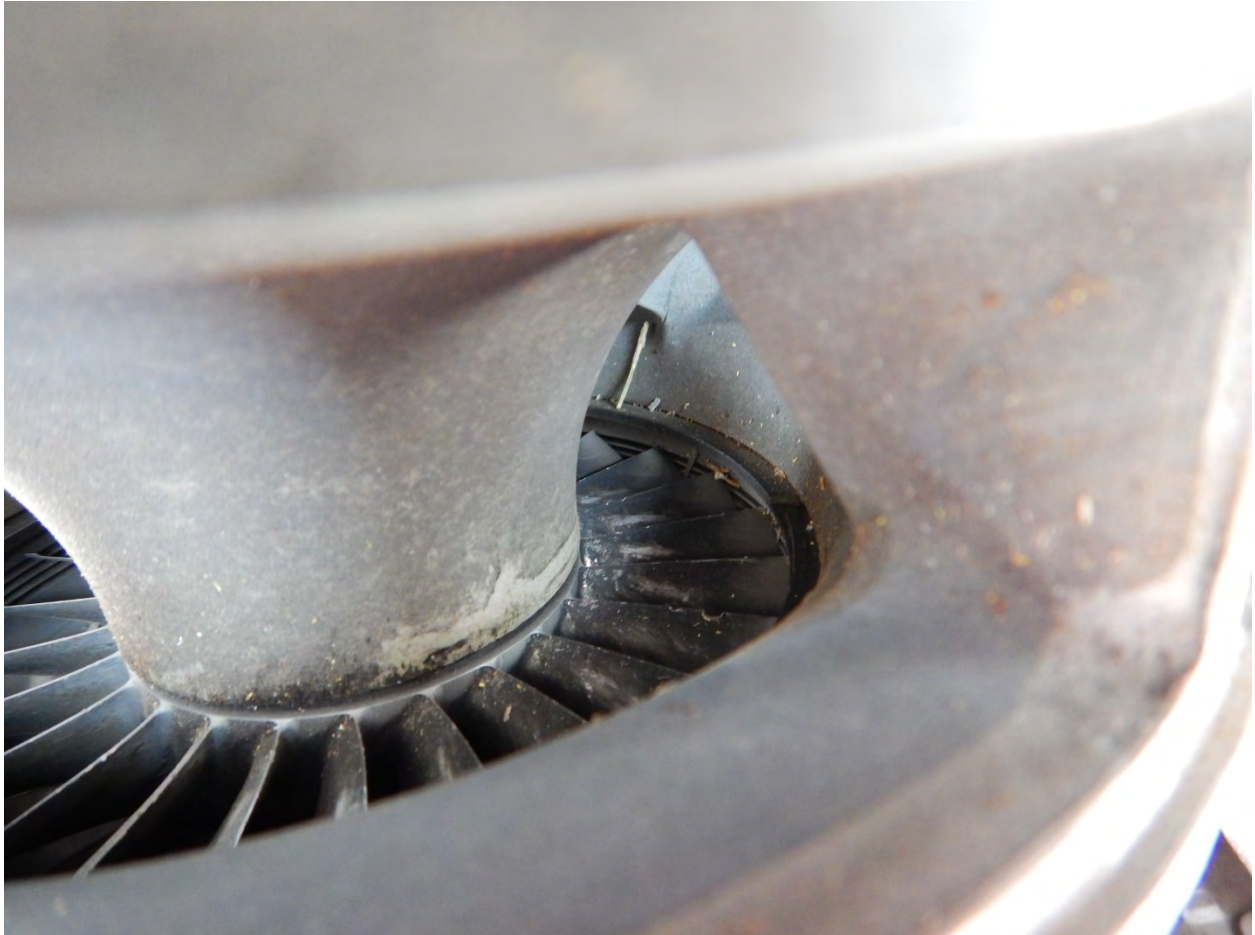
There was debris in the inlet similar to dried grass and twigs.

The axial compressor exhibited leading edge damage with the outer tips bent opposite the direction of rotation.

Photo 11 Honeywell Photo of Axial Compressor

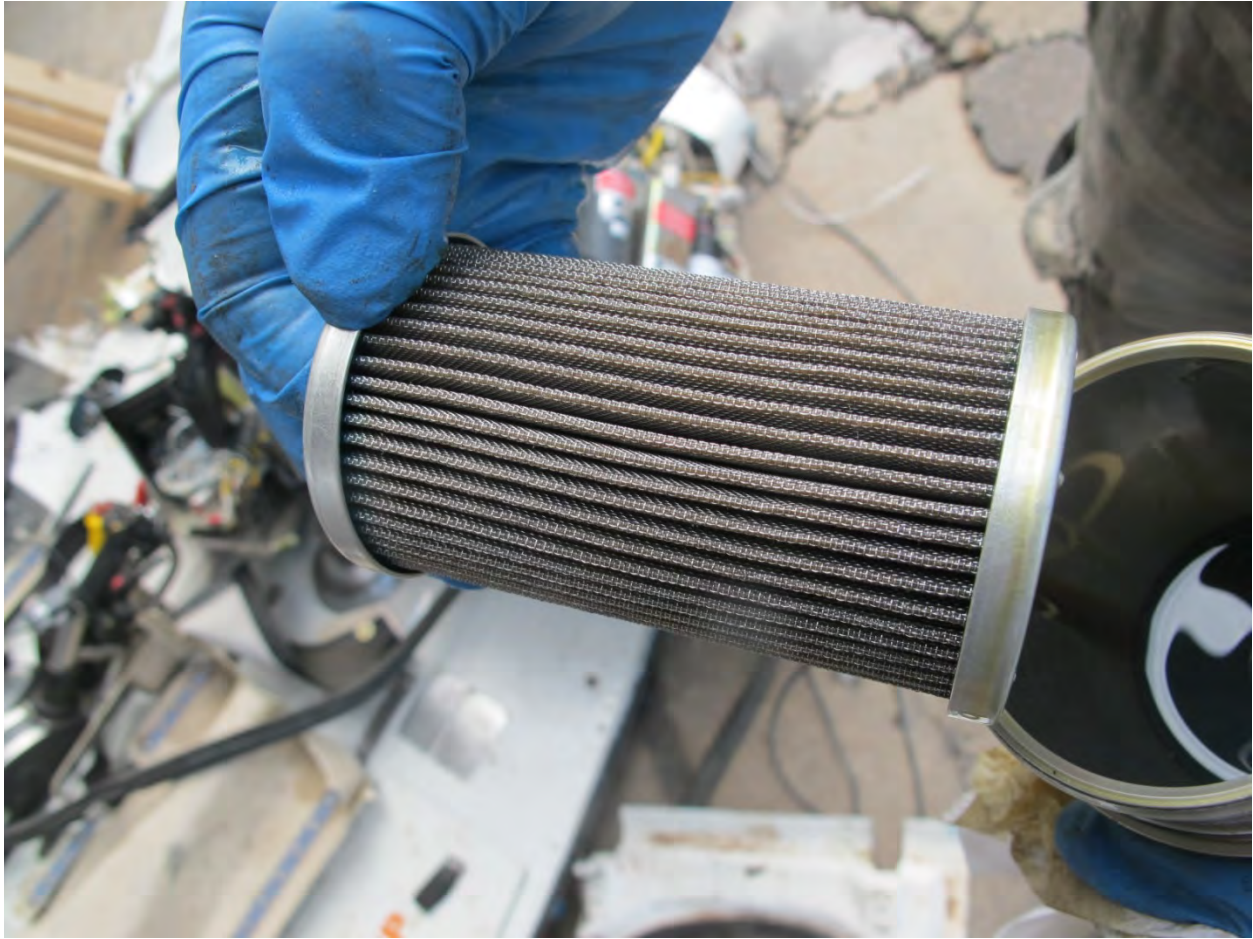
The engine fuel filter was clean, and the bowl contained a clear fluid.

Photo 12 Engine Fuel Filter
