NATIONAL TRANSPORTATION SAFETY BOARD

AIRFRAME EXAMINATION REPORT

WPR16FA157

Arion Aircraft LS-1; N341AL

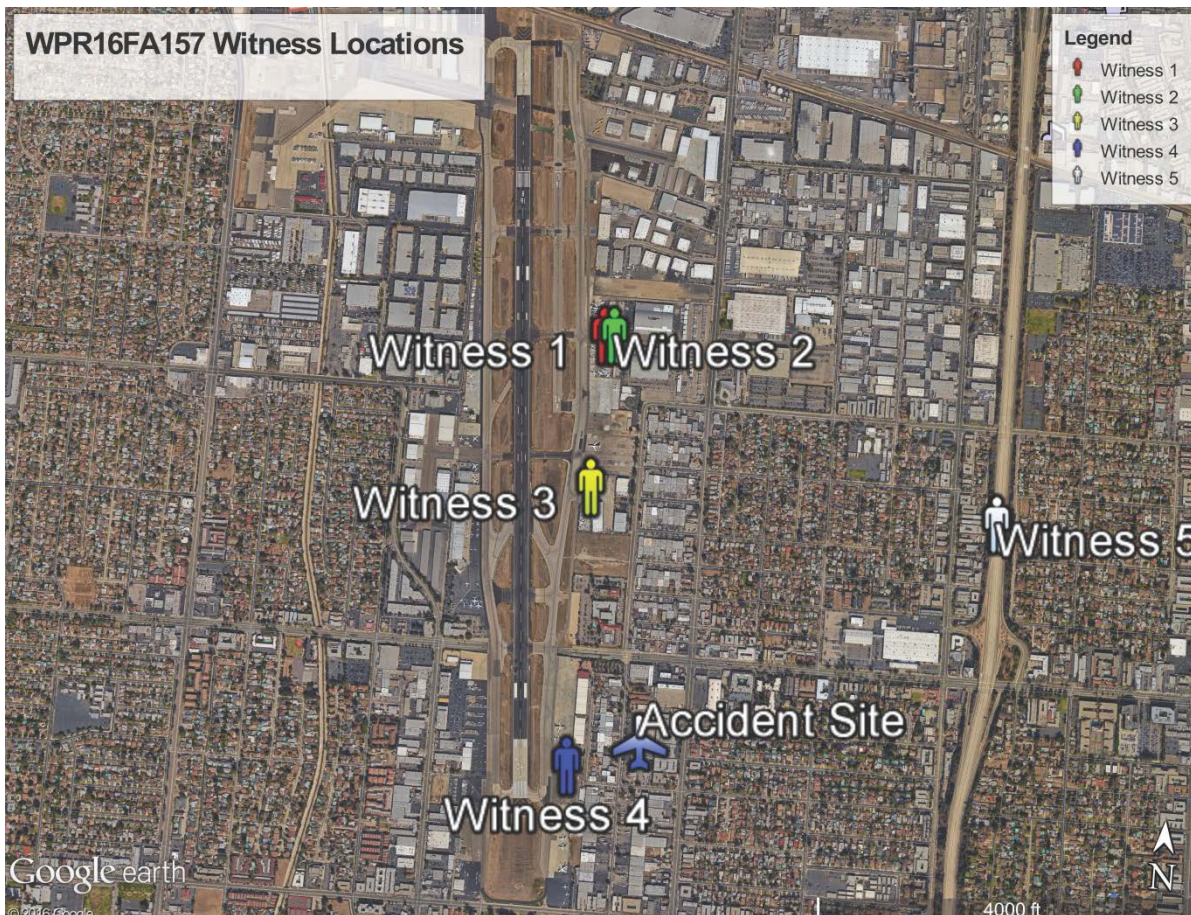
Figure 1 – Witness Locations

A total of 5 eyewitnesses were interviewed; two of which were in the cockpit about midfield of runway 16R, another witness was seated in a fuel truck facing south beyond the southern end of runway 16L, one witness was in the cabin of an airplane located at the south end of the airport, and another witness was in a helicopter east of the airport.

According to witnesses 1 & 2, they observed something dangling from the left main landing gear that appeared to be a wheel fairing. The airplane made exaggerated movements and was flying "erratically, like he [the pilot] was overcontrolling the airplane." The witnesses heard the pilot state that he was returning to the airport on the airport tower control radio frequency. Immediately following the transmission, the airplane entered a steep left turn. The airplane appeared to enter an accelerated stall as the nose continued through the horizon. Witness 1 further added that he witnessed an incipient stall, indicated by an increase in the airplane's attitude. The airplane subsequently rotated one quarter turn to the left and then entered a nose down attitude towards the ground and disappeared below the witnesses' field of view.

Witness 3 reported that he initially observed the airplane when he looked to his right and noticed it approximately 35 feet above ground level in a climb. The witness reported that the left landing gear was hanging by a brake line and the airplane was in a shallow climb and appeared to be incrementally gaining altitude. The airplane then began a left turn near the south end of the airport. Initially, the turn "looked good," but then the airplane slowed, the airplane banked hard into a knife edge attitude and subsequently "fell." In this moment the airplane yawed to a nose down position and the airplane entered a rapid descent. The airplane disappeared from the witnesses' view. The witness did not recall if the engine was functioning at the time of the event.

According to witness 4, located at the south end of the airport adjacent to the accident site, he heard a small single engine airplane overhead. He remarked that the engine was "cutting in and out" for a moment and then the sound abruptly stopped. Approximately 5 seconds later, the witness heard a "whack" sound. He reported that this event took place about 1354 on the day of the accident.

Witness 5 reported that he was in a traffic helicopter at the time of the accident. He started to watch the airplane seconds after the pilot reported that he wanted to return to the airport on the

airport's tower control radio frequency. The airplane entered a steep left turn from approximately 350 feet above ground level and the nose appeared to be in a level attitude. Subsequently, the airplane began a descent and impacted an industrial building east of the airport. The witness' pilot notified the tower controller that an airplane had crashed. His pilot reported to the witness that the airplane's attitude through the steep turn resembled an accelerated stall.
