NATIONAL TRANSPORTATION SAFETY BOARD

AIRFRAME & ENGINE EXAMINATION REPORT

WPR17FA066

Cessna T310Q; N1246G

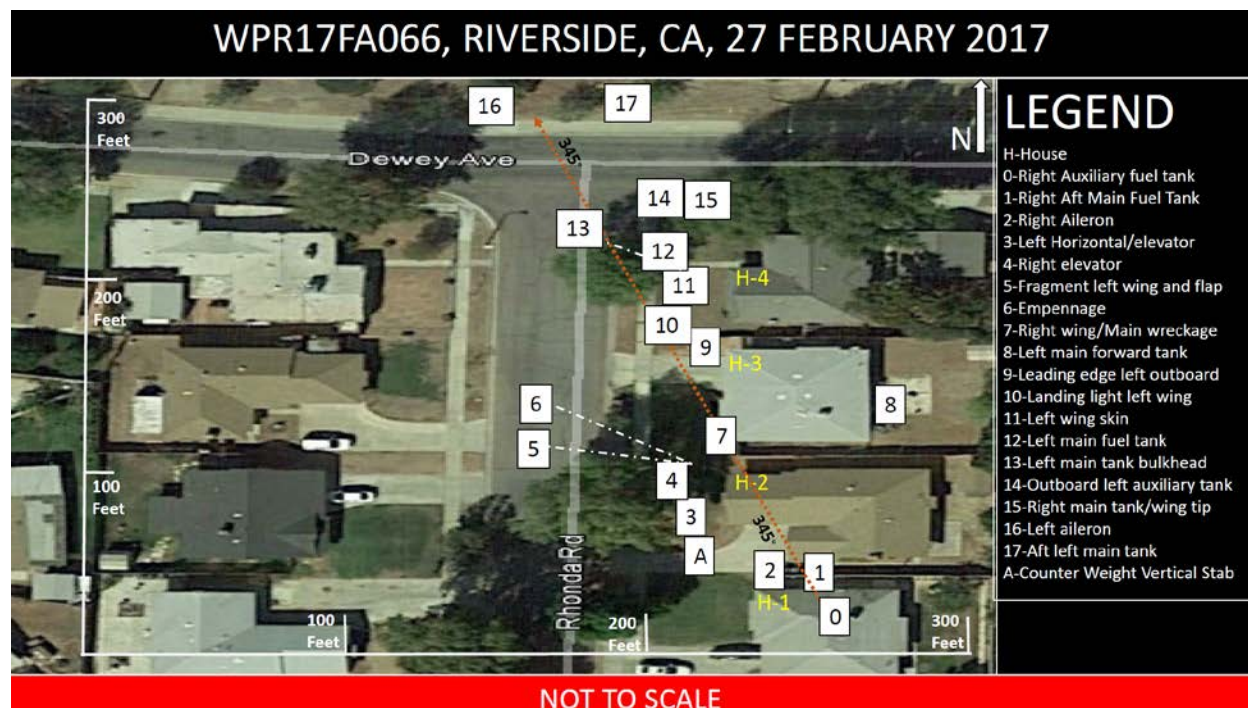
The airplane came to rest in a residence approximately 1 nautical mile northeast of RAL. The initial impact point (IIP) was identified by a broken chimney and a section of airframe located on the roof of house no. 1. Multiple airplane fragments were found along the debris path, which was oriented on a heading of about 345 degrees magnetic. An intermediate impact point was marked by house no. 2 approximately 50 feet from the IIP, which was consumed by fire. The main wreckage was found in a bedroom on the southwestern end of house no. 3 about 100 feet from the IIP, and had also been consumed by the postcrash fire. Portions of the empennage, fuselage, and wings found along the debris path from the IIP to the main wreckage. The main wreckage was comprised of the aircraft cabin, both engines, a portion of the left and right wings, and the left propeller, which was underneath the main wreckage. Left wing fragments were distributed throughout the front lawn of house no. 3. and house no. 4, located 75 feet forward of the main wreckage. The left main tank fuel cap was found approximately 50 feet forward of the main wreckage near the front entrance to the north side yard of house no. 3. The left auxiliary tank and a portion of the left main tank came to rest 100 feet beyond the main wreckage on the lawn of house no. 4. The fuel cap to the left auxiliary tank was secured. A portion of the left main tank was found 200 feet forward of the main wreckage and co-located with the left aileron, which was intact.

The wreckage diagram below shows the wreckage energy path and the location of various aircraft parts that separated during the accident sequence.

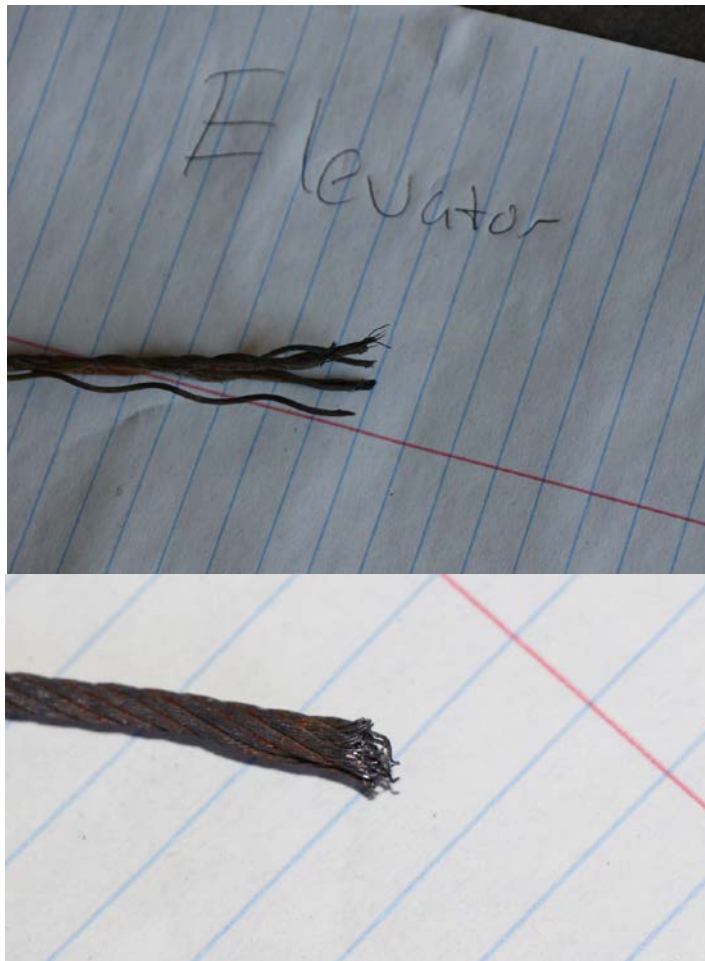
Photograph 1: View of Elevators Cables at Empennage

push/pull tube to the forward empennage through the elevator cables, which were secured to the bell crank. One elevator cable displayed polishing at the cable tip, consistent with being severed. The other elevator cable exhibited broomstrawing (see photograph 1).

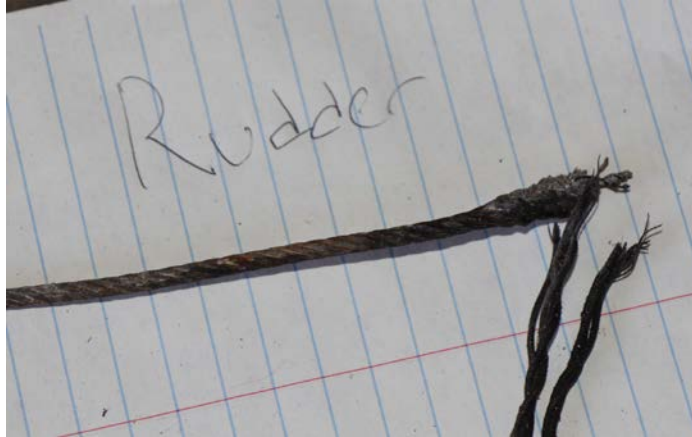
Photograph 2: View of Rudder Cables at Empennage

The vertical stabilizer and rudder were thermally damaged, but remained attached to the empennage through the vertical stabilizer spar. Both elevators were recovered; the left elevator was separated about midspan, but remained attached to the horizontal stabilizer and displayed a large depression. The right elevator separated from the empennage and right horizontal stabilizer, which was not recovered. The elevator trim tab was secured to the right elevator, but separated from the trim tab actuator, which displayed continuity to the forward empennage through the elevator trim tab cables, which exhibited broomstrawing. A measurement of the elevator trim tab actuator showed that approximately 1.75 inches of the rod was exposed, consistent with 5 degree tab up deflection. Rudder trim tab continuity was verified from the trim tab to the forward empennage. Both rudder trim cables were cut by recovery personnel. The rudder trim tab actuator measured 1.23 inches, consistent with 21 degrees of right deflection. Rudder cable continuity was traced from the bell crank to the forward empennage. Both rudder cables were cut by recovery personnel; one cable was melted and the other cable displayed broomstrawing (see photograph 2). Continuity of the elevator was confirmed from the aft end of the elevator

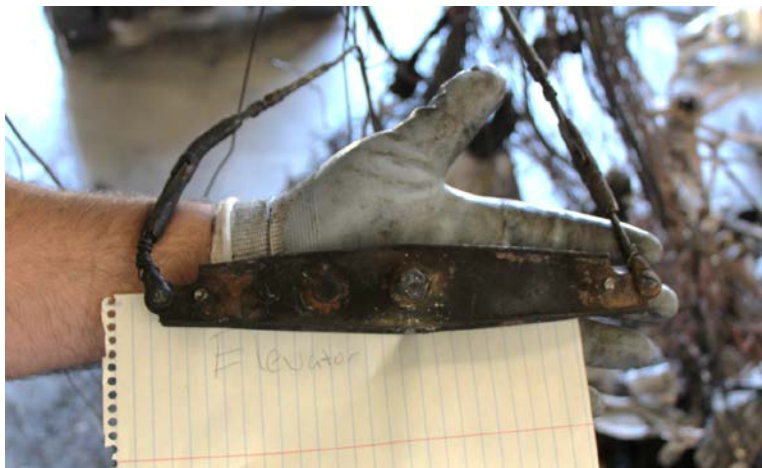
Photograph 3: View of Cockpit Elevator Bell Crank

The cockpit and cabin were consumed by postcrash fire. The emergency manual gear extension pin and gear handle were in the extended position. However, the gearbox arms indicated that the nose landing gear was in the up position. Elevator control was traced from the aft fuselage to the cockpit through the forward bell crank (see photograph 3). The elevator cable ends at the aft fuselage were cut by recovery personnel. Aileron control was confirmed from the control column to the right wing through the forward bell crank. The left aileron cable was traced from the control column to the left wing root. The flap cable was continuous from the chain to the bell crank at both the right and left wings. Rudder control authority was traced from the rudder pedals to the aft fuselage. One cable displayed broomstrawing and the other was molten, but both cables exhibited some polishing at the cable strand tips.

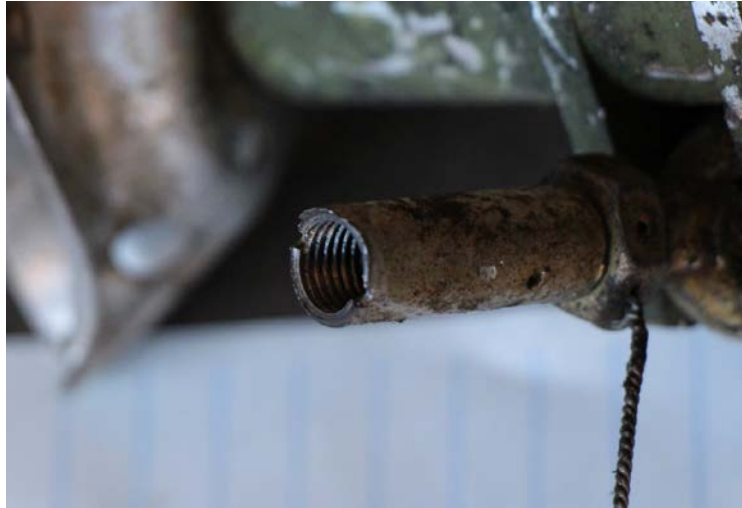
Photograph 4: View of Left Aileron Bell Crank Push/Pull Tube Rod End

The right and left wings were fragmented; the right wing was consumed by fire and both left wing fuel tanks were thermally damaged. Control continuity of the aileron balance cable was confirmed from the outer bell crank to the left wing root. The left wing bell crank stops were unremarkable; however, the aileron push/pull tube had fractured and separated from the bell crank (see photograph 3). The left aileron control and balance cables displayed broomstrawing at the wing root (see photograph 4). The cables separated from the bell crank and were not recovered. Examination of the right aileron bell crank revealed that the stop was secured and the aileron push/pull tube remained attached to the bell crank at the rod end (see photograph 5). The left and right ailerons displayed evidence of buckling, but remained intact.
