## **NATIONAL TRANSPORTATION SAFETY BOARD**

### **AIRFRAME AND ENGINE FOLLOW-UP EXAM REPORT**

WPR16FA130

Location: Wikieup, AZ  
Date: June 23, 2016  
Aircraft: Robinson R66, Registration Number: N117TW, Serial #: 0042  
NTSB IIC: Howard Plagens

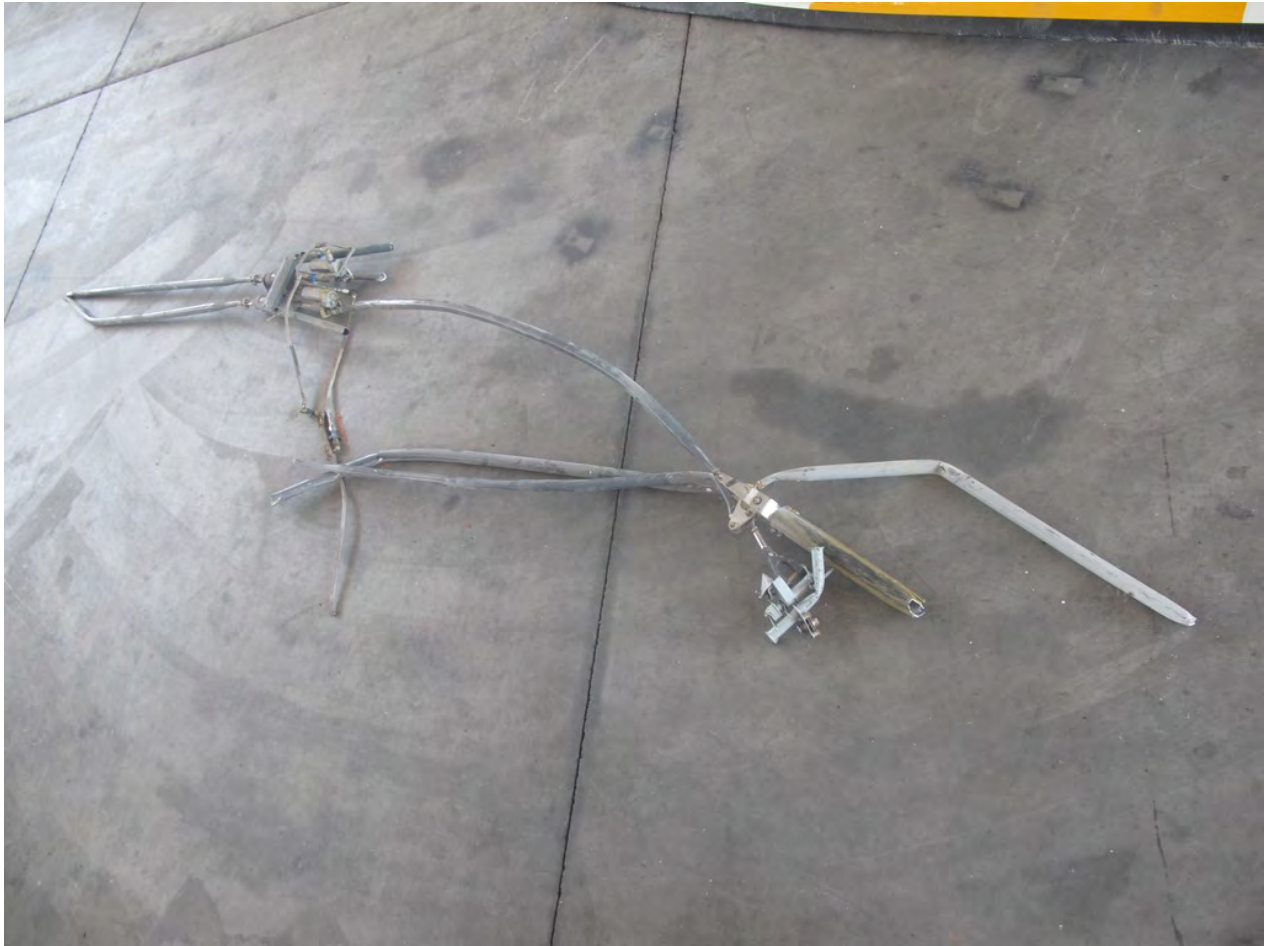
All main rotor flight control rod ends and attachments were accounted for. All identified fracture surfaces were angular and jagged. Some control tube sections were consumed by fire.

Photo 1 Main Rotor Flight Controls

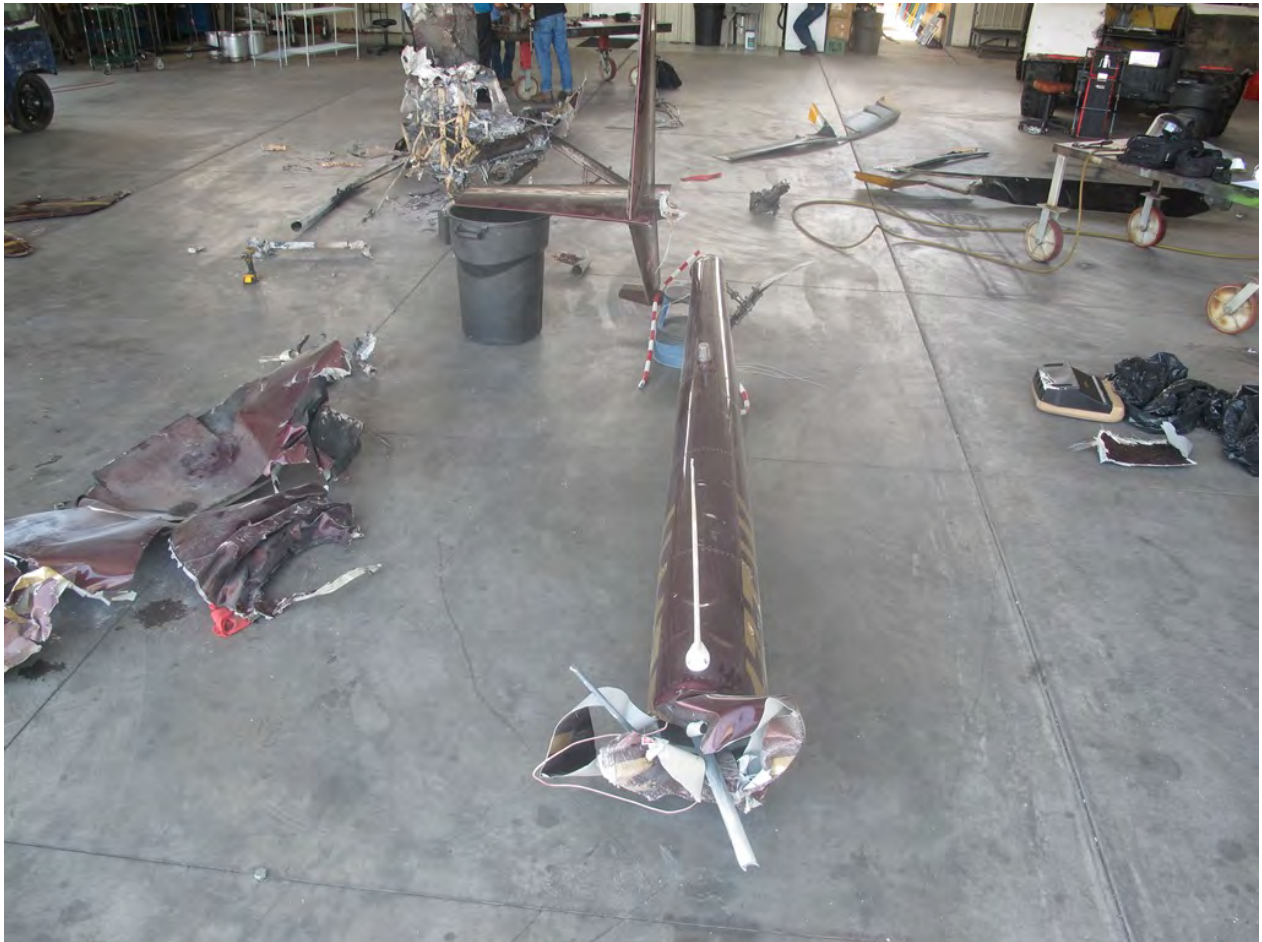
The tail rotor driveshaft was disconnected from the main rotor gearbox; the forward section remained within the airframe. The aft section of the tail rotor driveshaft remained within the tail cone. The tail rotor gearbox rotated 360 degrees by hand.

One tail rotor blade bent outward near the root. There was no directional or chordwise scoring on either blade.

The empennage separated from the tail cone along an angular and jagged plane.

The tail cone separated near the forward mount; the fracture surface was angular and jagged. There was no indication of contact from a main rotor blade.

Photo 2 Tail Boom and Tail Section

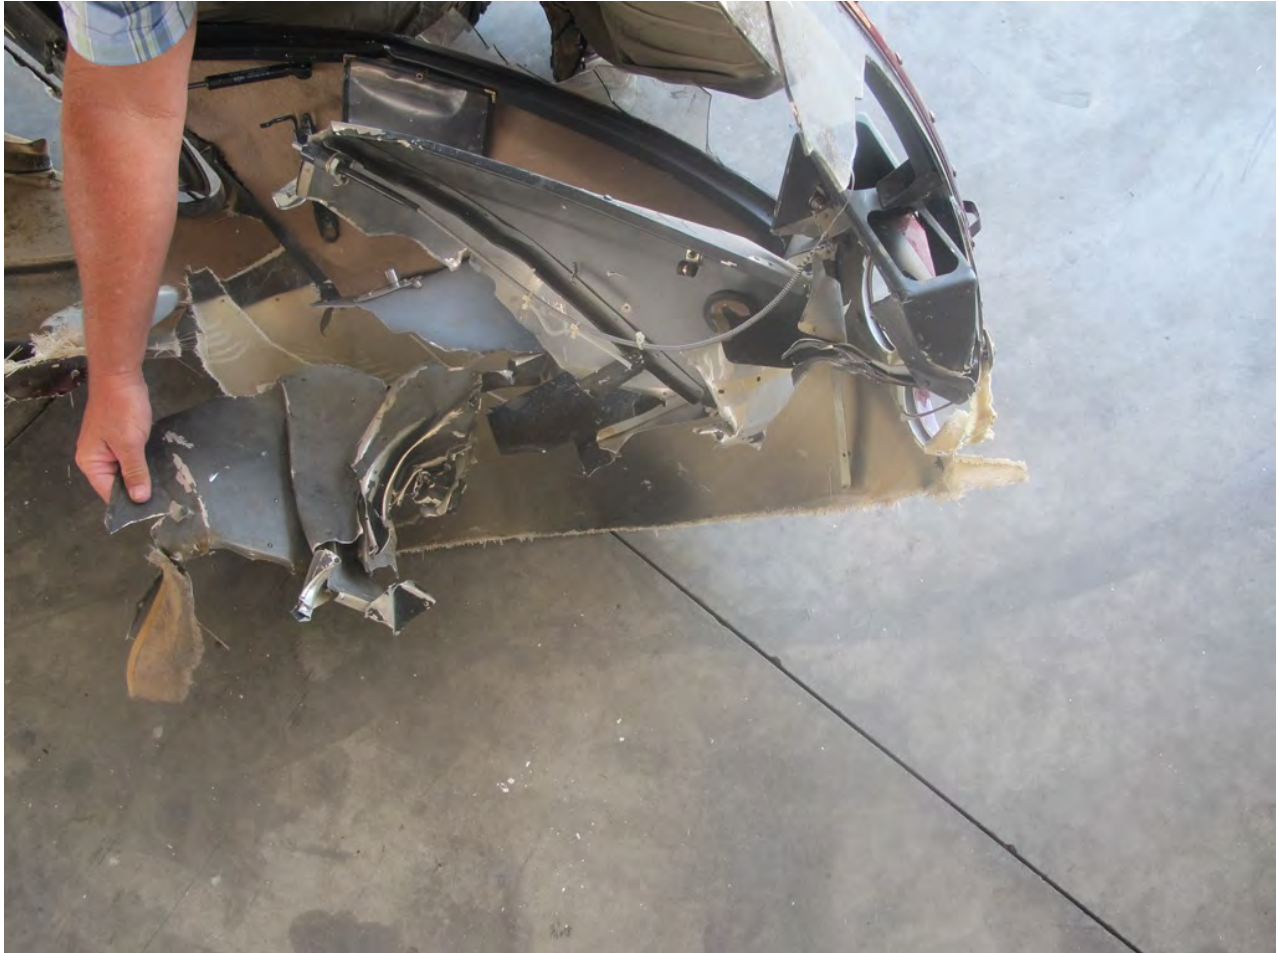
The forward left nose of the fuselage, including the windshield bow and left front door, were separated along a straight slice along with some accordianed floor panels at the aft end of the slice.

**Photo 3 Left Nose and Floor Sections**

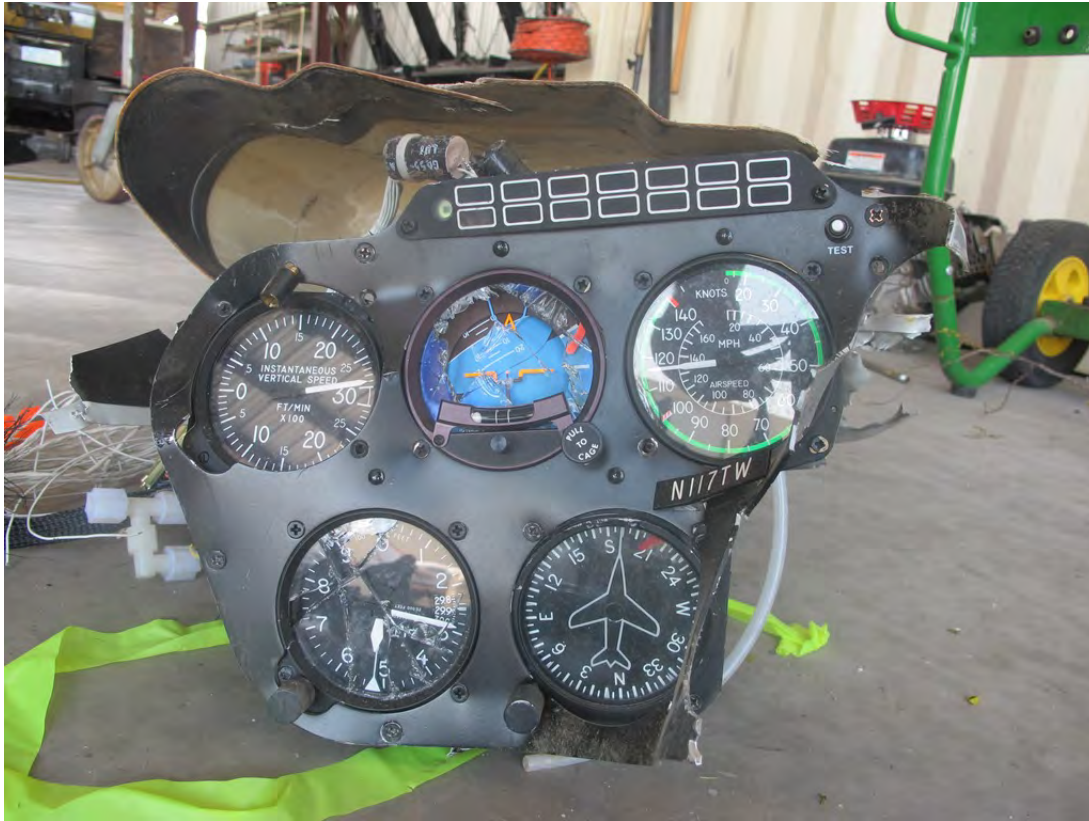
The right side of the console sustained impact damage.

Photo 4 Instrument Panel

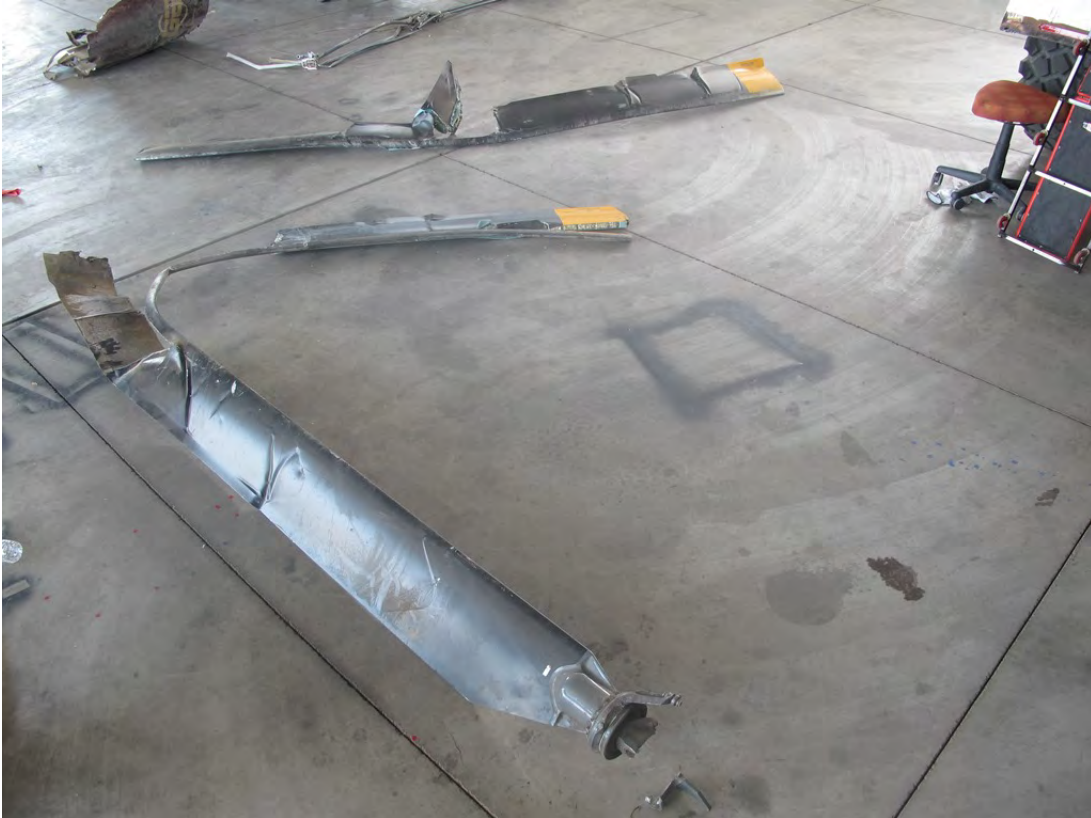
About 5 feet of one main rotor blade after-body was recovered at the beginning of the debris field. The spar for that blade was bent 130 -140 degrees forward in the direction of rotation. The spindle for that blade was fractured and separated with the coning bolt remaining in the hub. There were black paint transfer marks near the tip. The coning bolt was bent. Both teeter stops were smashed across the center. The other blade was bent midspan approximately 10-20 degrees opposite the direction of rotation.

Photo 5 Main Rotor Blades

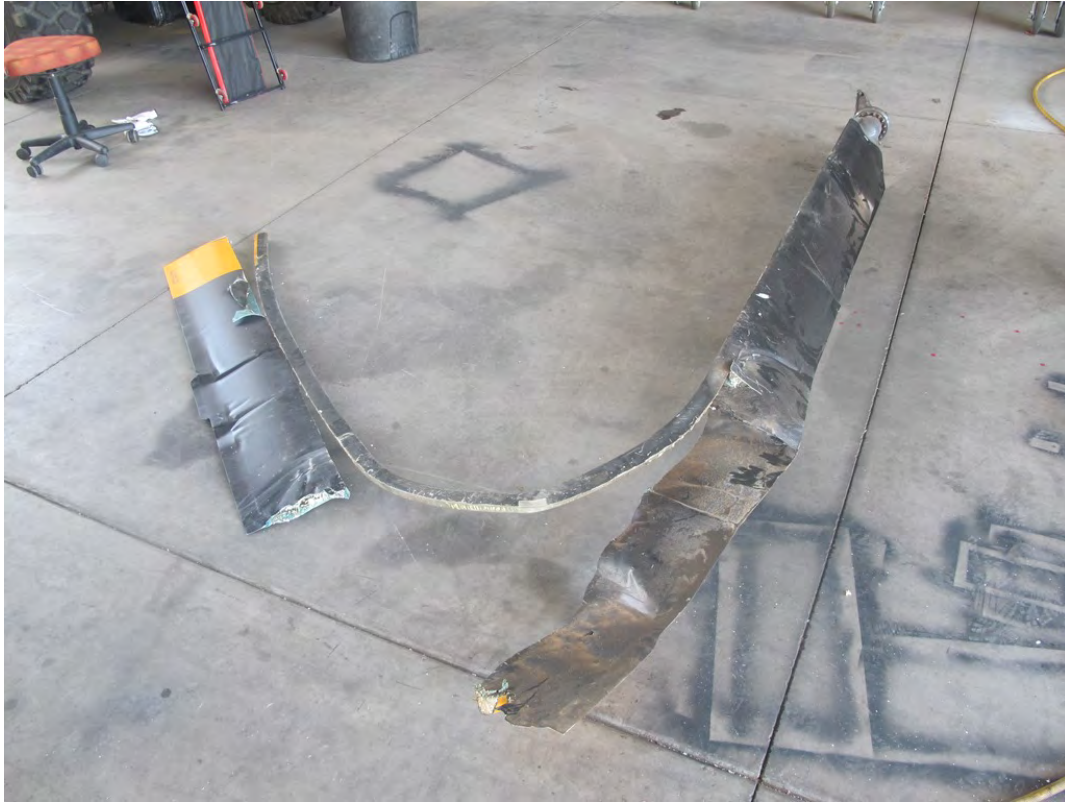
Photo 6 Separated Man Rotor Blade

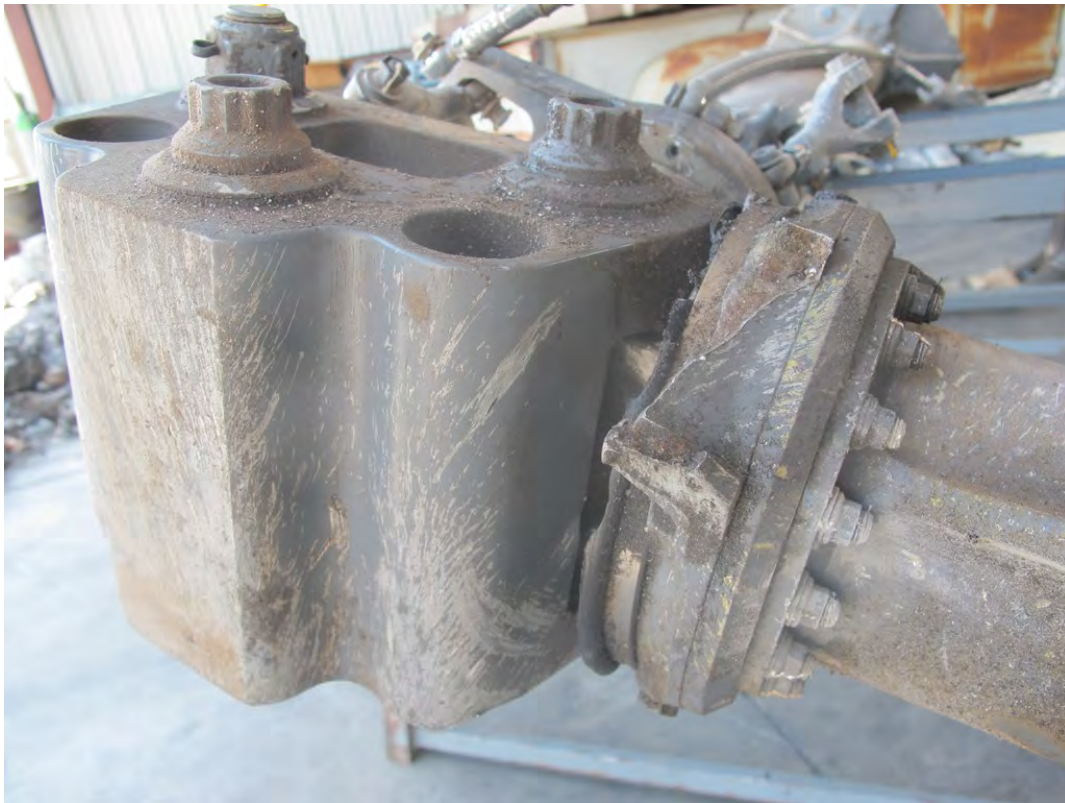
Photo 7 Hub at Retained Blade

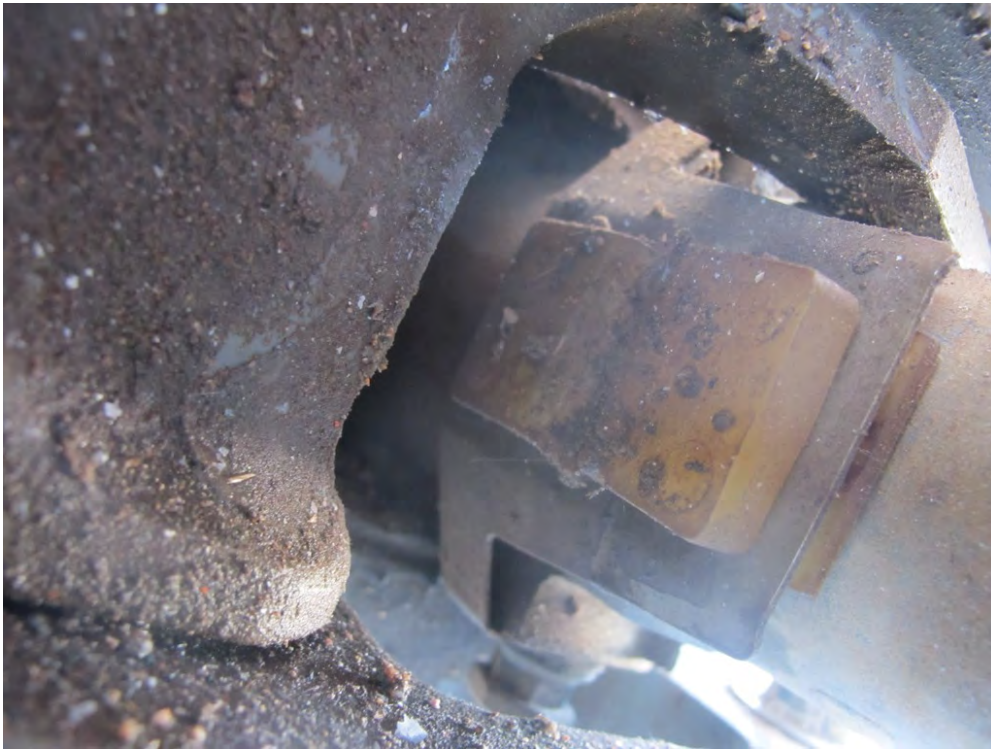
Photo 8 Teeter Stop of Attached Blade

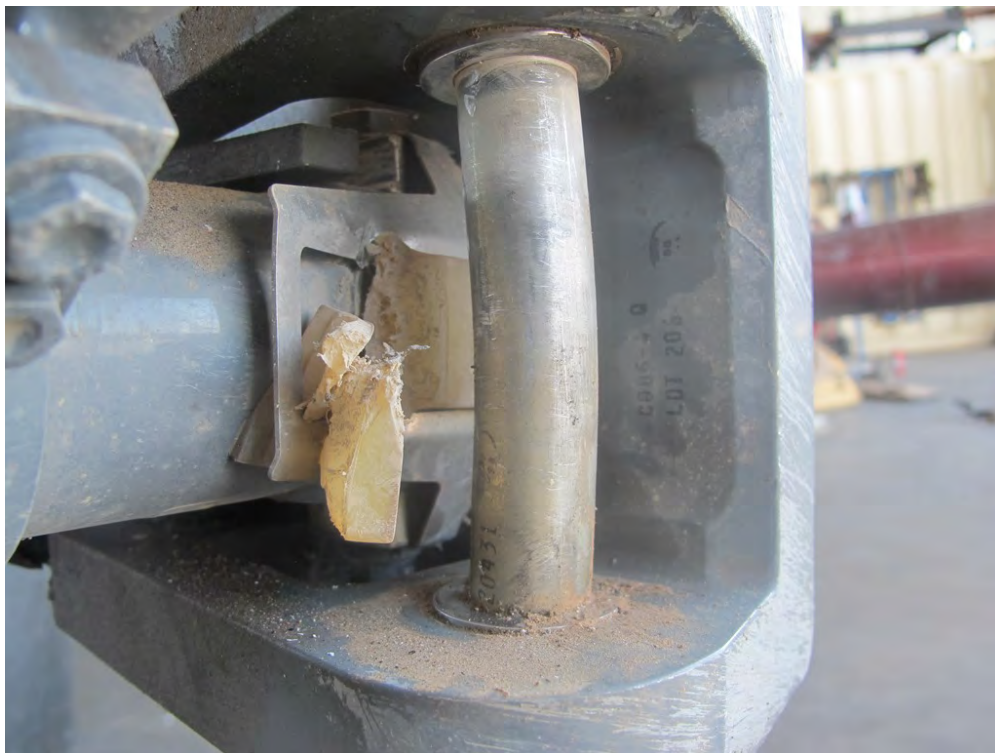
Photo 9 Teeter Stop and Coning Bolt of Separated Blade

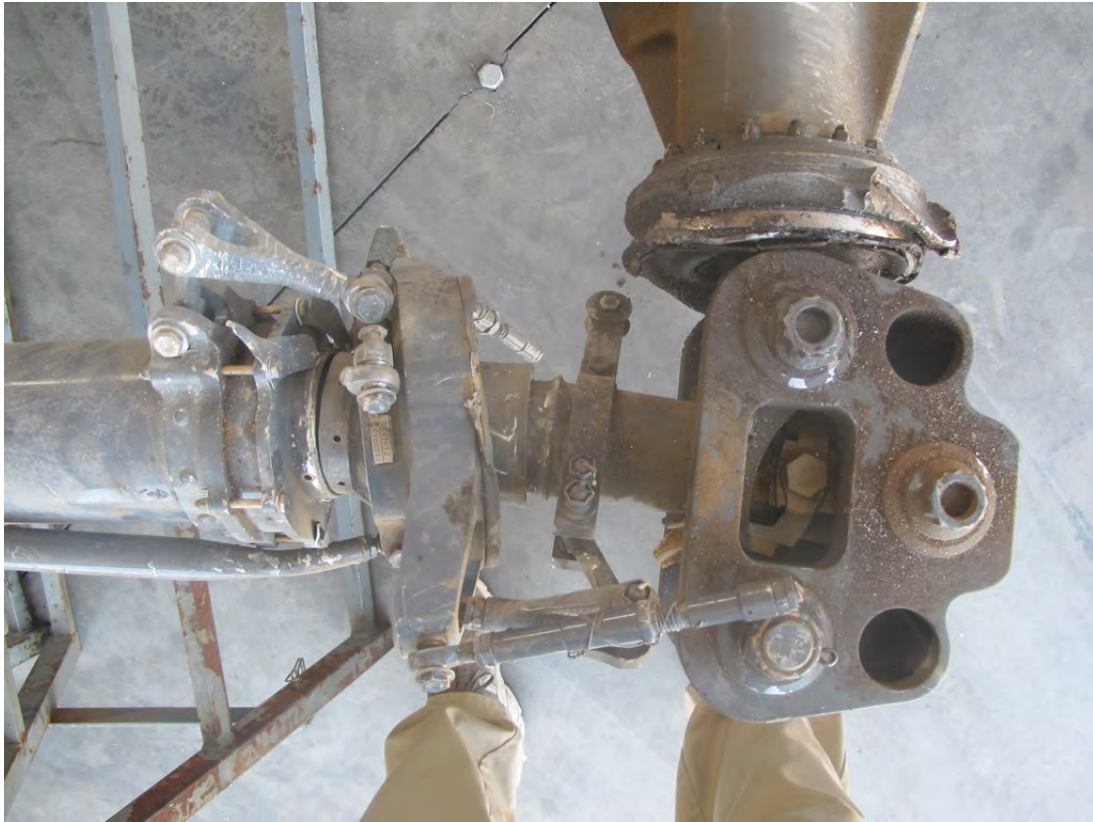
The main rotor drive shaft was bent approx. 10 – 15 degrees. The main rotor drive shaft rotated by hand about 300 degrees in both directions.

**Photo 10 Bent Main Rotor Drive Shaft**

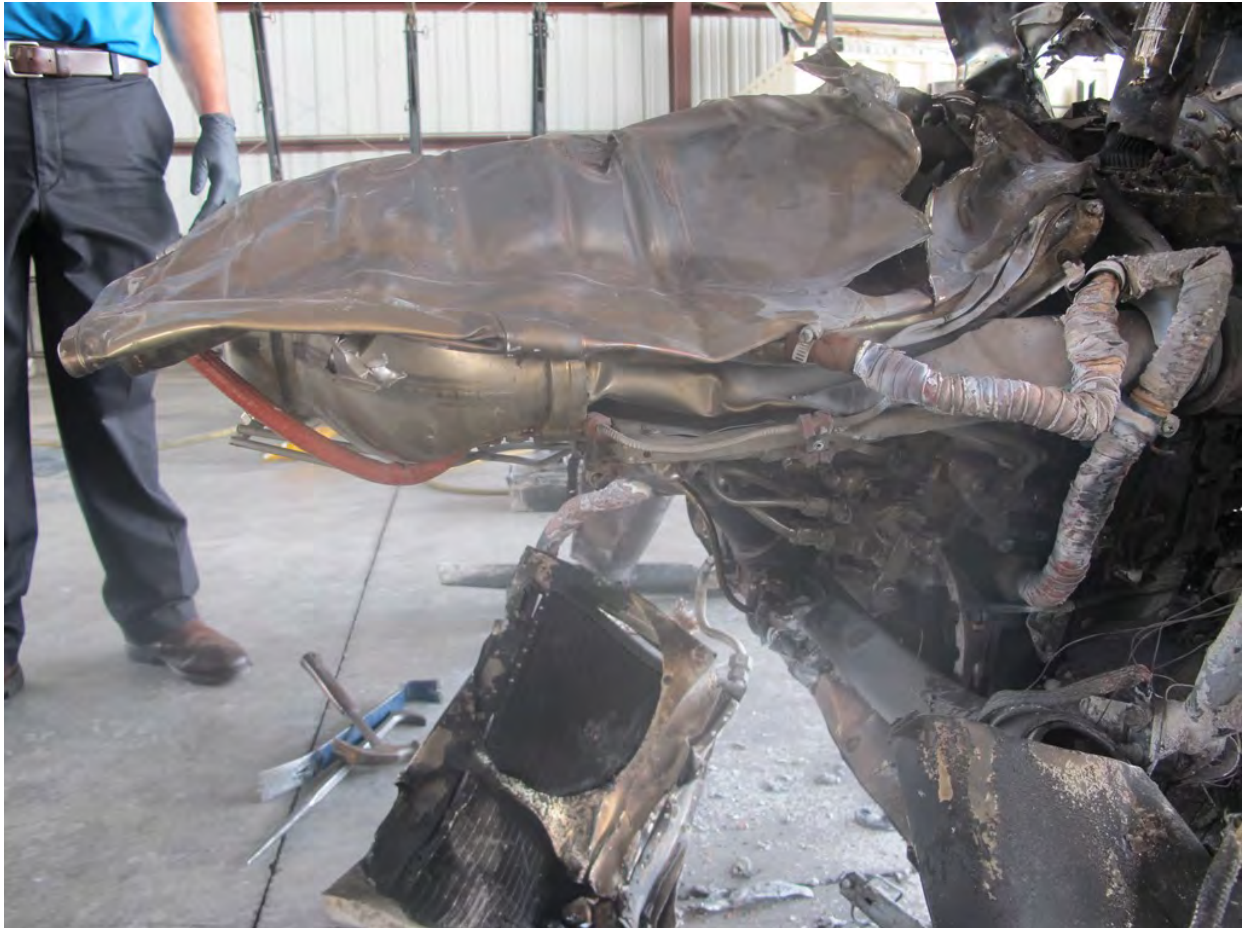
There was no evidence of preimpact failure or malfunction.

The crush damage was consistent with a hard, inverted vertical impact.

Photo 11 Engine

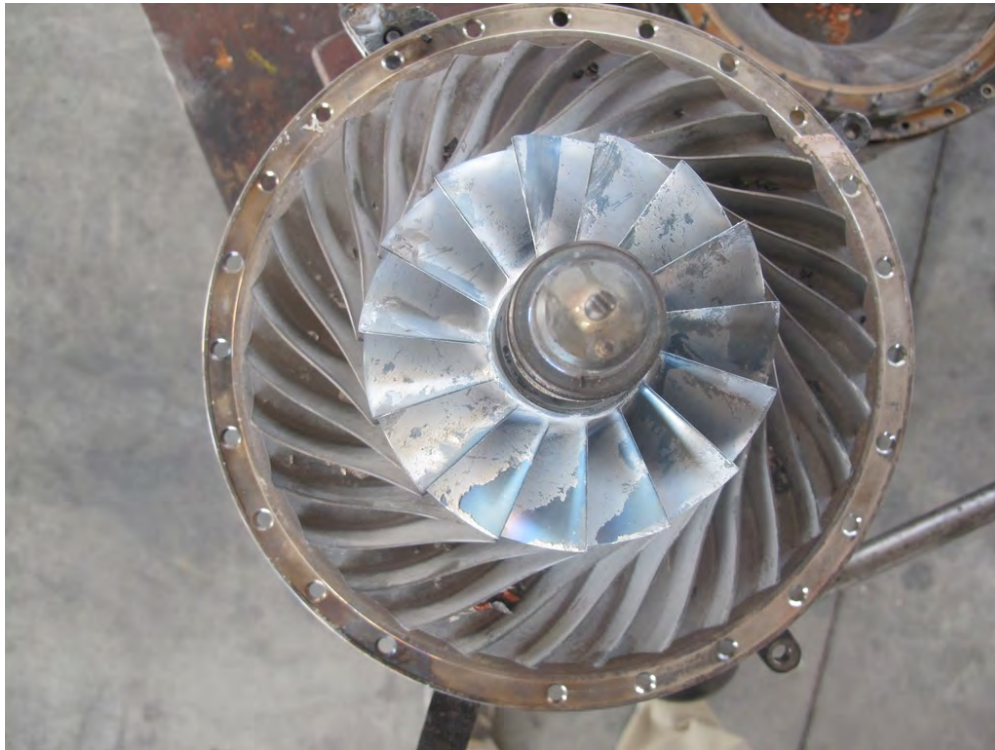
There was evidence of N1 and N2 rotation at impact. When removed, the compressor rotated freely.

Photo 12 Compressor Section

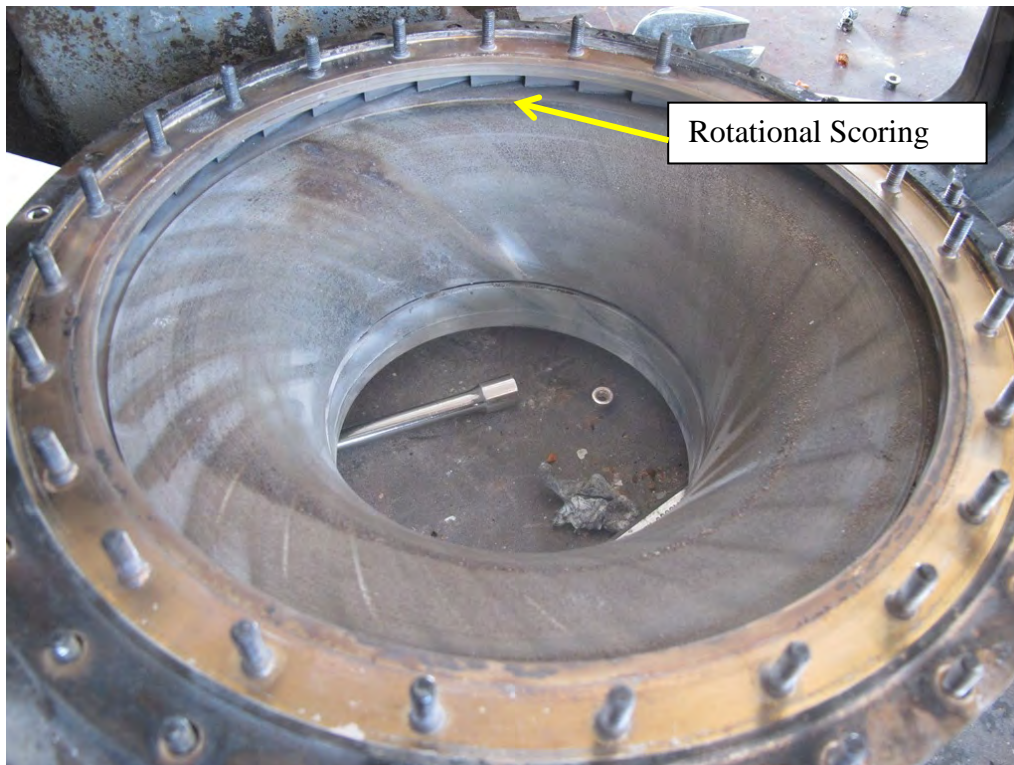
Photo 13 Compressor Shroud

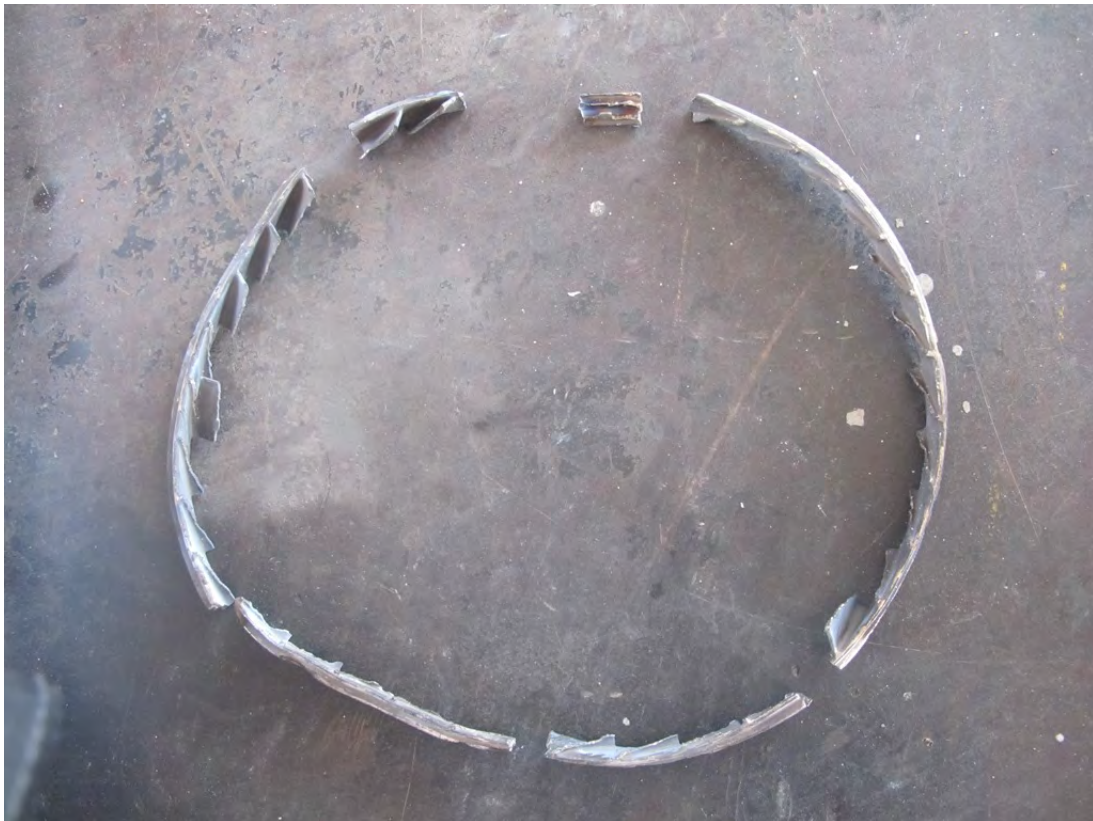
The fourth stage turbine wheel fragmented. The outer ring was in several pieces. All blades were liberated, and the remaining bases were bent opposite the direction of rotation.

**Photo 14 Fourth Stage Turbine Compressor Wheel**

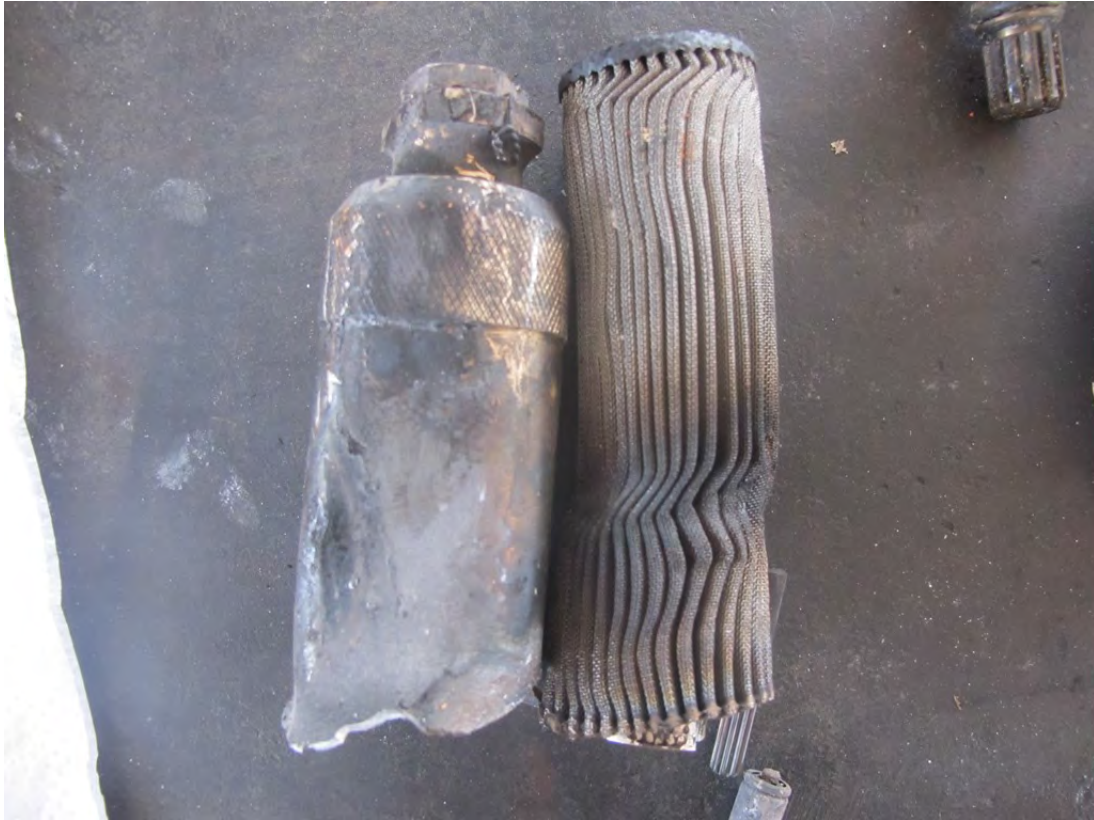
There was no metallic contamination of the oil filters or chip detectors. The oil filter was not in bypass.

Photo 15 Oil Filter

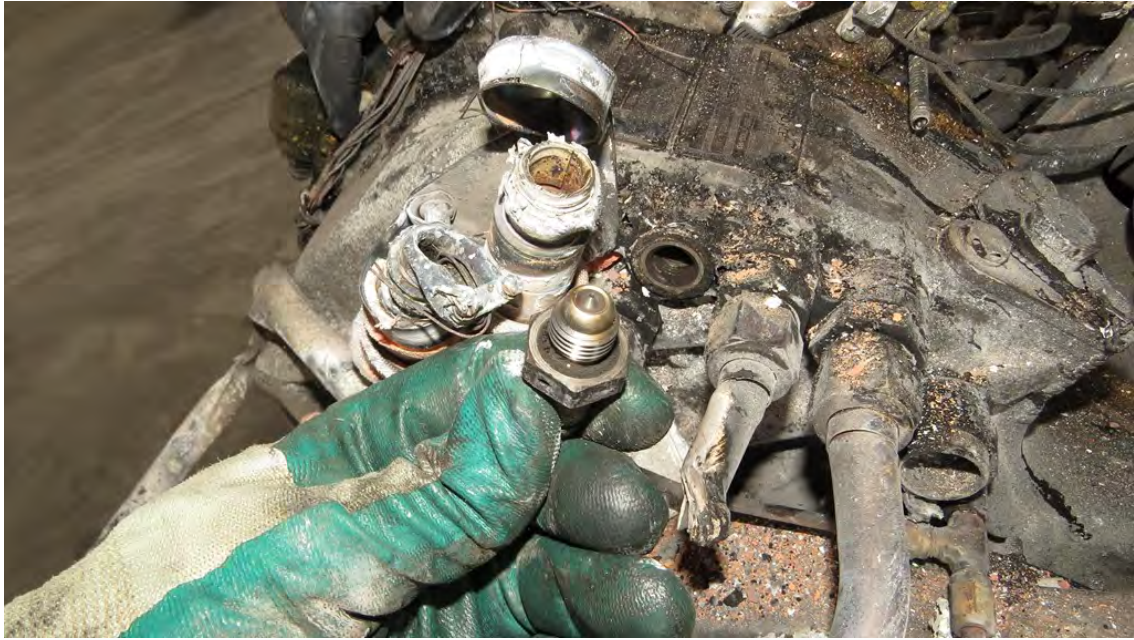
Photo 16 Upper Chip Detector

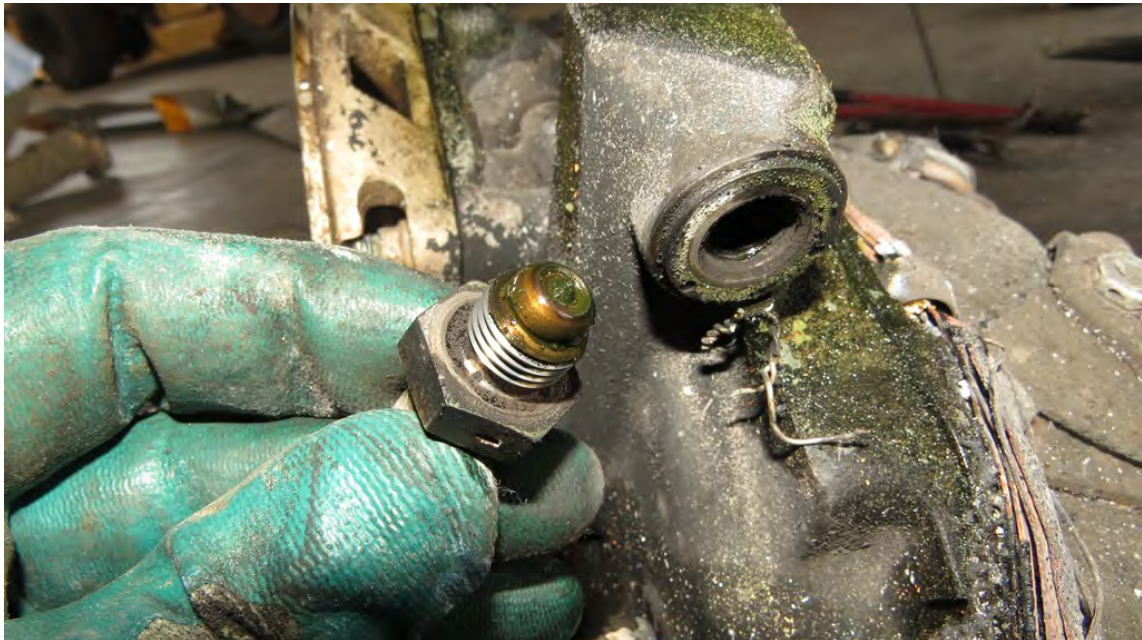
Photo 17 Lower Chip Detector

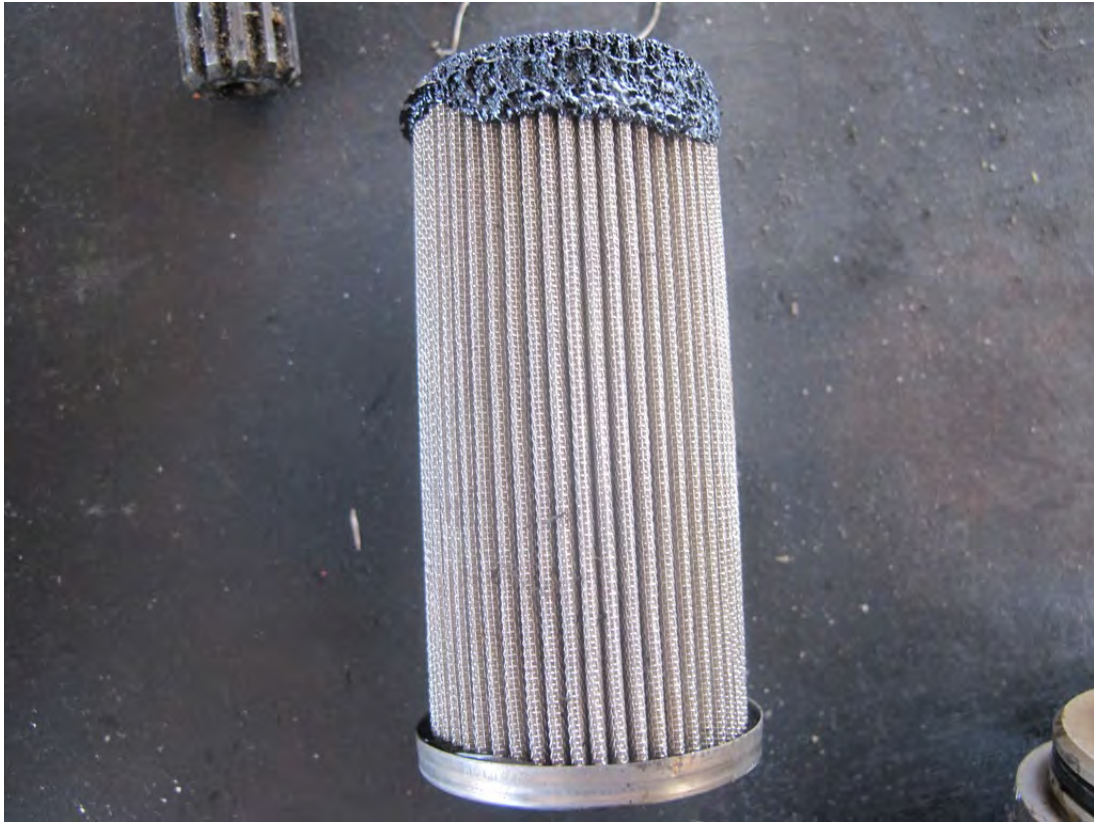
There was no evidence of contamination of the fuel filter.

Photo 18 Fuel Filter

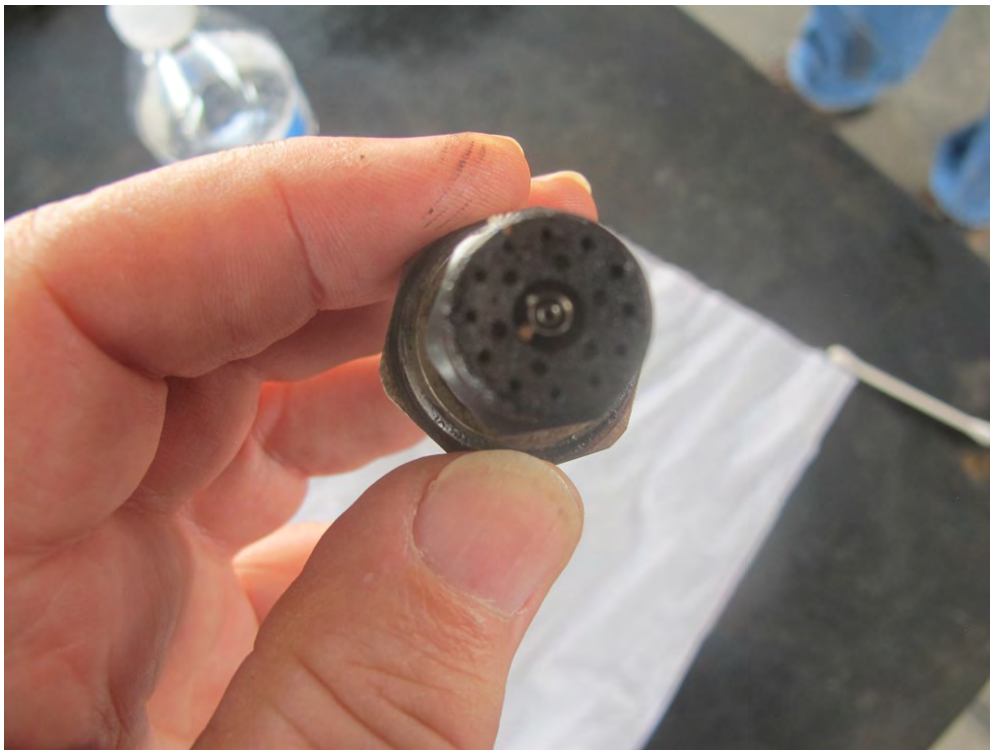
There was clean, clear liquid that smelled like jet fuel in the supply line to the fuel spray nozzle. A water paste test indicated that there was no water contamination. The fuel spray nozzle was normal, and the fuel spray nozzle filter was clean.

Photo 19 Fuel Nozzle

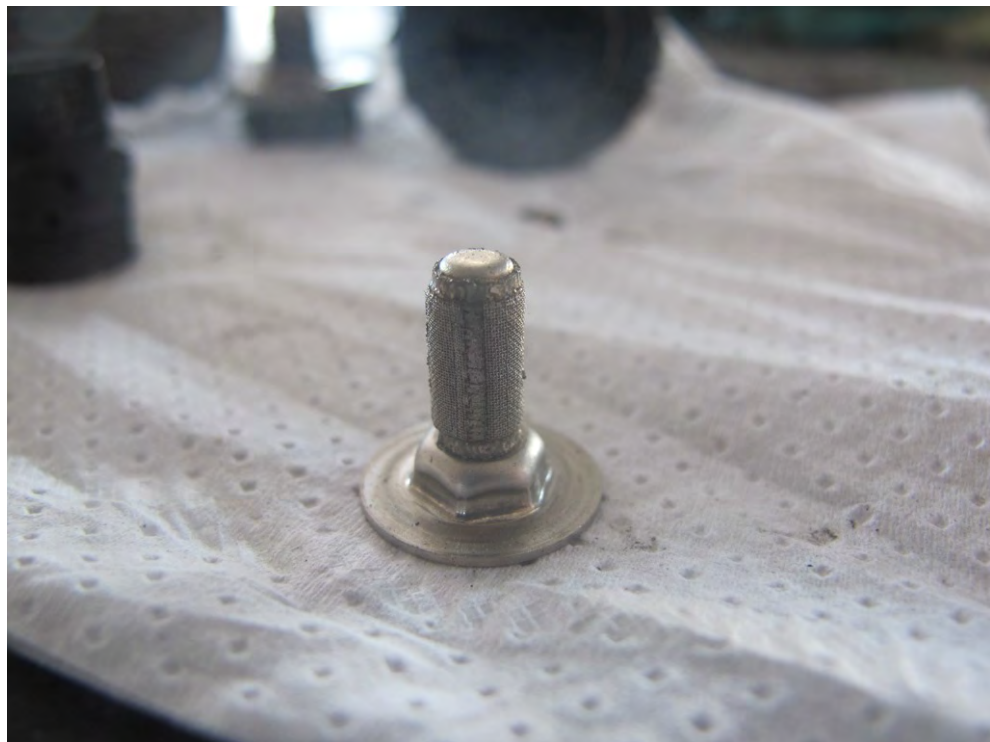
Photo 20 Fuel Spray Nozzle Filter

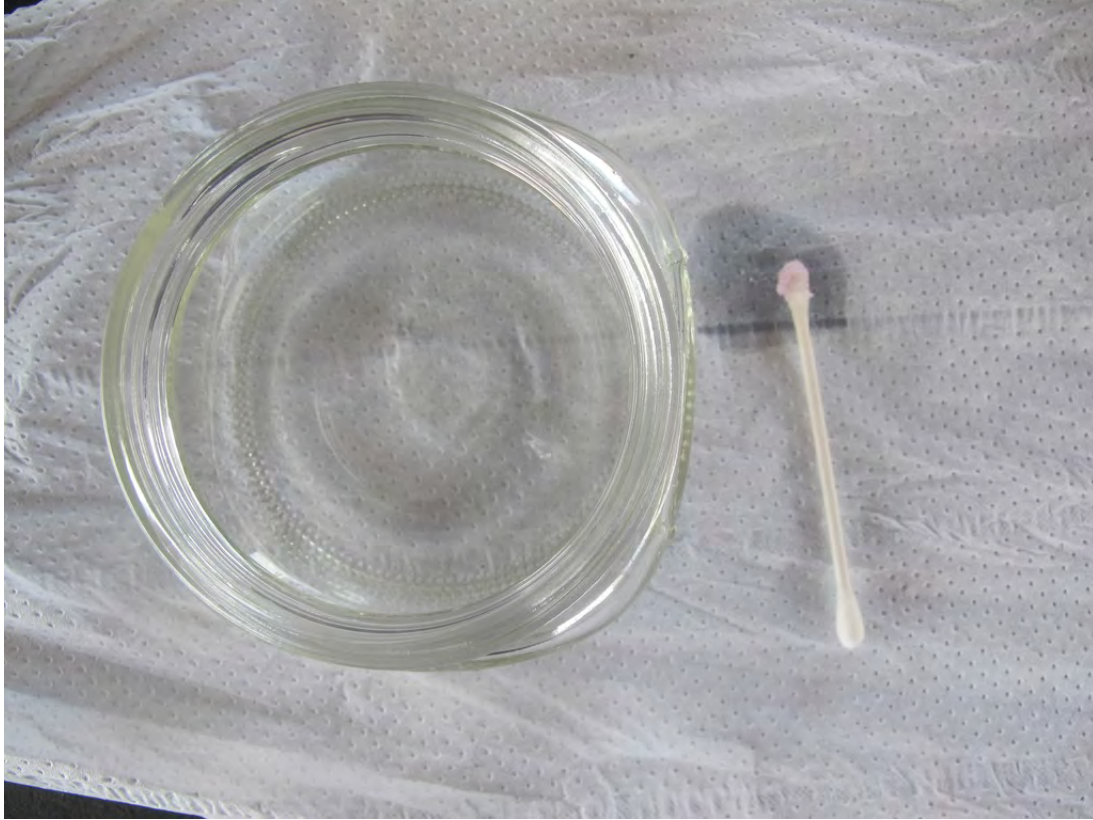
Photo 21 Fuel Sample Water Test
