AIRPLANE EXAMINATION

WPR16FA035

Apple Valley, California

Aero Vodochody – N39AY

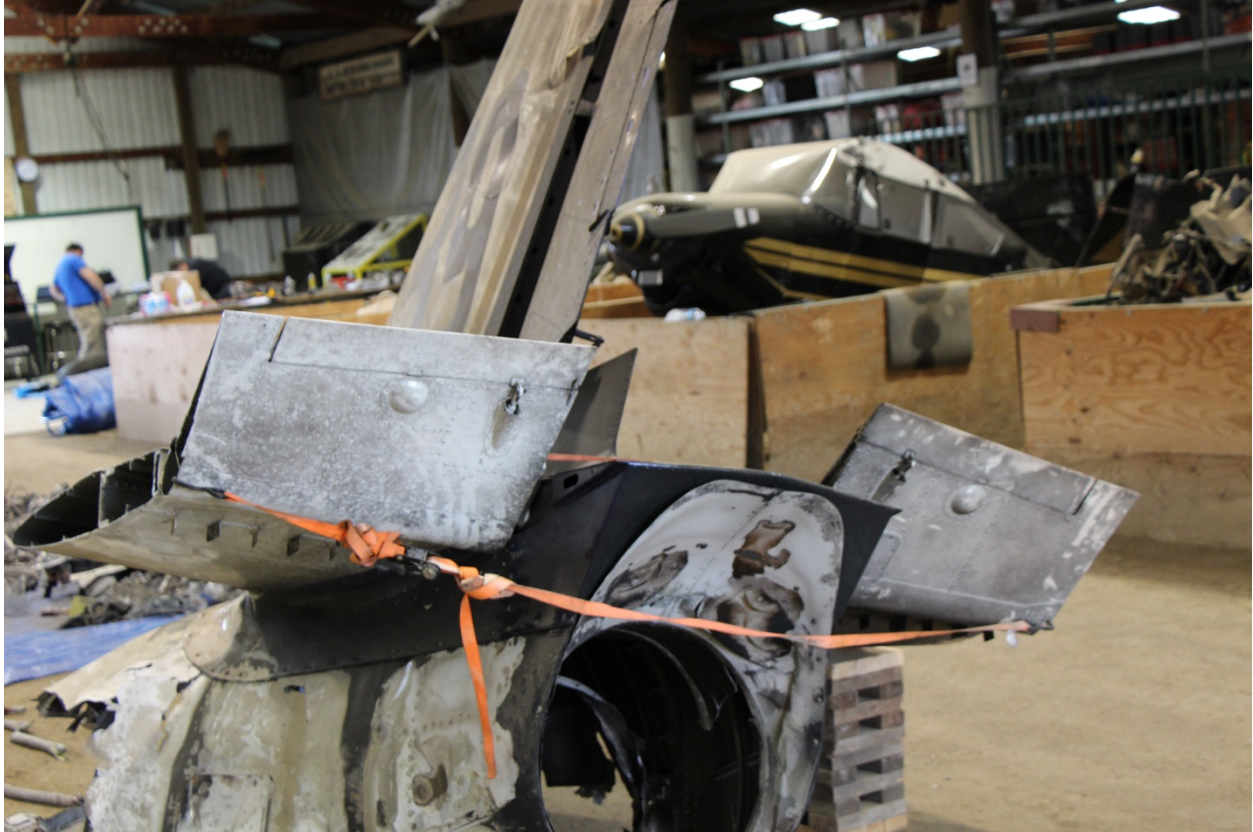
Photograph 1: Flap and pitch trim tabs

The airplane was equipped with flap trim located on the left elevator and an elevator trim tab on the right elevator. According to the manufacturer, the flap trim deflects with the flaps to compensate for aerodynamic ballooning during landing. The flap trim will not display a deflection when the flaps move between the neutral and 25° positions. The elevators were cut one inch outboard of the flap trip and elevator trim tabs in preparation for recovery. Both the elevator and flap trim were in the neutral position (see *photograph 1*); however, the manufacturer reported that a takeoff can be accomplished with elevator trim in either the neutral or takeoff "2 tick mark down" position. The flap and elevator trim surfaces could not be manipulated by hand.

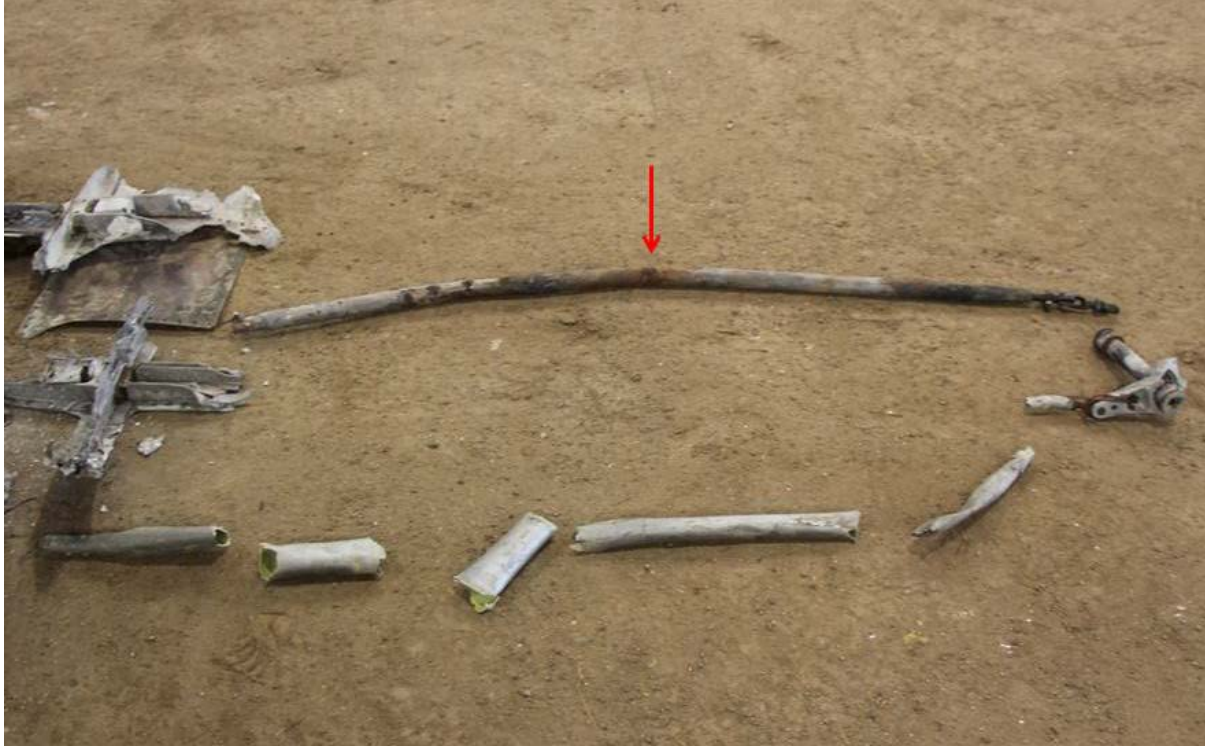
Photograph 2: Elevator/rudder steel control tube

Two control tubes from the elevator and rudder assembly were recovered from the wreckage. The steel control tube normally suspended over the engine was thermally damaged, but remained intact with a slight bend (see *photograph 2*). The aluminum control tube separated from the elevator/rudder bellcrank and fractured into 5 pieces that displayed signatures consistent with overload separation (see *photograph 3*).

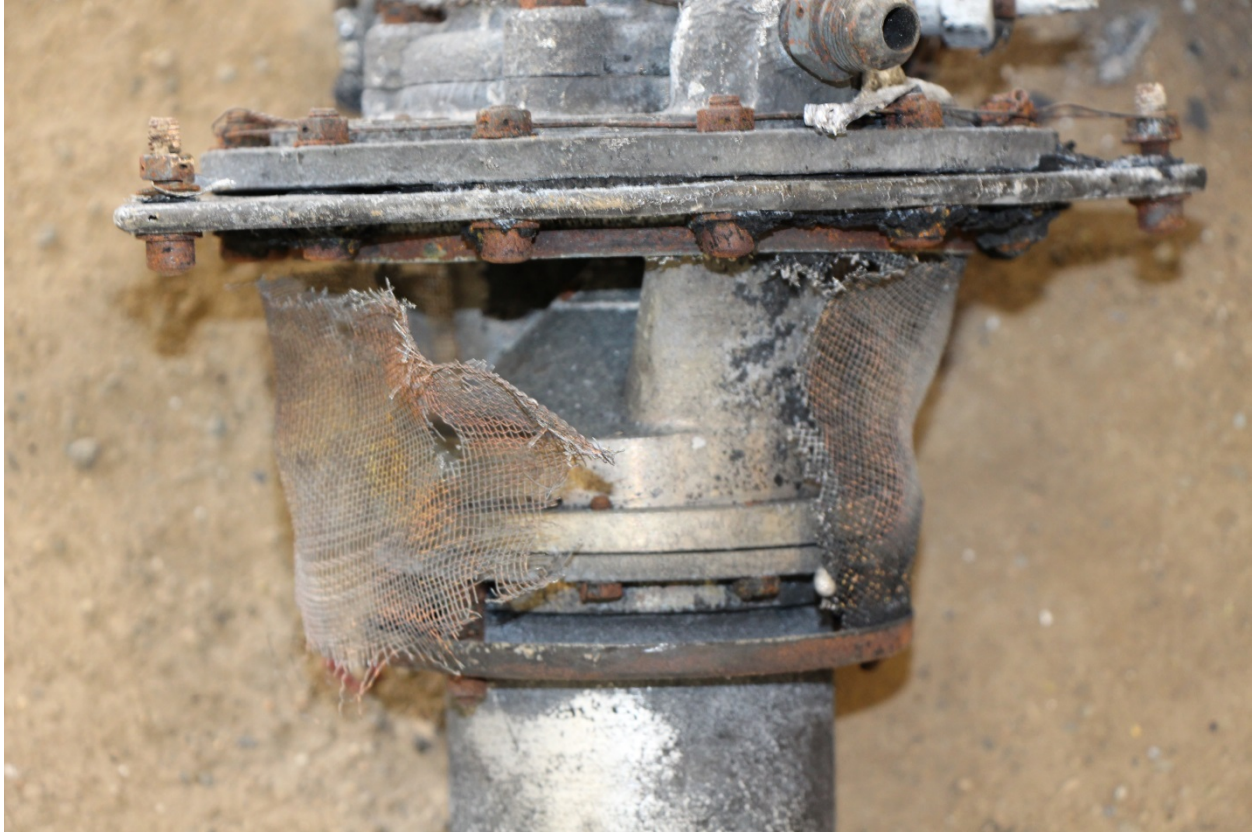
Photograph 4: Low pressure fuel boost pump

The air conditioning unit and most of its assembly, hydraulic bay, low pressure fuel boost pump, and several steel tube bleed lines were recovered from the accident site. The hydraulic tank was breached and the hydraulic bay was melted; some of which was fused to the center fuselage airframe skin. The low pressure fuel boost pump, normally attached to the main tank, was thermally damaged and the screen was partially separated, but did not contain any debris (see *photograph 4*). Examination of the smoke oil tank used to distribute white smoke during aerobatic flights revealed no evidence of a tank breach; however, the unit was void of any oil. Several bleed air tubes exhibited thermal damage and exposure to high temperatures as evidenced by pieces of molten aluminum that were attached to the threaded ends of many of the tubes. Several components of the air conditioning assembly including the condenser, filter, turbo cooler, overpressure relief valve, and assembly tubes were damaged by fire, but did not display any evidence of deformation.

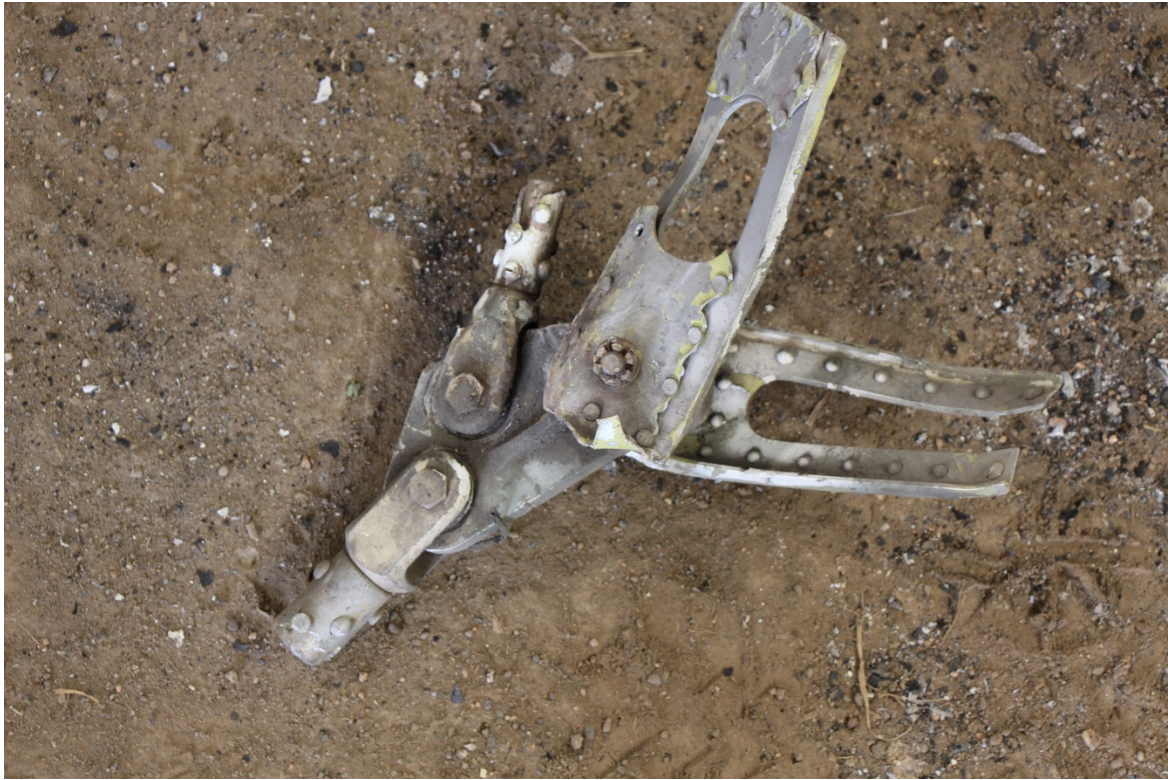
Photograph 5: Left aileron turnbuckle

The bottom half the left aileron with its corresponding trim tab and the bottom half of the right aileron were damaged by fire. The left aileron trim tab separated at the rod end from the aileron hinge, but remained connected to a push pull tube. The left aileron turn buckles were intact; however, the control tubes had separated (see *photograph 5*). The left wing tip tank exhibited significant vertical crush damage indicated by its accordion-like appearance and the containment tank was breached. The left aileron steel and lead balances remained attached to the airfoil. The

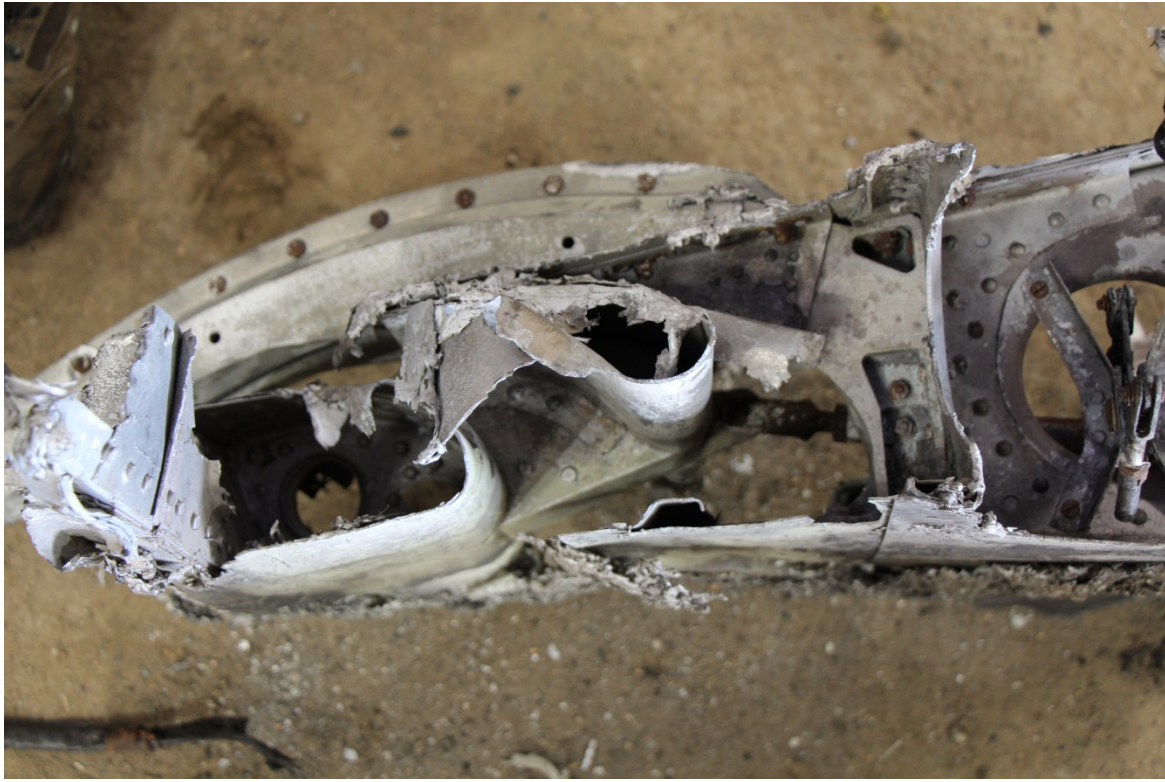
Photograph 6: Right wing flap track

main aileron bell crank was intact, but also separated from its control tubes. The inboard and outboard right wing flap tracks had separated from the wing, but portions of the flaps remained attached to their respective tracks, which indicated a 25° deployed (takeoff) position (see *photograph 6*). The right aileron turnbuckle was attached to a portion of the wing through a bearing (see *photograph 7*). The right aileron leading edge steel balance bar was thermally damaged, but remained connected to a portion of airframe skin. The right main landing gear uplock assembly was intact, but thermally damaged. The left landing gear door bell-crank was intact. The right wing pitot tube was intact, but the hoses were impacted separated at the tube root.

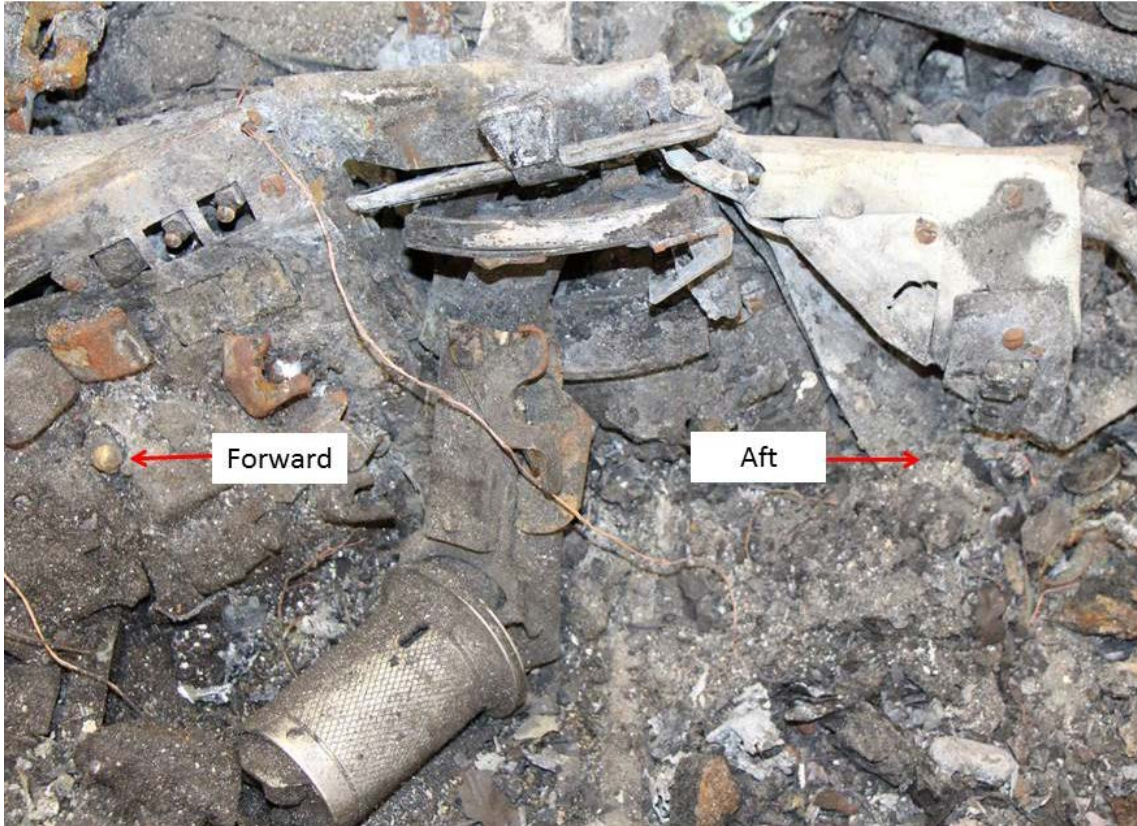
Photograph 8: Front seat occupant throttle

The front seat occupant throttle lever was located in the full forward position beyond the detent and fixed (see *photograph 8*). The rear seat occupant throttle had broken free of the fuselage structure and could be manipulated by hand, which precluded an evaluation of the lever position (see *photograph 9*). The front seat occupant's rudder pedal assembly remained intact and had been adjusted to the forward position; however, the left rudder pedal was bent approximately 50° forward and the right rudder pedal was bent about 25° forward (see *photograph 10*). Both control tubes separated from the pedals and bell crank mounts. The rear seat occupant's rudder assembly was also intact; the control tubes remained attached and the rudder pedal mounting tubes were straight (see *photograph 11*). The rudder assembly was in the aft position.

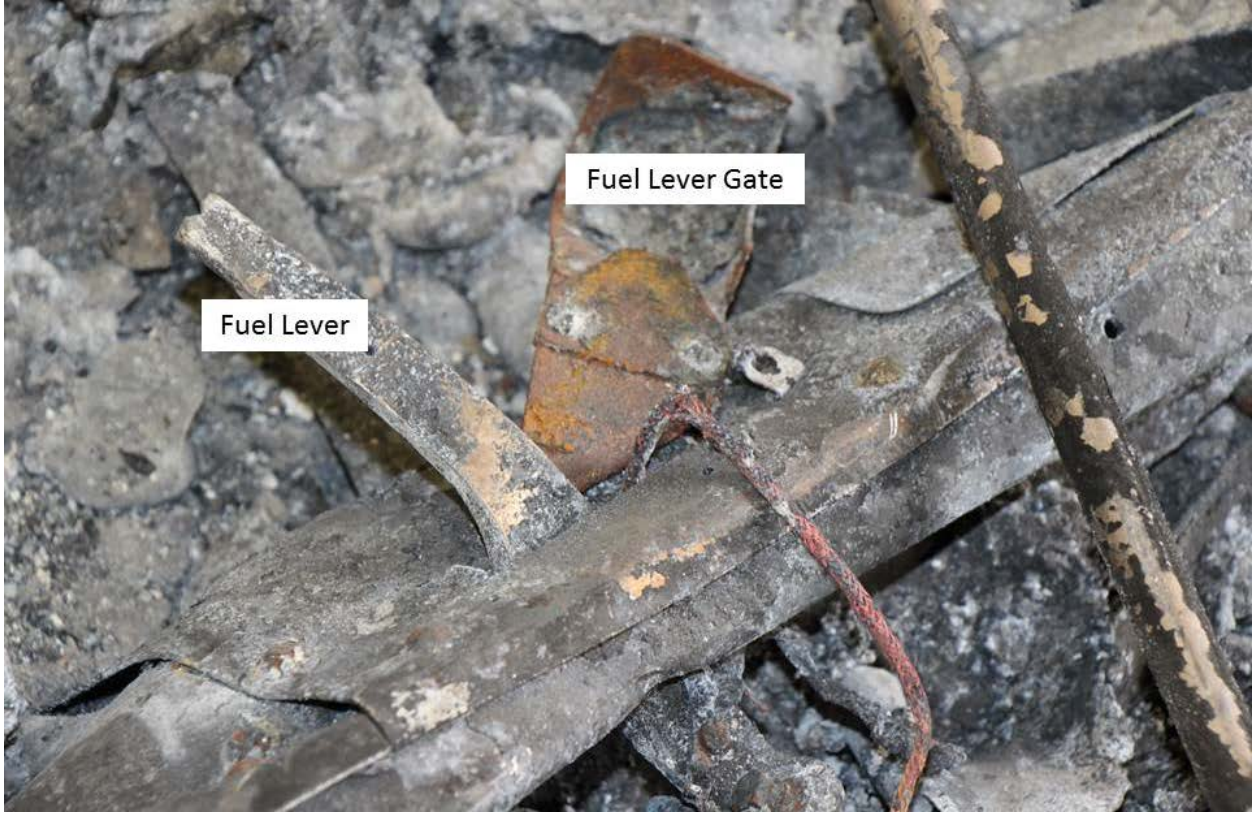
Photograph 12: Fuel cutoff lever and protective gate

The front seat passenger fuel cutoff remained attached to the left side cockpit fuselage. The fuel lever was in the full aft position (closed) and bent about 10° (see *photograph 12*). The fuel lever was in the full aft position (closed) and the protective gate that prevents inadvertent manipulation of the fuel cutoff remained attached to the fuel lever assembly. Both the lever and the gate were bent to the side about 10° by impact forces (see *photograph 12*).

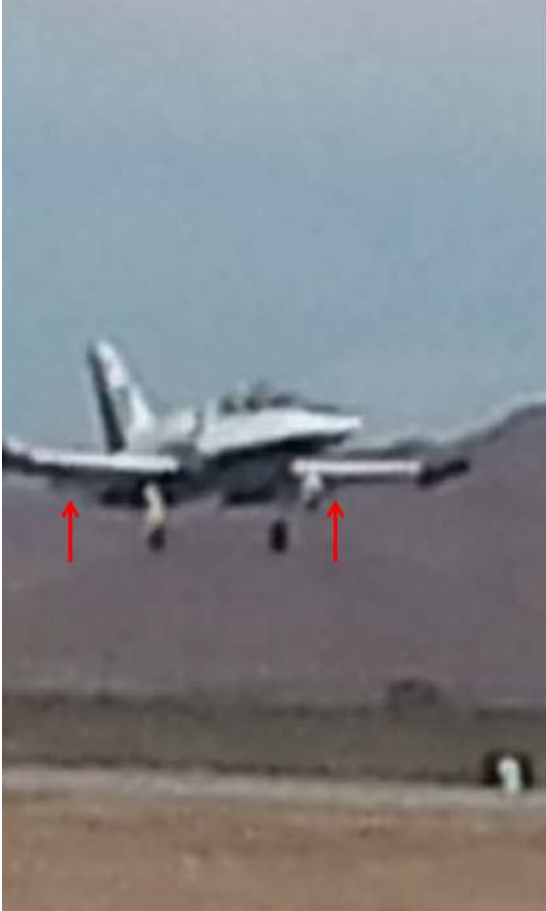
Photograph 13: Airplane during takeoff

A photograph taken by an observer revealed that the flaps were deployed during takeoff (see *photograph 13*).
