**National Transportation Safety Board**  
Office of Research and Engineering  
Washington, D.C. 20594

**Airplane Performance Study**

Location: Duluth, MN  
Date: June 7, 2014  
Time: 1121 CDT  
Airplane: Lancair IV, Registration N86NW  
NTSB Number: CEN14FA278

**CEN14FA278, Experimental Lancair IV, N86NW, 6/7/2014**

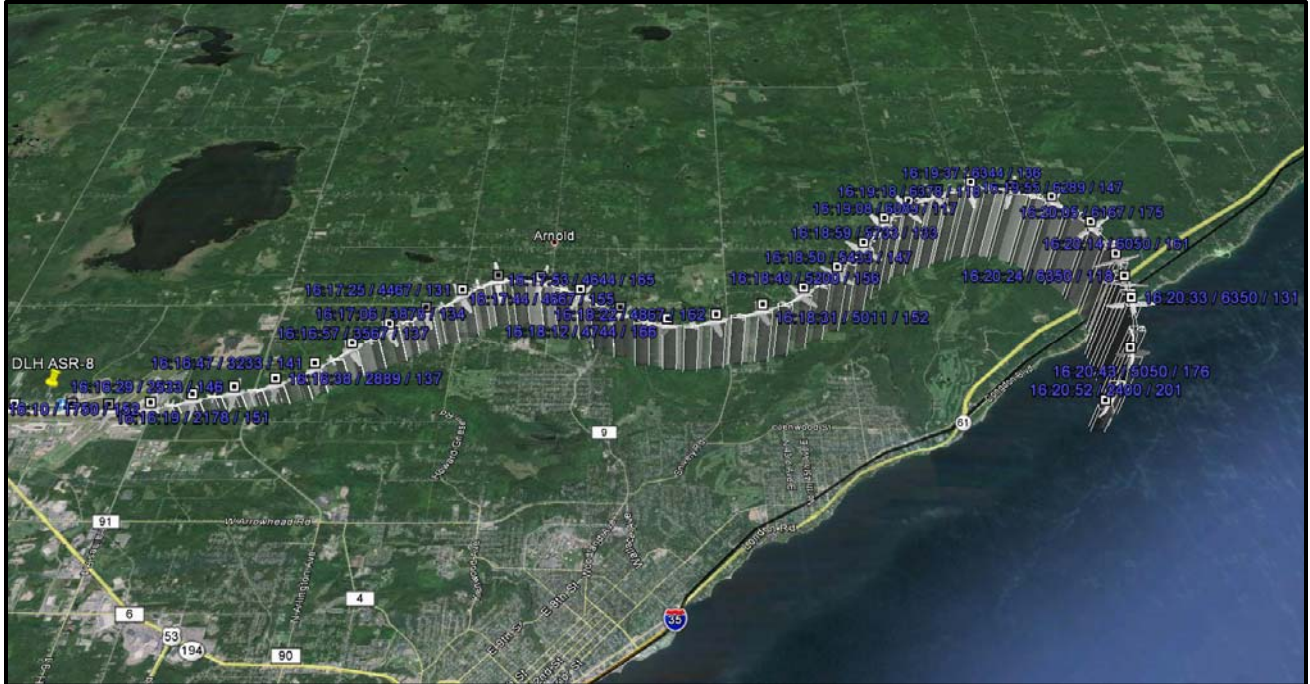
**Figure 4: Radar Ground Track with hh:mm:ss (GMT) / hmsl (ft) / Vc (kt)**

Figures 4 and 5 highlight the radar ground track for N86NW as the airplane departed Duluth International airport. Each radar point in the figures has an associated GMT time, altitude above mean sea level  $\pm$  50 ft, and a calculated calibrated airspeed in knots (in blue)<sup>2</sup>. Figure 6 shows the airport diagram for Duluth International including the departure runway 9.

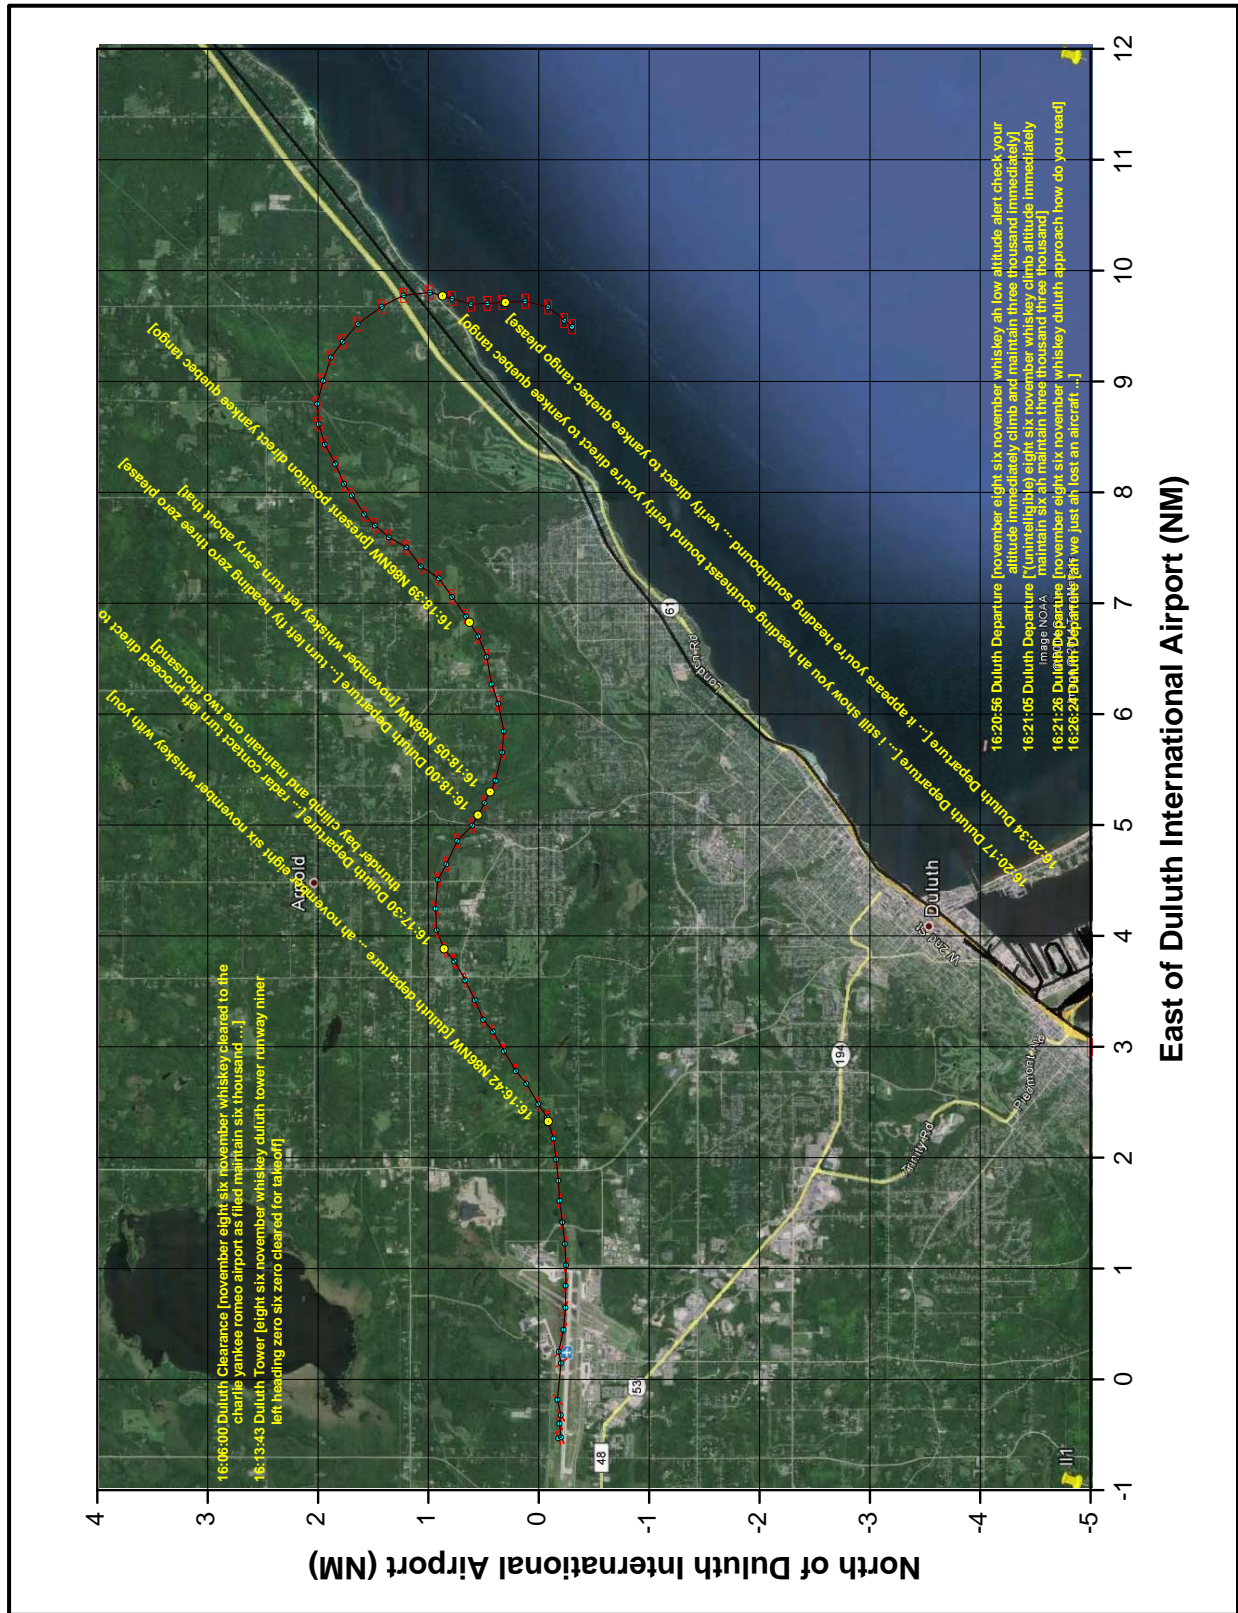
**Figure 7: Radar Track from Duluth International Airport (KDLH ASR-8 Radar) with Select ATC Communications**

Figure 7 shows the radar points<sup>3</sup> as well as select radio communications between N86NW and the Duluth control tower and departure control. Duluth departure control repeated N86NW's assigned heading (zero three zero/direct CYQT) twice in the short five minute accident flight. This is consistent with the secondary radar returns in Figure 7 that show the airplane repeatedly turning to the southeast instead of the assigned northeast heading.

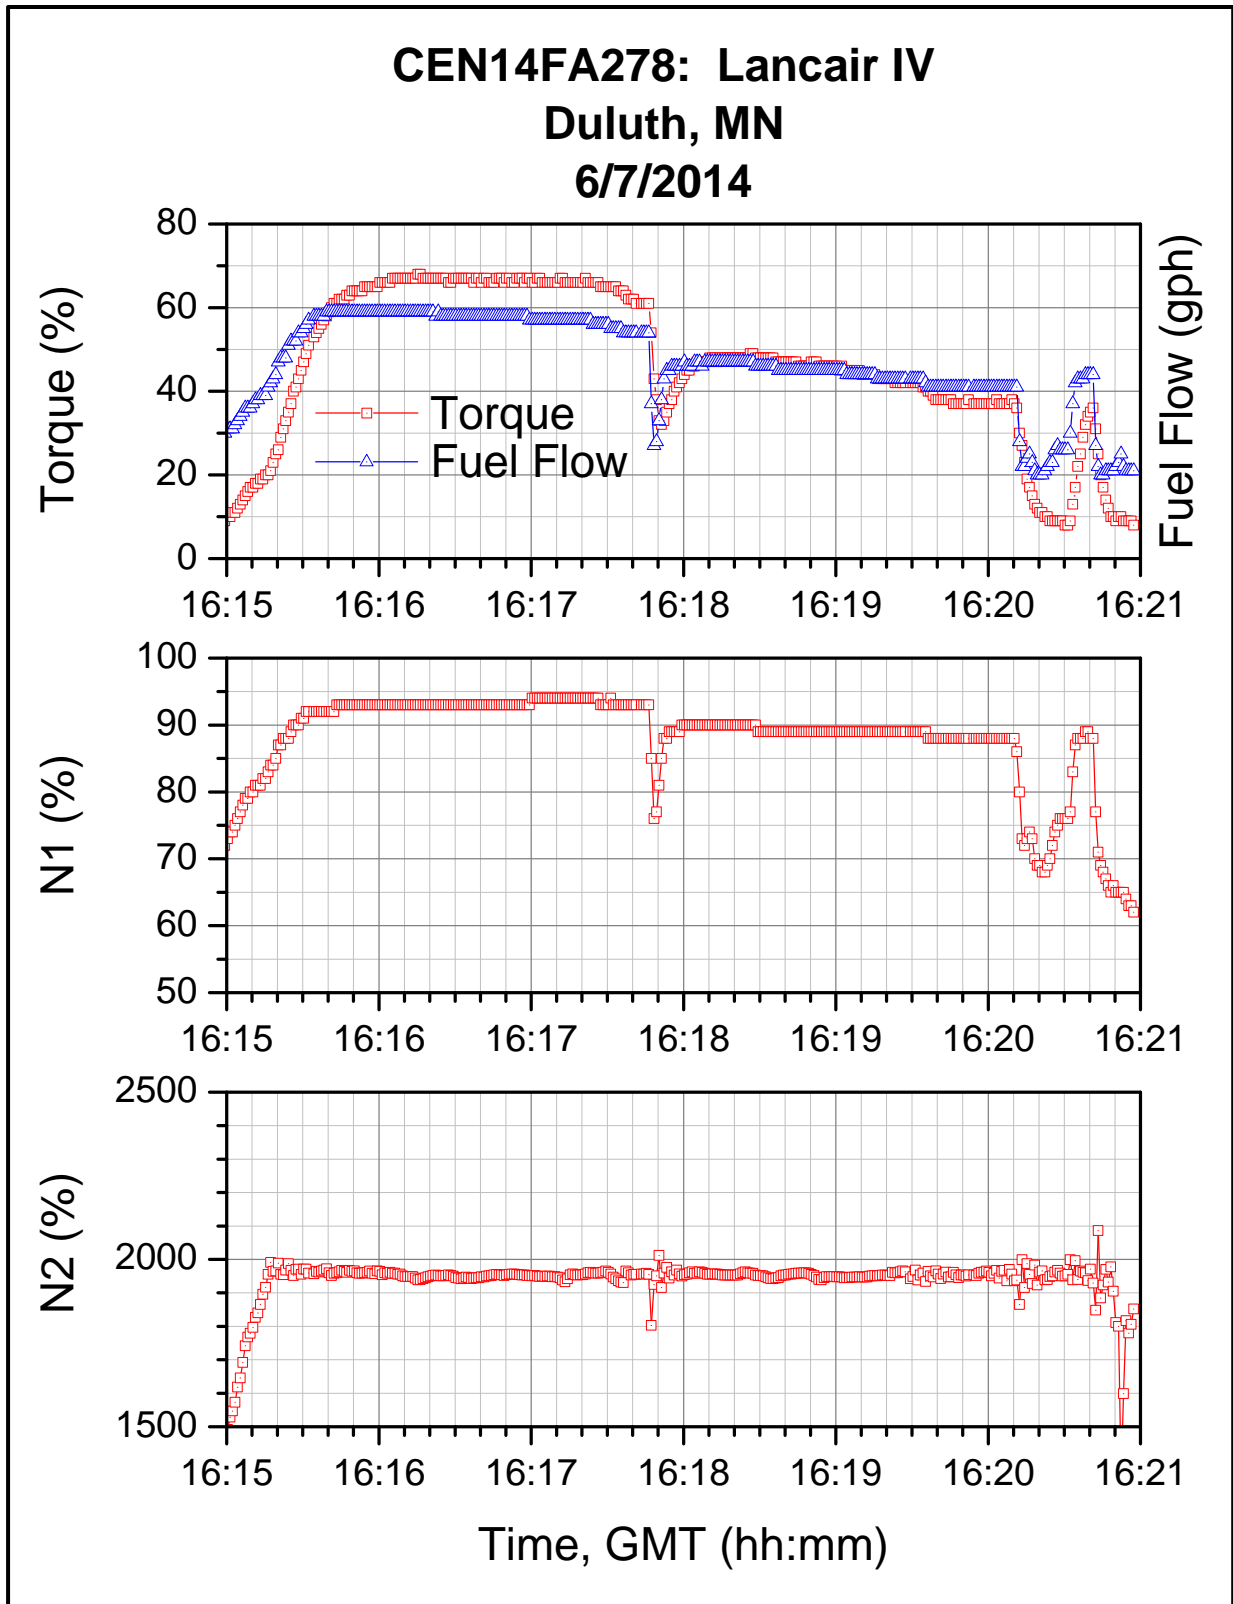
Figure 12: Engine Parameters Based on Chelton IDU

Figures 12 through 14 include engine and wind parameters recovered from the Chelton IDU. Figures 12 and 13 indicate that the engine was operating at or near 90% N1 with torque between 40% and 70% until just before the final descent into Lake Superior. There was a momentary reduction in N1, torque, and fuel flow at about 16:17:46 where the airplane leveled off at approximately 4,600 ft msl before continuing to climb to 6,600 ft msl.

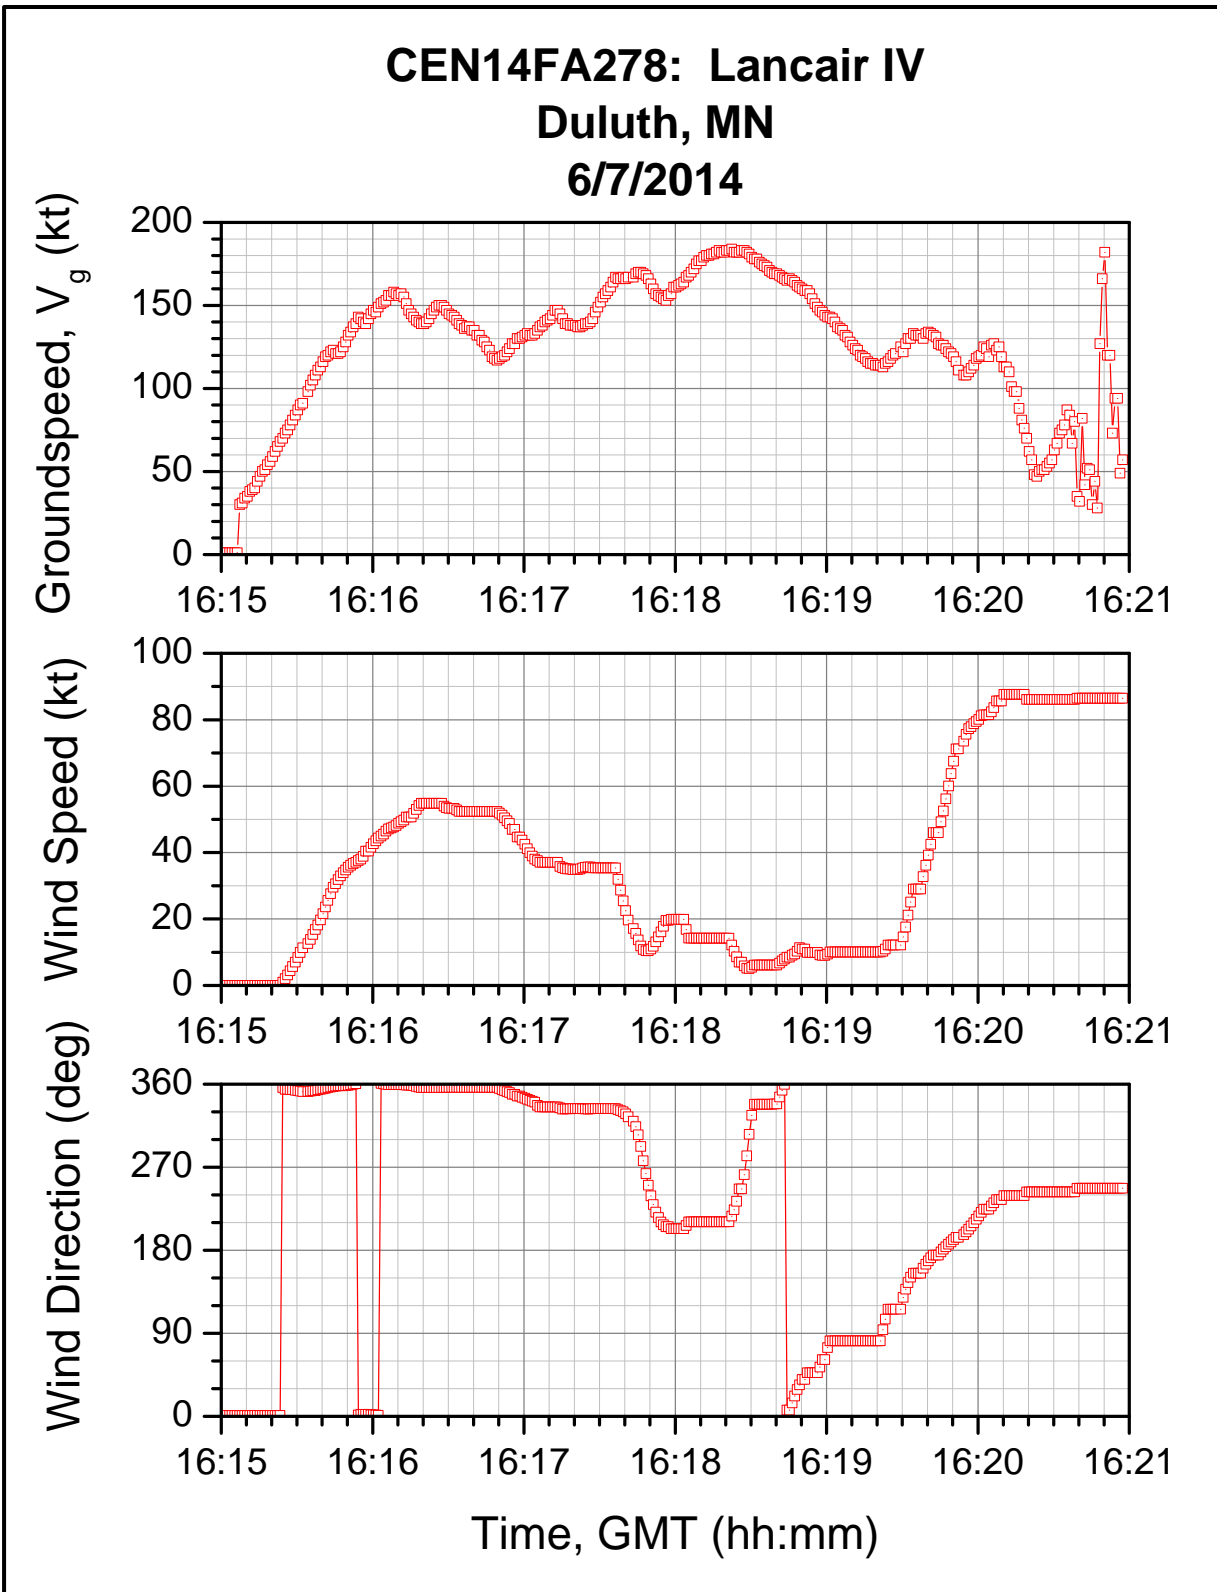
Figure 14: Groundspeed, Wind Speed and Wind Direction Based on Chelton IDU

Figure 14 highlights the groundspeed, wind speed, and wind direction recorded in the Chelton log files during the climb. Wind speed on the climb to 6,600 ft msl varied between 5 kt and 88 kt. Wind direction in the log varied counterclockwise from 360° to 203° and then back (clockwise) to 338°. It then continued clockwise from 338° to 247° when the data ended. This represents over a 360° change in wind direction (i.e., 203° clockwise to 247°) in less than three minutes.

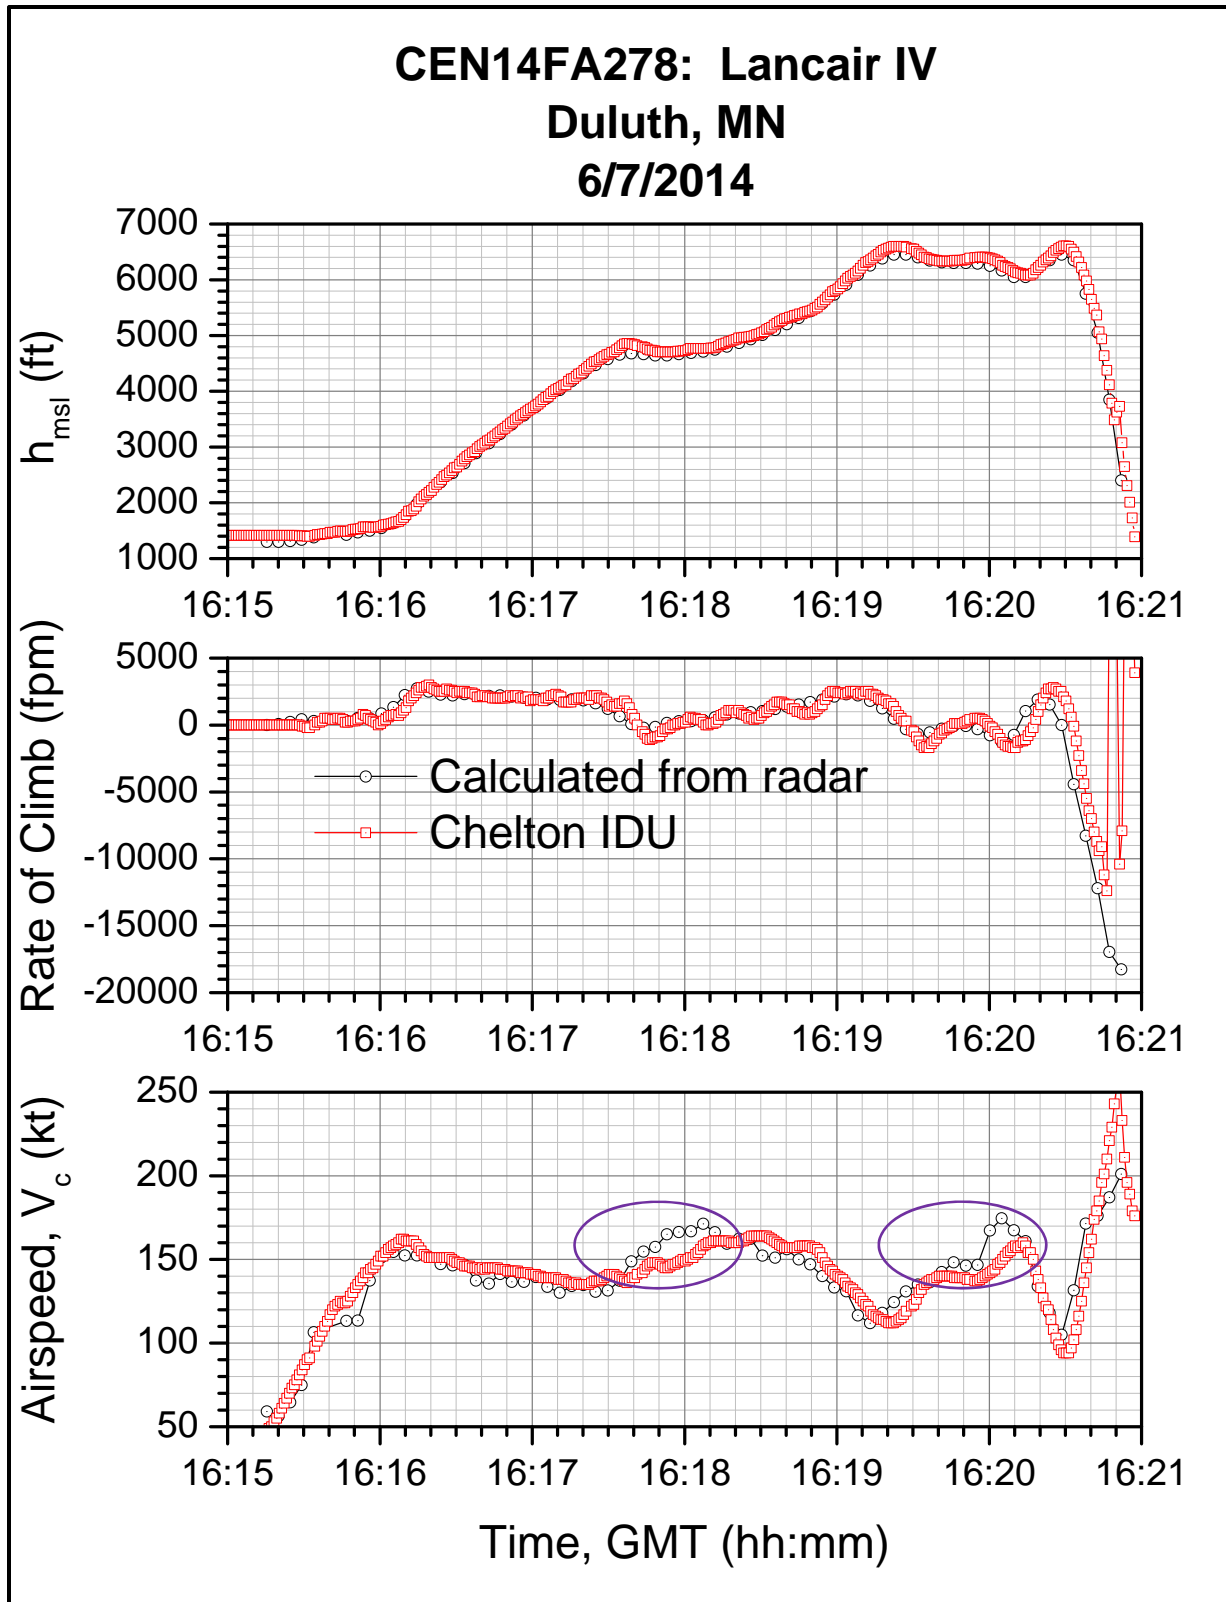
Figure 15: Altitude and Speed Based on Radar with Chelton IDU Overlaid

Figures 15 through 17 reproduce some of the earlier radar plots but with the recovered Chelton log data overlaid for comparison. Figure 15 shows a relatively good match between the recorded altitude, rate of climb, and airspeed with the equivalent parameters derived from KDLH radar data. However, there are two windows approximately 30 sec in length (the first centered around 16:17:40 and the second at 16:19:50, both highlighted in purple in the figure) where the radar-derived airspeed exceeds the airspeed recorded in the log file by 10 kt to 20 kt.

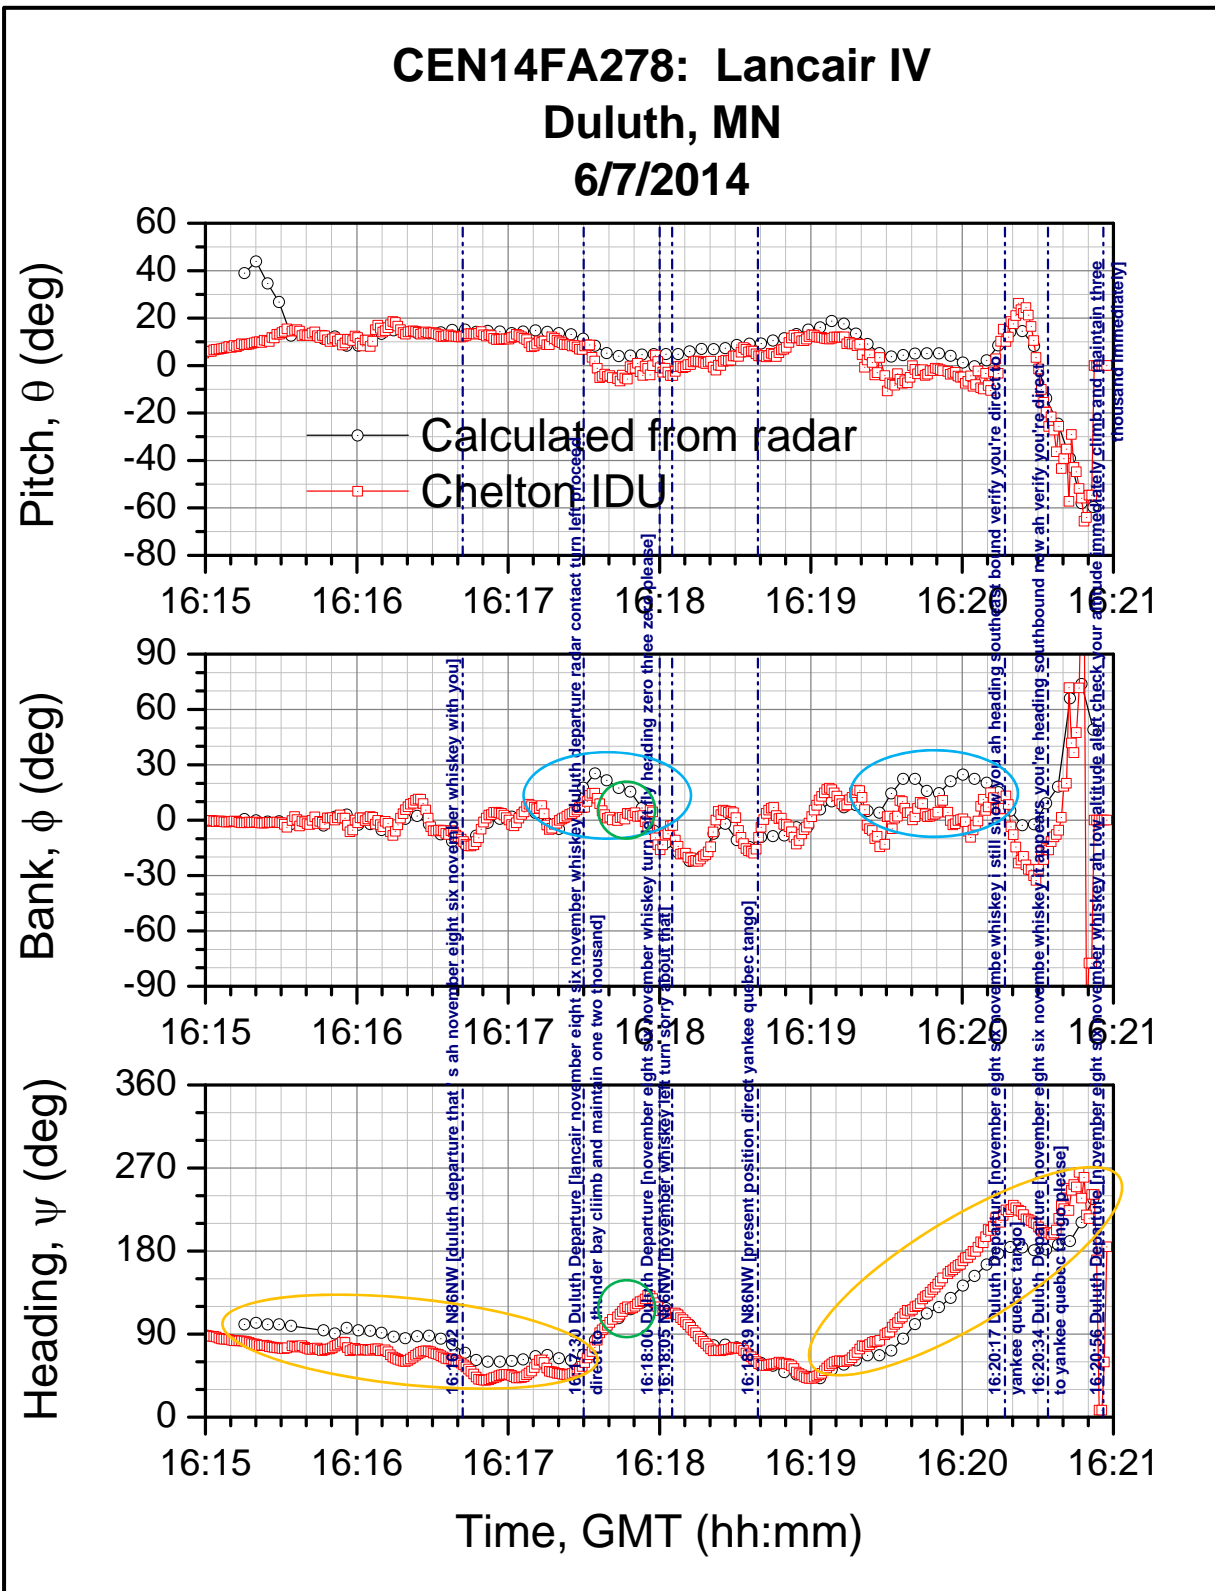
Figure 16: Pitch, Bank, and Heading Based on Radar with Chelton IDU Overlaid

Figures 16 and 17 highlight the differences between the radar-derived Euler angles and those recorded in the log file. These figures also include timing of select radio communication between ATC and N86NW. As previously mentioned with Figure 7, Duluth departure control repeatedly reminded N86NW of its assigned heading (030°) to Thunder Bay.

The two windows described above for airspeed in Figure 15 also apply to bank angle in Figures 16 and 17 and are also highlighted in blue. While the timing is similar, the magnitude of the differences is different. The radar-derived bank angle exceeds the bank recorded in the log file by as much as 25° (i.e., more right-wing-down). Figure 17 breaks out bank angle for more clarity.

The other notable difference in the comparison is between the heading derived from radar and that recorded in the log file (shown in orange in Figure 16). For nearly two minutes, early in the flight, the log file heading is 20° to 25° more airplane-nose-left than that estimated from radar. (This could account for the 30 kt to 50 kt wind from the north recorded in the log file and shown in Figure 14.) From 16:19:20 until the end of the data the log file heading is upwards of 45° more airplane-nose-right than that estimated from radar. (This could account for the 88 kt wind from the southwest recorded in the log file and shown in Figure 14.)

Finally, there appears to be an anomaly between the recorded log file bank angle and the recorded heading shown in Figure 16. During the first 30 sec window centered at 16:17:40, the log data show little or no bank while the heading shows the airplane turning to the south/right<sup>5</sup>. The anomaly is highlighted in green in the figure.
