Sinking of Cargo Vessel *El Faro*  
Atlantic Ocean, Northeast of Acklins and  
Crooked Island, Bahamas  
October 1, 2015

## Accident Overview Sinking of Cargo Vessel *El Faro*

## Accident Narrative: Sinking of Cargo Vessel *El Faro*

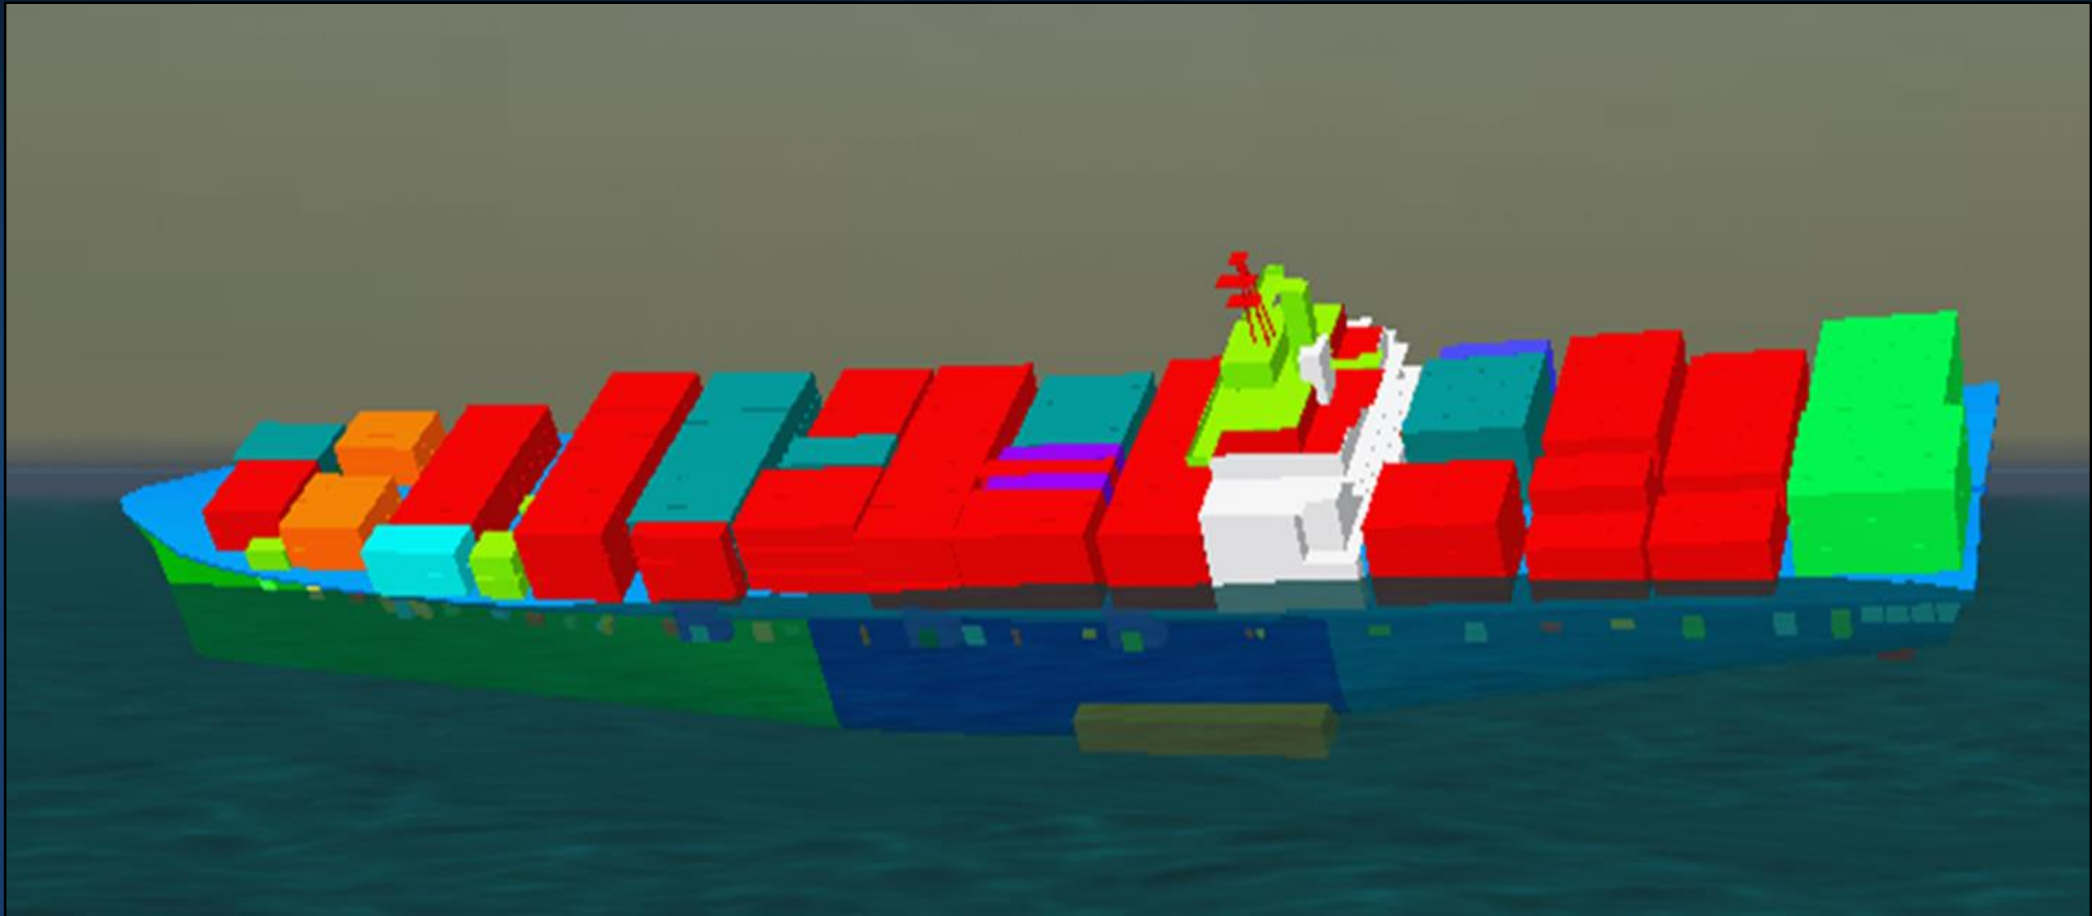
Extreme list to port

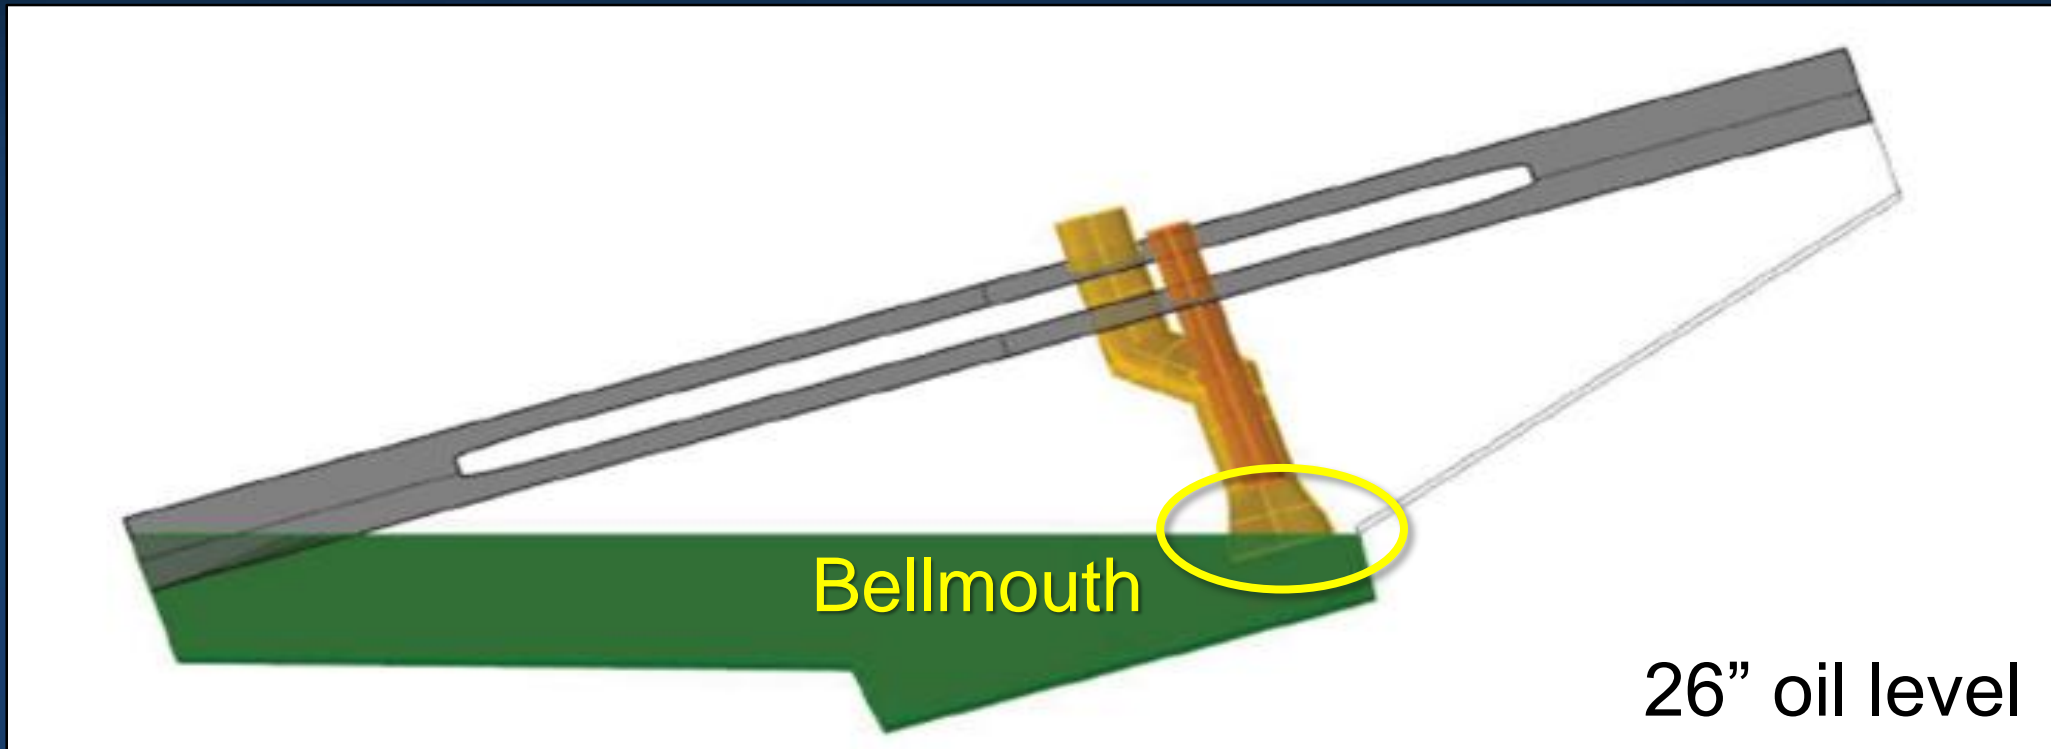
18° list to port – looking forward

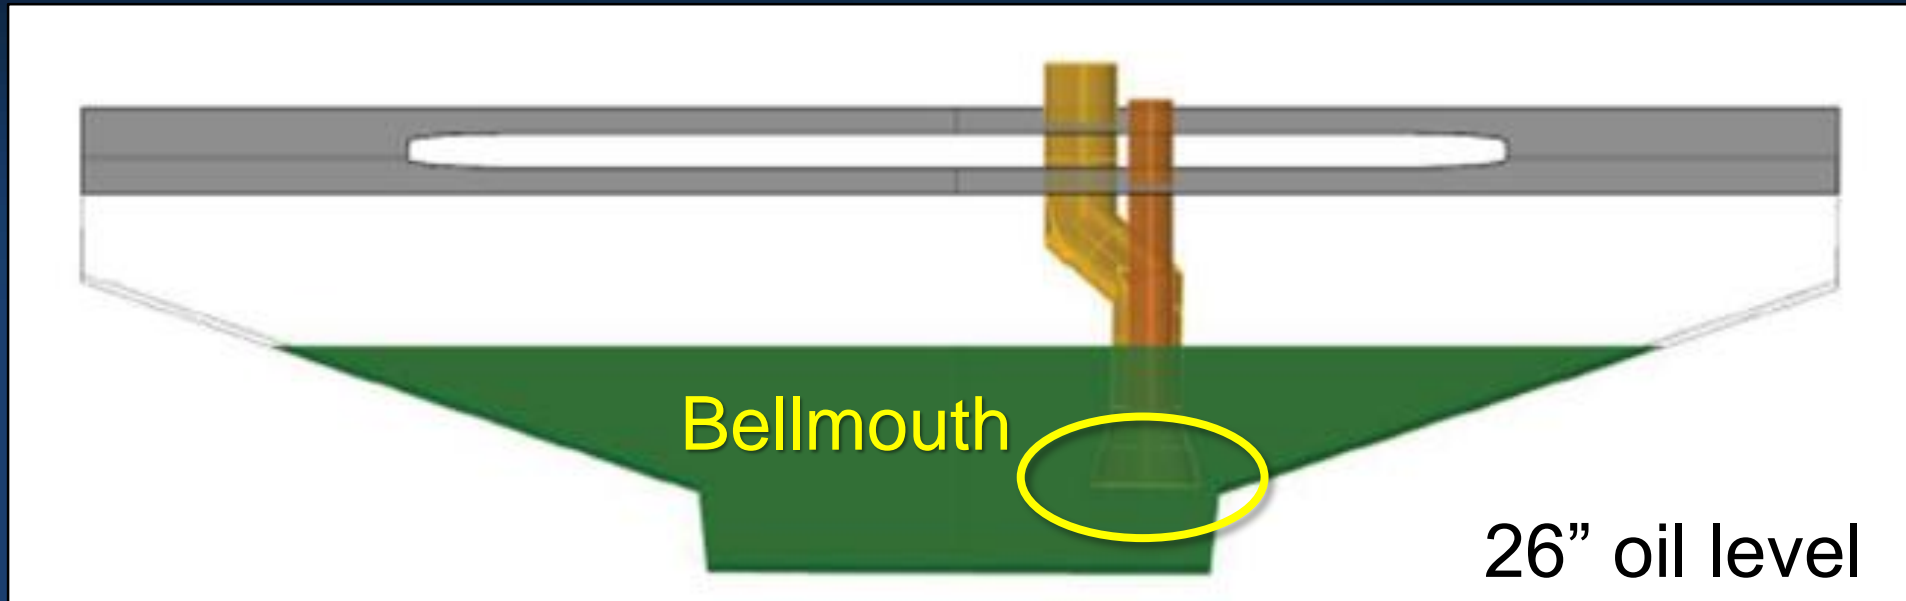
25" = 1,255 gallons

26" = 1,346 gallons

27" = 1,436 gallons

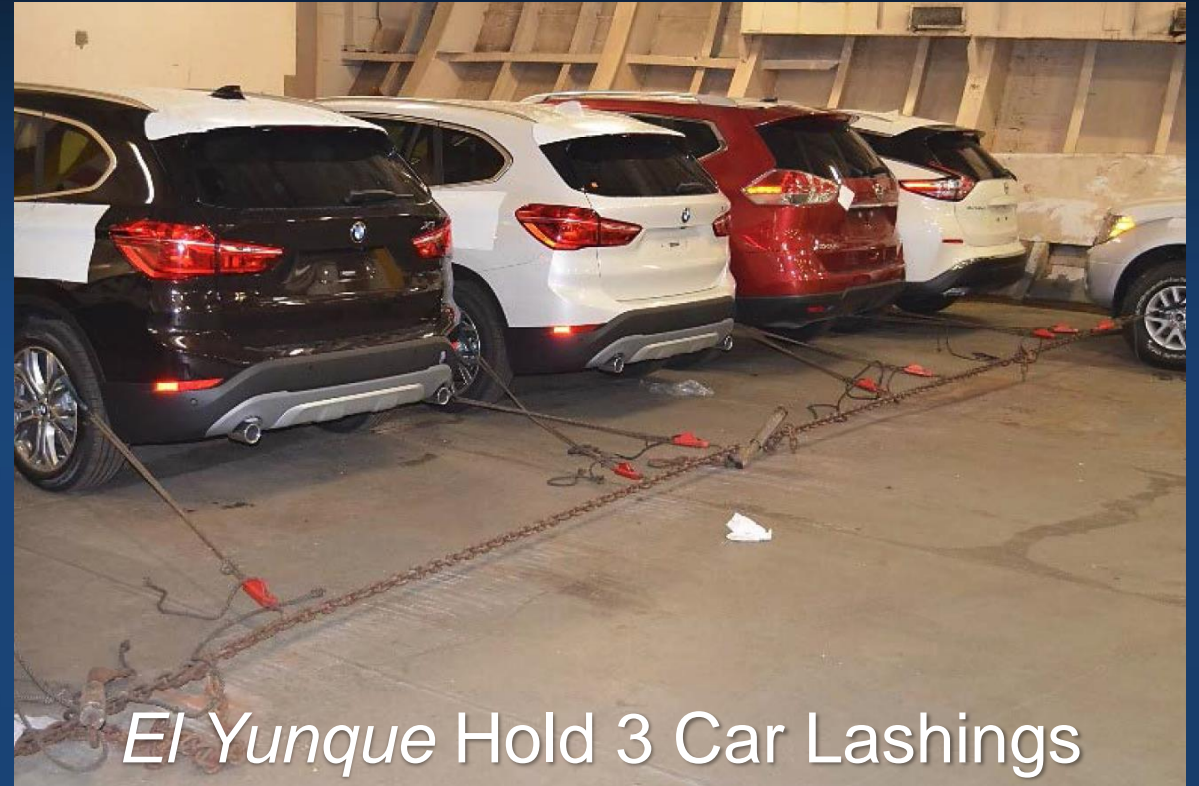
*El Yunque Hold 3 Car Lashings*

- Automobile lashings did not conform to cargo-securing manual
- Cars were more likely to shift during heavy weather

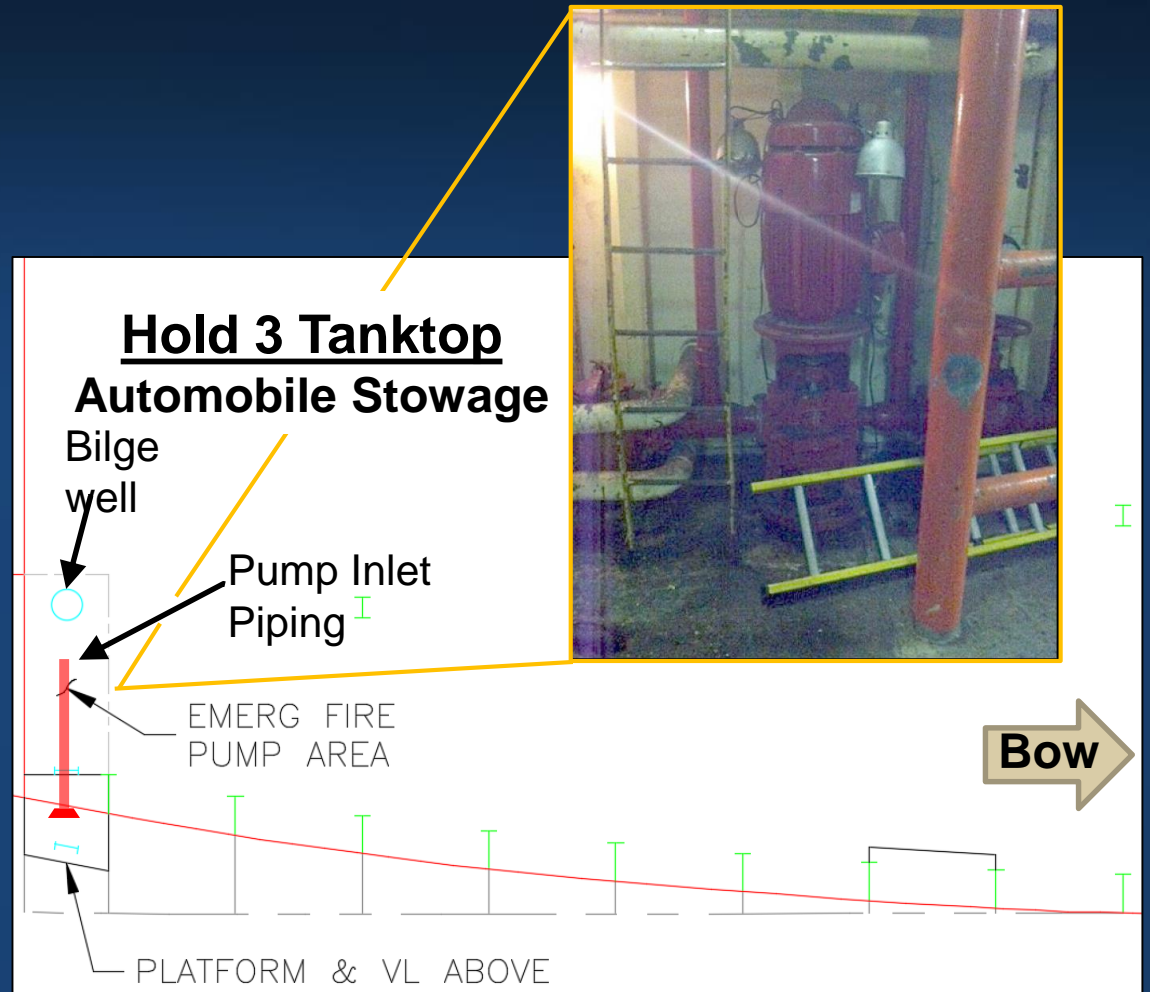
- Cars loose in hold 3 at 0544
- Bilge pumps already running
- Scuttle secured about 0600, but hold 3 still flooding
- Piping to fire pump possible source of flooding
- Loose cars could have struck piping to fire pump

- Damaged piping potentially flooded hold 10% to 20% by 0716
- MSC hydrostatic analysis
  - Beam-to 80-knot wind after loss of propulsion
  - Hold 3 flooded 10% to 30%
  - Rolling about sustained windheel
  - Vessel susceptible to capsizing
- Damage to seawater piping in hold 3 most likely led to flooding in the hold, which significantly compromised vessel's stability

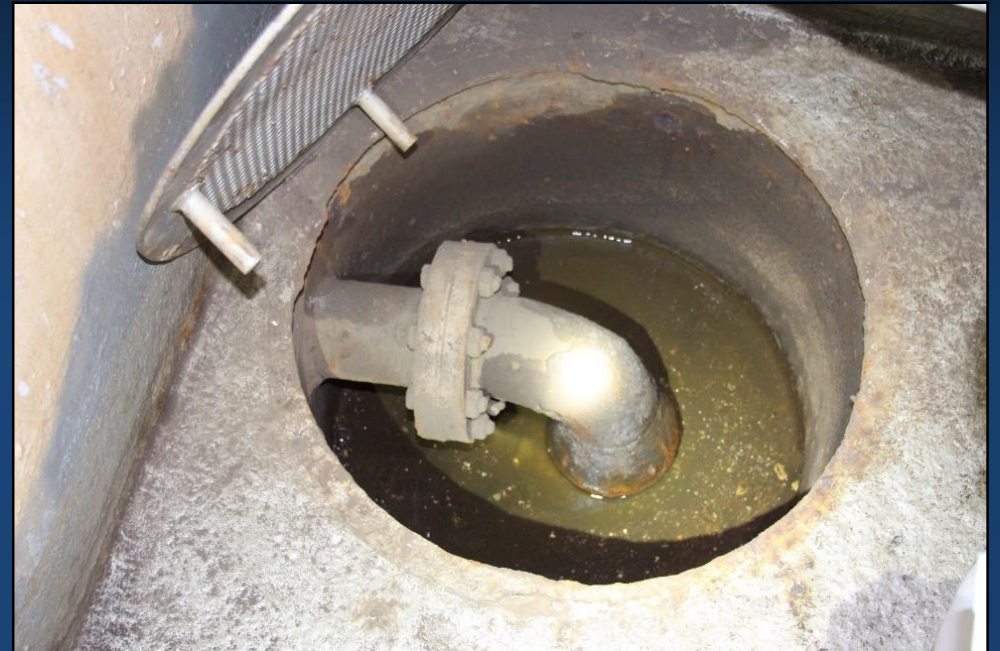
*El Yunque Bilge Well, Hold 3*

- Two bilge wells per cargo hold (port and starboard)
- Bilge system operated continuously from at least 0544
- Flooding in hold 3 exceeded design capacity of bilge pumps
- Water level continued to rise despite pumping

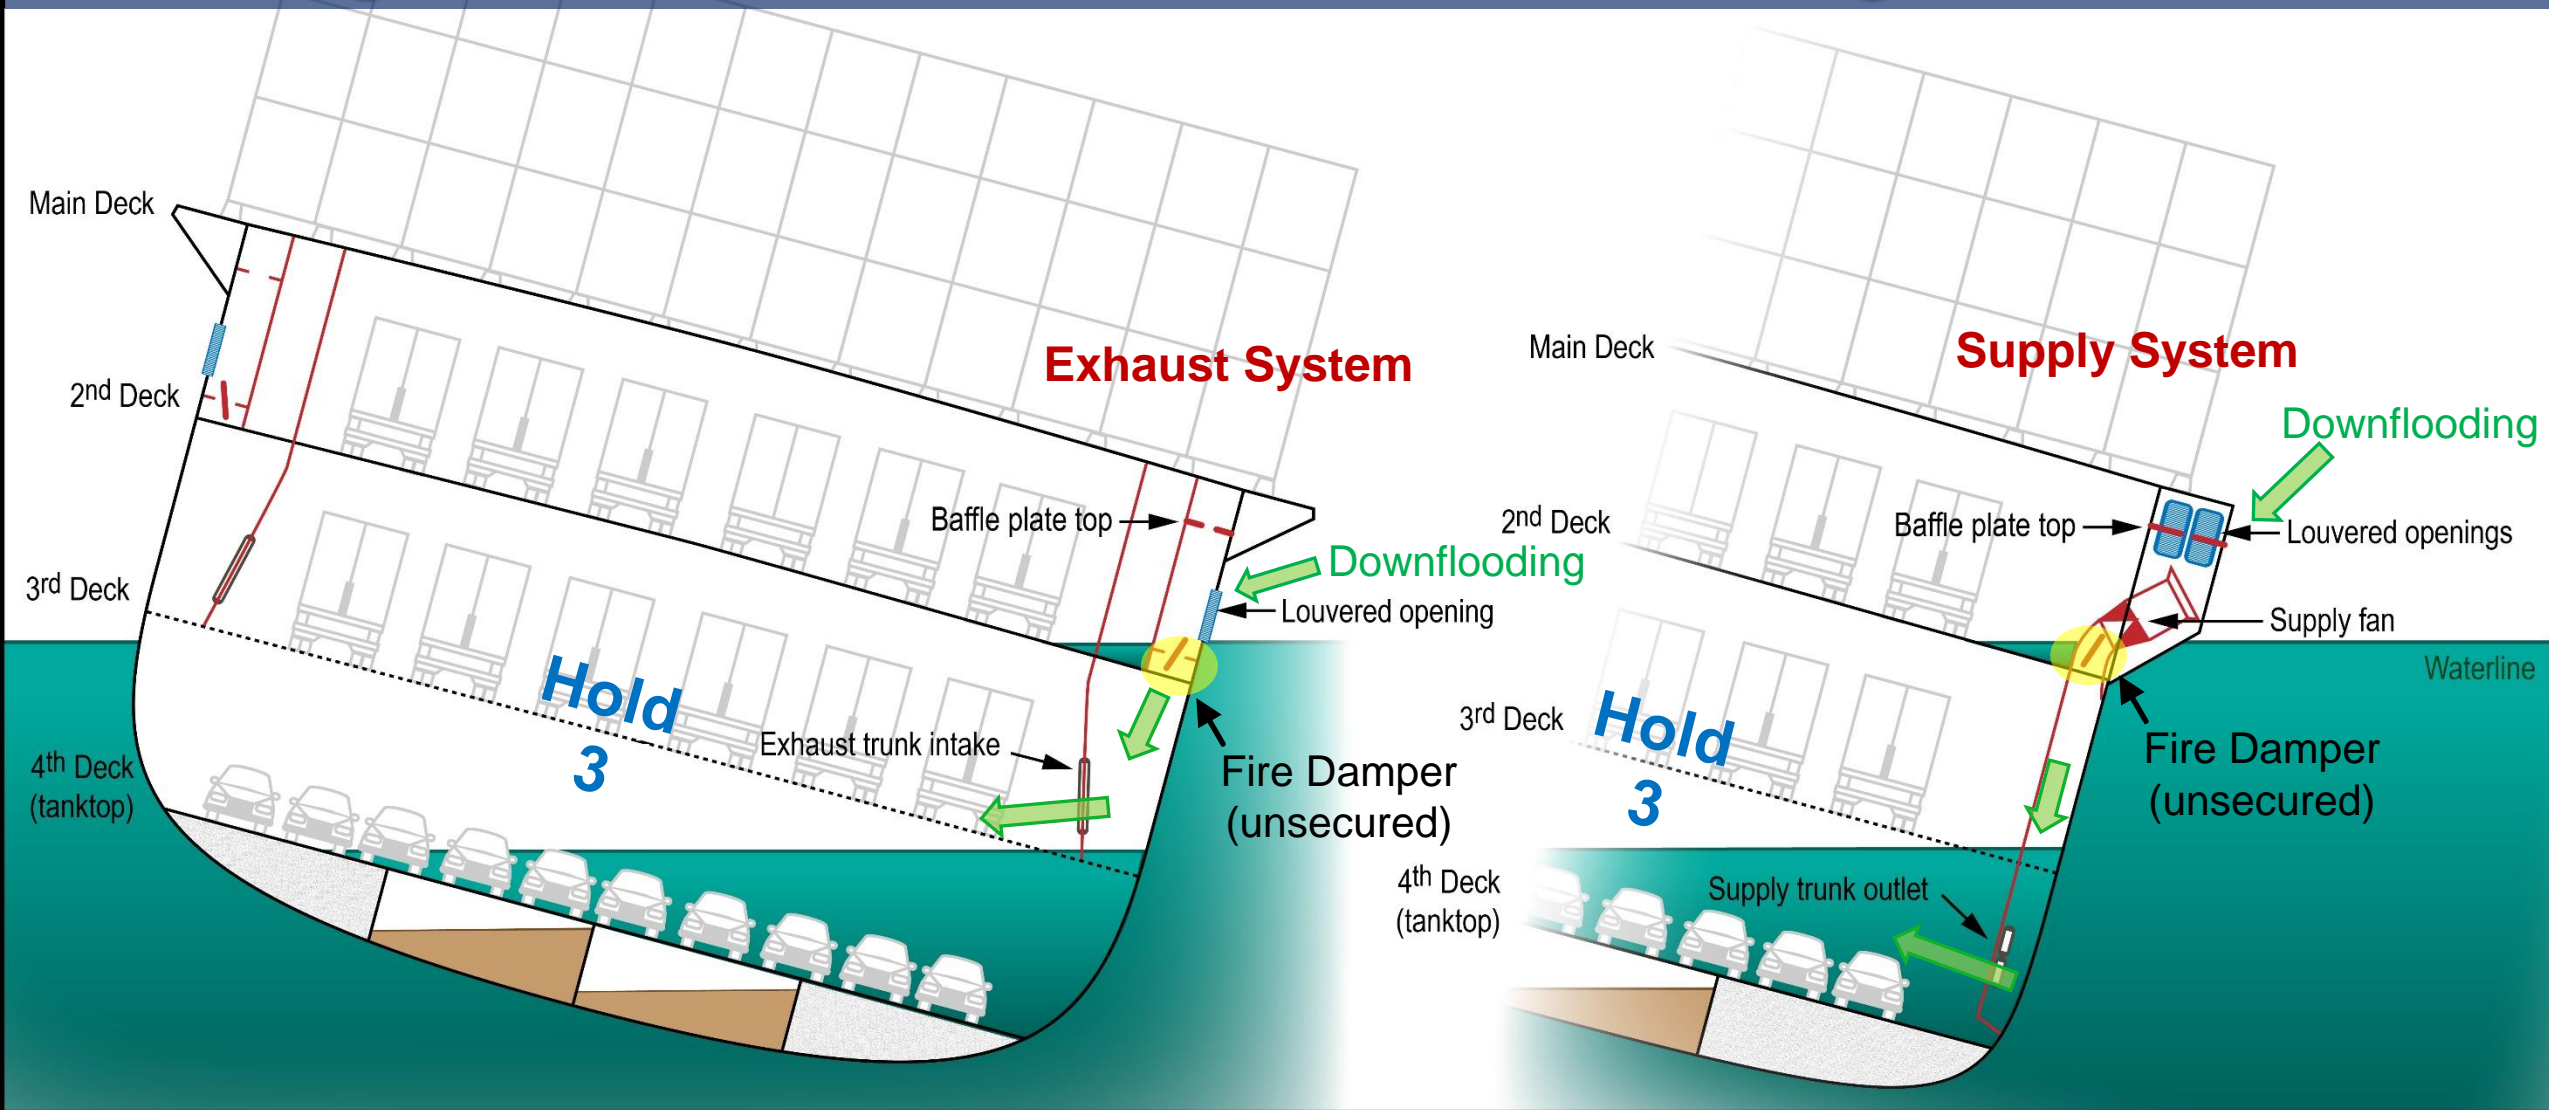
- Ventilation closures most likely remained open throughout sinking
- COI required ventilation of holds at sea
- Intact and damage stability standards consider ventilation openings to be closed
- Vessels should not have conflicting requirements

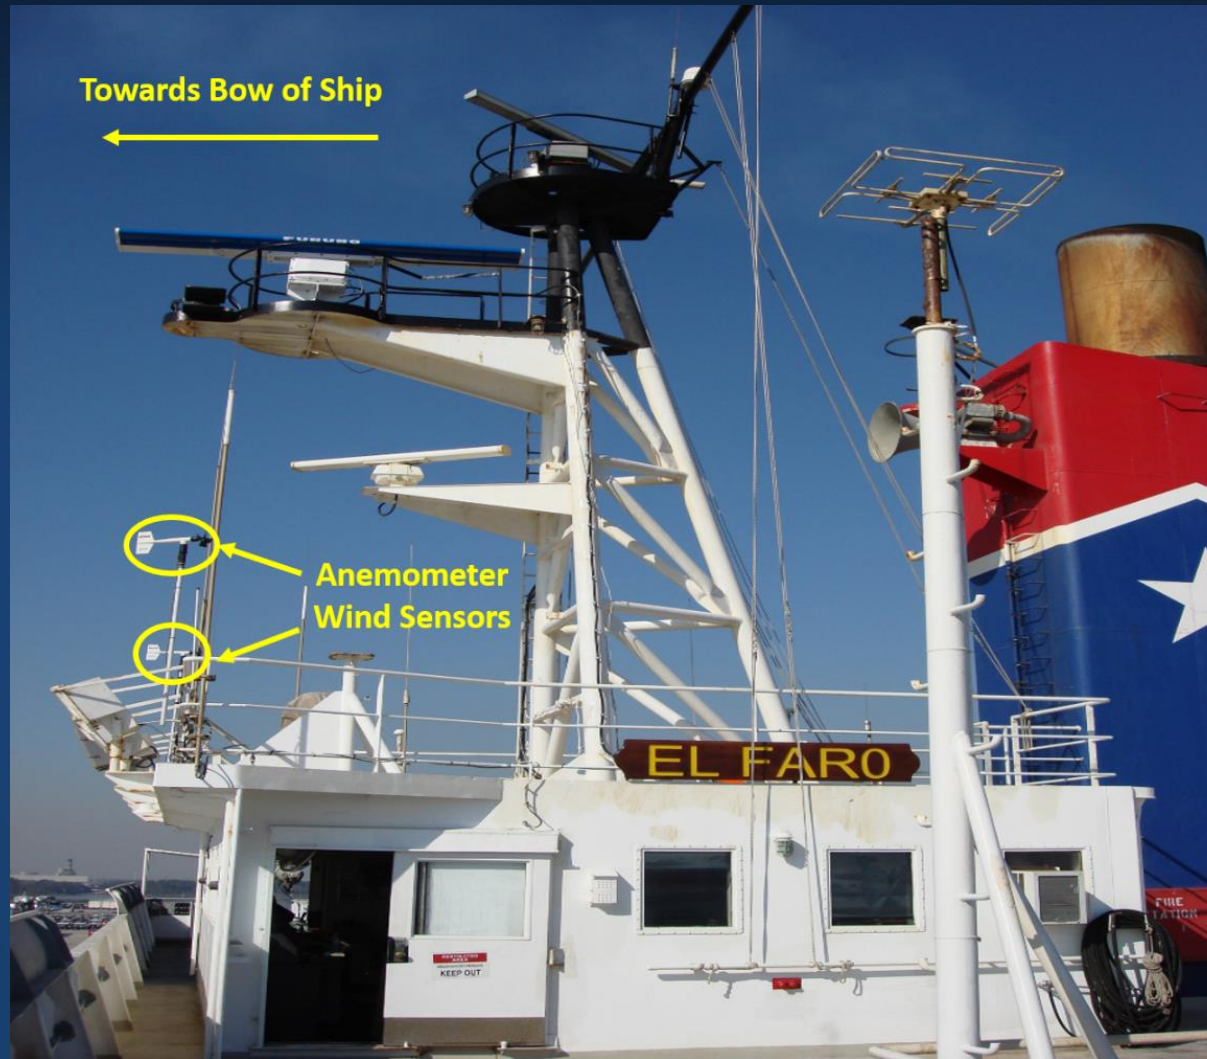
- Anemometer
  - Wind direction and shift are best guides to a storm's position and movement
  - Crew statements about “white out” conditions
  - *El Faro* did not have a properly functioning anemometer
