NATIONAL TRANSPORTATION SAFETY BOARD

Computed Tomography Specialist's Factual Report

ERA14FA300

Operator: Synfuels Holdings Finance LLC
Location: Huntsville International Airport-Carl T. Jones Field, Huntsville,
Alabama
Date: June 18, 2014
Time: 1424 central daylight time
Vehicle: Israel Aircraft Industries 1124A, N793BG

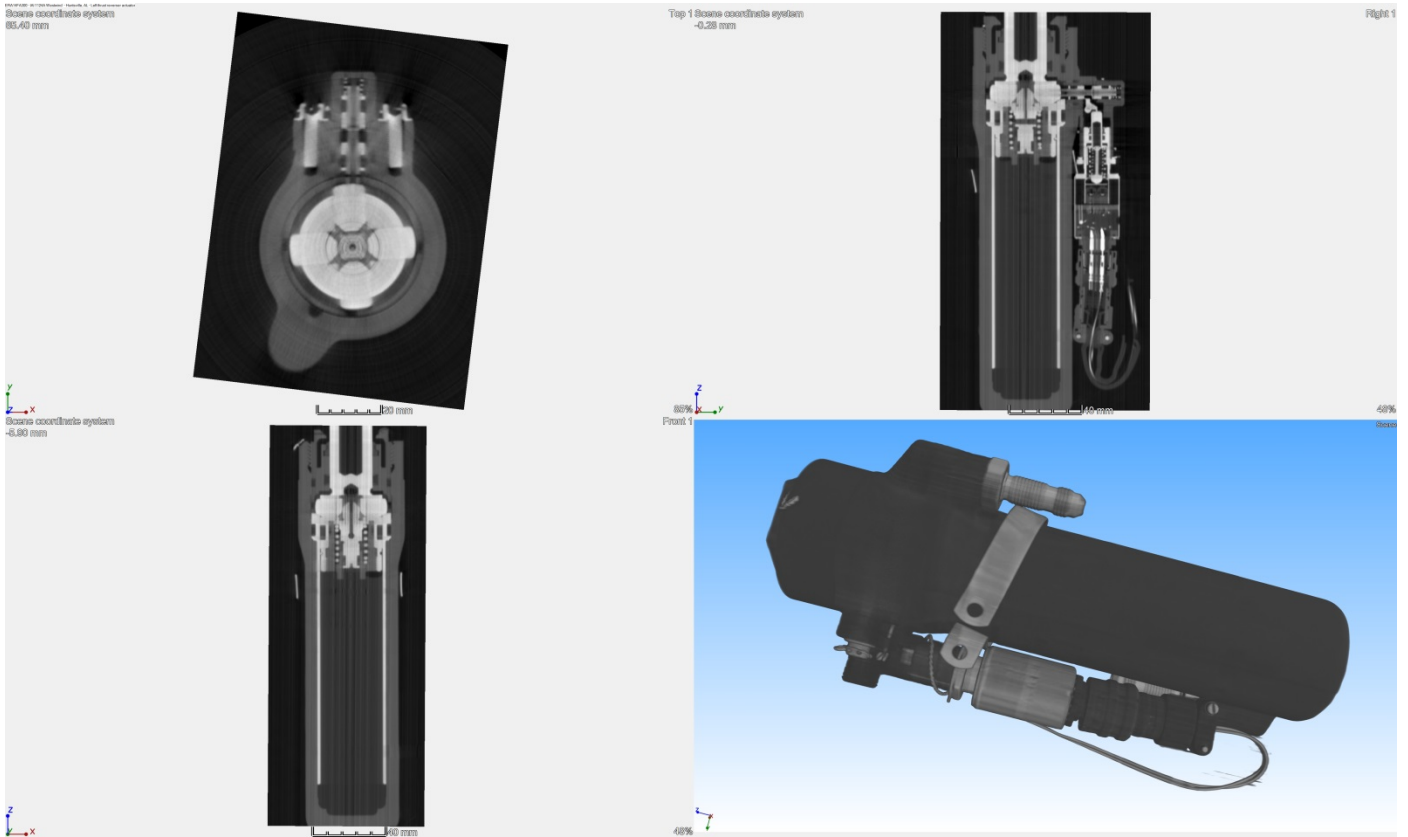
Figure 1
Left thrust reverser actuator – standard focus – overall cross section

1. The left thrust reverser actuator appeared to be in the extended position and the pawls appeared to be extended out over the piston sleeve;
2. The left thrust reverser actuator switch moving contacts appeared to be in contact with the lower switch arm (i.e. the arm on the plug side of the switch);

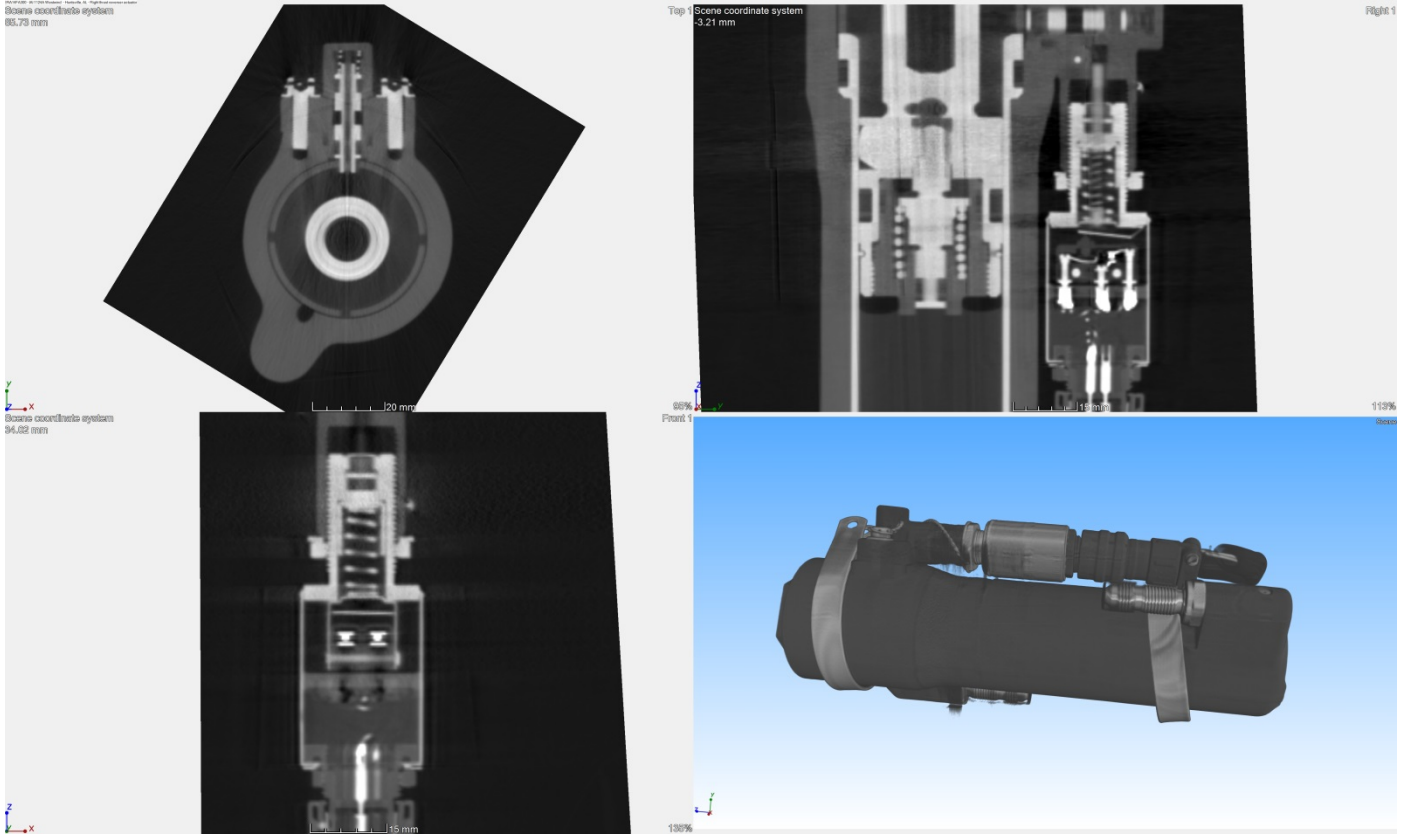
Figure 13
Right thrust reverser actuator – standard focus – switch contacts

3. The right thrust reverser actuator was in a non-extended position and the pawls were retracted within the piston sleeve;
4. The right thrust reverser actuator switch moving contacts appeared to be in contact with the upper switch arm (i.e. the arm on the plunger side of the switch);

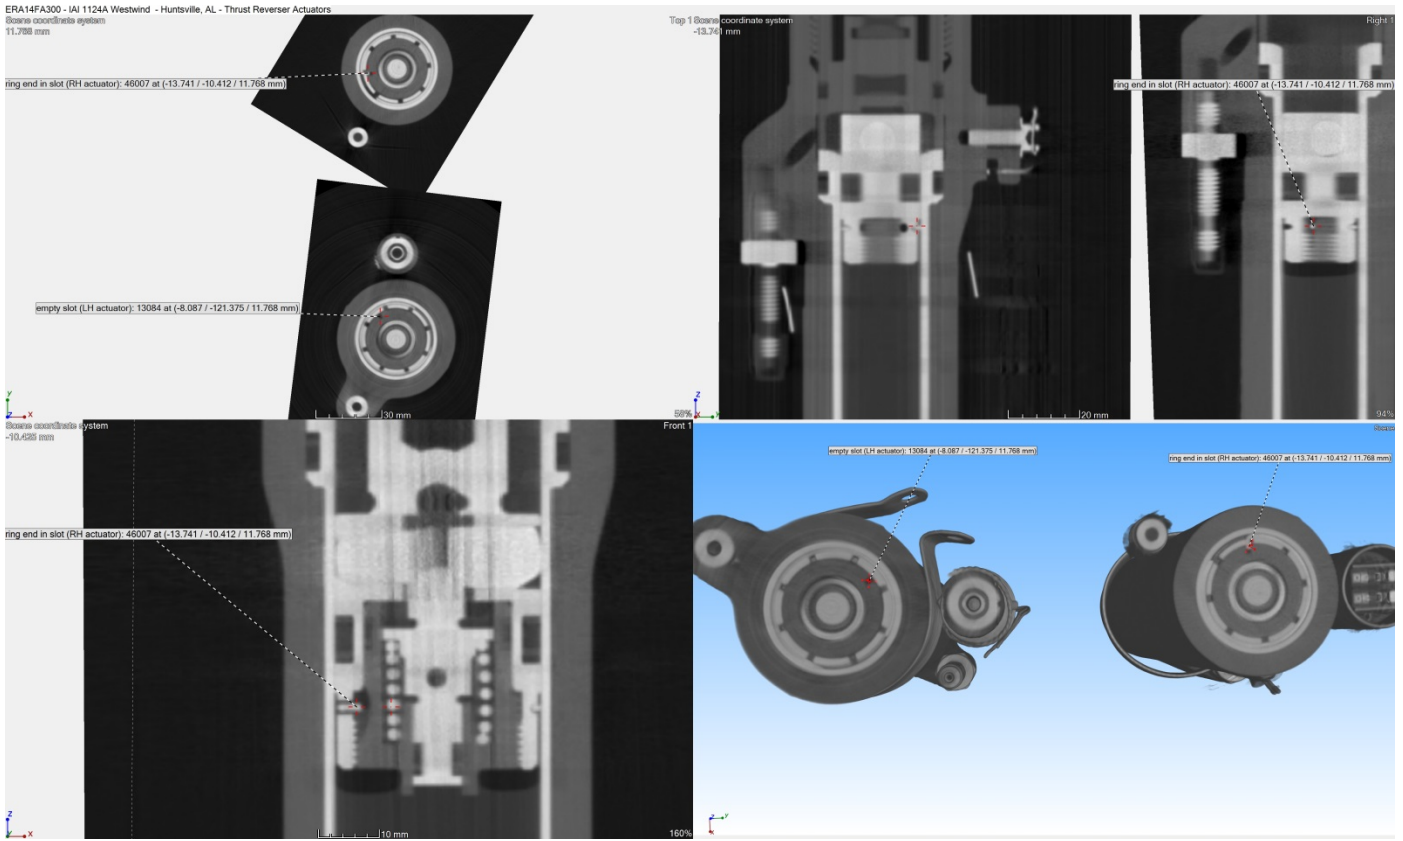
Figure 22
 Left and right thrust reverser actuators – standard focus – ring end and slot comparisons

5. A difference in a piston ring end and slot configurations existed between the pistons of the left and right thrust reverser actuators. In the right thrust reverser actuator, the ring end was contained within the slot. In the left thrust reverser actuator, the ring end was not contained within the slot;

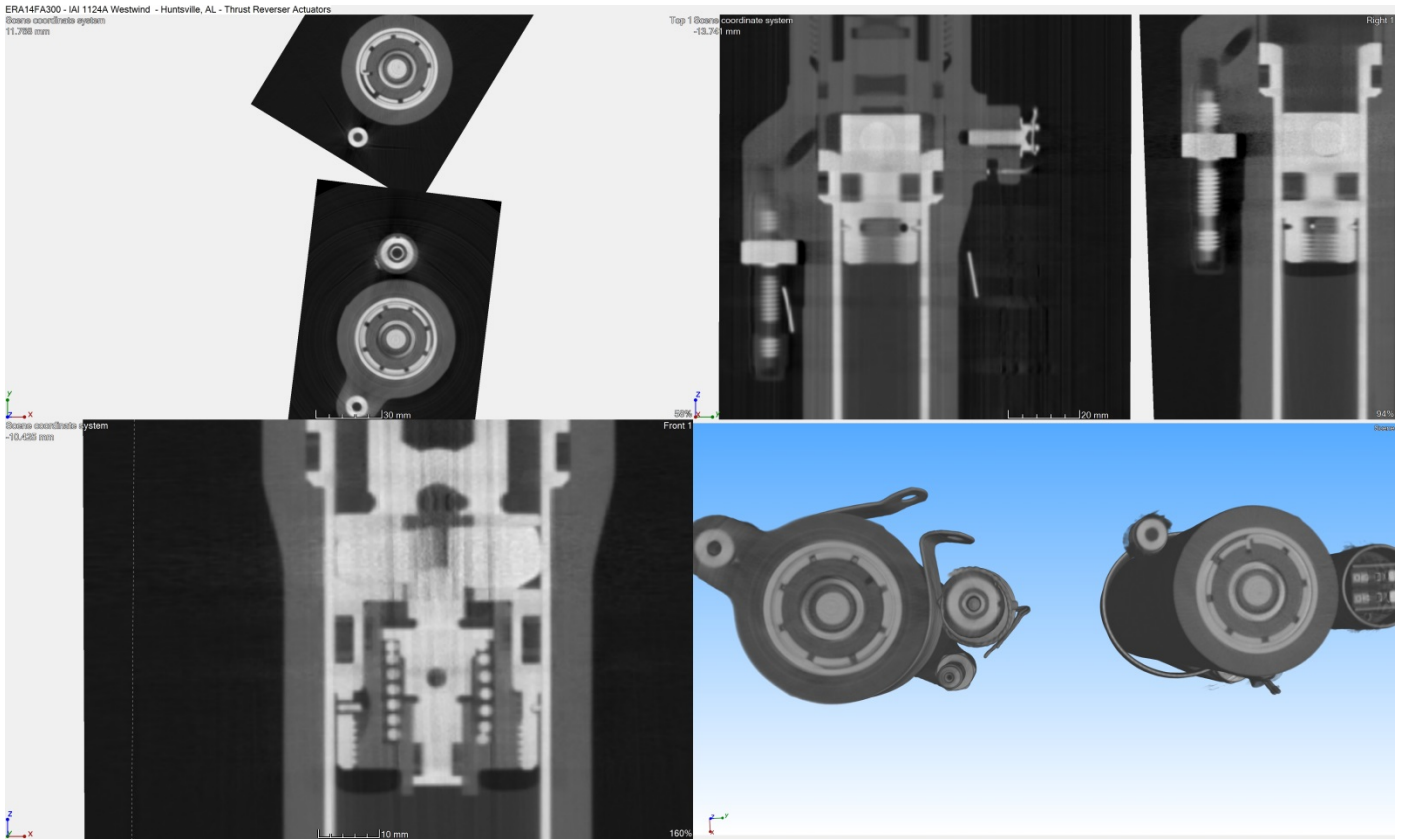
Figure 23

Left and right thrust reverser actuators – standard focus – ring end and slot comparisons – no indicators

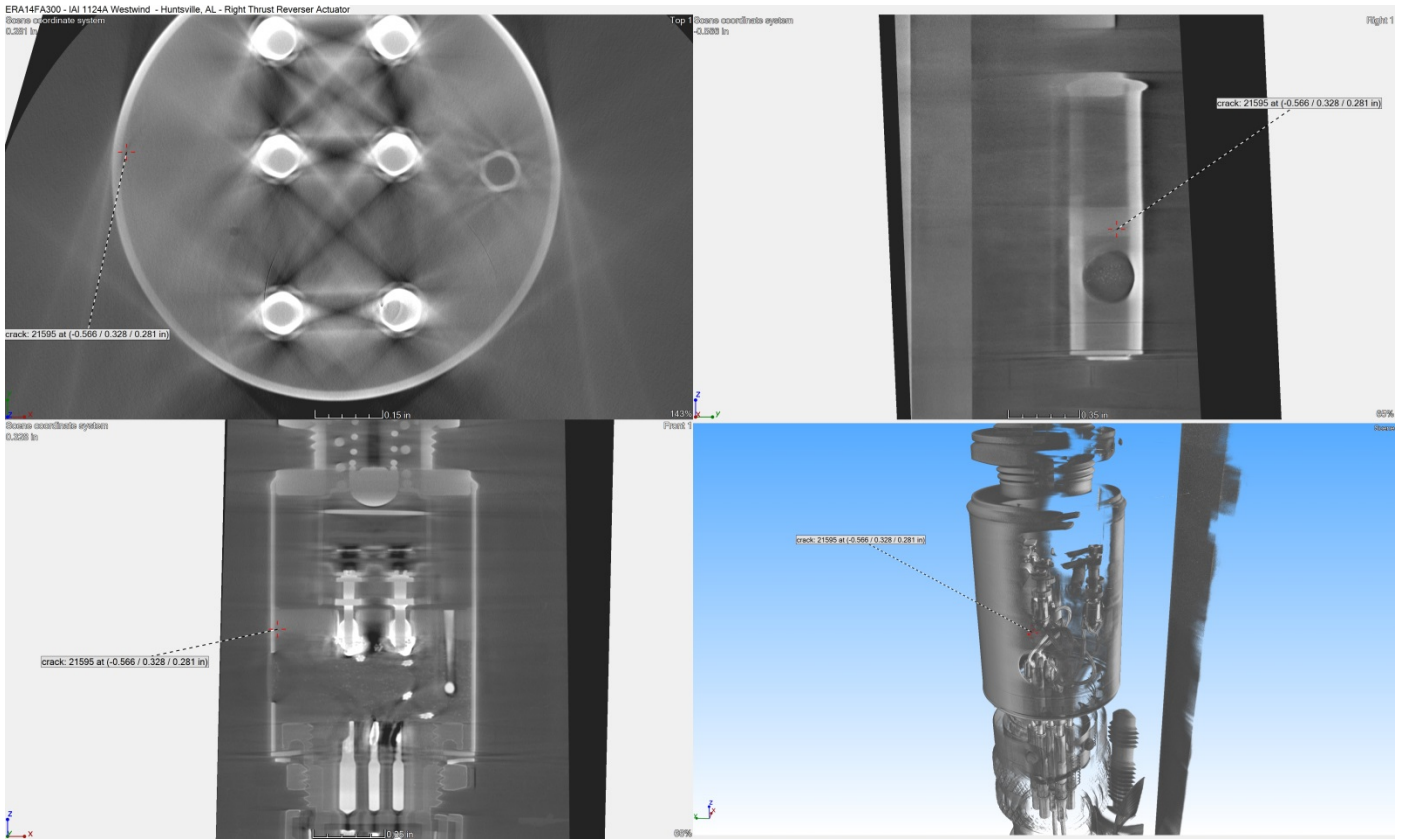
Figure 24
Right thrust reverser actuator – target CT – crack in switch housing

6. A crack was noted in the right thrust reverser actuator switch housing;
7. No indications of particles or other obstructions were noted in either the left or right thrust reverser control valve passages;

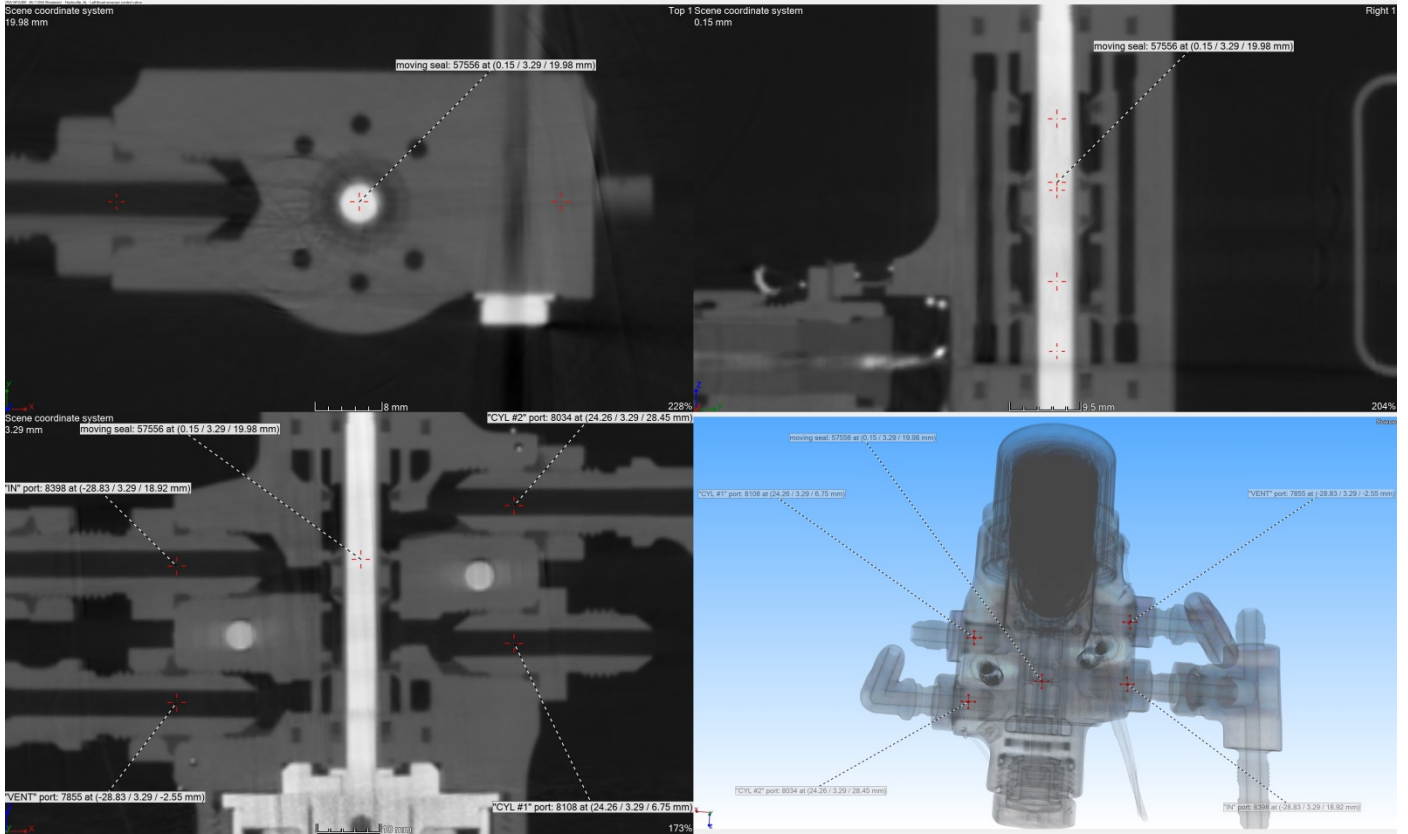
Figure 28
Left thrust reverser control valve – standard focus – moving seal

8. The moving seals within the left and right thrust reverser control valves were both indicated to be in contact with their respective mating surfaces. In some areas, a material consistent with hydraulic fluid obscured the actual seal to surface contact area.
