NATIONAL TRANSPORTATION SAFETY BOARD

ELT SWITCH EXAMINATION SUMMARY

WPR16FA040

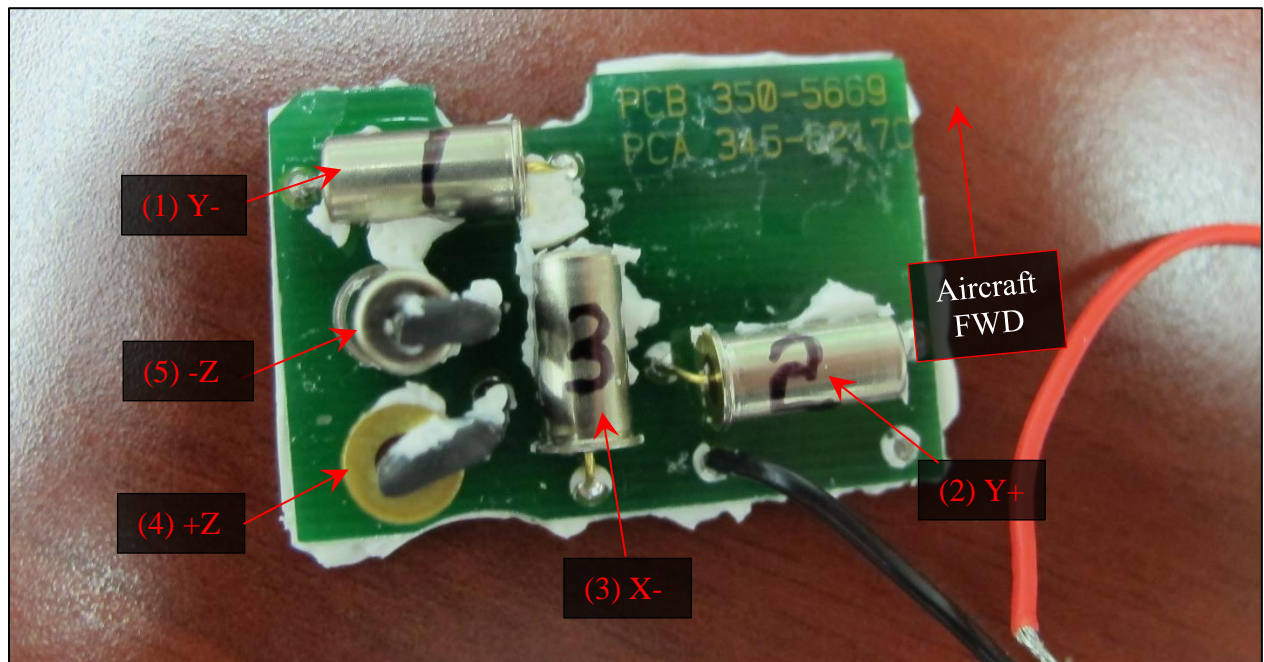
Figure 1, 5-Axis G-Switch Modular

The white colored silicone mix was removed from the switches and no anomalies were noted during the visual examination. The 5-axis individual G-switches remained attached to the circuit board and were identified and numbered. The primary G-switch was undamaged. There was an audible difference between the accident primary G-switch and an exemplar switch when activated by hand.

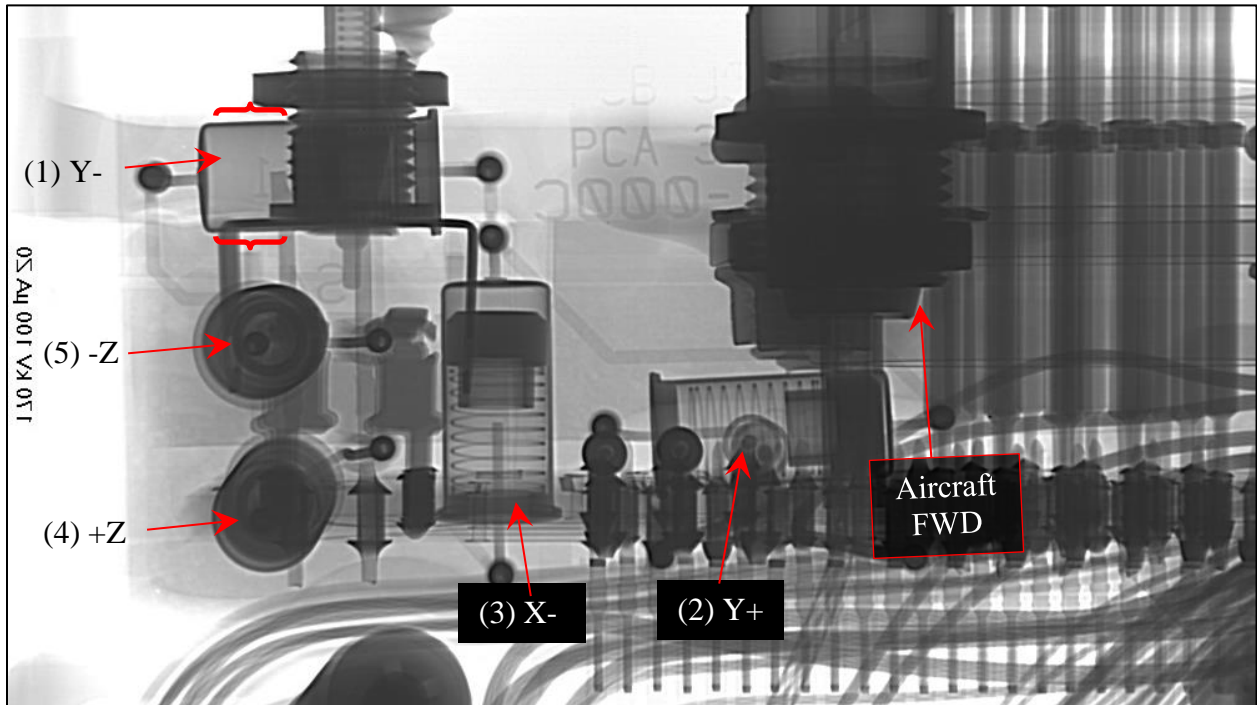
Figure 2, X-ray of 5-Axis G-Switch Modular

X-ray images of the ELT were created at the NTSB materials laboratory. The examination of the image revealed that the No. 2 (Y+) and 3 (X-) pistons and springs were positioned in their shell [housing] as designed. The No. 1 (Y-) switch piston was in a position which had compressed the accelerator spring to the contact side of the shell. The contact side for the switch is on the flared end of the shell. The side views of the No. 4 (+Z) and 5 (-Z) pistons were not available.

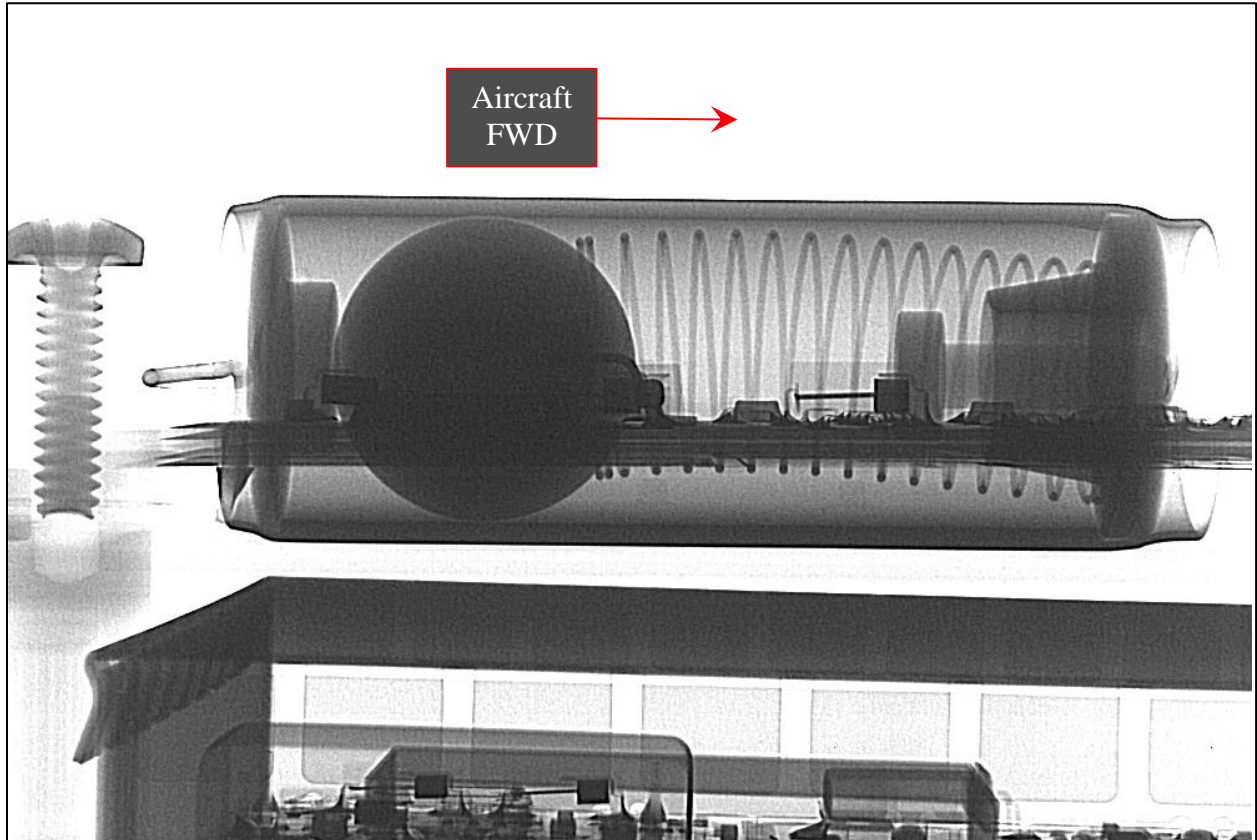
Figure 4, X-ray of Primary G-Switch

The X-ray images of the primary G-switch revealed the acceleration spring was bent to one side of the switch's housing, resulting in the spring not sitting centered on the ball. No other anomalies were noted.

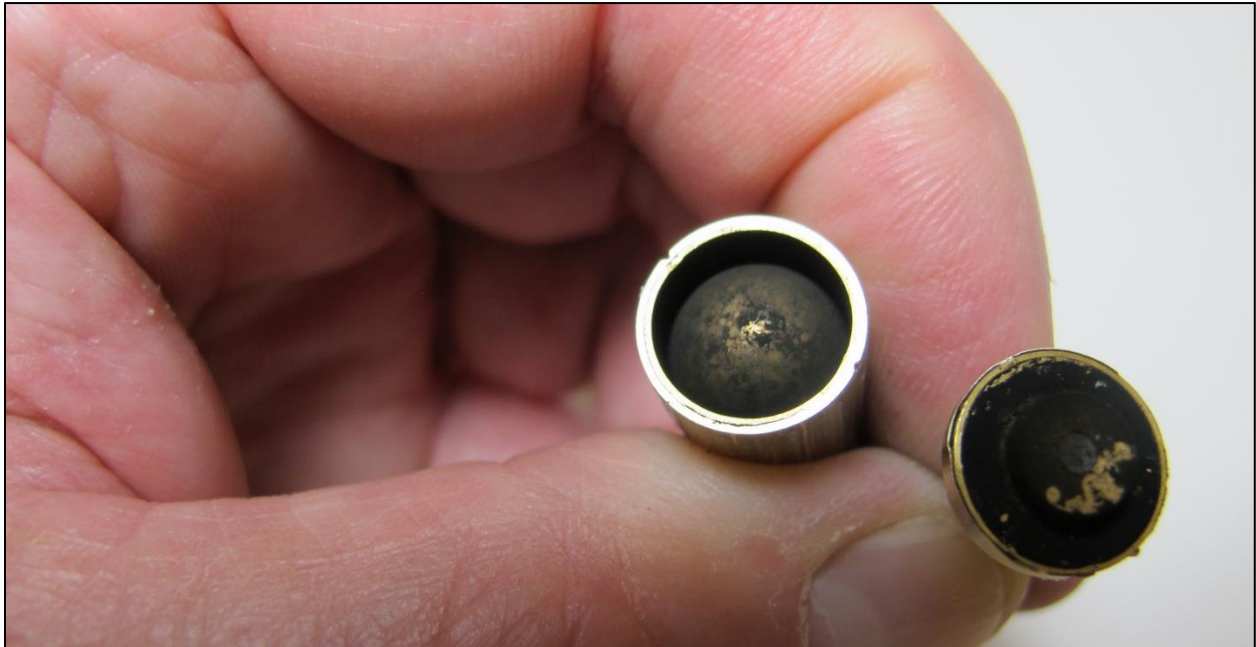
Figure 6, Primary G-Switch Internal Ball and Contact End

The internal examination of the primary G-switch revealed a black powder residue on the ball, contact area and the housing's internal surface areas. The spring was covered in the black powder residue and was unremarkable. Due to the method on how the switch was opened, the ball could not be removed completely from a small portion of the housing.

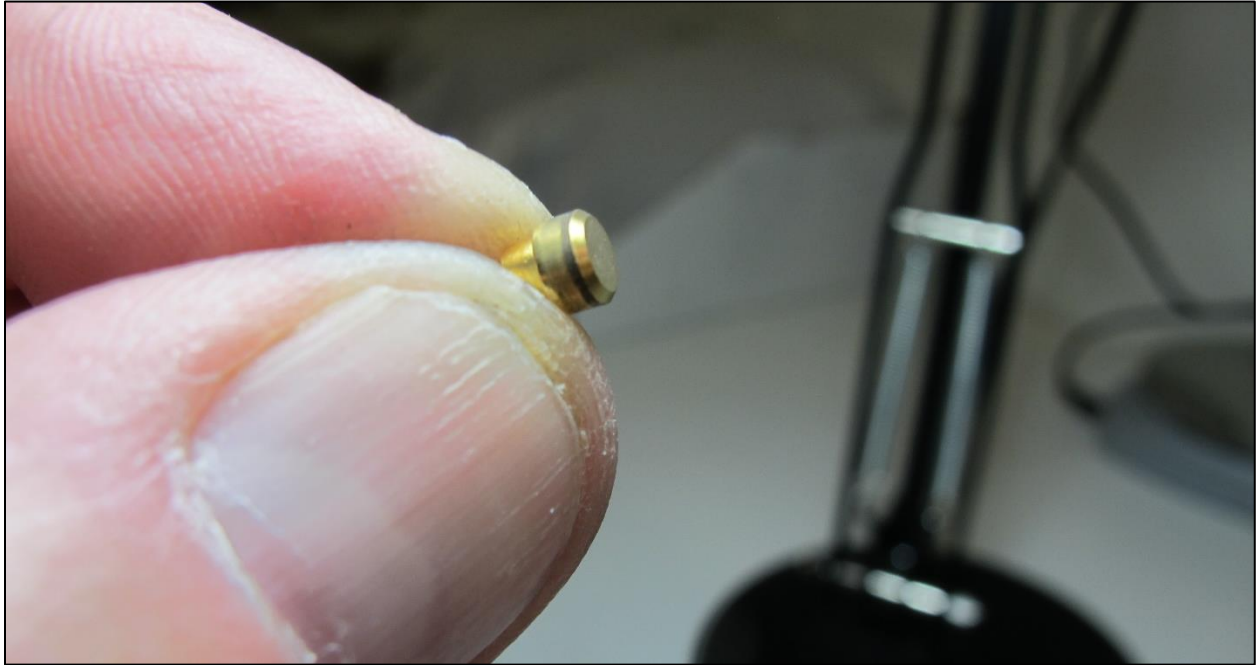
Figure 8, Modular G-Switch No. 5 Piston

The examination of the 5-axis G-switches internal components, revealed wear signatures on the outer circumference of the pistons; Nos. 1, 2, 4 and 5. The No. 3 piston could not be removed from its housing. The No. 3 housing non-contact end had a dark residue.
