NATIONAL TRANSPORTATION SAFETY BOARD

Electronic Devices

Specialist's Factual Report By Bill Tuccio, Ph.D.

NTSB Number: ERA14FA288

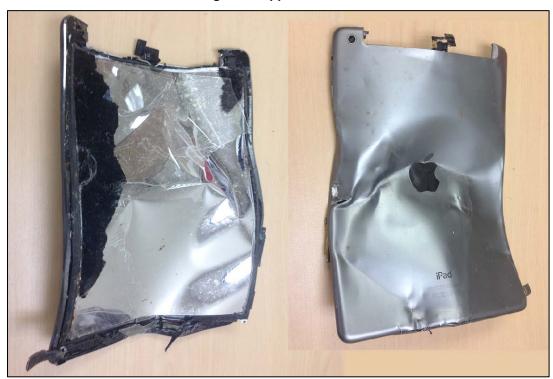
The Apple iPad Air is touchscreen capable tablet device. Upon arrival at the Vehicle Recorder Laboratory, an exterior examination revealed the unit had sustained significant structural damage, as shown in figure 1. An internal inspection revealed damage to some internal components; figure 2 shows the main processor and main memory chips (center two chips) were undamaged, while the other chips were cracked. In agreement with the Investigator-in-Charge, no further recovery attempts were made.

Figure 1. Apple iPad Air.

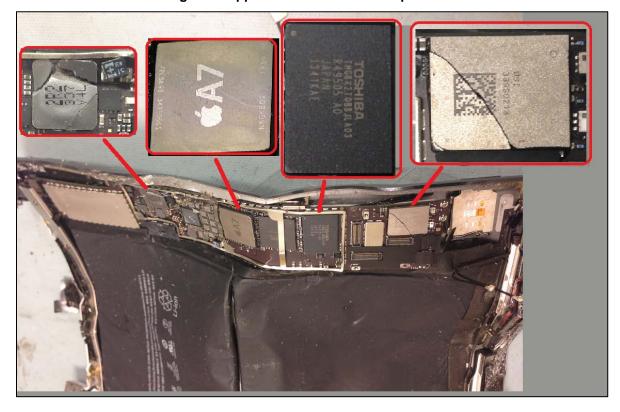
Figure 2. Apple iPad Air internal components.

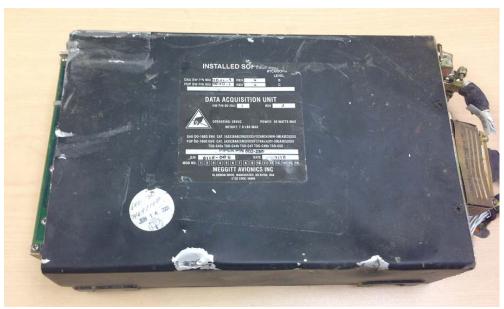
Upon arrival at the Vehicle Recorder Laboratory, an exterior examination revealed the DAU had sustained minimal damage, as shown in figure 3. An interior inspection revealed some of the internal connections were loose. The internal connectors were tightened. The ECTM and exceedance data from both channels of the DAU were downloaded at the NTSB's Vehicle Recorders Laboratory using the Meggitt Avionics, Inc. download software; the download software also converted the data to engineering units.

Figure 3. Meggitt DAU as received.
