# NATIONAL TRANSPORTATION SAFETY BOARD

## Engine Data Monitor JPI-830

### FACTUAL REPORT

Location: Chuckanut, Washington  
Date: February 12, 2018, 1913 PST  
Aircraft: Mooney M20K  
Registration: N123JN  
Operator: Private  
NTSB Number: ANC18FA024

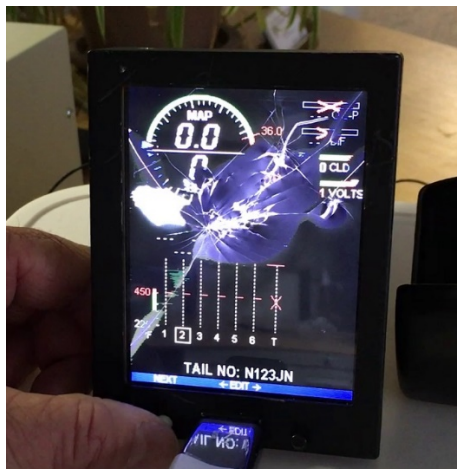
A JPI EDM 830 engine data monitor was removed from the wreckage after recovery at the examination facility. The unit had cracked a glass face and was otherwise undamaged. See figure 1.

Figure 1. JPI EDM-830 during download.

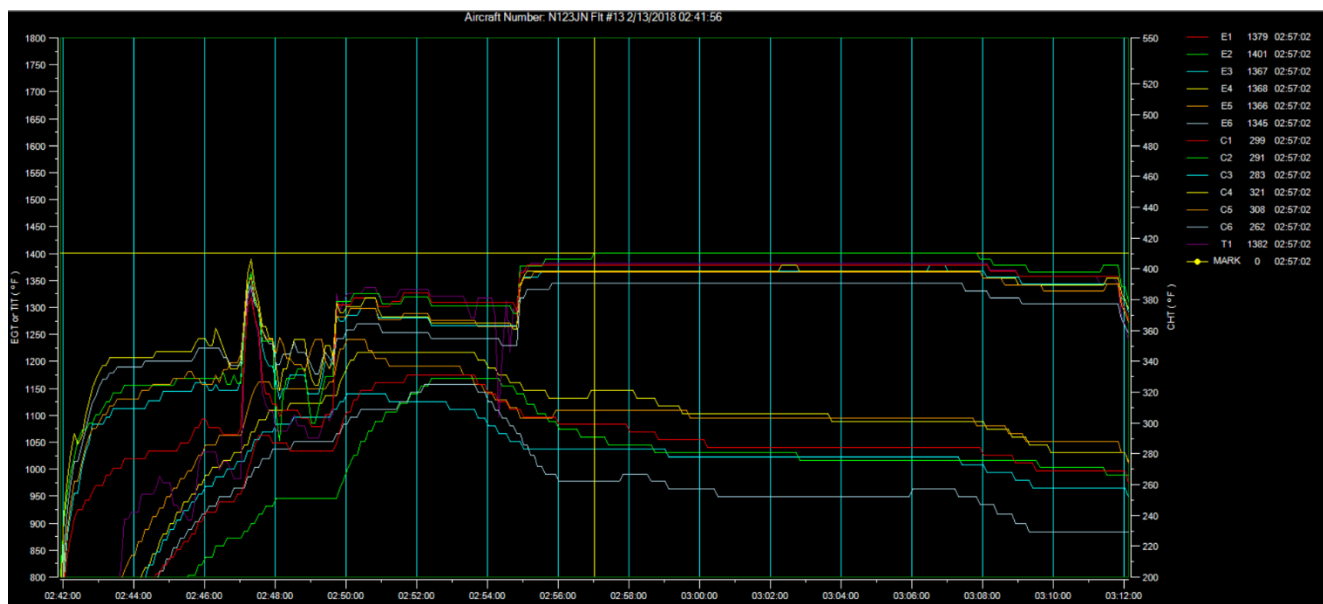
The engine data indicated a normal start up and ground runup profile. The takeoff and cruise profiles were also normal, indicated by stable EGTs, CHTs and TIT temperatures. After the takeoff, RPM and MAP were steady about 2400 and 25 inches, respectfully. About 0308 the CHTs decreased about 15 to 20 degrees likely due to increased airspeed during the descent. The last 3 data points indicated a MAP decrease to 17.8 inches with RPM steady about 2400. All temperatures decreased a corresponding amount. The last data point indicated no anomalies or impact indications.

Figure 1 is a plot of parameters from the accident flight recorded on the JPI EDM-830 device for the entire flight. The time interval is 02:41:56 to 03:12:08 UTC.

Figure 2. EZ Trend graphical display of engine data
