NATIONAL TRANSPORTATION SAFETY BOARD

ENGINE EXAMINATION REPORT

WPR12MA034

Aircraft: Eurocopter EC 130 B4, N11QV

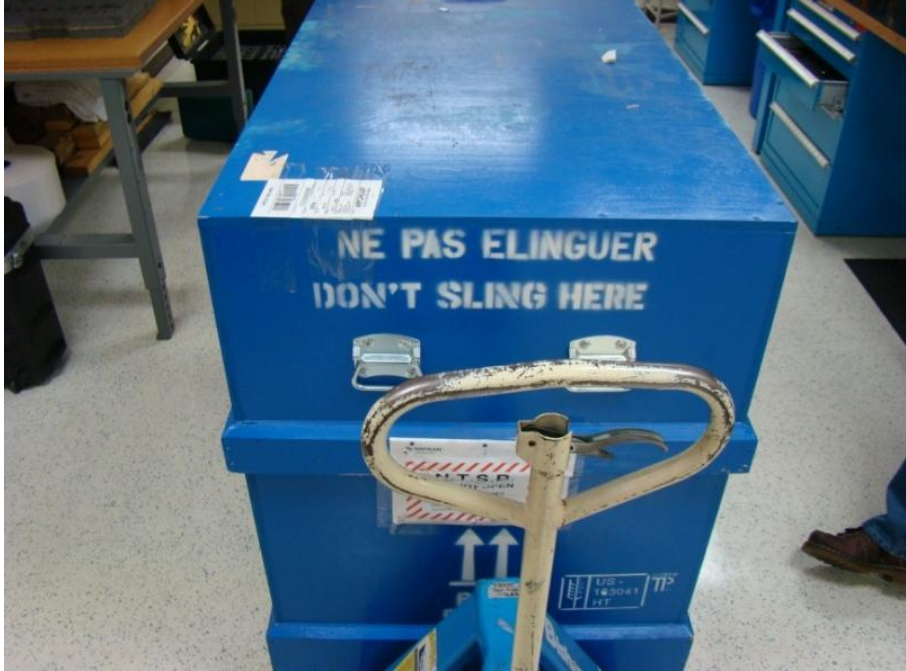
Figure 1 – As received sealed shipping container

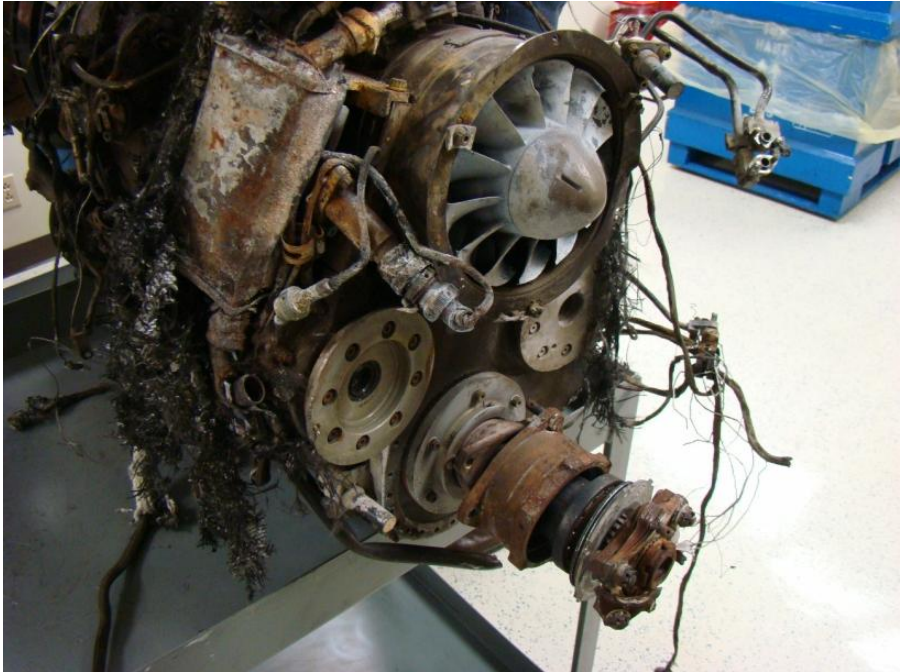
The engine was enclosed in a sealed shipping container and opened in the presence of the Powerplants Group. The engine was removed from the container; heavy soot and extensive thermal damage was noted to the 5 individual modules. A majority of the electronic accessories and associated wiring was damaged and melted away. There were no indications of a case rupture or uncontainment. A boroscope examination of the gas generator was performed and showed the presence of foreign material, consistent with dirt seen at the accident site, in the high pressure turbine inlet.

Figure 2 - As received engine assembly

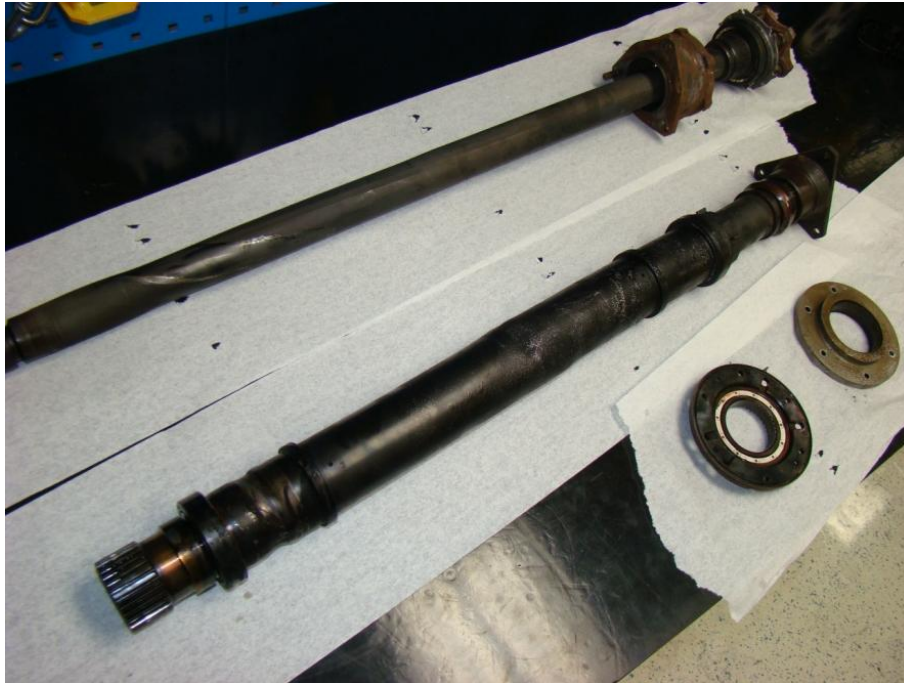
The freewheel shaft and power shaft were removed. The freewheel shaft showed twist in the clockwise direction (viewed from the aft of the engine) just before the tail rotor drive shaft connection point. A representative from the engine manufacturer indicated that the observed twist was consistent with sudden stoppage of the tail rotor with continued engine drive. The power shaft showed thermal damage at the mid section and rotational scarring on the aft section. The area of the rotational scarring on the shaft is consistent with the area of damage on the external linking tube.

Figure 3 - The freewheel shaft (top) and power transmission shaft (bottom)

Note: When viewed from the aft position forward, the power transmission shaft rotate in a clockwise direction.

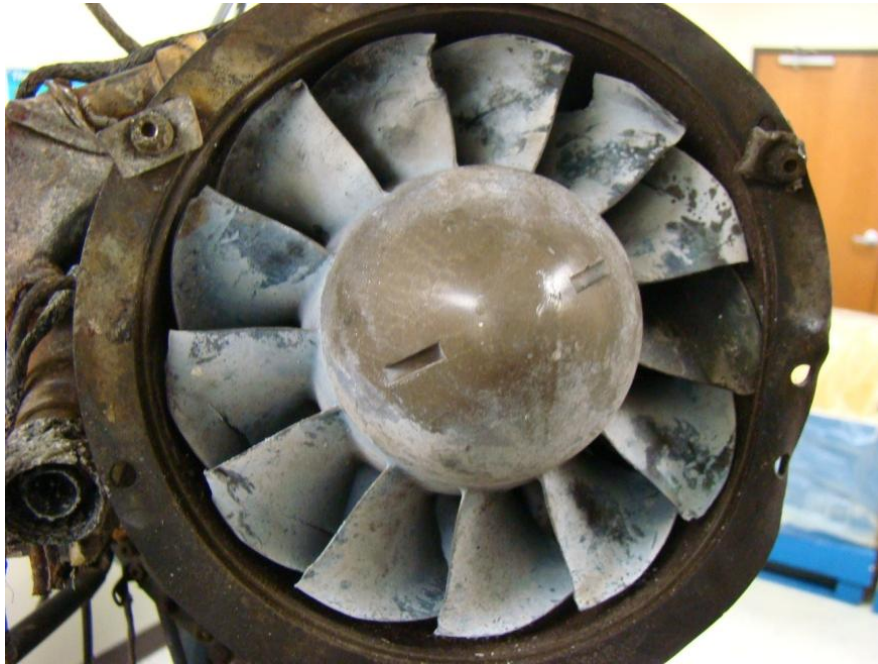
The compressor case, inlet cone and compressor wheel and associated blades were in place. Impact related damage, case deformation and heat distortion were noted to the assembly.

Compressor blade tip curl, opposite direction of rotation, was noted. The assembly would not rotate and foreign material (dirt) was noted inside the compressor casing.

Figure 4 - Module M02 – Axial compressor

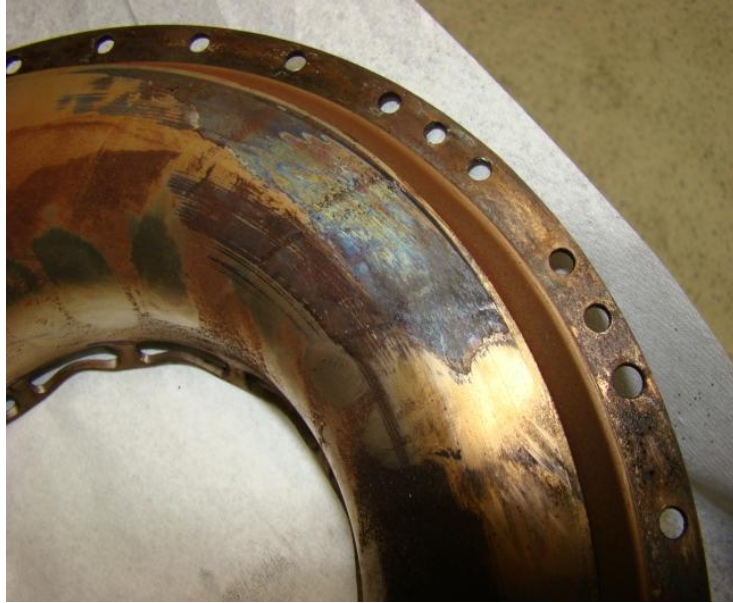
The gas generator was intact; however, impact related damage and case deformation was noted. Disassembly of the gas generator revealed that the splined portion of the centrifugal compressor was fractured. The fracture features were consistent with over stress separation. Rotational scoring was noted to the centrifugal compressor and adjacent compressor cover. The combustion chamber was intact; deformation consistent with impact was noted. Mud/dirt and organic debris was observed in the combustion chamber. The centrifugal injection wheel was intact and appeared to be clear of debris. The turbine wheel was removed. The blades were intact and no anomalies were noted.

Figure 5 - Centrifugal compressor cover

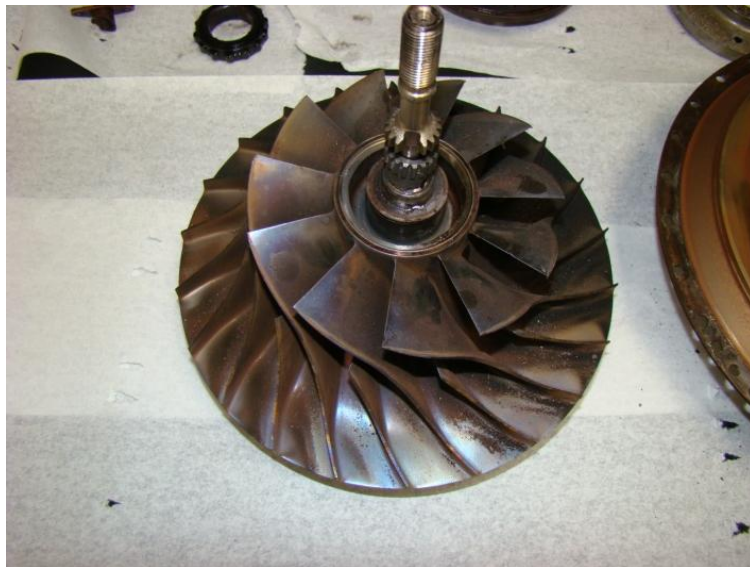
Figure 6 – Centrifugal compressor

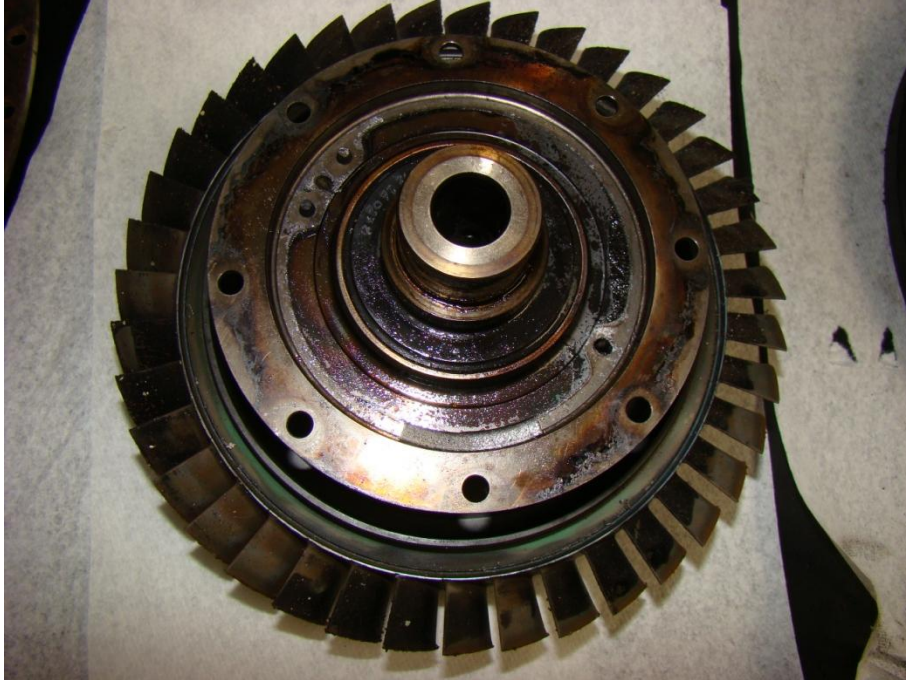
Figure 7 –Gas generator turbine wheel

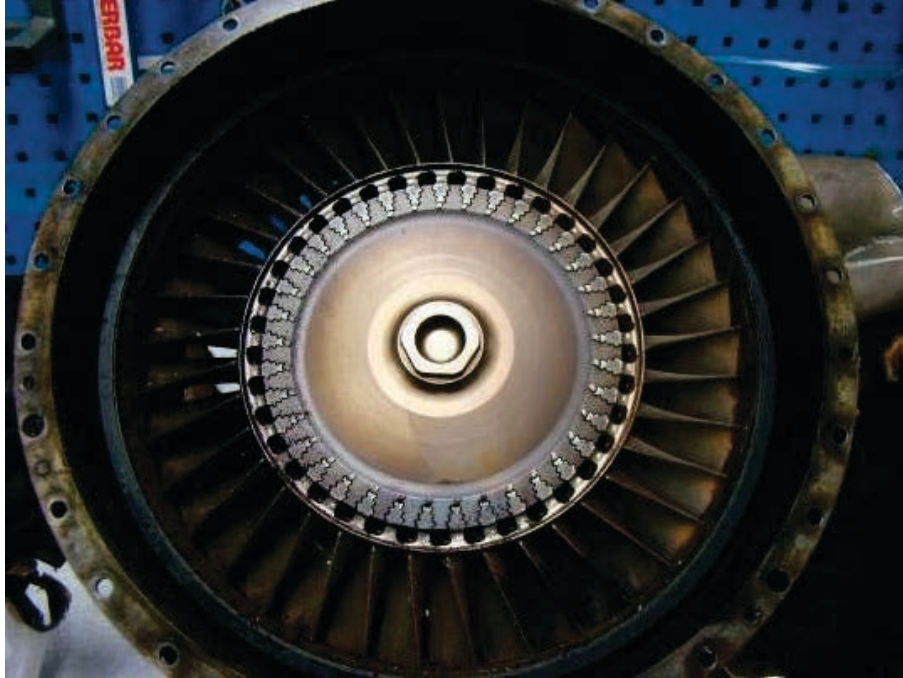
The power turbine section was removed and examined. The power turbine wheel was intact and rotated freely. The turbine wheel was in place and secured within the bearings. The power turbine blades were in place and undamaged. The power turbine casing and containment ring were intact and undamaged.

Figure 8 - Module M04 power turbine wheel

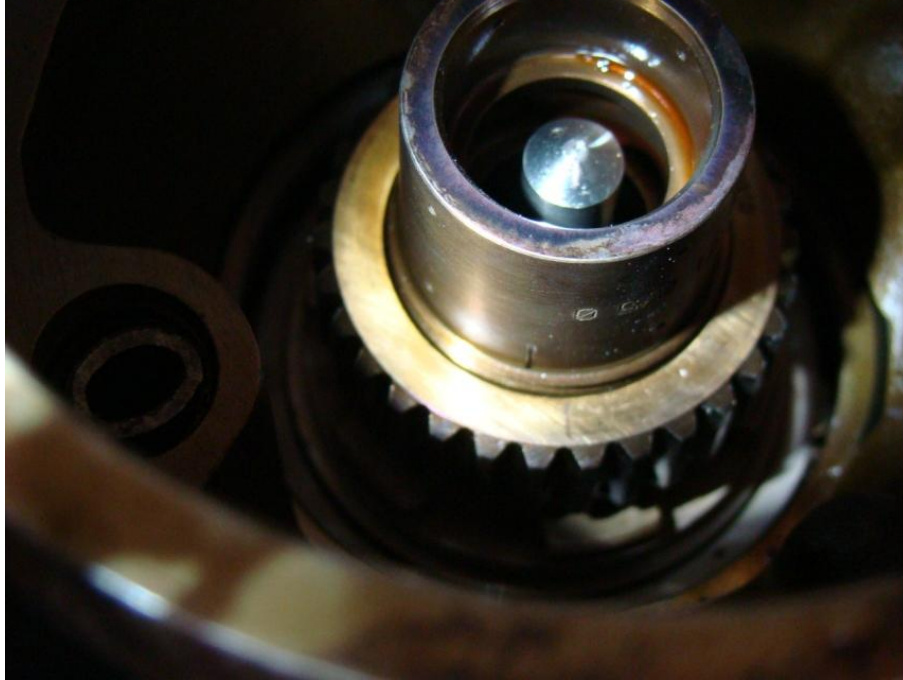
The reduction gearbox was removed from the engine. The N2 drive gear was in place and the gear assembly rotated freely and no binding was noted. The splined nut, which attaches the power turbine to the reduction gearbox, was misaligned about 2 mm (in a torquing direction) with its reference point on the inlet pinion. According to the manufacturer, the misalignment represents approximately 513 foot pounds of torque applied to the splined nut pinion coupling. This reference point is established by the manufacturer to determine sudden stoppage of main rotor blades when the engine is producing power.

Figure 9 - Splined nut pinion coupling, 2 mm displacement

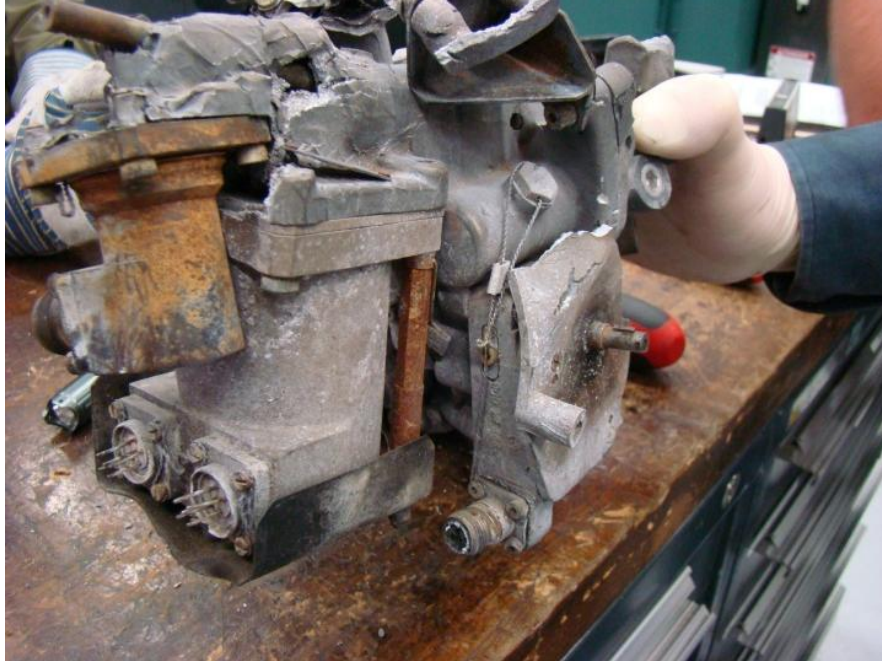
The fuel pump/metering unit (hydro mechanical unit) was in place, however, sustained extensive thermal and impact related damage. Postaccident functional testing of the unit was not possible due to the damage. The emergency backup control auxiliary unit (EBCAU) was removed and the unit was disassembled. Disassembly of the unit revealed that the emergency throttle keyed shaft (which actuates the emergency throttle) was in the 12 o'clock position, which, according to the manufacturer, equates to the neutral or closed position. It was the consensus of the group that the fuel control unit was not in emergency mode during the accident sequence.

Figure 10 - Fuel metering unit (HMU)

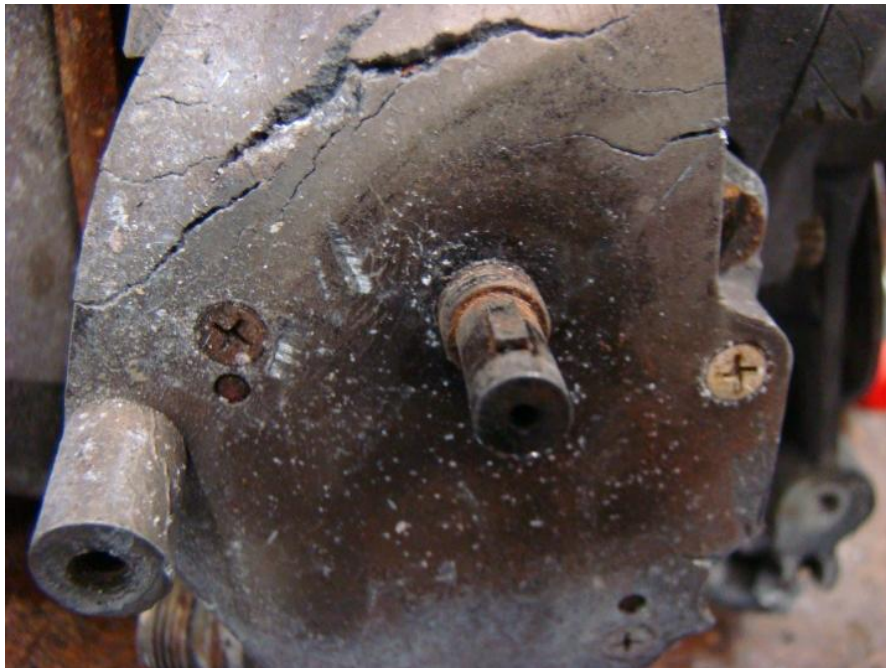
Figure 11 - Emergency backup control shaft - found in the 12 O'clock (closed / neutral) position

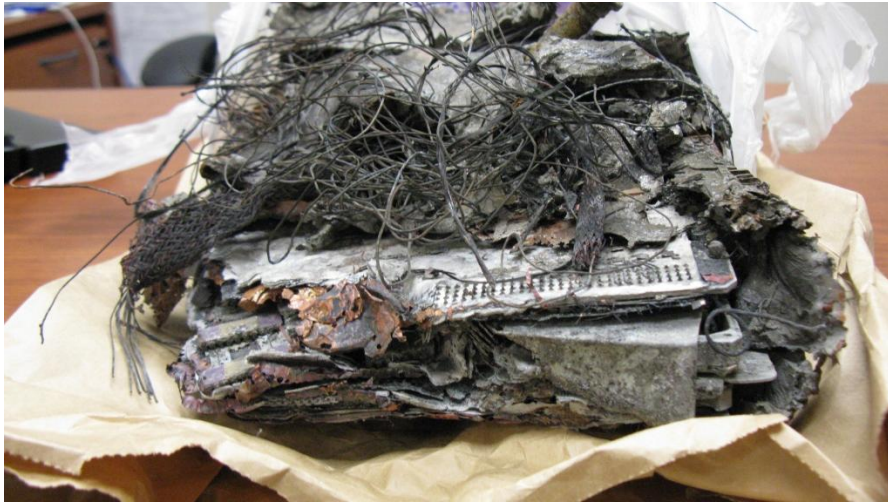
Engine Electronic Control Unit (EECU), also referred to as the Digital Engine Control Unit (DECU), was located with the main wreckage. The unit sustained extensive thermal and impact related damage during the accident sequence and postaccident functional testing was not possible.

Figure 12 - Digital Engine Control Unit (DECU)
