## NATIONAL TRANSPORTATION SAFETY BOARD

### ENGINE EXAMINATION REPORT

**WPR13LA321**

Location: Fallon, Nevada  
Date: July 10, 2013  
Aircraft: Beech A36, Registration Number: N517DJX, Serial #: E-3075  
NTSB IIC: Patrick H Jones

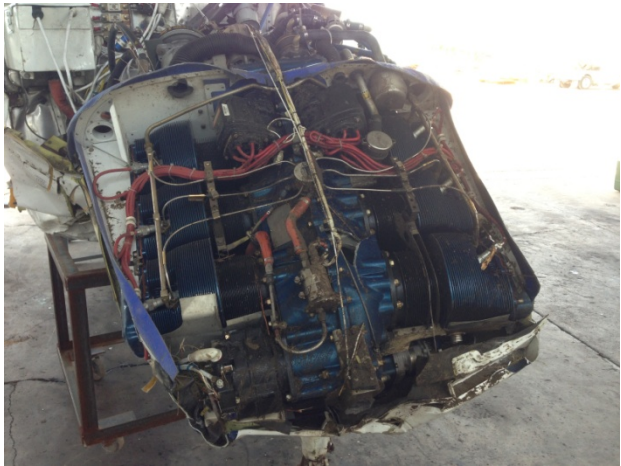
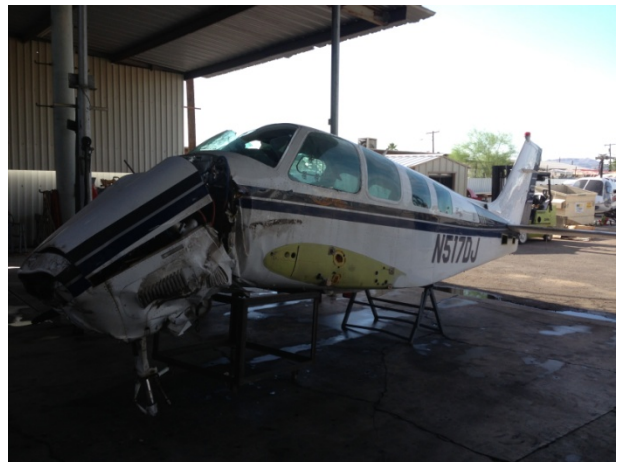
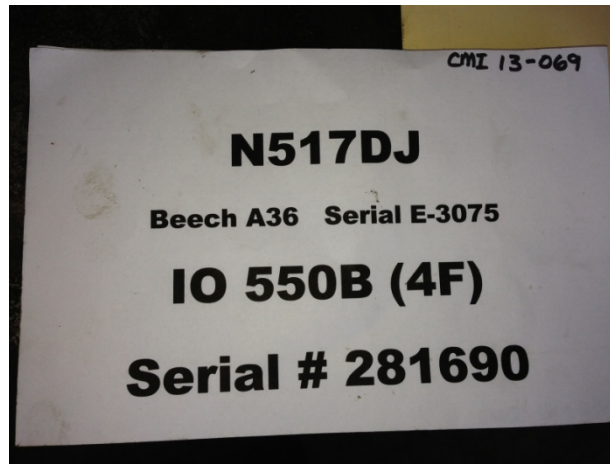
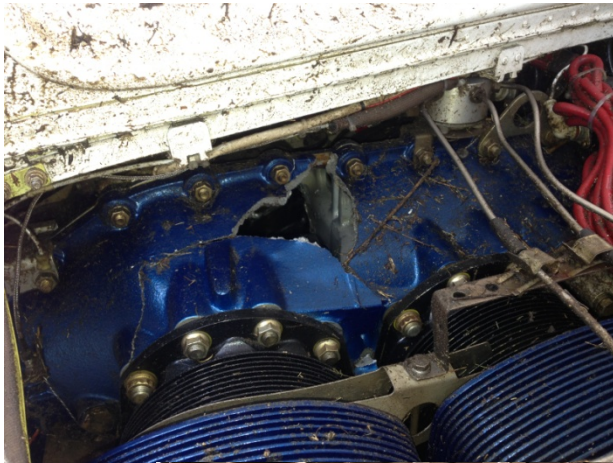
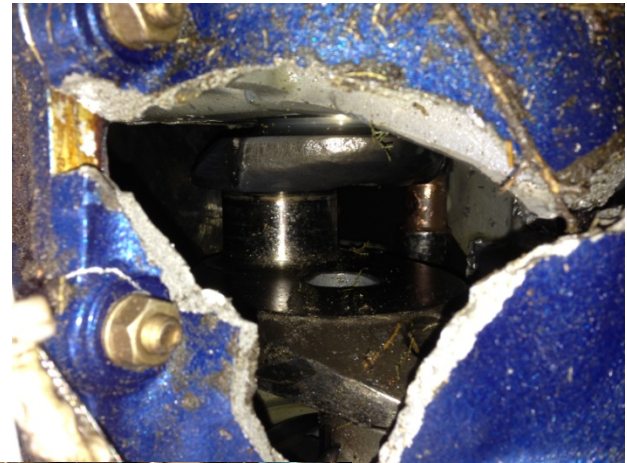
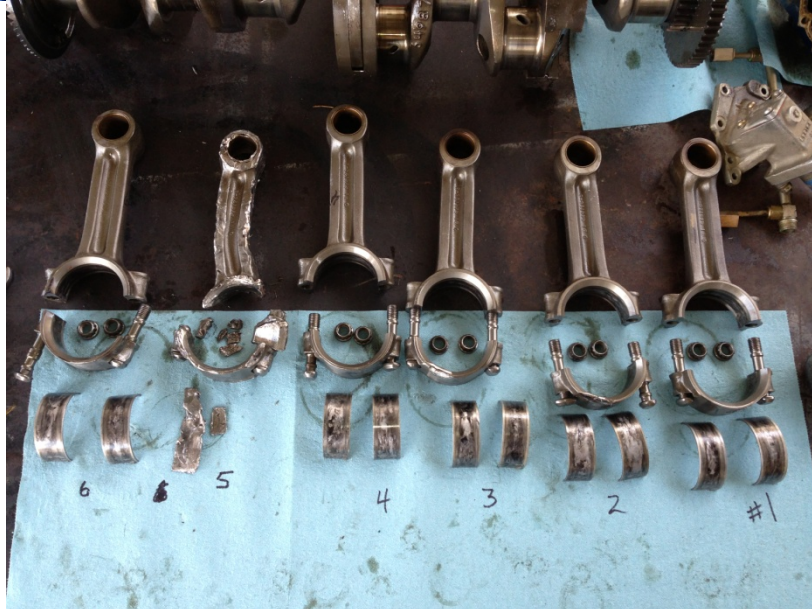
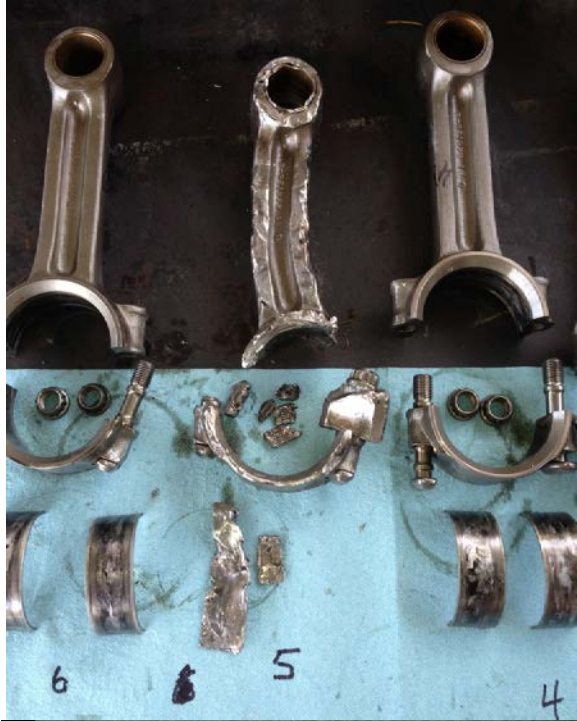
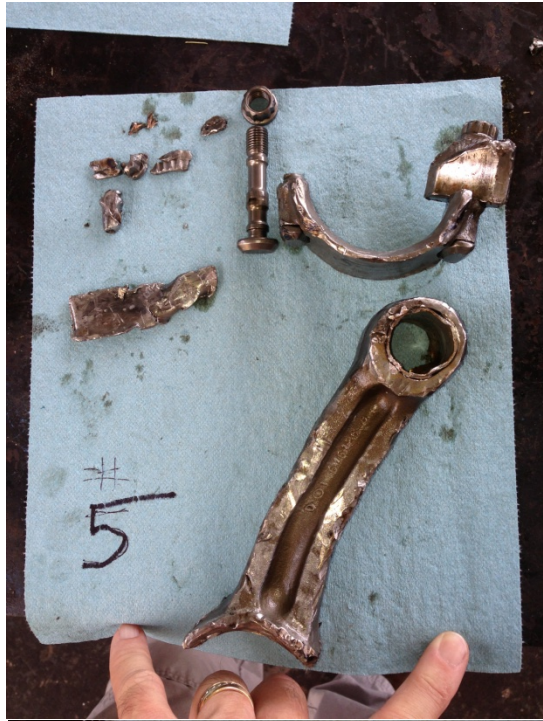
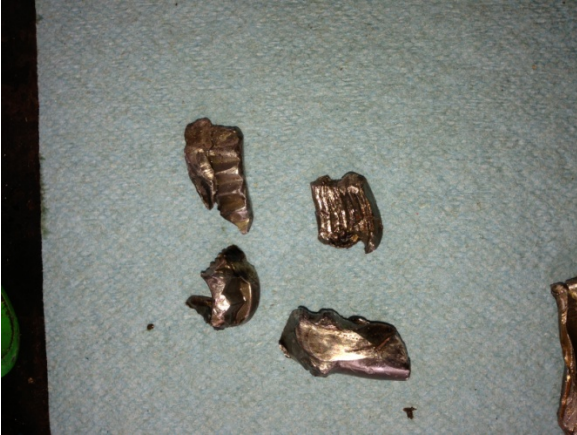
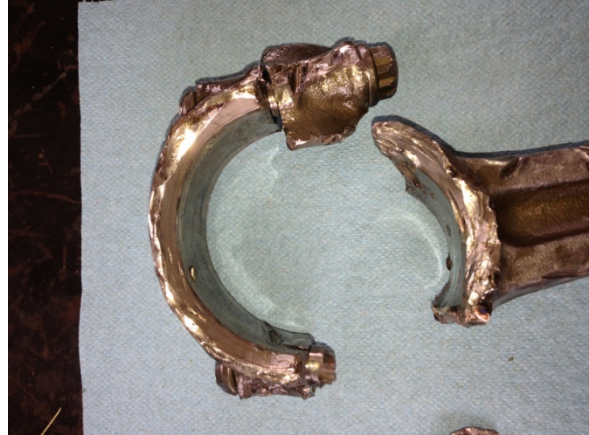
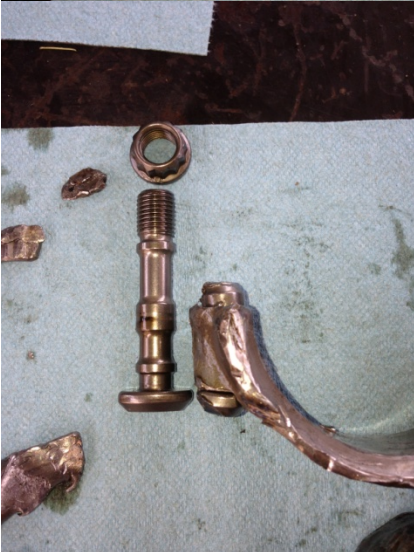
## 1.1 Engine Exam Photos

During recovery of the airplane it was noted that there was a breach of the engine case adjacent to the number five cylinder. The airplane was recovered for further examination.

Examination of the engine revealed a failure of one of two of the connecting rod bolts. The resulting failure continued with a catastrophic breach to the left side of the engine case between the number 6 and 4 cylinders.
