NATIONAL TRANSPORTATION SAFETY BOARD

ENGINE EXAMINATION REPORT

WPR16FA157

Arion Aircraft Lightning LS-1 – N341AL

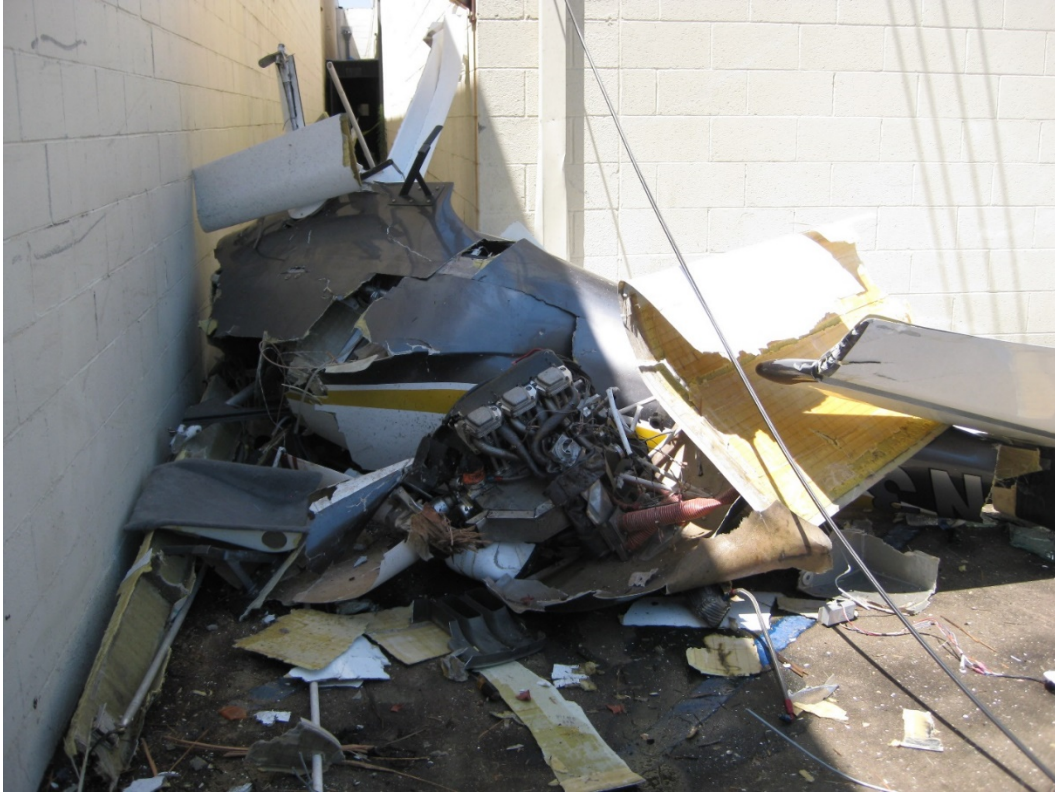
Photo 1: Airplane at Rest

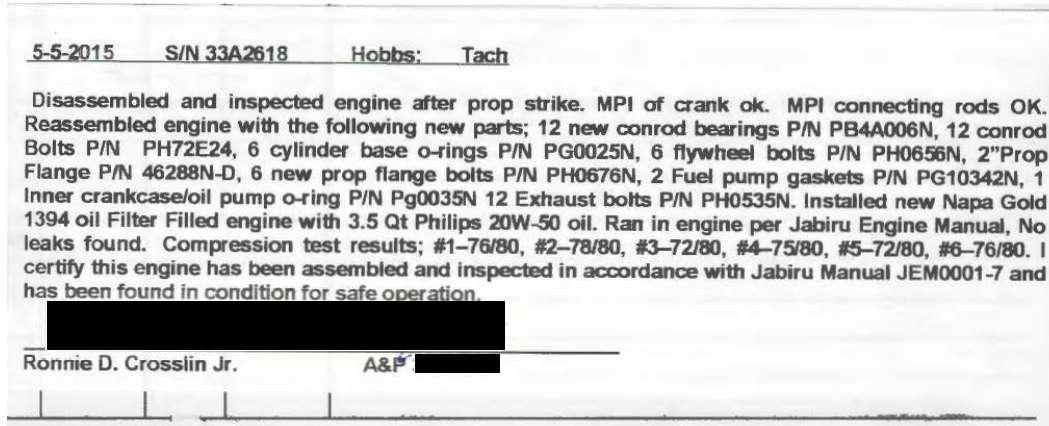
Recent Recorded TSMOH: 46.3 hours – recorded at major overhaul following a propeller strike dated May 5, 2015

Photo 3: Recent Overhaul

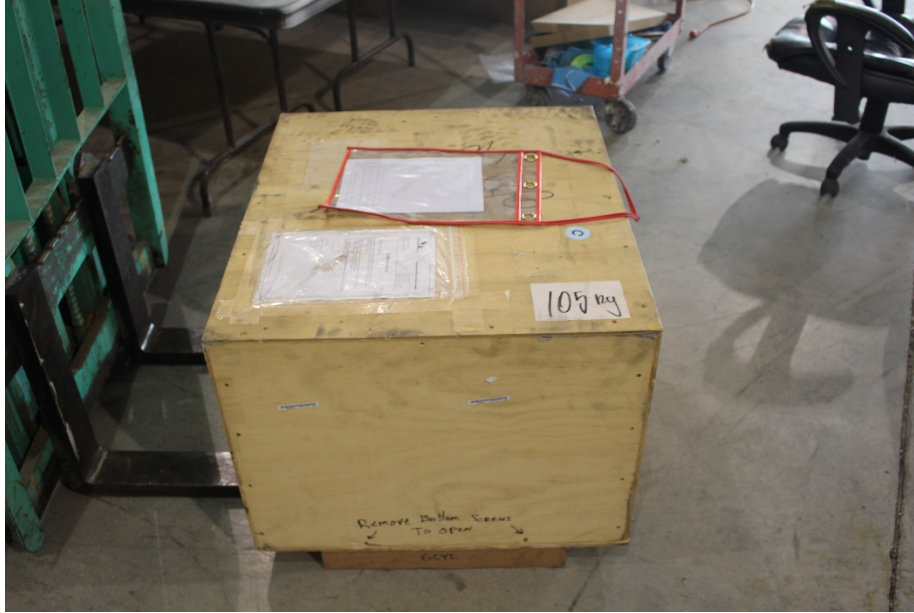
The engine was shipped from the recovery facility in Santa Paula, California to Jabiru’s maintenance facility in Shelbyville, Tennessee via crate and bonded shipment. Upon receipt the engine was immediately logged and placed in bonded/secure storage and was not opened. The crate was viewed by the IIC as unopened and subsequently photographed and opened for examination. The propeller hub was bent and replaced with a serviceable unit.

Photo 4: Engine as Received

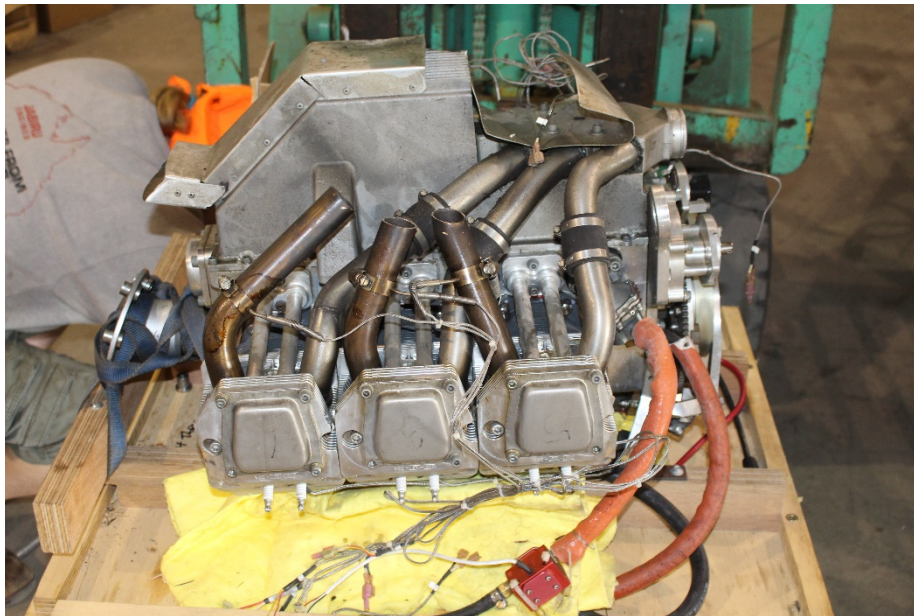
Photo 5: Engine After Secure Crate Removed

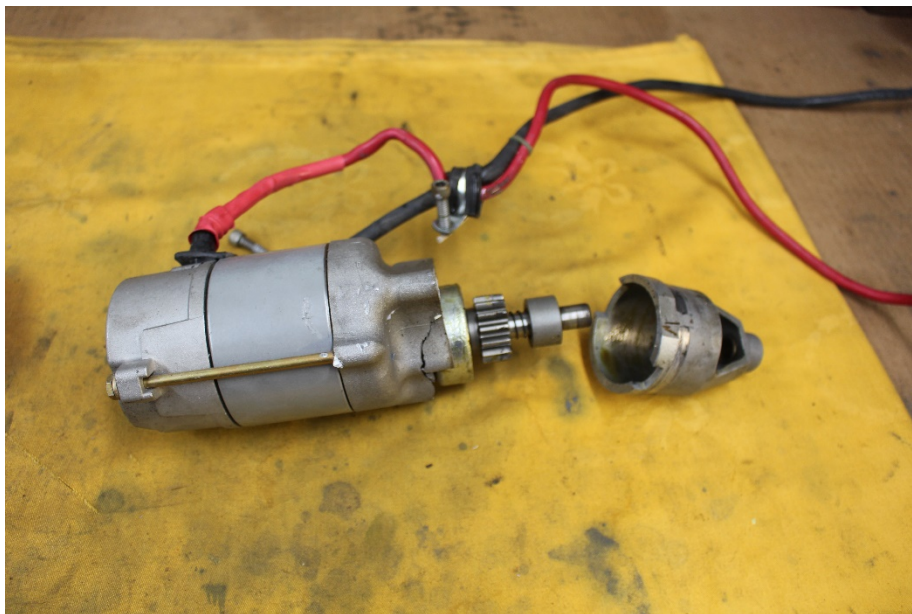
The starter motor did not have a data plate or any record of a part or serial number. According to the engine manufacturer, the starter motor was built by Jabiru and is a generic version of a Nippondenso starter motor.

Photo 6: Starter Motor

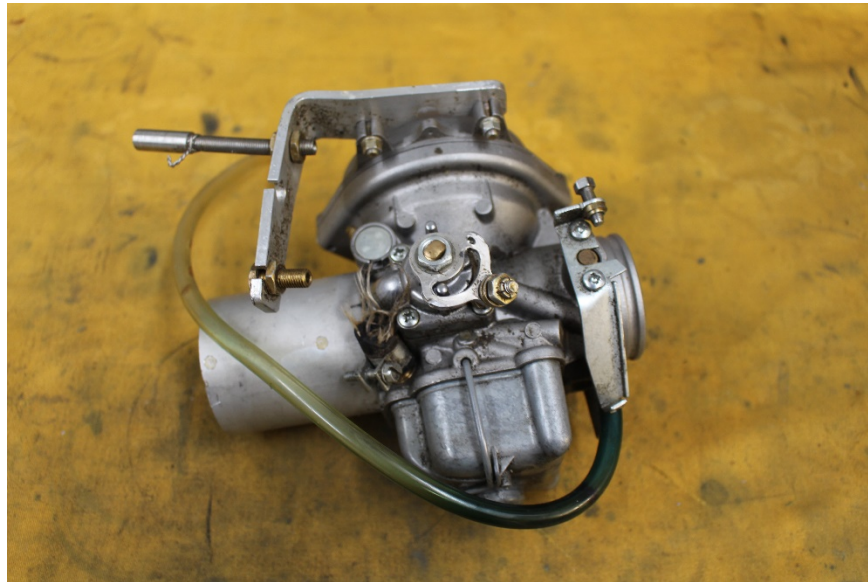
The carburetor was manufactured by Bing. A representative of the engine manufacturer reported that the unit's model designation was 94CV. The unit did not have a data plate, serial number, or part number listed. The needle valve diaphragm displayed a tear along the outer rim and one of the floats was canted. A green residue was observed along the rim of the dome; however, the manufacturer showed an exemplar factory new unit that contained a white power and a green residue.

A representative of the engine manufacturer reported that he had only seen two torn diaphragms in 17 years. In his experience, a torn diaphragm will produce a leak of differential pressure in the

piston channel. A leak will cause the ambient air to reach the top of the dome, which will reduce the piston's travel. Depending on the severity of the tear, the piston could drop into the jet, which will restrict fuel flow. An overly lean mixture and possible fuel starvation may result if the butterfly valve is open and the piston is near the top of the dome.

According to manufacturer, if one float was level and the other float was canted towards the carburetor, then fuel may shutoff early. If one float is canted towards the carburetor case and the other was level, similar to the accident airplane, then the carburetor would continue to feed fuel to the engine, which would allow it to run. If power went to idle then carburetor would flood the engine.

Photo 7: Carburetor

enough takeoff power for the load during the accident flight. The reduction in power from the first test was attributed to the tear in the diaphragm.

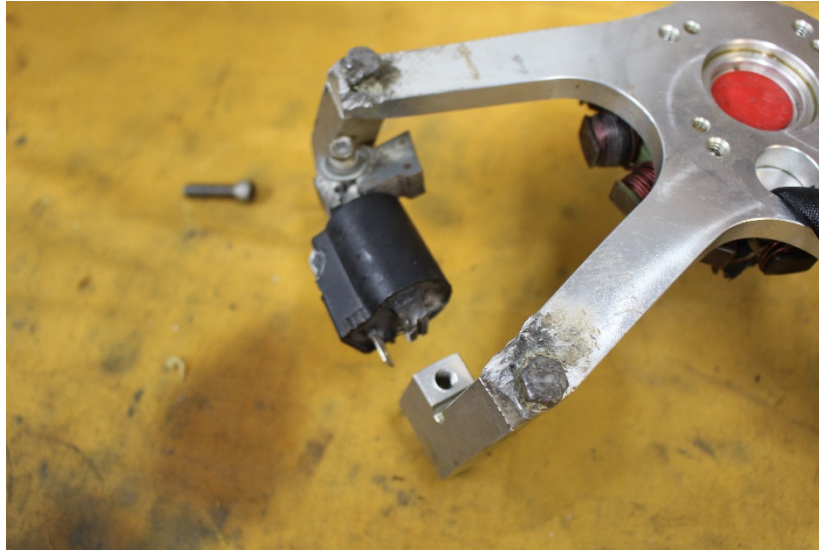
According to the manufacturer, right magneto was a Honda unit. The magneto remained attached to one bracket of the stator mount; the unit had fractured free from the other mount. The magnetos are fixed at 25 degrees BTDC. The magneto was tested using a multimeter and measured approximately 4.8 ohms at the terminal end. The manufacturer prescribed range is 2 – 5 ohms.

Photo 8: Right Magneto

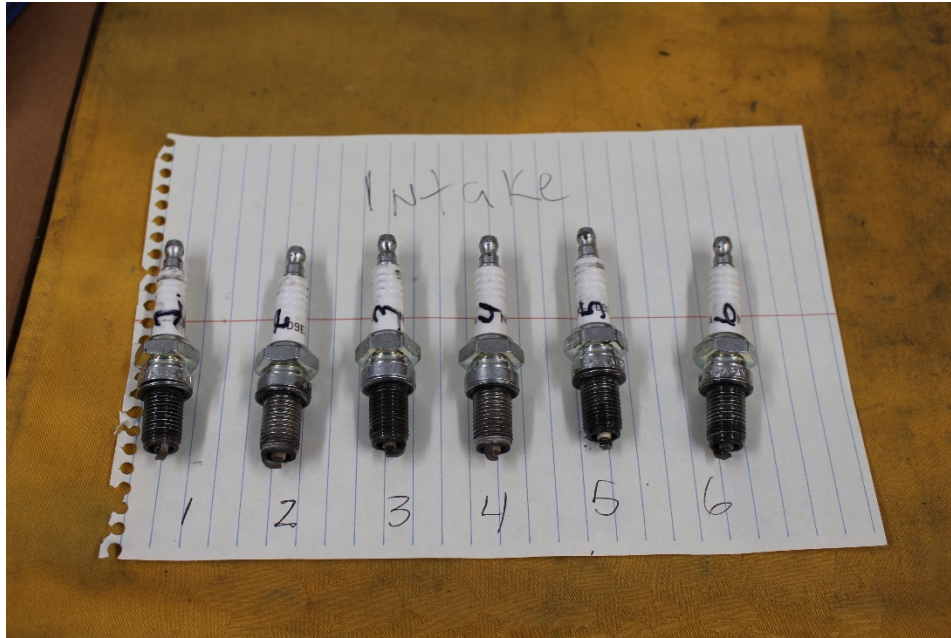
The intake and exhaust spark plugs, manufactured by NGK (part no. D9EA), were removed and examined. The plugs displayed normal wear. The spark plug ground electrodes gaps measured 0.018. According to the engine manufacturer, the prescribed spark plug gap should be approximately 0.022.

According to the engine manufacturer they have seen people run spark plugs at 0.010 and the engine continues to run normally. A shorter gap means that the spark will be shorter, but the engine will continue to run normally.

Photo 9: Intake Spark Plugs
