NATIONAL TRANSPORTATION SAFETY BOARD

ENGINE EXAMINATION

WPR16FA115

Location: Santa Monica, California
Date: May 22, 2016
Aircraft: Czech Aircraft Works SPOL SRO, SportCruiser, N1111X
NTSB IIC: Elliott Simpson

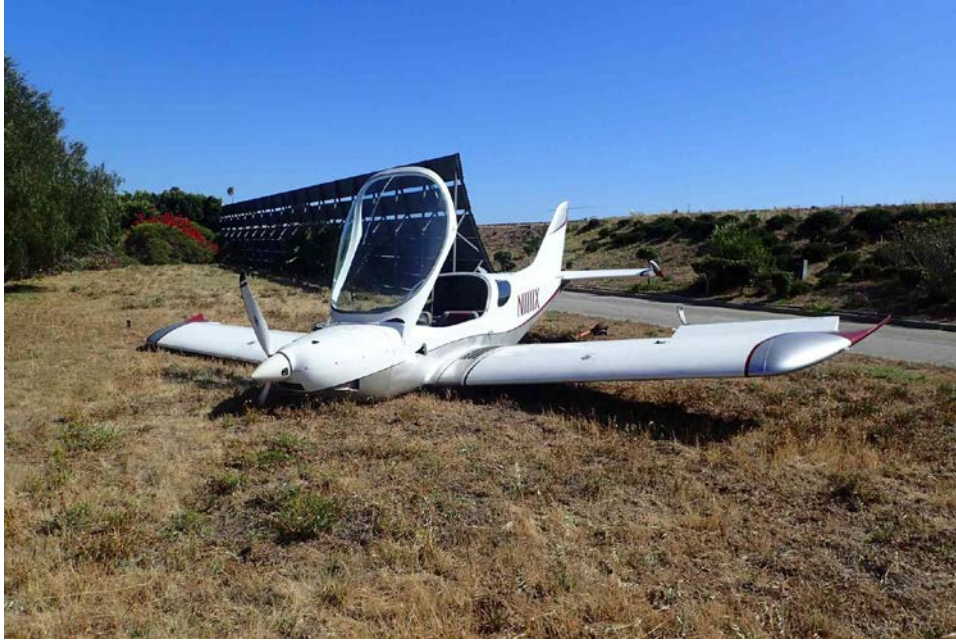
Photo 1 – Airplane at Accident Site

The airplane sustained substantial damage to the firewall and lower fuselage structure during the accident sequence, and both wings along with their integral fuel tanks were intact and undamaged (Photo 1). Both tanks contained fuel to at least half of their capacity when viewed through the filler necks. The upper cowling was removed, and all fuel lines were intact throughout the engine compartment through to the gascolator fitting (Photo 2). The gascolator fitting remained attached to the lower firewall, however the bowl, which sustained crush damage, was located along with the screen at the initial ground impact point in the debris field. The inner surface of the bowl was free of debris, and the screen was clear. The fuel lines from gascolator fitting through to the engine driven fuel pump contained no fuel. The fuel line from the fuel pump through to the carburetors contained residual fuel drops. The air induction scats tubes for both the filtered and carb heat air lines were intact and free of internal blockage, and the carb

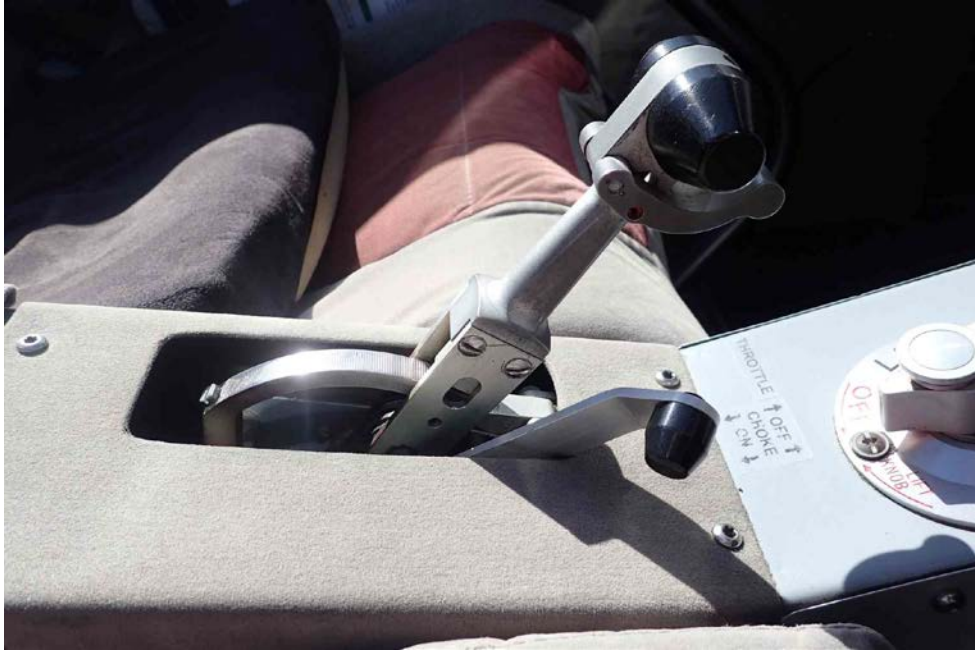
Photo 3 – Engine Controls in Cockpit

heat “flip flop” valve within the inlet manifold was intact and operated with movement of the carb heat control in the cabin. The engine throttle and choke controls were intact, continuous and operational through to their respective cockpit controls, which were both in the aft position (Photo 3).

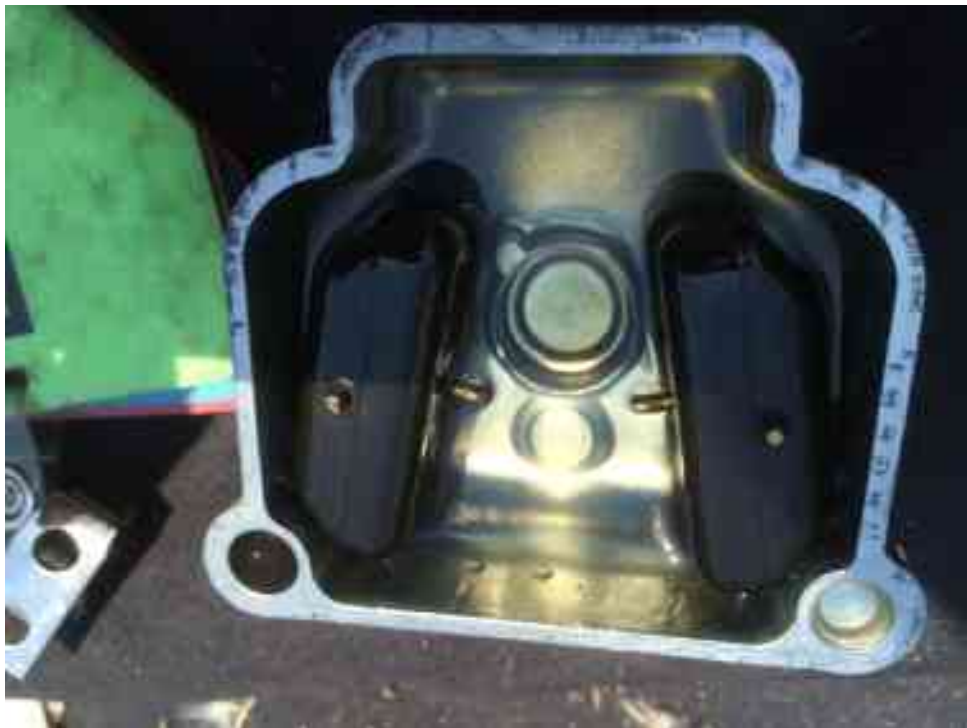
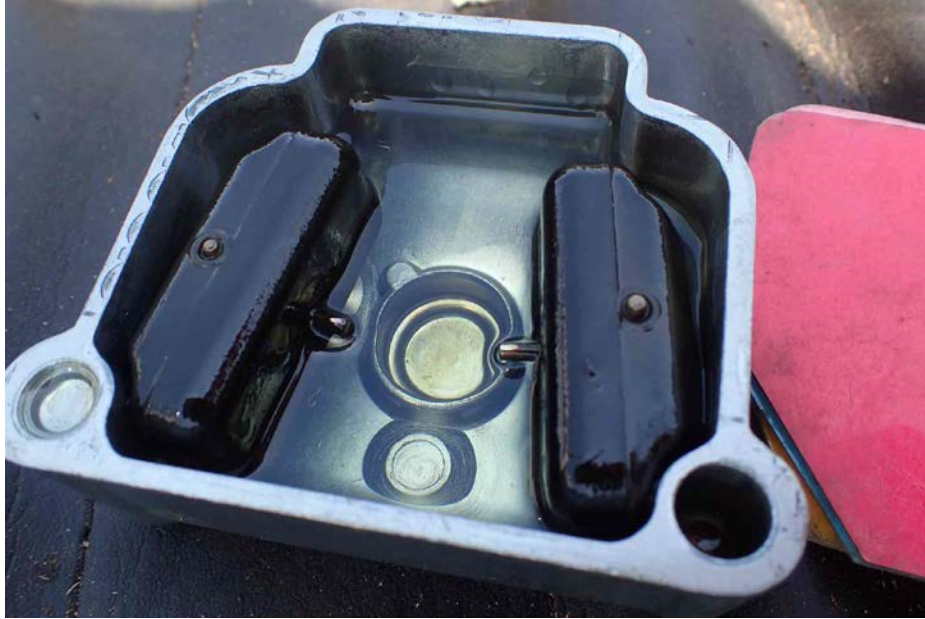
Both carburetor bowls were removed at the accident site, and contained fuel to about 3/4 of their capacity. Both floats were present in each bowl, and were floating such that their float pins were at the fluid surface (Photo 4,5).

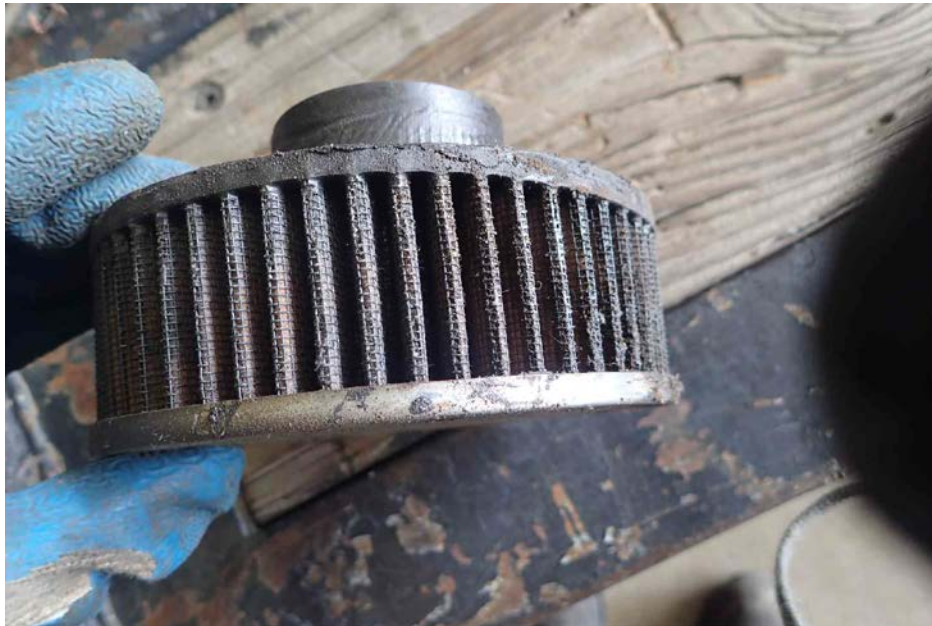
Photo 6 – Air Filter

The lower canopy was removed and the engine examined further. All oil and coolant lines were intact, and no indication of catastrophic engine failure, or oil/coolant loss was noted. The air filter remained attached to the lower cowling, and exhibited an oily dark coating to its exposed lower surfaces (Photo 6).

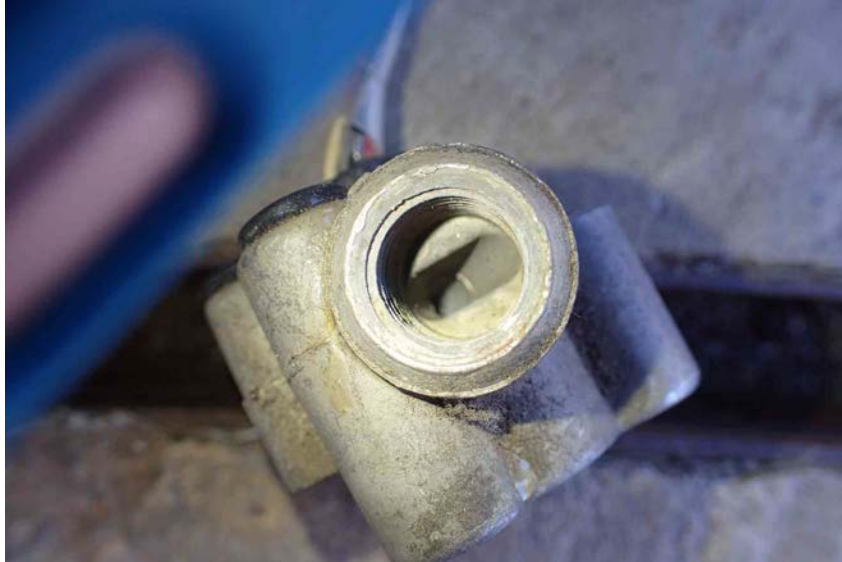
Photo 7 – Fuel Flow Transducer The air filter remained attached to the lower cowling, and exhibited an oily dark coating to its exposed lower surfaces

The engine oil filter was the reuse/cleanable type, and remained safety wired and firmly in place. The fuel line from the tanks through to the flow transducer behind firewall had separated adjacent to the crumpled cabin floor. The transducer was removed, and no blockage was observed (Photo 7). Air was applied to the input side, and the internal vanes could be heard spinning.

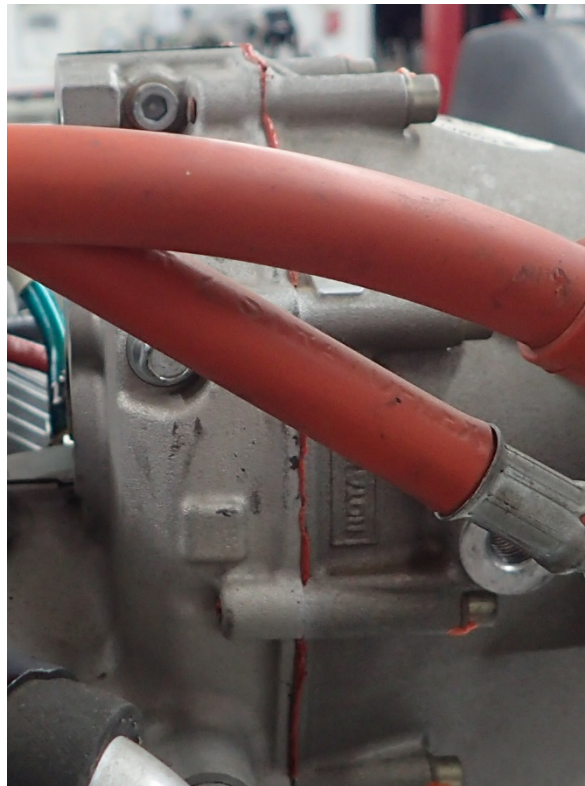
Photo 8 – Gearbox Sealant

The propeller gearbox was clean and appeared to have been recently installed. The incorrect sealant (orange silicone-type) was noted extruding from the gearbox seal at the case halves (Photo 8).

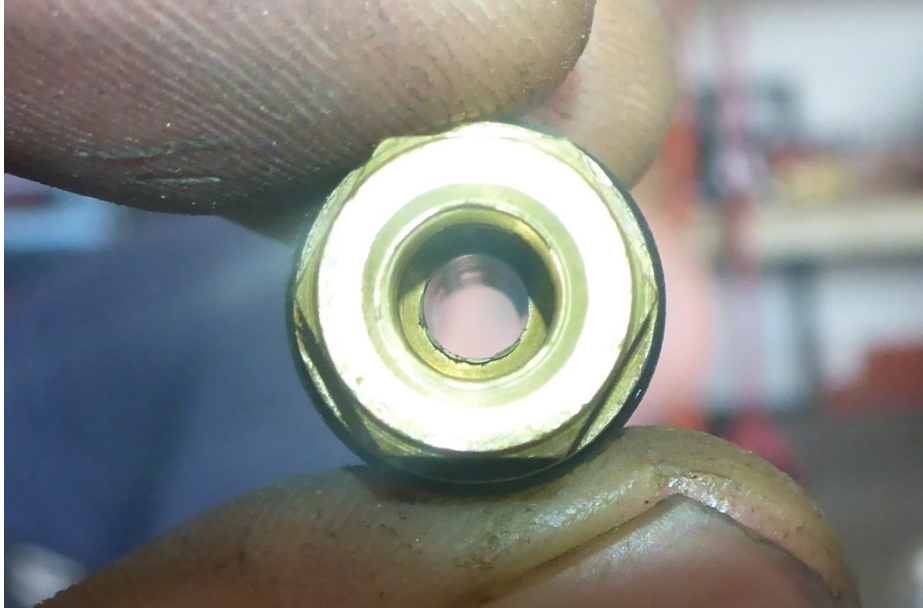
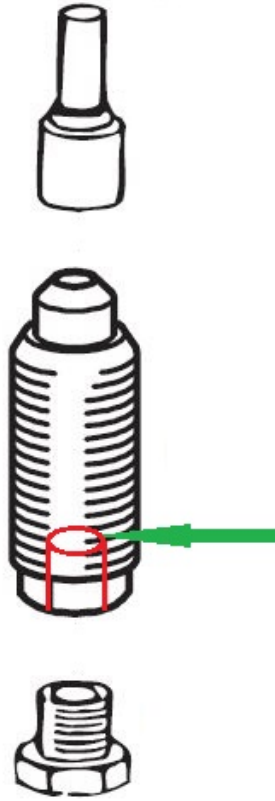
Photo 9 – Left (Cylinders 2/4) Carburetor Mixing Tube Bore

The carburetor jets were removed and examined for both carburetors. Both jets exhibited markings indicating that they were the correct size for the engine application (2.7mm). The left carburetor (cylinder 2/4) lower bore of the mixing tube exhibited a series of brass burrs on the

countersunk surface adjacent to the main jet (Photo 9, Figure 1). One burr projected into the bore of the mixing tube upon disassembly, and was removed for further examination (Photo 10).

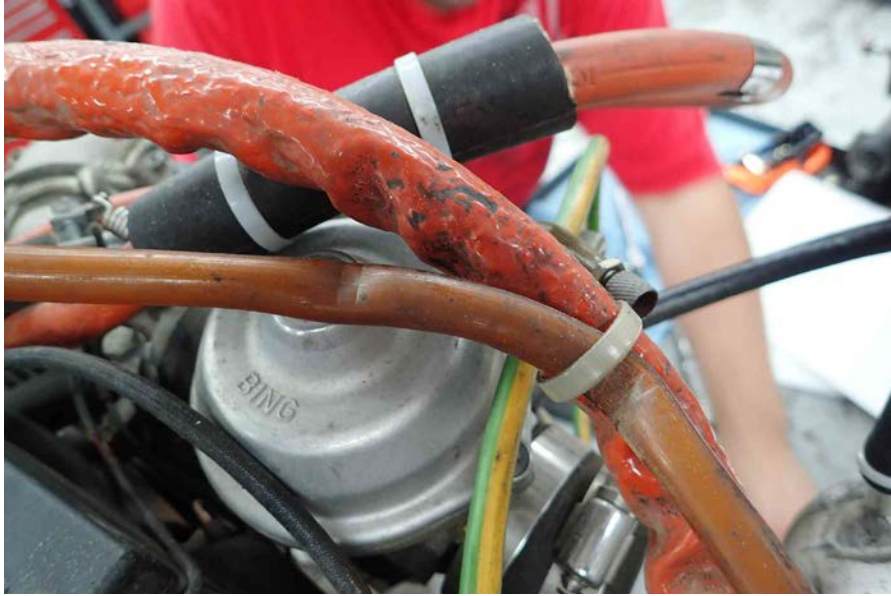
Photo 11 – Coolant Overflow Line

The coolant system was drained, and contained about 2 liters of red-colored fluid, consistent in appearance and texture with the approved 50/50 Dexcool fluid and water combination. The coolant overflow pipe appeared to have been pinched in multiple locations, and the material type was not appropriate for the installation, and had become brittle (Photo 11). About 3 liters of dark-brown colored oil was drained from the engine crankcase.

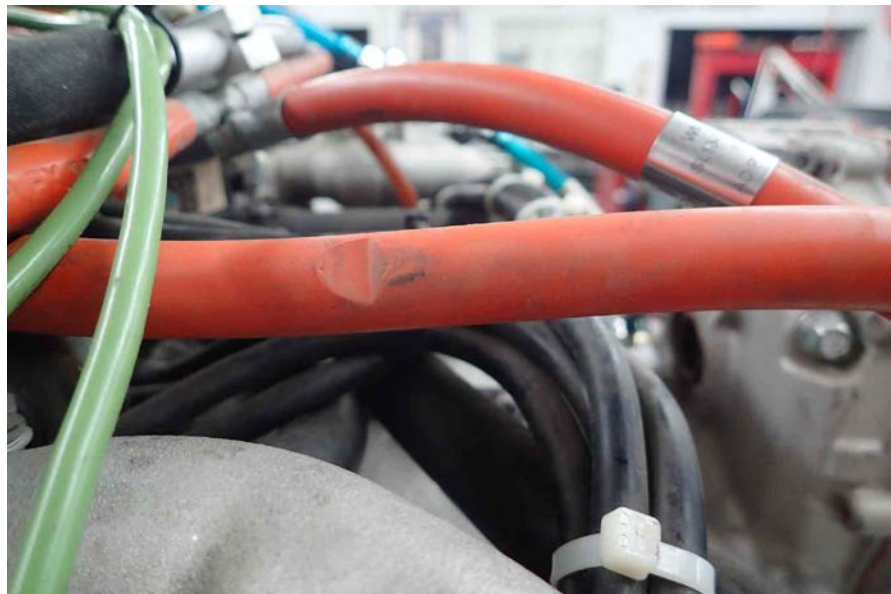
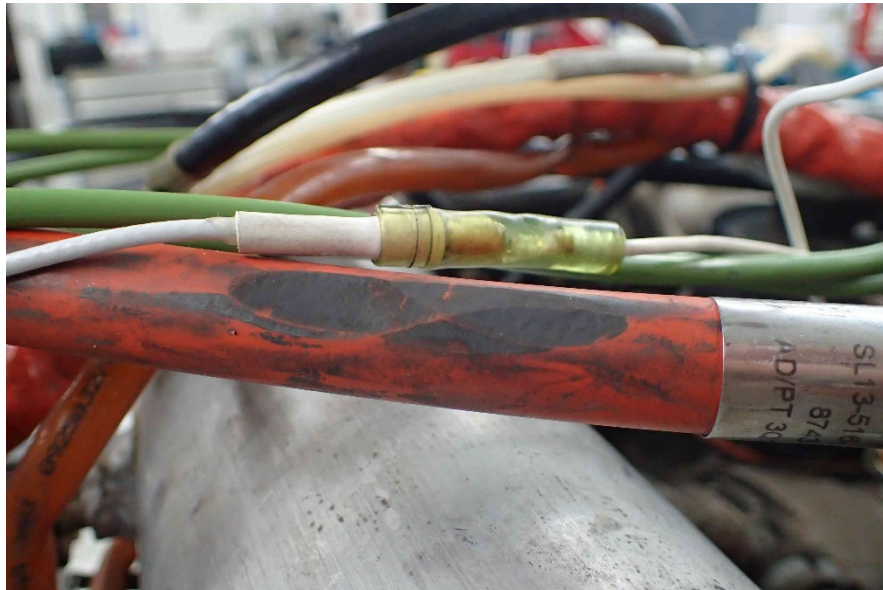
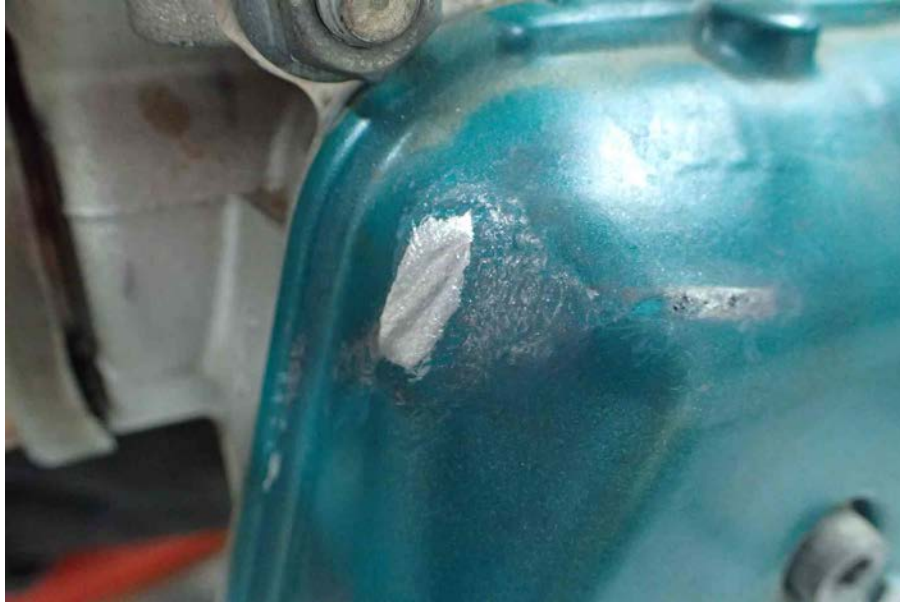
Multiple indications of chaffing were found throughout the engine compartment including the fuel line to the engine driven fuel pump, and the cylinder 3 rocker cover (Photo 12, 18, 13), along with the forward surface of the oil cooler (Photo 14). Both the yellow fuel pressure gauge line and the blue inlet manifold pressure gauge lines were intact and free of leaks. The balance tube did not exhibit indications of blockage.

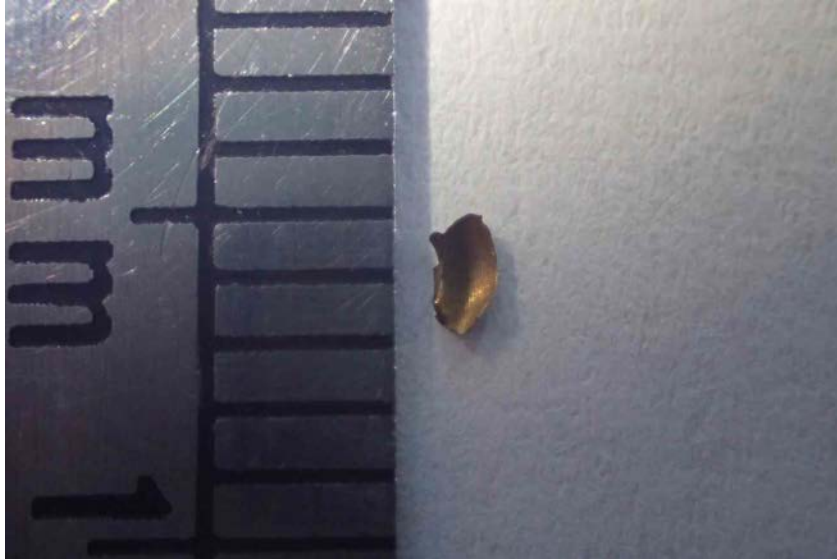
Photo 15 – Brass Burr

The bore of the left carburetor mixing tube was then reexamined. The bore diameter was 3.5 mm wide at multiple locations throughout its length and up to the area of the burrs. An exemplar bore was measured and found to be 3.51 mm wide along its length. The brass burr which projected into the bore was then measured and found to be, 1 mm wide, and 2.7 mm long. (Photo 15)

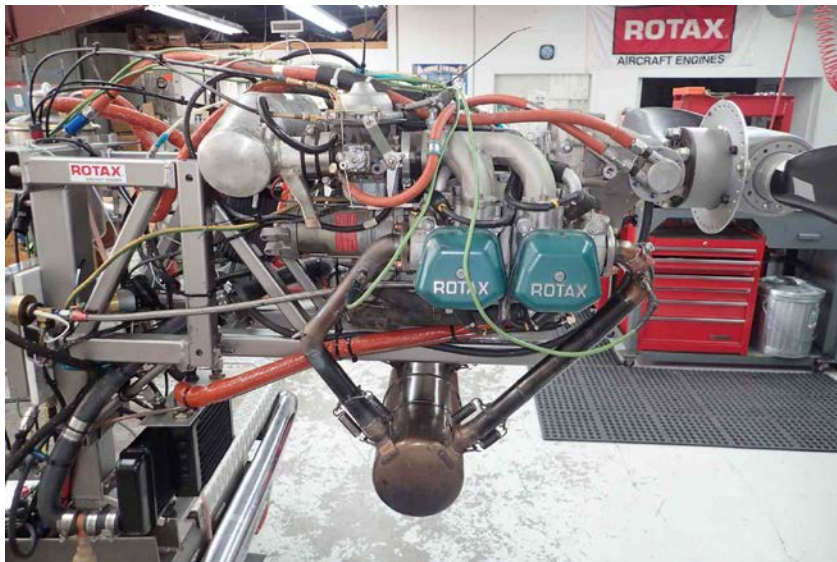
Photo 16 – Engine on Test Stand

The exhaust pipes, along with the radiator and oil cooling assemblies were removed, and the engine was attached to an engine test stand, and configured with a two-blade composite propeller configured for the pitch appropriate to the engine (Photo 16).

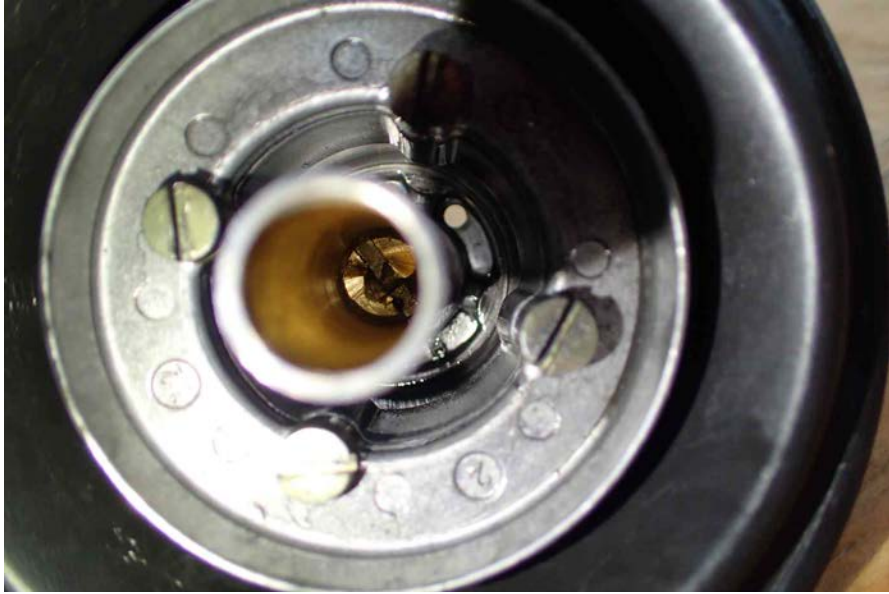
Photo 17 –Left (Cylinders 2/4) Carburetor Fixation Screw Head

The left carburetor (cylinders 2/4) exhibited similar characteristics, except that the needle valve could not be removed because the fixation screw appeared to have frozen within the carburetor piston. Closer examination revealed that the fixation screw head had surfaces had become smeared, consistent with a previous attempt to remove the jet needle (Photo 17). The needle was therefore examined in place; it exhibited the same two score marks on its shank, and an extension from the piston consistent with a circlip in position 3.
