NATIONAL TRANSPORTATION SAFETY BOARD

ENGINE EXAMINATION

CEN18LA156

Location: Beegles Recovery & Storage, LLC
Date: 13 June, 2018
Aircraft/Case: CEN18LA207
NTSB IIC: Jennifer Rodi

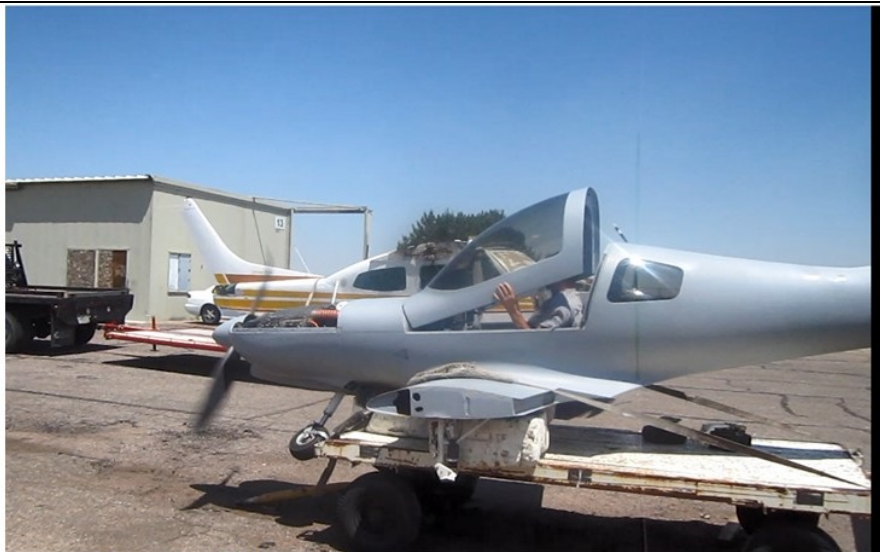
The airplane was transported to a salvage yard. For the engine test run, the fuselage is strapped down to a trailer.

The recovery crew stated about 30 gallons of fuel was recovered from the airplane; the header tank was “nearly” full, with the remainder of the fuel coming from the wing tanks.

The airplane was equipped with a (fuel) header tank (located in front of the windscreen), and left and right, wing fuel tanks.

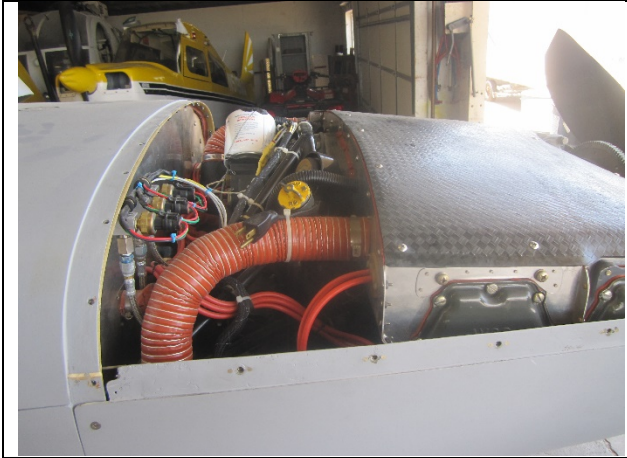
The top cowling was removed from the engine.

After the engine run the plenum cover was also removed.

The engine was identified from records as a Lycoming IO-360-C1E6

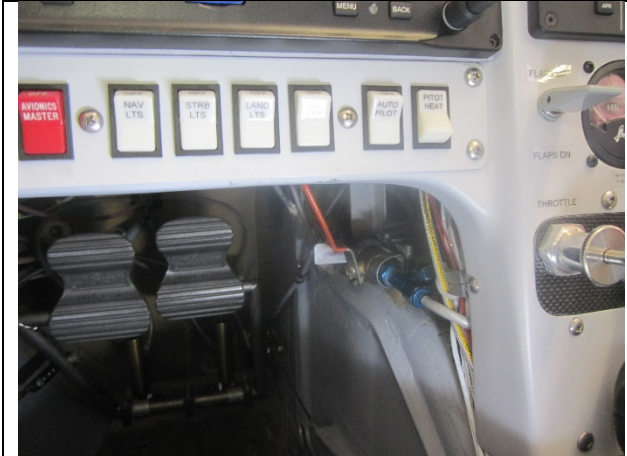
Two levers, believed to be fuel shut-off, were located on the left and right side below/behind the center console.

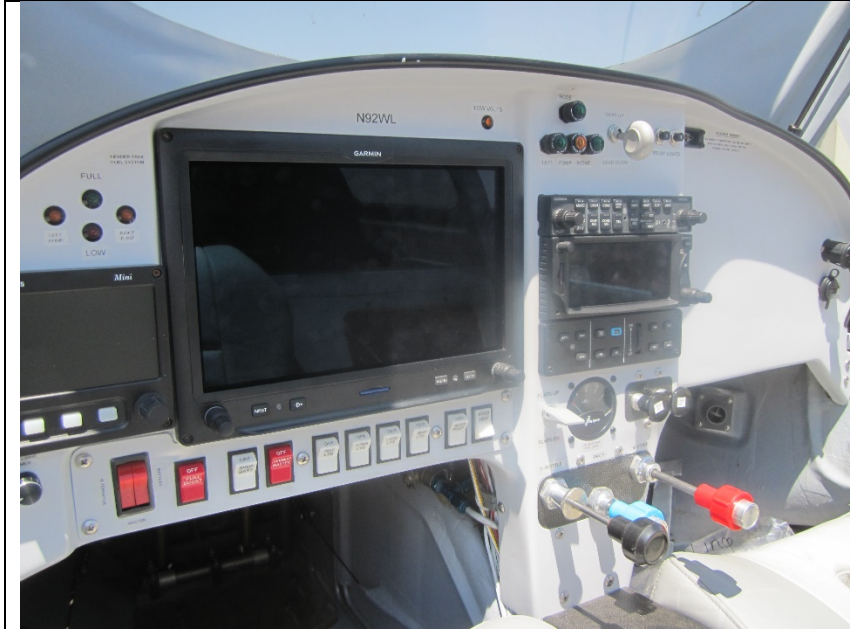
The airplane was equipped with a Garmin EFIS, and “standard” throttle, prop, and mixture controls

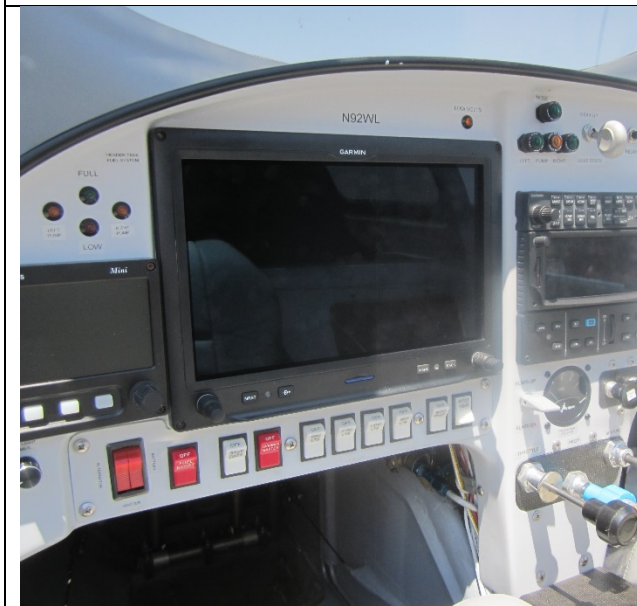
An SD card located at the bottom of the EFIS display was copied.

The unit recorded various flight and engine parameters.

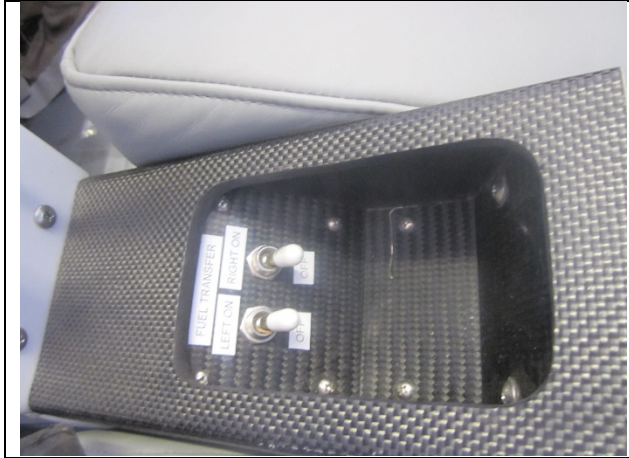
Transfer pumps, for wing fuel tanks

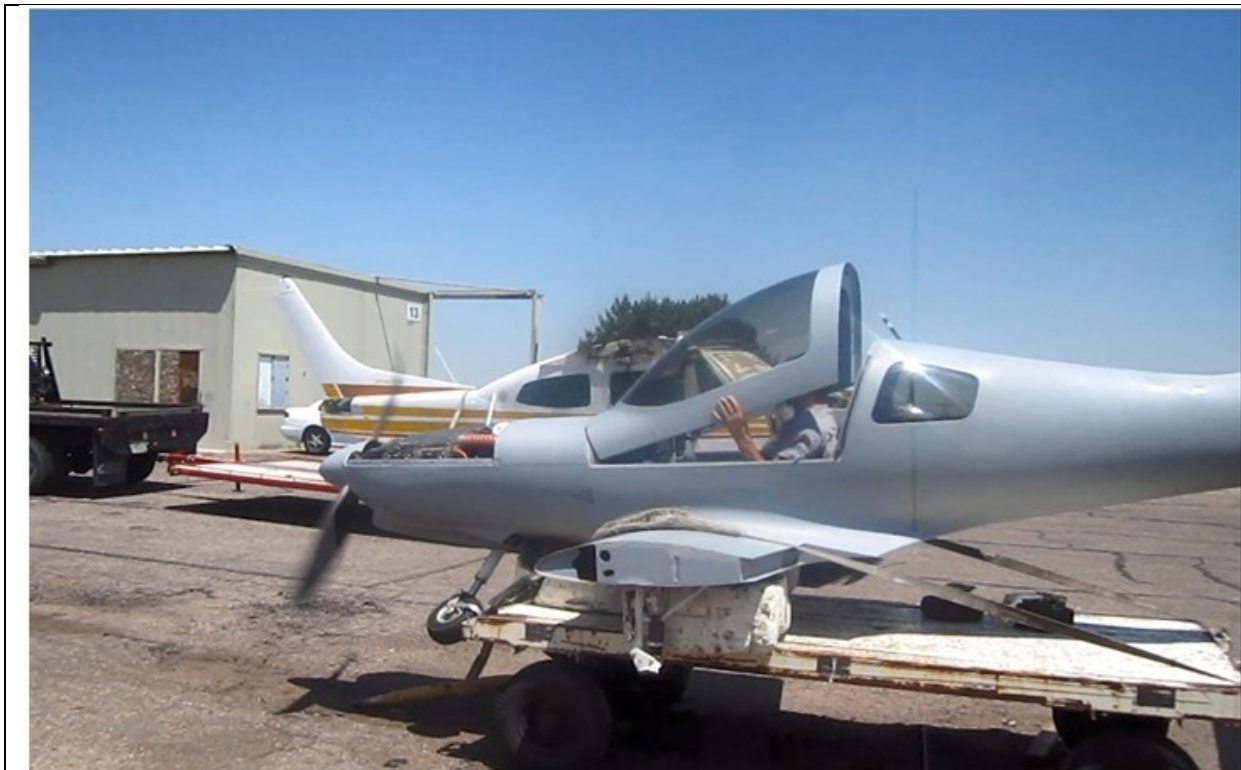
Fuel was added to the airplane header tank. The engine was started and run at various power settings. The magneto drop was “high” but similar between both left and right magnetos.

The engine performed satisfactory on the test, a reason for the lost power on the accident flight was not found.
