NATIONAL TRANSPORTATION SAFETY BOARD

AIRFRAME AND ENGINE EXAMINATION

WPR12LA302

N718JT, Bunch, Cozy 3

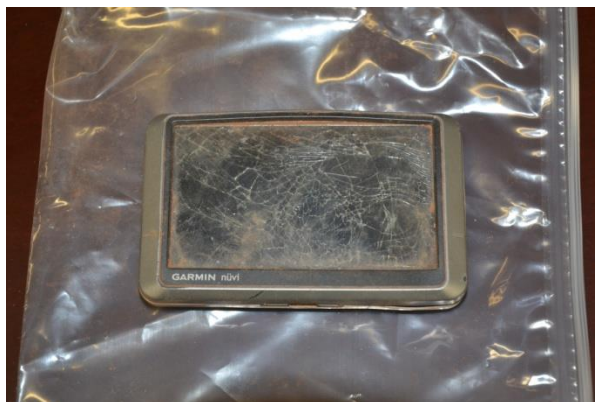
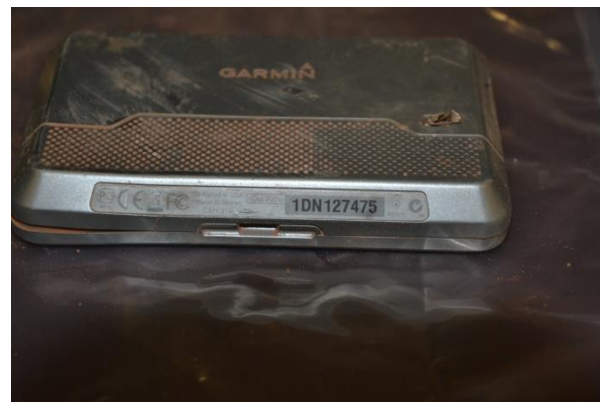
A Garmin Nuvi 200W portable GPS unit was recovered at the accident site by investigators. The unit was photographed and shipped to the NTSB Recorders lab for download. The unit was damaged in the accident sequence.

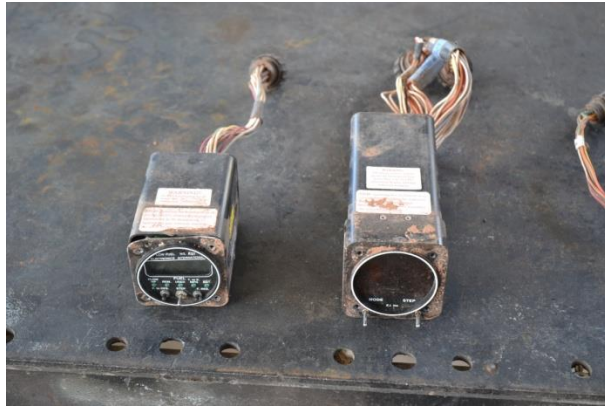
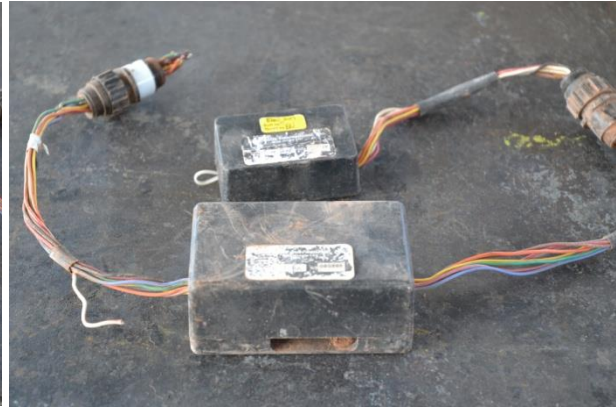
The airplane was equipped with a fuel flow/pressure instrument (FP-5L) and an engine monitoring instrument (UBG-16). Also installed was the interface module (MUX-8A). Manufacturer- Electronics International Inc., 6329 Powell Butte Hwy., Bend, Oregon 97701, (541) 318-6060. The units were removed and retained by the NTSB for further examination.
