ERA15LA062

Hampton, South Carolina

Cirrus Design Corp. SR22T

NTSB ENGINE EXAMINATION REPORT

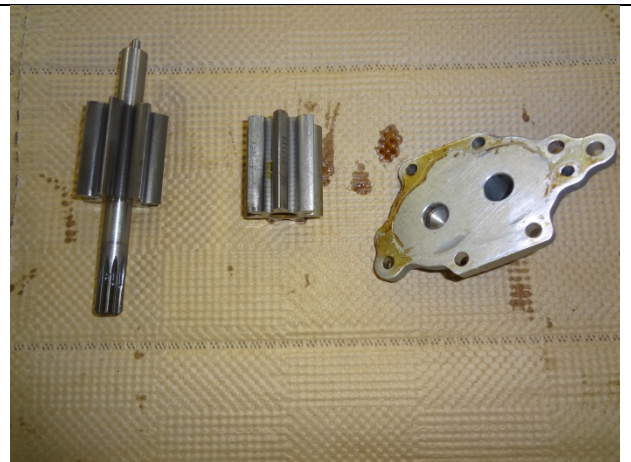
Photo 12: Oil Pump as Viewed

During examination the oil dipstick was found in place, examined and revealed about 8 quarts of oil. The oil was drained and appeared free of debris and was unremarkable. The oil pump cover which had been previously removed at the salvage facility, was re-strung with silk thread. Numerous fuel and oil lines were not sent with the engine and stock lines were utilized to facilitate the engine run. The Nos. 1, 3, and 5 exhaust riser was replaced with a similar riser, due to impact damage noted at the No. 5 cylinder elbow. The intercoolers were reattached to the engine. Fuel lines were reattached.

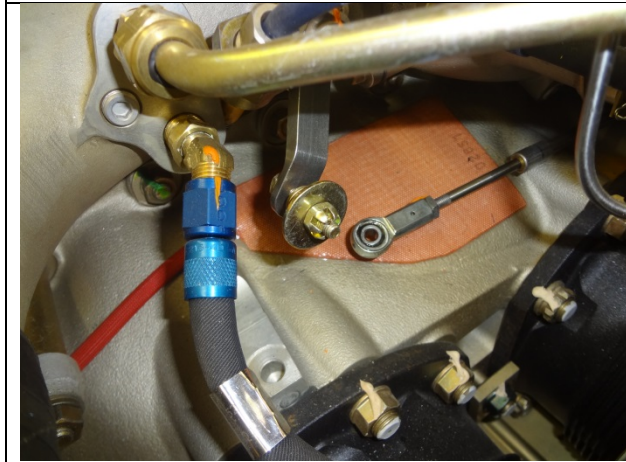
Photo 13: Throttle Cable as Viewed

- Impact crush damage to Cylinder No. 5 exhaust riser (Photo 14)
- Throttle Cable disconnected from throttle body/metering unit³ (Photo 13 and 20)
- Aneroid adjustment screw on the engine driven fuel pump was bent (Photo 18).
- Cylinder No. 5 rocker box covers exhibited impact damage on the lower approximate 1 inch of the cover

³ According to photographs taken by a representative of CMI the throttle arm on the throttle body was attached as first viewed at the salvage facility prior to shipment

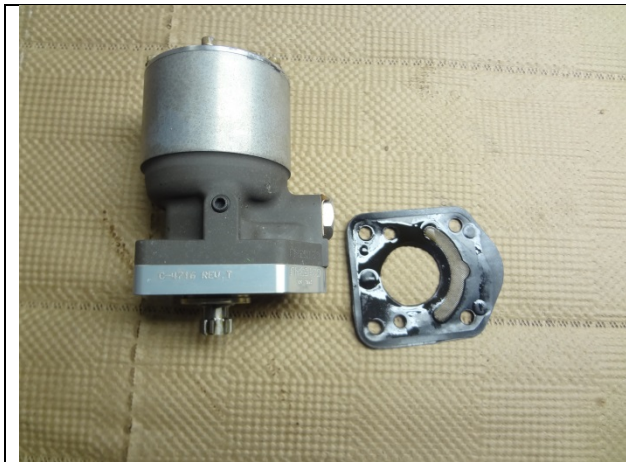
Photo 15: Propeller Governor - After Removal

The propeller Governor was manufactured by Hartzell, Model No. 8-1-44F, Serial No. G2153NJ. The unit was removed, as it was not needed for the engine run. The oil screen was examined and was free of debris and unremarkable.

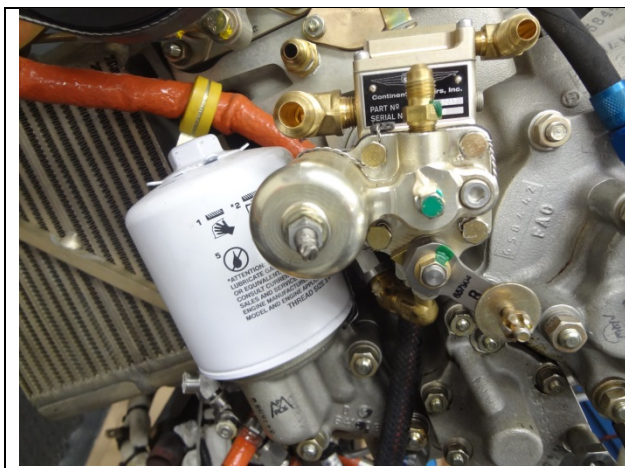
Photo 19: Engine Driven Fuel Pump as Viewed

The engine driven fuel pump remained attached to the rear side of the engine. The pump was unremarkable except for the aneroid adjustment set screw which was bent in the negative direction about 45 degrees and to the right about 10 degrees.

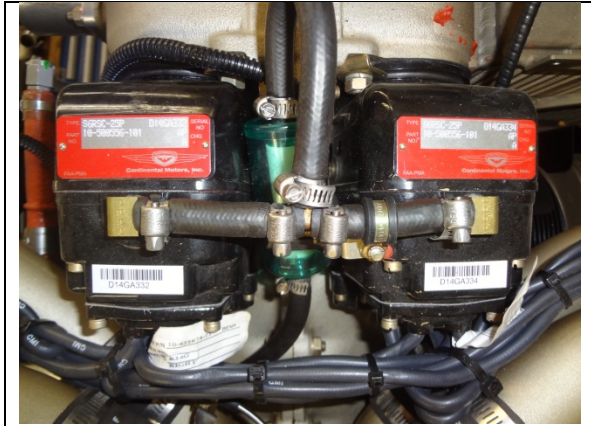
Photo 21: Both Magnetos as Viewed Mounted to Engine

The left magneto was a CMI manufactured, Part No. 10-500556-101, Serial No. D146A334. The magneto was found timed at 25°. Optimal timing was 24°.

The right magneto was a CMI manufactured, Part No. 10-500556-101, Serial No. D146A332. The magneto was found timed at 26°. Optimal timing was 24°.

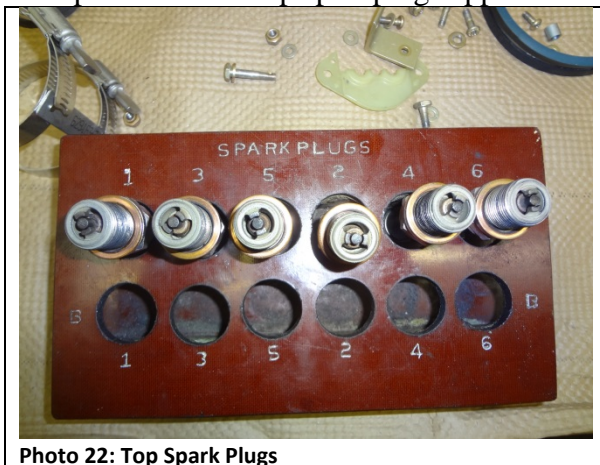
Photo 22: Top Spark Plugs

The sparkplugs were Tempest, Part No. URHB32E. The top sparkplugs were removed to check compression. The top sparkplugs appeared normal in color and like new.

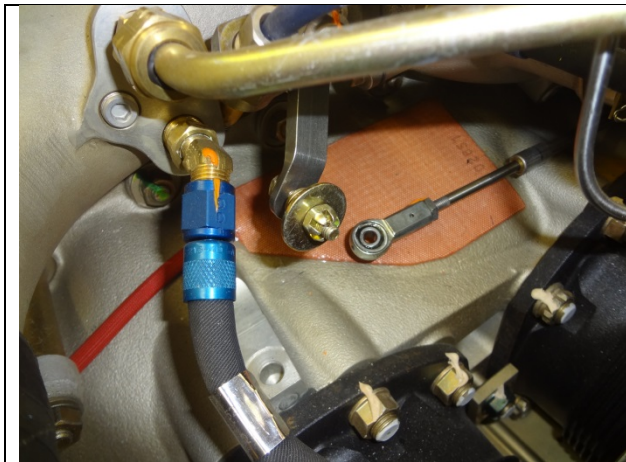
Photo 23: Throttle Body Metering Unit as Found

Was manufactured by CMI, Part No. 656785-4, Serial No. A146A184. The interface plate was examined and the torque stripe remained in place, with no evidence of slippage. The throttle body operated as expected and no abnormalities were noted.

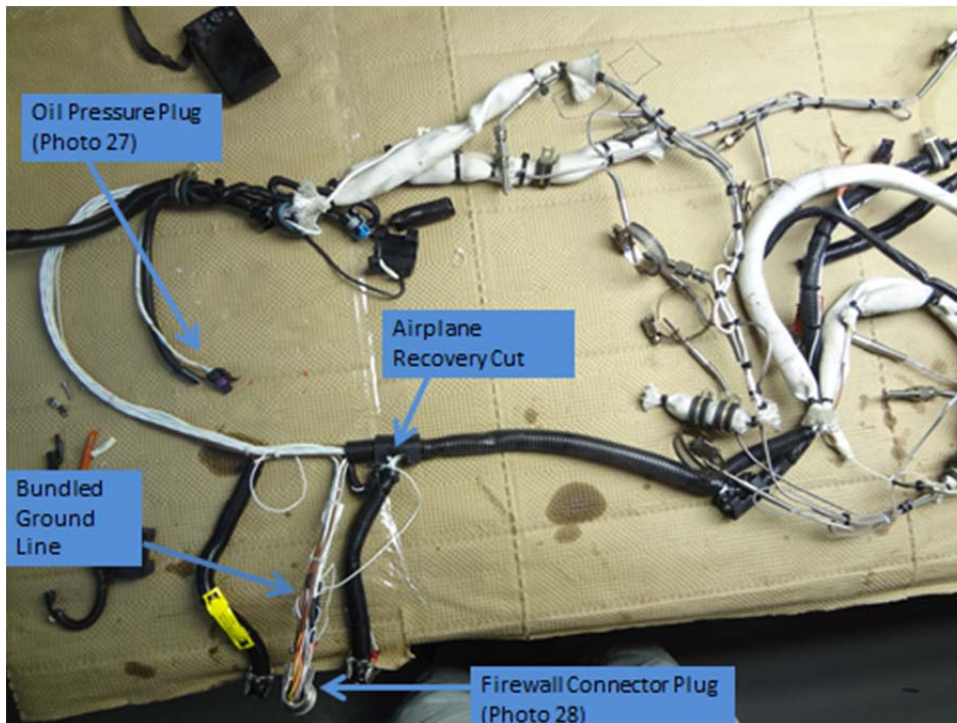
Photo 26: Oil Pressure Transducer Wiring

The oil pressure transducer electrical wiring was examined. The wire remained attached to the plug unit and wire continuity was confirmed from the plug to the firewall. Wire continuity was confirmed from the oil pressure plug to ports marked "B" and "C" on the firewall connector plug, as expected. The shielded line was traced from the oil pressure plug to a bundled ground line with continuity confirmed from oil pressure plug, to the soldered bundle, to the recovery cut made to separate the engine from the airframe.
