**NATIONAL TRANSPORTATION SAFETY BOARD
OFFICE OF AVIATION SAFETY
WASHINGTON, D.C. 20594**

POWERPLANTS GROUP CHAIRMAN'S ENGINE TEARDOWN REPORT

NTSB ID No.: CEN-14-LA-278

Location: Duluth, Minnesota
Date: June 7, 2014
Time: 1123 Central Daylight Time
Aircraft: Lancair IV, Registration: N86NW

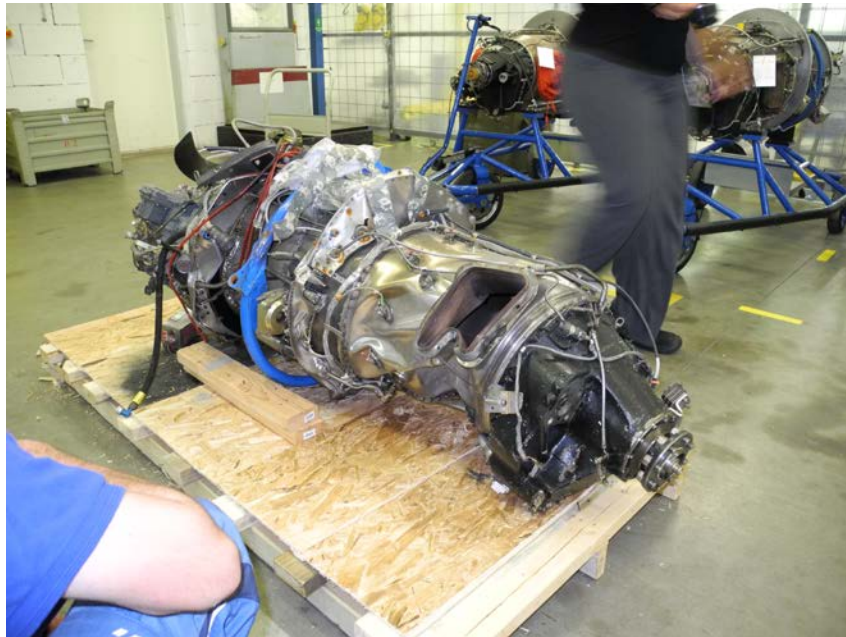
Figure 2 – Engine as Recieved

The engine was contiguous (Figure 1). All the external tubes, control cables and linkages were present, however, all were deformed and some were broken. The external accessories were present except the propeller governor. The propeller control linkage from the propeller governor to the prop-reversing cambox was present and continuous, however, it was deformed. The lever arm of the propeller governor was still attached to the forward end of the linkage.

The exhaust case was intact, however, it was buckled, with the most severe damage occurring at the 4 to 8 o'clock¹ location. The buckling direction was inward, which caused an overall bending condition of the of the exhaust case, resulting in a lower displacement of the reduction gearbox (RGB) by approximately 2 inches (Figure 2). Additionally, the angle of the gearbox was changed by approximately 20 degrees

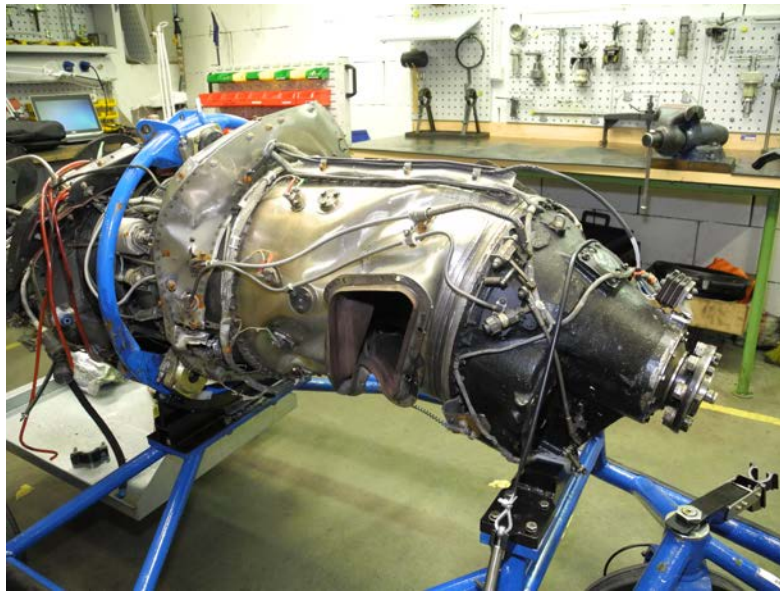
Figure 3 – Engine – Aft View

The fuel pump and fuel control unit (FCU) were still attached to the AGB (Figure 3). The oil fill and check hardware was present, secured and undamaged. The starter/generator (S/G) was not returned, however a fractured portion of the male spline from the S/G shaft was still retained in the engine splined S/G input shaft. The S/G mount pad was present, but fractured. The AGB tachometer generator was still mounted on the AGB, however it was fractured. The ignitor unit was separated from the engine flange, but it was still loosely restrained by the ignitor cables.

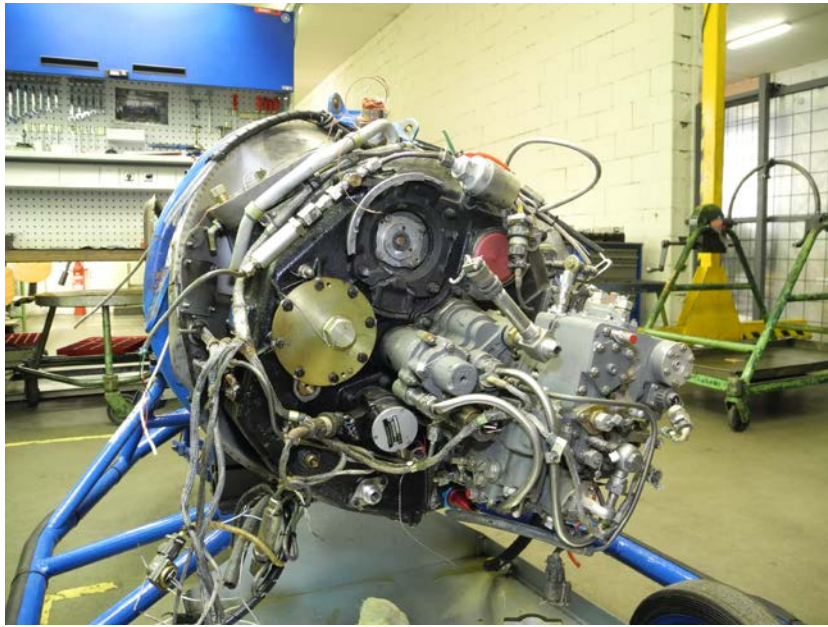
Figure 4 – Oil Filter

The oil filter (Figure 4) and fuel filter (Figure 5) were removed, examined and found to be clean.

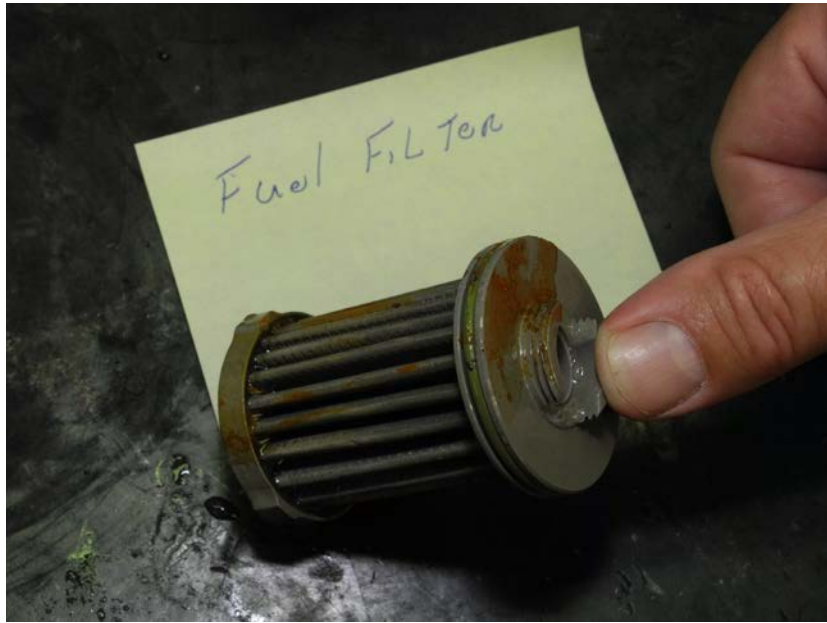
Figure 6 – RGB Removed From Engine

The RGB was generally intact however, the housing was fractured just forward of the aft attachment flange (Figure 6). The propeller governor was no longer attached to the RGB and was not present. The propeller governor mounting threads in the RGB were stripped and the holes were elongated. The RGB was dented at the location of the propeller governor. The RGB was removed from the engine at the SN-1 flange and moved to the gearbox assembly area in the factory for disassembly.

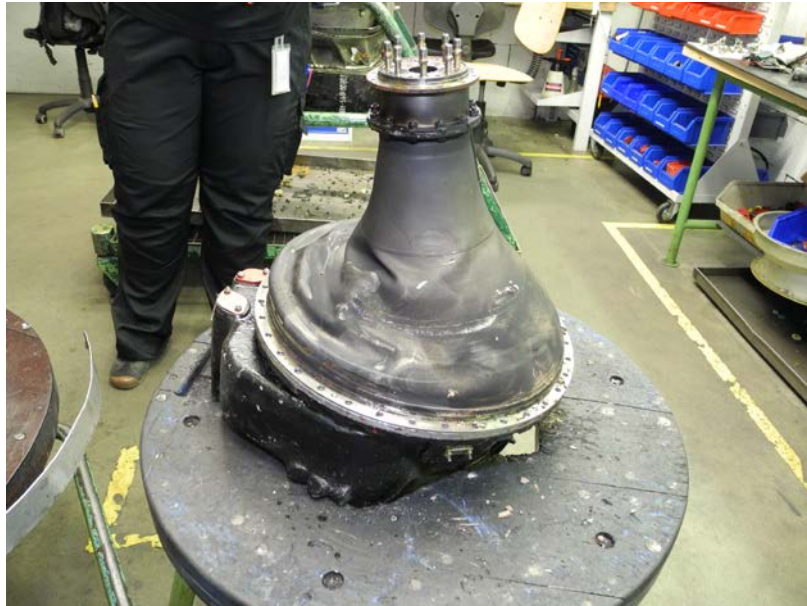
Figure 7 – Aft Diaphragm And Bearing Support

The aft diaphragm and bearing support was intact (Figure 7), however, there was a through crack from the edge of one bearing housing boss to the outer edge. The quill shaft was intact, however it was bent near the mid-length (Figure 8). The gear teeth were battered, dented and fractured and were still in contact with the 3 planet gears (Figure 9). All three planet gears were intact, however all the teeth were battered, scored, distorted and fractured. The aft roller bearings were intact with only slight external corrosion in some locations, consistent with water immersion.

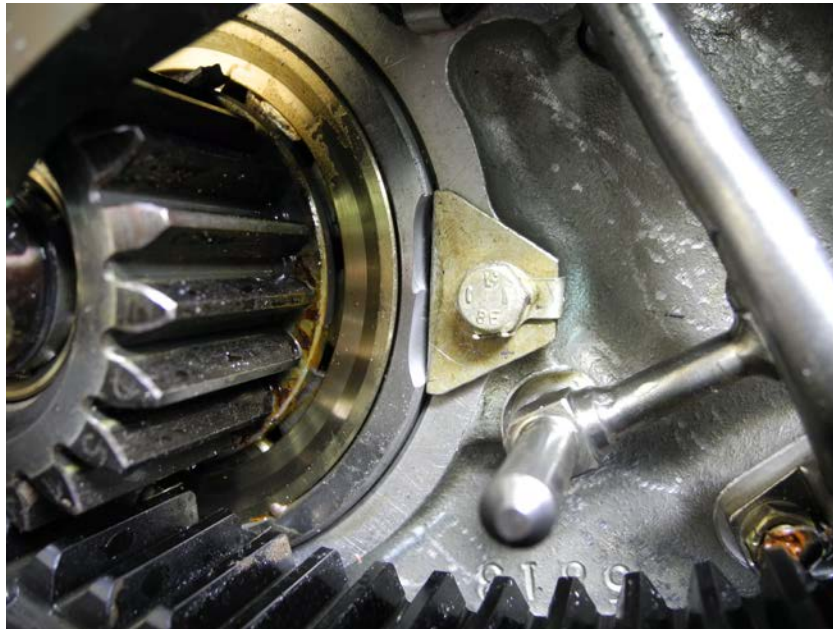
Figure 12 – Ring Gear - Installed

The ring gear was intact and undamaged (Figure 12), however the front retention lands for the conical prop shaft adapter spline had shiny witness marks around the circumference, consistent with contact against the conical prop shaft adapter spline during an axial impact. The conical prop shaft adapter spline was undamaged, however there were shiny witness marks on the spline teeth aft plane, consistent with contact against the ring gear front retention lands. The propeller shaft appeared to be undamaged (Figure 13), however it was located approximately ½ inch aft of its normal operating location. The propeller shaft roller bearing was intact, however it was no longer retained in the front RGB housing, rather 3 retaining bolts were pulled from the RGB housing and one tab of the bearing race was fractured.

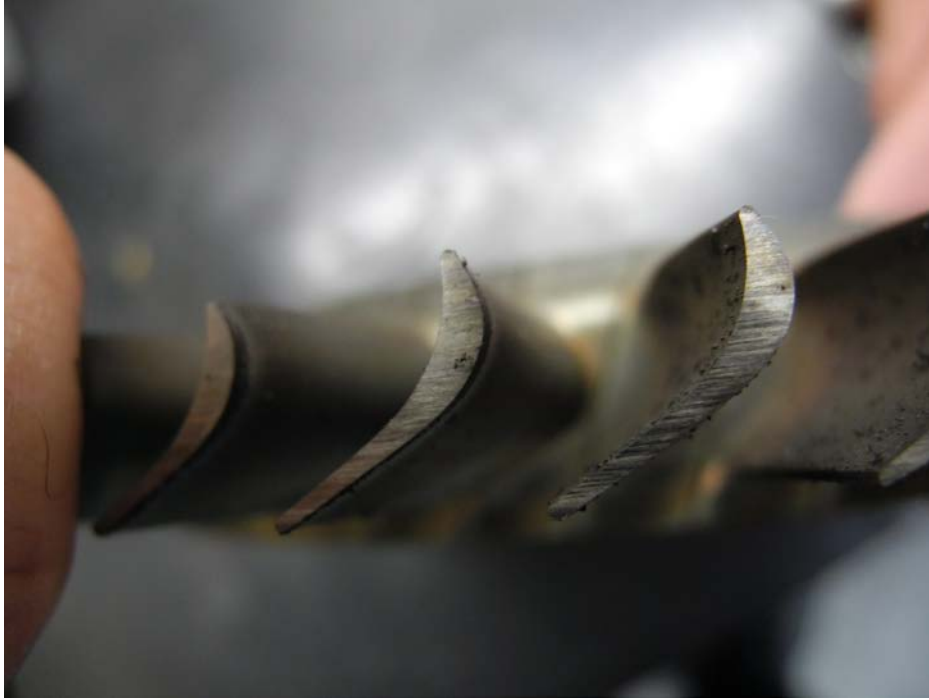
Figure 18 – Gas Generator Turbine Blades

The GGT was intact, however the blade tips were circumferentially scored with metal transfer evident on the convex sides of the tips (Figure 17), consistent with contact against the GGT shroud. Additionally, there were randomly distributed bright shiny flakes deposited on the convex side of some of the blades (Figure 18), consistent with metal spray² condition.

² Metal Spray – During engine operation, compressor rotors turn at high speeds. Shrouds are stationary, are typically coated with a thick aluminum spray material and are in close proximity to the turning rotors. Impact forces can force these components to contact with each other. During contact, the high speed rotors shaves the soft aluminum material off the shrouds and the engine airflow sends the small shaved particles through the engine. As the aluminum particles enter the combustor, they become molten if there is a flame. The melted particles continue to flow along the air stream and become deposited on the cooler surfaces of the turbine blades and stator vanes. Visually, they appear as silver colored speckles. The evidence of metal spray is an indication of engine operation; it indicates that there is engine rotation, positive engine airflow, and flame in the combustor.

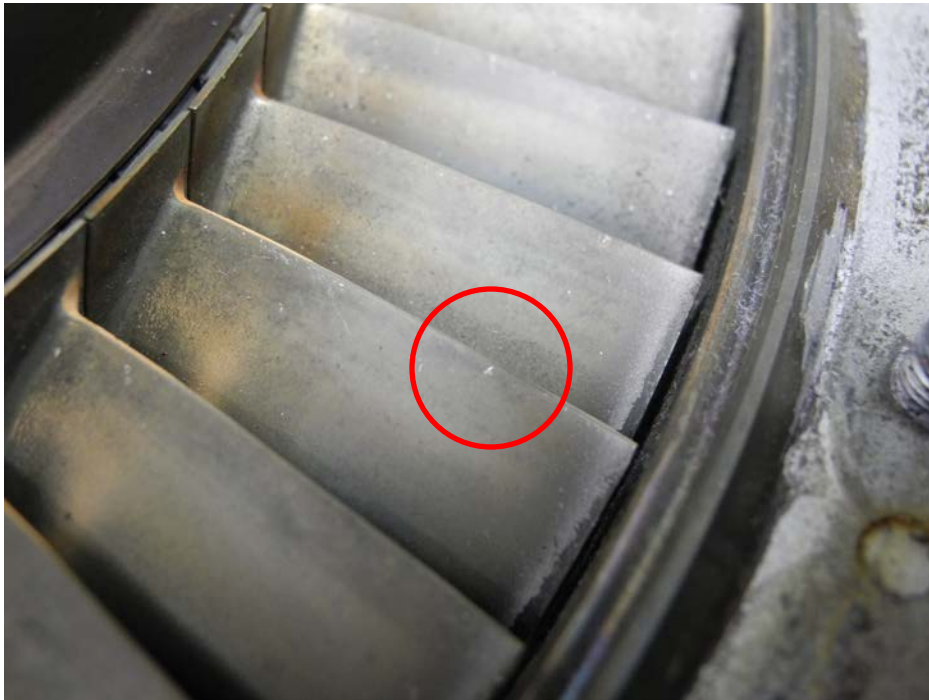
Figure 19 – Gas Generator Turbine Nozzle Guide Vane Ring (GGTNGVR)

The GGTNGVR was intact, however the GGT shroud was rotationally scored in the plane of the GGT blade plane from 5 to 9 o'clock ALF (Figure 19).

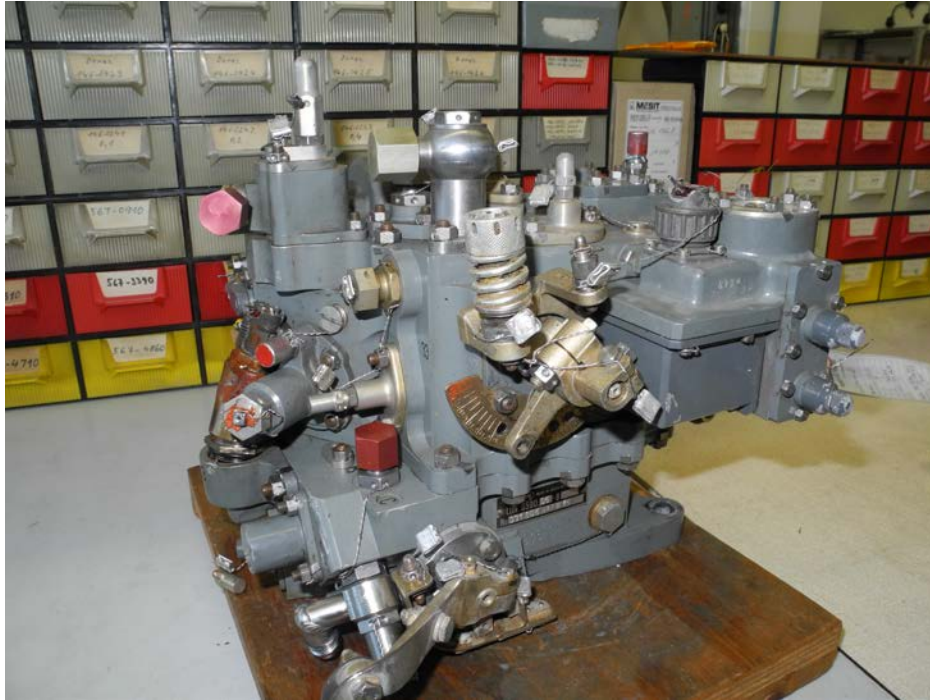
Figure 26 – FCU Prior to Teardown

The flapper nozzle cover plate had a yellow anti-tamper paint on the four attachment screws, which is not an original feature, indicating that the plate had been removed at some time during service (Figure 26). Upon inspection, it was found that the internal serialized rubber/fabric diaphragm was the original installed, however it had been improperly re-installed, causing a tear and extrusion (Figure 33) of the external rubber ridge. A leak in this diaphragm would not result in a sudden loss of power.

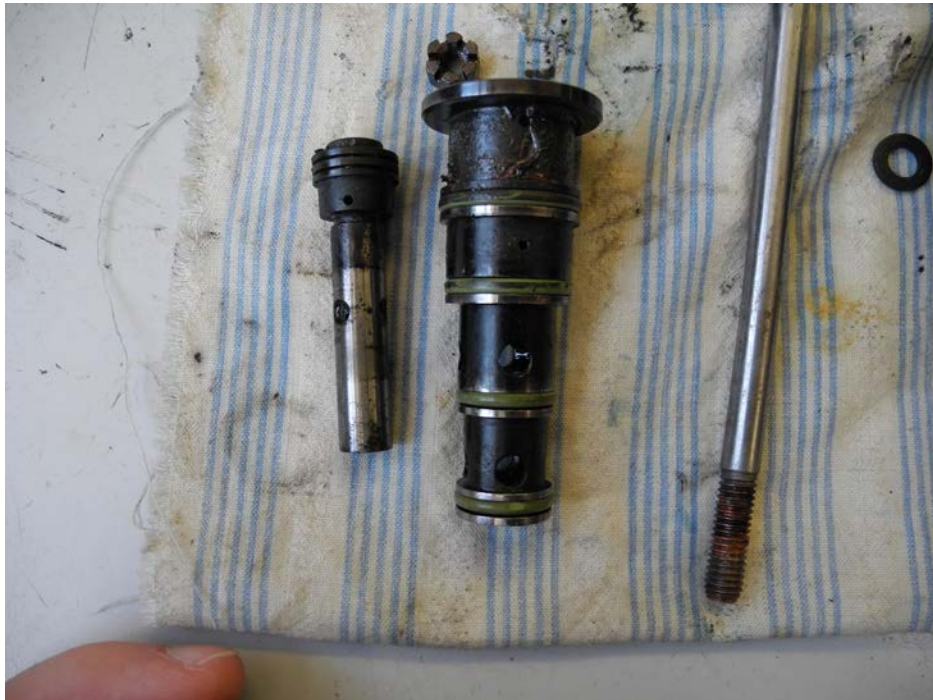
Figure 31 - Accelerator Valve Filter (1 of 2)

The two internal accelerator valve filters and the internal teeter valve filters were examined and found to be free of debris (Figure 31 & Figure 32).

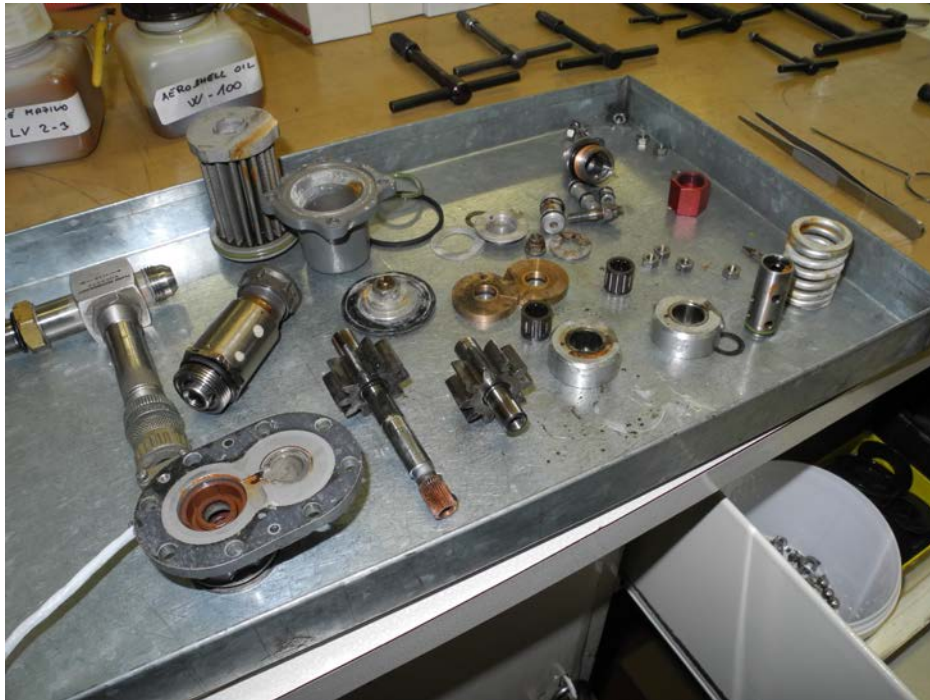
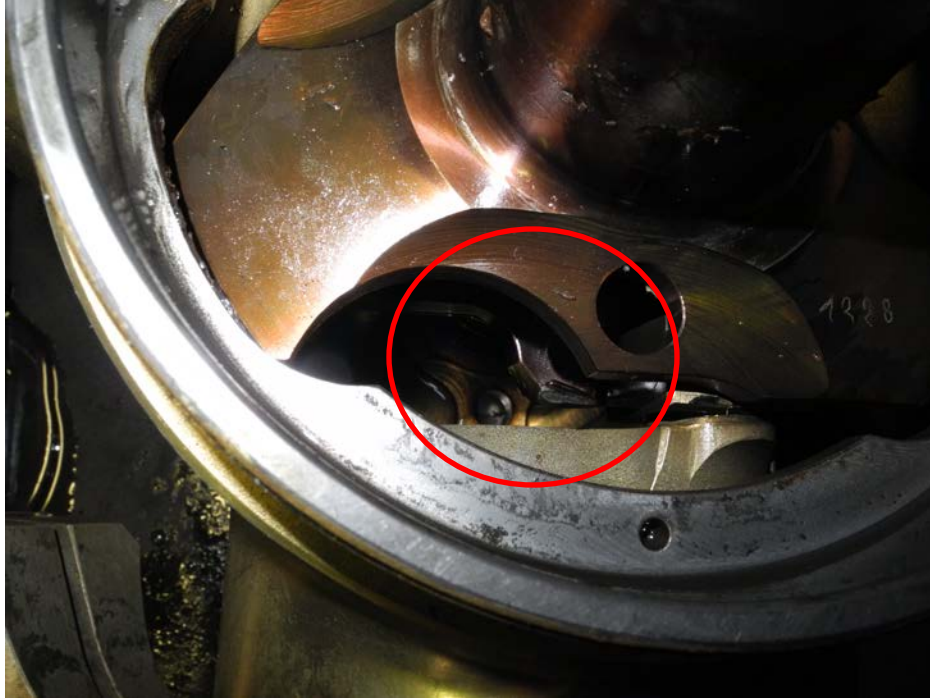
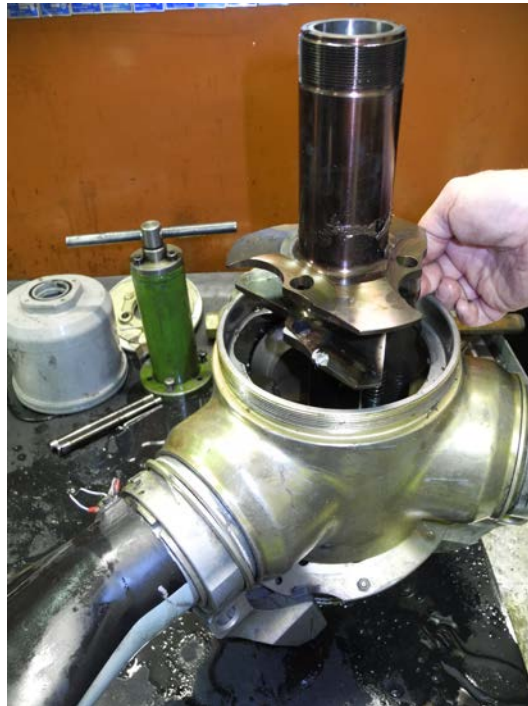
Figure 37 – No. 1 Blade Pitch Actuation Flange On The Piston Fork

The hub was disassembled and the inner mechanism was examined. The No. 1 blade pitch actuation flange on the piston fork was bent (Figure 37, Figure 38 & Figure 39) and impact damaged from the pitch change block. There was corresponding damage to the No.1 blade bushing (Figure 40). The No. 1 blade piston guide rod was slightly dented at the dimension 28.78 millimeters (mm) from the aft end. The dent could only have occurred during an impact that causes the piston fork flange to bend. With this dent dimension, Avia calculated the corresponded to blade pitch to be 15 degrees, a low angle

corresponding to the hydraulic low pitch stop. This, in turn, corresponds to a lower power setting of the engine.

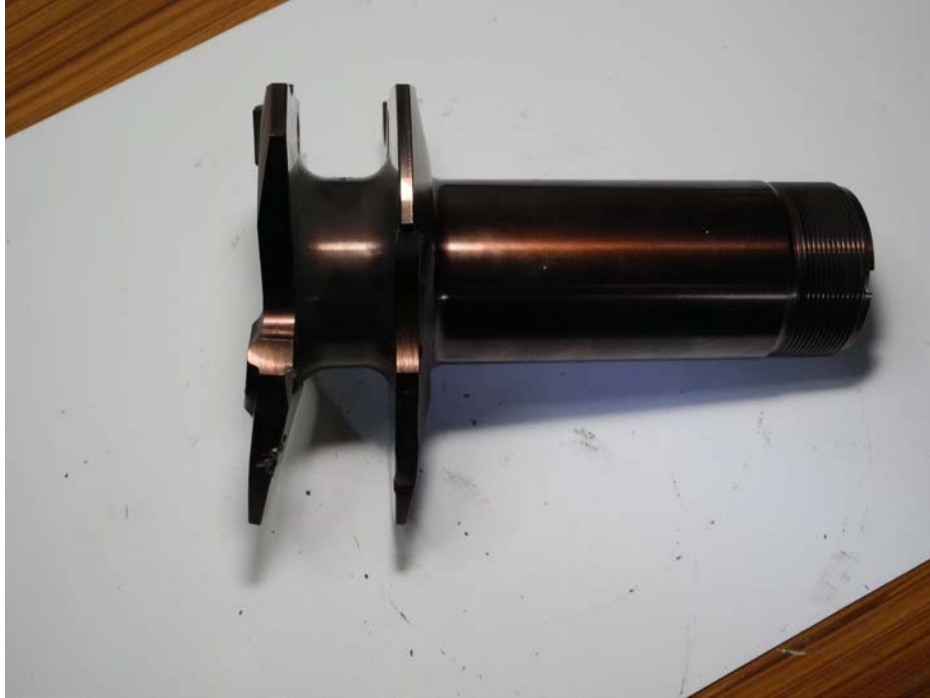
Figure 40 - Corresponding Damage to the No.1 Blade Bushing
