**NATIONAL TRANSPORTATION SAFETY BOARD
Western Pacific Regional Office
Federal Way, Washington**

**Exam Report
July 24, 2016
Zamora, California**

On July 23, 2016, about 0745 Pacific daylight time (PDT), two Air Tractor AT-502Bs, N502WC, and N5044N, collided in-flight near Zamora, California. The commercial pilot of N502WC was fatally injured; the airplane was destroyed. The commercial pilot of N5044N received minor injuries; the airplane sustained substantial damage. N502WC was operated by Farm Air Flying Services, and N5044N was operated by Growers Air Service. Both flights were operated under the provisions of Title 14 Code of Federal Regulations Part 137 as aerial application flights. Visual meteorological conditions prevailed, and company flight plans had been filed for both flights.

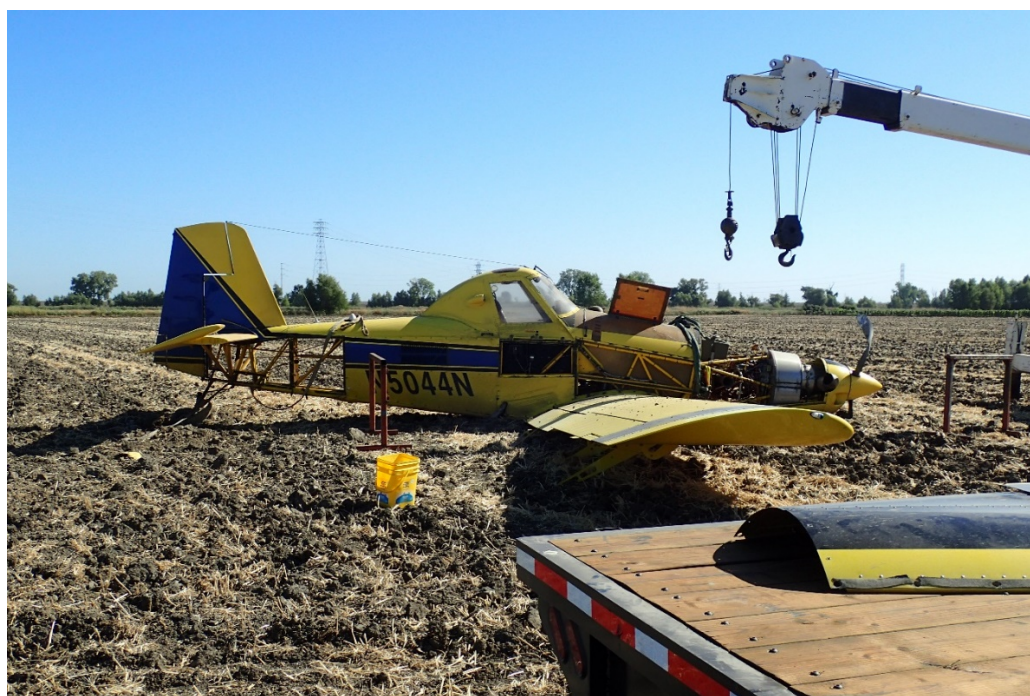
Photo 01 – right side of Airplane N5044N (Air Tractor)

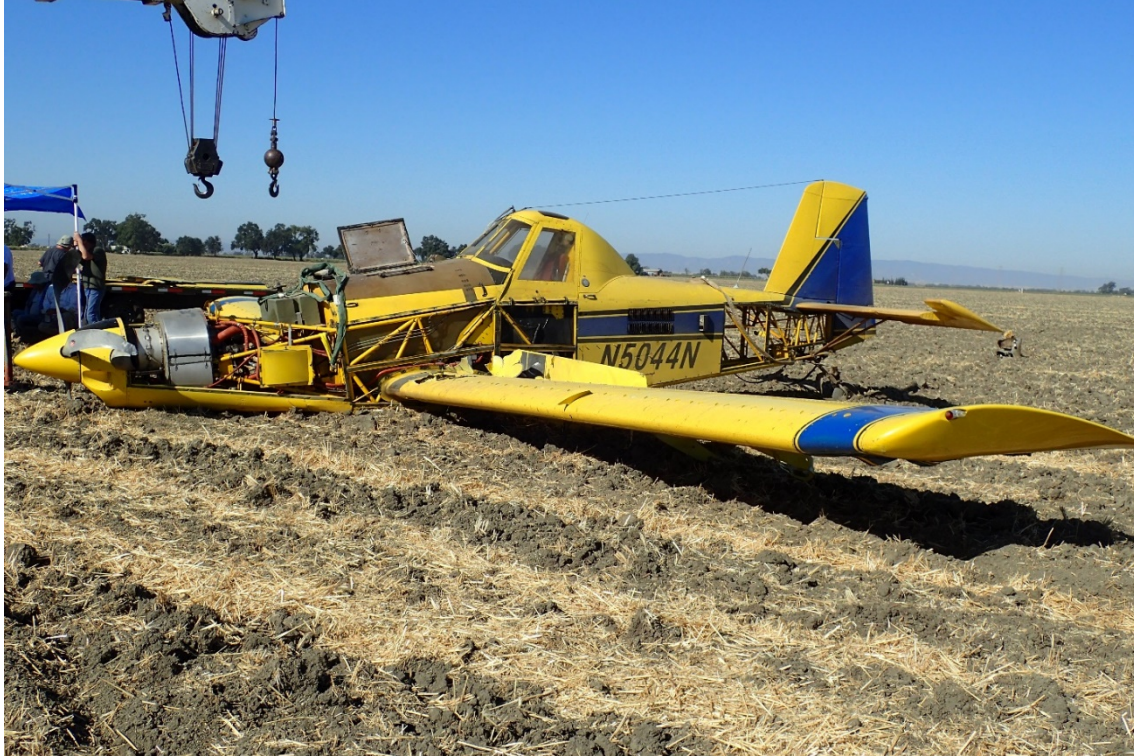
Photo 2 – Left Side of Airplane N5044N (Air Tractor)

Part not recovered from N5044N, one whole landing gear assembly.

Airplane was intact, landing gear sheared off

Propeller remained attached to the engine, which remained attached to the airframe.

Wings remained attached. The left wing was damaged the length of the wing. The aileron was damaged and one of the spray attachments was bent toward the front of the airplane.

The tailwheel remained attached and the tail section remained attached to the fuselage.

About midspan/outboard of the wing, was blood transfer. Outboard to the tip had blue paint transfer.

Fuel observed leaking out when the airplane was lifted. Minuscule amount.

Airplane equipped with airbags in seatbelt. The seatbelt did not deploy; requires 9 g's to activate.

Flight control continuity was established from the cockpit to all flight control surfaces.

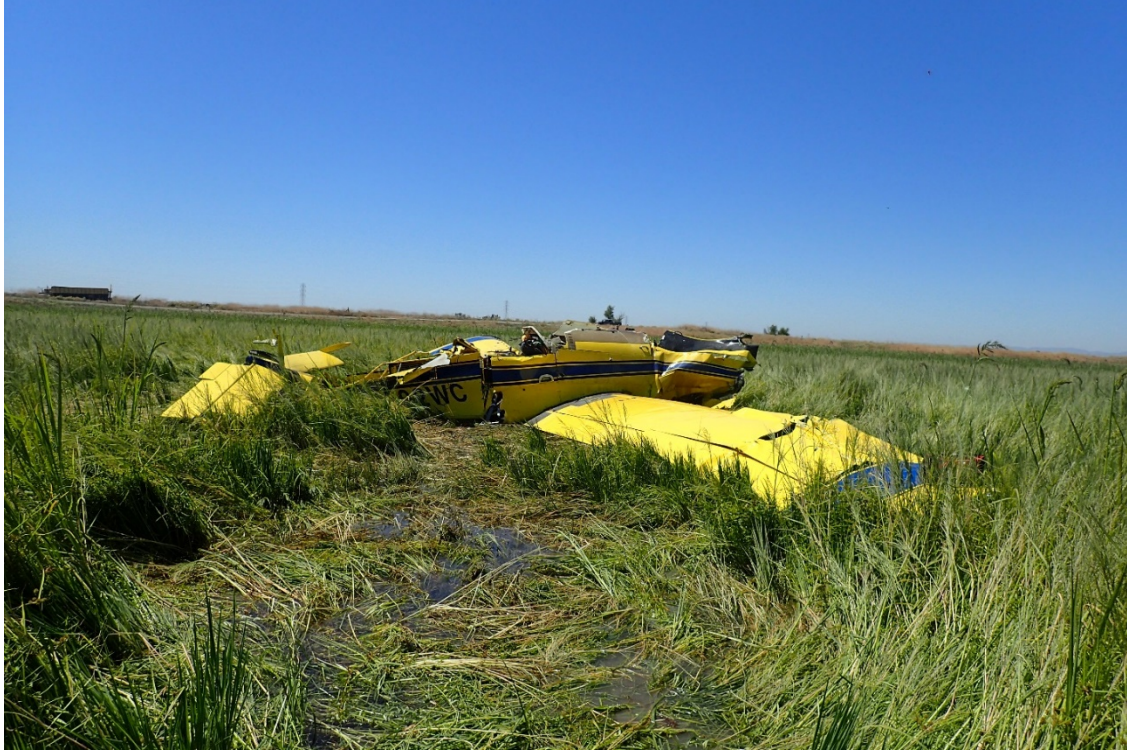
Photo 3 – Right side of N502WC (Air Tractor)

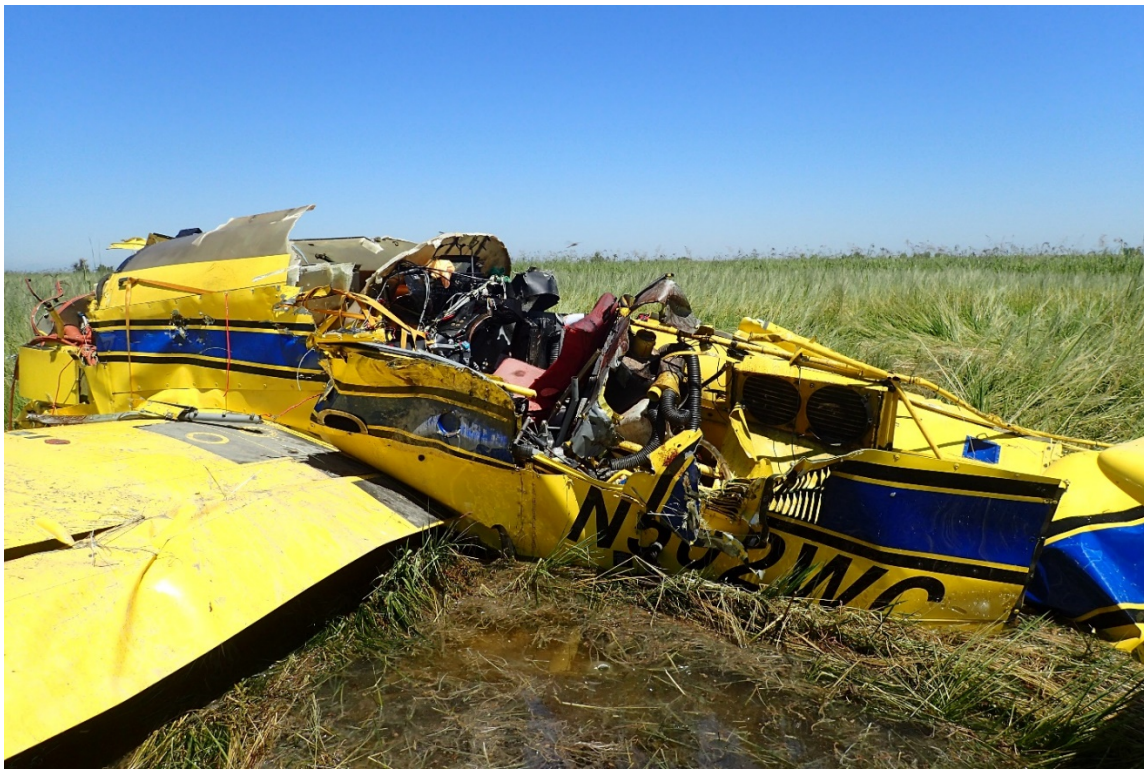
Photo 4 – Left Side View of N502WC (Air Tractor)

Parts that were not recovered from N502WC

Right rudder and rudder cable

Majority of the vertical fin

The cockpit overturn structure roll cage (over the pilot's head)

Windshield

Both doors

Hopper lid

One propeller blade

Upper longerons aft of the cockpit

Turtle deck skin, curved skin right behind the cockpit.

Flight control continuity was established.
