NATIONAL TRANSPORTATION SAFETY BOARD

Exam Report

October 11, 2011

NTSB Accident Number: WPR11FA230
IIC: T. Cornejo
Aircraft: N121J - Lancair Legacy

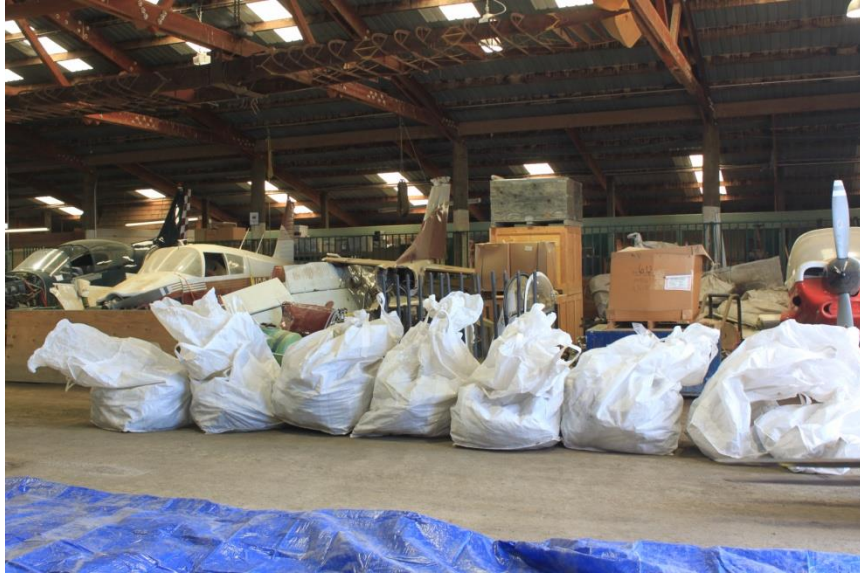
The exam commenced on the morning of October 12, 2011 at Plain Parts, Pleasant Grove, CA. The airplane was a 2004 experimental amateur built Cameron Lancair Legacy, and engine, a CMI IO-550-EXPERIMENTAL, serial number EXP687922, were transported from the accident site and was in storage at Plain Parts. The wreckage consisted of 8 large-white canvas bags.

Photo 2 – Airplane Wreckage (NTSB)

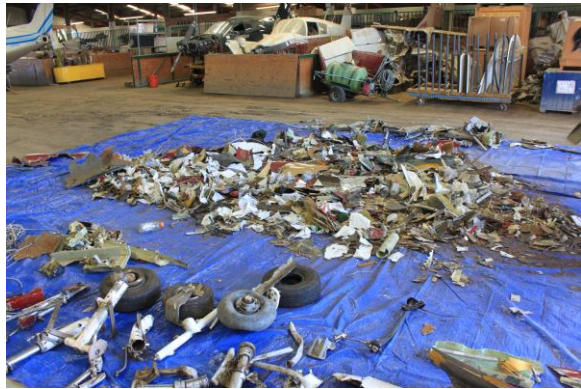
The airframe was heavily fragmented and impact related damage was noted throughout. Due to the heavy fragmentation, pieces of flight control surfaces were located and accounted for. All of the cockpit components and instrumentation were severely fragmented and crushed.

Photo 3 – Airplane Layout Examination (NTSB)

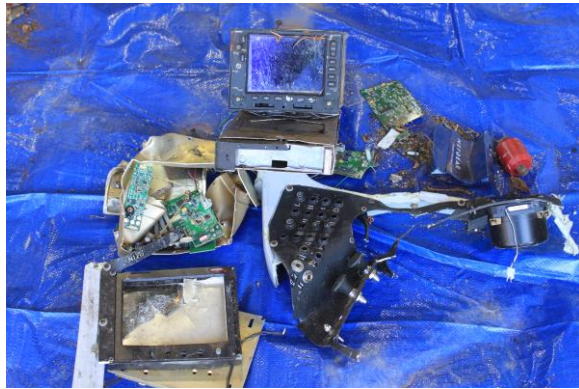
Photo 4 – Instrument Panel (NTSB)

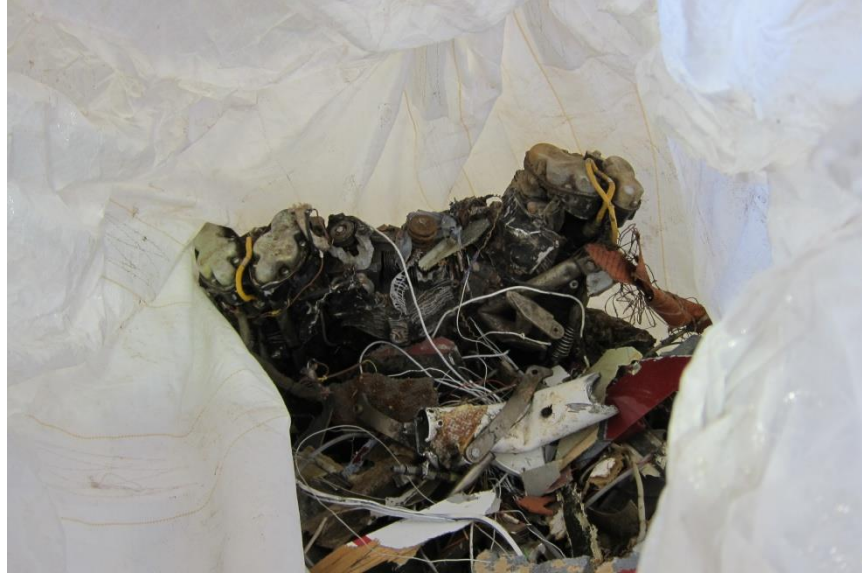
Photo 5 – Engine (CMI)

The engine separated from the airframe and had extensive impact damage. The propeller hub and partial blades remained attached to the crankshaft propeller flange.

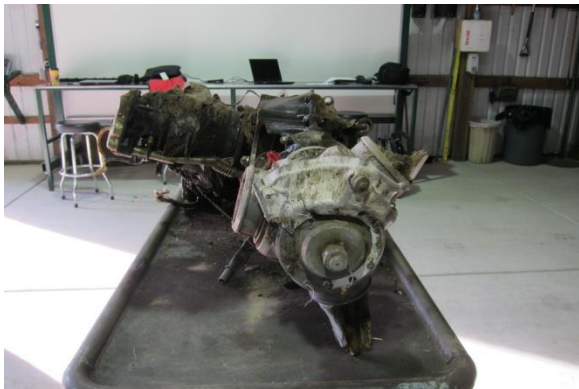
Photo 6 – Front View of Engine (CMI)

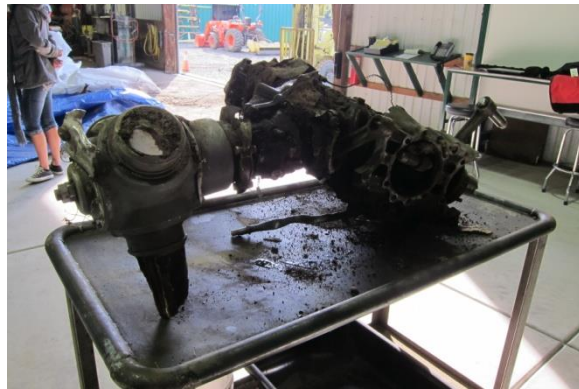
Photo 7 – Left Side View of Engine (CMI)

The accessory section of the crankcase, oil sump and attachment flange, upper crankshaft surfaces and cylinders 2, 4 and 6 separated from the engine and sections were found with the wreckage debris. The crankshaft was visible and all connecting rods remained intact and 2, 4, and 6 were bent in the forward direction. Main bearing journals were visible and no thermal discoloration was noted. The camshaft separated forward of the number 4 cam lobes.

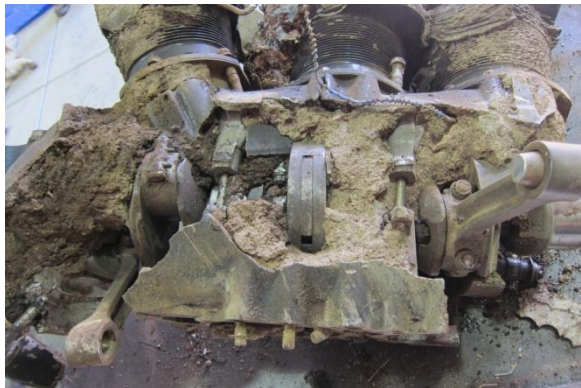
Photo 8 – Top View of Engine (CMI)

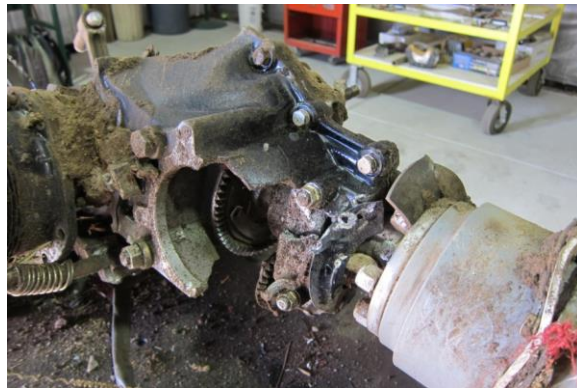
Photo 9 – Right Side View of Engine (CMI)

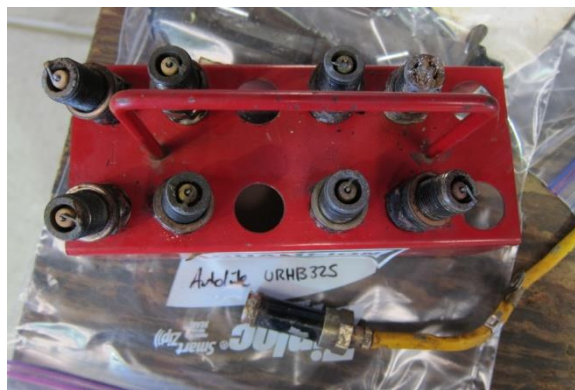
The remainder of the camshaft was found in the wreckage debris. The induction and exhaust assemblies were found with the wreckage debris and had impact damage. The spark plugs were removed from cylinders 1, 2, 4 and 5. Cylinder 3 spark plugs could not be removed from the cylinder due to impact damage. The no. 6 cylinder head had impact damage and separated from the cylinder barrel. The spark plugs for cylinder 6 were visible and undamaged. The spark plugs had (Worn out-Normal) wear conditions when compared to a Champion AV-27 comparison chart.

Photo 10 – Spark Plugs (CMI)

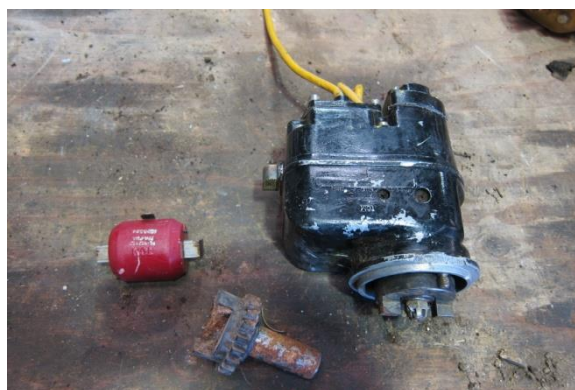
One magneto was found in the wreckage debris. The magneto impulse coupling engaged and spark was obtained from the damaged leads and distributor cap. The internal coil of the other magneto was found with the main wreckage.

Photo 11 – Magnetos (CMI)
