NATIONAL TRANSPORTATION SAFETY BOARD

AIRFRAME EXAMINATION

WPR13FA227

Location: McMinnville, Oregon
Date: May 13, 2013
Aircraft: Gates Learjet 35A
NTSB IIC: Elliott Simpson

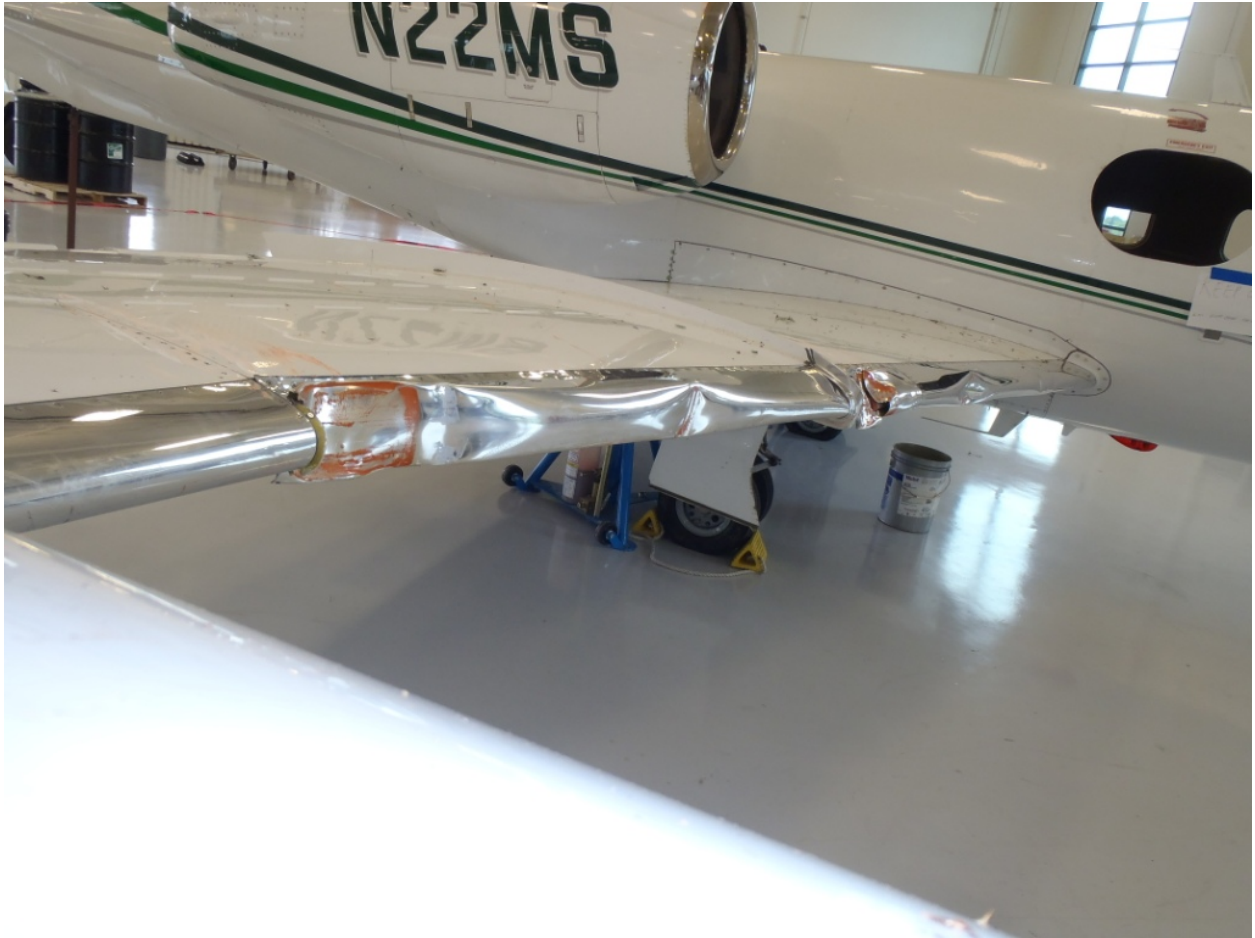
Both wings exhibited four indentations to their leading edges, crushing the leading edges back to the forward spar (Photo 1). The indentations exhibited red transfer markings consistent with the ILS antenna contact. The right wingtip fuel tank sustained crush damage to its outboard skin, with similar transfer marks. The right and left engine sustained 1-inch-wide indentations to their inlet cowlings.

Photo 1 – Leading Edge Damage

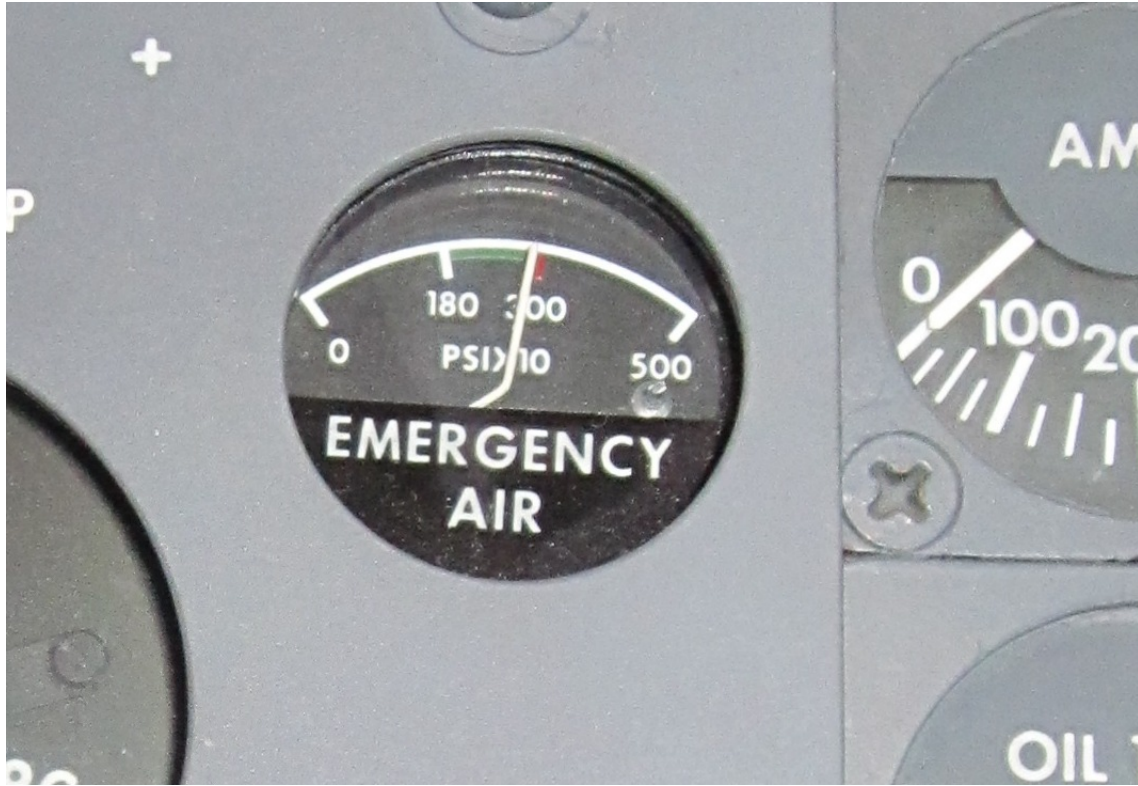
The emergency brake, emergency air indicator needle was within the green limit, one needle-width below the red line 3,000 psi value (Photo 2). Hydraulic fluid was observed leaking below the damaged nose wheel strut.

Photo 2 – Emergency Air

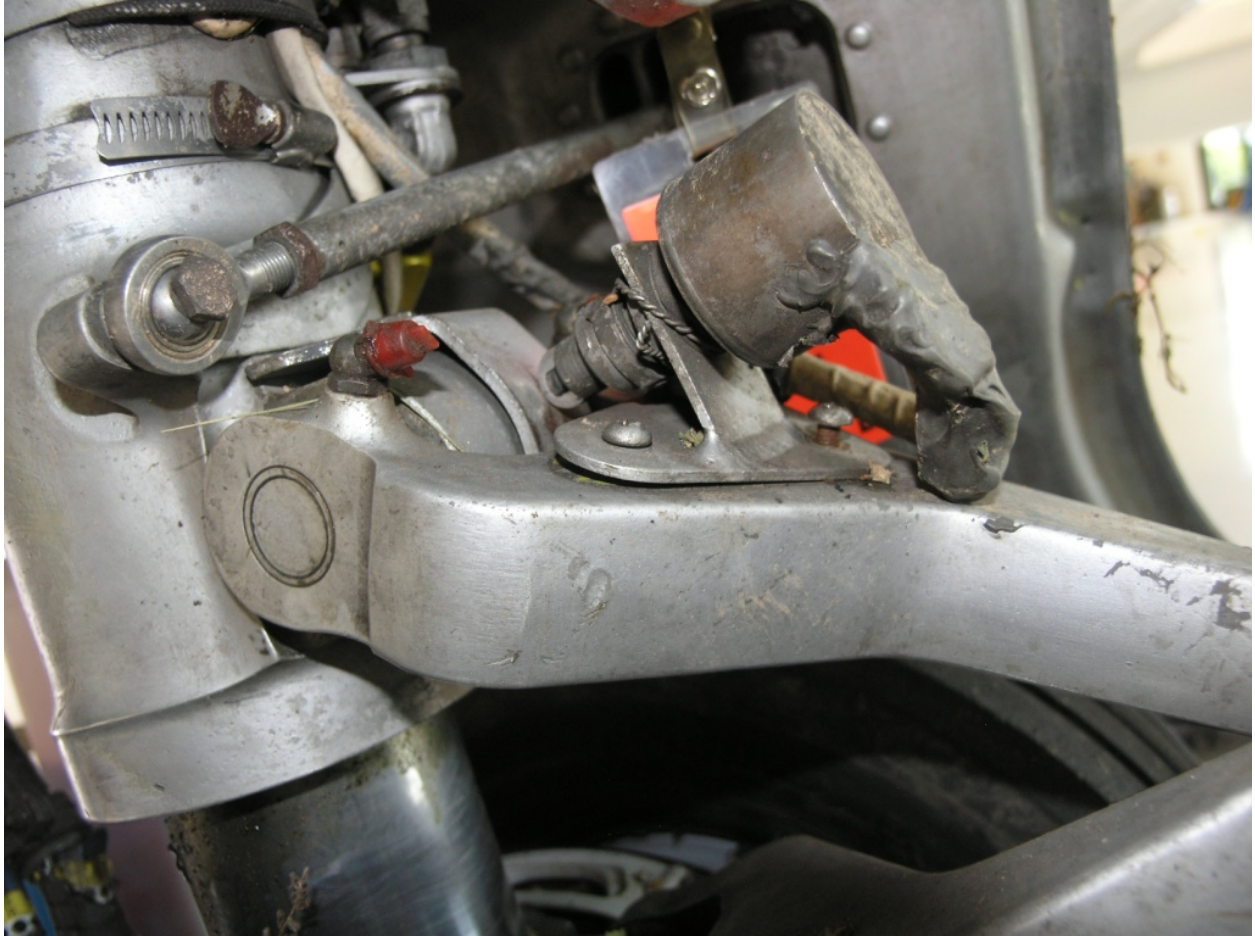
Examination of both the left, and right landing gear squat switches revealed that their assemblies had become partially separated from their upper scissor fork pads. All three attachment bolts were loose, and the assemblies had risen between 1/8 and 1/4 inches from their pads (Photo 3, 5, 6). The right squat switch roller bearing surface was not in contact with the scissor arm cam, and the left roller bearing surface was resting lightly against the cam (Photos 4,6). The attachment nuts were loose, and could be unscrewed by hand, with no visible bolt thread present at their crowns (Photos 7,8). The left landing gear nuts were removed; two unscrewed from their associated bolts after about five turns, with one separating after a single turn. Two of the corresponding right landing gear nuts unscrewed after three full turns, with the third after a single turn. All the bolt threads were sharp, with no flattening damage noted to their crests. All nuts exhibited friction and locking action when screwed onto their bolts by hand. The scissor pad and squat assembly mating surfaces were coated in oil, and grime, and were free of rub marks and fretting damage.

Photo 3 – Left Squat Switch

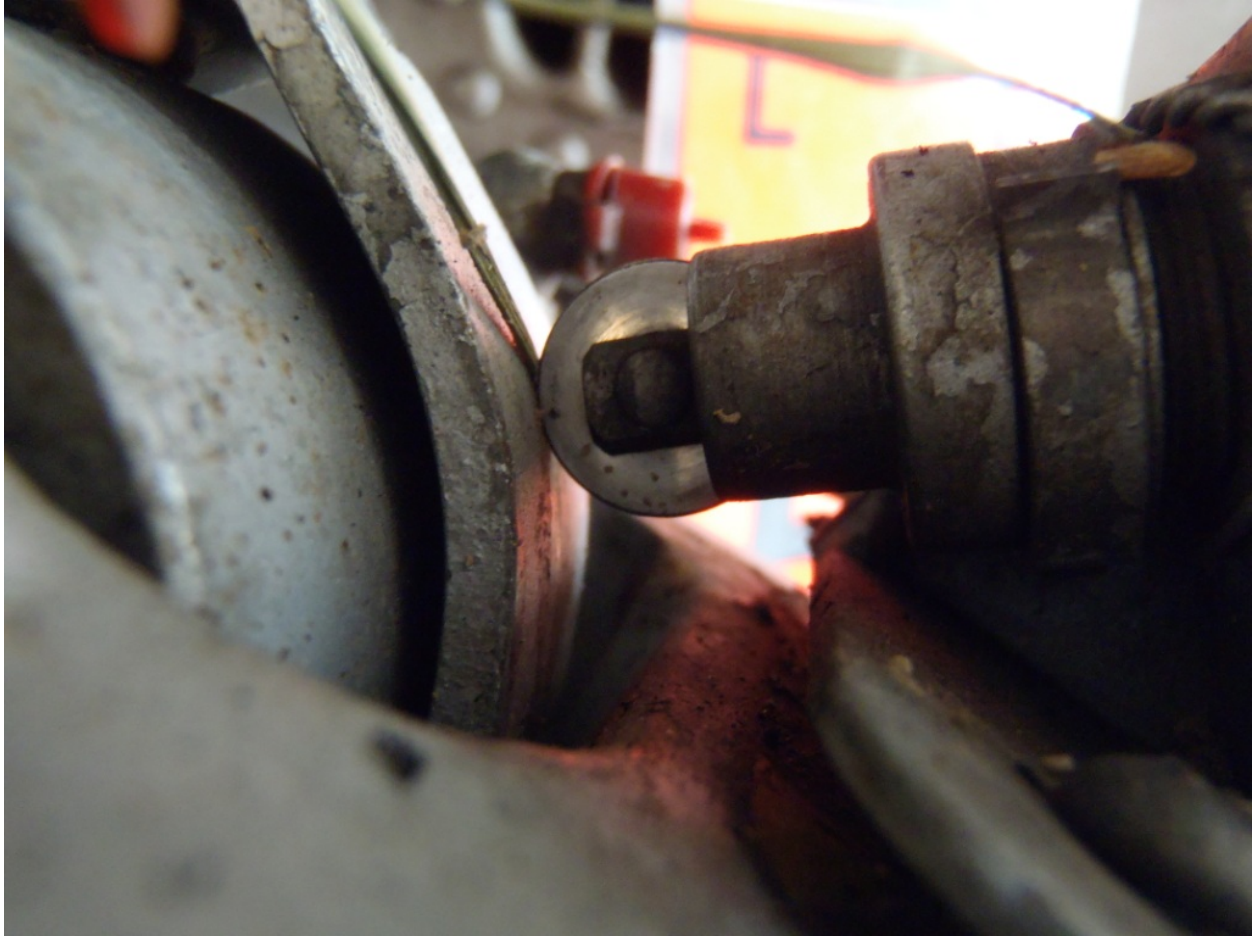
Photo 4 – Left Squat Switch Roller

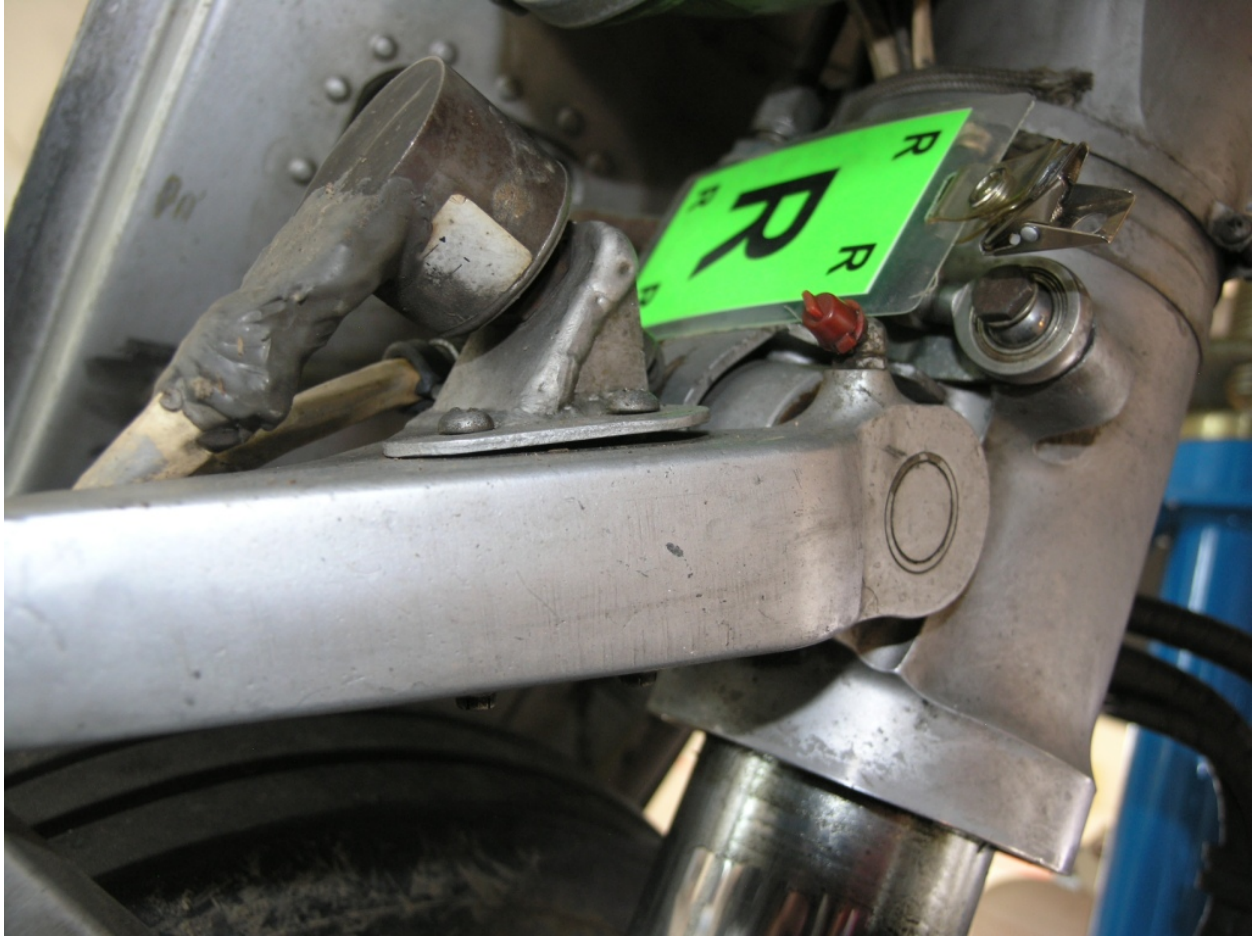
Photo 5- Right Squat Switch

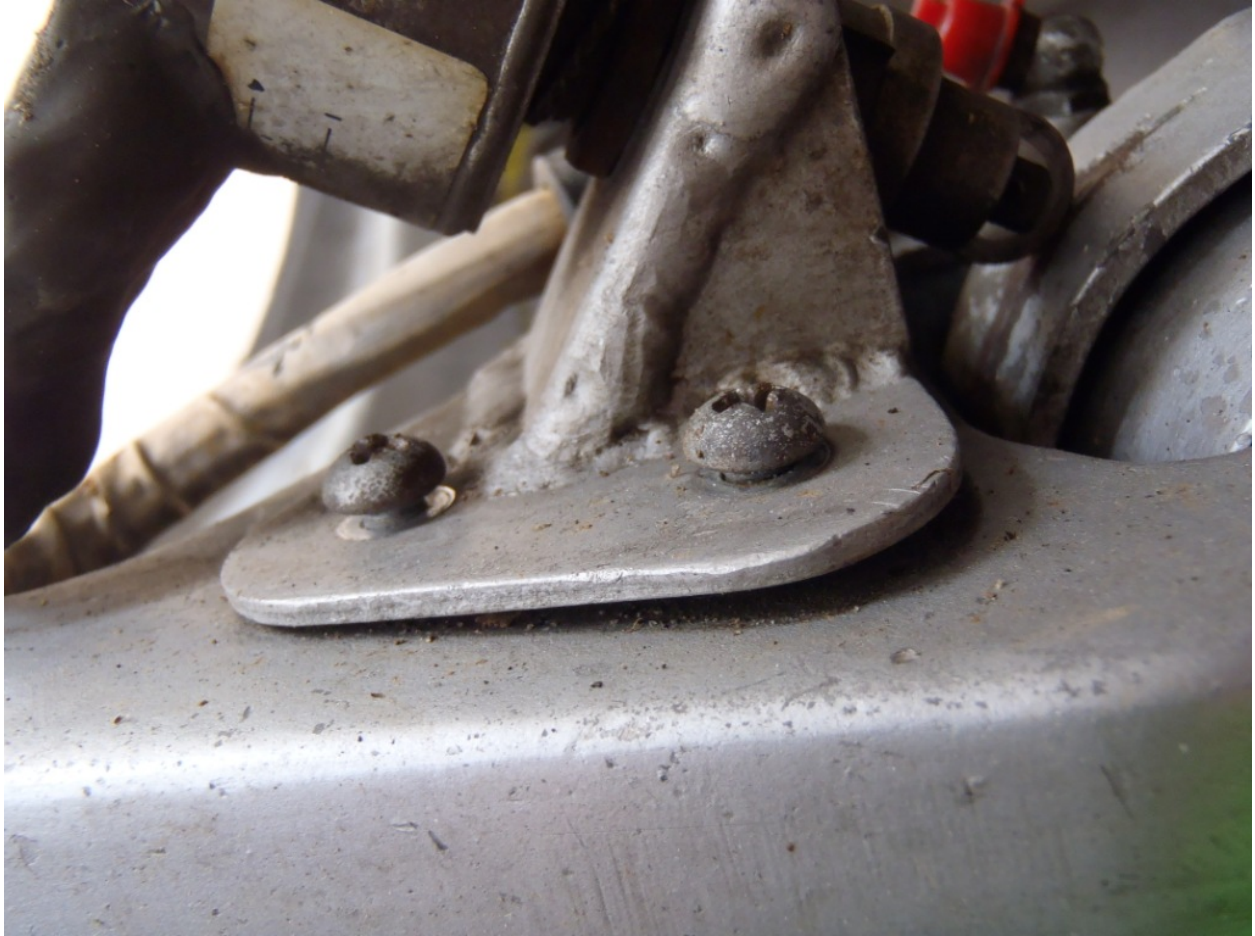
Photo 6 – Right Squat Switch Mounting Screws

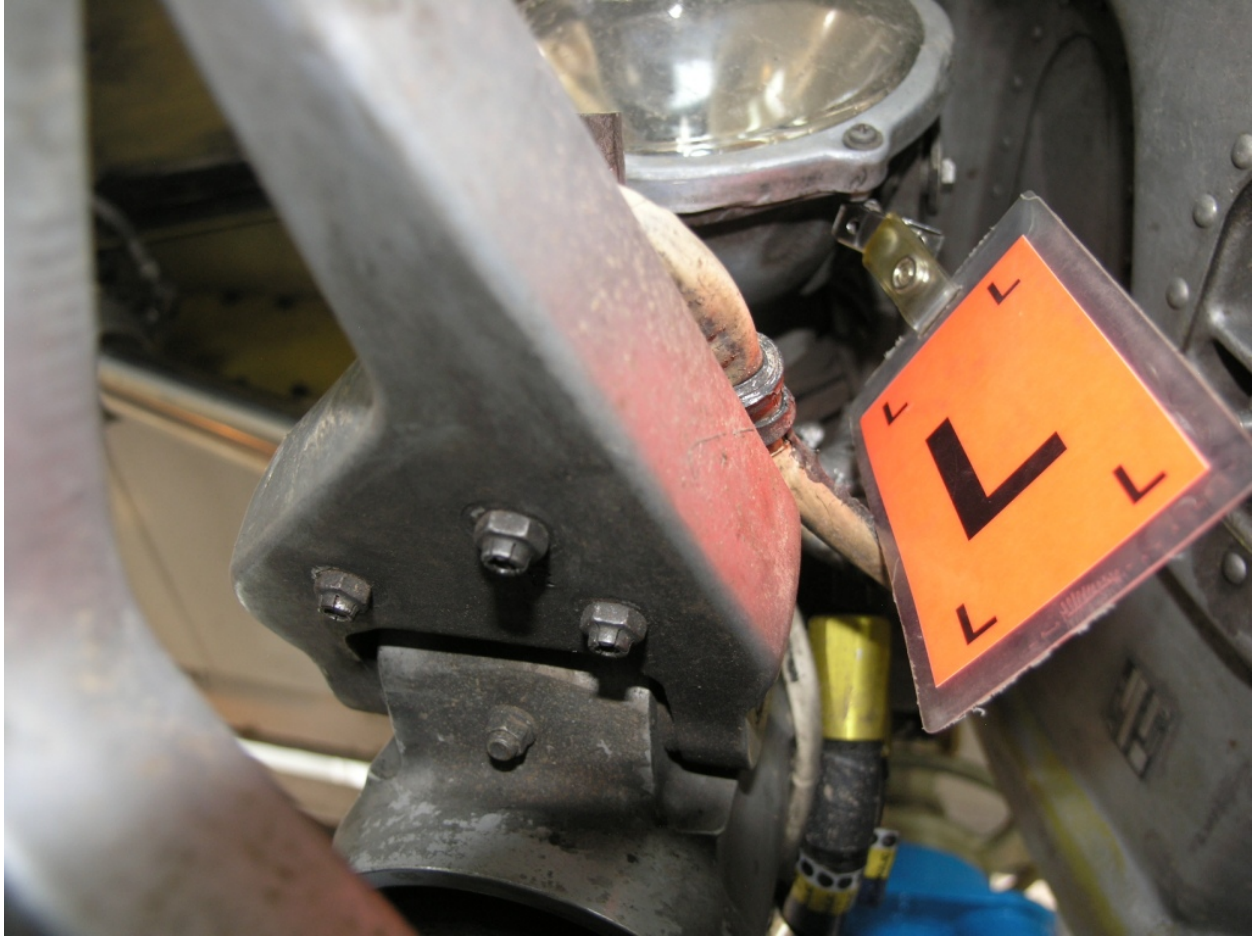
Photo 7 – Left Squat Switch Mounting Nuts

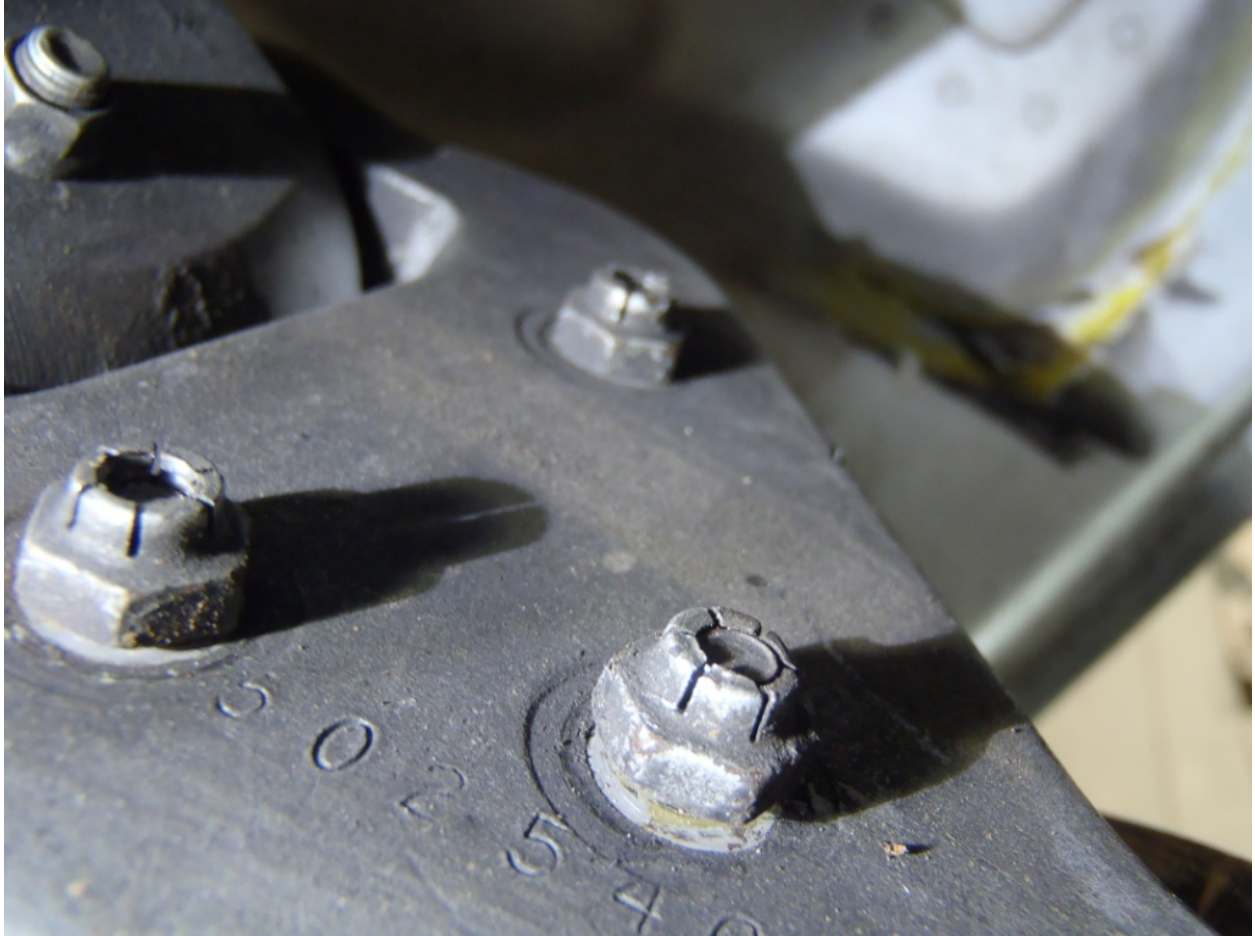
Photo 8 – Right Squat Switch Mounting Nuts

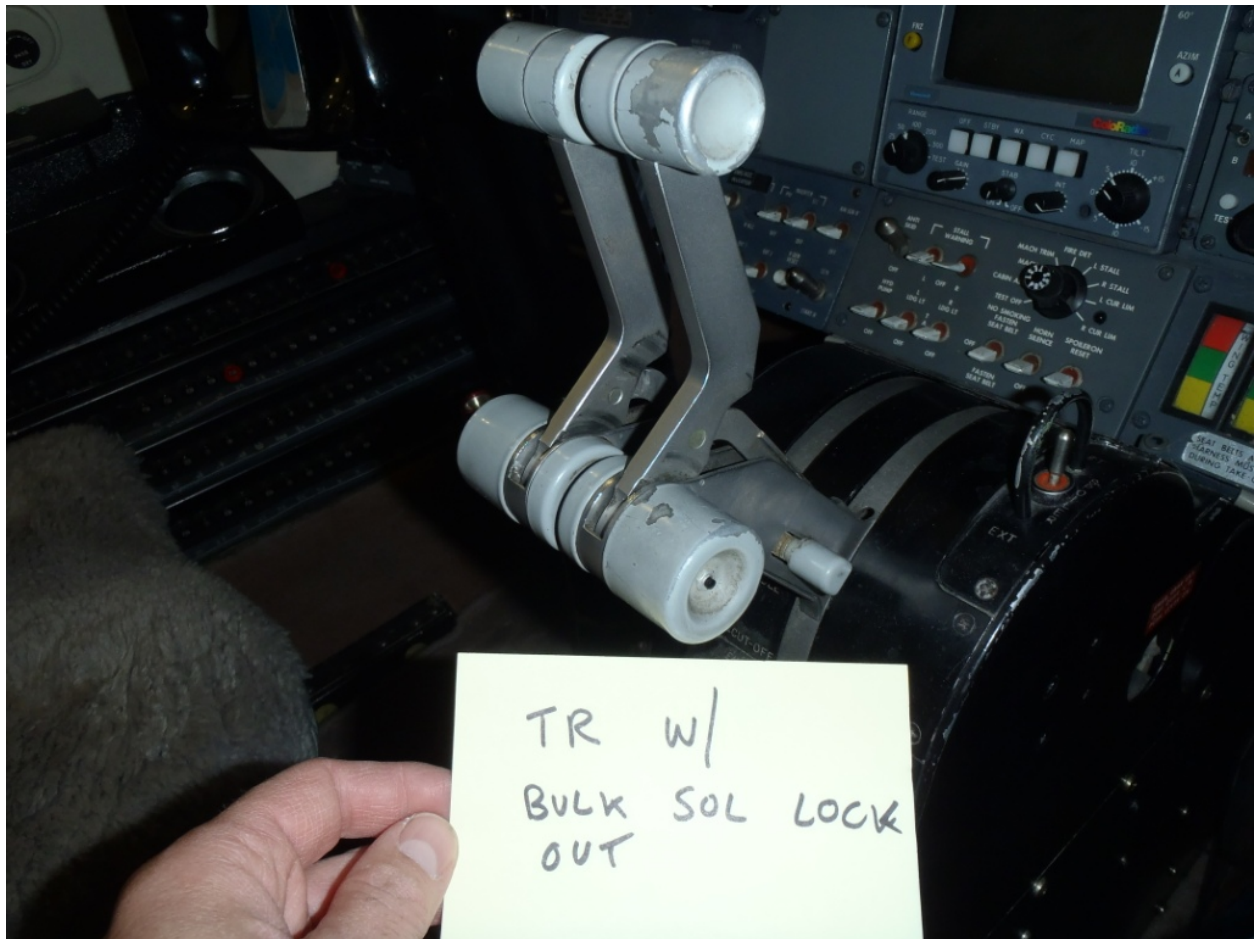
With the reverse thrust levers pulled back to the bulk solenoid-stop position, the left PLA indicated 42 degrees, with the right 39 degrees (Photo 9).

Photo 9 – Thrust Levers with Bulk Solenoid Out

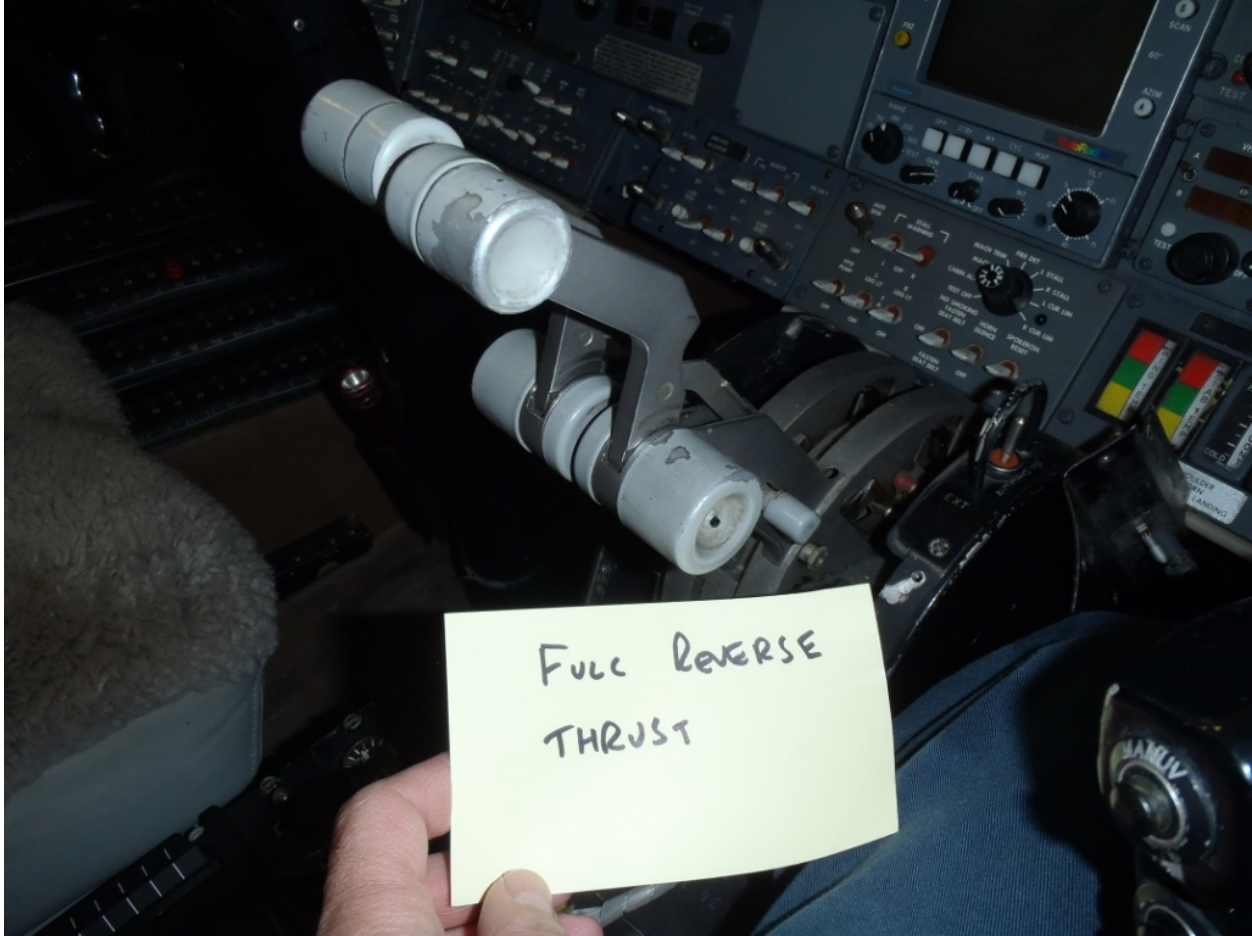
The bulk solenoid was then disengaged by hand, and the thrust reverse lever was moved back to the full reverse thrust position. Both the left and right PLA indicated 116 degrees (Photo 10)

Photo 10 – Thrust Levers in Reverse Position
