## **NATIONAL TRANSPORTATION SAFETY BOARD**

#### **Airframe and Engine Examination Summary**

NTSB Number: ANC18FA024

Aircraft: Mooney M20K, S/N 25-0060, TT 4,775.7

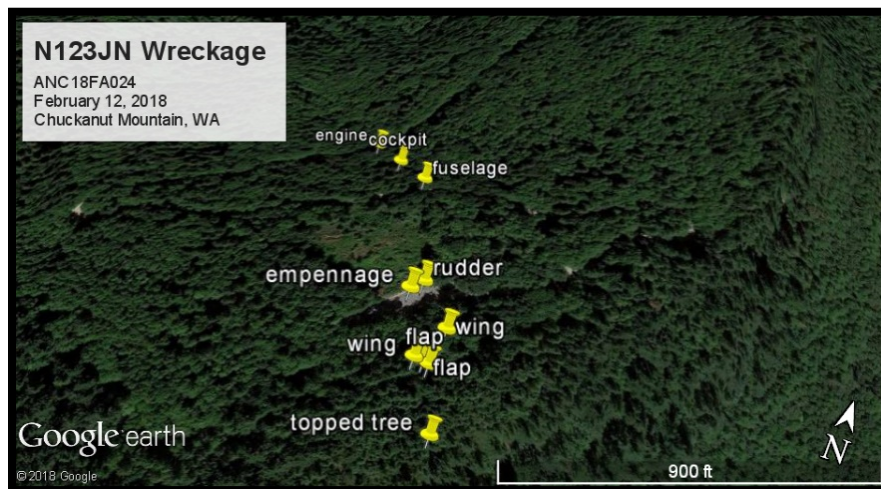
The accident site was located on the north face of the mountain in an area of dense forest with no lighted structures. Large portions of the fragmented airplane were scattered along a 1,200 ft debris path which started at the ridgeline above the Cyrus Gates Overlook at 1900 ft and continued on a course of 344° true downhill through large trees to an elevation of 1589 ft. (See figure 1.) Aerial photographs indicated the initial impact area was a section of tall trees (about 50 to 75 ft) that exhibited tree top fractures on the ridge above the wreckage. (See figure 2.) All major components were located at the site.

*Figure 1. Wreckage debris locations on Google Earth image.*

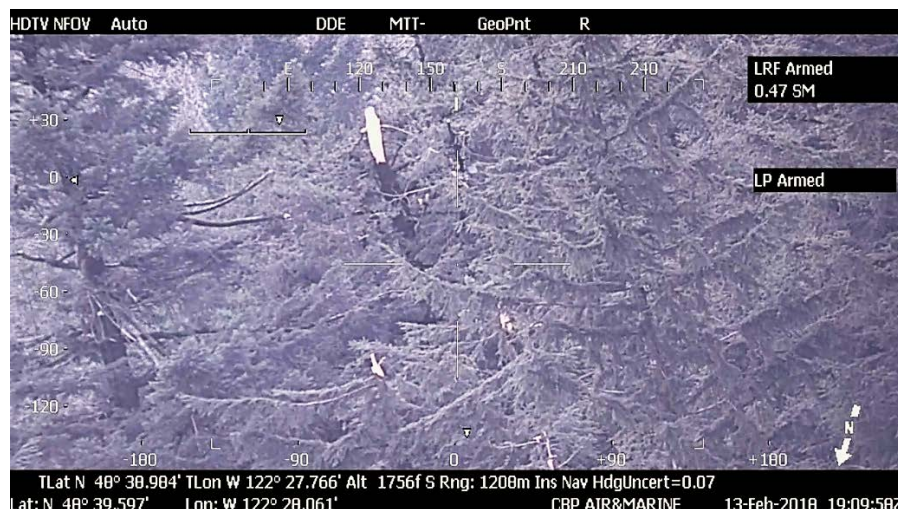
*Figure 2. Aerial photograph of tree top fractures on north side of ridge. (Courtesy of US Customs and Border Patrol)*

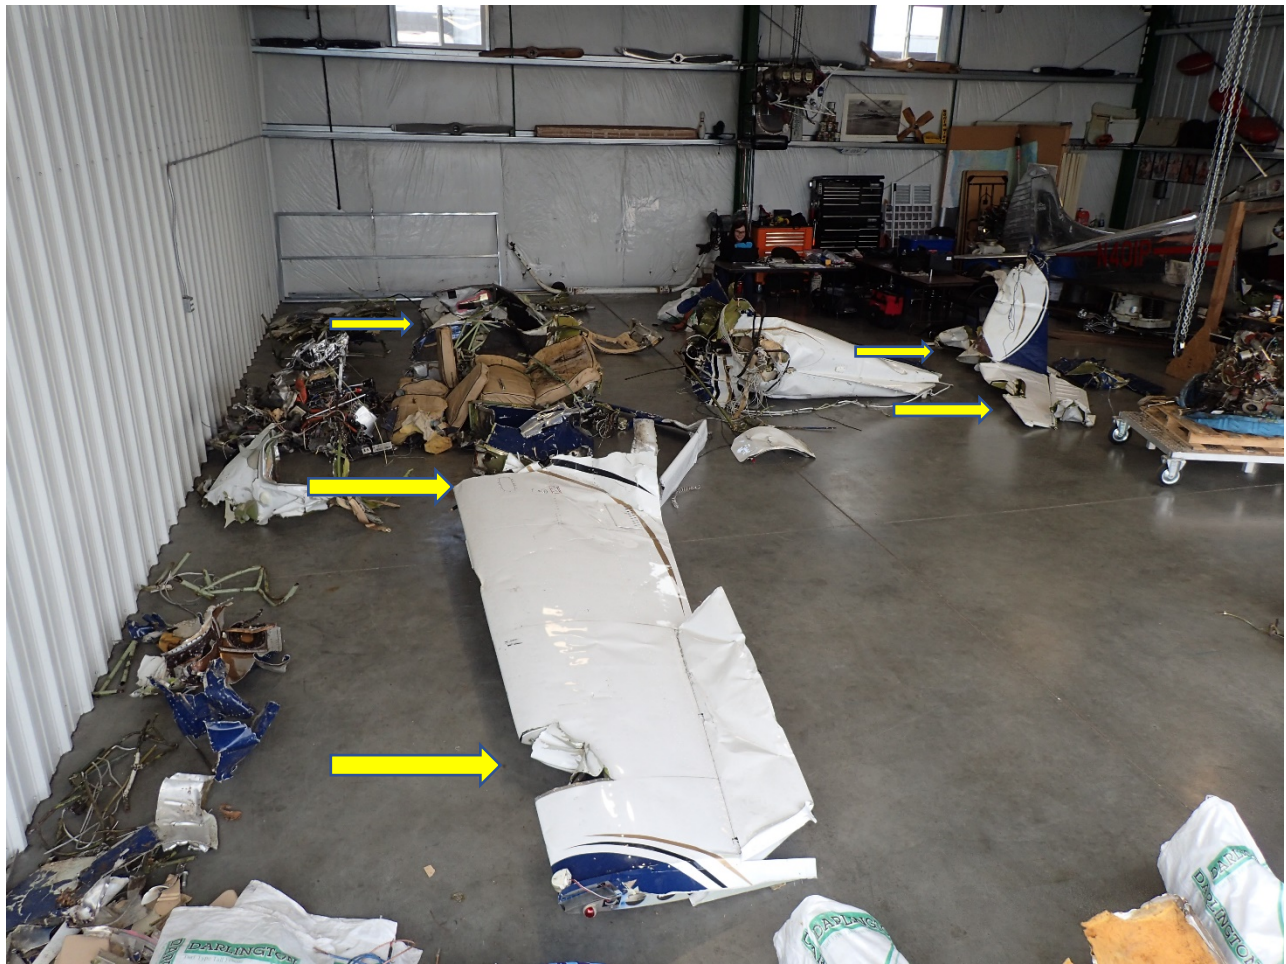
The wreckage was in 9 primary sections: Engine, cockpit (2 sections), fuselage center wing section, aft fuselage, upper empennage, lower empennage, right wing, and left wing. Damaged flaps, aluminum skin sections, door, windows, torque tubes, plexiglass and other debris were recovered. See figure 3.

Figure 3. Wreckage at examination hangar with yellow pointers indicating tree strikes.

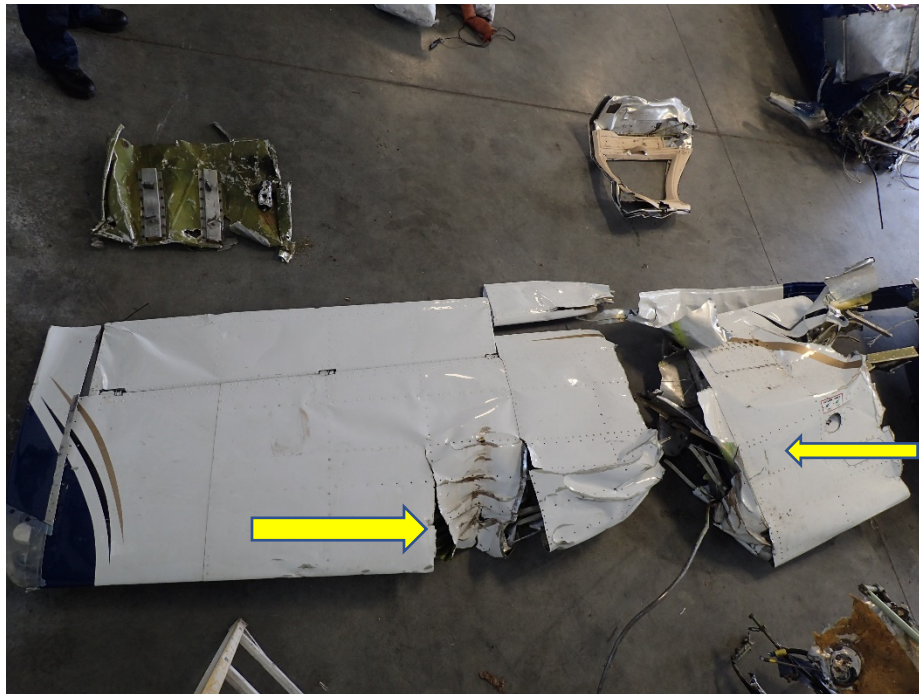
aileron control tubes. The outer section exhibited upward and rearward compression buckling at the inboard trailing edge and fore to aft accordion buckling at the inboard leading edge. Another 14 inch section of the outboard leading edge exhibited deep semicircular compressions with some upward bending indicative of tree trunk strikes. The flap brackets were attached, however the flap was separated at torn skin sections with tension signatures present. The aileron was in tact and attached with impact related buckling. The right wing also separated into two sections at WS 103.5 and WS 88.75 and exhibited separation signatures and tree strike compressions similar to the left wing. The right flap was separated by fractured flap brackets and the aileron remained attached. The right and left speed brakes were intact and retracted. See figure 1.

*Figure 4. Right wing exhibiting tree strike impacts.*

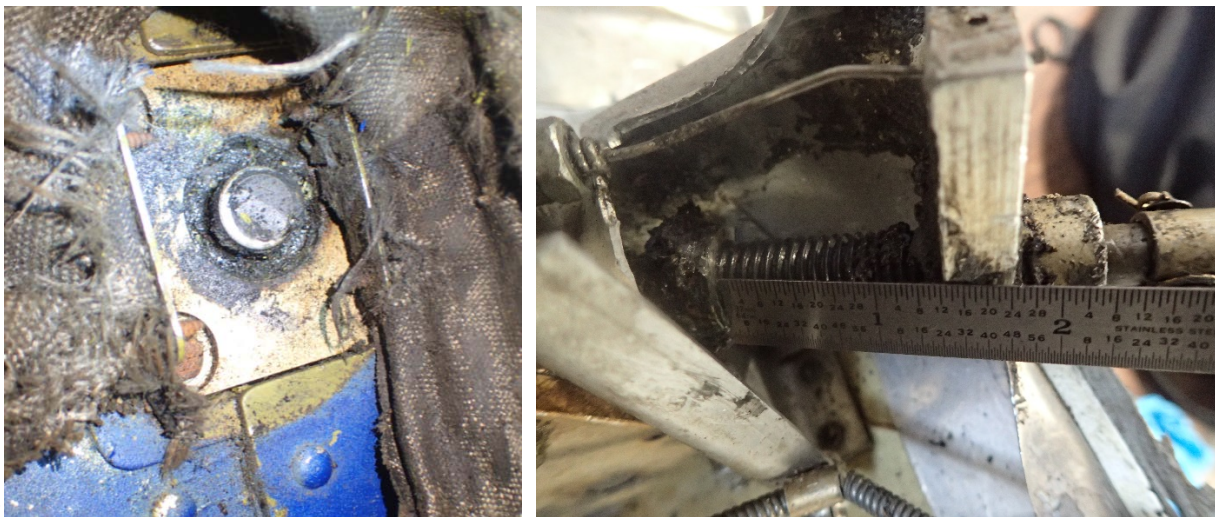
Examination of the flight controls confirmed flight control continuity from the ailerons through fractured control rods to the forward end of fractured push rods in the center wing section. The left rudder pedals were displaced with multiple deformations and fractures present in the attached rods and crushed tubes. Continuity from the elevator to fractured control rod ends in the cockpit area was established. The pitch stabilizer jack screw (at the rear fuselage bulkhead) was fractured at the base with overload signatures present. The forward elevator trim assembly was located on the ground near the fuselage and the trim jack screw was bent at the housing. The traveling trim screw nut was against the rear stop nut, which according to Mooney corresponded to full nose down trim. See figure 5. Impact damage and missing and fractured debris prevented continuity checks forward of the center section. The flaps exhibited impact damage. The flap motor actuator was extended .2 ft which corresponded to flaps retracted (up) configuration.

*Figures 5. Fractured aft pitch trim jack screw (left) and Elevator Trim Assembly jack screw (right) indicating full nose down trim.*

There was no evidence observed at the examination of any preexisting engine, propeller or airframe discrepancies that would have resulted in a loss of control. The impact damage noted was consistent with the airplane striking trees at high speed while in a controlled descent. The elevator trim actuator position was beyond the full nose down trim position, which was likely the result of either pilot input during the accident sequence or impact forces. The elevator pitch trim assembly was located outside of the fuselage in the debris and likely sustained significant forces during impact.

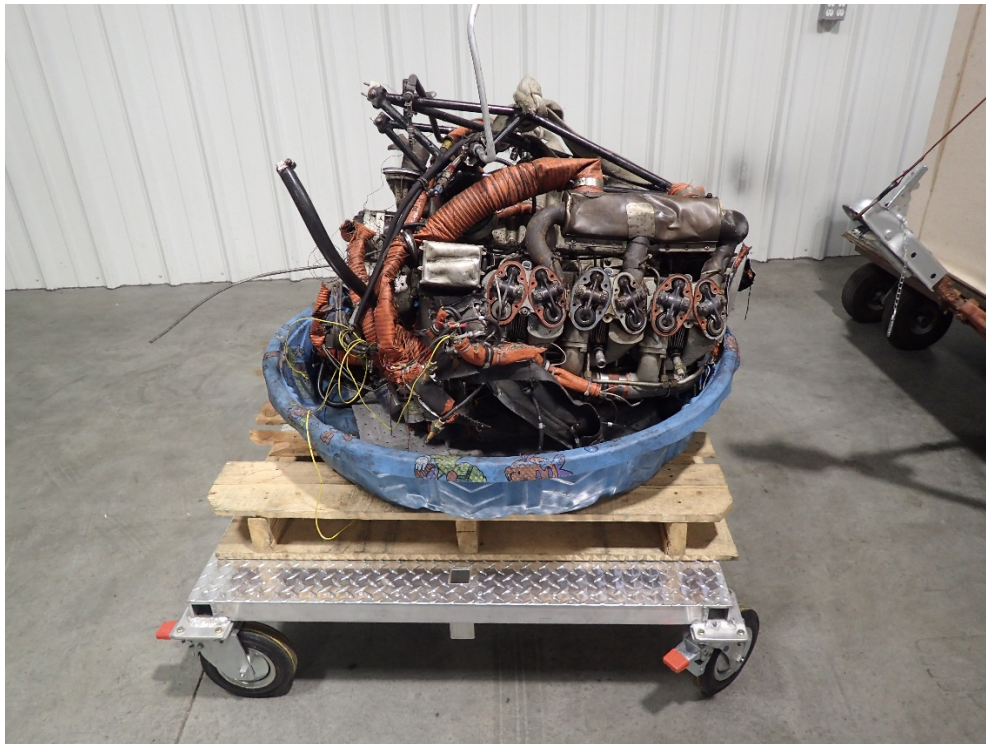
Crankshaft and camshaft continuity were confirmed. Thumb compression was obtained, and rocker movement was verified during manual rotation of the crankshaft.

The ignition system was functionally tested with no evidence of pre-accident malfunction. The right magneto was observed separated from the mounting pad. This was likely recovery related damage. Both the left and right magnetos were functionally tested during manual rotation of the drive shafts with spark visible from the leads and audible snap of the impulse couplings.

The fuel system components revealed no evidence of pre-accident malfunction. The fuel manifold valve remained secure with all injector lines intact. The valve was disassembled, and residual fuel was found in the housing and the screen was unobstructed. The engine driven fuel pump components were disassembled and examined with no anomalies noted. The fuel injectors were removed, and all were unobstructed.

The vacuum pump was removed and disassembled. The shear coupling was intact but displayed permanent torsional twisting and a semi-circular score mark indicative of rotation at time of impact.

*Figure 6. Continental TSIO-360 engine at examination.*

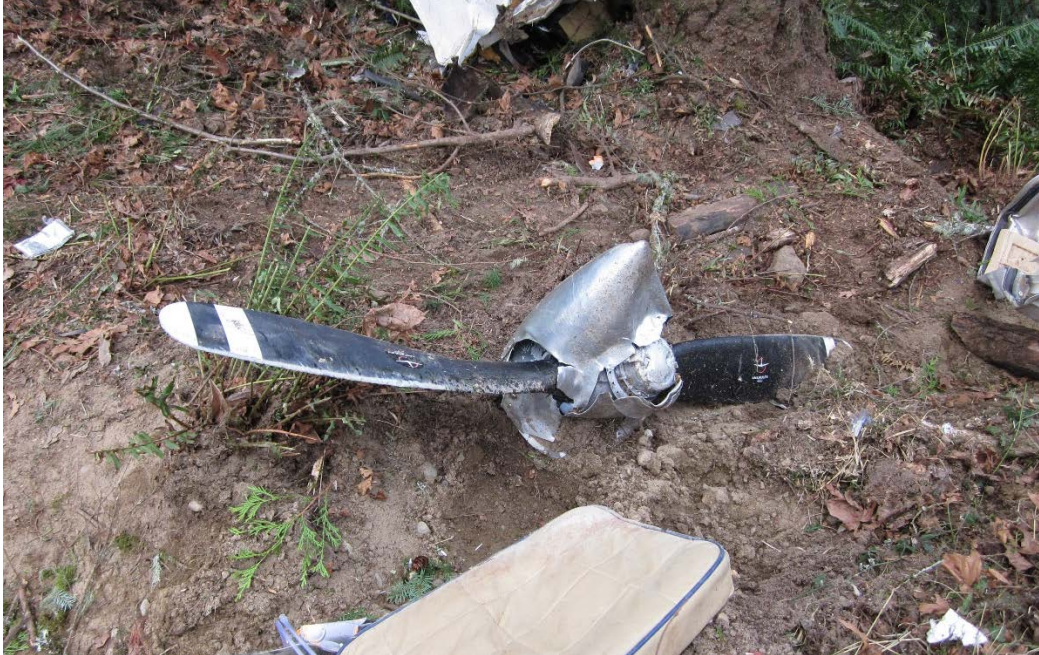
The propeller was located north of the fuselage on the ground with the spinner pointing skyward. The rear spinner assembly was caked with dirt and the spinner was fractured open on one side and had compression buckling at tip. The assembly separated from the engine at the crank shaft near the nose seal. Overload fracture signatures were present on the shaft.

The hub exhibited impact related deformation.

One blade was secure in hub bent forward slightly and exhibited high blade angle. The other blade was secure in the hub and straight with low blade angle. Chordwise scratches were evident along the span from the leading edge back. One large nick was evident on the leading edge. Refer to figure 6.

*Figure 7. McCauley propeller at the accident scene.*
