On April 17 and 18, 2014, the fuel shut off valves (FSOV) from the Garrett TPE331-5-511K engines that were installed on the Gulfstream Commander 690C, N840V, that crashed at Bellevue, Tennessee, on February 3, 2014, were disassembled and examined at National Flight Services Component Repair and Overhaul facility, Holland, Ohio. National Flight Services is an FAA Part 145 Repair Station, No. DSCR311D. The National Flight Services Component Repair and Overhaul facility is a Honeywell authorized TPE331 component overhaul and repair center. Present for the disassembly and examination were representatives from the NTSB, Honeywell, and National Flight.

Left engine fuel shut off valve

Right engine fuel shut off valve

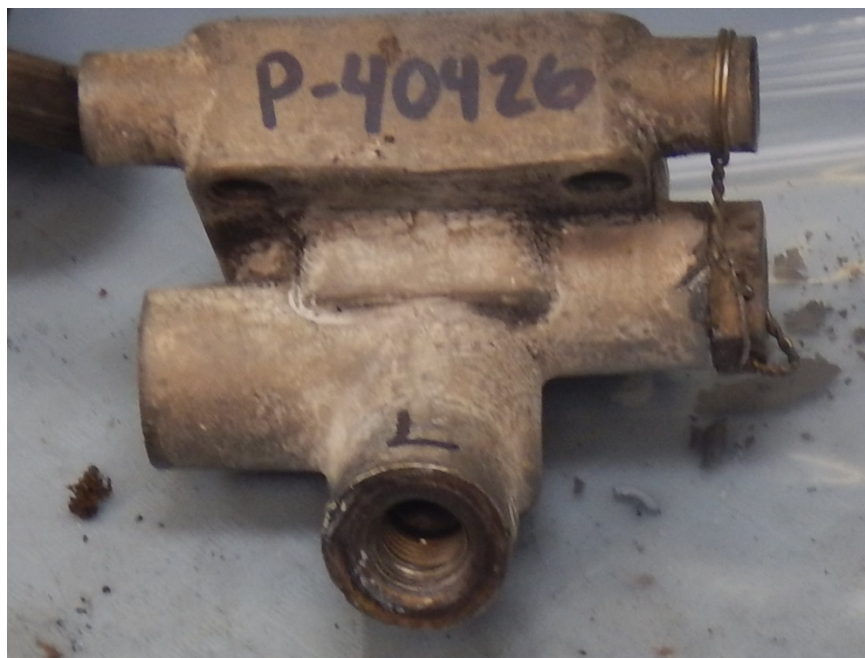
The left engine's FSOV was part number (PN) 394230-4-1, serial number (SN) P7984. The lower body of the left engine's FSOV was marked with the left engine's SN and a capital L. (Photo No. 1)

Photo No. 1: Close up view of the lower body of the FSOV showing engine serial number and the letter L. (Honeywell)

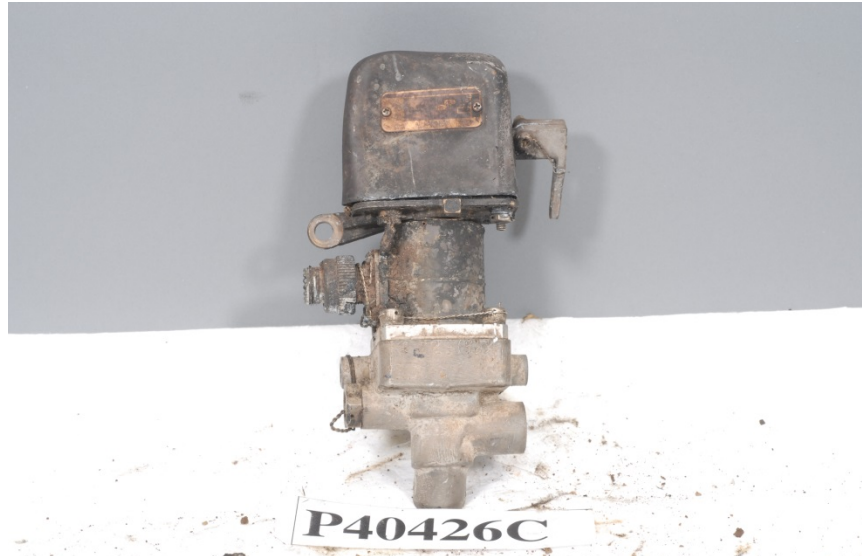
The FSOV was complete from the top of the manual shutoff lever cover to the bottom at the fuel inlet port. The exterior of the FSOV was sooted. (Photo No. 2) The wire connector was in place on the side of the FSOV, although the wire harness to the connector had been cut about 6 inches from the connector. The manual shut off lever was in place on the spindle. The spindle was rotated so that the index mark on the spindle end was pointed to the left as viewed looking directly at the spindle end, which is 180° opposite from the normal closed position. (Photo No. 3) The front of the manual shutoff lever cover was dented on the left side.

Photo No. 2: View of front of left engine's FSOV showing sooted body.

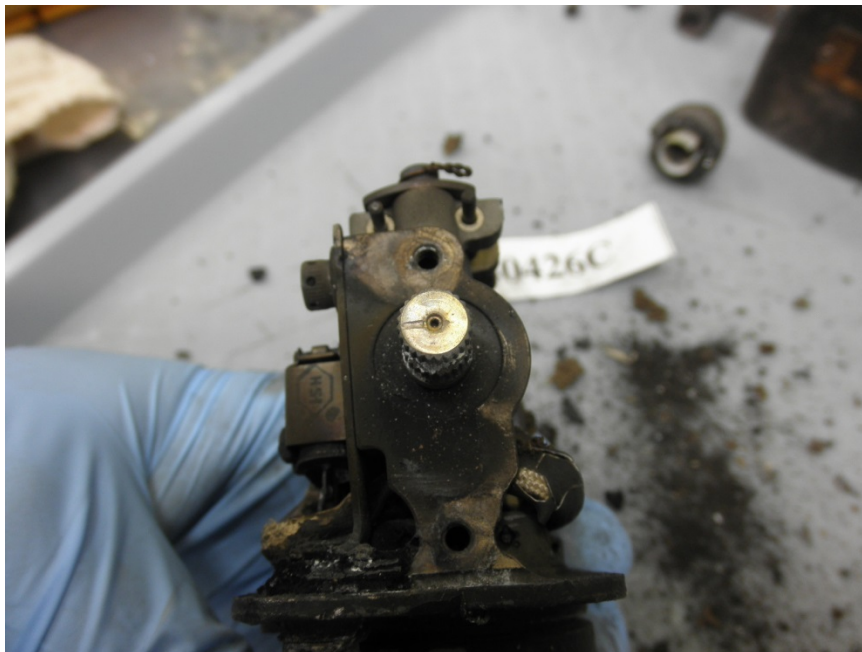
Photo No. 3: Close up of manual lever arm spindle with indexing line pointing to left.

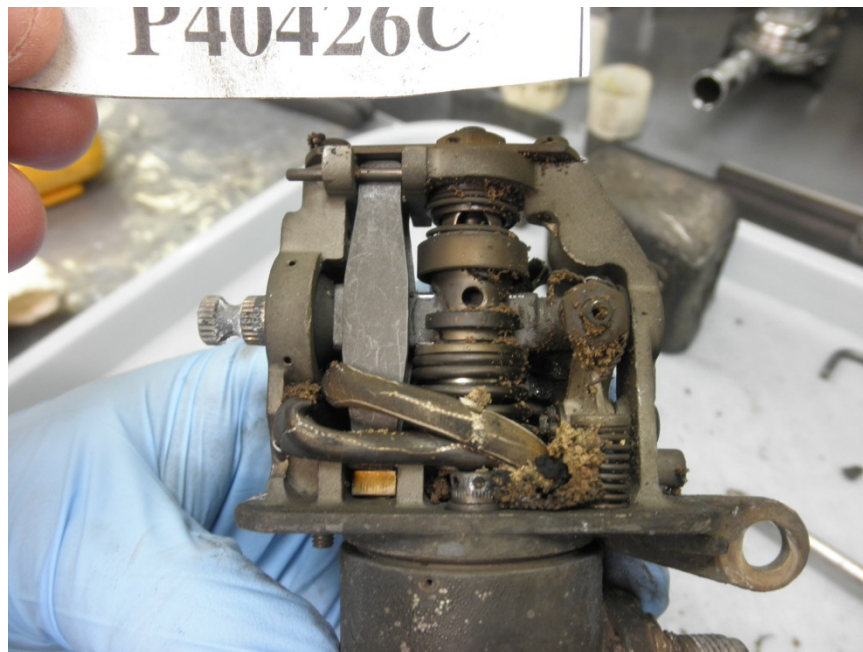
The manual lever spindle frame was intact. The frame appeared to be sooted. There were clumps of fibrous material around the spindle frame and the switches. (Photo No. 4) The manual lever spindle was rotated so that the flat was facing downward, which is the closed position. The leaf springs were in place and when they were removed, they still had their spring resistance. The O-rings were dry and broken up. The ball was stuck in the opening of the Vespel bushing. (Photo No. 5)

Photo No. 4: Close up of top of fuel shut off valve with cover removed showing fibrous material.

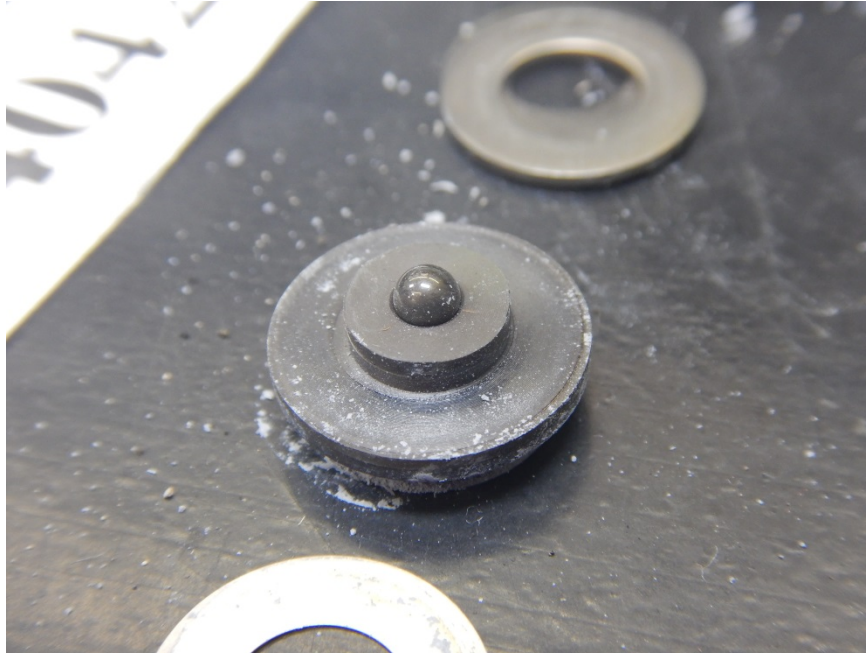
Photo No. 5: Close up of ball embedded in the Vespel seal seat. (Honeywell)

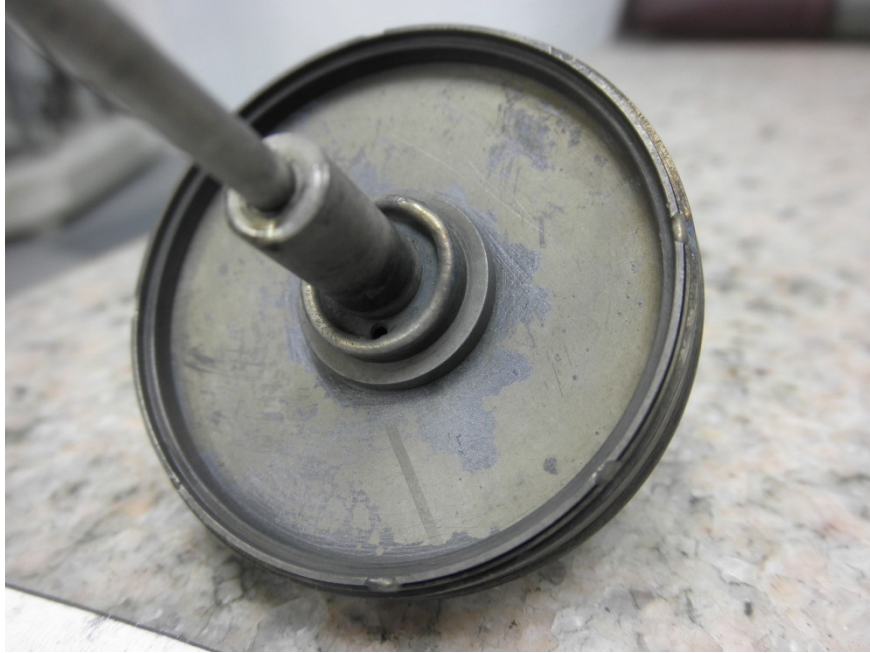
The Belleville washer was in the closed position. The Belleville washer was intact and there was no apparent damage to either side of the washer. (Photo No. 6) The Belleville washer could be moved between the open and closed position with finger pressure. The underside of the washer had a coating that was flaking off. (Photo No. 7) According to Honeywell, the engineering drawing shows the underside of the washer has a dry film lubricant applied. The FSOV poppet was the long stem configuration which is the -4 configuration and shows that the FSOV was pre-Service Bulletin (SB) TPE331-73-0208 that was issued on May 20, 1993. (Photo No. 8) According to Honeywell, SB TPE331-73-0208 was a category 2 bulletin meaning that it must be complied with when the component is accessible.

Photo No. 6: Close up of Belleville washer showing that it is intact.

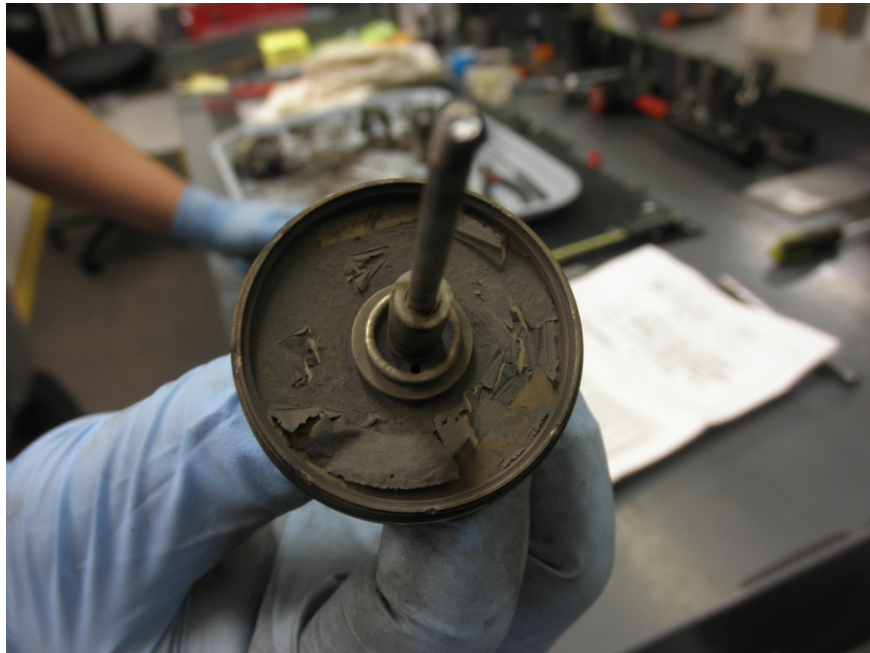
Photo No. 7: Close up of back side of Belleville washer showing coating peeling off.

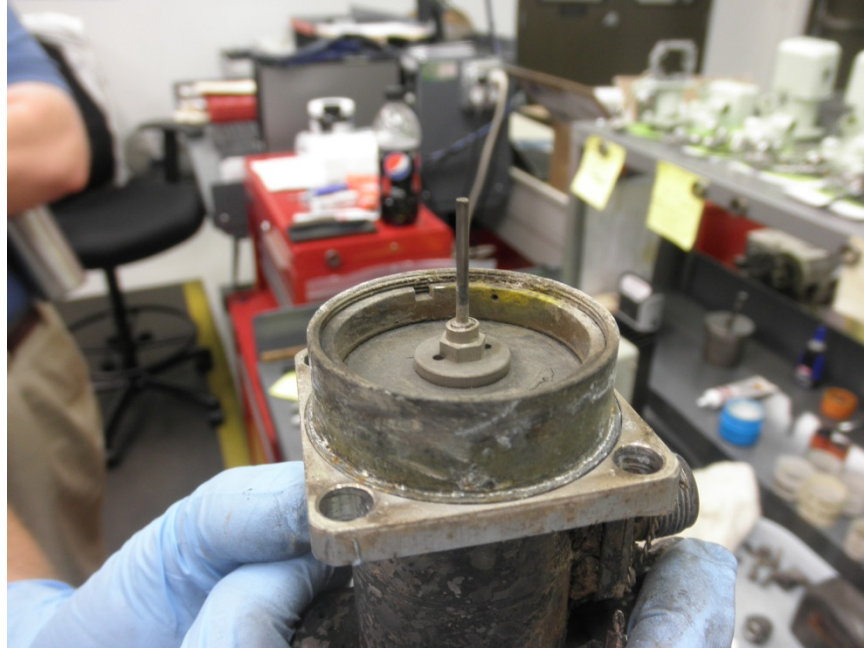
Photo No. 8: View of poppet stem showing it is a long stem and does not have the ball end.

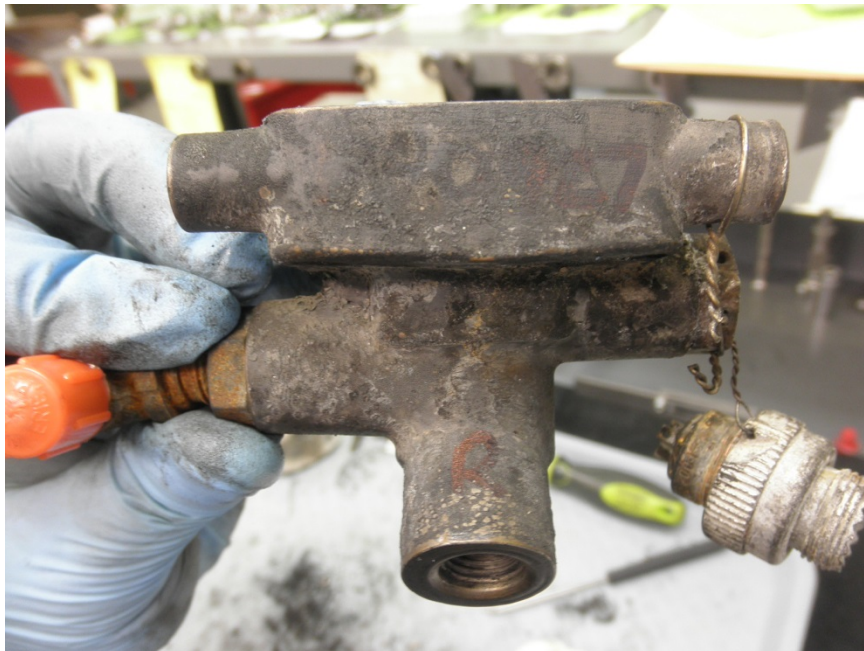
The right engine's FSOV was missing the data plate, so the PN and SN could not be determined. The FSOV's lower body was marked with the right engine's SN and a capital R. (Photo No. 9)

Photo No. 9: Right engine's FSOV lower body showing it marked with the engine serial number and the letter R.

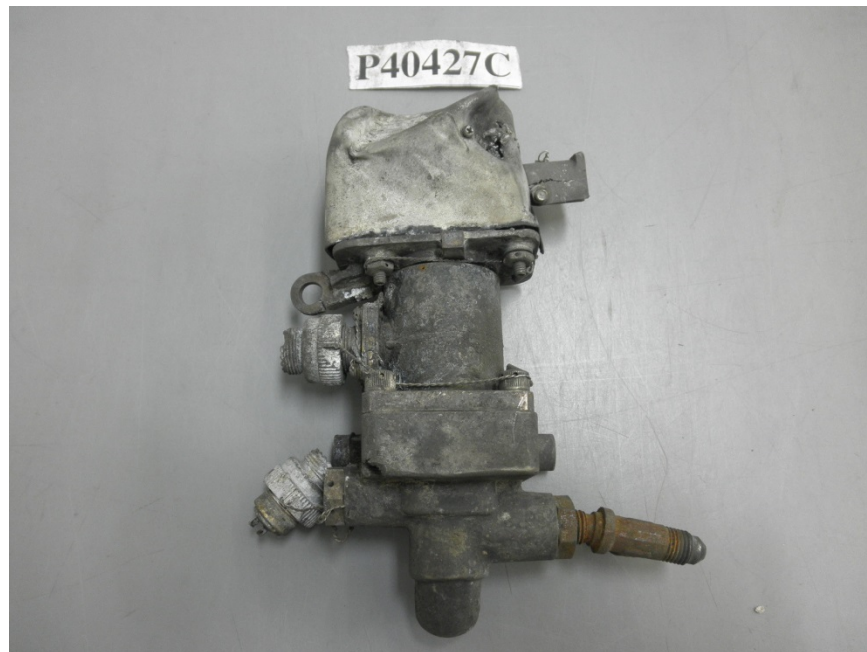
The FSOV was complete from the top of the manual shutoff lever cover to the bottom at the fuel inlet port. The exterior of the FSOV was sooted. (Photo No. 10) The wire connector was in place on the side of the FSOV, although the wire harness to the connector had been cut about 6 inches from the connector. The manual shut off lever was in place on the spindle. The spindle was rotated so that the index mark on the spindle end was pointed 90° to the right as viewed looking directly at the spindle end, which is the normal direction of rotation. (Photo No. 11) The manual shutoff lever cover was buckled and partially melted.

Photo No. 10: Left engine's FSOV showing body sooted and cover partially melted.

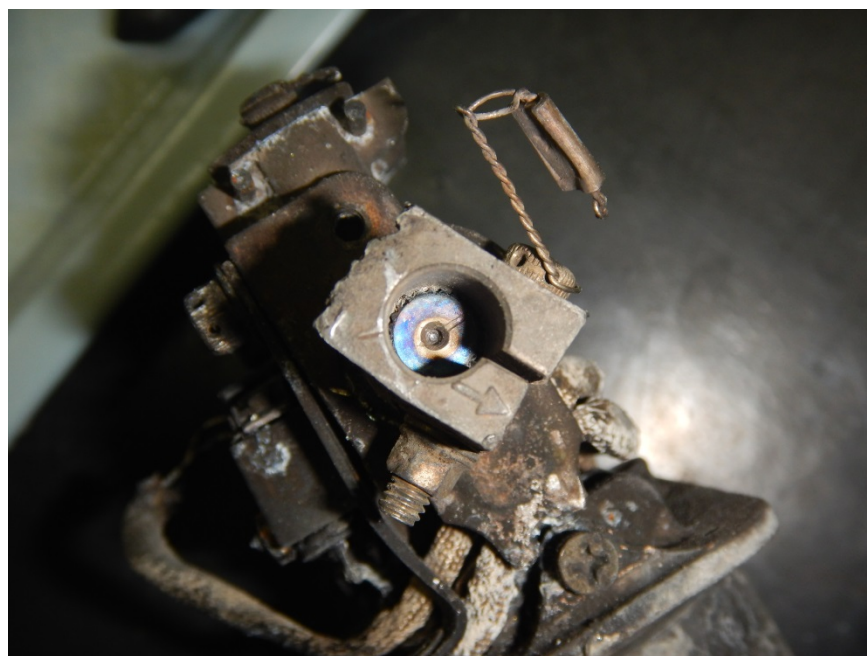
Photo No. 11: Close up view of manual lever arm spindle

showing indicator line pointing to the right. (Honeywell)

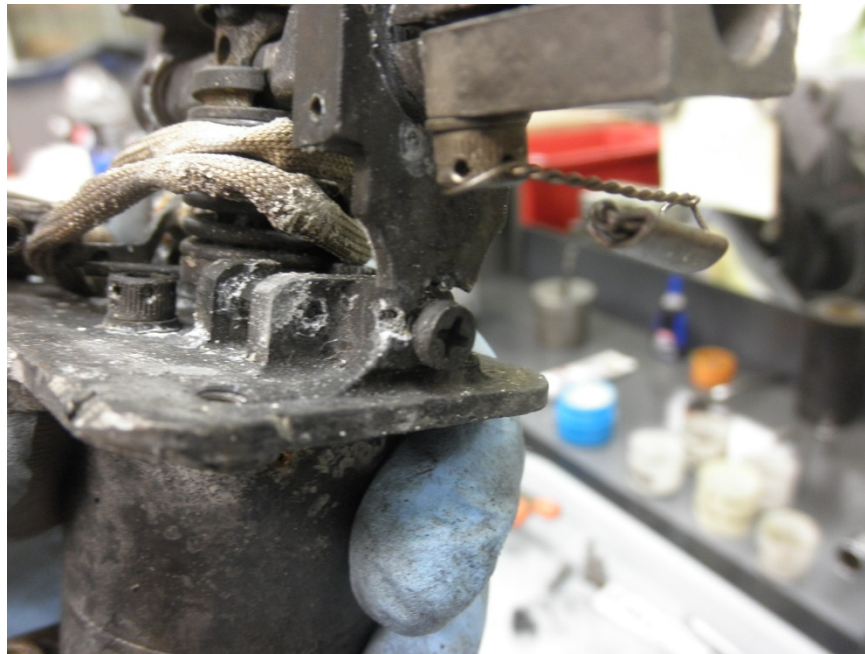
The manual lever spindle frame was broken on the right side as viewed looking at the front of the valve. The fracture surfaces were coarse and grainy and the edges appeared to have shear lips. (Photo No. 12) The frame appeared to be sooted. The manual lever spindle was rotated so that the flat was facing downward, which is the closed position. The leaf springs were in place and when they were removed, they still had their spring resistance. The O-rings were dry and broken up. The ball was loose, which is normal. (Photo No. 13)

Photo No. 12: Close up view of base of manual lever arm spindle support broken on right side.

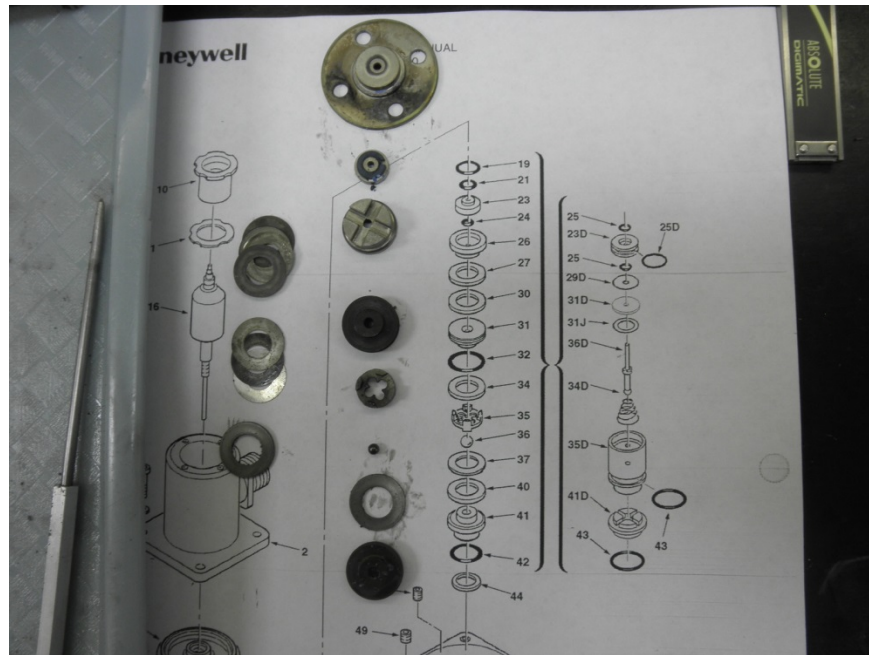
Photo No. 13: View of pieces including the ball, Vespel seal seat, and shims over the respective page of the Illustrated Parts Catalog.

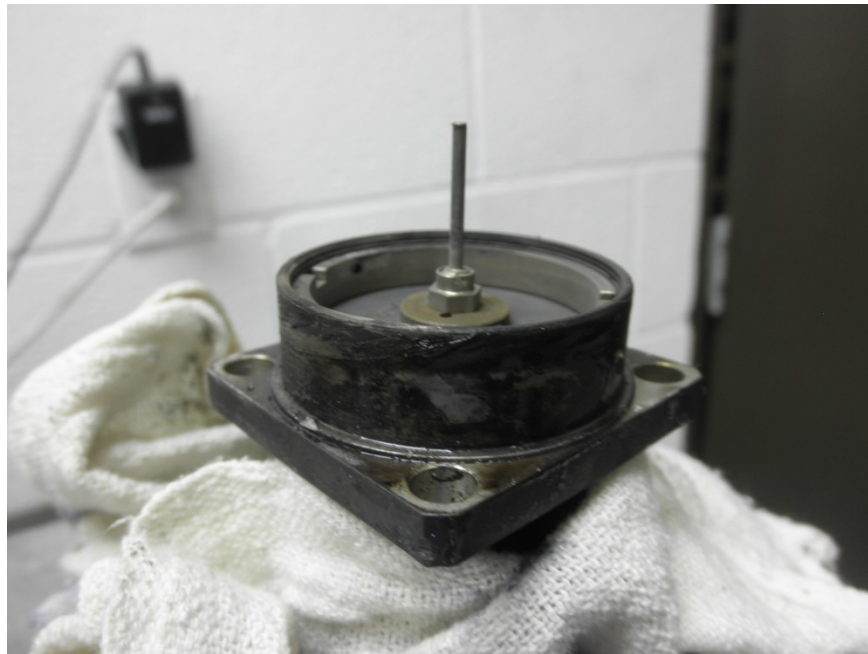
Photo No. 14:

The Belleville washer was in the closed position. The Belleville washer was intact and there was no apparent damage to either side of the washer. (Photo No. 13) The Belleville washer could be moved between the open and closed position with finger pressure. The FSOV poppet was the long stem configuration which is the -4 configuration and shows that the FSOV was pre-Service Bulletin (SB) TPE331-73-0208. (Photo No. 14)

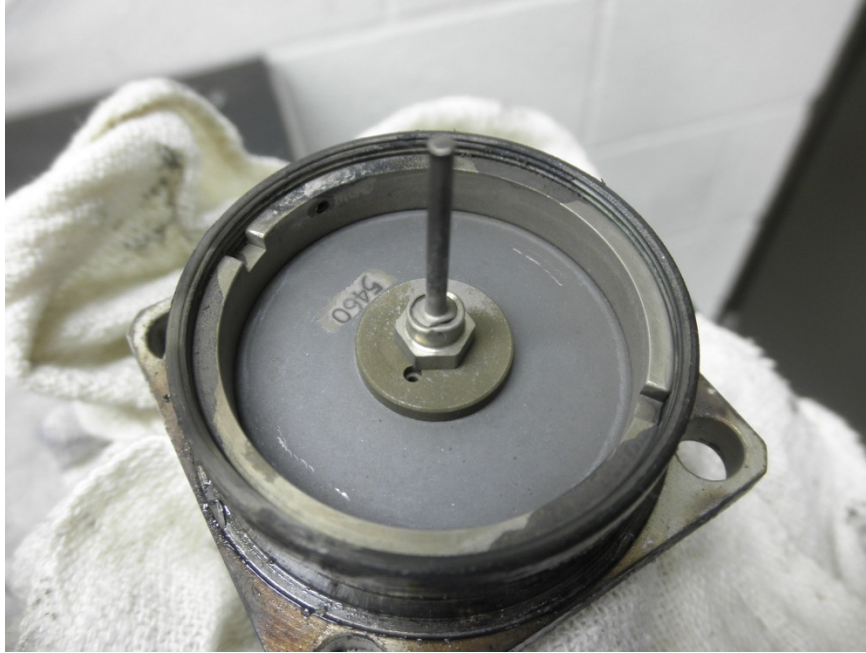
Photo No. 15: View of poppet stem showing it is a long stem and does not have the ball end.
