NATIONAL TRANSPORTATION SAFETY BOARD
Office of Aviation Safety
Washington, D.C. 20594

HELICOPTER SPECIALIST'S FACTUAL REPORT

NTSB No: WPR16FA040

Operator: Air Methods Corporation
Aircraft: Airbus Helicopters AS350 B3, Registration N74317
Location: Superior, Arizona
Date: December, 15, 2015
Time: 1723 mountain standard time

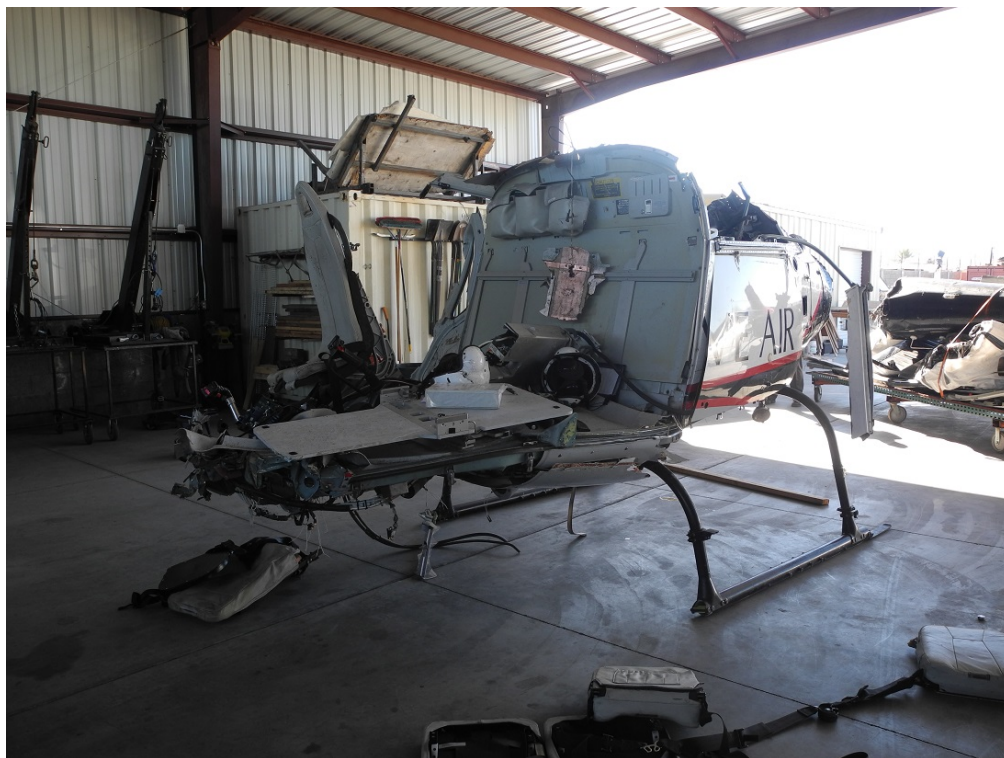
The forward section of the cabin, including the windscreen, the majority of cockpit instruments, and the cabin roof, were separated from the main fuselage (**Photo 1**). The all cabin doors except for the rear-right door were separated as well. The forward-right portion of the cabin floor was crushed aft, and the cabin floor buckled upward immediately behind the pilot seat (**Photo 2**). The pilot seat remained attached to the seat track, which remained attached to the cabin floor. However, both left and right seat tracks were fractured adjacent to the rear of the seat attachment; the fracture exhibited signatures consistent with overload (**Photo 3**). The pilot seat was angled slightly forward and to the right due to the buckled cabin floor. The pilot seat remained mostly intact with no evidence of a downward seat stroke. The stretcher remained attached to the cabin floor to the left of the pilot seat. The cargo pallet was found loose in the wreckage. The cargo pallet's lower brackets, used to attach it to the lower lateral track, were fractured from the pallet. The fractures exhibited signatures consistent with overload. The lower brackets remained attached to the lower lateral track via quick release pins.

Photo 1. The remnant cockpit and cabin.

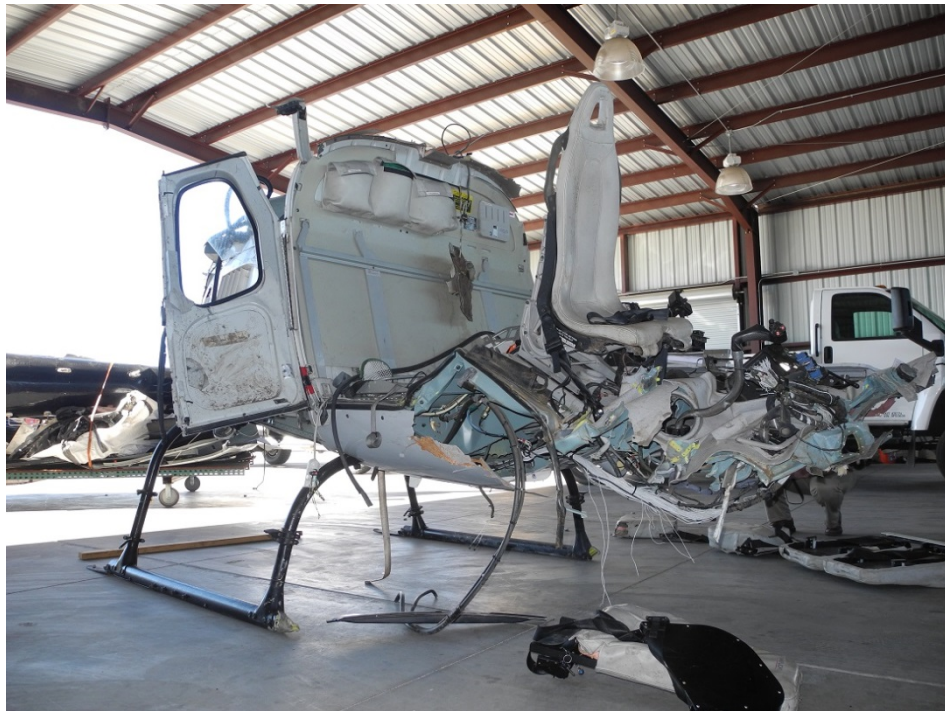
Photo 2. The pilot seat and cabin floor buckling.

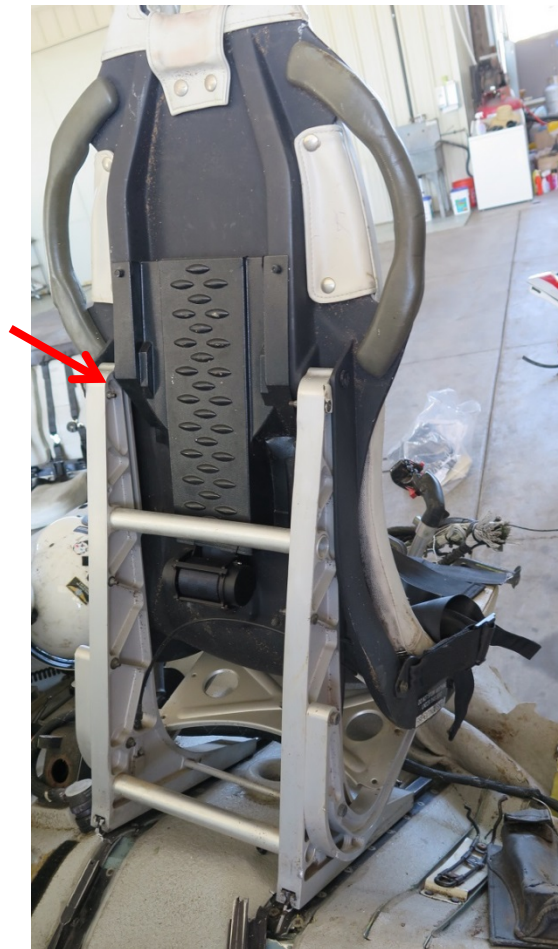
Photo 3. The pilot seat mounted to the floor tracks. The unlabeled arrow points to the seat stroking track. (Photo courtesy of Airbus Helicopters)

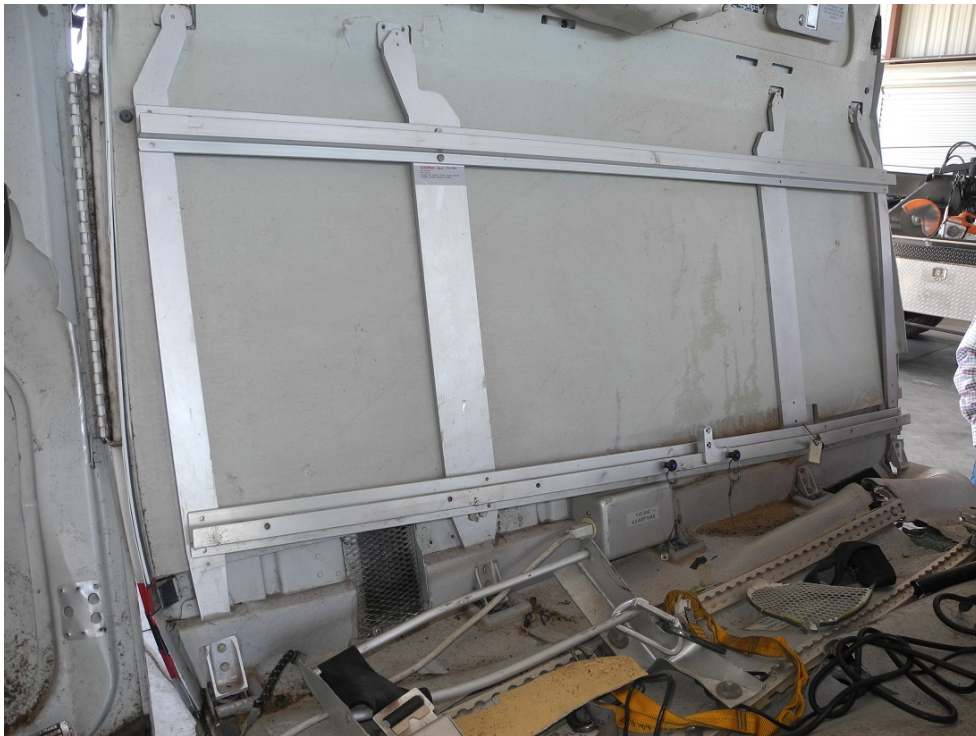
Three of the [rear seat] vertical straps (right, center-right, and center-left positions) remained attached to the aft vertical wall. The fourth vertical strap (left position) was found loose in the wreckage. The upper portion of the left vertical strap exhibited bending deformation in the forward direction, and its upper end had fractured immediately below the attachment point to the transmission deck structural support. The left seat belt pan was found to have shifted outboard. The right vertical strap's lower attaching mount was separated from the seat belt pan. The bolt and nutplate for the right vertical strap's lower attaching mount was not recovered. The center-right vertical strap's lower attaching mount remained attached to the seat belt pan, but the upper end of the center-right strap was separated from the transmission deck structural support. Both ends of the center-left vertical strap remained attached to both the transmission deck structural support and the seat belt pan.

The upper lateral track was only attached to the center-right vertical strap via two bolts, but did not exhibit evidence of deformation or damage. The lower lateral track was found loose in the wreckage with two seats still attached to it. The lower lateral track was bent in the forward direction near the third quick release pin hole from the left. A fracture, with signatures consistent with overload, was collocated at the third quick release pin hole from the left. The first and second from the left quick release pin holes exhibited deformation near the hole edges on the forward face of the lower lateral track. **Photo 4** shows a reconstructed assembly of the lateral tracks and vertical straps on the aft vertical wall (after removal of the right and middle seats that were attached to the lower lateral track).

Photo 4. A reconstructed assembly of the lateral tracks and vertical straps.

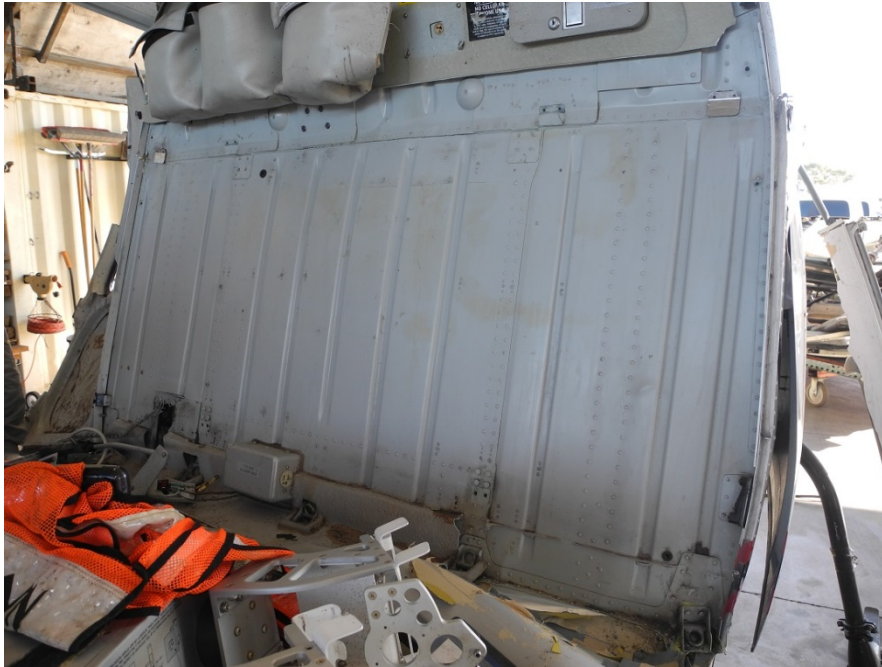
bolts, normally securing the center-right vertical strap to the transmission deck structural support, was fractured, with the remnant threaded shanks retained within the transmission deck structural support. The remnant threaded shanks exhibited signatures consistent with overload; the fractured bolt heads were not recovered. The remaining bolts securing the center-right and center-left vertical straps to the aft vertical wall were removed; there were no anomalous findings with the remaining mounting assemblies. The aft vertical wall generally did not exhibit significant damage or distortion (**Photo 5**).

Photo 5. The aft vertical wall after removal of the lateral tracks, vertical straps, and wall cover.

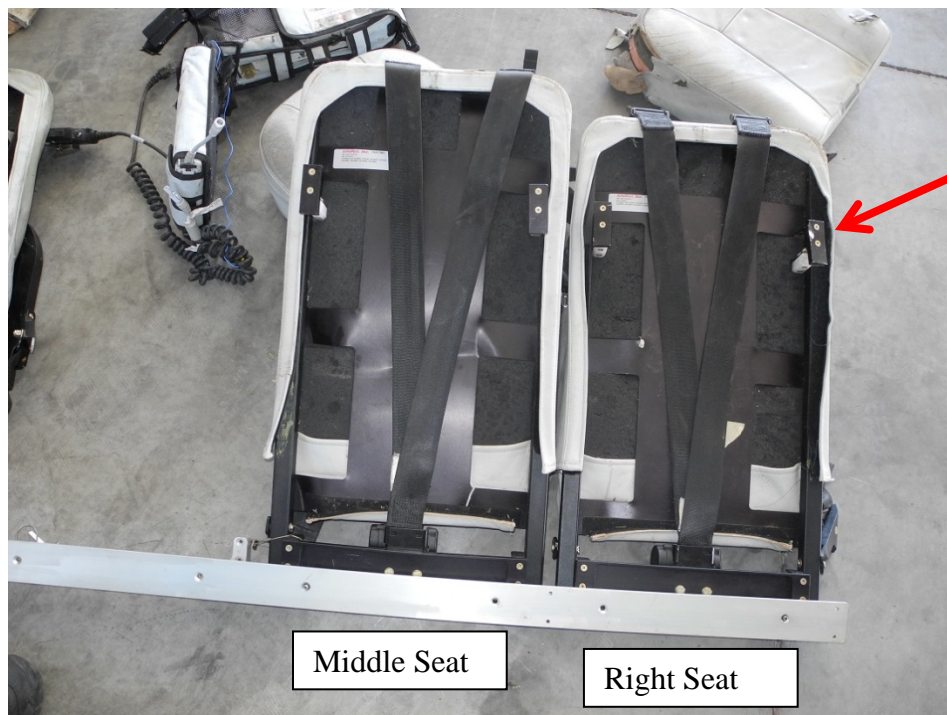
The right rear seat back remained attached to the lower lateral track on its lower mounting plate and quick release pins. The seat bottom was separated from the seat back structure, but remained connected to the seat belt restraint, which was connected to the seat belt inertial reel assembly attached to the lower mounting plate. The seat bottom's left and right mounting brackets were fractured and exhibited signatures consistent with overload. The remnant mounting brackets remained attached to the seat back structure. The left hook (normally attached to the upper lateral track) on the seat back did not exhibit evidence of deformation, but the lower portion of the right hook exhibited deformation in the aft and slightly outboard direction (**Photo 6**). The seat cushions and covers remained installed on both the seat back and seat bottom.

Photo 6. A view of the rear of the middle and right seat backs installed on the lower lateral track. The unlabeled arrow points to the deformation on the right hook of the right seat.

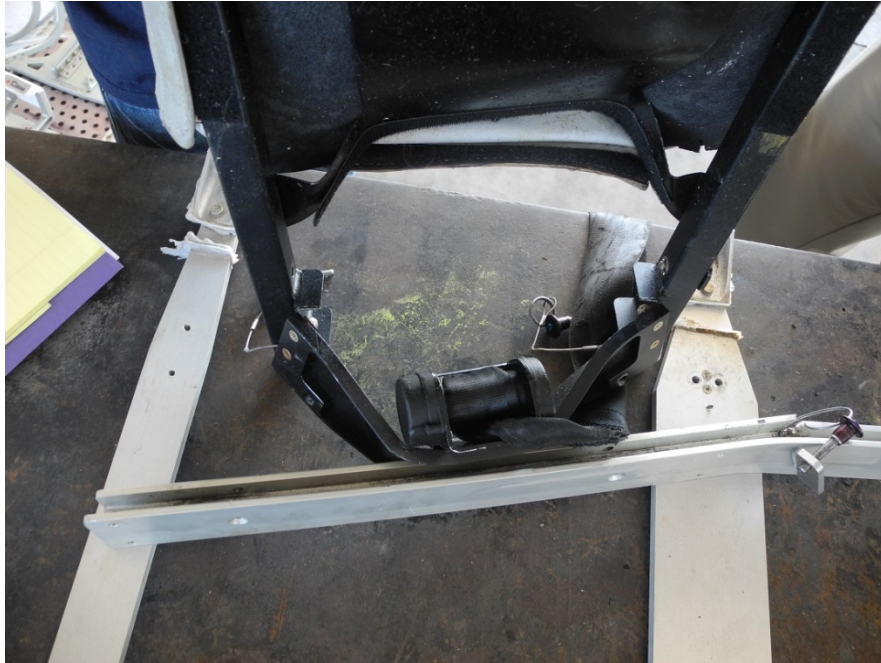
The left rear seat back and seat bottom were found loose in the wreckage, separated from both upper and lower seat tracks. The seat bottom was separated from the seat back structure, but remained connected to the seat belt restraint, which was connected to the seat belt inertial reel assembly attached to the lower mounting plate. The lower mounting plate exhibited severe rearward deformation (**Photo 7**). Additionally, the left and right sides of the lower seat back frame was deformed inward (toward the vertical centerline of the seat) and the sheet metal back rest was deformed aft. The distance between the left and right sides of the lower seat back frame was about 11.5 inches (**Photo 8**); for comparison, the same distance was measured on the right seat (15.0 inches) and middle seat (14.8 inches). The seat bottom's left mounting bracket remained intact, but the attaching hardware was missing. The seat bottom's right mounting bracket was fractured and exhibited signatures consistent with overload. The remnant right mounting bracket was attached to the seat back structure. Both quick release pins remained attached to the seat back structure via metal wire. The seat cushion and cover remained installed

Photo 7. Rear left seat lower mounting plate deformation.

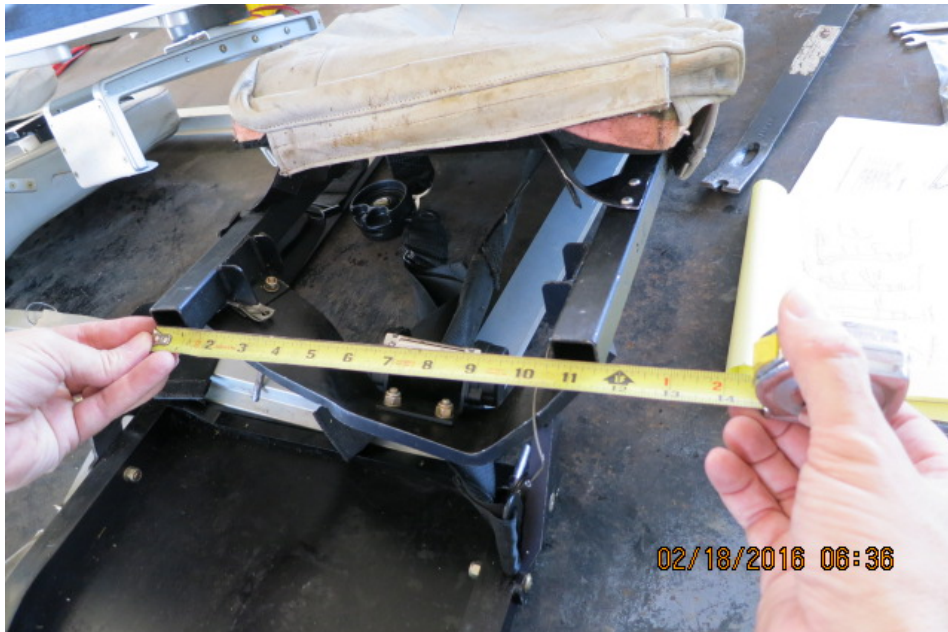
Photo 8. Measurement of the lower seat back frame deformation for the rear left seat. (Photo courtesy of Air Methods)

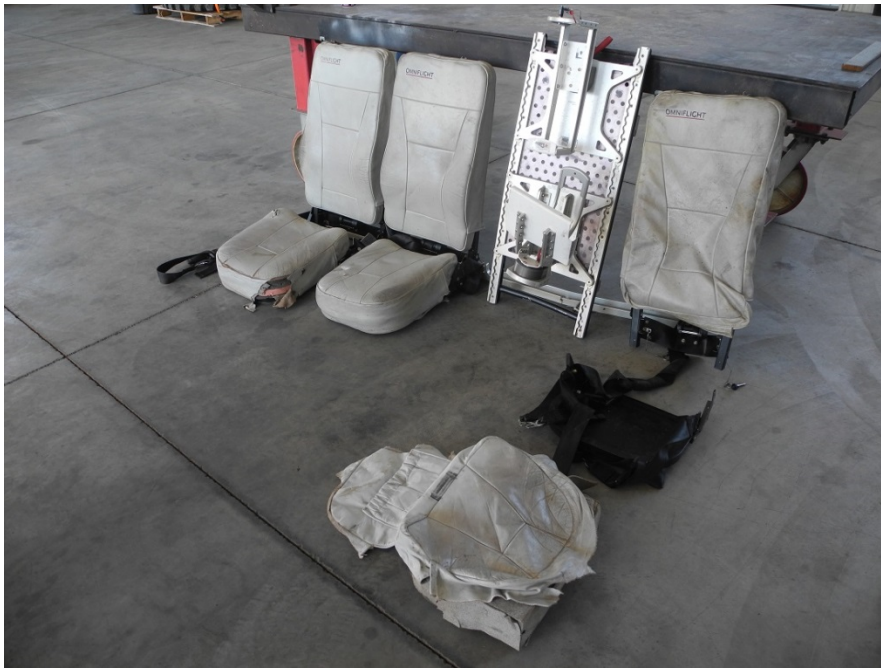
on the seat back. The seat cushion and cover was not installed on the seat bottom, but was found separately in the wreckage. **Photo 9** shows a reconstruction of the three seats and cargo pallet to the lower lateral track.

Photo 9. Reconstruction of the three seats and cargo pallet.
