NATIONAL TRANSPORTATION SAFETY BOARD

INITIAL EXAM REPORT

WPR16LA078

Aircraft: Boeing A75N1 (PT17), Registration Number: N63555, Serial #: 75-8914

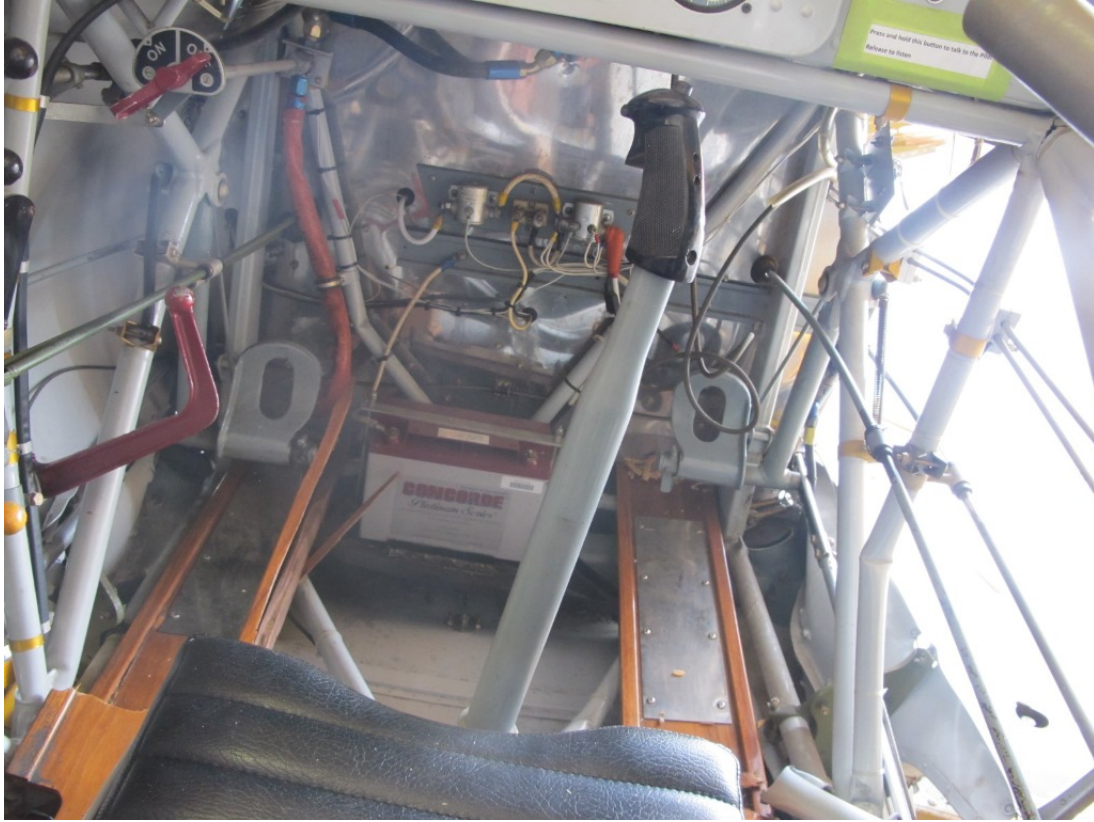
Photo 1 Front Cockpit

Flight control continuity was established for all flight controls; the control surfaces followed manipulation of the control sticks.

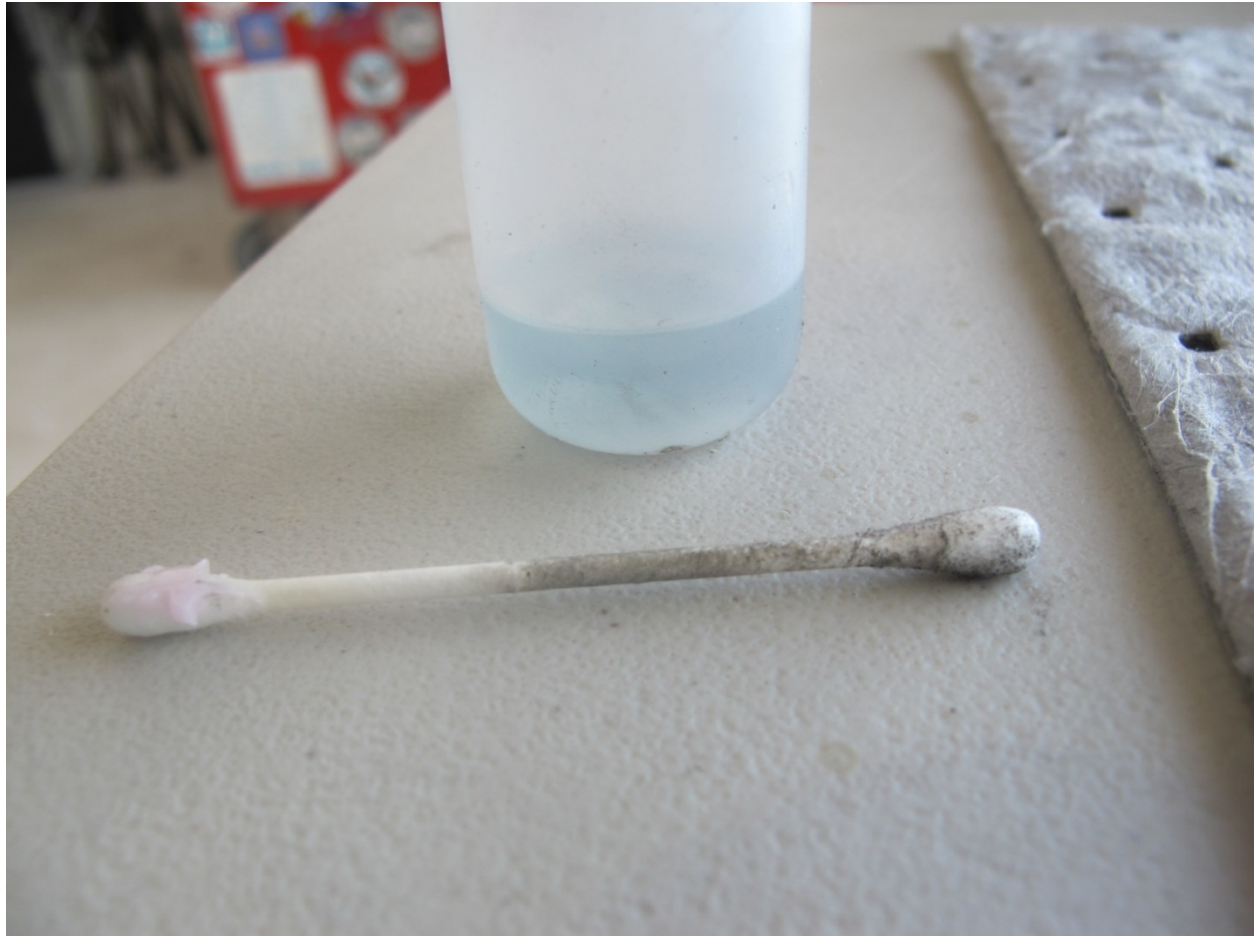
Blue fluid that smelled like aviation gasoline was drained from the left and right fuel drains from the wing fuel tank. There was no visible contamination. Investigators drained a clear blue fluid that smelled like aviation fuel from the gascolator, and the screen was clear. A water paste test did not change color indicating no water contamination.

Photo 3 Water Paste Test of Fluid from Gascolator

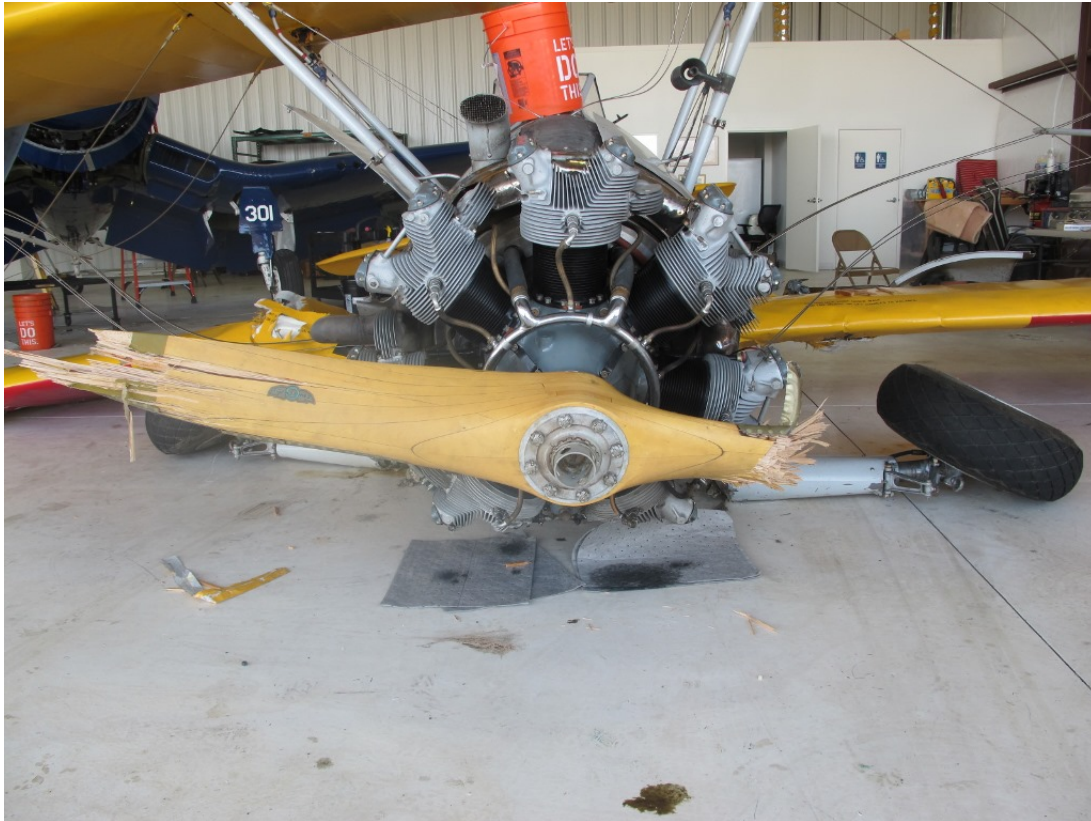
Photo 4 Front View of Engine and Propeller

The radial engine had seven cylinders with number one at the top, and the numbering proceeded clockwise. The bottom two cylinders (four and five) sustained aft crush damage. All fittings that could be reached were finger tight. A black fluid was evident on the dipstick.

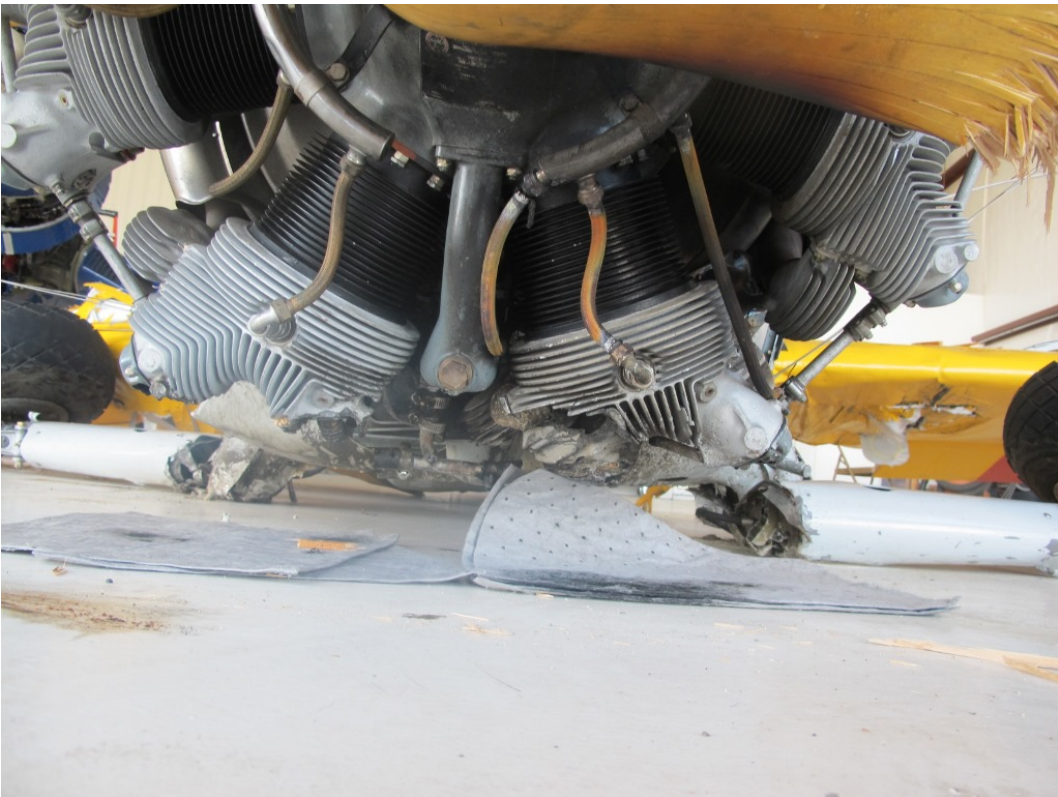
Photo 8 Bottom Cylinders

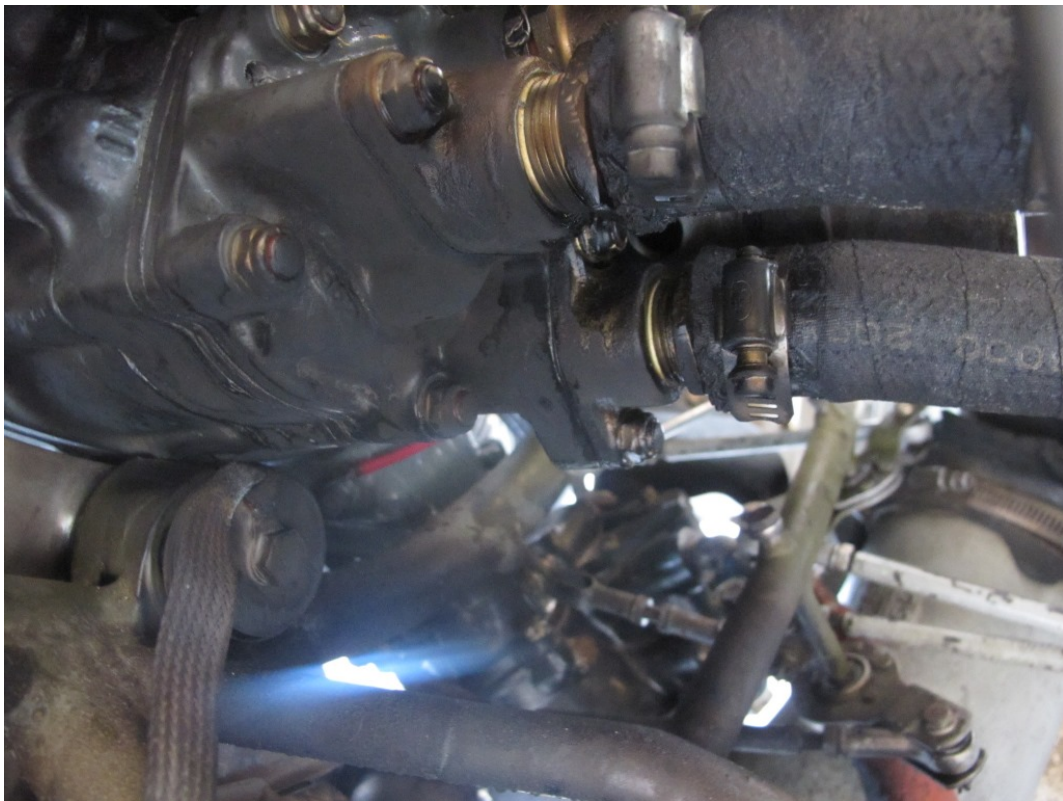
Photo 10 Charred Aft Section of Engine
