INVESTIGATION NOTES

NTSB ACCIDENT NUMBER: **WPR12FA385**

AIRCRAFT REGISTRATION: N346PE

WPR12FA385 – SeaRey – Friday Harbor, WA

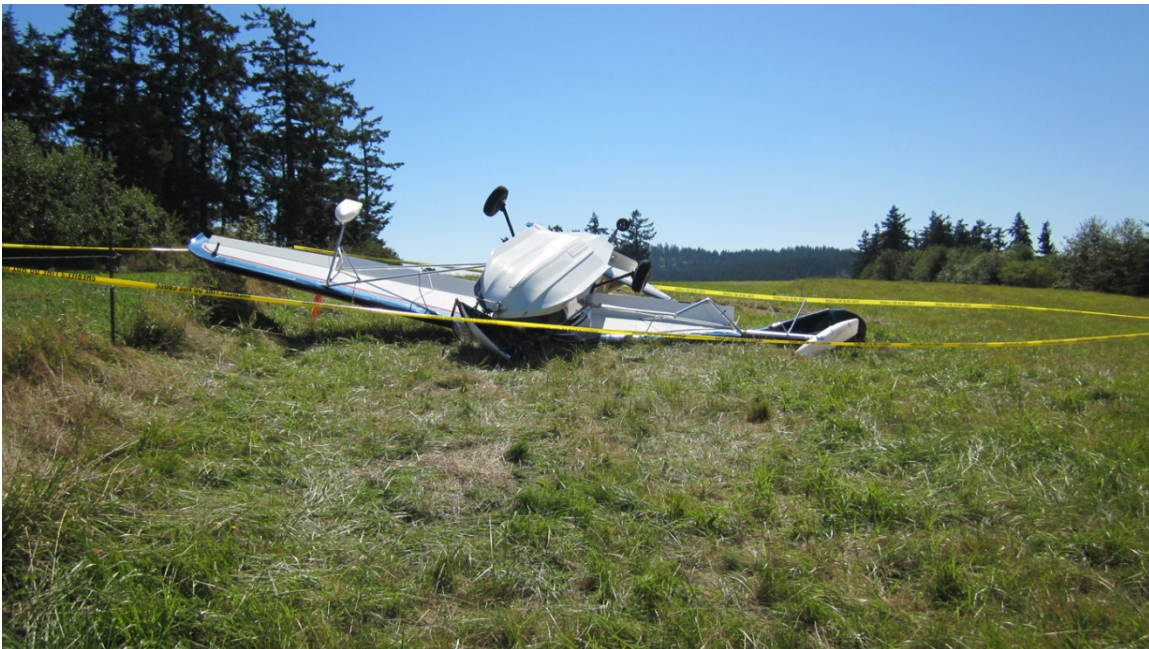
The airplane was found inverted on the approach end of runway 20. The fuselage was on a magnetic heading of about 030 degrees. The airplane was mostly intact. Photo 1 was taken looking south.

Photo 1. Main wreckage looking south.

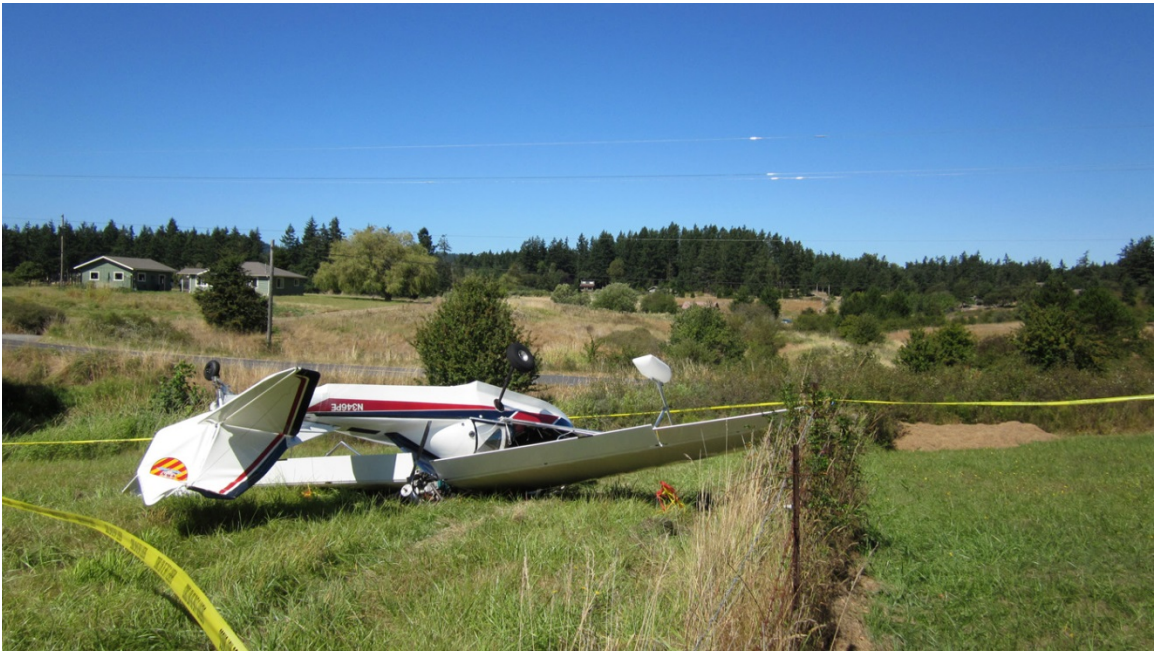
Photo 2 was taken looking north showing the wreckage in the foreground with the transmission wires visible above it.

Photo 2. Main wreckage looking north.

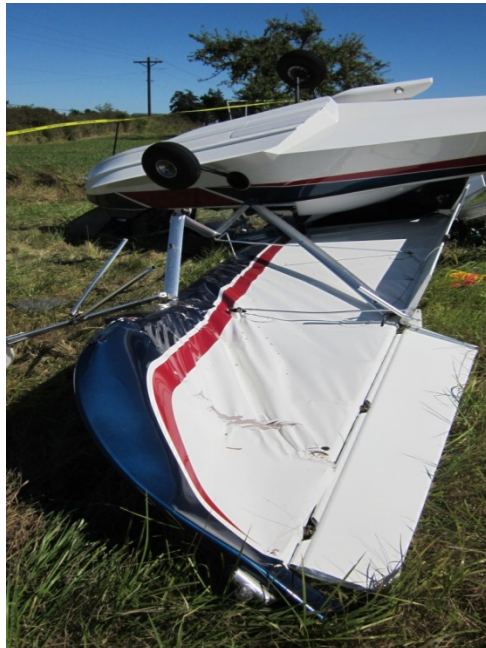
As shown in figure 3, the right wing outboard half was bent and wrinkled. The forward wing strut was bent, and the right sponson was separated and found in front of the wing.

Photo 3. Right wing.

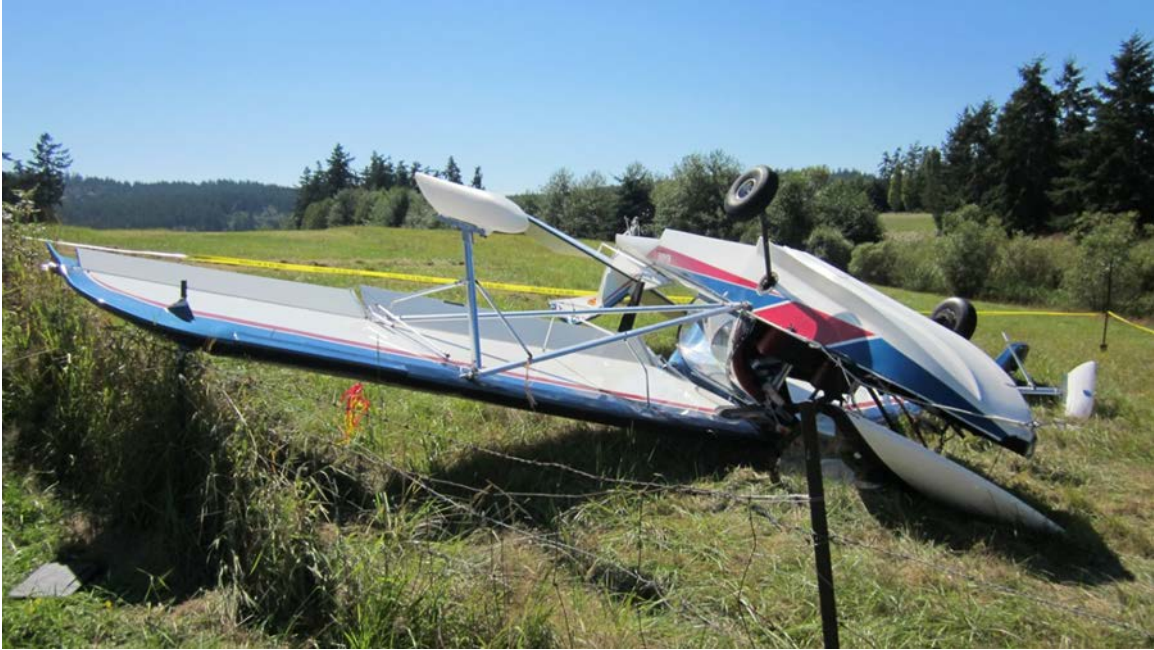
As shown in Figure 4, the left wing had wrinkles at the root and a fence post through the tip.

Photo 4. Left wing.

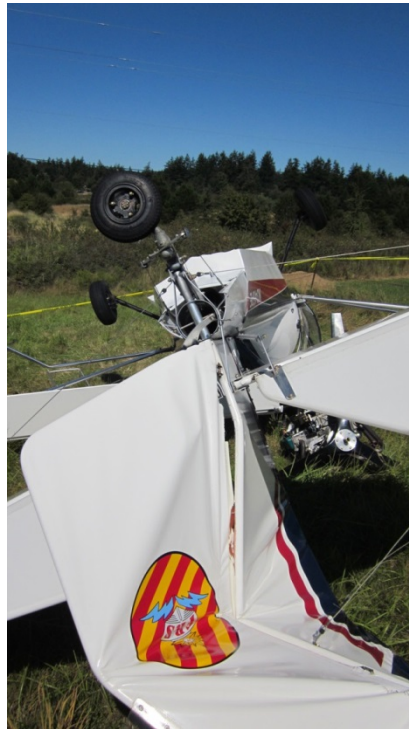
As shown in Figure 5, the vertical stabilizer and rudder were bent and wrinkled.

Photo 5. Empennage.

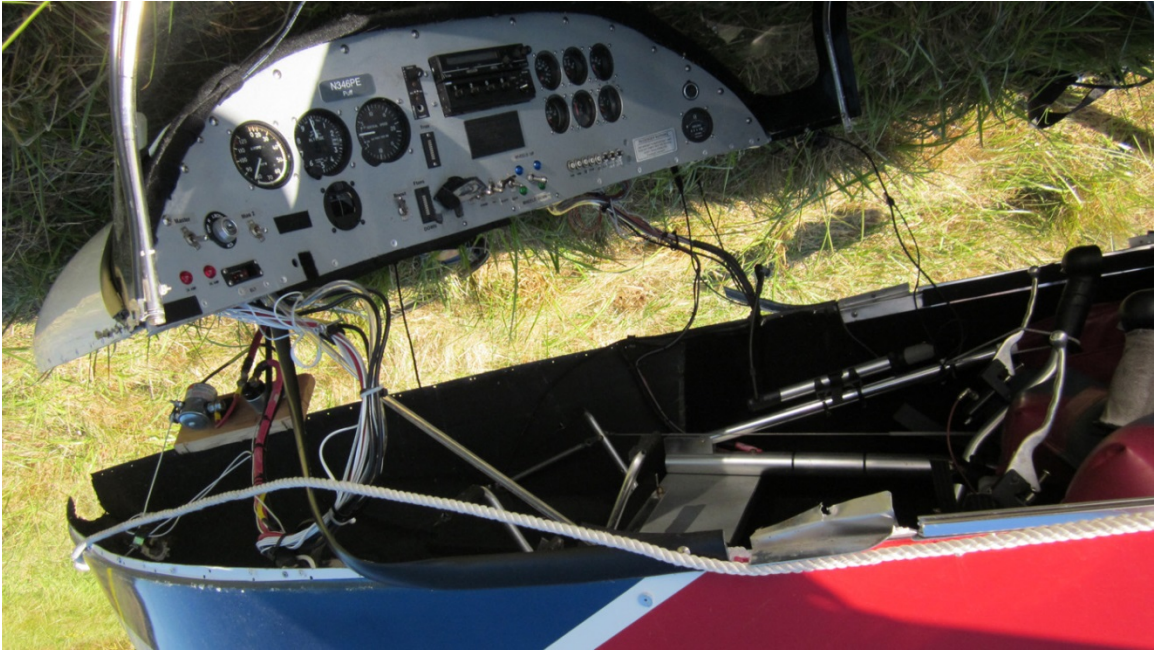
As shown in photo 6, the cabin area structure was split in half.

Photo 6. Cabin area damage.

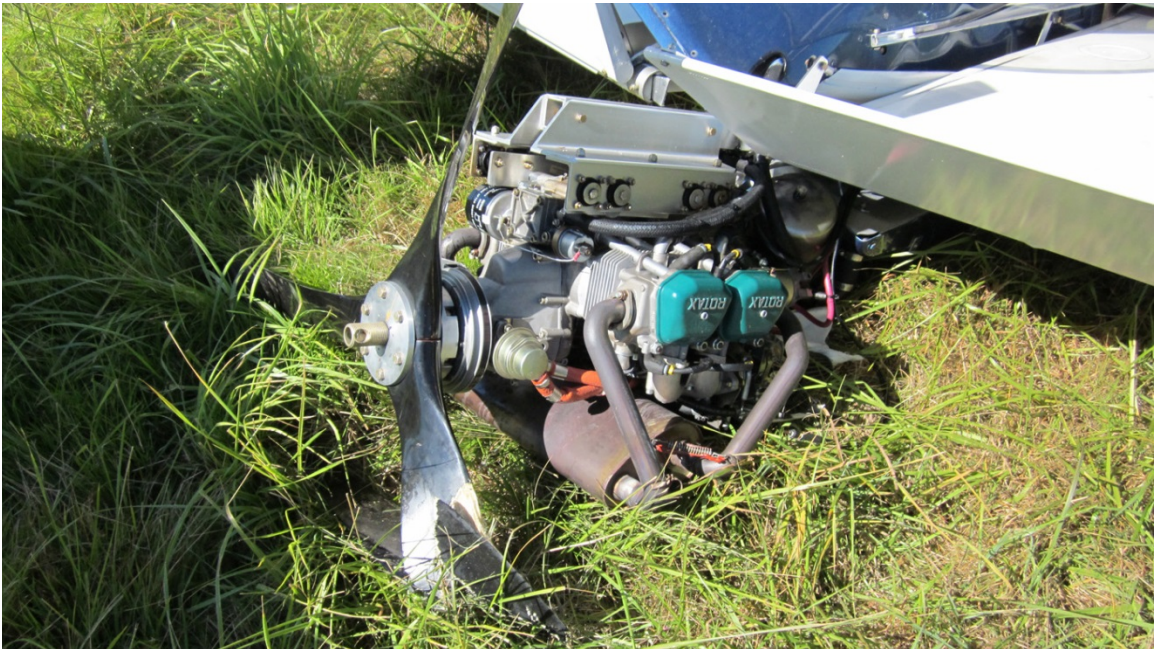
As shown in photo 7, the engine remained attached to the engine mount with the propeller still attached to the crankshaft propeller flange. One propeller blade was broken.

Photo 7. Engine and propeller.

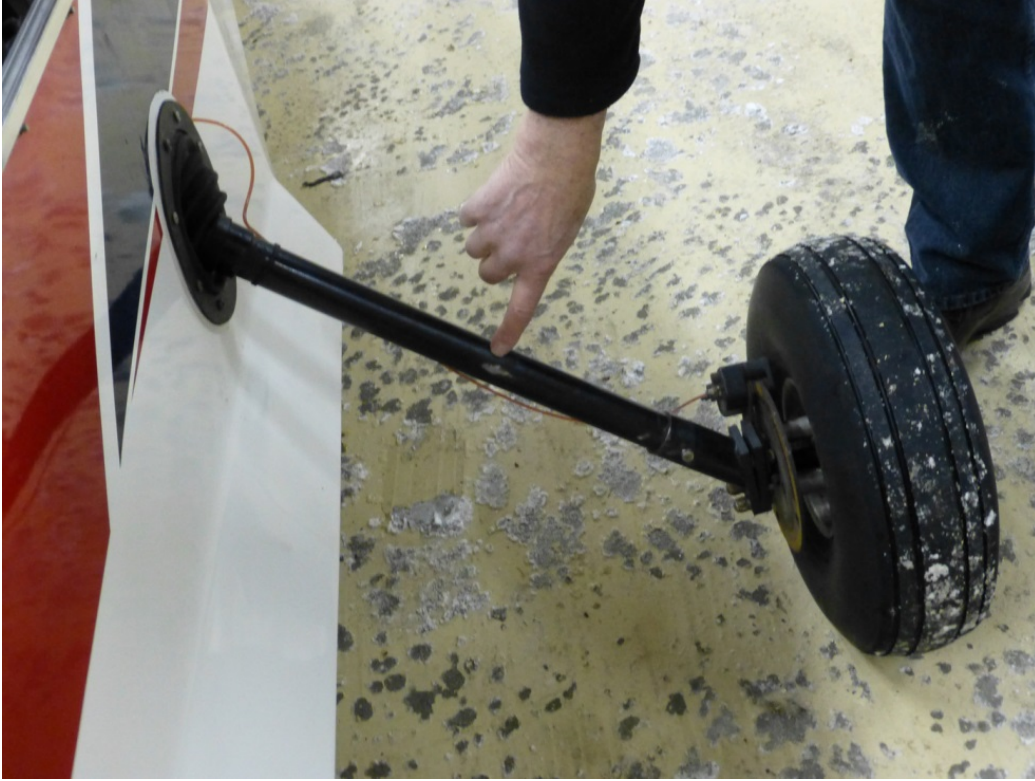
The left main landing gear strut (photo 8), the bottom (keel) of the fuselage (photo 9), and the right main landing gear tire (photo 10) exhibited evidence of contact with wires.

Photo 8. Wire strike mark on left main landing gear strut.

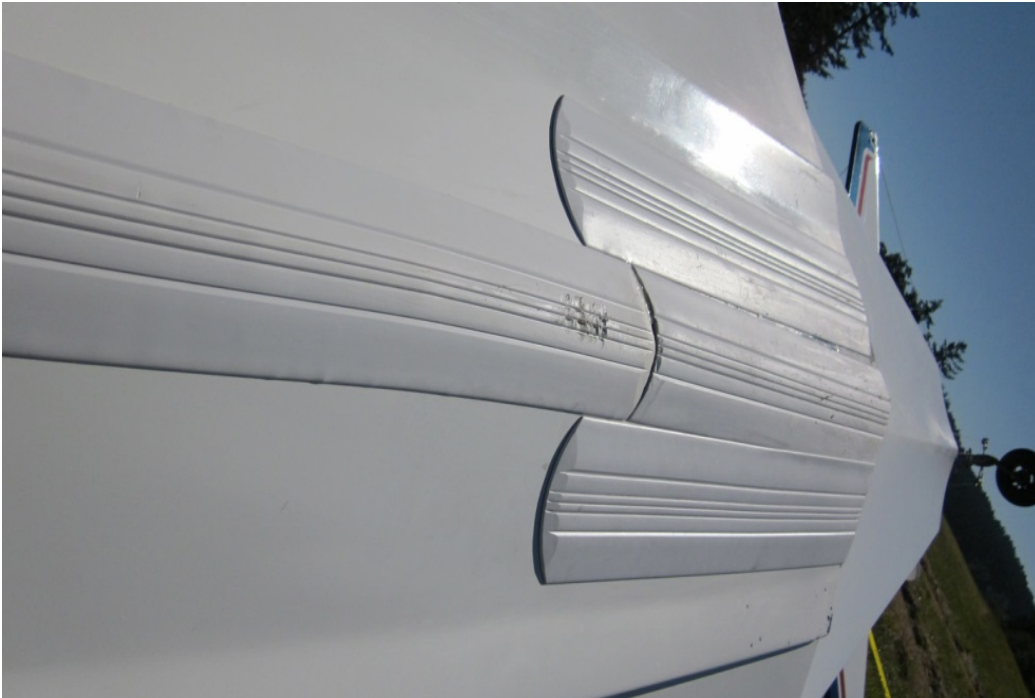
Photo 9. Wire strike on the bottom of the fuselage.

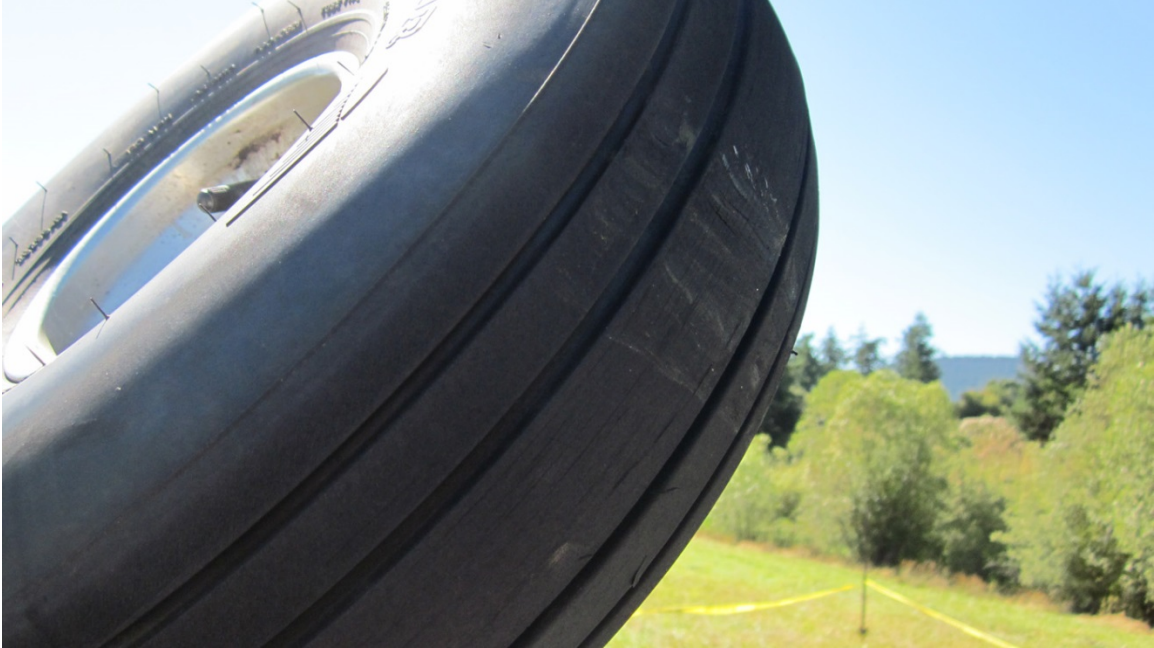
Photo 10. Right main tire.
