National Transportation Safety Board

Marine Accident Brief

Fire aboard Cargo Ship *Chipolbrok Moon*

Accident type	Fire/Explosion	No. DCA18FM025
Vessel name	<i>Chipolbrok Moon</i>	
Location	Industrial Terminal West, Greens Bayou, Port of Houston, Texas 29°44.94'N; 95°10.07'W	
Date	May 23, 2018	
Time	0010 central daylight time (coordinated universal time – 5 hours)	
Injuries	None	
Property damage	\$12 million est.	
Environmental damage	None	
Weather	Partly cloudy, light east winds, air temperature 73°F	
Waterway information	Greens Bayou is located at about mile 43 on the north side of the Houston Ship Channel, which extends from Galveston across Galveston Bay to the city of Houston.

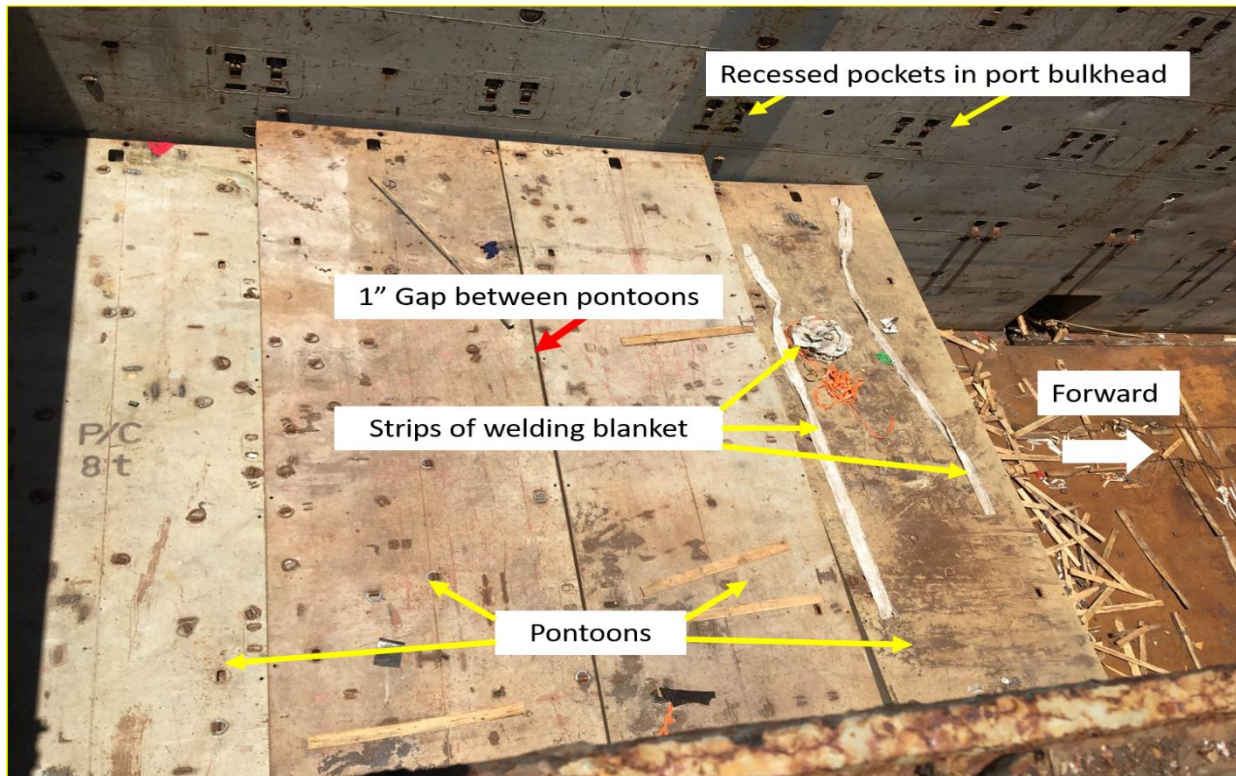
***Chipolbrok Moon* pontoon decks in cargo hold. A gap between the pontoons is identified by a red arrow.**

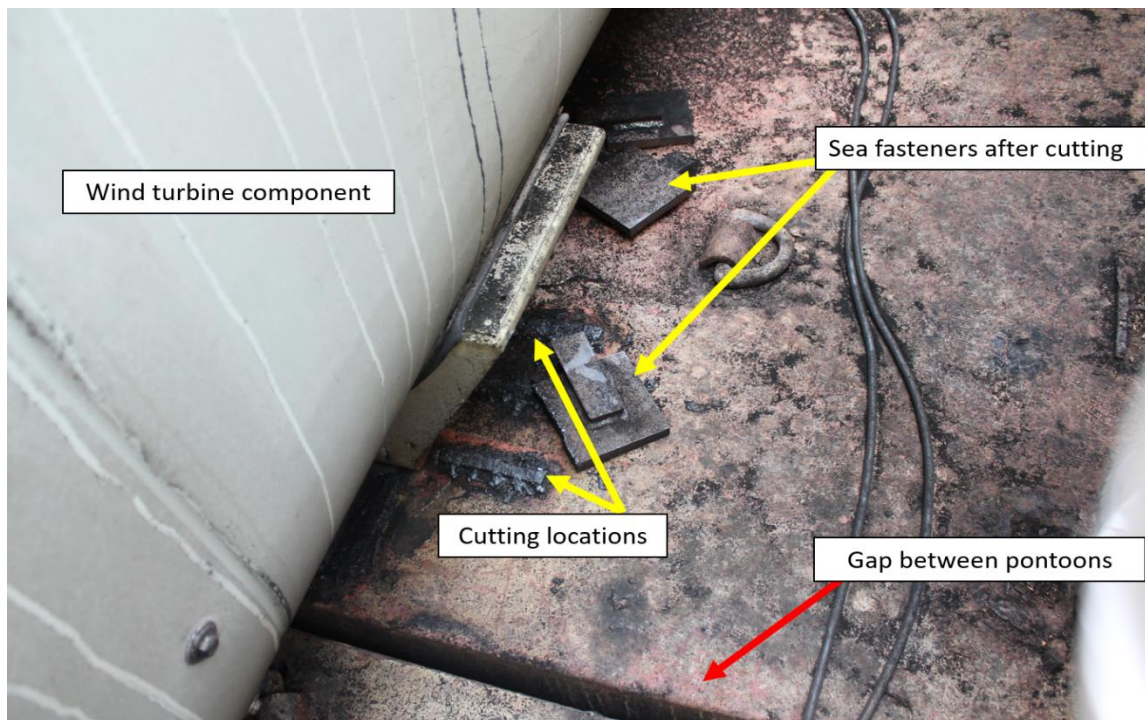
Steel sea fasteners cut from deck in the portside no. 3 hold aboard *Chipolbrok Moon*, identified with yellow arrows. The gap between pontoons is identified with a red arrow. (Photo by Harris County Fire Marshal)

The cargo of transmission hubs was located on the lower deck just below the pontoons making up the lower tween deck level. The crew was conducting hotwork near a gap between two pontoons on the deck above, and sparks/welding slag were able to fall from the work location through the unprotected gaps between the pontoons, igniting the turbine component's dust-protective transport plastic and blanket. The area above the transmission hubs and below the pontoon deck was difficult to access and hard to see given the lack of lighting in the hold. In addition, transmission hubs stored aboard the vessel were wrapped in a material that ignited relatively easily. The crew of the *Chipolbrok Moon* did not ensure adequate placement of fire blankets, particularly in areas that were difficult to access. Further, the modification of the fire blankets into narrow strips (about 7 inches wide) could have easily led to shifting, uncovering the gaps between the pontoons. In his permit, the marine chemist noted that hotwork areas needed to be at least 35 feet (12 meters) away from flammable and combustible materials. However, because of the loading configuration, the hubs were located less than a foot below the hotwork area on the lower tween deck in port cargo hold no. 3. Additional fire blankets should have been placed over the hubs.

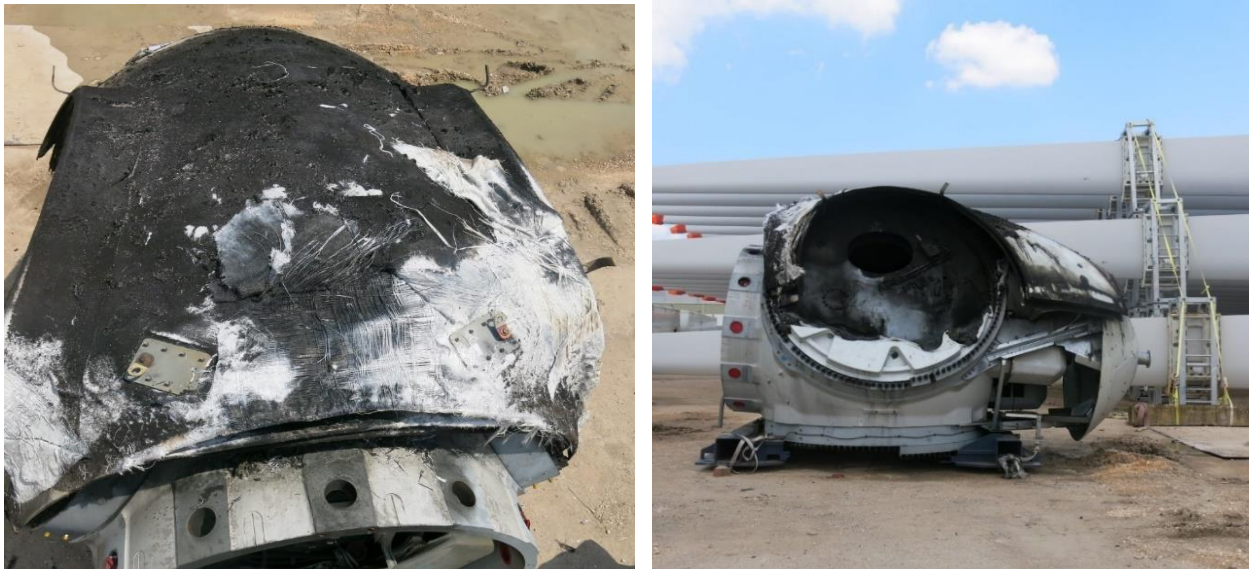
After the fire, the chief investigator from the Harris County Fire Marshal's Office inspected the damaged hub and identified smoke and fire damage consistent with sparks and slag falling onto

the plastic and blanket kit covering the hubs from a gap in the pontoons from the deck above. The burn pattern indicated that the worst damage was to the area directly below the gap in the pontoons. Many other components were damaged by smoke, which entered the interior spaces of the hubs and nacelles during the fire. The hubs and nacelles were equipped with sensitive electronics, hydraulic systems, gears, and bearings.

Fire damage to transmission hub as seen from above (left) and side (right) after removal from port cargo hold no. 3 of the *Chipolbrok Moon*.

Investigators determined that the blanket kit material was polyethylene terephthalate (PET), the same plastic from which water bottles are made. The melting temperature range for PET is 250–255°C (482–491°F). Without the addition of fire-retardant material, PET will combust like any hydrocarbon fuel once liquified. Slag resulting from cutting with a torch can reach 6,000°F and the sparks generated from the torch can exceed 3,000°F. Hot welding sparks and byproducts can easily ignite combustible materials, particularly low temperature melting material like the PET fiber in the blanket.

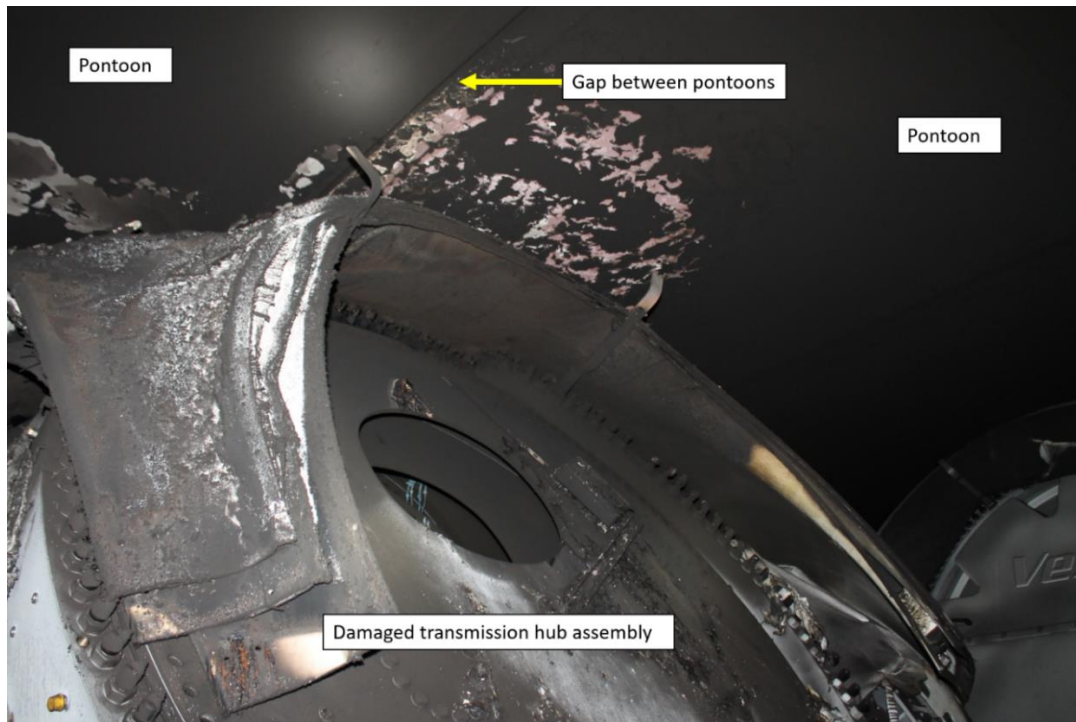
Fire damage to transmission hub in cargo hold no. 3 aboard *Chipolbrok Moon* directly below gap between pontoons. (Photo by Houston Fire Marshal)

The National Transportation Safety Board determines that the probable cause of the fire aboard cargo vessel *Chipolbrok Moon* was the crew's lack of adherence to the company's safety management system and the marine chemist's instructions pertaining to hotwork precautions, which allowed sparks and slag to fall through unprotected gaps between the removable decking pontoons and ignite the dust-protective covering of the transmission hubs.
