NATIONAL TRANSPORTATION SAFETY BOARD

MATERIALS LABORATORY FACTUAL REPORT

Report No. 15-060

Place : Hector, Arkansas
Date : October 14, 2013
Vehicle : Piper PA-32R-300 (N5605V)
NTSB No. : CEN14LA030
Investigator : Michael Folkerts (AS-CEN)

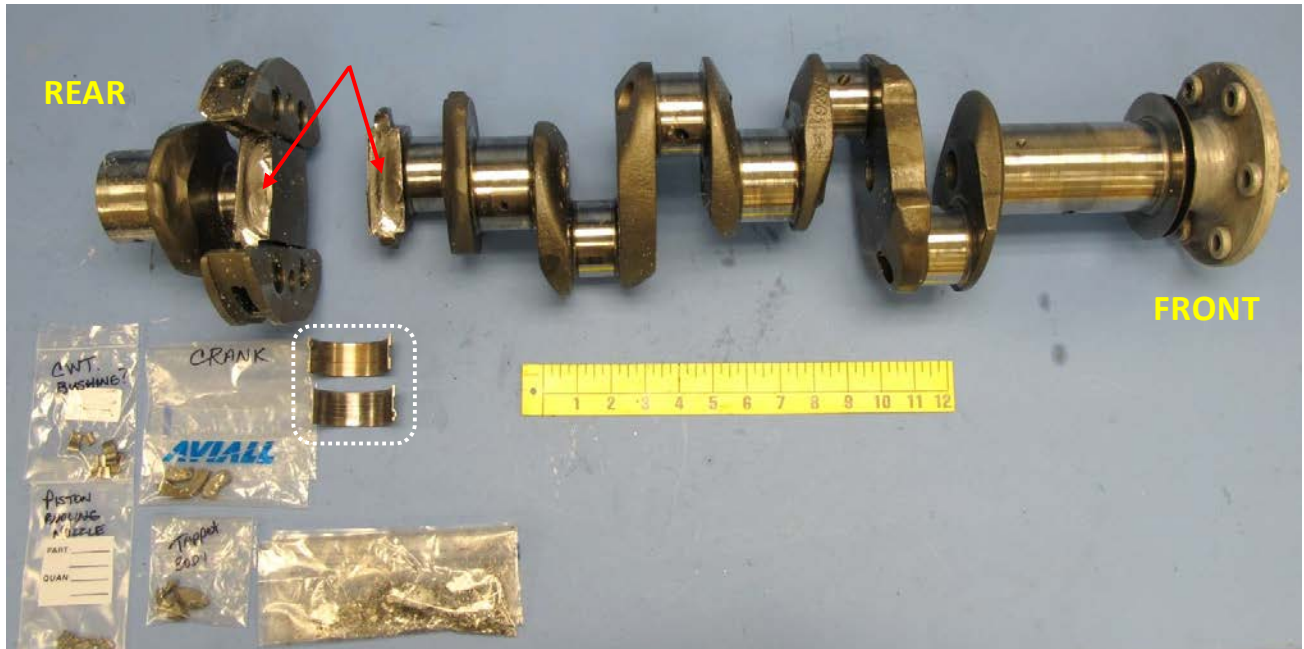
The separation in the submitted crankshaft occurred through the #8 cheek position, which is between the #5 and #6 piston¹, as shown in Figures 1 and 2. The fracture surface of the crankshaft separation is shown in Figure 3. The fracture surface has repeated crack arrest marks consistent with fatigue cracking. The fatigue cracking emanated from the cylinder journal where the #5 connecting rod mates. No gouges or wear was observed at the fatigue cracking initiation area and, as shown in Figure 4, no evidence of thermal distress was visible on the #5 connecting rod journal.

Figure 1: Overall photo of the submitted components. The separation through the crankshaft is indicated by the red arrows. The white dotted line indicates the two halves of the connecting rod journal bearing.

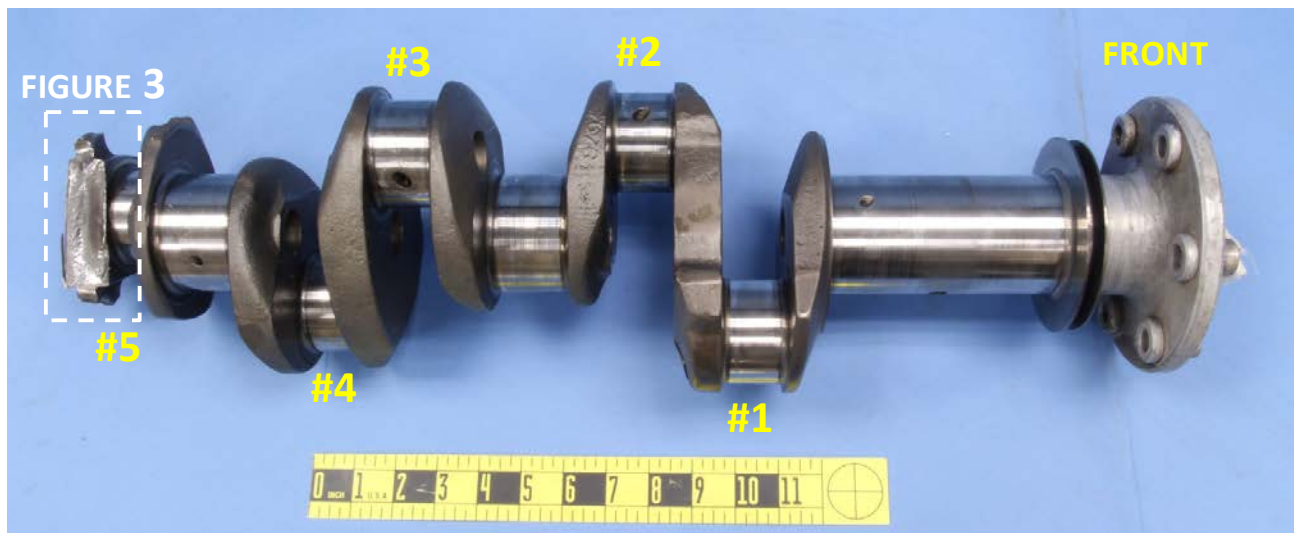
Figure 2: Overall photo of the separated crankshaft with the connecting rod journal numbered. The indicated fracture surface is shown in more detail in Figure 3.

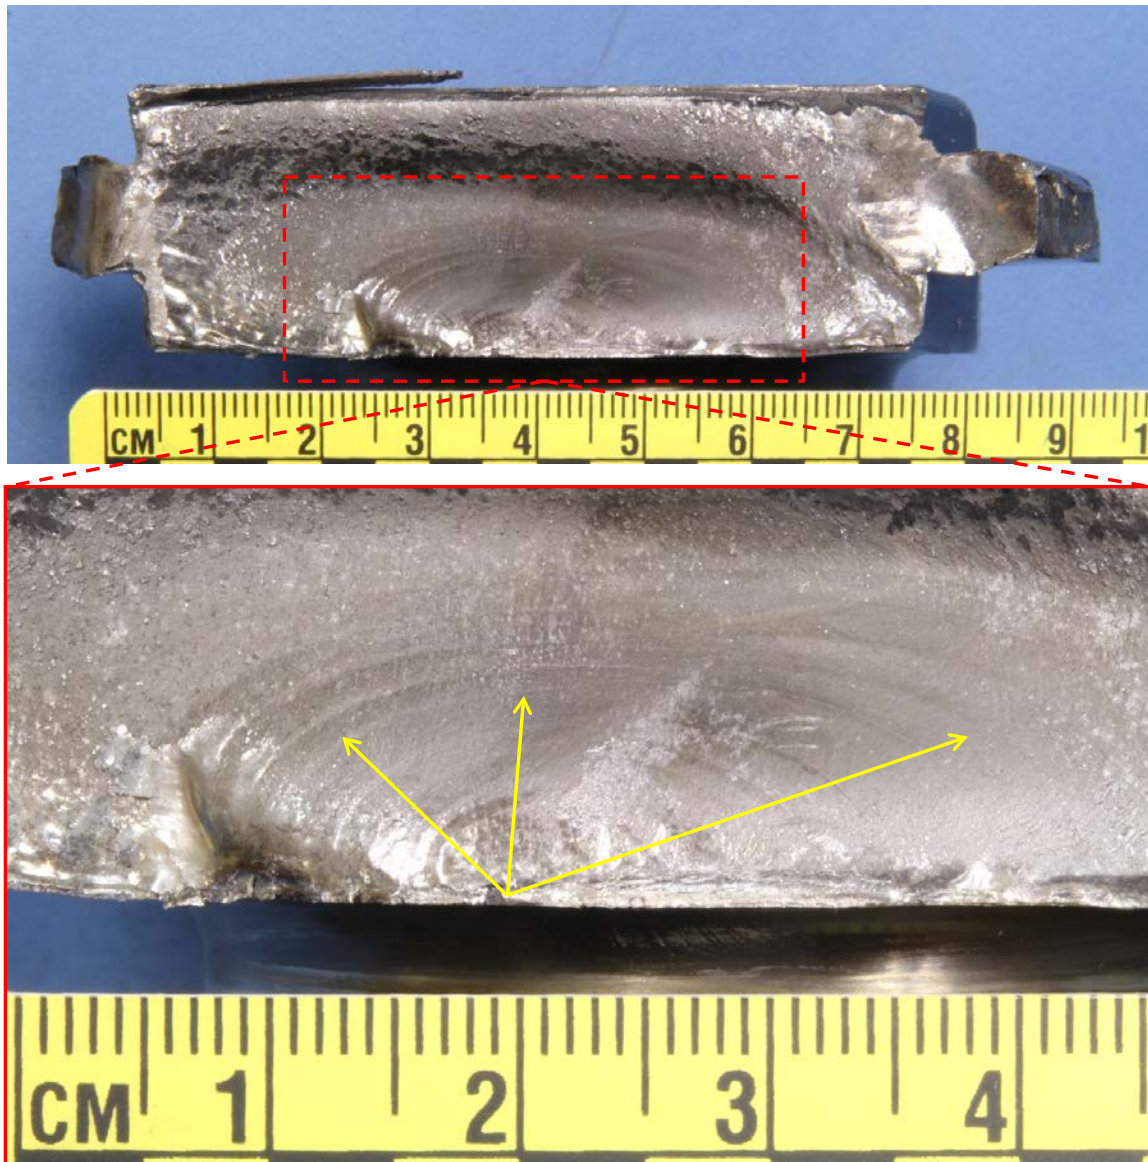
Figure 3: Close-up photos of the fracture surface of the crankshaft separation. The fracture surface had repeated crack arrest marks consistent with fatigue cracking. The fatigue cracking emanated from the connecting rod journal and propagated outward, as indicated by the yellow arrows.

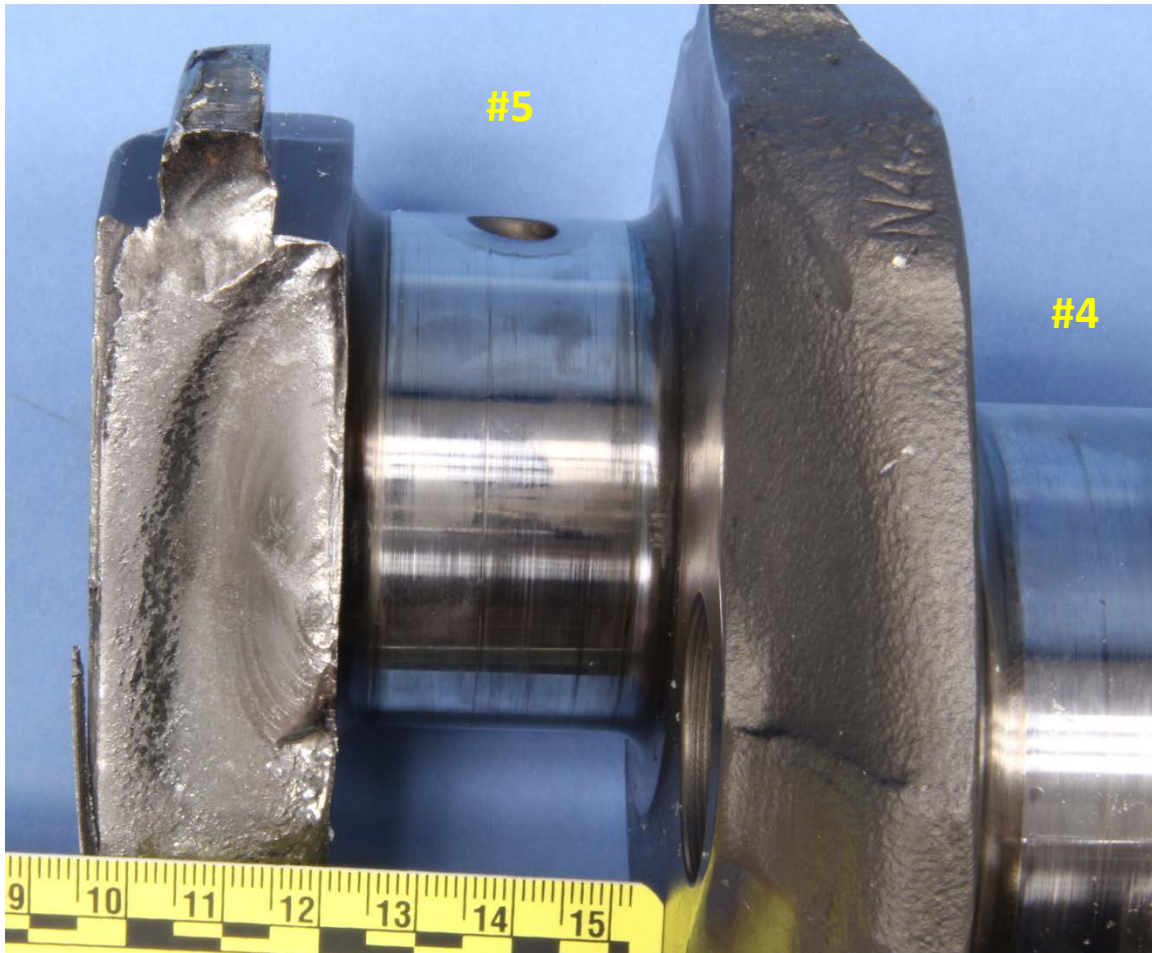
Figure 4: Close-up photo of the #5 connecting rod journal on the crankshaft.

According to a Lycoming representative, the standard diameter of the connecting rod journal has a manufacturer's minimum and maximum diameter of 2.2485 inches and 2.2500 inches, respectively. The serviceable maximum permissible wear of the crankshaft journals, both connecting rod and main bearing journals, is minus 0.0015 inches on the diameter, which would make the minimum serviceable diameter of the connecting rod journal 2.2470 inches. In order for the connecting rod journal to mate properly with a 'M03' coded connecting rod bearing, the journal diameter would have to be polished or ground to 0.003 inches undersize; this means the connecting rod journal would have a minimum and maximum diameter of 2.2455 inches and 2.2470 inches, respectively, and including the allowable wear of 0.0015 inches means the minimum serviceable diameter of the connecting rod journal would be 2.2440 inches. The measured diameter of the #5 connecting rod journal met the specifications for a journal ground to 0.003 inches undersize.

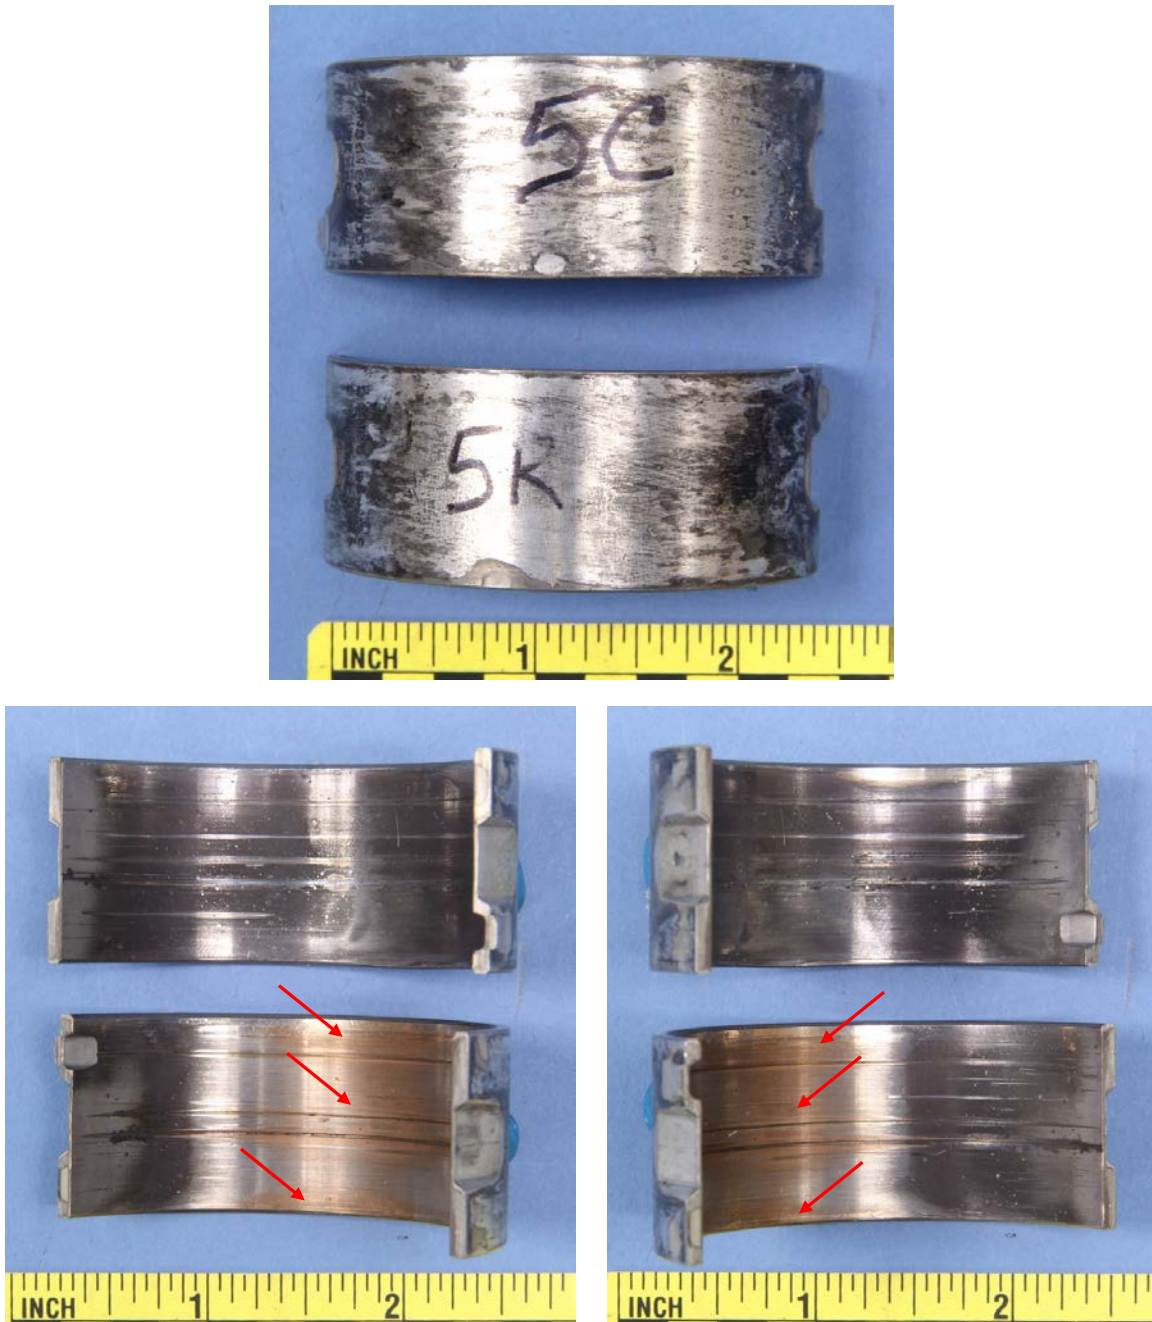
Labelling on the connecting rod bearing indicated it was in the #5 position on the crankshaft. The bearing halves were also identified as being installed in the cap or rod position on the connecting rod. Wear was observed on the inner diameter (ID) of the bearing halves. The wear was heavier on the rod half of the connecting rod bearing, where the Babbitt metal appeared to be worn through. Images of the wear on the ID of the #5 connecting rod bearing are shown in Figure 5. A 'M03' code, circled by red dots in Figure 6, was stamped on the sides of the connecting rod bearing halves, and indicates the connecting rod bearing is oversize to accommodate a mating crankshaft journal that has been ground/machined or reworked.

Figure 5: Overall photos of the connecting rod bearing. The red arrows point to areas on the ID of one bearing half where the Babbitt metal was worn through.

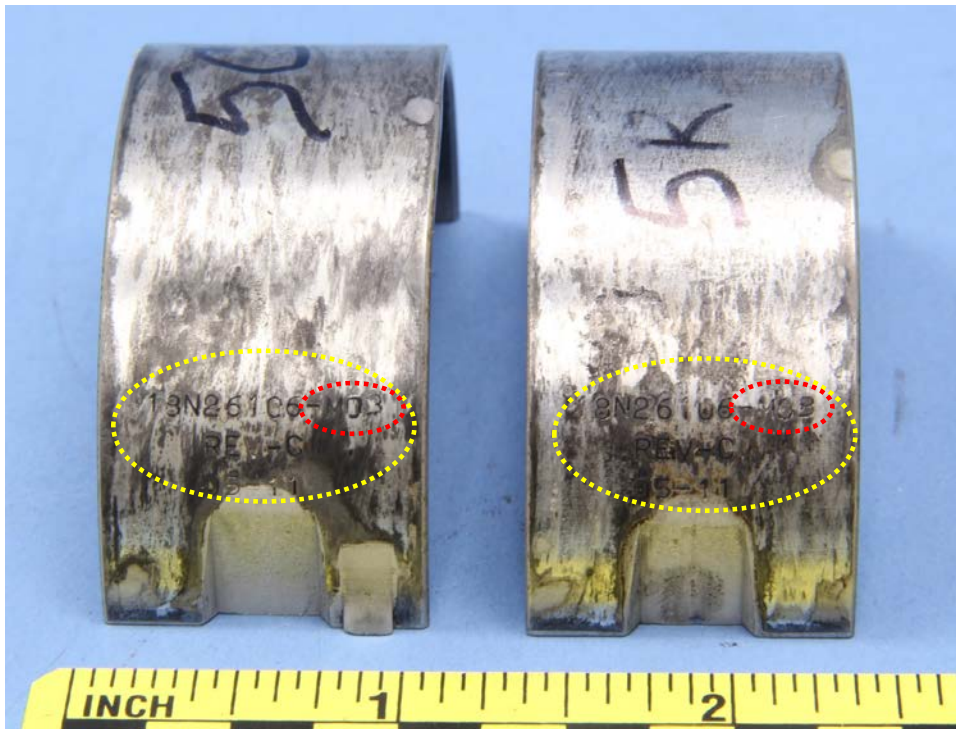
Figure 6: Close-up photo of the part markings (yellow dotted circles) and the 'M03' code (red dotted circles) on the sides of the connecting rod bearing.

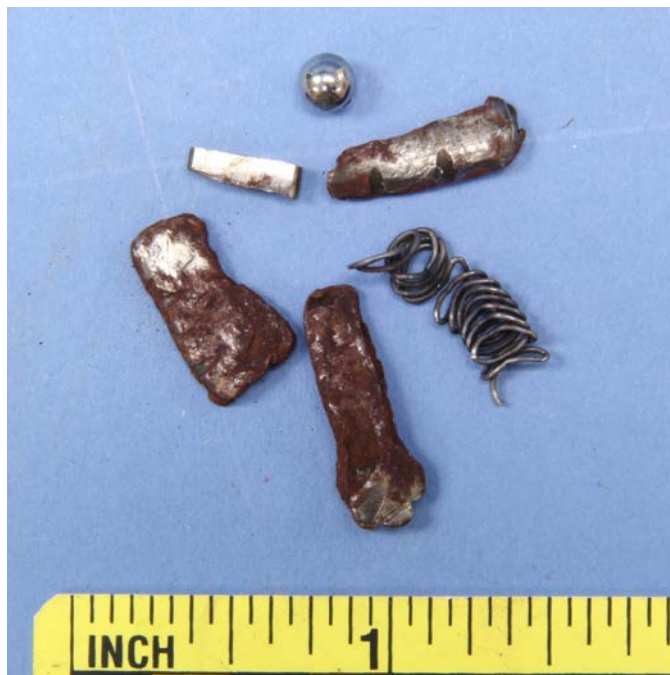
Figure 7: Overall photo of the cooling nozzle pieces.

The fracture surfaces on the remaining bagged components all had extensive impact damage. The features visible on the fracture surfaces were consistent with overstress. The pieces in the bag labeled "crank" were determined to be from the crankshaft counterweight pin boss. As shown in Figure 7, the pieces of the cooling nozzle found in the bottom of the sump did not have evidence of thermal distress.
