NATIONAL TRANSPORTATION SAFETY BOARD

MATERIALS LABORATORY FACTUAL REPORT

Report No. 19-022

Place : Firestone, Colorado
Date : April 17, 2017
Vehicle : Pipeline
NTSB No. : DCA17FP005
Investigator : Chuck Koval (RPH-20)

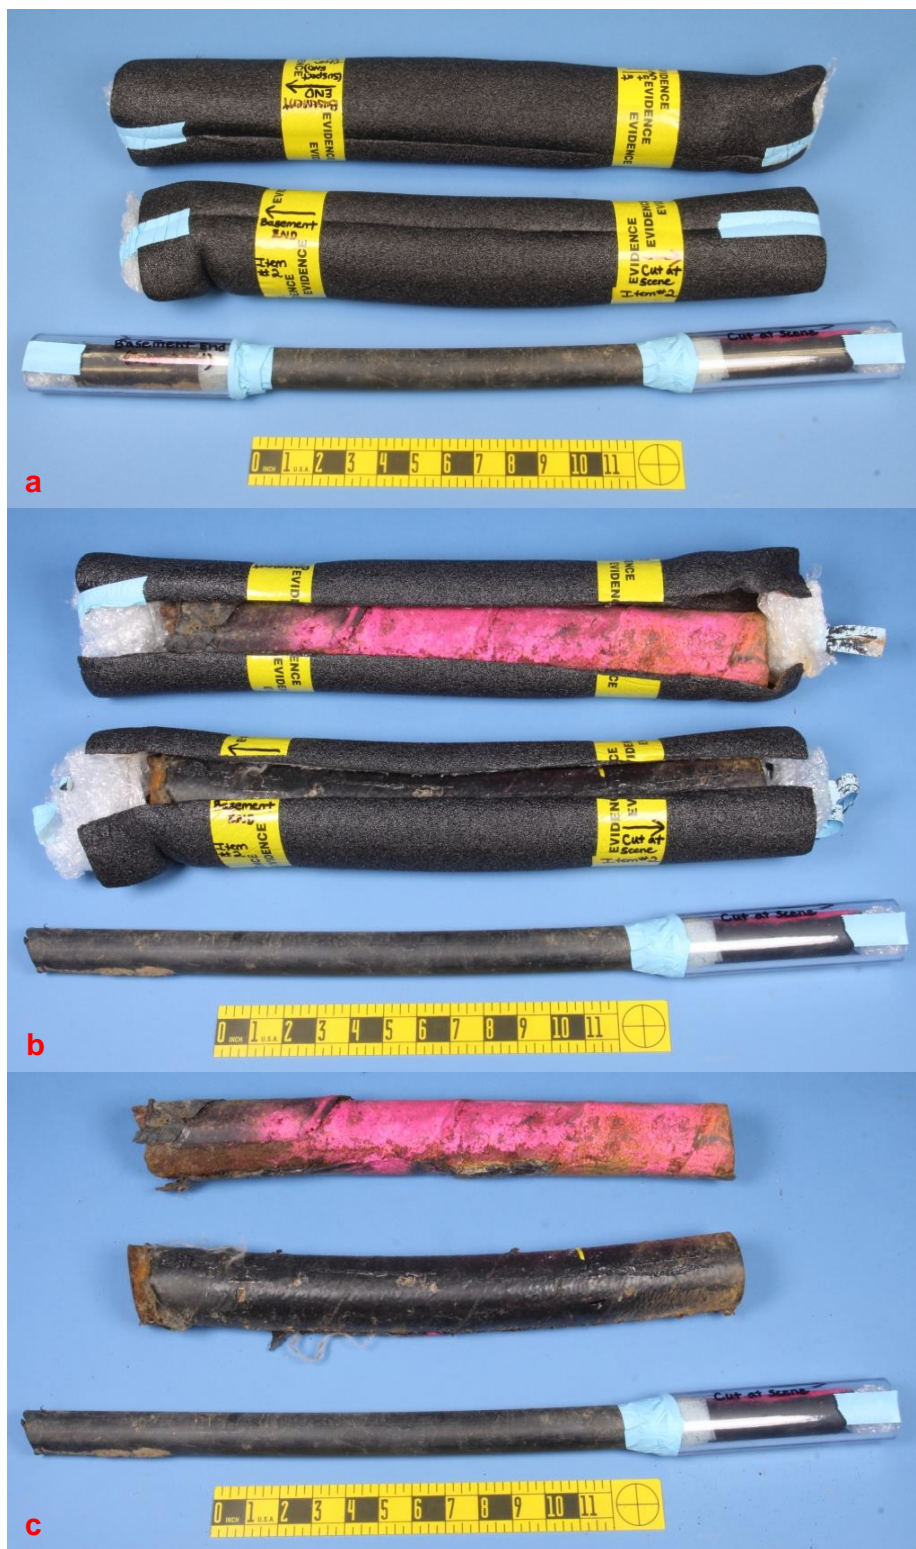
Three pieces of pipe are shown in figure 1 in various stages of unwrap. Both 2-inch steel pipe pieces were packed solid with a soil-clay material from one end of the pipe to the other. The focus of this examination is the black plastic 1-inch pipe piece shown in the bottom of each of the images in figure 1. All pipe pieces in figure 1 are arranged so the basement foundation ends are toward the left and the cut-at-site ends are toward the right. Figure 2 is of the cut-at-site end of the 1-inch black plastic pipe showing deep grooves along with tear and cut-off burrs. Presence of the grooves and burrs are consistent with using a hacksaw, a reciprocating saw, or some other power blade tool to cut this side of pipe.

Figure 1) As-received photos of the three pipes in various stages of enwrapment. The 1-inch black plastic pipe piece is at the bottom of each image. The cut-ends-of-interest (Basement End) are all positioned facing left.

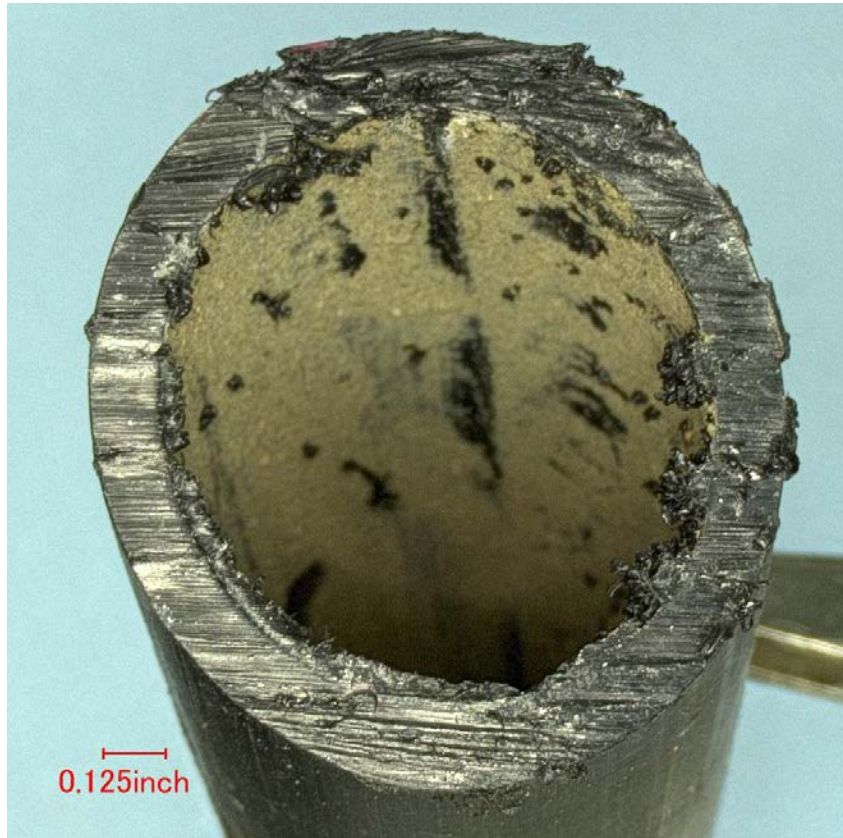
Figure 2) Image of cut-at-site end of the 1-inch black plastic pipe piece.

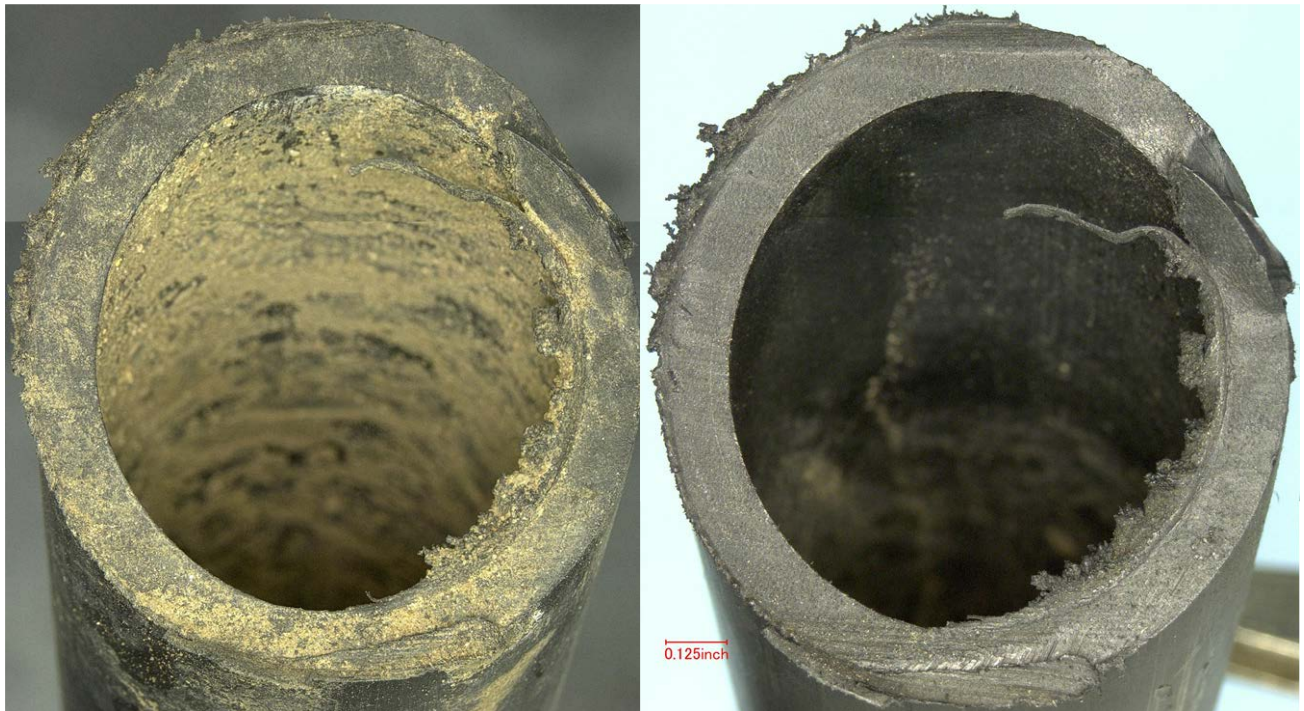
Figure 3 shows the basement foundation cut-end of the 1-inch black plastic pipe comparing the cut surface prior to and after cleaning with a non-ionic detergent and water solution. Figures 4 and 5 are representative closer views showing the cut surface of the basement foundation cut-end plastic pipe piece. In figure 3b, the cut surface shows tear and cut-off burrs on one side of the pipe located partially around the inside diameter while on the opposite side, the burrs are on the outside diameter. Much of the cut surface is relatively smooth and without deep grooves or gouges. The smooth cut surface is consistent with being cut using a blade-like plastic pipe cutting tool, either a manual type or ratcheting action type. It appears from the shallow grooves (figure 4 top) and tears (figure 5 bottom) that the tool did not cut through the pipe on its first attempt. The images in figure 6 are oblique side views of the cut basement end of the black plastic pipe piece.

Figure 3) Basement foundation cut-end (region-of-interest). View (a) is before cleaning. View (b) is after cleaning.

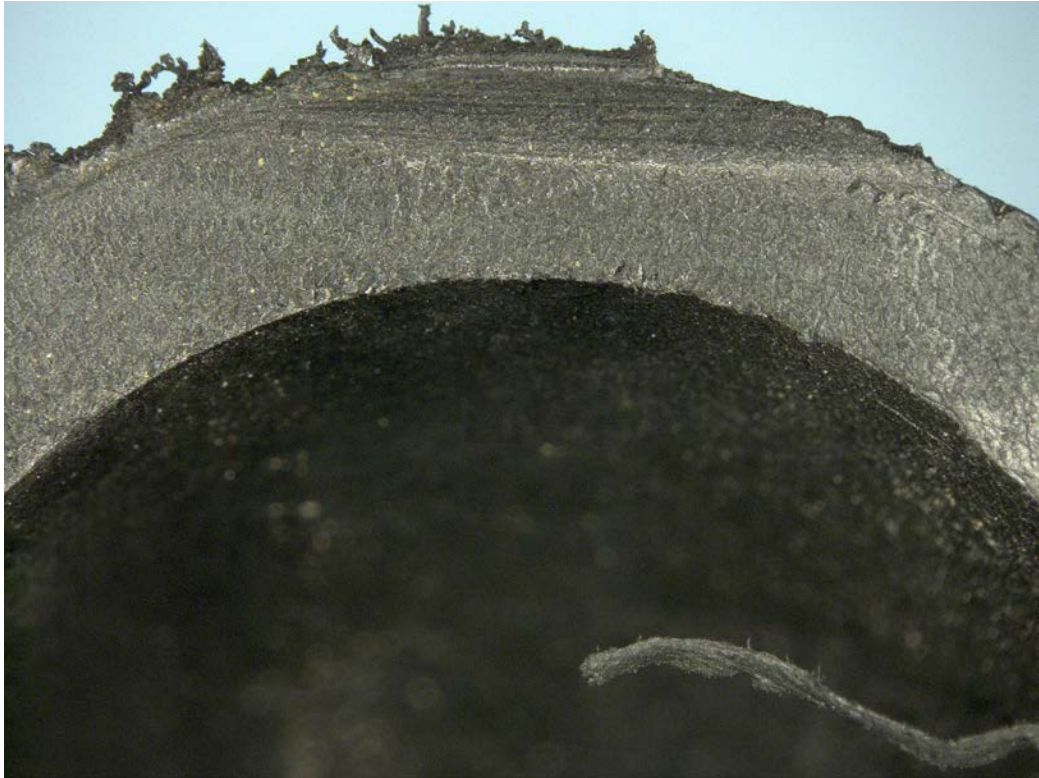
Figure 4) Closer view (20X) of the cut surface showing the top area in figure 3b.

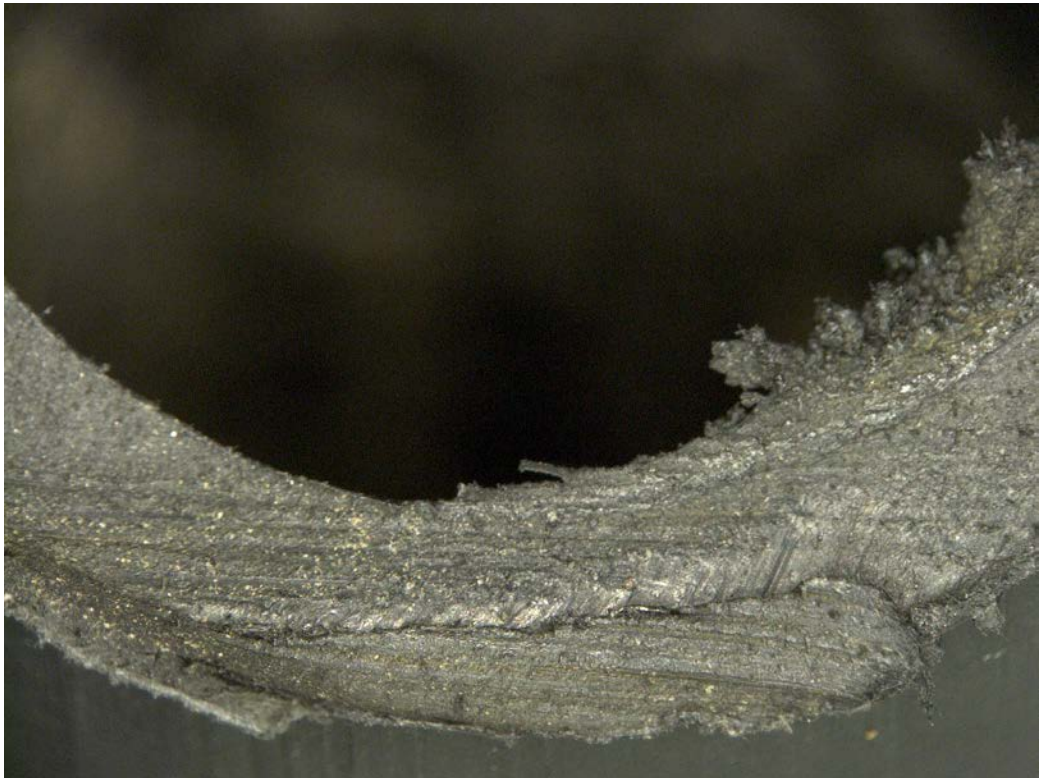
Figure 5) Closer view (20X) of the cut surface showing the bottom area figure 3b.

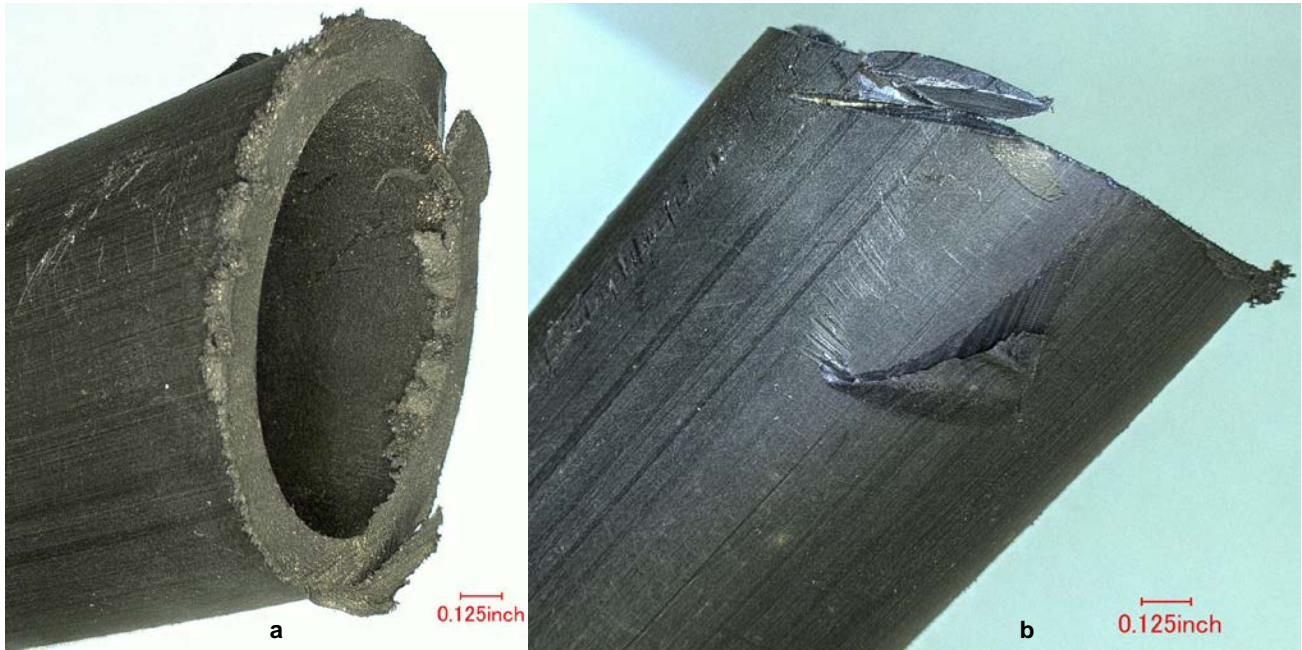
Figure 6) Oblique side views of the cut basement end of the black plastic pipe piece.
