# NATIONAL TRANSPORTATION SAFETY BOARD

MATERIALS LABORATORY FACTUAL REPORT

Report No. 16-088

Place : Texarkana, Arkansas  
Date : May 23, 2016  
Vehicle : Cessna 501, N804ST  
NTSB No. : CEN16LA197  
Investigator : Mitchell Gallo, AS-CEN

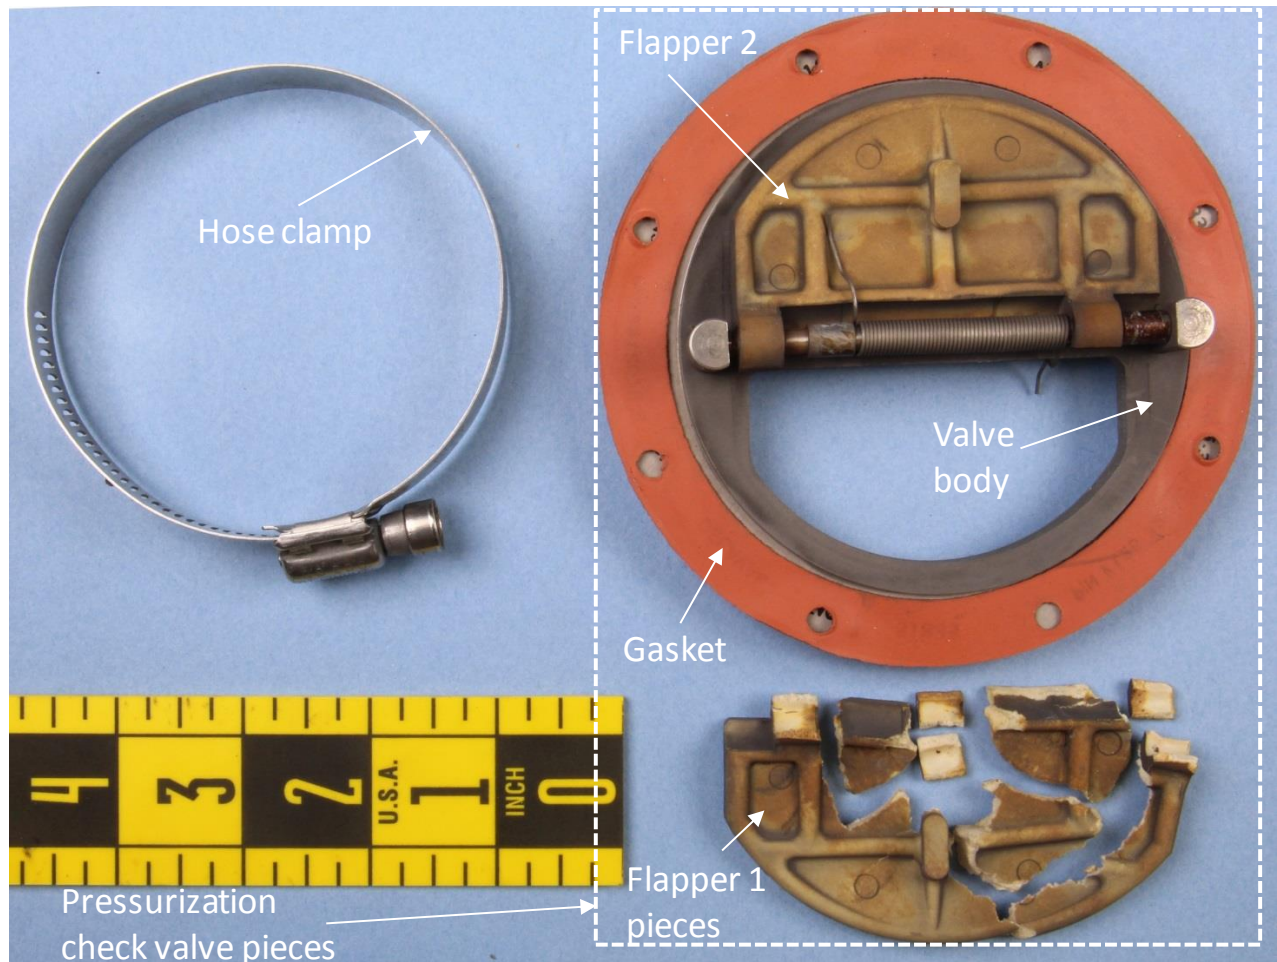
Figure 1 shows the as-received pieces of a pressurization check valve and a hose clamp. As indicated in Figure 1, the check valve has two flappers, arbitrarily numbered 1 and 2 for the purposes of identification in this report. Flapper 1 was fractured into numerous pieces and not all pieces were recovered or submitted.

Figure 1 As-received pieces of the pressurization check valve and an hose clamp. The flappers are consistent with being molded from natural-colored polymeric resin, however, the surfaces are discolored and appear dark grey-brown.

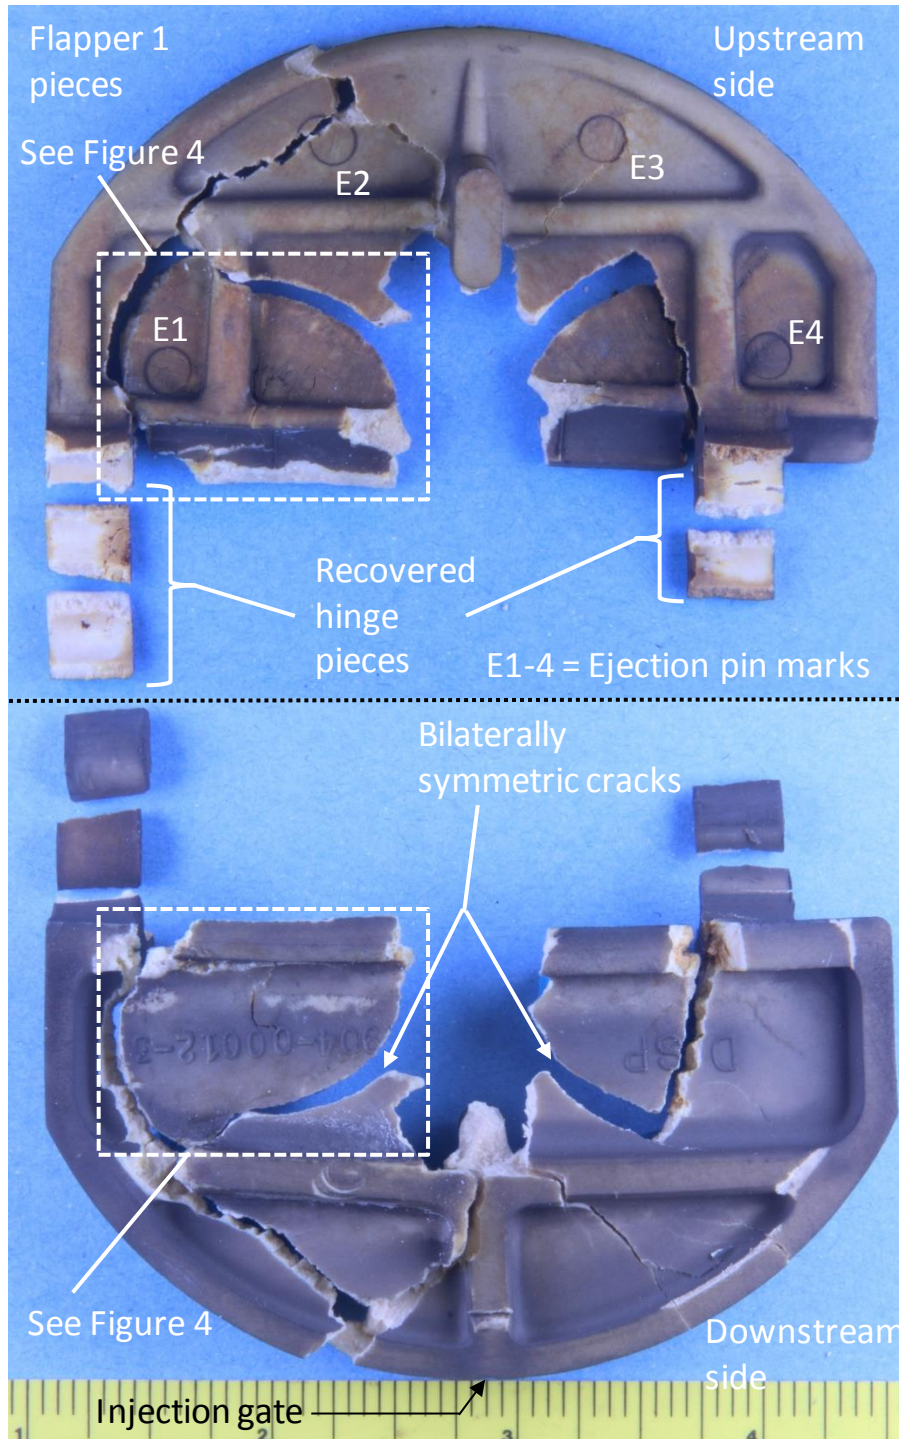
The submitted pieces from flapper 1 are shown in Figure 2, with the pieces arranged in their approximate position on the part. Based on Fourier-transform infrared spectroscopy and fractographic analysis, the flappers are fabricated from glass-filled polybutylene terephthalate (PBT). Based on the presence of an injection gate and ejection pin marks, the flappers are fabricated by injection molding (See Figure 2). Flapper 1 had the following number molded onto the downstream side surface: DSP 904-0012-3 and did not exhibit any other identifying marks such as a date code or mold cavity number.

Figure 2 Pieces from flapper 1, arranged to reconstruct the original flapper shape. Some portions of the flapper were not recovered after the accident.

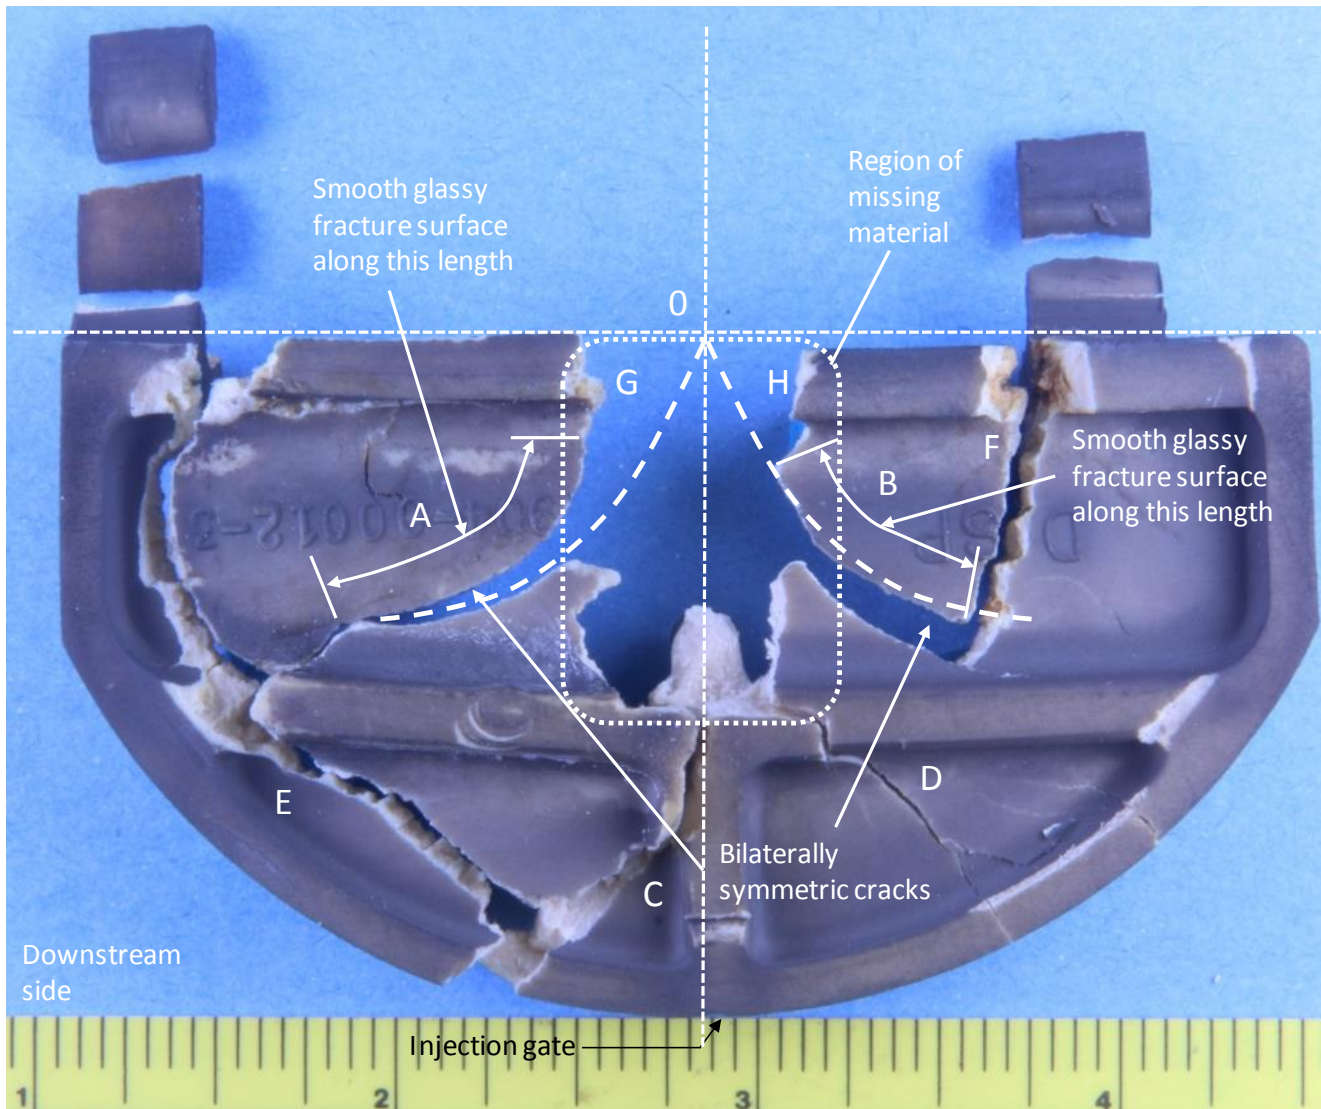
For identification purposes, individual cracks within flapper 1 were arbitrarily identified by letters A through H. Flapper 1 exhibited radially-oriented cracks originating within the identified region in Figure 3 (Cracks A, B, C, D, G, H). Two of the primary cracks (Cracks A and B) were nearly bilaterally symmetric in shape consistent with possible flow patterns and knitting in the part from the mold filling process. In all instances, the cracks initiated on the downstream side and propagated through the thickness towards the upstream side—driven primarily by bending stresses on the flapper. As indicated in Figure 3, some portions of the flapper were not recovered after the accident.

Figure 3 View of the downstream side of flapper 1 with annotations to identify the individual cracks and well as the areas of missing material.

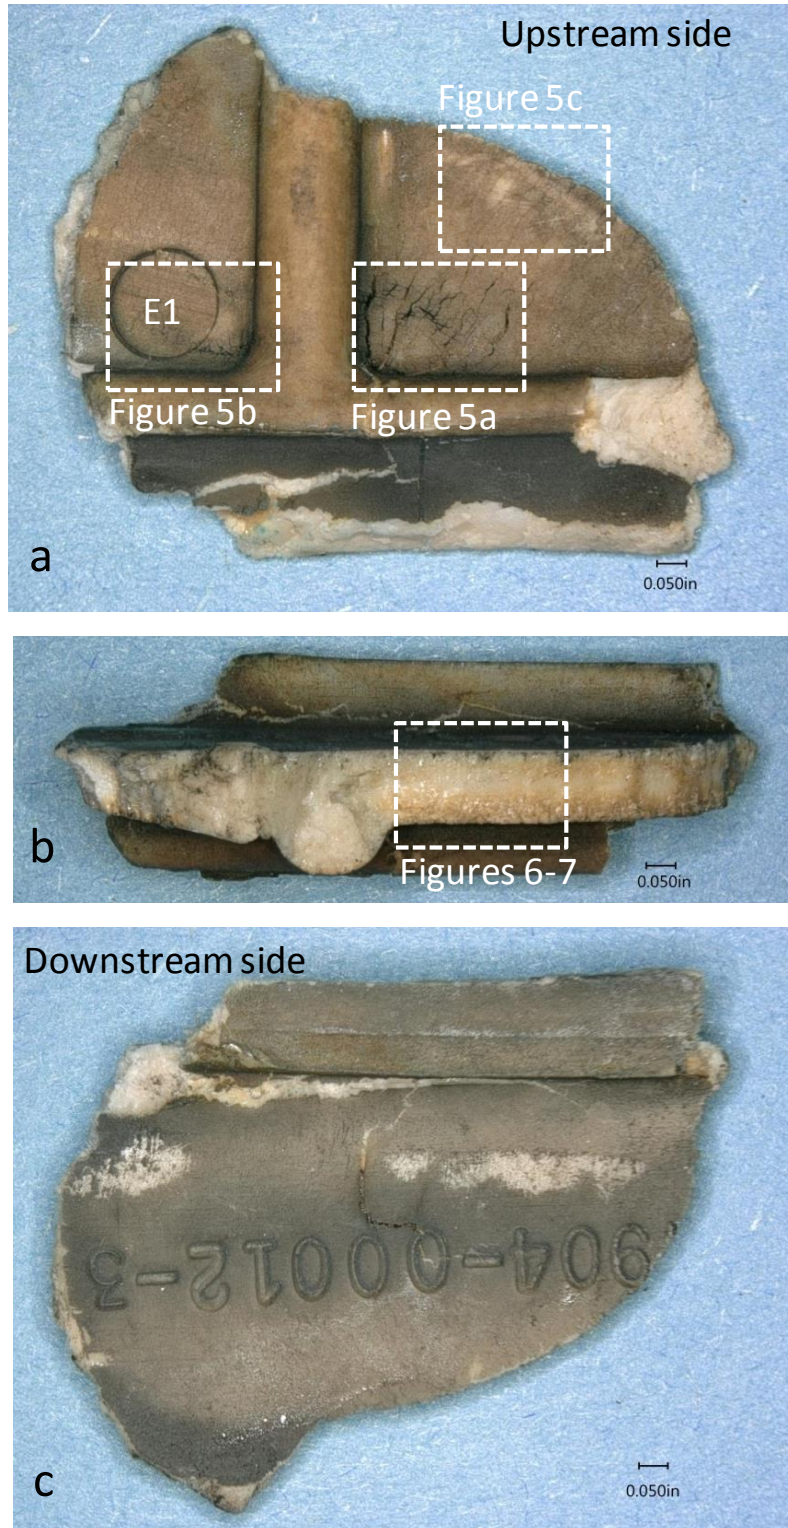
Figure 4 Closer views of an individual piece of flapper 1. See Figure 2 for the location of this piece.

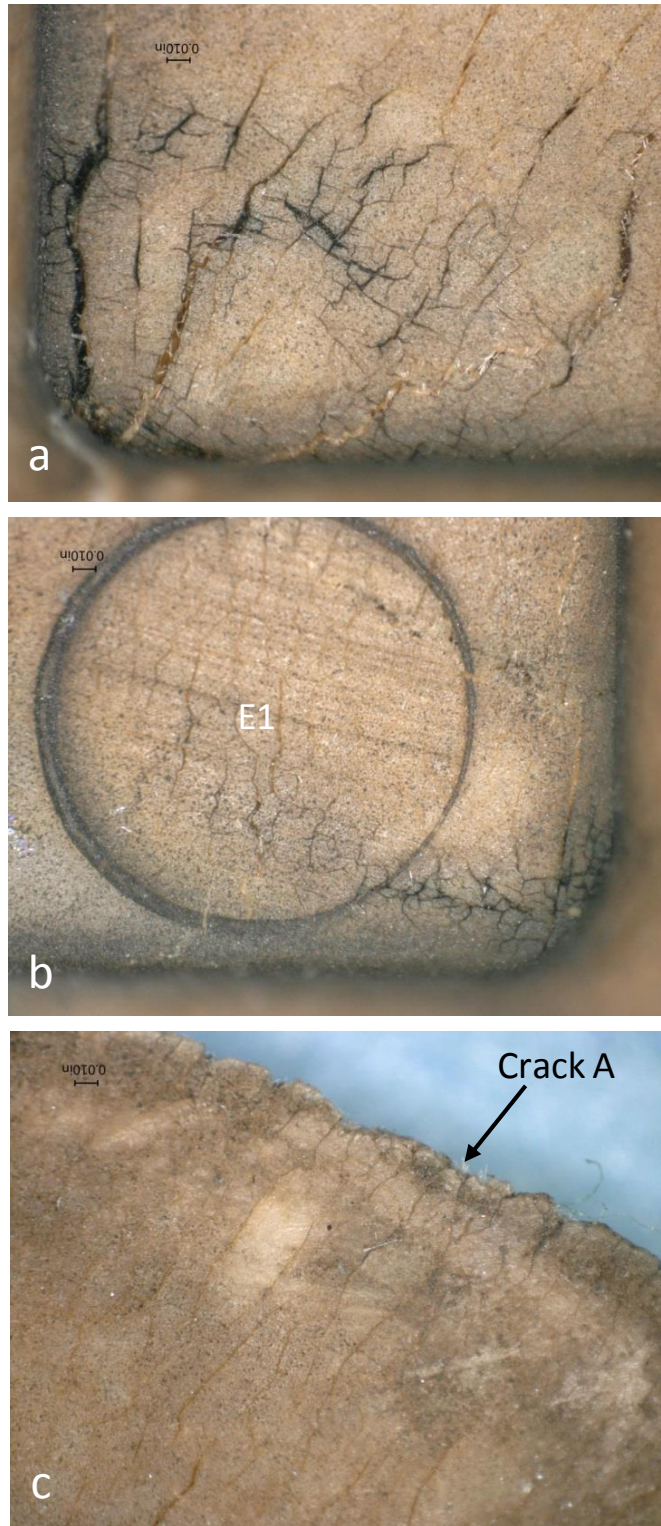
As identified in Figure 2, one fragment from flapper 1 was selected for deeper examination as shown in Figures 4 and 5. Figure 5 shows close views of the downstream surface and the presence of networks of fine cracks (also known as surface checks, surface crazing, or craze cracks). In Figure 5c a fine network of cracks are present adjacent to the main fracture surface. Figure 6 shows an oblique top-down view of the fracture surface of Crack A (see Figures 3, 4, and 5). The fracture surface of the polymeric resin phase was smooth and glassy with hackle marks indicative of through-thickness crack propagation from the downstream side to the upstream side. The fracture surface exhibited yellow discoloration in areas along its length indicating that portions of Crack A were pre-existing. Scanning electron microscope examination of Crack A as shown in Figure 7 revealed a fine network of secondary cracks along the main fracture. Similar observations were made for Crack B.

Figure 5 Digital microscope images of the downstream side surface of the piece shown in Figure 4. In all images, fine network cracks are observed.

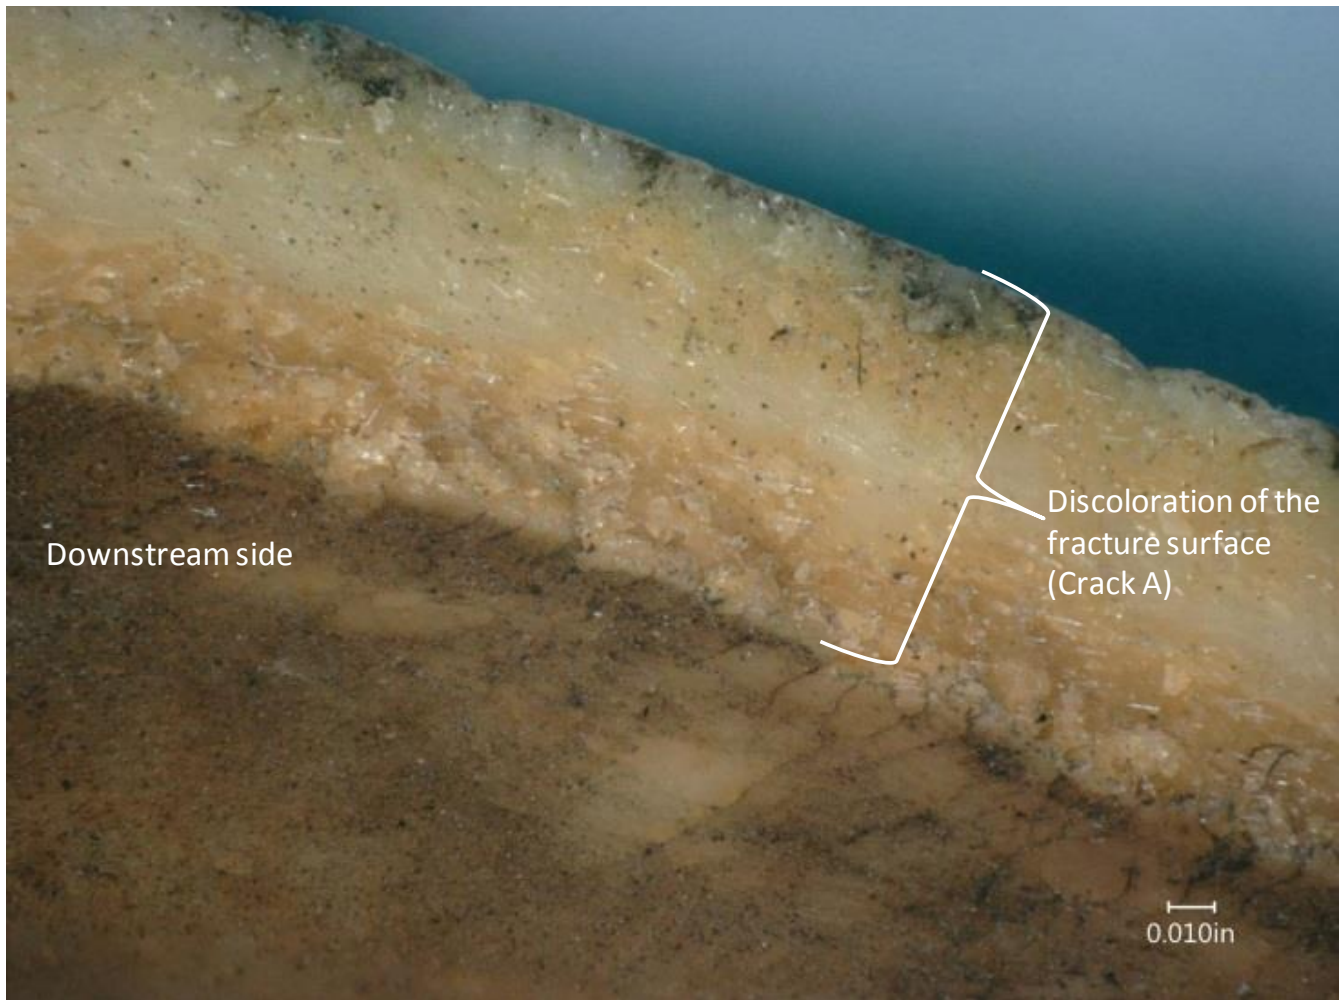
Figure 6 Digital microscope image of the fracture surface identified as Crack A in Figure 3. Fine network cracks are noted adjacent to the main crack on the downstream side. Also yellow discoloration on the fracture surface is indicative of a preexisting crack.

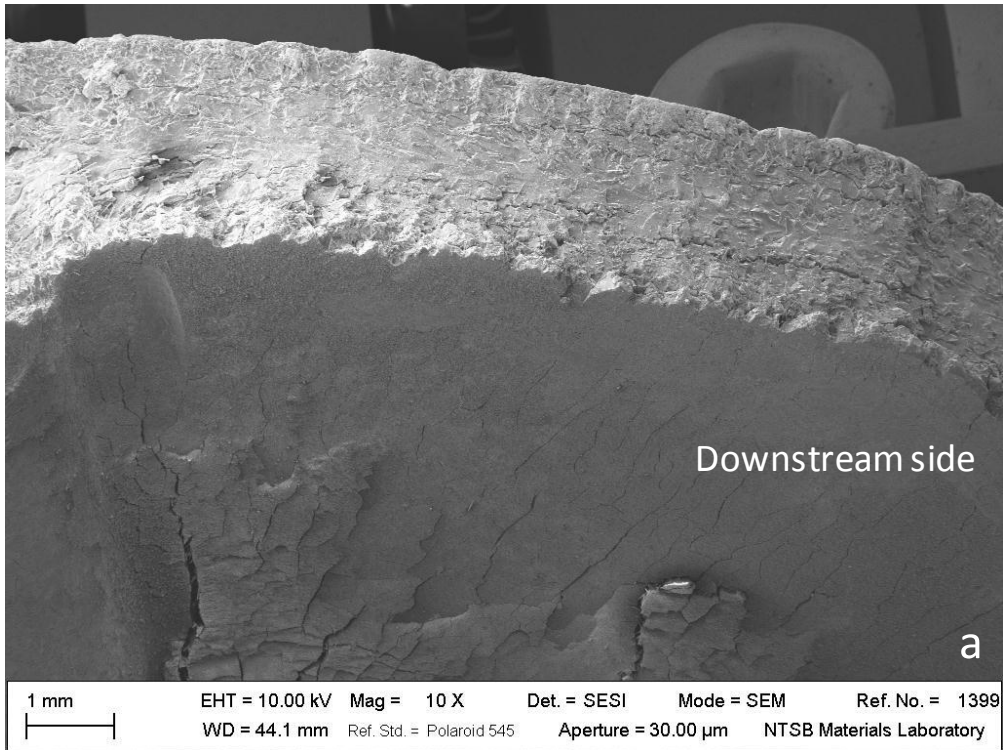
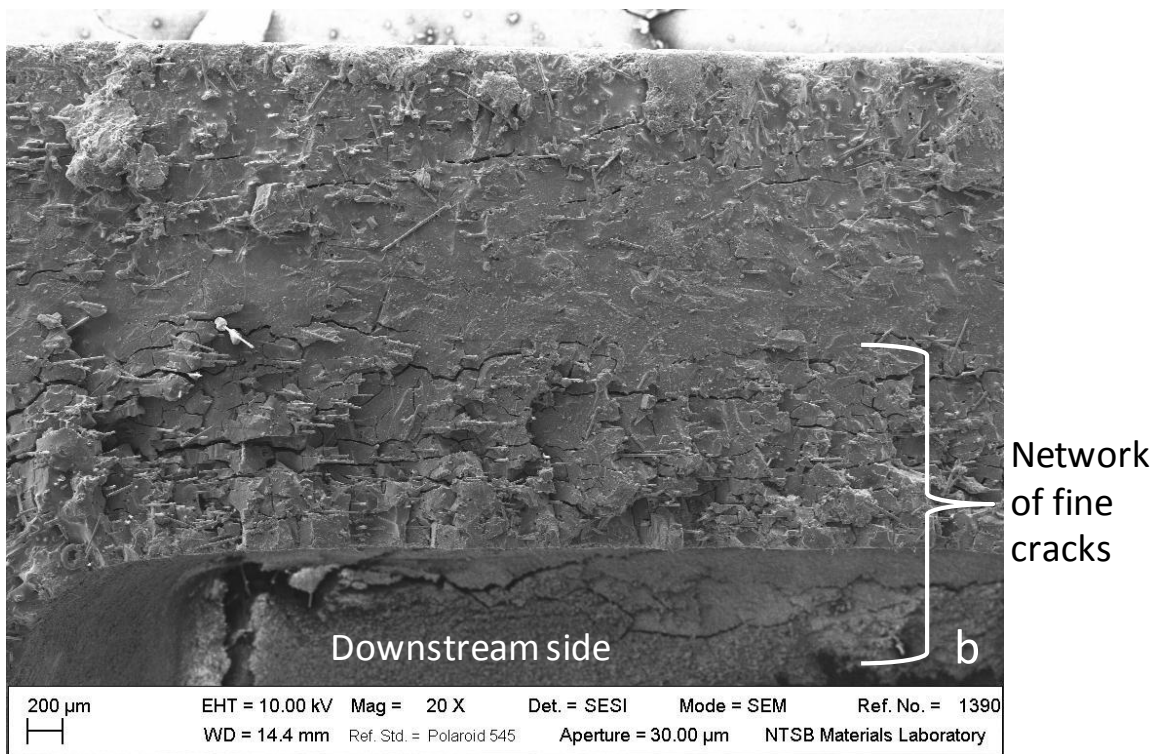
Figure 7 Scanning electron micrographs of the fracture surface identified as Crack A in Figure 3. Fine network cracks are identified in view b.

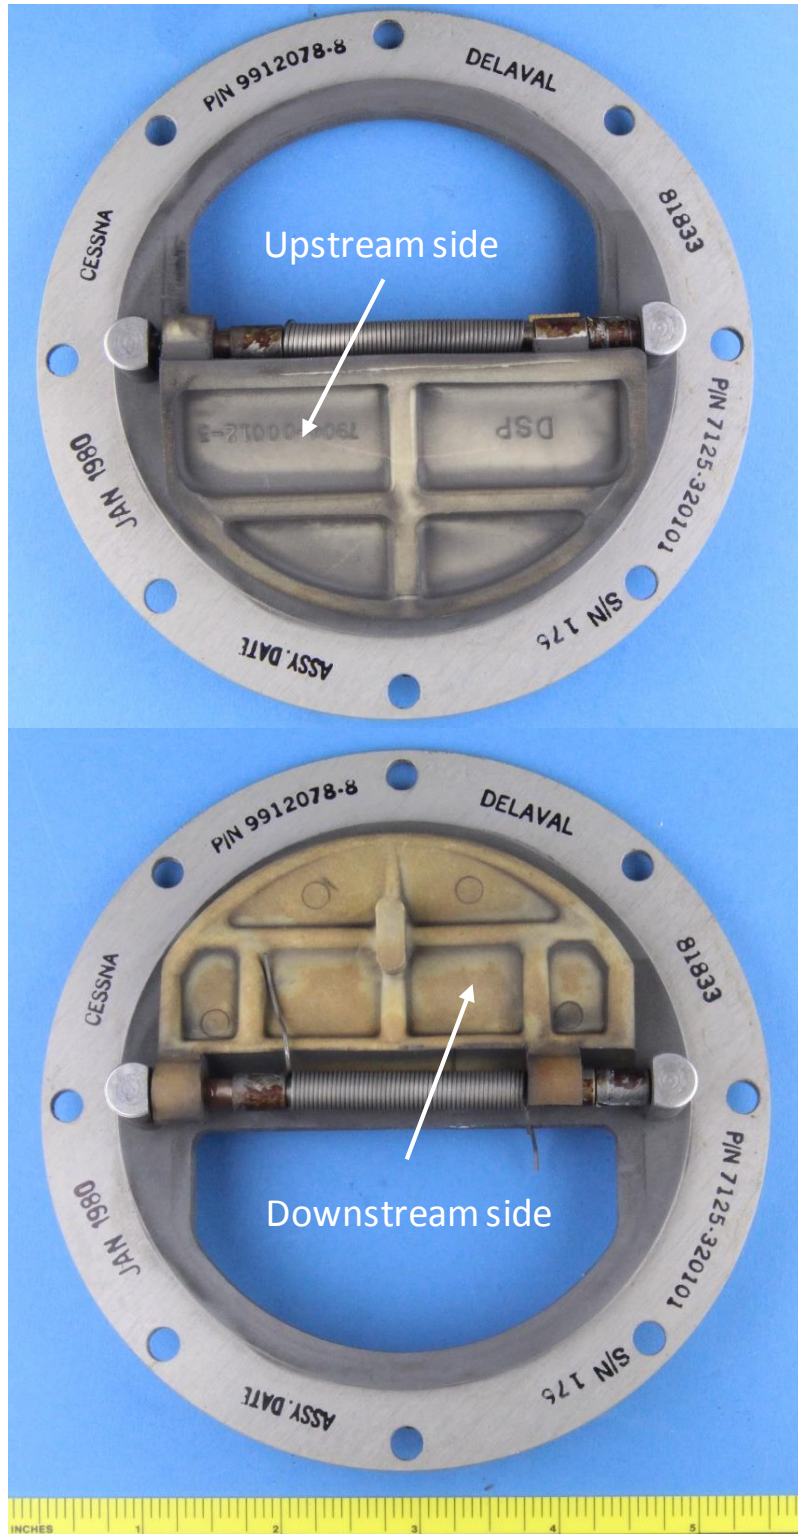
Views of the check valve housing and flapper 2 are shown in Figure 8. Manufacturer markings are clearly indicated on the upstream side of the housing. Flapper 2 had the following number molded onto the downstream side surface: DSP 904-0012-3 and did not exhibit any other identifying marks such as a date code or mold cavity number. Flapper 2 exhibited a primary crack on the downstream side as indicated in Figure 9. A portion of one hinge was also missing as indicated in the figure. Closer views of the hinge with missing material are shown in Figure 10. Stereo-zoom microscopic evaluation indicated that a portion of one of the hinges fractured due to the development of a crack that initiated at the inner surface and propagated to the external surface. One of the fractures exhibited yellow discoloring, consistent with progressive crack development with time (slow crack growth).

Figure 8 Images of the pressurization check valve body and flapper 2.

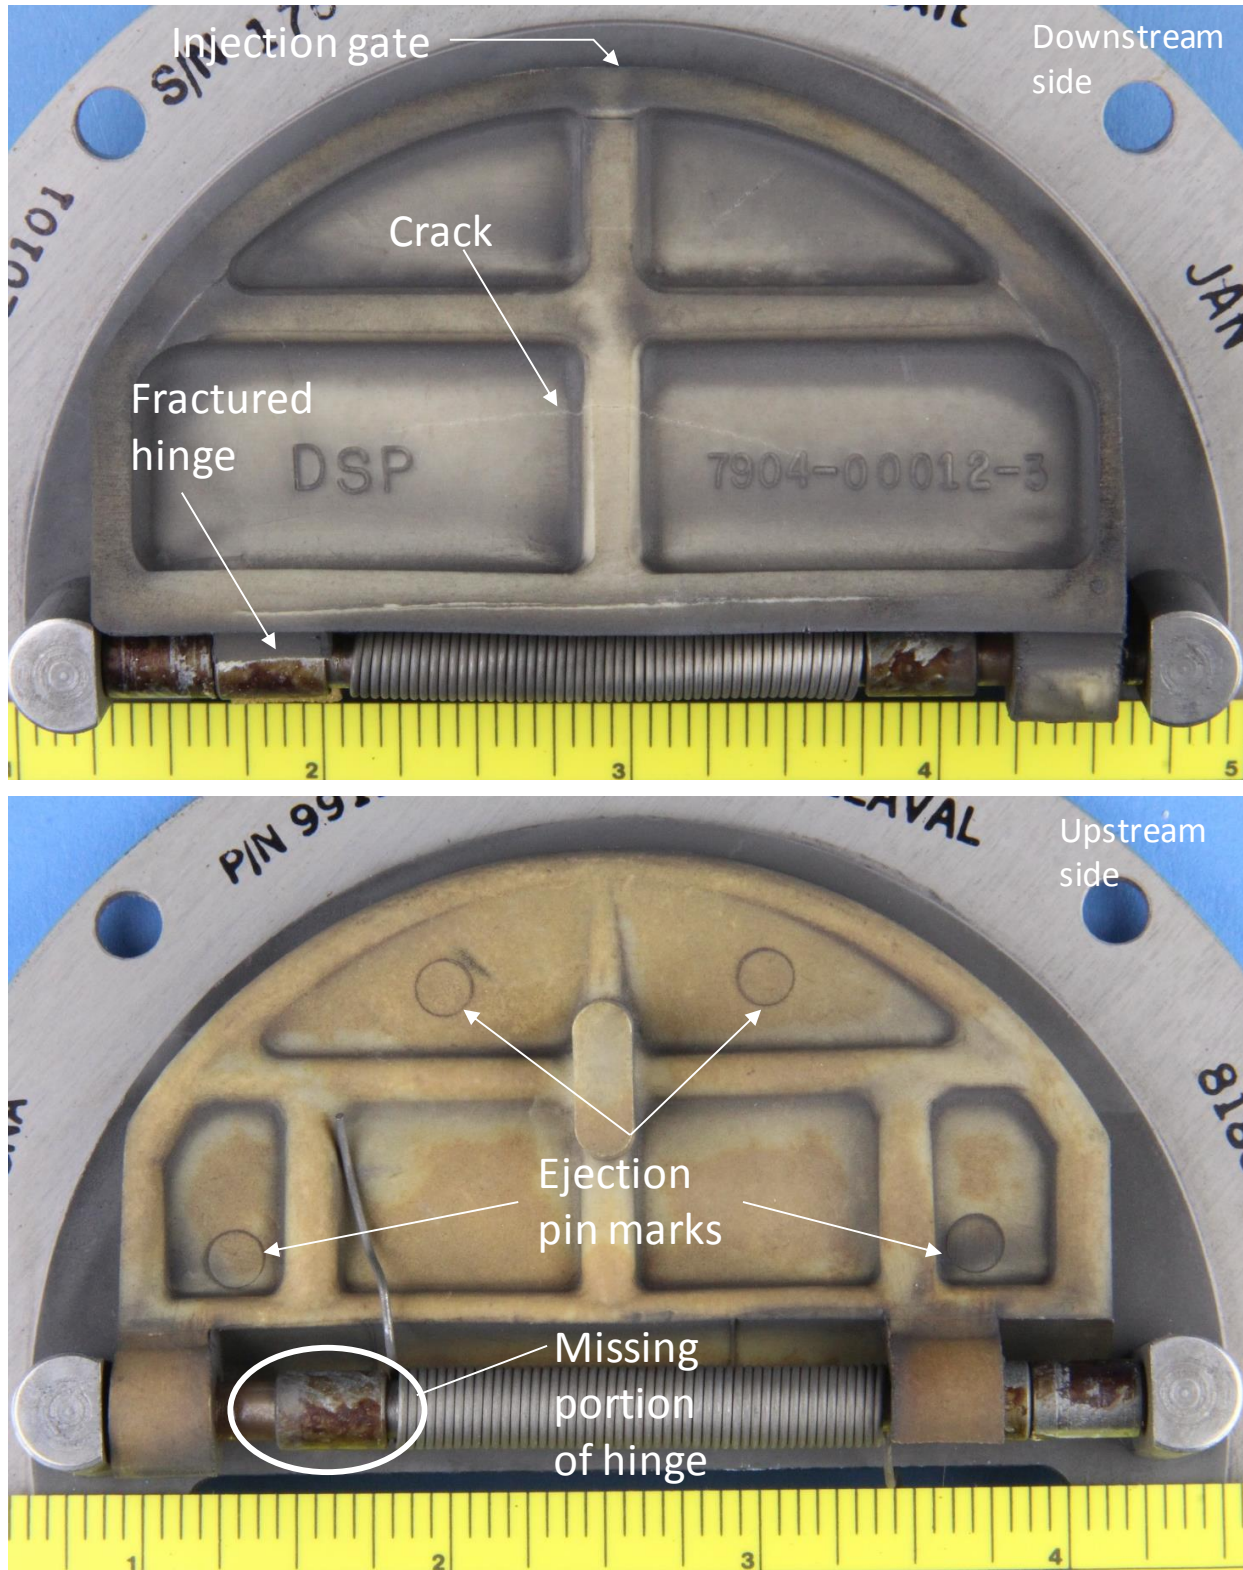
Figure 9 Views of the upstream and downstream faces of flapper 2.

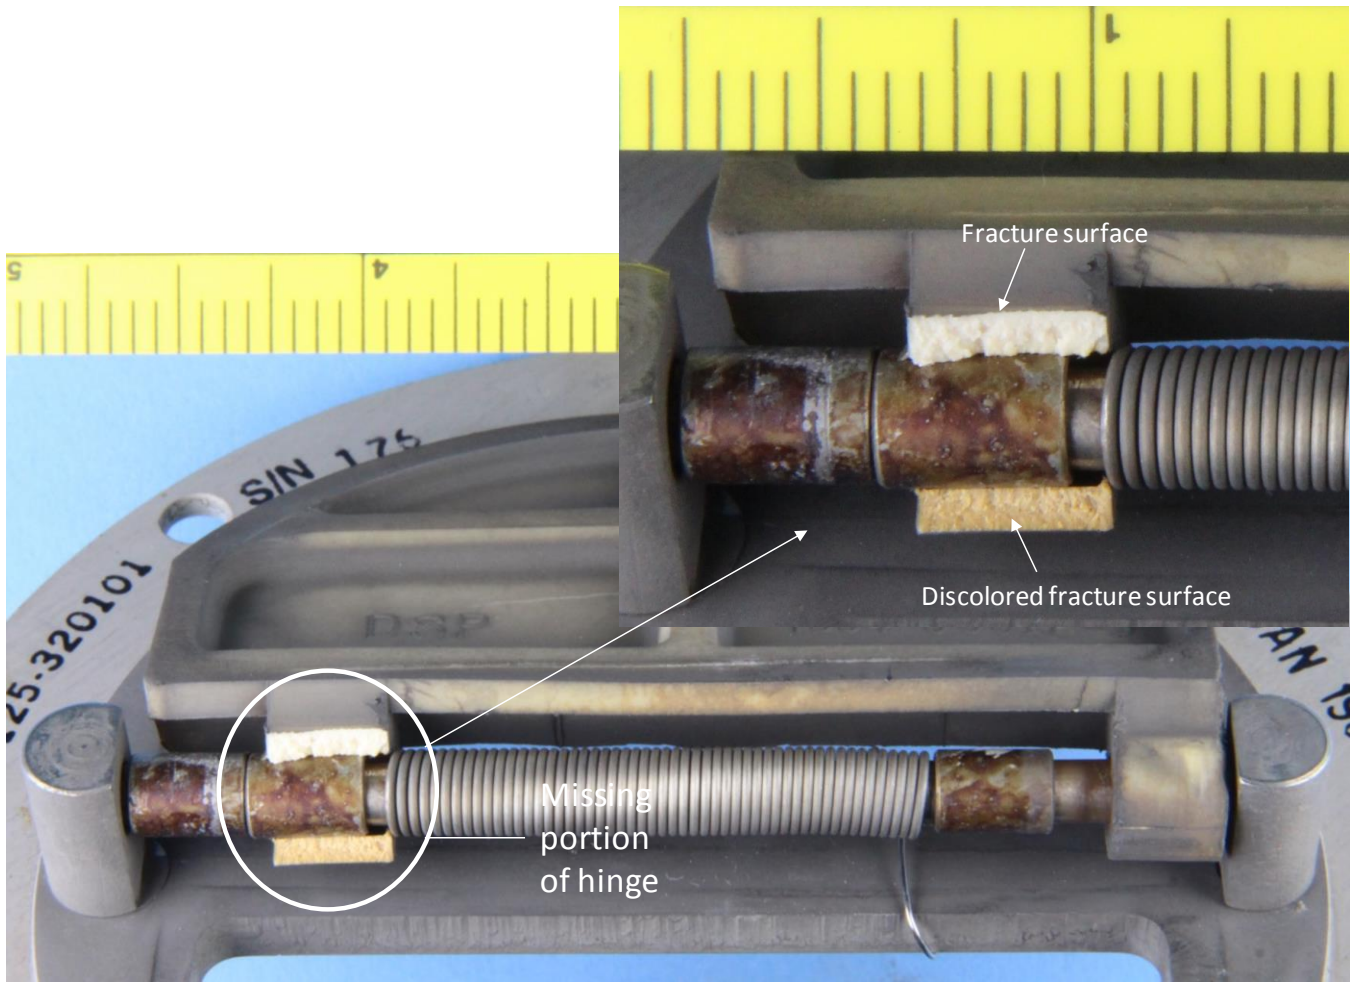
Figure 10 Closer views of the fractured hinge on flapper 2.

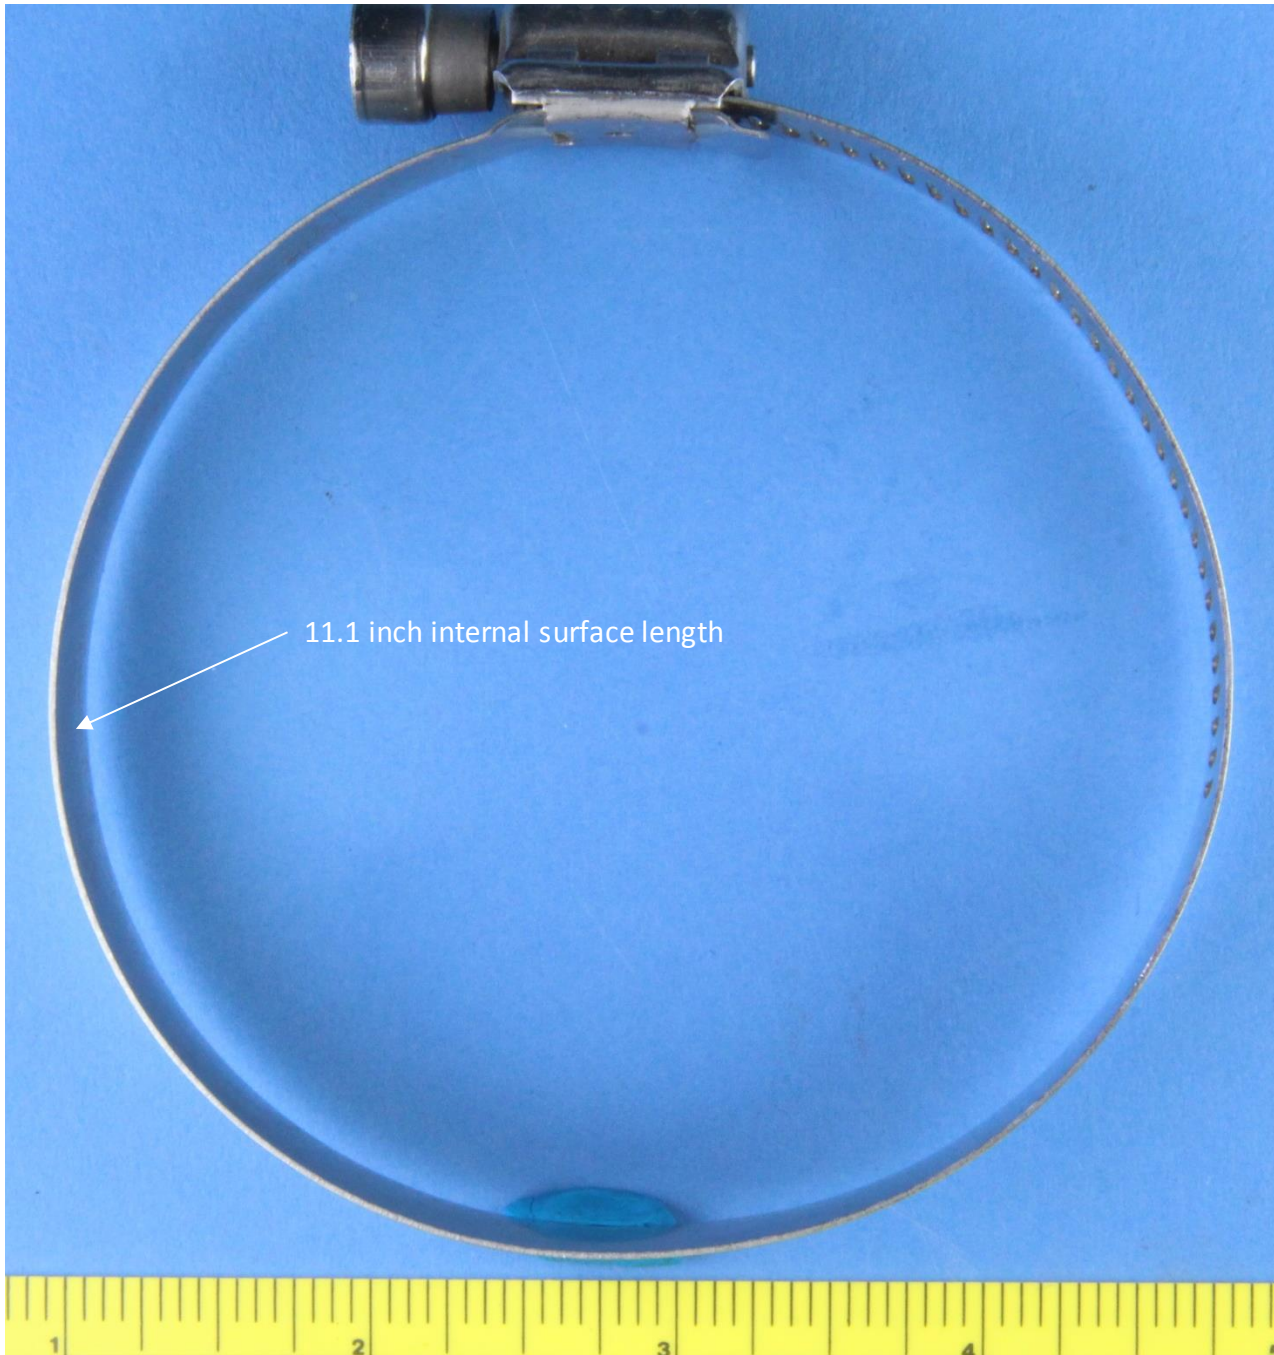
The inside surface length of the hose clamp is about 11.1 inch and corresponds to an approximately 3.5 inch diameter. The hose clamp design is consistent with a worm gear style with a safety collared screw and perforated band manufactured by C. McGunnigle Co. Inc. Kenilworth, NJ, under the Breeze Aero Seal ® trademark. The clamp is consistent with an SAE J1508 Type F size 48 (2 9/16 to 3 1/2 diameter size range).

Figure 11 Overall view of the submitted hose clamp.

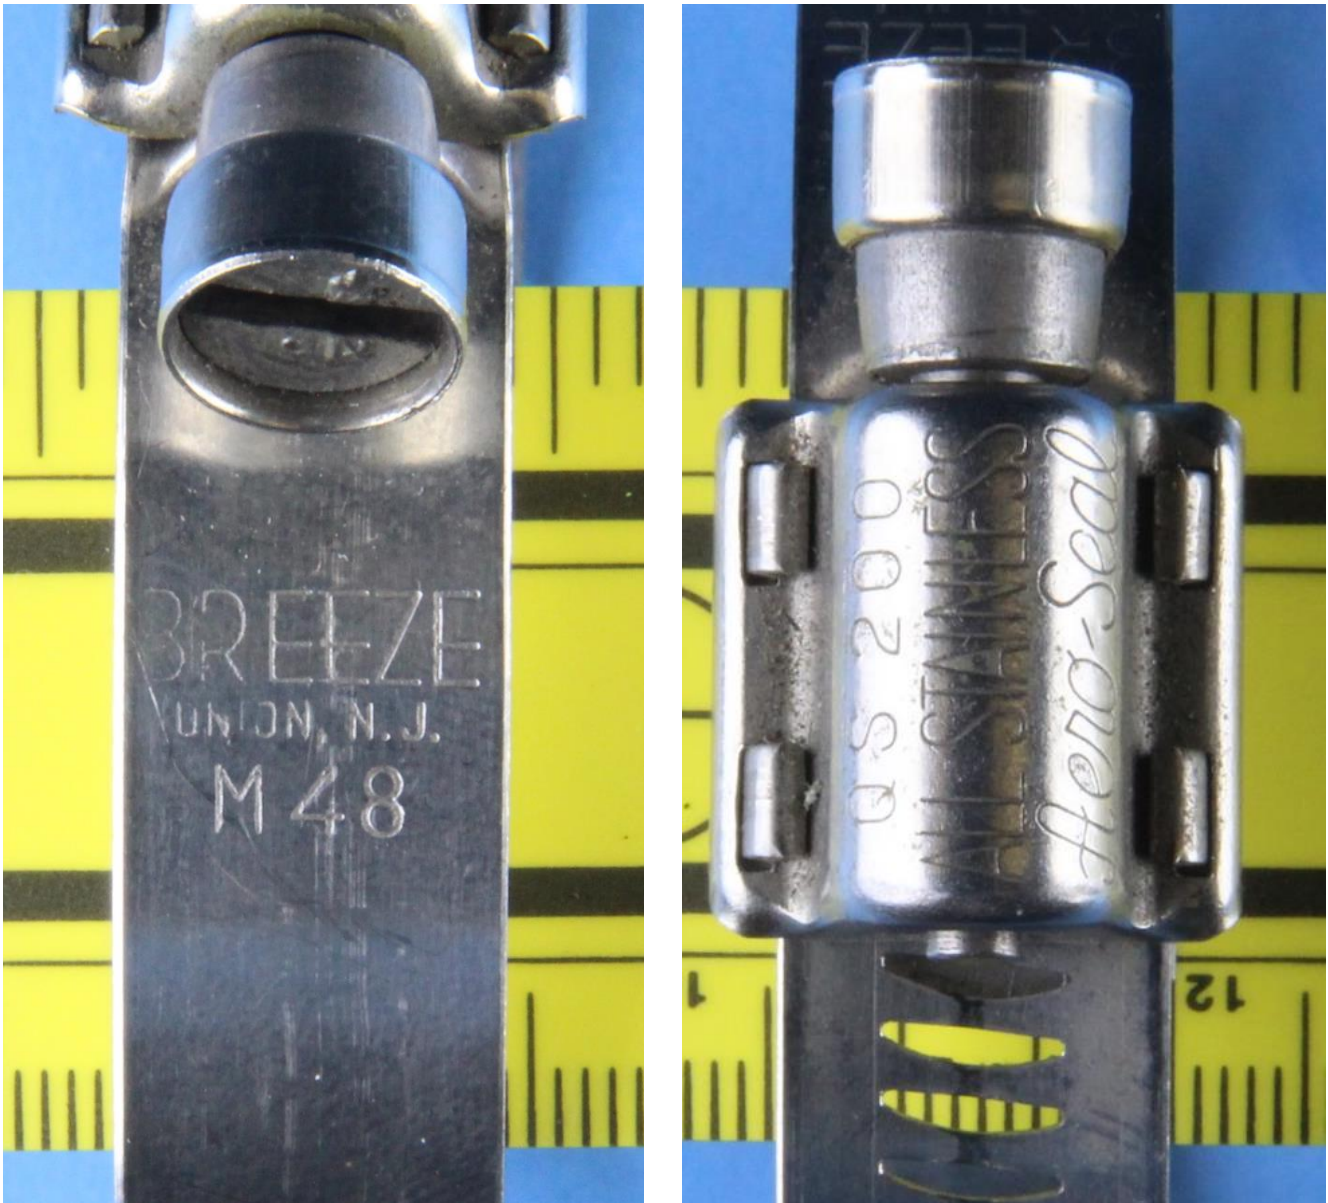
BREEZE  
UNION, N.J.  
M48

Q.S. 200  
ALL STAINLESS  
Aero-Seal

Figure 12 Views of the manufacturer's marks on the hose clamp.
