NATIONAL TRANSPORTATION SAFETY BOARD

MATERIALS LABORATORY FACTUAL REPORTReport No. 15-043

Place : Washington, DC
Date : January 12, 2015 3:15 p.m. eastern standard time
Vehicle : WMATA train #302
NTSB No. : DCA15FR004
Investigator : Robert Gordon

Portions of the four traction power jumper cable assemblies removed from the WMATA electrical arcing accident location near the bottom of fan shaft FL1.

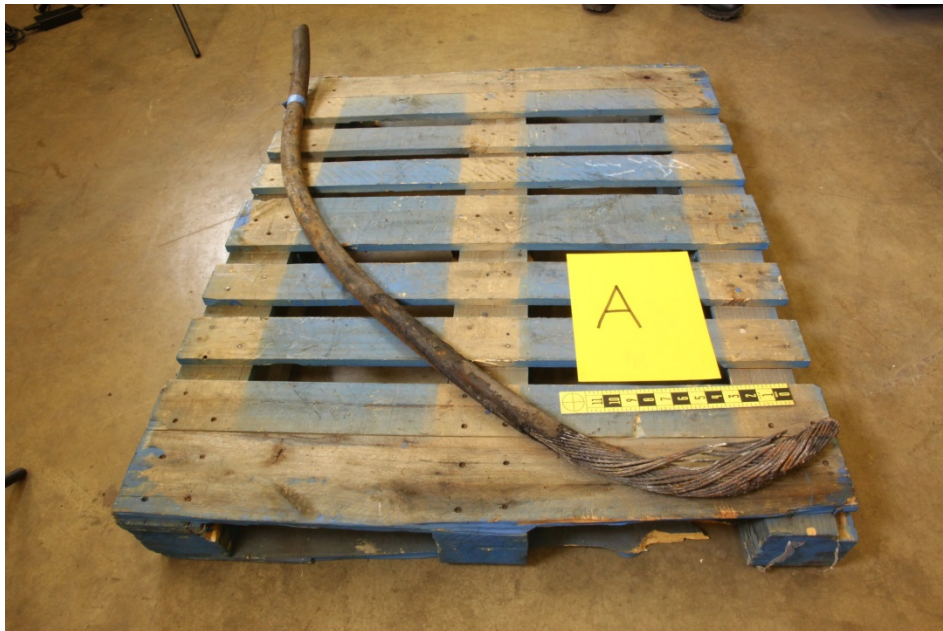
The recovered portion of the North end pig tail cable A was approximately 69 inches long (figure 3). The cable end that would have been welded to the 3rd rail was cut for removal. The cable end that would have had a lug and been bolted to the lug on the power feed cable was electrically damaged exhibiting fused and beaded strands. There was a sharp demarcation between the fused and beaded strands and the non-fused strands. The lug was missing from this cable and about 19 inches of the cable was missing insulation. There were about 14 inches of charred insulation leading up to the portion of the cable missing insulation. The undamaged portion of the insulation was covered with an orange or rust colored deposit¹. A sample of insulation was removed from this cable approximately 24 inches from what would have been the welded end of the pig tail cable. The conductor underneath the removed portion of insulation appeared clean with no evidence of corrosion (figure 4).

Figure 3 North end pig tail cable A.

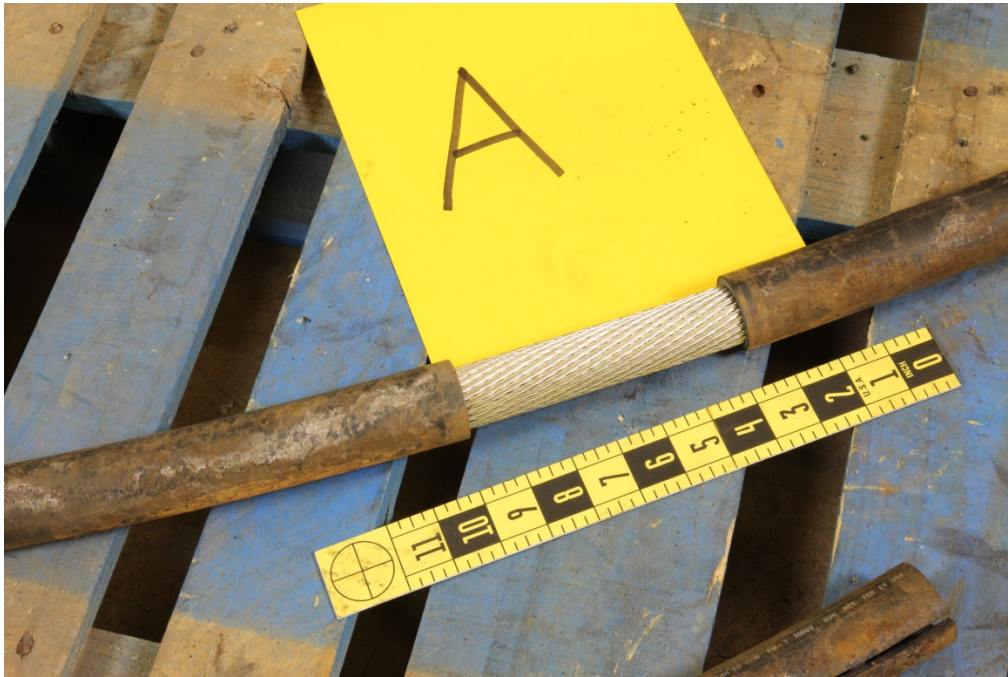
Figure 4: Portion of insulation removed from pig tail cable A.

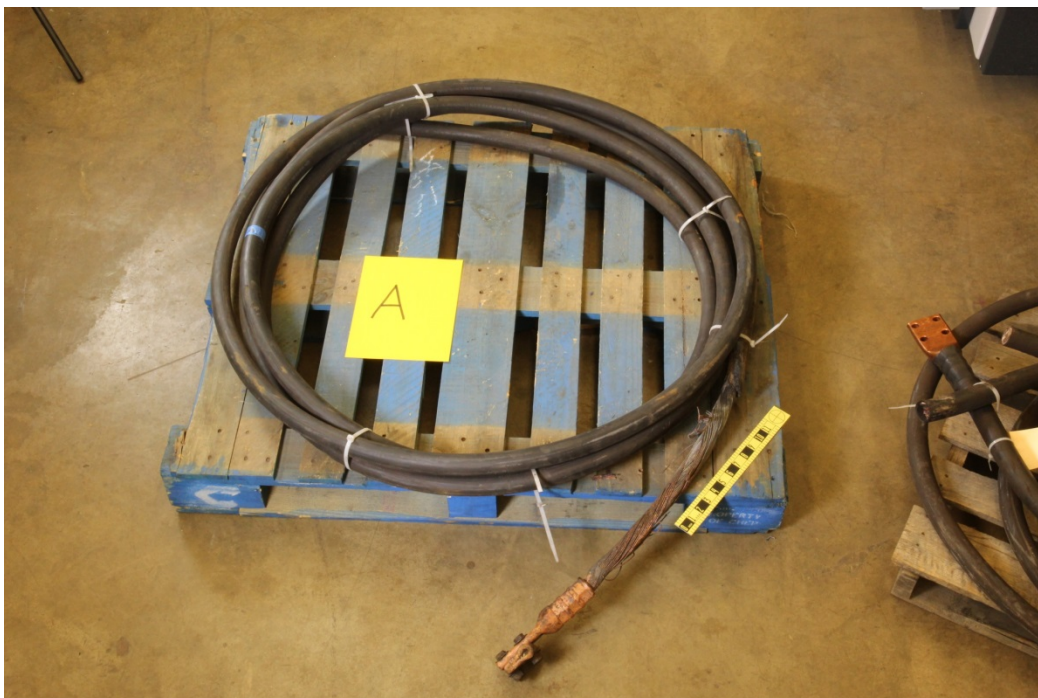
The recovered portion of the power feed cable A is shown in figure 5. The end that would have connected to the South end pig tail cable was cut during removal. The end that was connected to the North end pig tail cable still had the lug attached and a portion of its corresponding South end pig tail cable lug (figure 6). The portion of the South end pig tail cable A lug exhibited fusion damage consistent with electrical arcing. The cable connector cover was missing. Downstream of the lug on power feed cable A the insulation was missing over an approximately 19 inch length of the cable. The exposed conductor in this area was oxidized and exhibited some severed strands. Further downstream of the missing insulation was a length of approximately 5 inches of charred insulation. A section of insulation was removed 6 ½ inches downstream of the charred insulation. The conductor under the removed insulation was clean and did not exhibit any evidence of corrosion (figure 7).

Figure 5: Portion of power feed cable A.

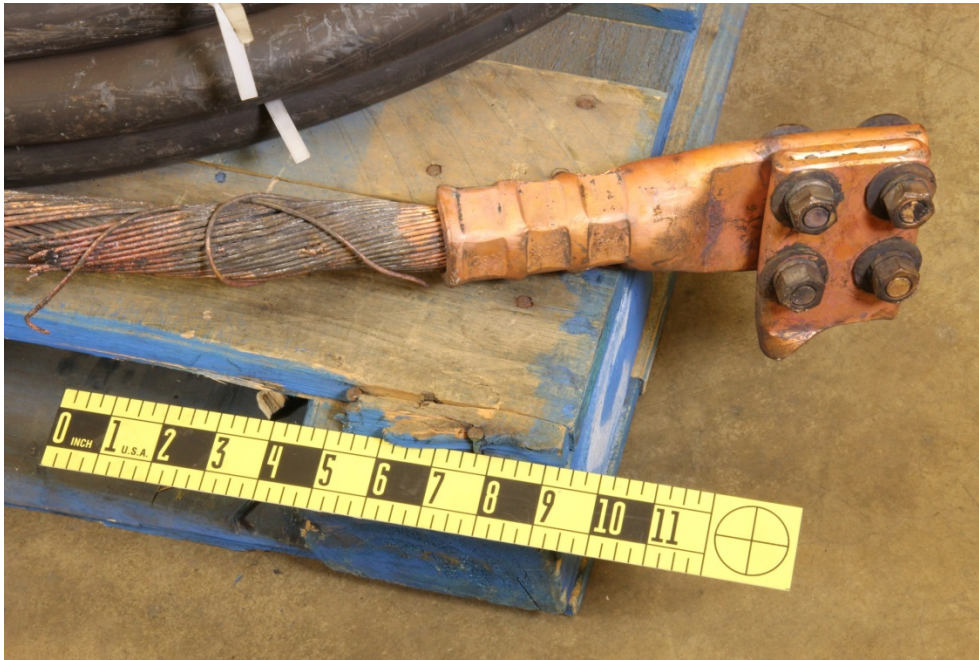
Figure 6: Remaining portion of the bolted connection between North pig tail cable A and power feed cable A.

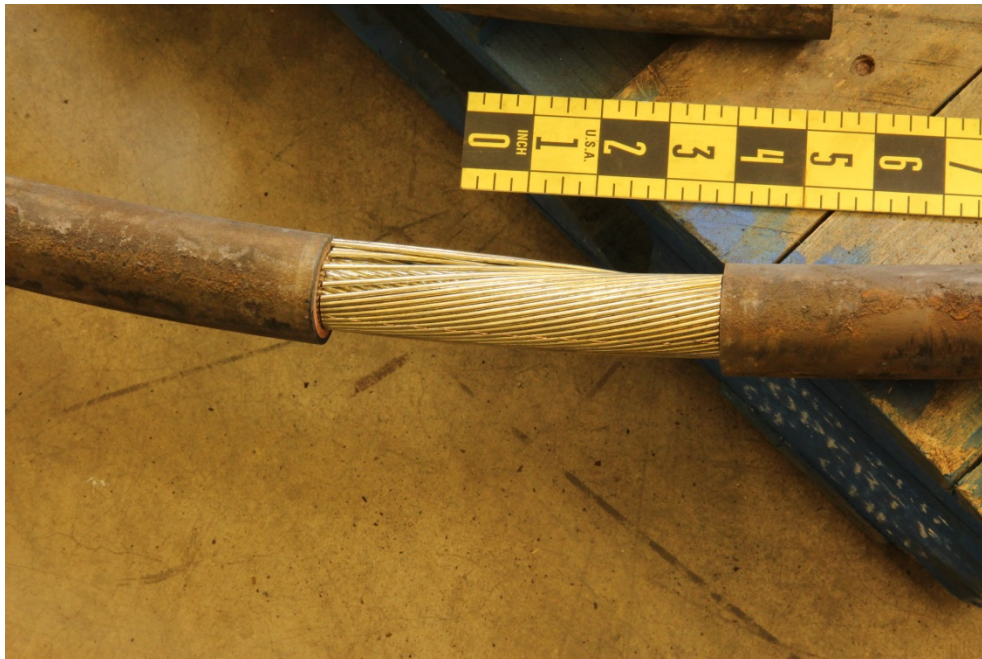
Figure 7: Portion of insulation removed from power feed cable A.

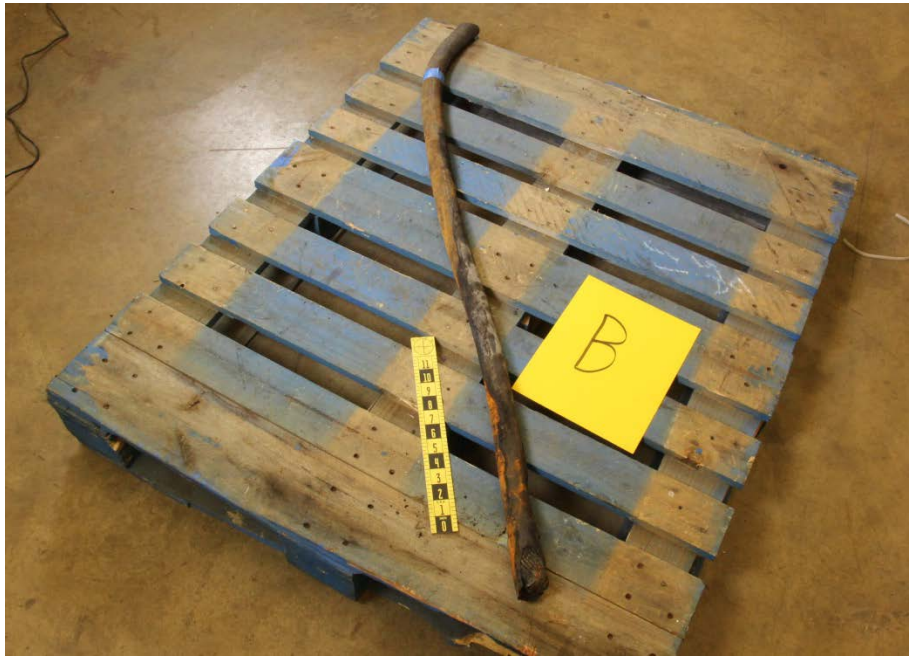
The recovered portion of the North end pig tail cable B was approximately 51 inches long (figure 8). The cable end that would have been welded to the 3rd rail was cut for removal. The cable end that would have had a lug and been bolted to the lug on the power feed cable was electrically damaged exhibiting fused and beaded strands (figure 9). There was a sharp demarcation between the fused and beaded strands and the non-fused strands. The lug was missing from this cable and about 2 1/2 inches of the cable was missing insulation. There were about 26 1/2 inches of charred insulation leading up to the portion of the cable missing

Figure 8: Portion of North pig tail cable B.

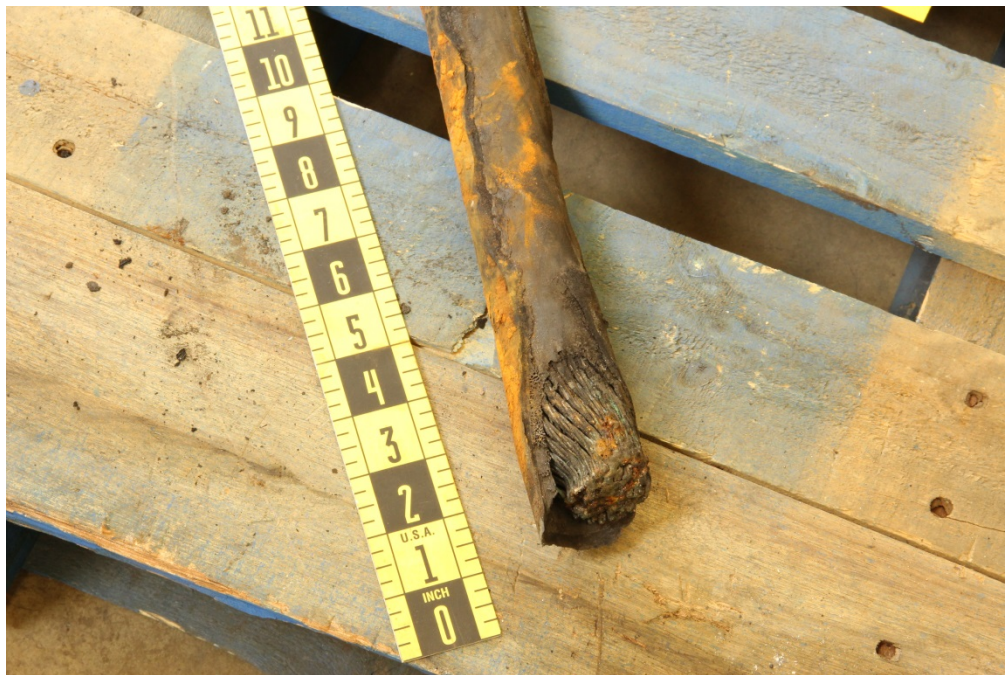
Figure 9: North end pig tail cable B with fused strands on the end.

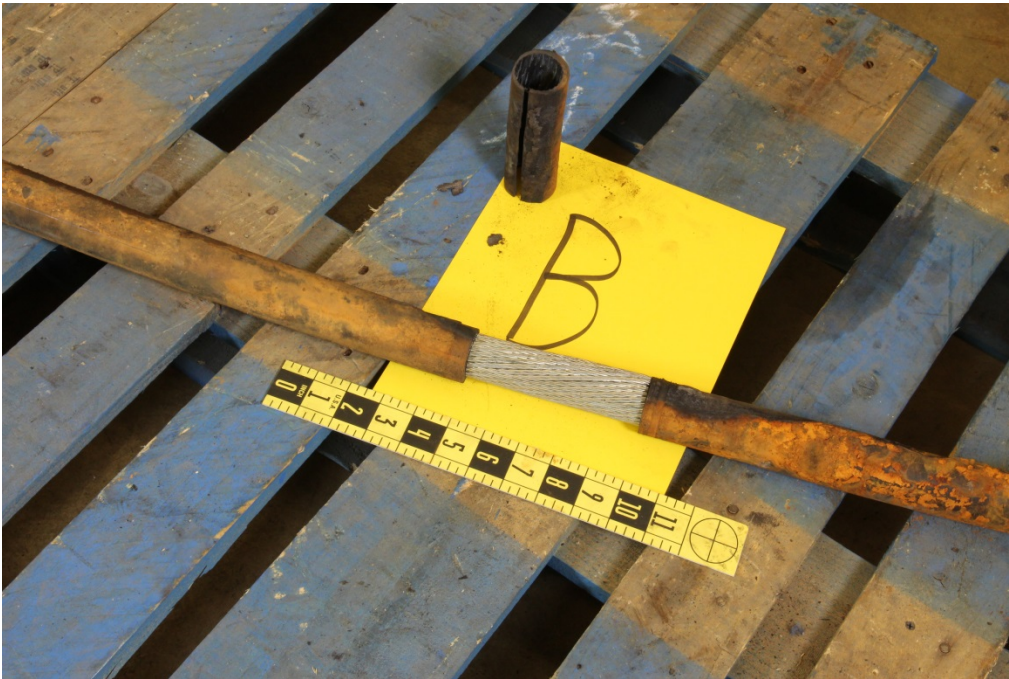
insulation. The undamaged portion of the insulation was covered with an orange or rust colored deposit. A portion of insulation was removed from this cable to examine the conductor. The conductor underneath the removed portion of insulation appeared clean with no evidence of corrosion (figure 10).

Figure 10: Insulation removed from portion of North end pig tail cable B.

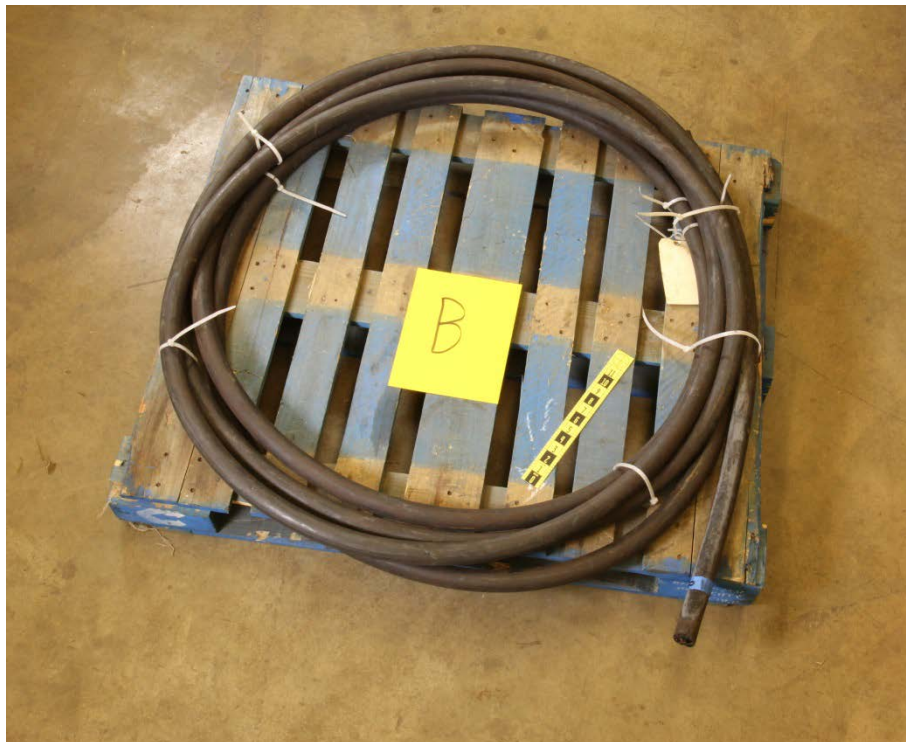
The recovered portion of the power feed cable B is shown in figure 11. The end that would have connected to the South end pig tail cable was cut during removal. The end that was connected to the North end pig tail was missing the lug and the conductor's strands were fused together (figure 12). Downstream of the fused end on power feed cable B the insulation was charred for approximately 12 inches on a portion of the circumference of the cable. A section of insulation was removed 10 inches downstream of the fused cable end. The conductor under the removed insulation was clean and did not exhibit any evidence of corrosion.

Figure 11: Portion of the power feed cable B.

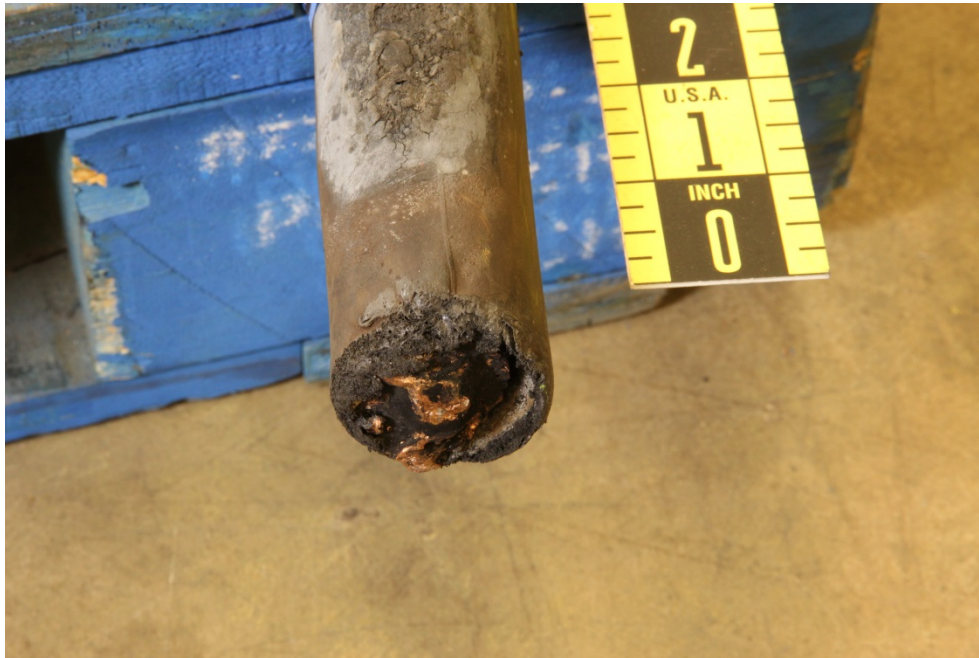
Figure 12: Fused end of power feed cable B.

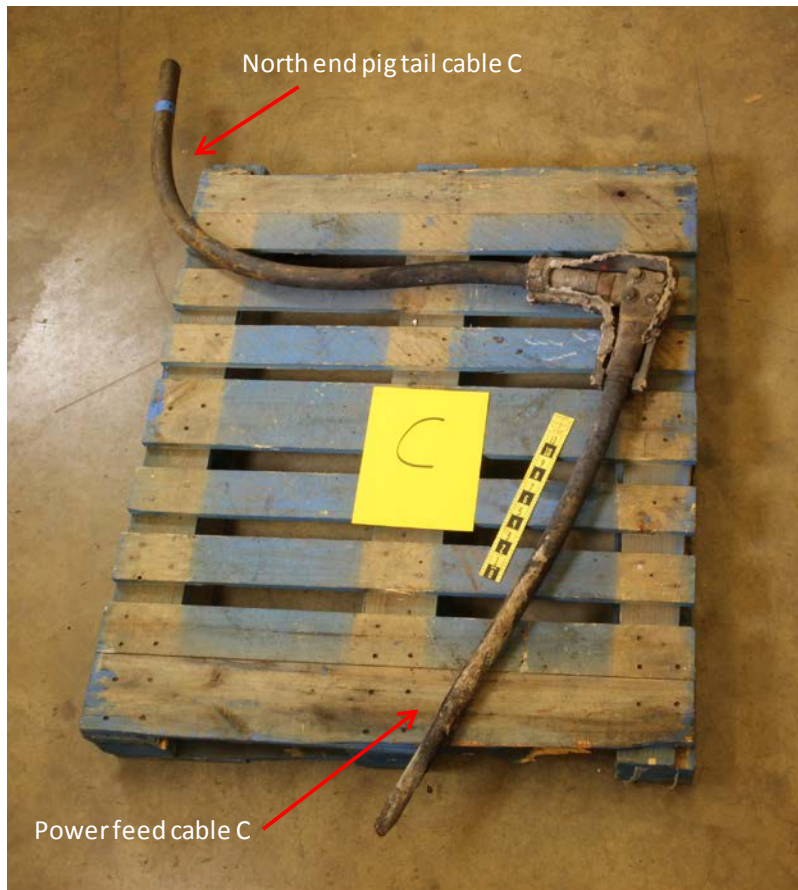
The recovered portion of the North end pig tail cable C was approximately 48 inches long (figure 13). The cable end that would have been welded to the 3rd rail was cut for removal. The other end of pig tail cable C had a lug which was still bolted to the lug on the power feed cable. The lug on the power feed cable C had a portion approximately 34 inches long of cable still attached. This portion of power feed cable had charred insulation and was missing the insulation over a length of 7 inches on the South end. The conductor in the section missing the insulation had an oxidized appearance and terminated at a fused end (figure 14). The lugs of the cable connector assembly were still intact and bolted together. Half of the cable connector cover was missing and the remaining half was thermally stressed (figure 15). A heat shrink insulation sleeve covered part of the cable and the attached lug on both the pig tail cable and power feed cable. No evidence of a sealing sleeve as indicated by the cable connector assembly drawing (figure 2) was found. A portion of insulation was removed near the lug end of the power feed cable to assess the condition of the conductor underneath. The conductor was clean and did not exhibit any evidence of corrosion (figure 15). North end pig tail cable C had mostly intact insulation with some charring over a length of 12 inches from the lug end. The undamaged portion of the insulation was covered with an orange or rust colored deposit.

Figure 13: Portion of North pig tail cable C with a portion of power feed cable C attached.

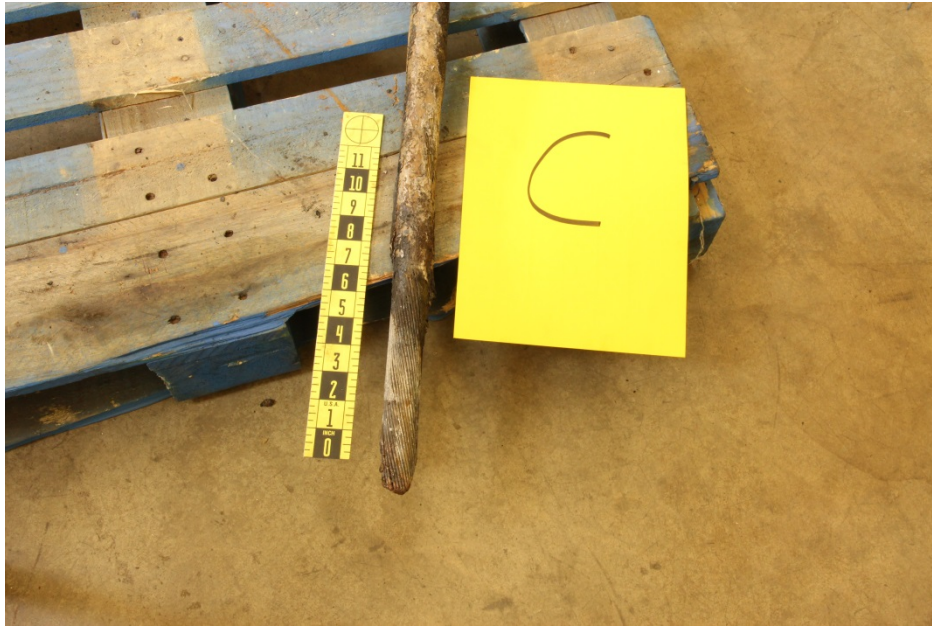
Figure 14: Fused end on portion of the power feed cable C still attached to the North end pig tail cable C.

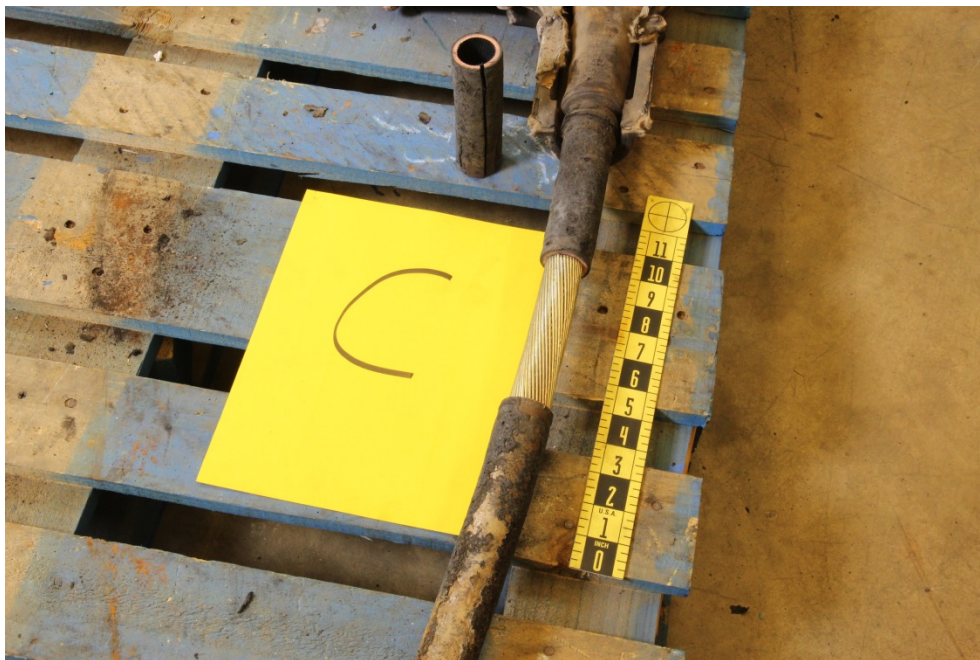
Figure 15: Insulation removed from portion of power feed cable C still attached to North end pig tail cable C.

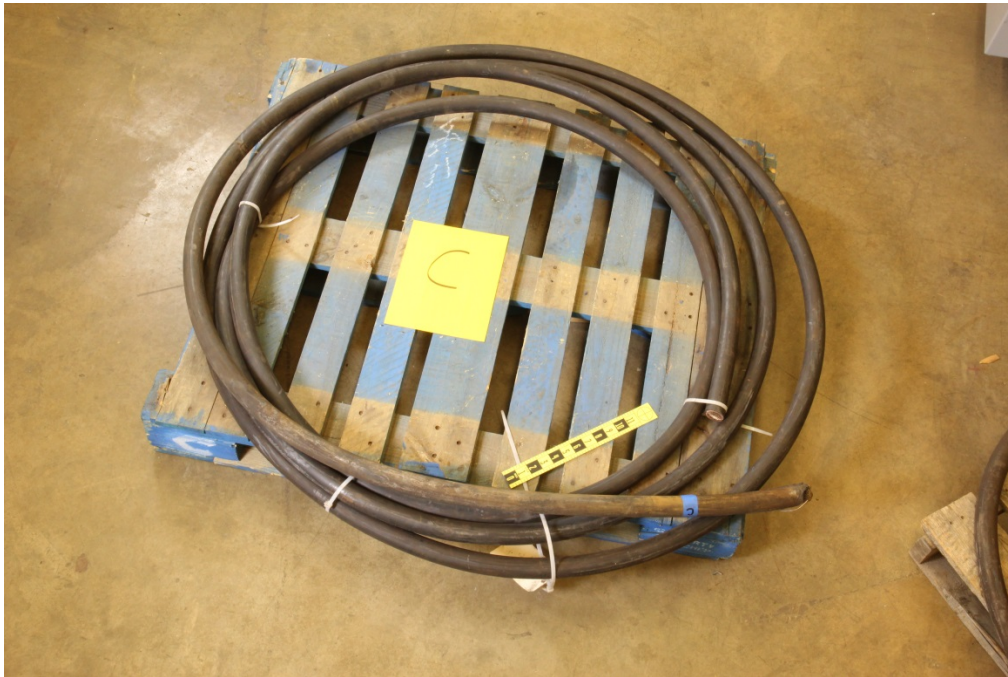
The recovered portion of the power feed cable C is shown in figure 16. The end that would have connected to the South end pig tail cable was cut during removal. The end leading to the North end pig tail was missing the lug and the conductor strands were fused together (figure 17). A portion of this power feed cable including the lug were still attached to the North end pig tail cable C. Near the fused end on power feed cable C the insulation was charred for approximately 5 inches on a portion of the circumference of the cable. A section of insulation was removed 12 inches away from the fused cable end. The conductor under the removed insulation was clean and did not exhibit any evidence of corrosion.

Figure 16: Portion of power feed cable C.

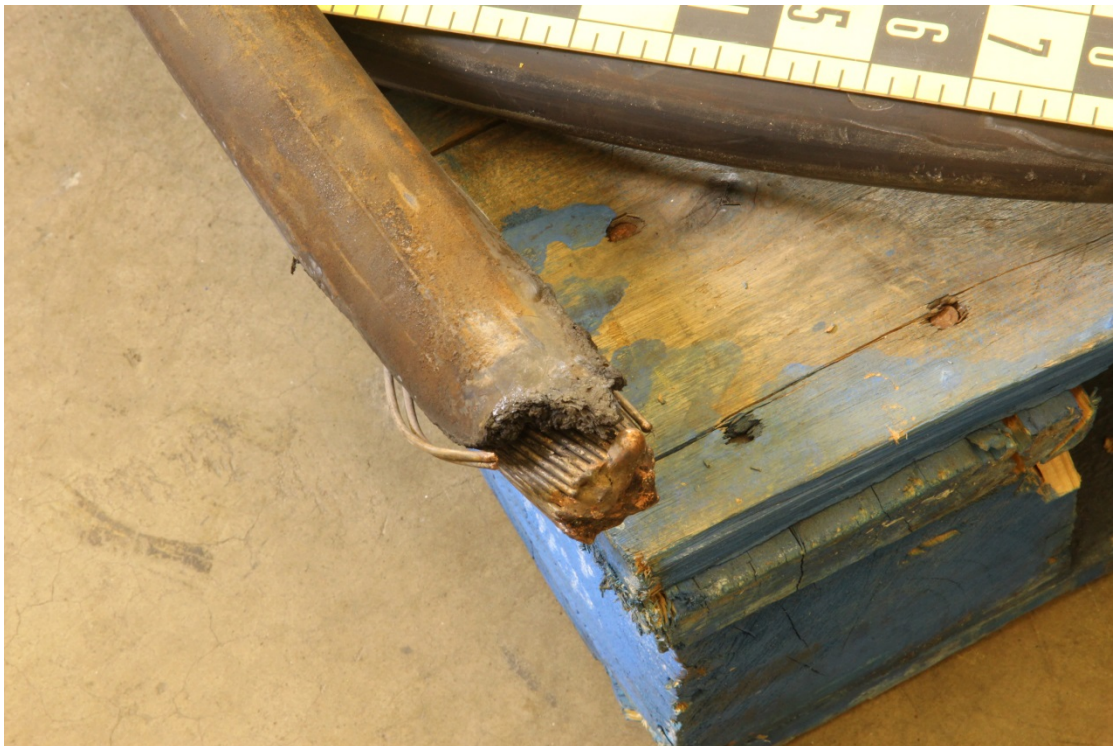
Figure 17: Fused end on North end of power feed cable C.

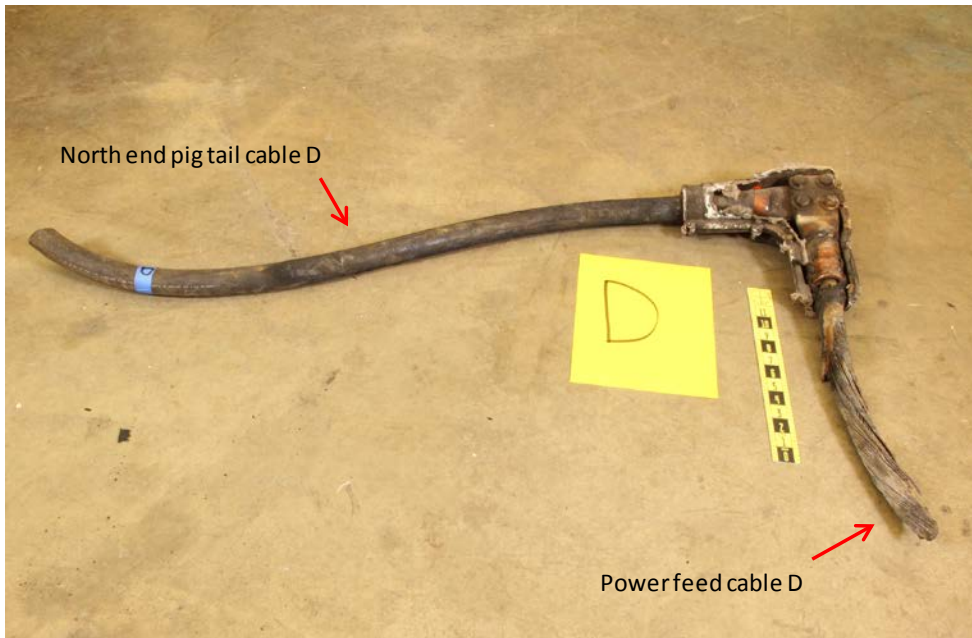
The recovered portion of the North end pig tail cable D was approximately 43 inches long (figure 18). The cable end that would have been welded to the 3rd rail was cut for removal. The other end of pig tail cable D had a lug which was still bolted to the lug on the power feed cable. The lug on the power feed cable D had a portion approximately 17 inches long of cable still attached. This portion of power feed cable was mostly missing the insulation except for a small portion near the lug end. The conductor in the section missing the insulation had an oxidized appearance and terminated at a fused end (figure 19). The lugs of the cable connector assembly were still intact and bolted together. Half of the cable connector cover was missing and the remaining half was thermally stressed (figure 19). A heat shrink insulation sleeve covered part of the cable and the attached lug on the pig tail cable. The heat shrink insulation was mostly charred and consumed on the power feed cable end. No evidence of a sealing sleeve as indicated by the cable connector assembly drawing was found. North end pig tail cable D had mostly intact insulation with some thermal stress near the lug end. The undamaged portion of the insulation was covered with an orange or rust colored deposit.

Figure 18: Portion of North end pig tail cable D with a portion of power feed cable D still attached.

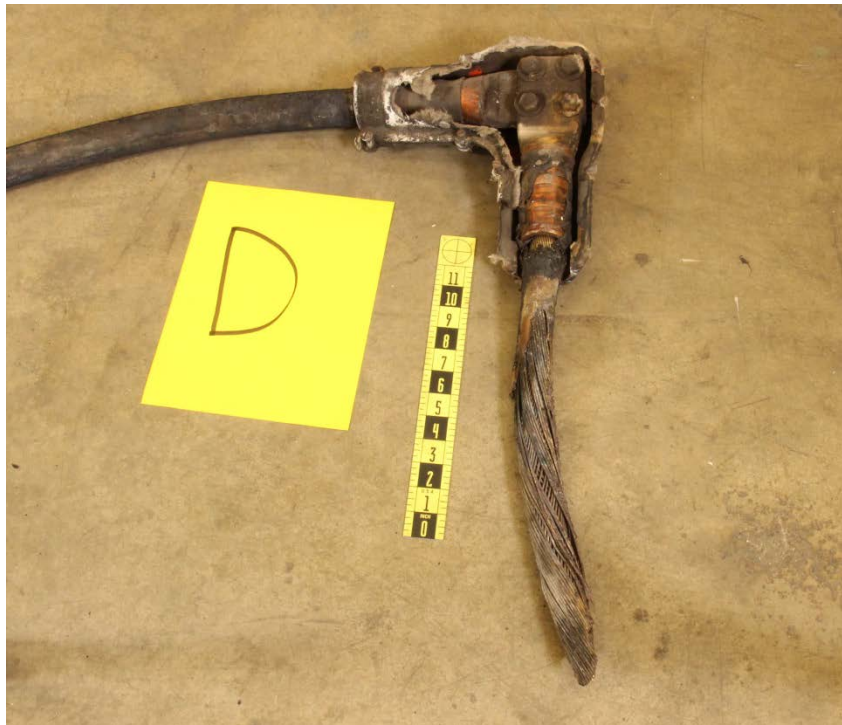
Figure 19: Fused end on portion of the power feed cable D still attached to the North end pig tail cable D.

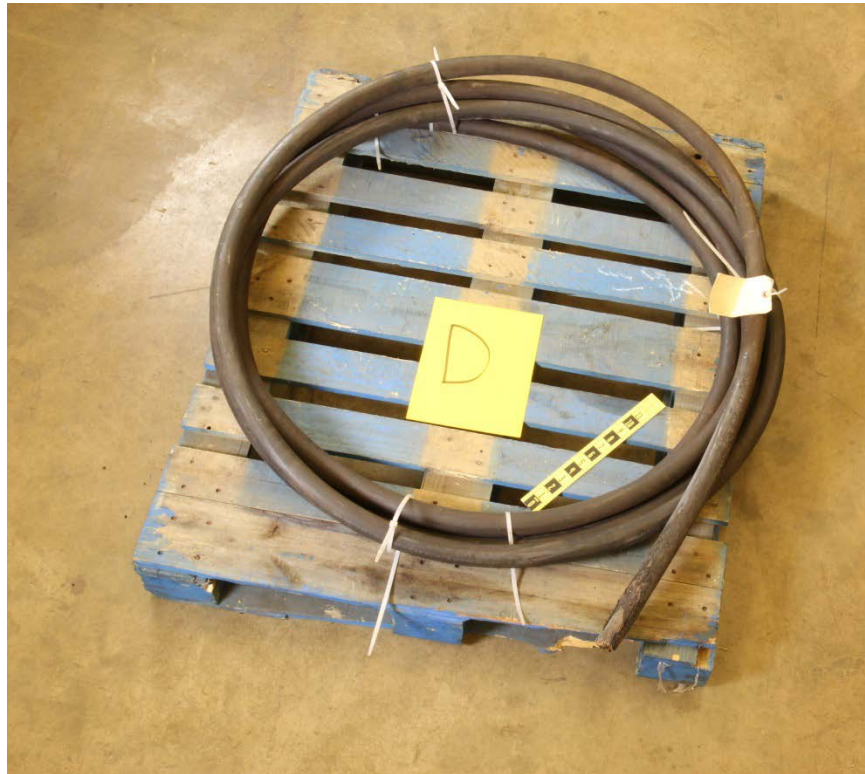
The recovered portion of the power feed cable D is shown in figure 20. The end that would have connected to the South end pig tail cable was cut during removal. The end leading to the North end pig tail was missing the lug and the conductor strands were fused together (figure 21). A portion of this power feed cable including the lug were still attached to the North end pig tail cable D. Near the fused end on power feed cable D the insulation was charred for approximately 5 inches on a portion of the circumference of the cable. A section of insulation was removed 11 inches away from the fused cable end. The conductor under the removed insulation was clean and did not exhibit any evidence of corrosion (figure 22).

Figure 20: Portion of power feed cable D.

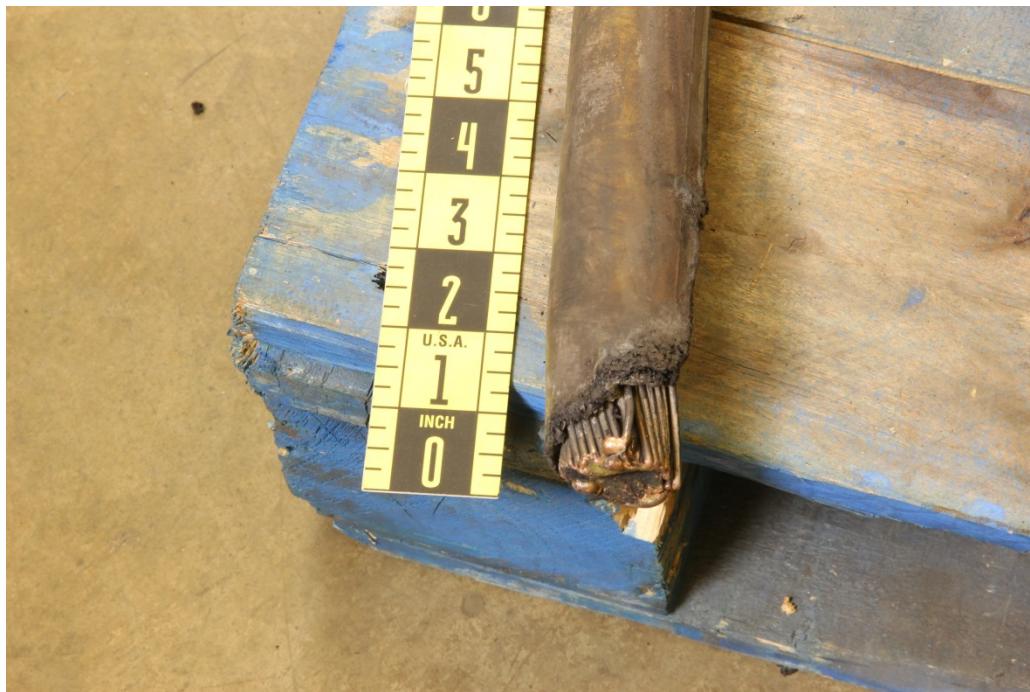
Figure 21: Fused end on portion of power feed cable D.

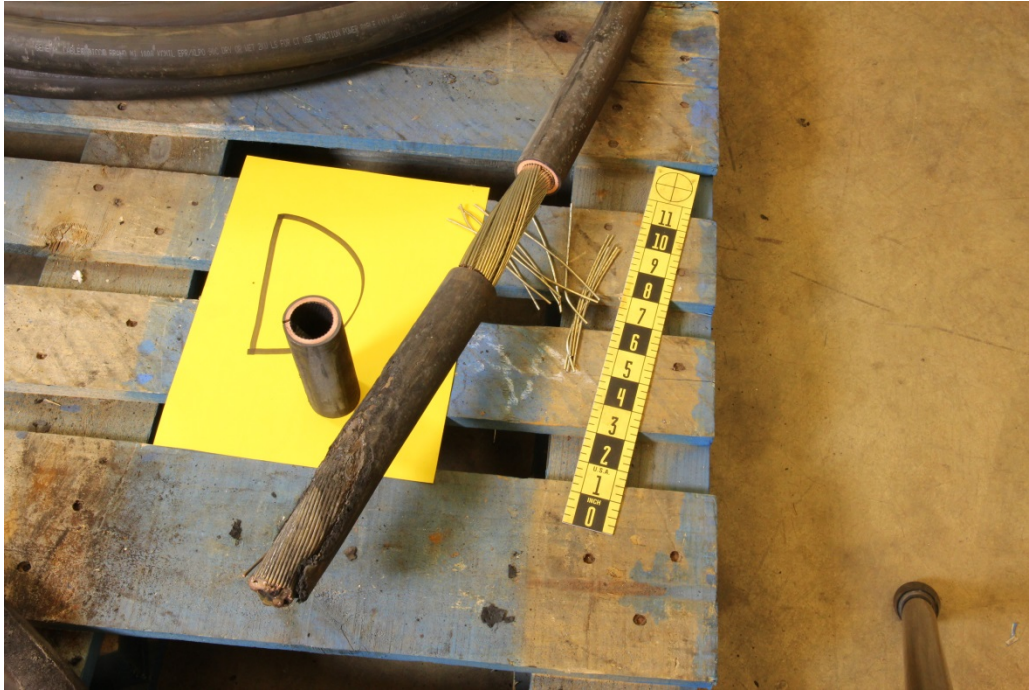
Figure 22: Portion of insulation removed from power feed cable D.

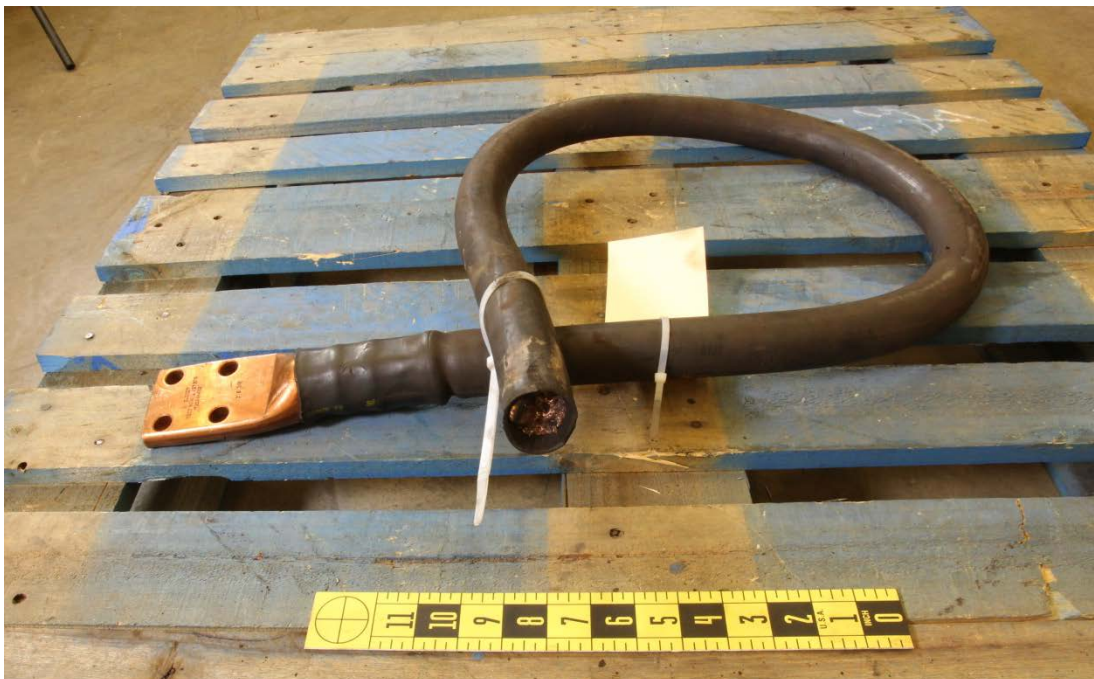
Of the south end pig tail cables only one was removed and not reused when the track was put back in service. It was not possible to identify which of the jumper cable assemblies this pig tail cable had been a part of. This pigtail cable had the lug still attached on one end (figure 23). The other end which would have been welded to the 3rd rail had a fused end (figure 24). The insulation at the fused end was removed and no evidence of corrosion was identified along the exposed conductor. The demarcation between fused and non-damaged conductor was very sharp.

Figure 23: South end pig tail cable.

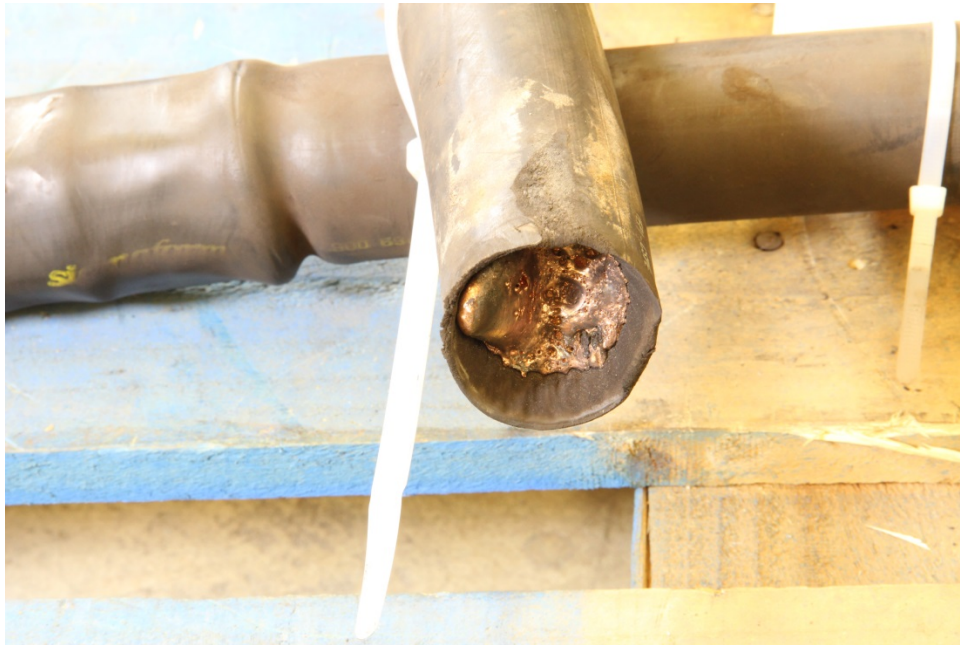
Figure 24: Fused end of South end pig tail cable.

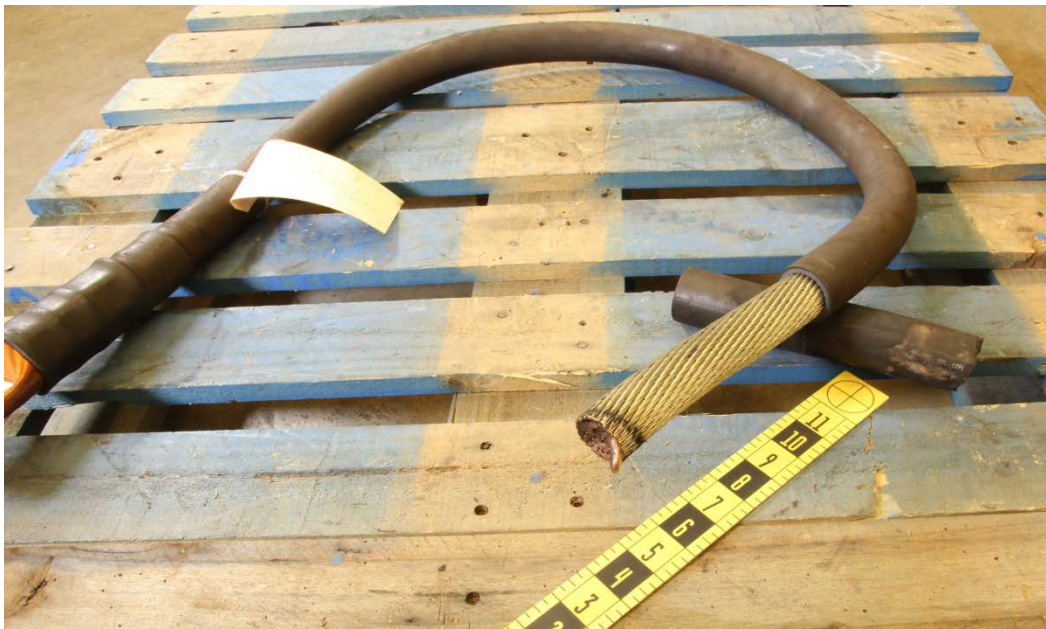
Figure 25: Fused end of South end pig tail cable with insulation removed.

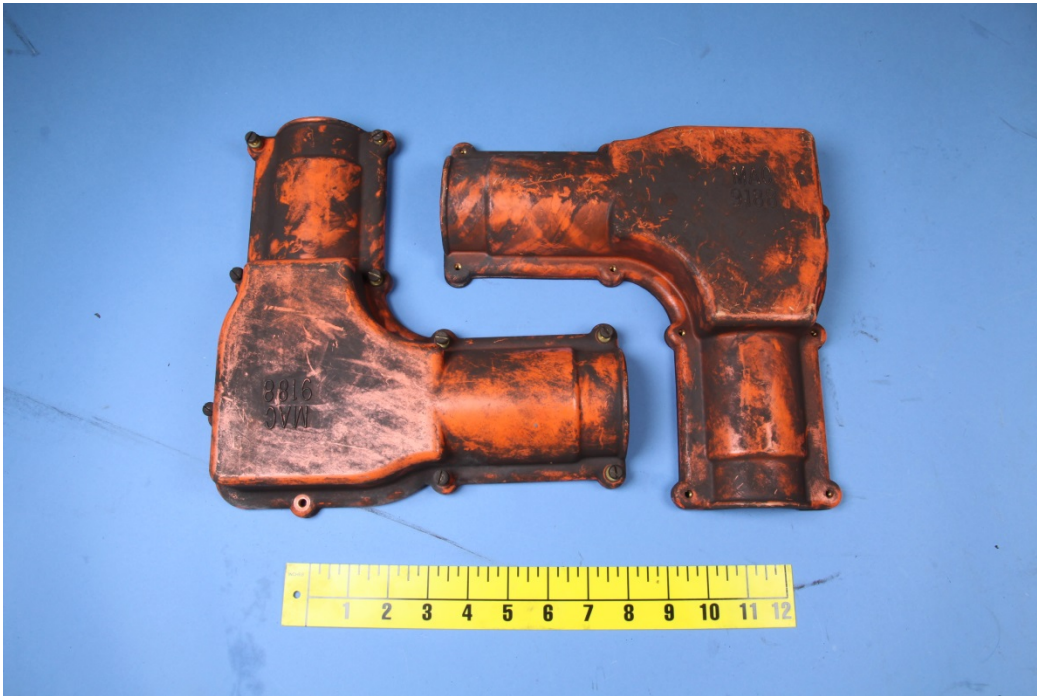
The cable connector covers that were provided to the NTSB originated from the south end of the jumper cable assemblies. It was not possible to determine which covers went with a particular jumper cable assembly. The covers were all the same type and did not have any features that would distinguish one from another. Both the exterior (figure 26) and interior

Figure 26: Cable connector cover exterior.

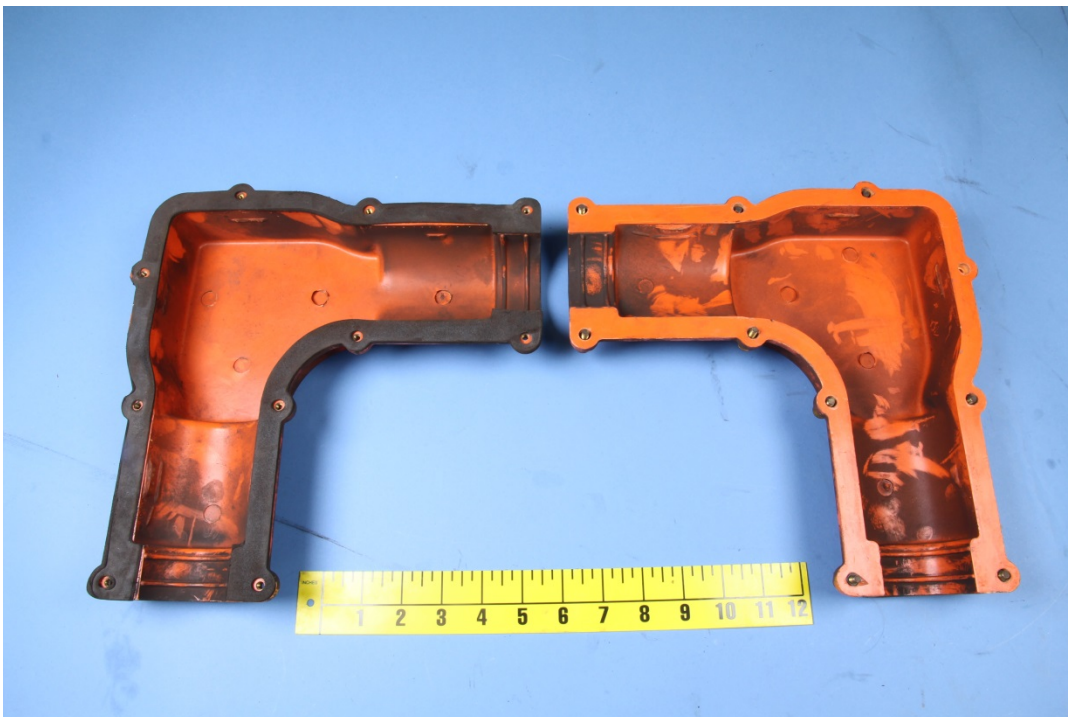
(figure 27) surfaces of the covers were contaminated with a dark colored deposit. A sample of this dust was collected for analysis. A sample of debris was also collected from the surface of one of the pig tail cables for comparison. The results of this analysis are contained in Materials Laboratory Report 15-103.

Figure 27: Cable connector cover interior.
