NATIONAL TRANSPORTATION SAFETY BOARD

MATERIALS LABORATORY FACTUAL REPORTReport No. 15-099

Place : Washington, DC
Date : January 12, 2015 3:15 p.m. EST
Vehicle : WMATA train #302 Yellow Line
NTSB No. : DCA15FR004
Investigator : Robert Gordon

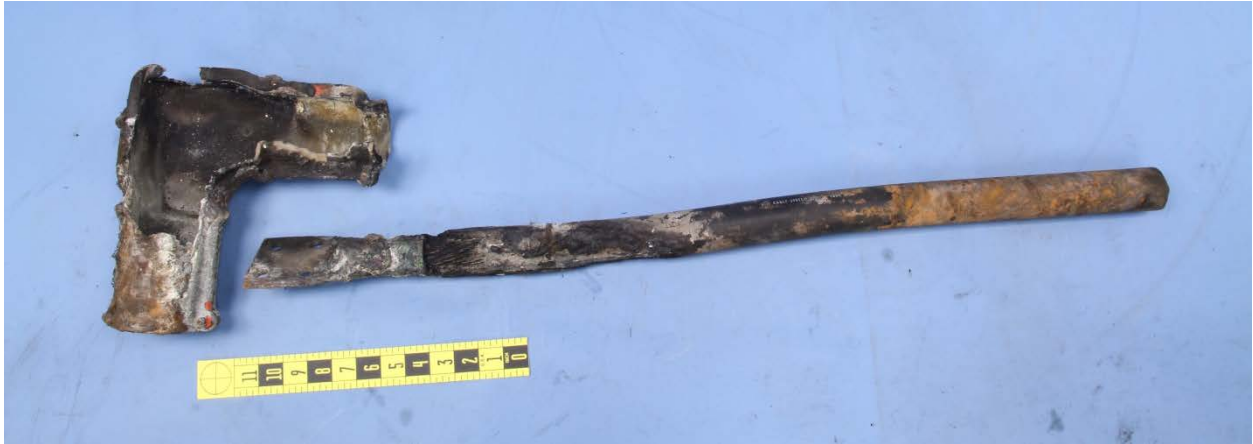
A portion of traction power supply pig tail cable and a portion of its associated cable connector cover (also referred to as a "boot")(figure 1).

Figure 1: Portions of pig tail cable and cable connector cover as received.

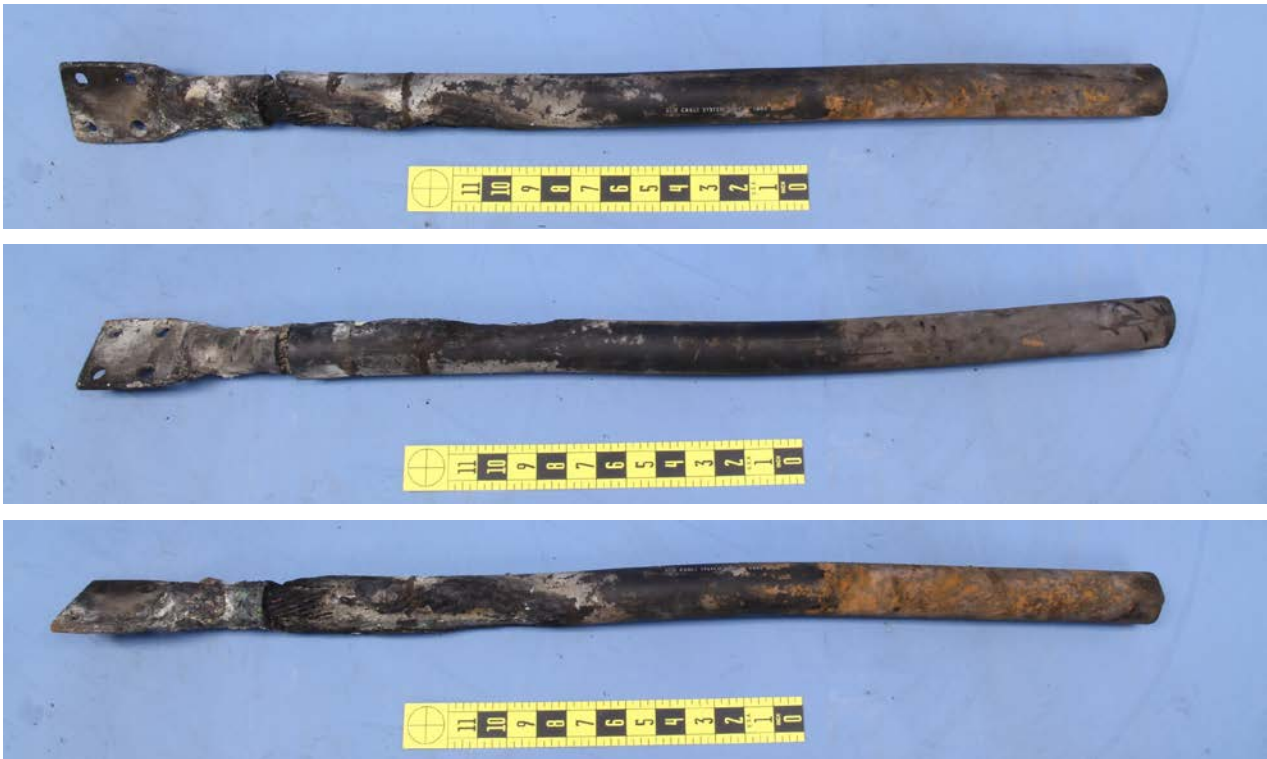
The portion of the pig tail cable was 37 inches feet long. One end had a clean cut which was made to facilitate removal of this cable after the incident. Brown rust colored debris was adhering to the cable's insulation on this end. The cut end would have been welded to the 3rd rail. The other end of the cable had a lug crimped onto the conductor (figure 2). Areas with yellow/white powder from the fire extinguisher are also visible on the cable's surface.

Figure 2: Portion of the pig tail cable (3 views).

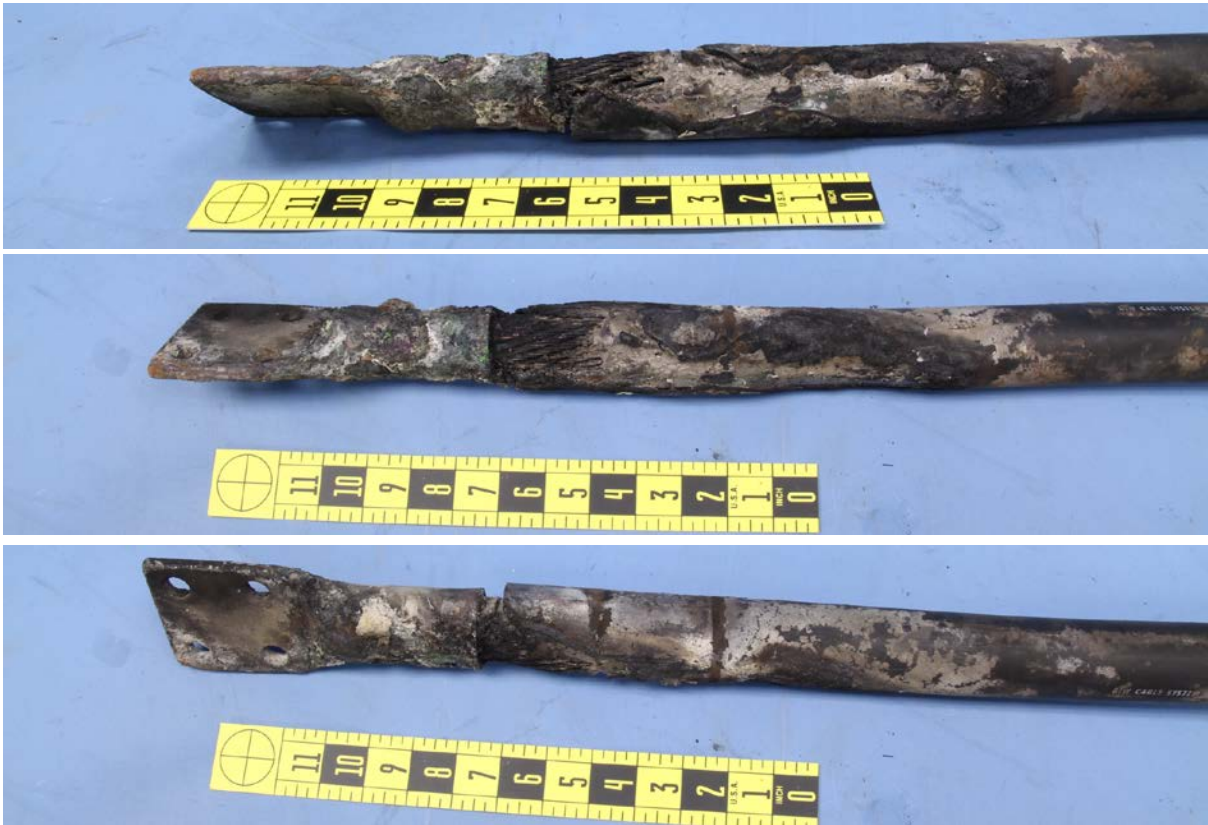
The examination of the pig tail cable found no evidence of substantial short circuit or electrical arcing damage on the conductor or cable lug. The cable insulation exhibited areas where it was thermally damaged and charred. This damaged portion of cable insulation was on the lug end of the cable and extended approximately 12 inches towards the other end. The damage to the cable insulation was continuous over the 12 inches but it did not cover the entire periphery of the insulation (figure 3). The thermal damage to the insulation was external exhibiting more damage to the exterior than the interior. Insulation resistance measurements¹ at 1000VDC across the damaged insulation surface indicated reduced dielectric properties (0.3 – 85 MΩ depending on the measurement points) when compared to similar measurements on the non-damaged insulation (>11 GΩ)

Figure 3: Close up of damage to the lug end (3 views).

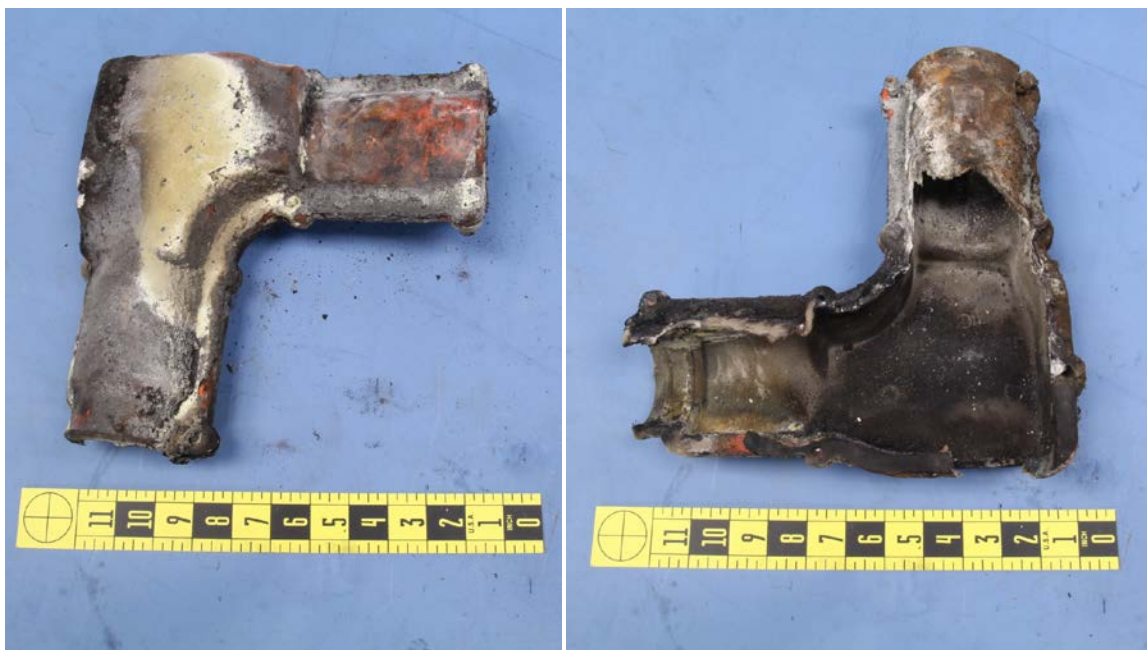
The cable connector cover which was installed with this pig tail was partially missing with the remaining portions exhibiting thermal damage (figure 4). The cable connector cover also had powder on its exterior from the use of the fire extinguisher.

Figure 4: Damaged cable connector cover ("boot").

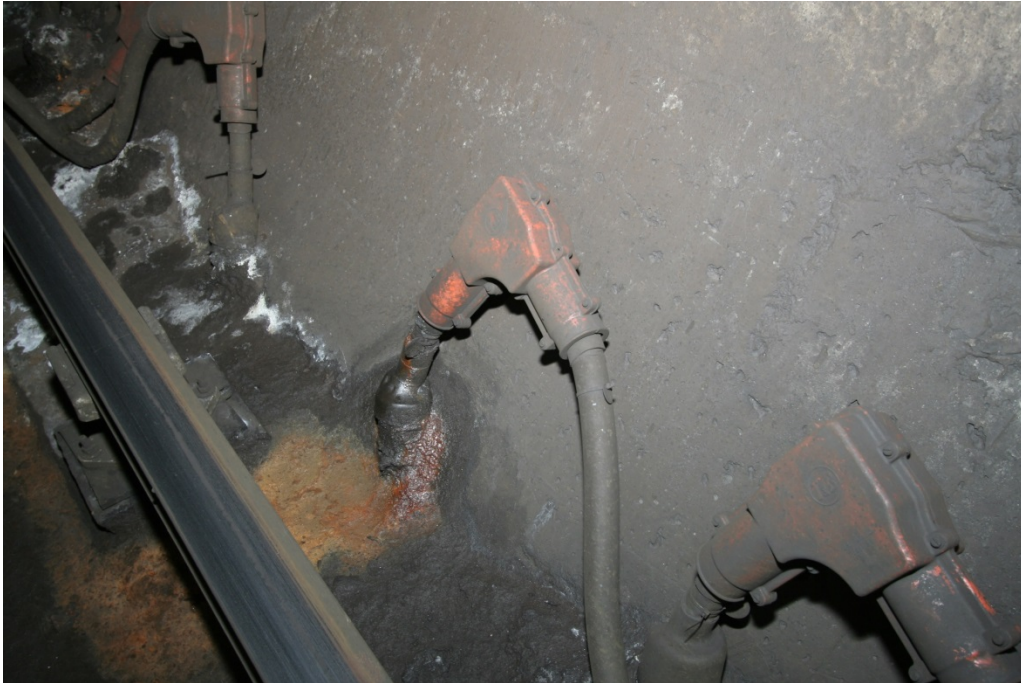
At the site where the incident took place there were additional power supply cables providing power to the 3rd rail. These additional power cables were visually examined and found to have areas where debris was adhering to their insulation surface. In addition a rust colored liquid was observed to be weeping from some of the stub up conduits where these cables extended from (figure 5). Examination of the cable connector covers revealed large gaps between the cable insulation and the body of the cable connector covers (figure 6). The drawing for the cable connector assemblies (figure 7) indicated the use of sealing sleeves to make the assembly weather tight. No sealing sleeves were observed among the cable connector assemblies at the site of the incident. Additionally, no evidence of a sealing sleeve was identified on the incident pig tail cable.

Figure 5: Power supply cables in the vicinity of the incident cable.

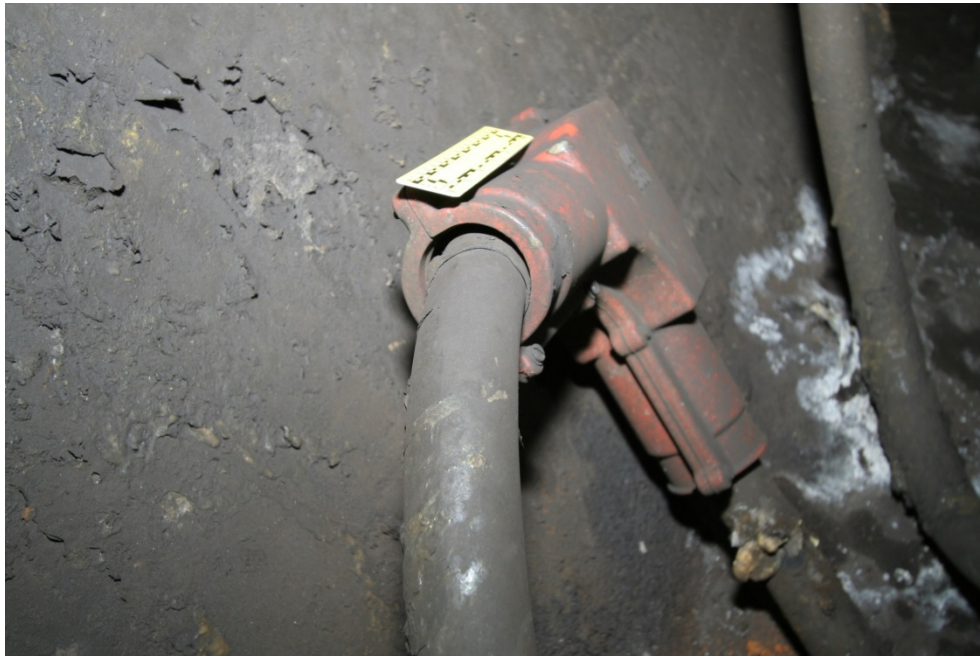
Figure 6: Cable connector cover lacking sealing sleeve.
