NATIONAL TRANSPORTATION SAFETY BOARD

MATERIALS LABORATORY FACTUAL REPORTReport No. 15-100

Place : Washington, DC
Date : January 12, 2015 3:15 p.m. EST
Vehicle : WMATA train #302 Yellow Line
NTSB No. : DCA15FR004
Investigator : Robert Gordon

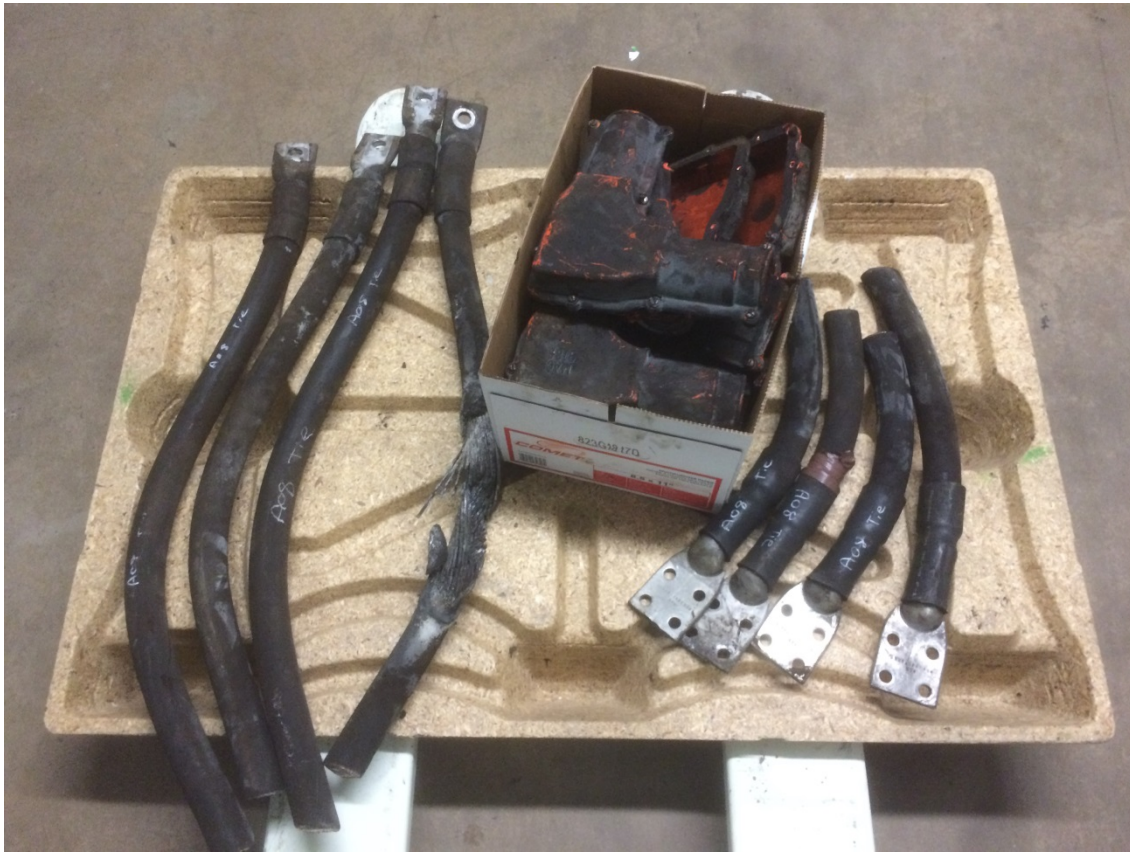
Figure 1: Portions of pig tail cables and cable connector covers as received from WMATA.

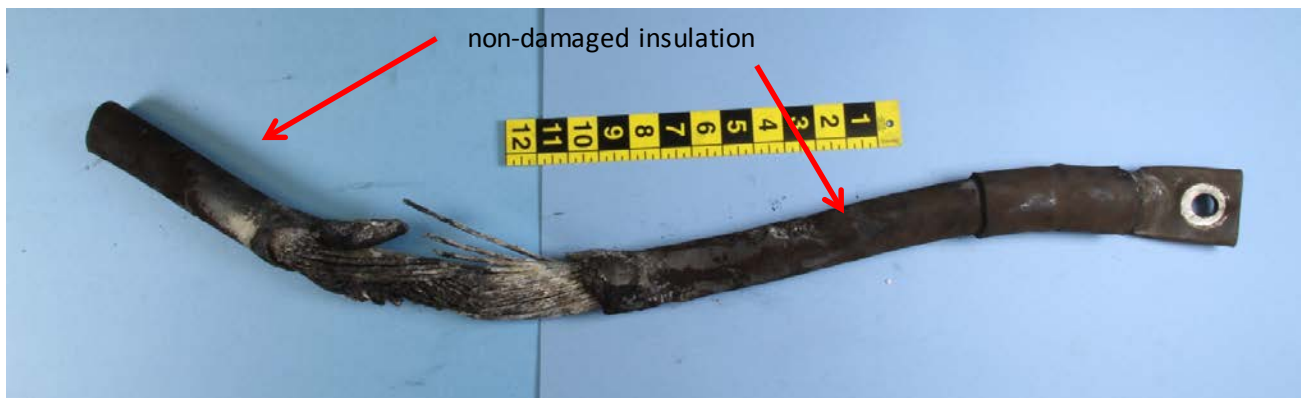
Portions of 4 pig tail cables were examined. Each of the pig tail cables had been cut to facilitate their removal from the incident site. Each pig tail cable consisted of one portion of cable with a single hole lug and a smaller portion of cable with a 4 hole lug. One of the portions of cable with a single hole lug attached had an area of thermal damage near the middle, in between the lug end and the cut end (figure 2). Adjacent to the damaged area of insulation were non-damaged sections of insulation. The thermally damaged area exhibited bare conductor in the middle with some severed strands and re solidified beads of copper (figure 3). Examination of photos provided by WMATA indicate that the damaged portion of insulation was adjacent to a 3rd rail insulator² (figure 4 & 5).

Figure 2: Portion of pig tail cable exhibiting thermal damage.

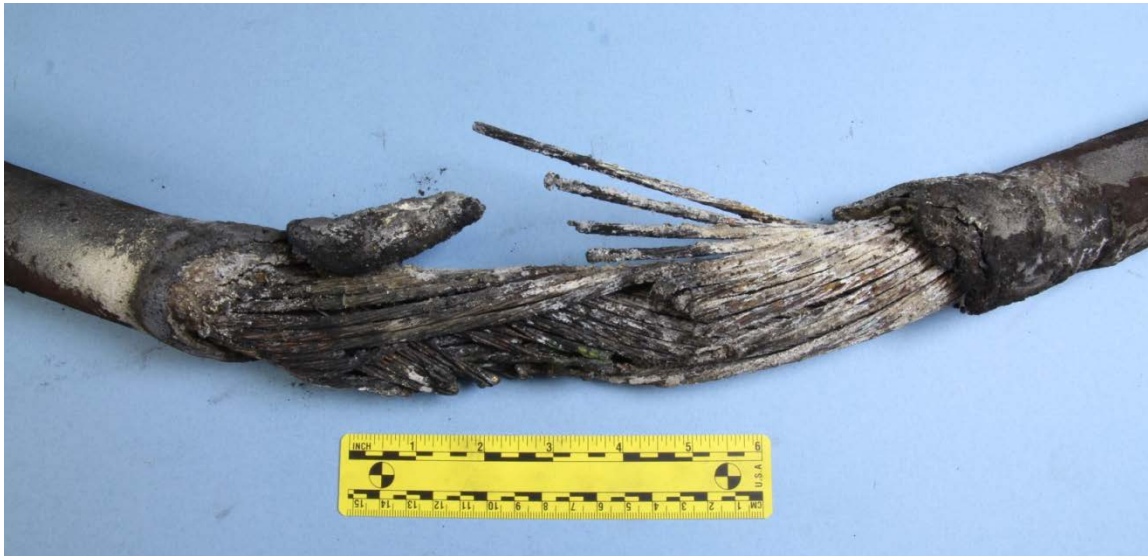
Figure 3: Close up of damaged section of pig tail cable.

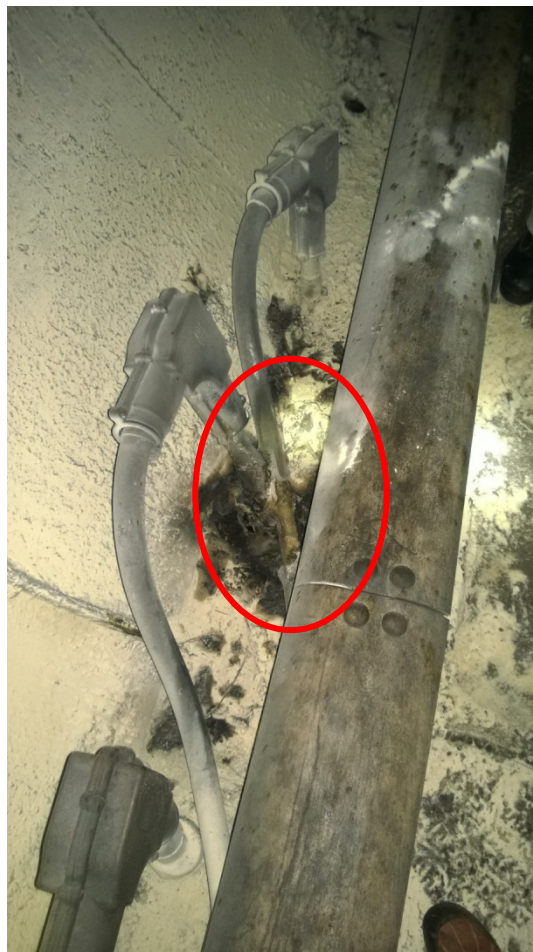
Figure 4: Photo provided by WMATA of the incident cable still in place. Red circle indicates location of thermal damage.

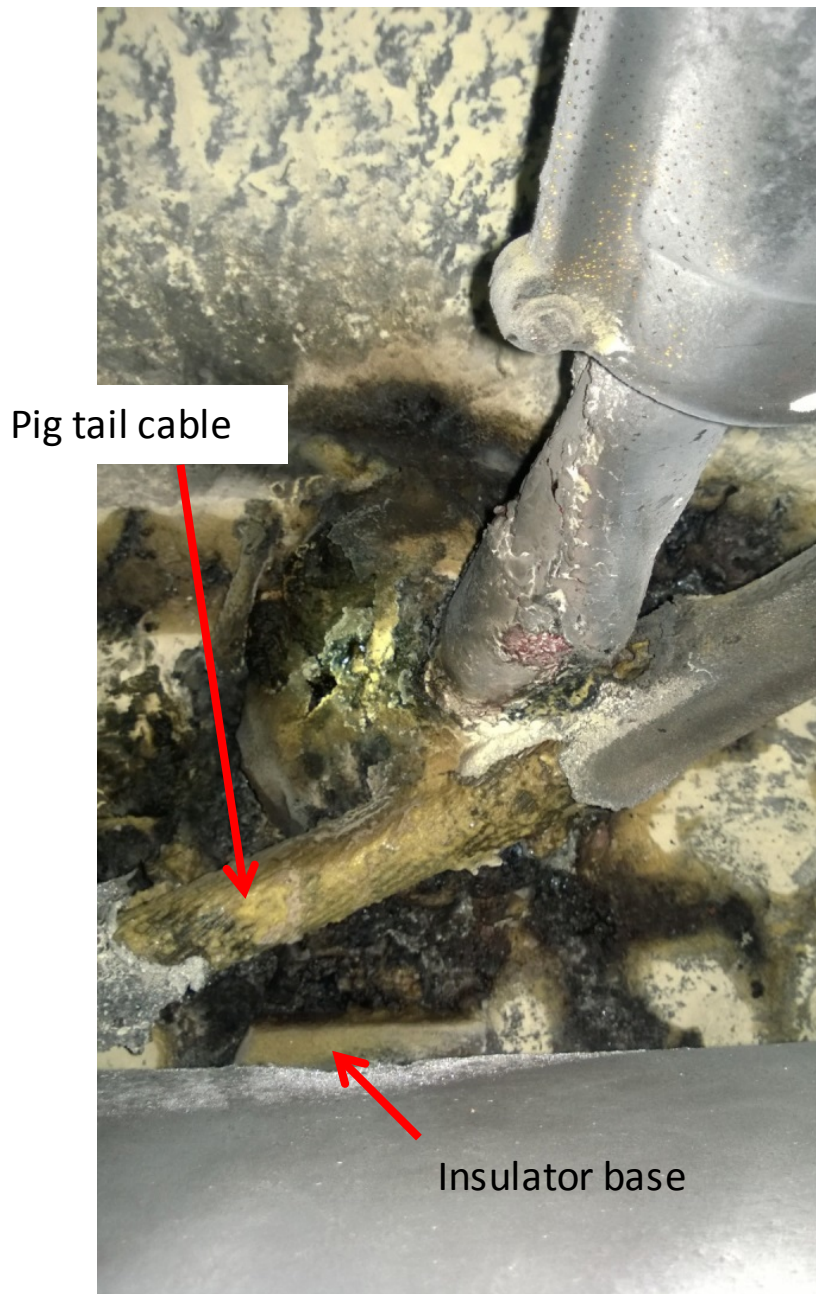
Figure 5: Close up of thermal damage to cable insulation and base of 3rd rail insulator. Photo taken by WMATA.

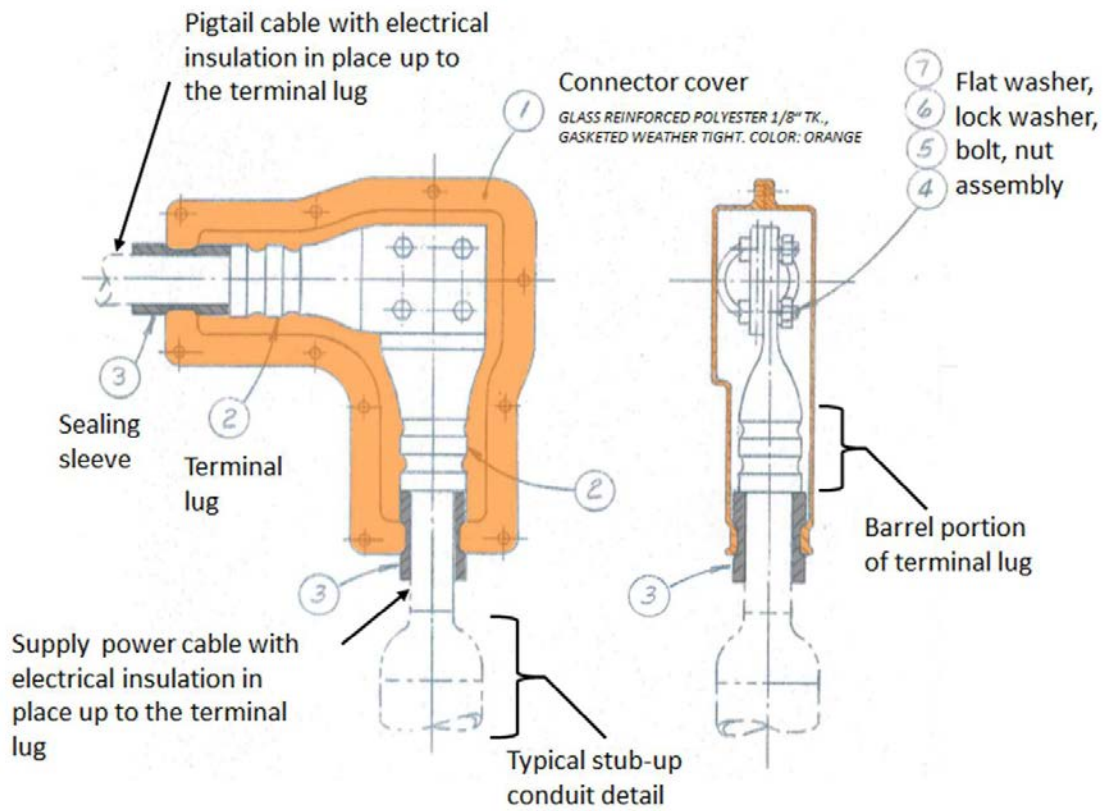
Figure 6: Drawing of cable connector assembly.

None of the portions of cable had sealing sleeves present. Sealing sleeves are used as part of the cable connector assembly (figure 6) . These cables all had heat shrink tubing bridging the gap between the cable's insulation and the barrels of the lugs. No anomalies were noted on the cable connector covers other than contaminants found on their interior surfaces.

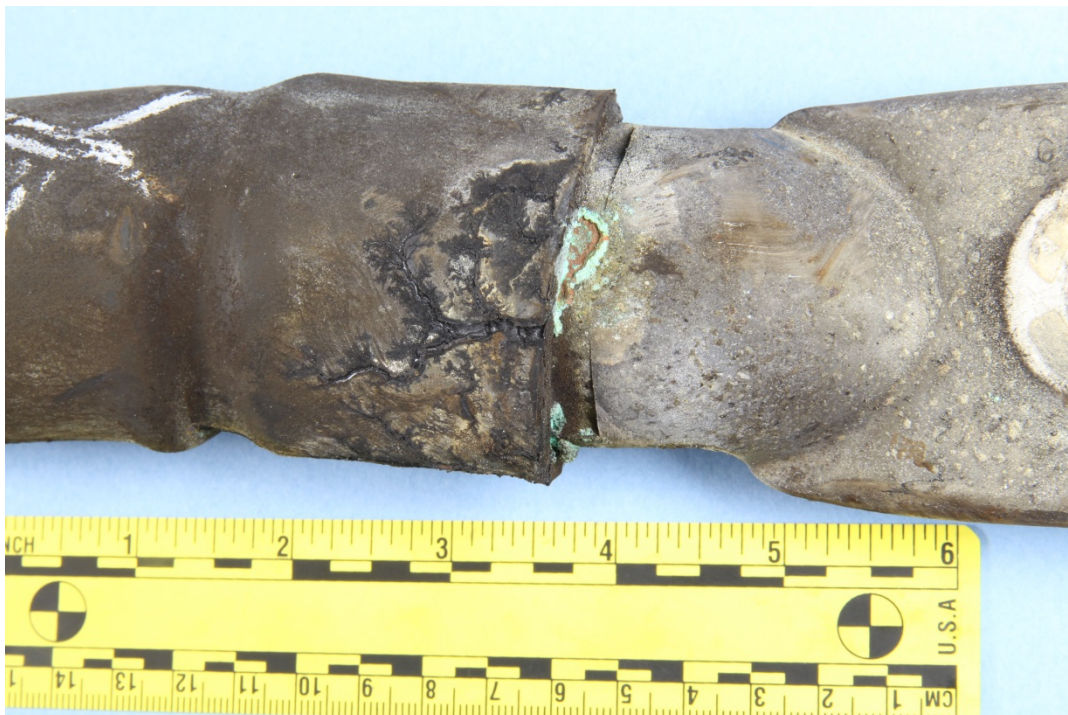
Three out of four of the ends of the pig tail cables with the one hole lugs exhibited varying degrees thermal damage on the insulation near the lugs. This damage consisted of carbonized paths leading from the lug end towards the opposite end of the cable (figures 7,8,9) These carbonized paths are consistent with electrical arc tracking over the exterior surface of the insulation.

Figure 7: Carbonized arc tracks over insulation exterior.

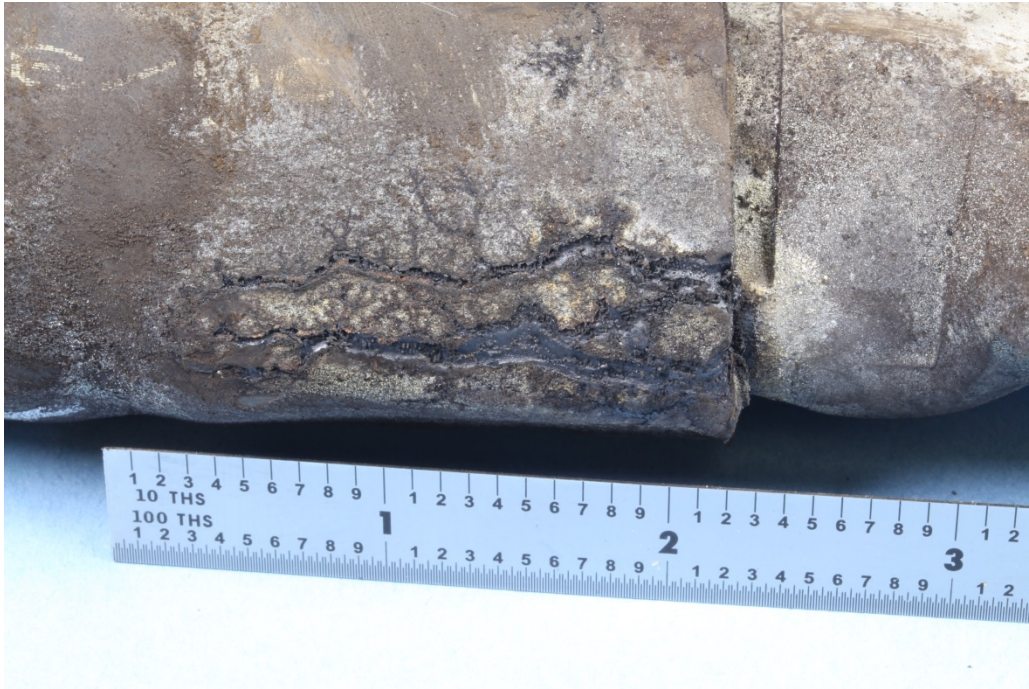
Figure 8: Carbonized arc tracks over insulation exterior.

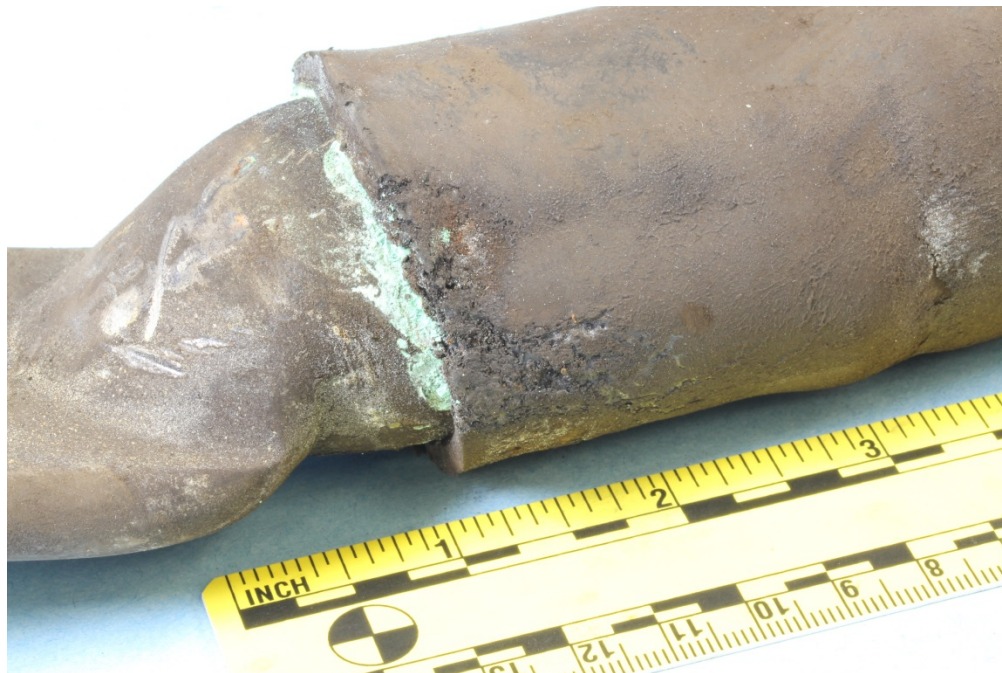
Figure 9: Carbonized arc tracks over insulation exterior.
