NATIONAL TRANSPORTATION SAFETY BOARD

MATERIALS LABORATORY FACTUAL REPORT

Report No. 15-028

Place : Clay, AL
Date : February 14, 2014
Vehicle : Cessna 210L, N732EJ
NTSB No. : ERA14FA120
Investigator : Timothy Monville, AS-ERA

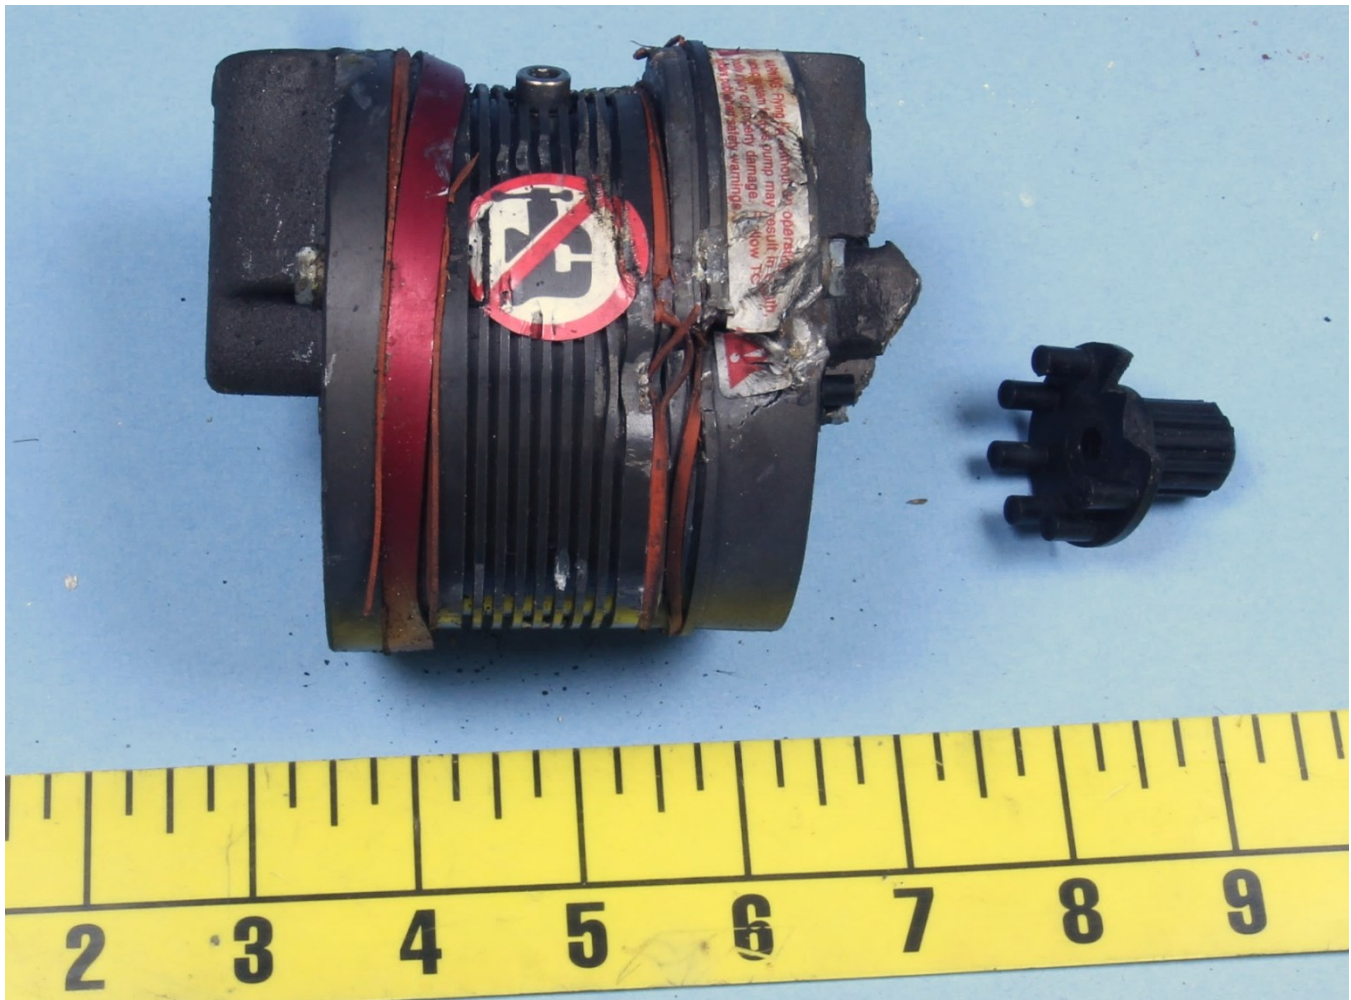
Figure 1 shows the pump and the mating drive gear coupling as received. The pump exhibited indications of damage consistent with impact damage—this included crushing of the pump housing, gouging and scarring of the pump, and tearing of the orange pump seals. The drive side flanges had fractured from the rest of the pump housing (see Figure 2).

Figure 1 – The vacuum pump and drive gear coupling, as received.

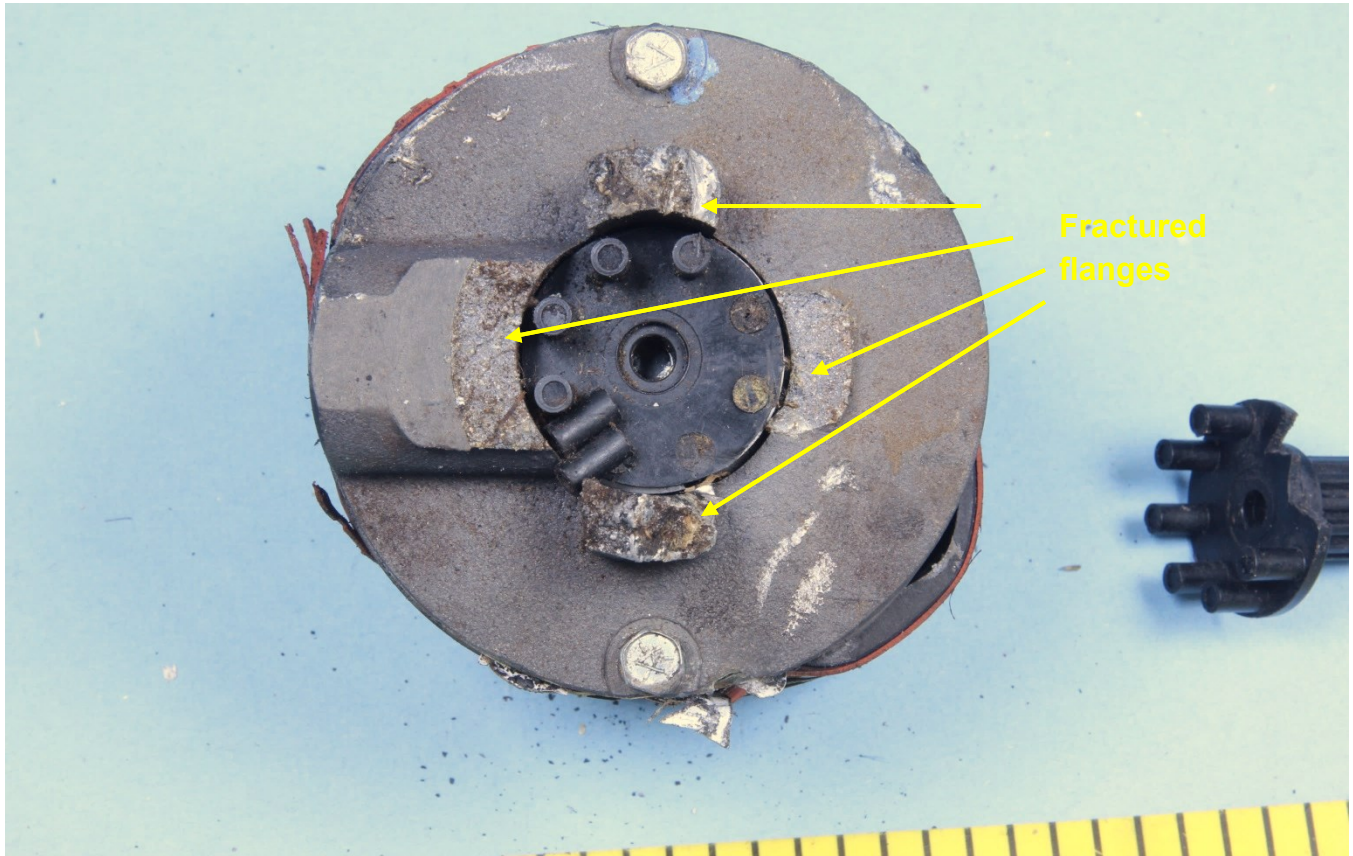
Figure 2 – The pump housing, view from the drive or inlet side, showing fractured flanges.

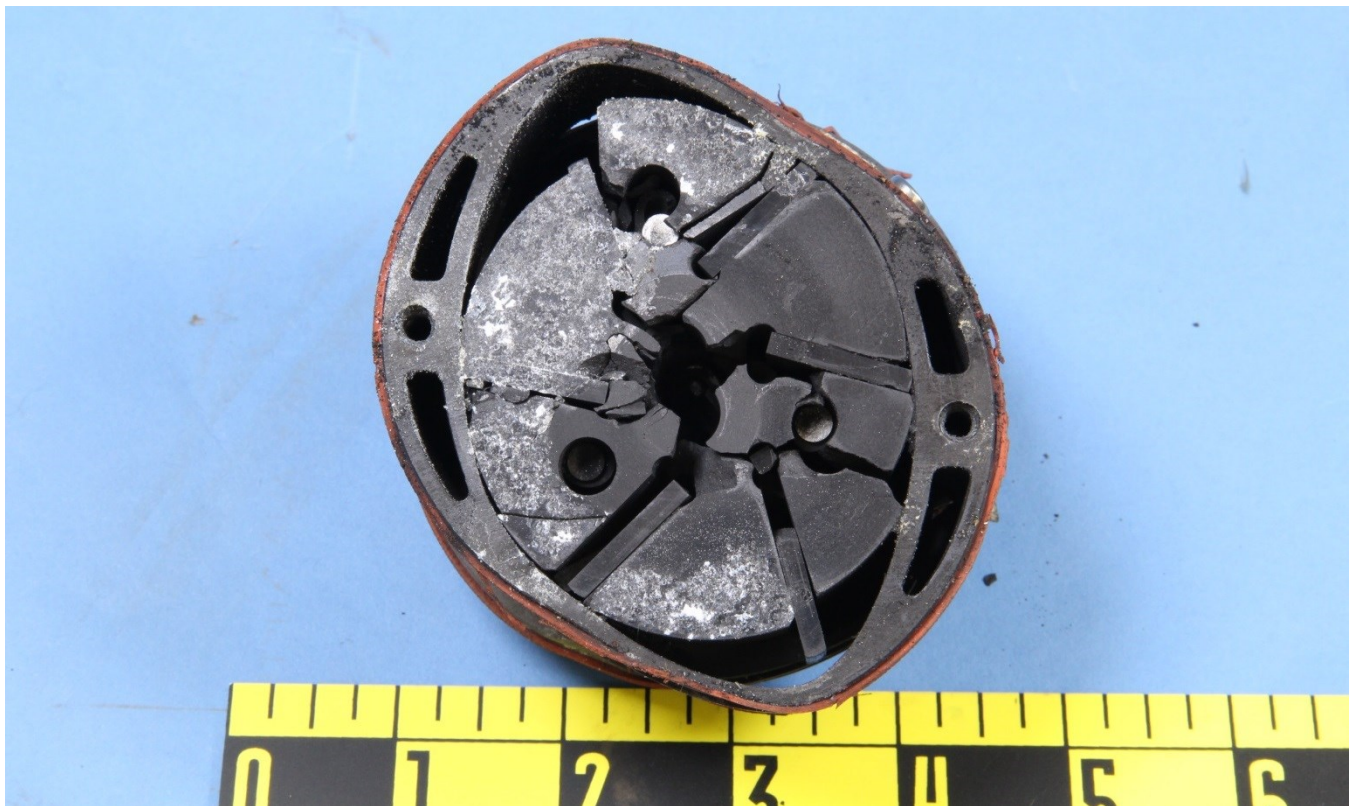
However, upon opening the pump, both the rotor and the six vanes were found fractured in multiple places with no obvious initiation site (see Figure 3). The rotor had fractured in a direction consistent with the deformation in the circumferential pump housing, as see in Figure 3. This face of the fractured rotor also exhibited a white dried substance, consistent with residual compounds from a dried fluid that had pooled in the pump.

Figure 3 – The interior of the vacuum pump, after removal of the drive side housing cover (shown Figure 2).

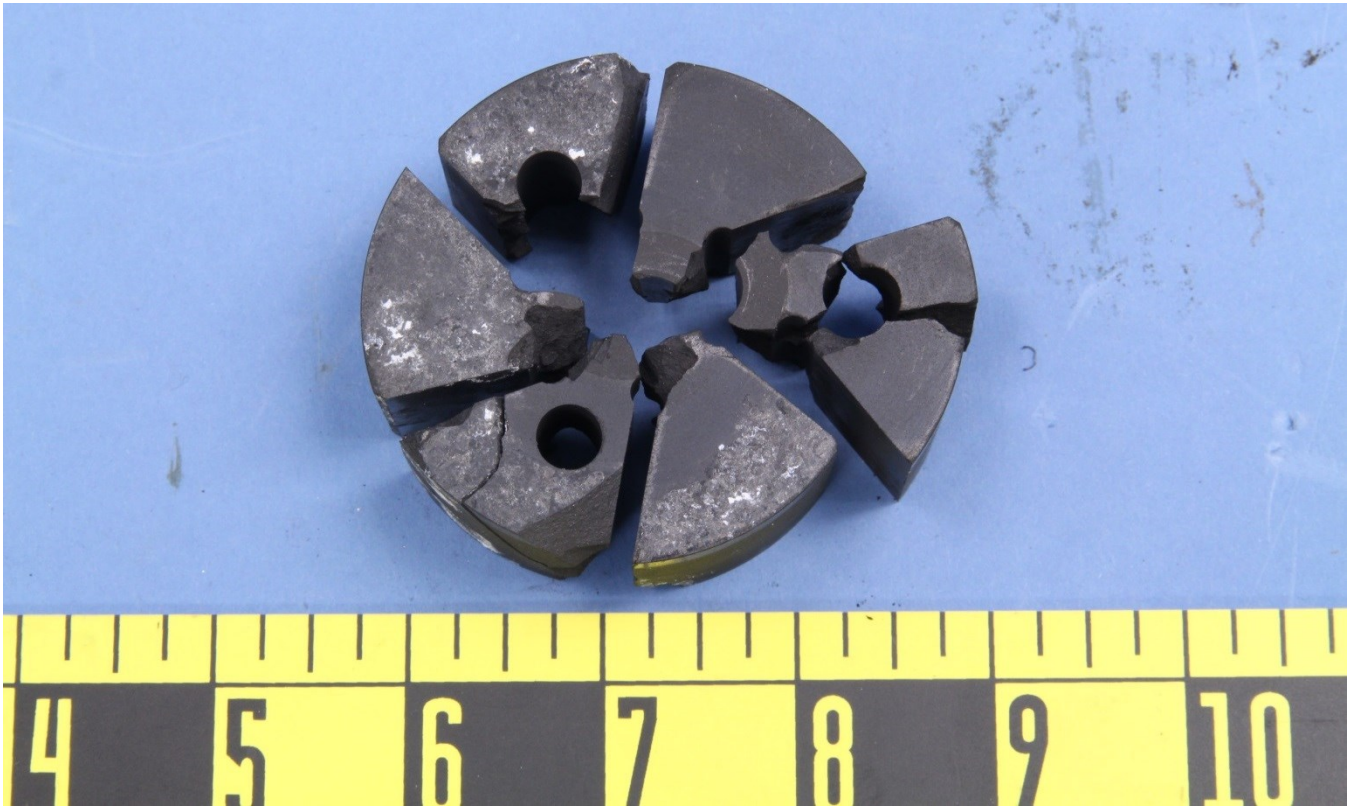
The rotor was removed from the pump housing, and it is illustrated in Figure 4 and Figure 5. The opposite face of the rotor pieces exhibited a circular grinding pattern on the outside of the rotor. This wear pattern was consistent with the rotor having turned while in contact with the adjacent pump housing. In addition, circumferential wear marks were found on the outside surfaces of the fractured rotor. These witness marks were generally located on either edge of the rotor, consistent with contact while rotating. The fracture surfaces of the rotor pieces exhibited a rough morphology with a dull luster—these features were consistent with overstress failure of brittle materials.

Figure 4 – The fractured rotor pieces, after removal from the pump housing.

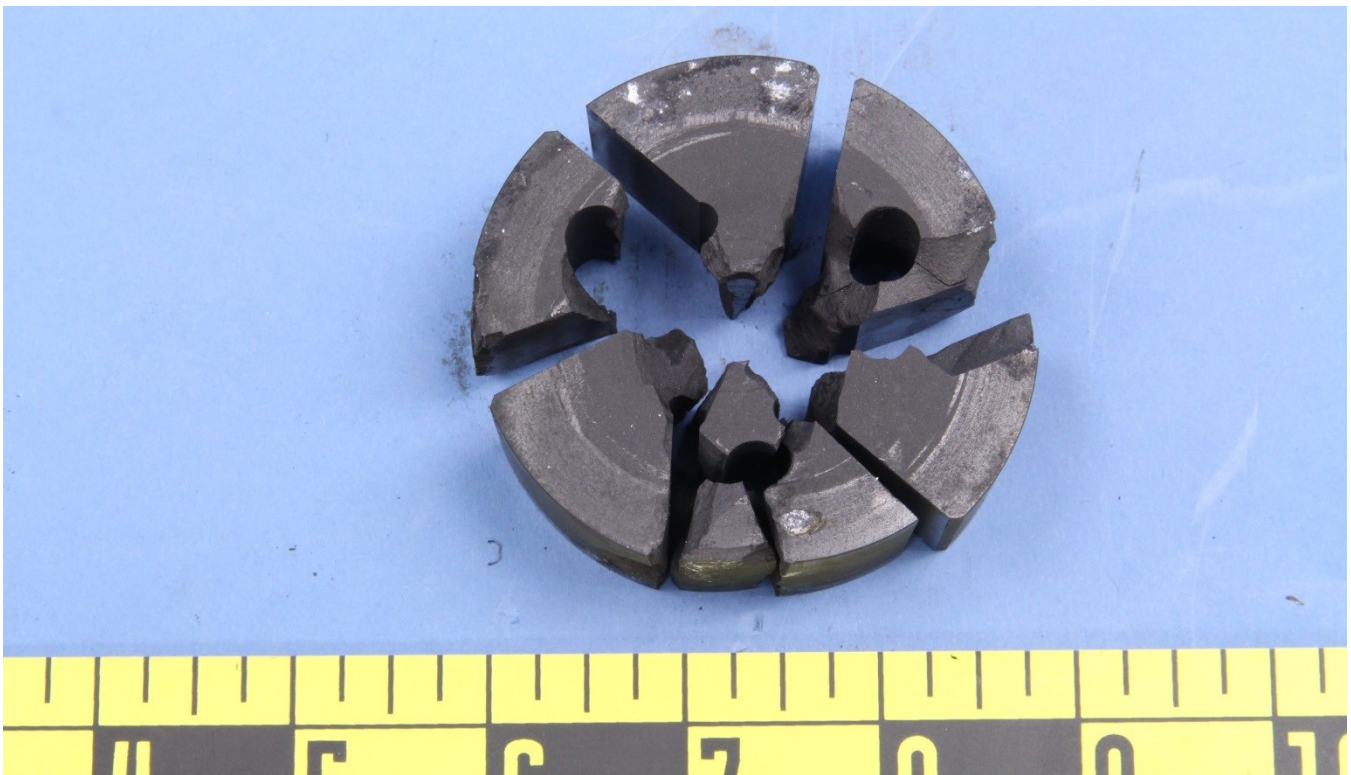
Figure 5 – The fractured rotor pieces, after removal from the pump housing, opposite side of that Figure 4.

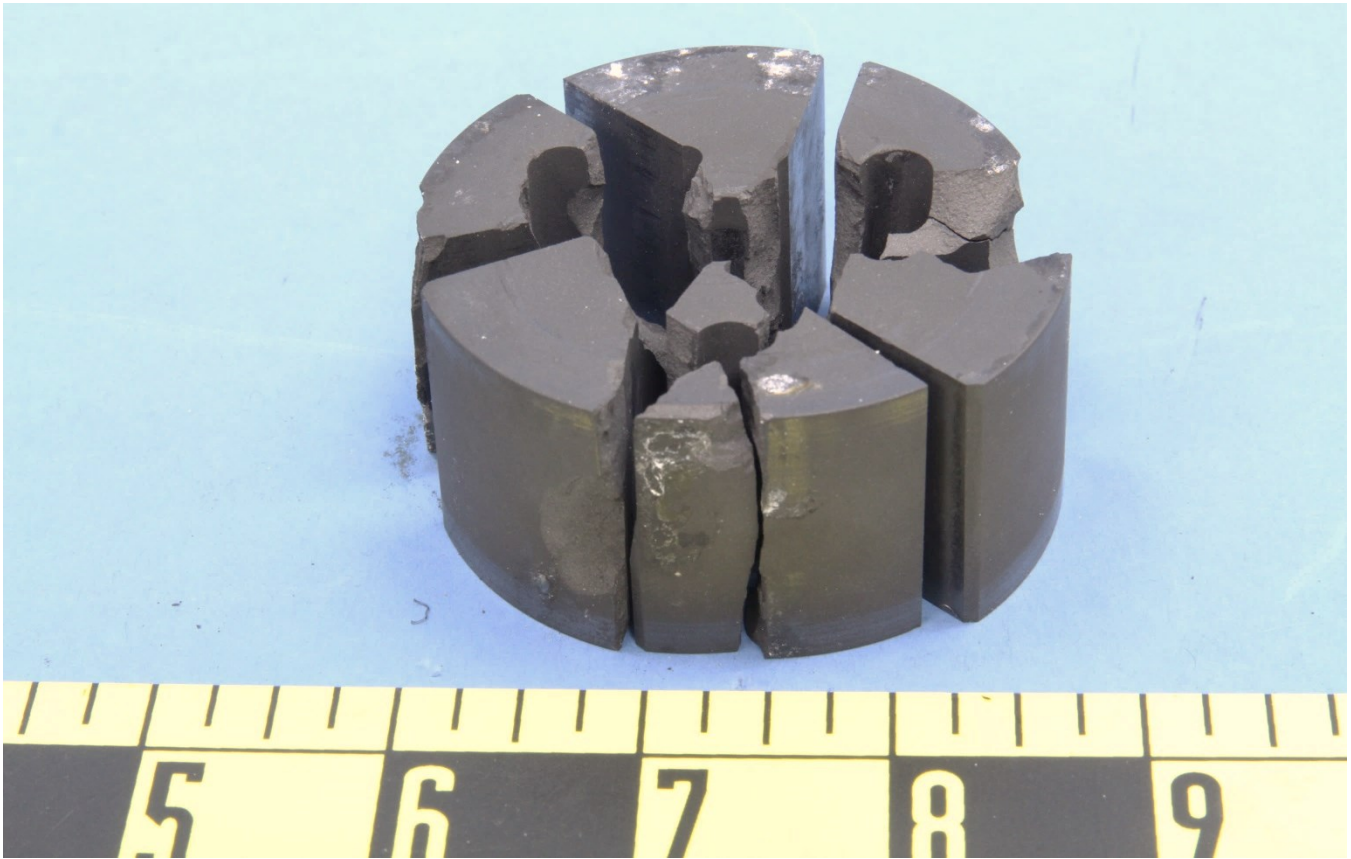
Figure 6 – The side of the fractured rotor, showing smoothed areas and circumferential wear marks.

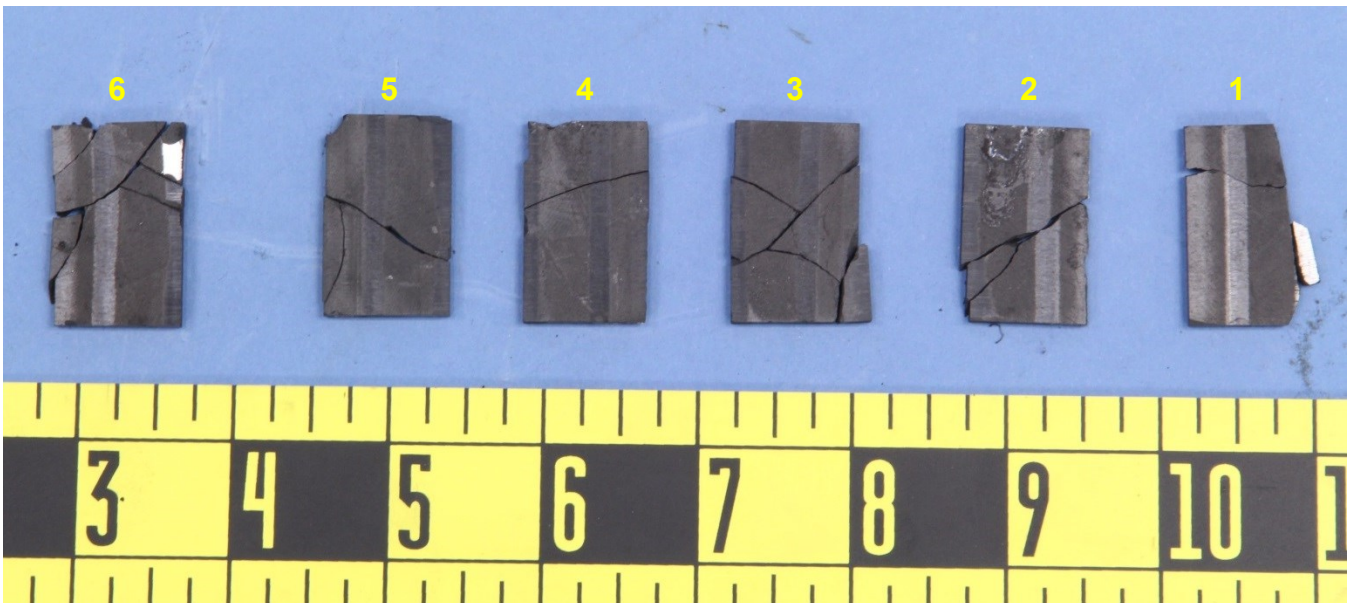
The six vanes were removed and reconstructed using the largest remaining pieces. The vanes were labeled 1 through 6 for the purposes of this report, and they are illustrated in Figure 7. All of the vanes had cracked in multiple places. Each vane generally contained a primary crack that had progressed from one edge to the other, typically with branching cracks emanating from the primary crack. The fracture surfaces of the vane fragments exhibited a rough morphology with a dull luster, consistent with overstress failure of brittle materials. Horizontal and vertical sliding marks were present on the faces of the vanes. These marks were consistent with similar marks on the machined inside faces of the rotor pieces. The horizontal marks were consistent with sliding of the vanes that occurred during rotational operation of the rotor. Each of the vanes exhibited one flat vertical face and one rounded vertical face. The vane widths were measured using a micrometer, and are listed in Table I. All of the vanes exhibited a thickness of 0.8155 inches, with the exception of Vanes 1 and 6.

Vane Number	Width (inches)	Notes
1	0.7935	Inner face chipped and broken, max width reported.
2	0.8155	
3	0.8155	
4	0.8155	
5	0.8155	
6	0.8125

Figure 7 – The fractured vanes, after removal from the pump housing. The vanes were labeled 1 through 6 for the purposes of this report.

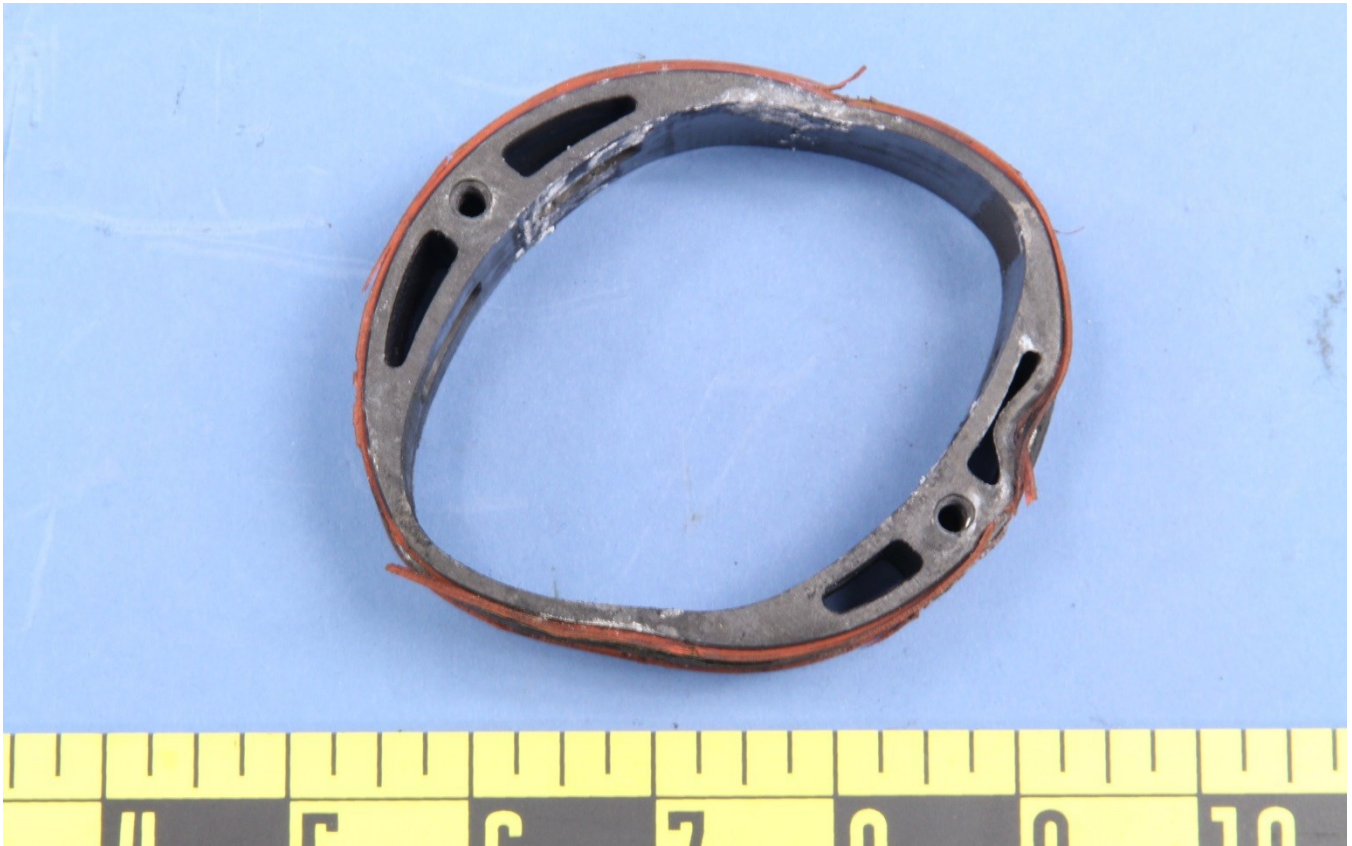
The pump housing is illustrated in Figure 8 and Figure 9, after pump disassembly. The circular housing had been deformed consistent with compressive crushing. One of the outer walls of the housing, adjacent to a through-bolt hole, had buckled inward. The interior face of the housing exhibited deep scarring consistent with contact with the rotor. Many of the interior scars exhibited features consistent with rotational wear. The dried white residue found on the rotor faces was present on the housing interior. The size of the one of the residue patterns was consistent with the size and shape of a rotor finger (see Figure 9).

Figure 8 – The crushed pump housing.

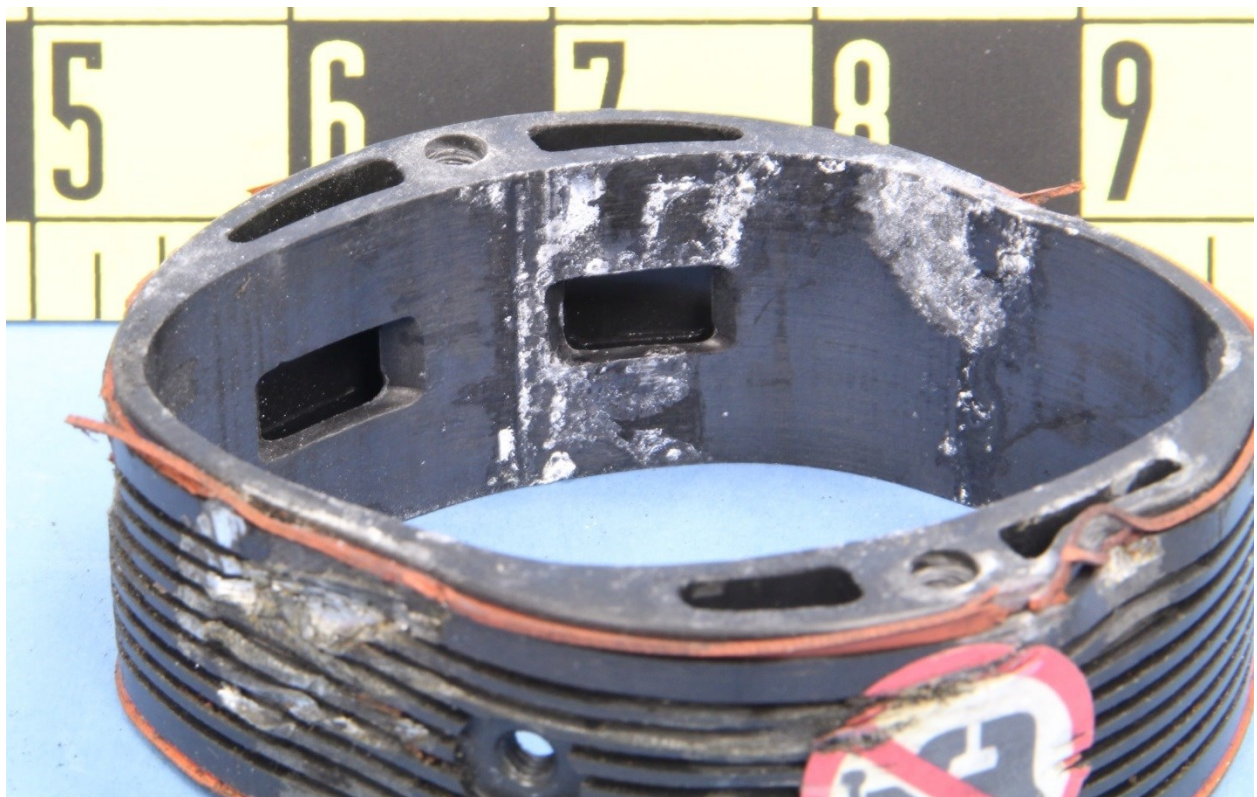
Figure 9 – Interior view of the crushed pump housing, showing witness marks of the mating rotor piece, circumferential wear marks and gouging, and indications of dried residue from pooled fluid.
