# NATIONAL TRANSPORTATION SAFETY BOARD

MATERIALS LABORATORY FACTUAL REPORT

Report No. 14-008

Place : Fallon, Nevada  
Date : July 10, 2012  
Vehicle : Raytheon A36, N517DJ  
NTSB No. : WPR13LA321  
Investigator : Patrick Jones, AS-WPR

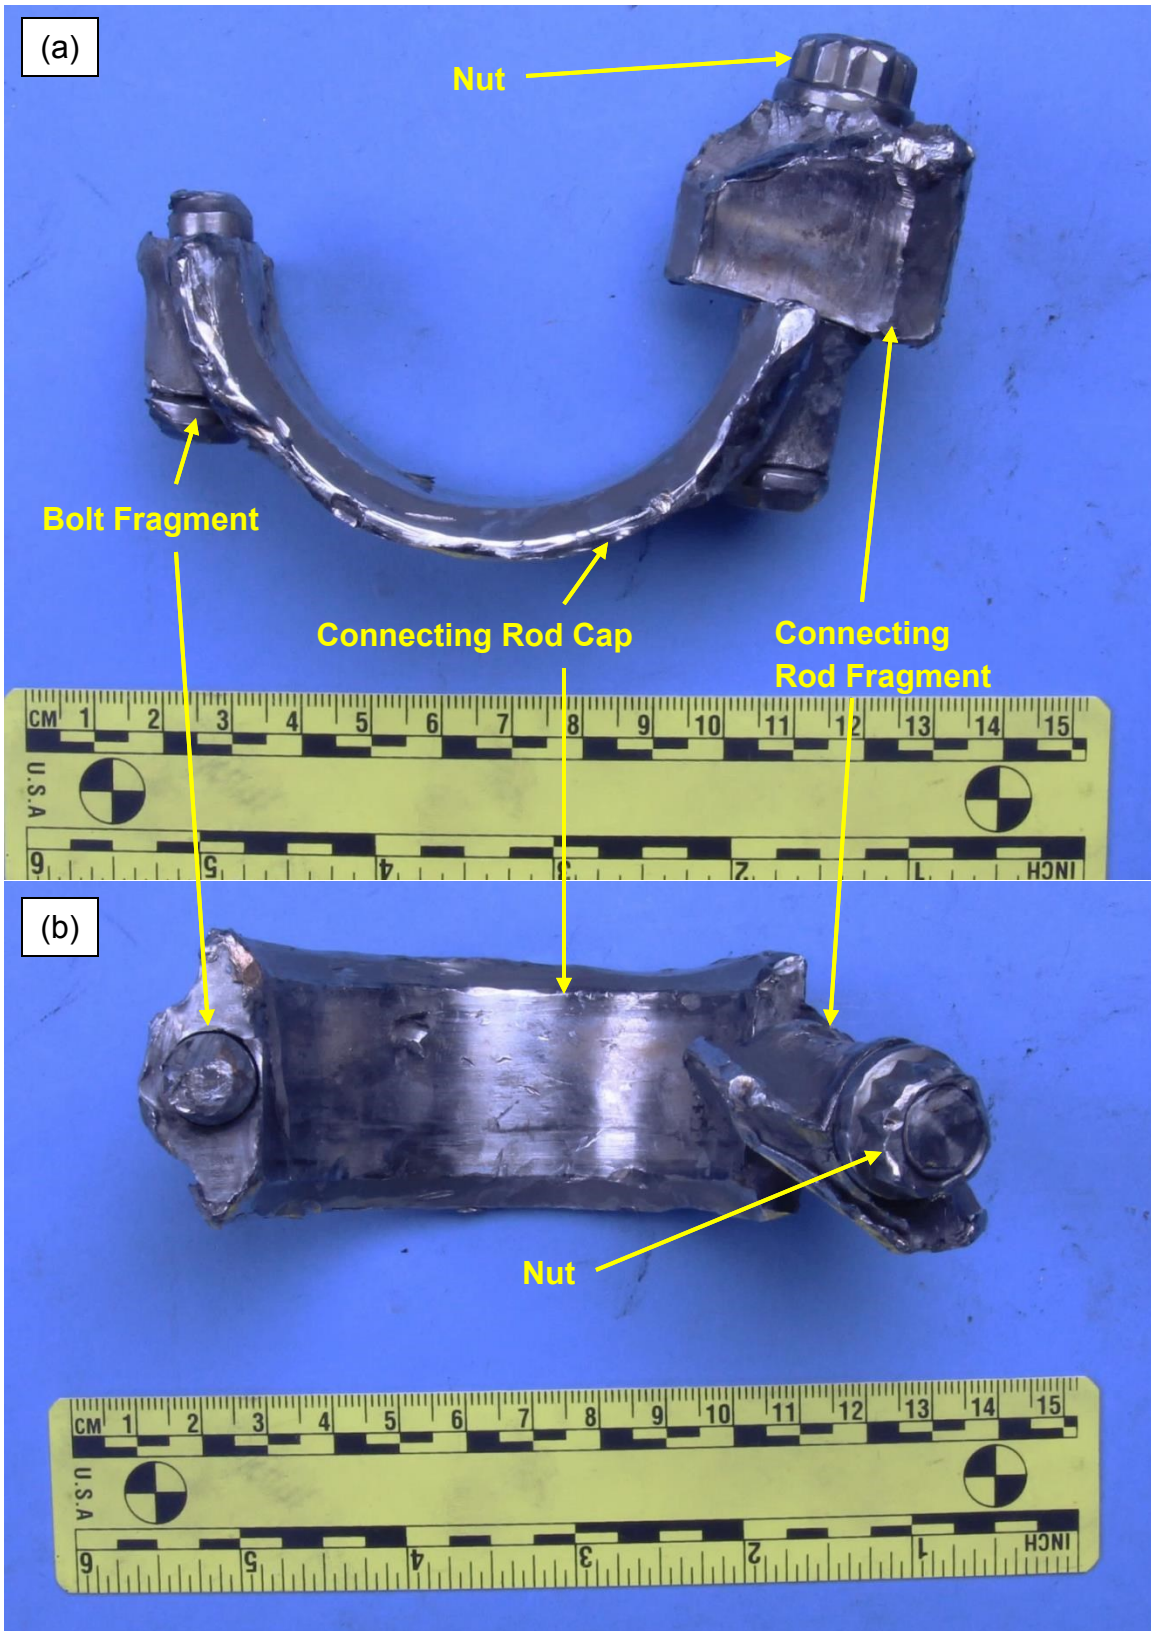
Of particular note was the #5 connecting rod cap assembly, shown in Figure 1. One of the bolts had fractured at midlength, whereas the opposite bolt was intact with the nut still fastened. This intact bolt still held a fragment of the connecting rod yoke against the rod cap. The #5 cap exhibited damage on all surfaces consistent with ground impact.

Figure 1 – The connecting rod cap, from (a) the side and (b) the inner race surface.

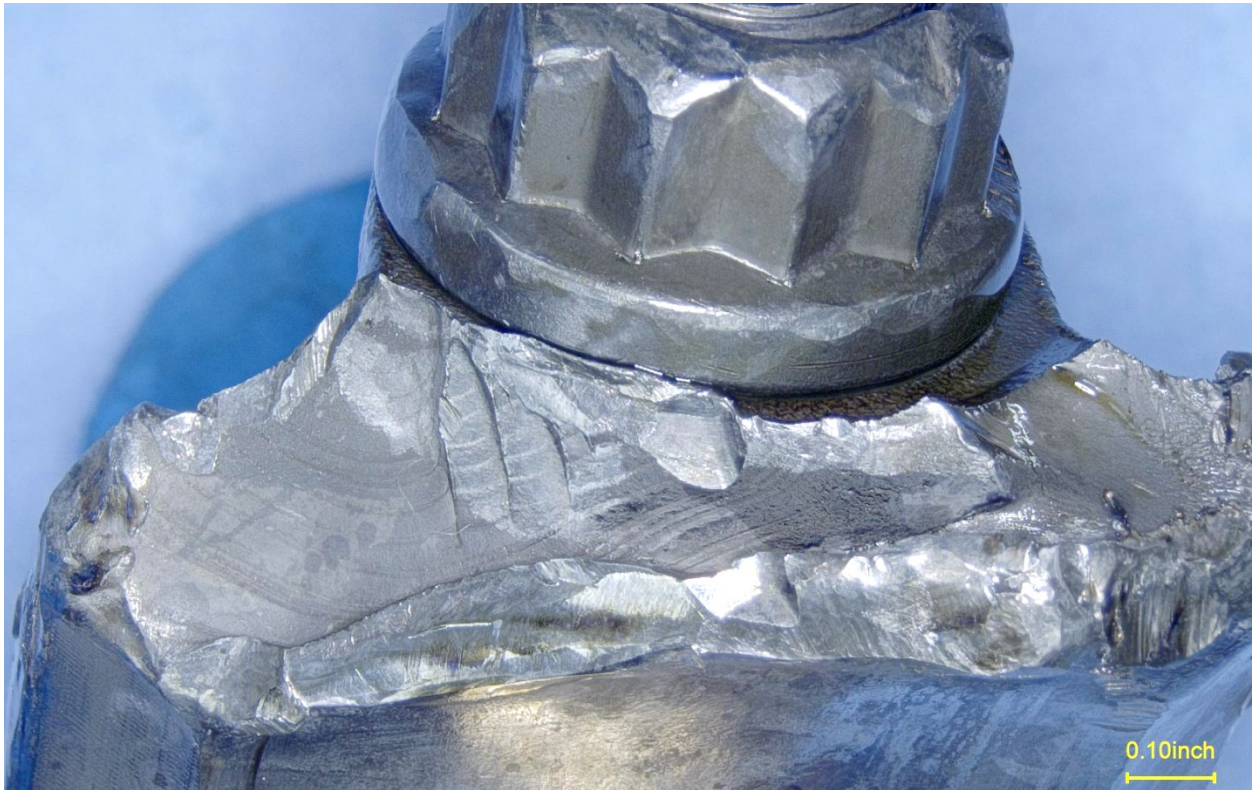
Figure 2 shows the fracture surface of the #5 connecting rod yoke fragment attached to the cap. The fracture features show crack arrest marks and ratchet marks, which are consistent with progressive fatigue cracking. The progressive cracking features were present over approximately 75% of the fracture surface. As shown in Figure 3, the crack propagated inward approximately 45° from the bolt direction, but approximately 90° to the connecting rod yoke fragment direction. The crack initiated on the outer surface adjacent to the nut-facing boss (Figure 4).

Figure 2 – The fragment of the connecting rod yoke, showing the fatigue crack.

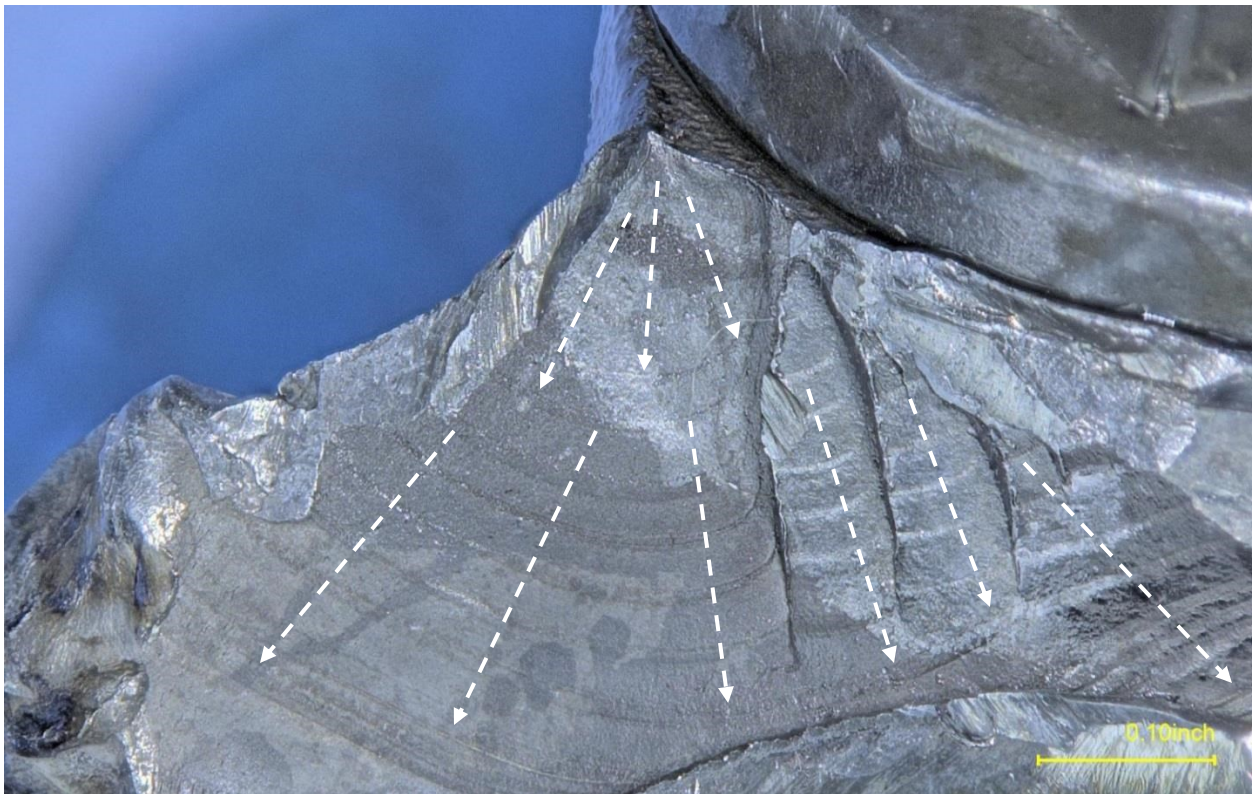
Figure 3 – Closer view of the fatigue crack in Figure 2, showing clear crack arrest marks with arrows denoting the crack growth direction from the initiation point.

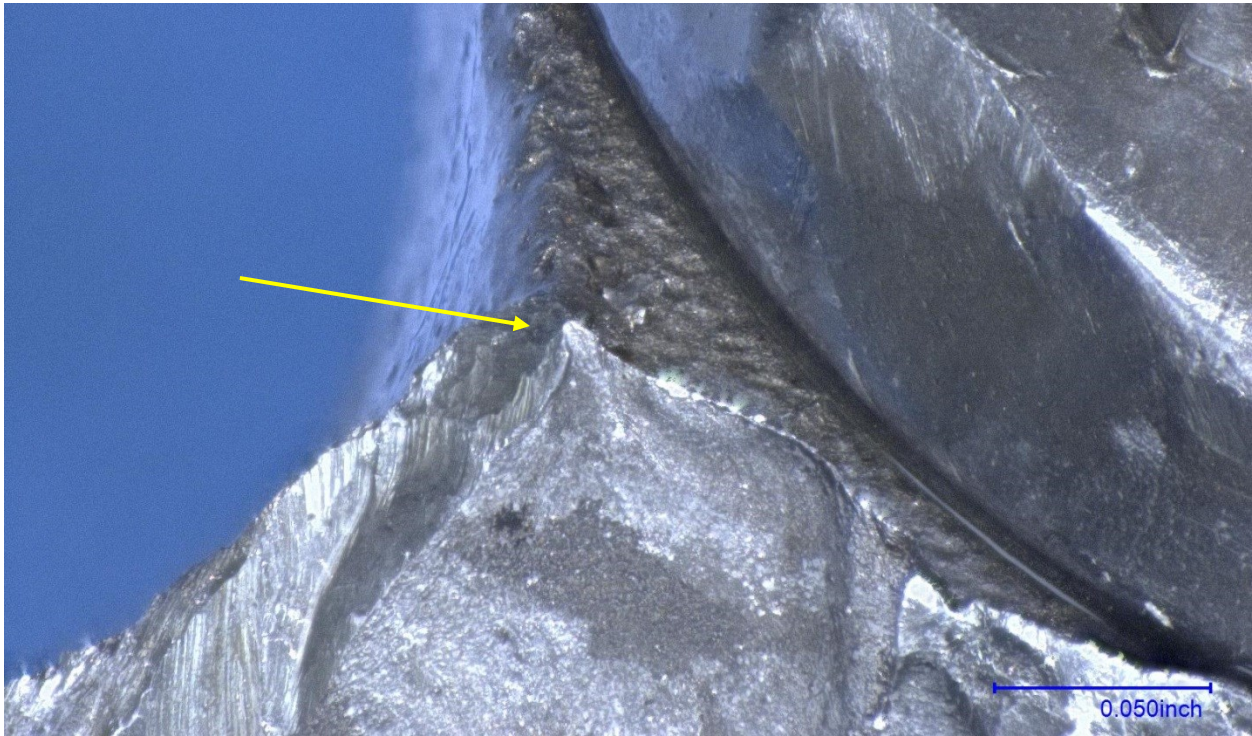
Figure 4 – The crack initiation point (arrow) of the fatigue crack on the connecting rod yoke fragment.

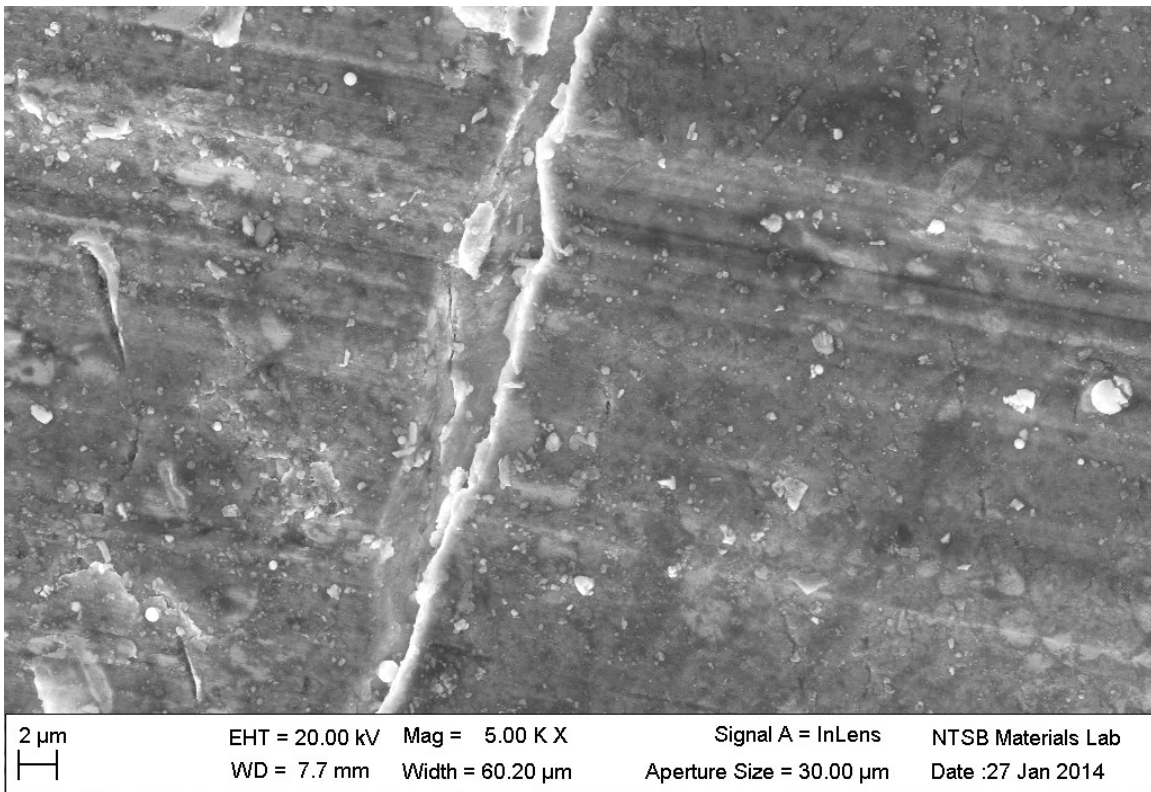
The connecting rod fragment fracture surface was inspected using a scanning electron microscope (SEM). As illustrated in Figure 5, the majority of the fracture surface exhibited striations, indicative of fatigue cracking. The crack initiation site is illustrated in Figure 6 and Figure 7. The initiation site shows material smearing over the beginning of the crack. In addition, inspection of the fracture surface using backscattered electron imaging revealed no dissimilar material embedded at the crack initiation site (see Figure 7)<sup>2</sup>. The end of the fracture surface exhibited dimple rupture, consistent with overstress.

Figure 5 – Secondary electron (SE) micrograph of the connecting rod yoke fracture surface, showing fatigue striations.

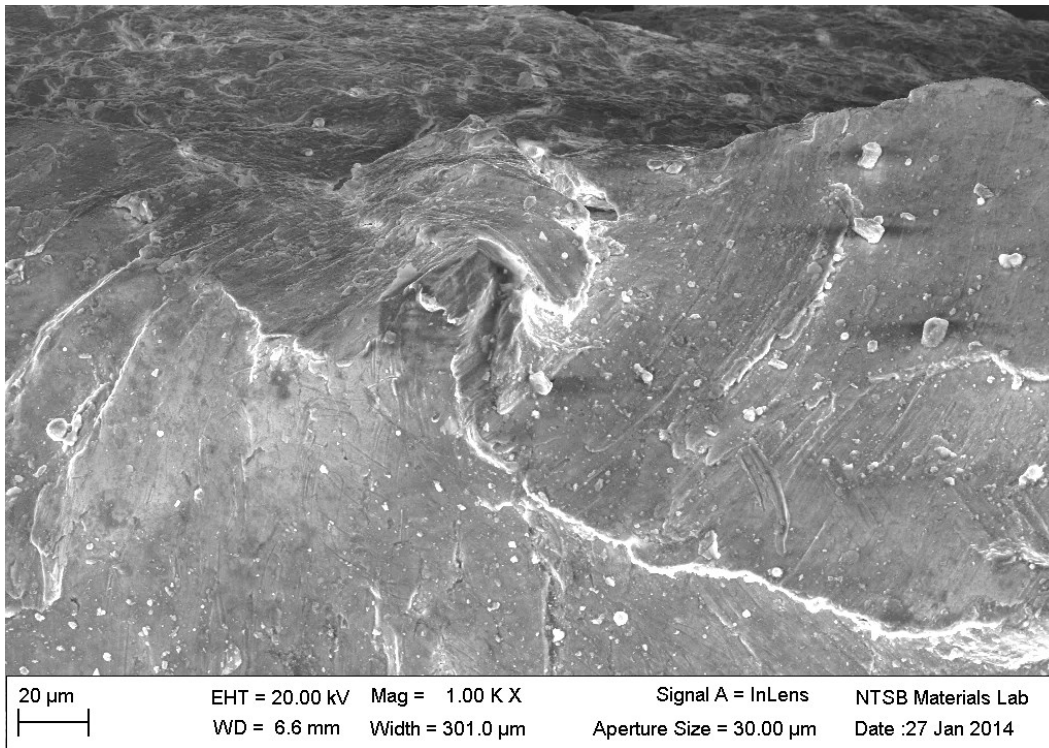
Figure 6 – SE micrograph of the connecting rod yoke fatigue crack initiation site.

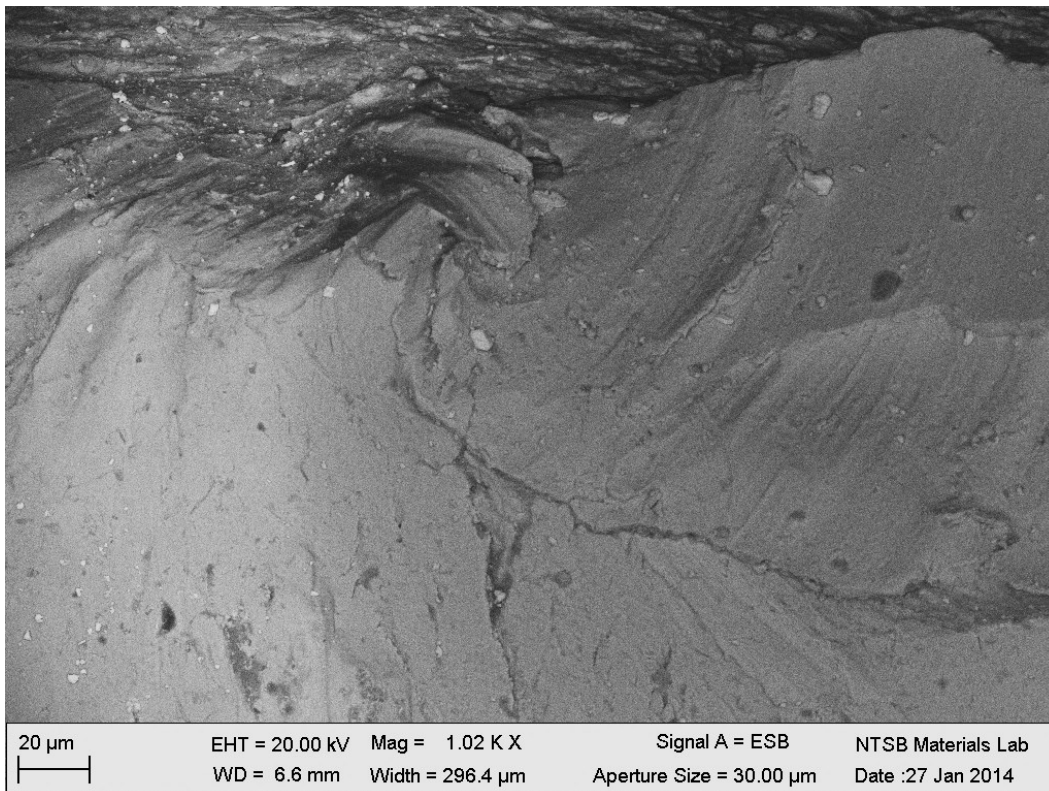
Figure 7 – BE micrograph of the connecting rod yoke fatigue crack initiation site. No foreign material was found at the initiation site.

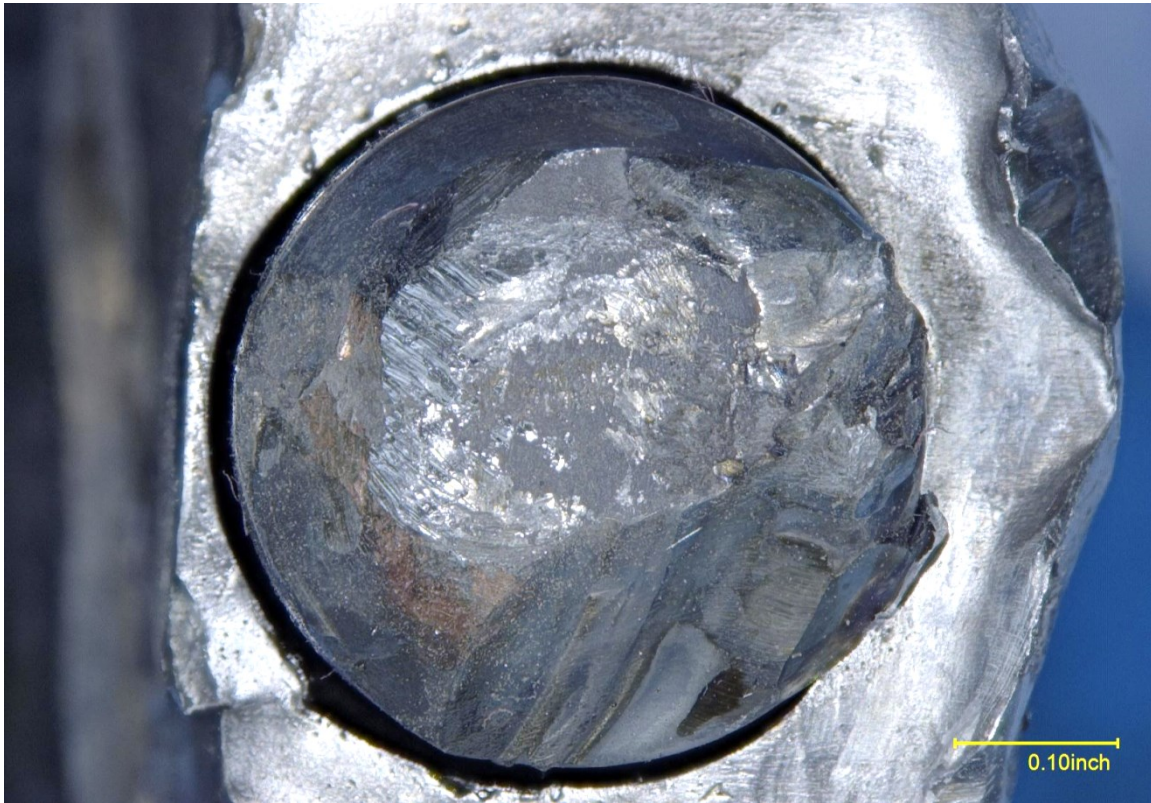
The fracture surface of the broken bolt from the #5 connecting rod assembly is shown in Figure 8. Most of the fracture surface had been obliterated by smearing, consistent with post-impact damage. The portions of the original fracture surface that remained are illustrated in Figure 9. The fracture surface was inspected using a SEM. As shown in Figure 10, the fracture features were consistent with dimple rupture, indicative of overstress. There were no indications of other failure modes. The chemical composition of the connecting bolt was inspected using EDS. The composition was consistent with nominal AISI 4340 and 4337.

Figure 8 – The fractured end bolt on the connecting rod cap.

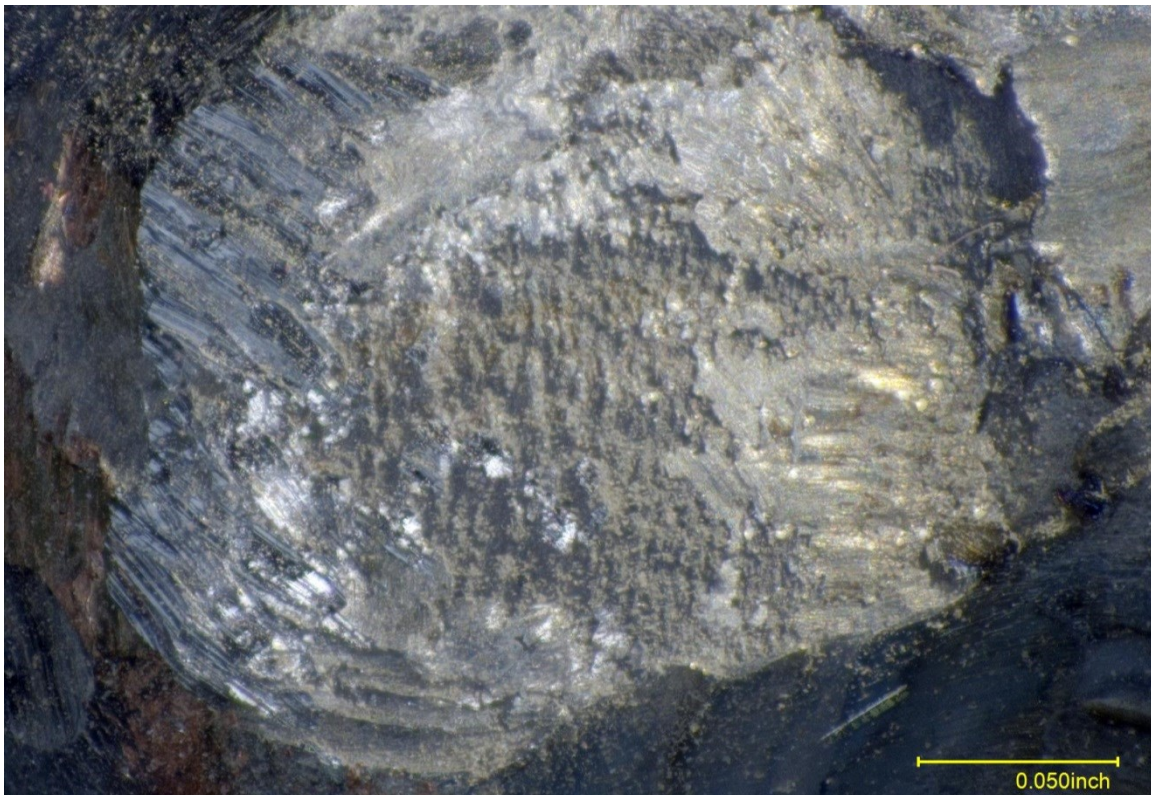
Figure 9 – Closer view of the undamaged fracture surface on the fractured bolt.

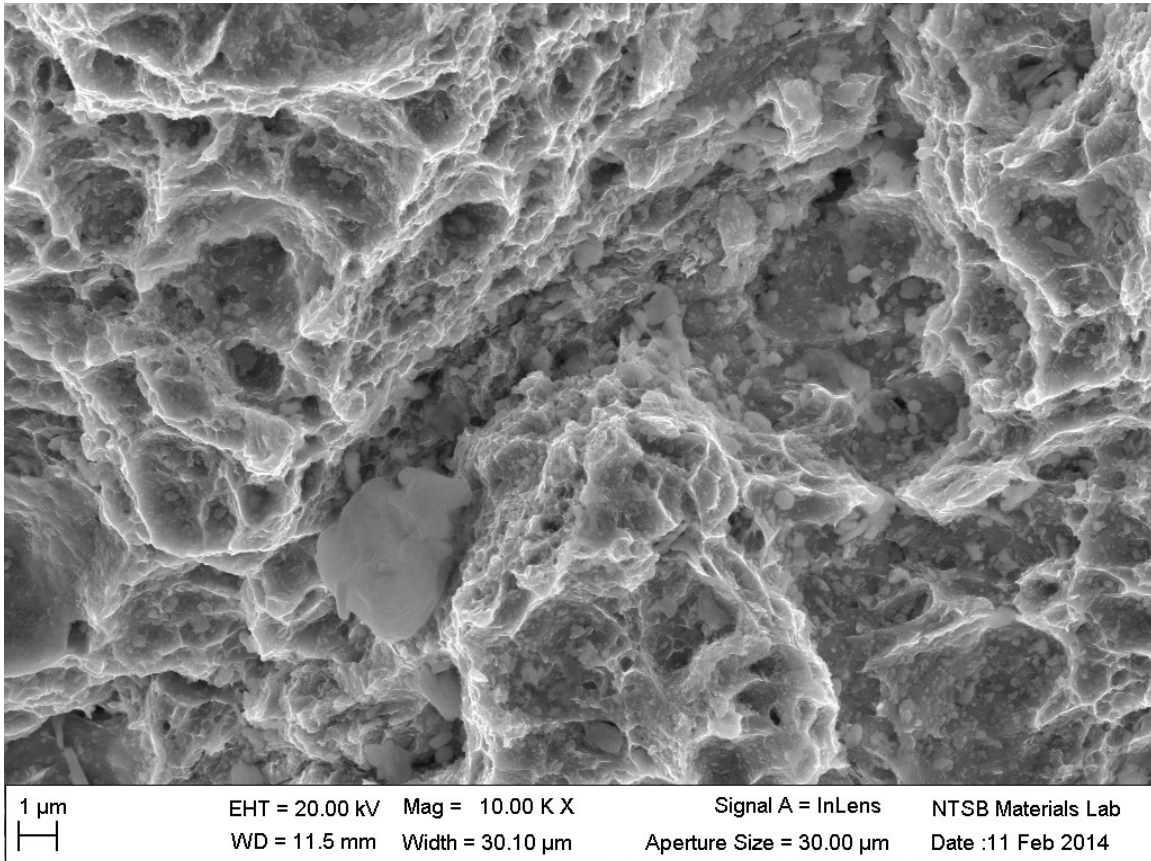
Figure 10 – SE micrograph of the bolt fracture surface, showing dimple rupture indicative of overstress.
