NATIONAL TRANSPORTATION SAFETY BOARD

MATERIALS LABORATORY FACTUAL REPORT

Report No. 15-085

Place : Marco Island, Florida
Date : March 1, 2015
Vehicle : Canadair CL-600-2A12, N600NP
NTSB No. : ERA15LA140
Investigator : Tim Monville, AS-ERA

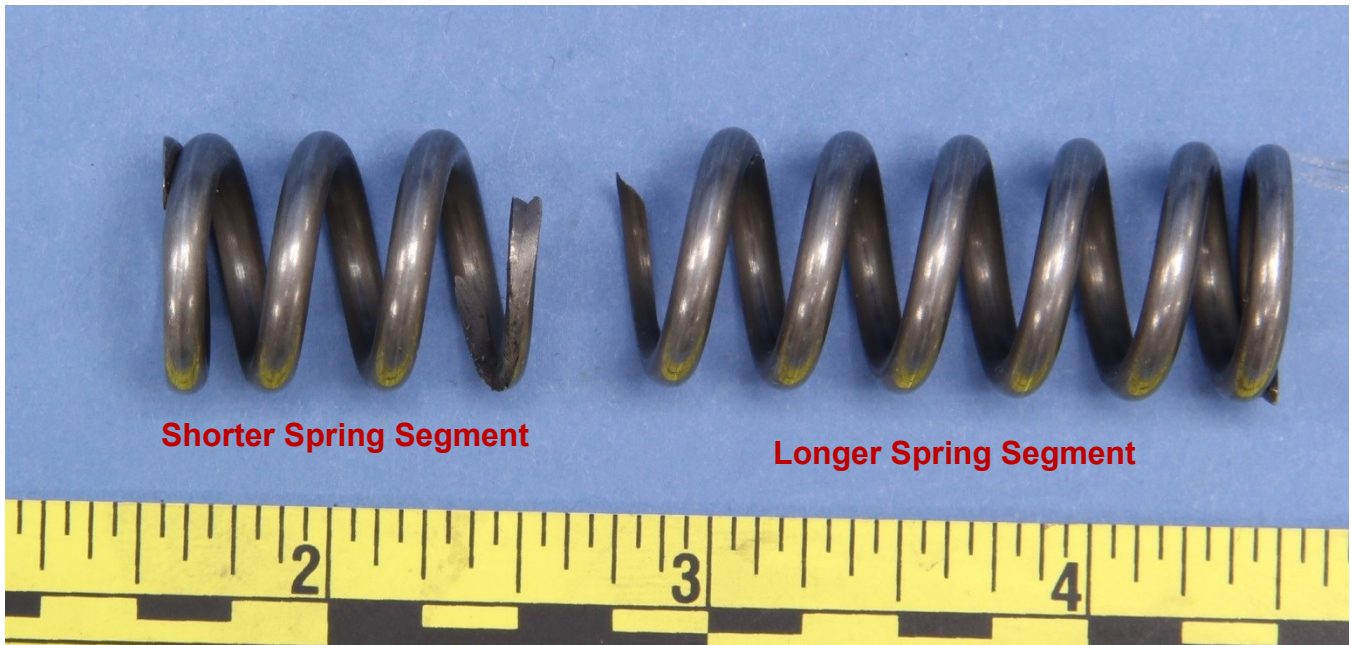
During the on-scene investigation, one of the brake springs was found fractured. This part, along with a fluid sample, was sent to the NTSB Materials Laboratory. Figure 1 and Figure 2 show the fractured power brake spring, as received. The spring had fractured at the fourth turn (from the left side, as depicted in Figure 1). The orientation of the fracture surface was generally angled parallel to the spring longitudinal direction, as opposed to a transverse orientation akin to a cross-section (the spring compression direction). For the purposes of this report, the mating fracture halves were identified as belonging to the shorter or longer spring fragment.

Figure 1 – The fractured power brake spring, as received.

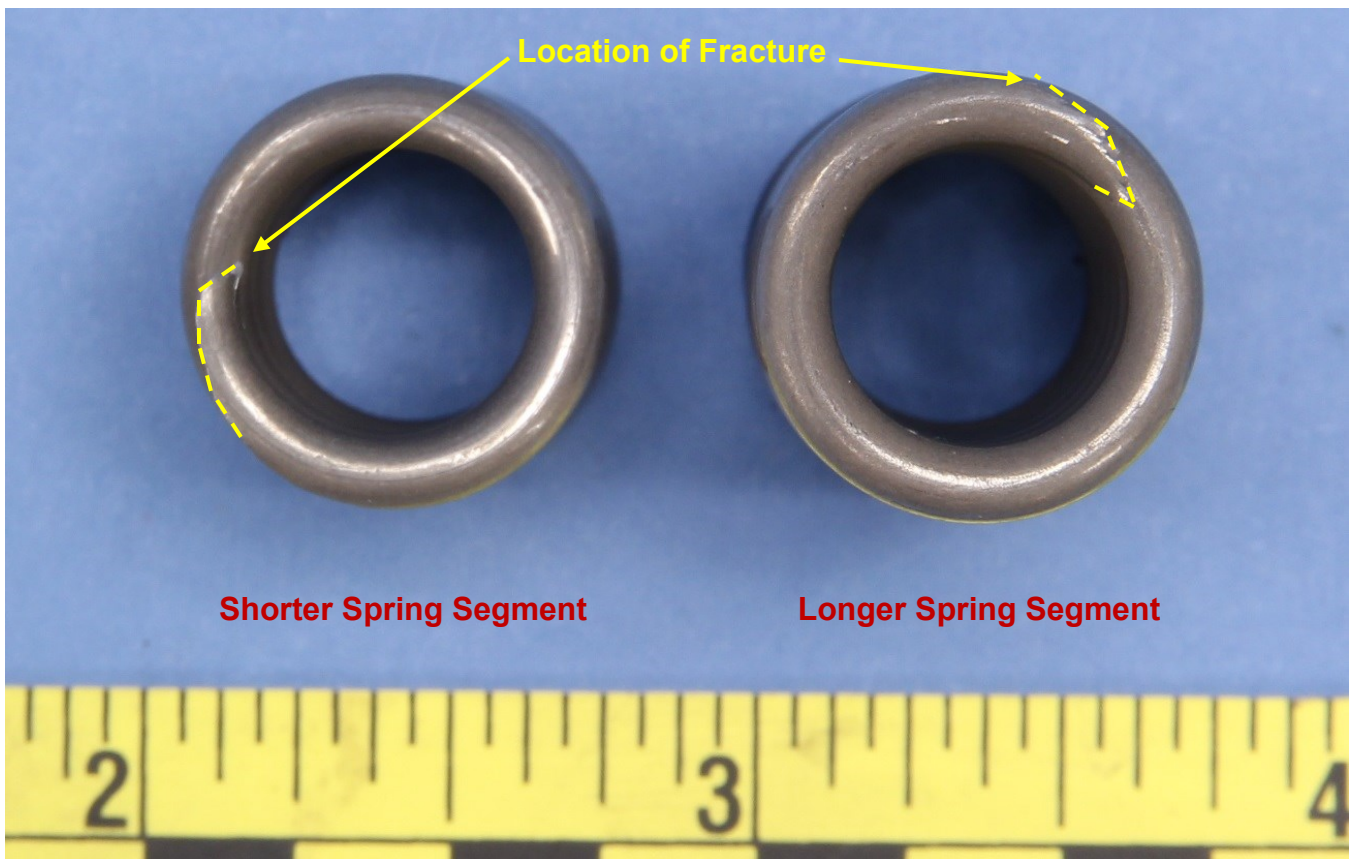
Figure 2 – The fractured power brake spring, as viewed from the fractured sides.

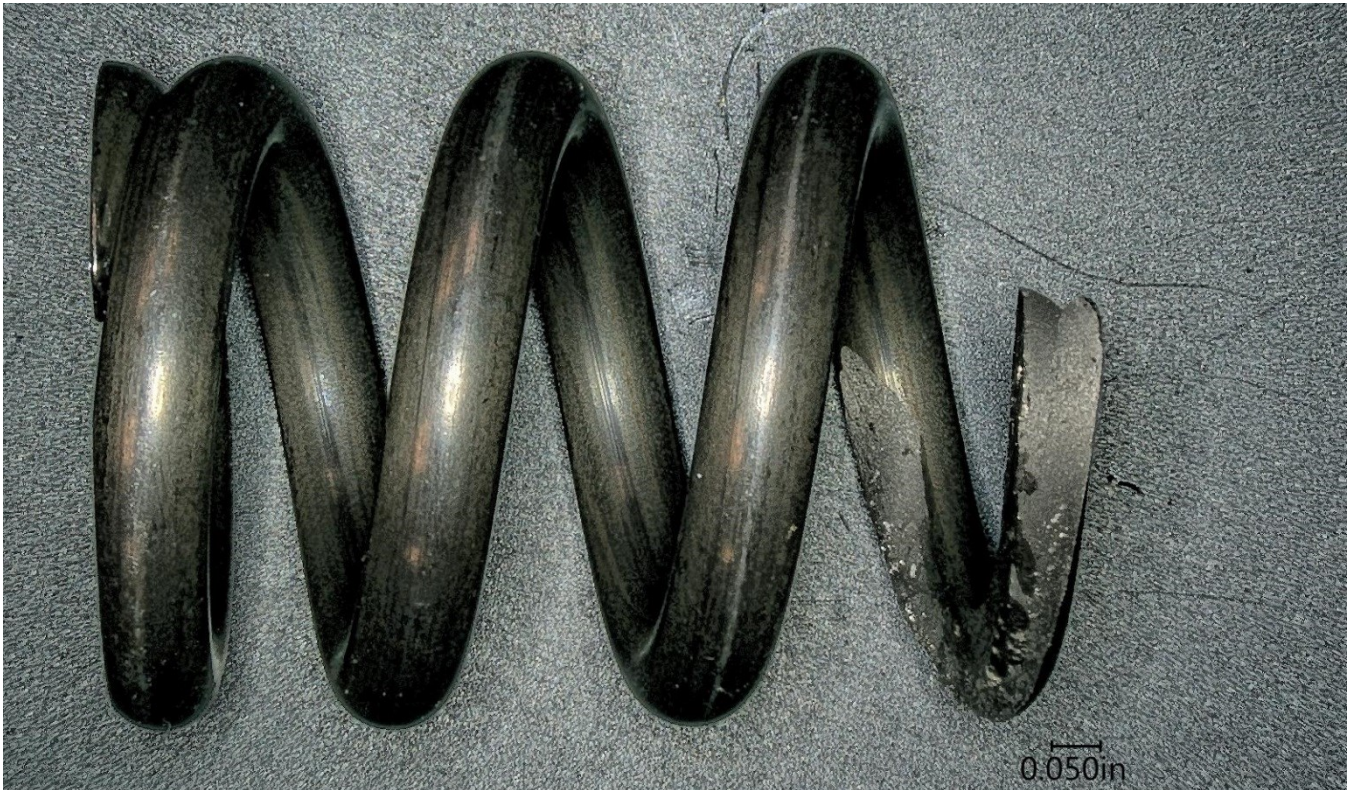
The mating fracture surfaces of the spring are highlighted in Figures 3 through 6. The fracture surface generally exhibited a curved, angled morphology that rotated around the spring (see Figure 4). The fracture surface generally was rough in appearance, with a dull, non-reflective luster.

The inner surface of the spring exhibited a flat smoother area, suggestive of a witness mark from contact with an adjacent component (Figure 5). This inner witness mark was collocated along the flatter smeared portions of the mating fracture surfaces (Figure 4). There was also a similar but less pronounced mark on the outside surface of the spring (Figure 3).

Figure 3 – The shorter spring fragment, showing the fracture surface, towards the right.

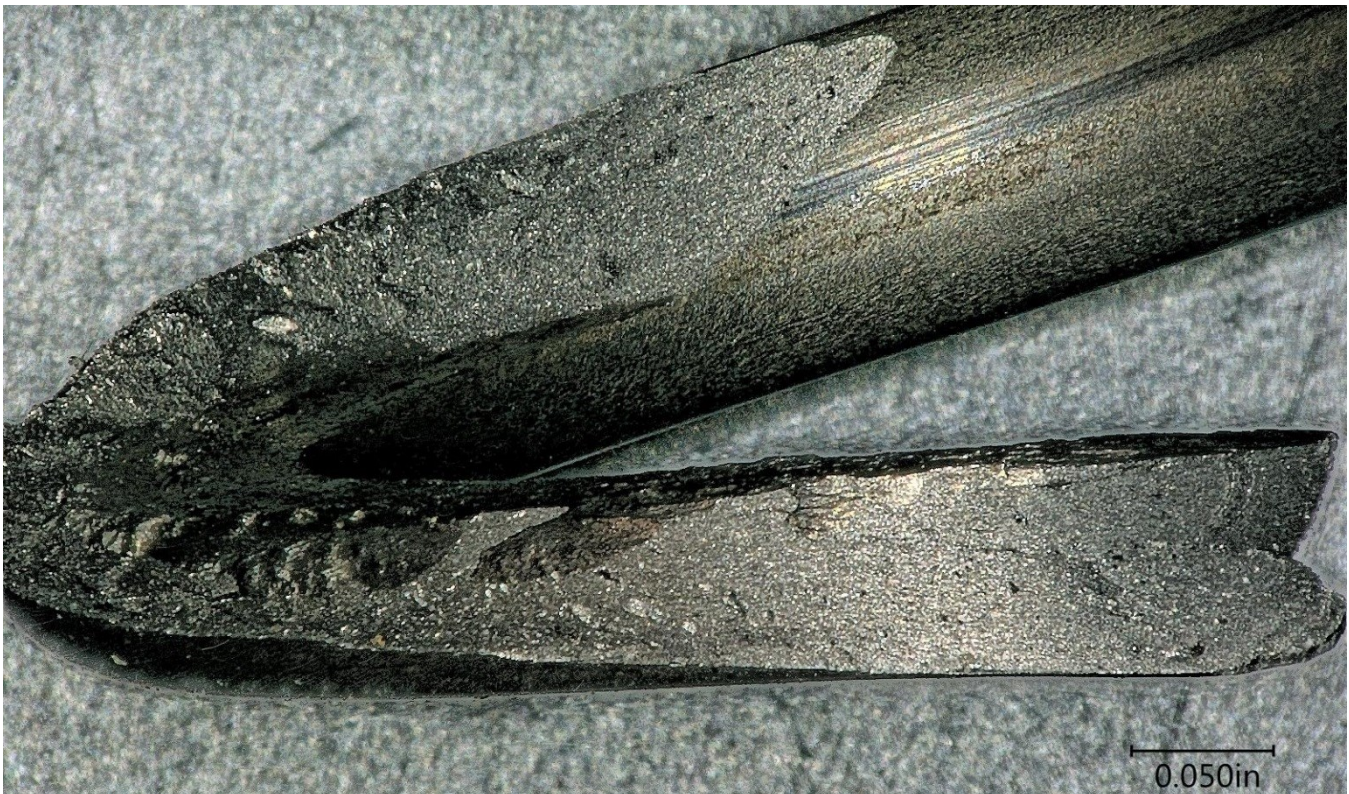
Figure 4 – Closer view of the shorter spring fragment fracture surface.

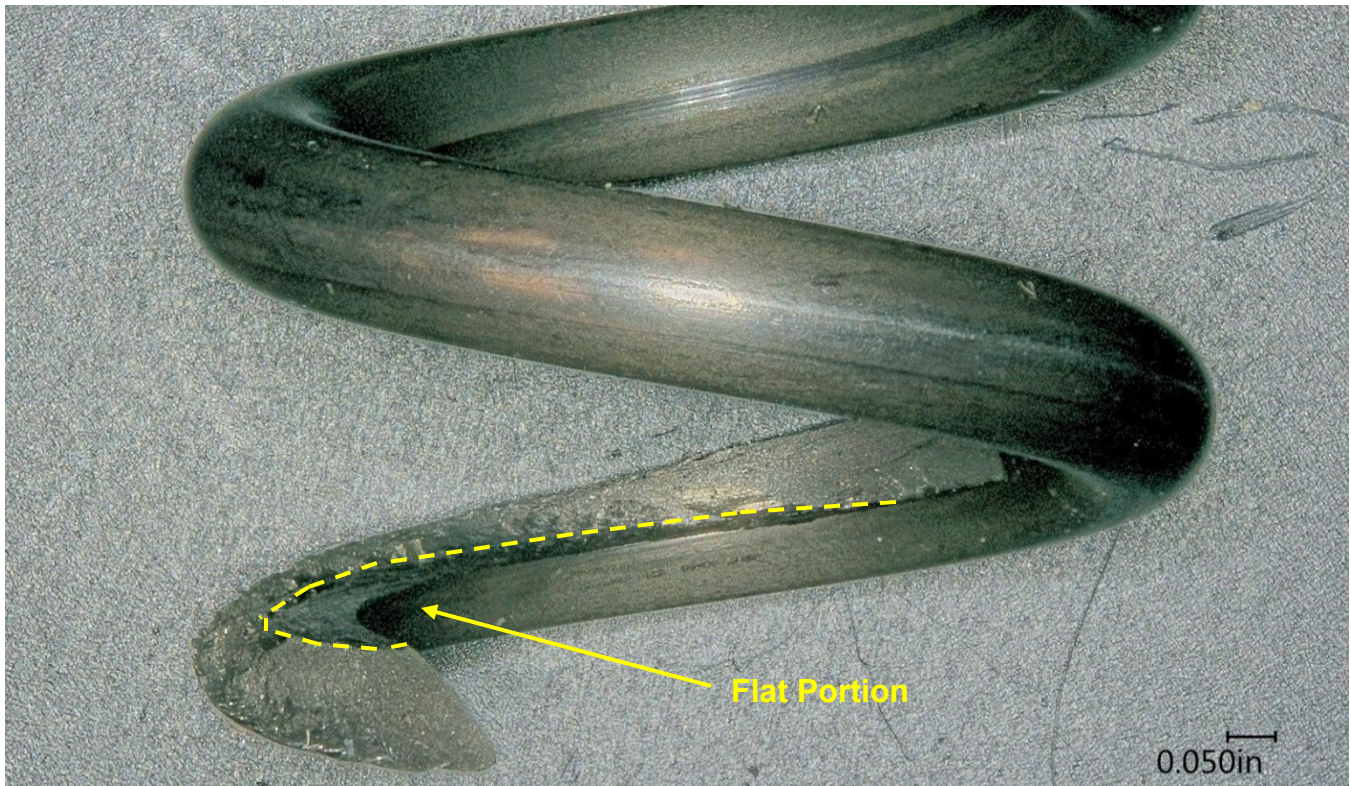
Figure 5 – The fracture surface of the longer spring fragment.

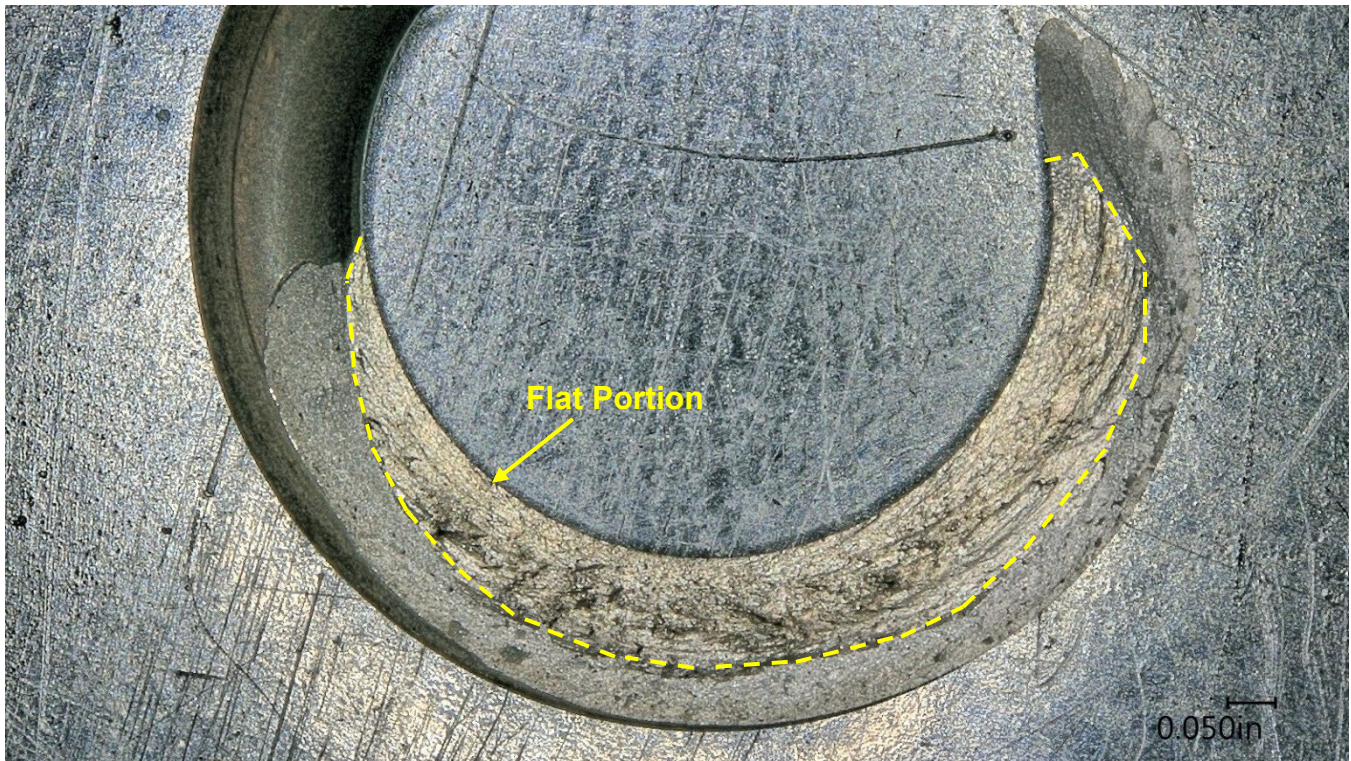
There was a portion of the fracture surface that was generally smoother and flatter, positioned on the inside surface of the spring. This portion of the fracture surface was most evident in Figure 6. Both mating halves of the fracture surface contained this flatter, reflective region.

Figure 6 – The longer spring fragment fracture surface, after sectioning from the rest of the spring fragment.

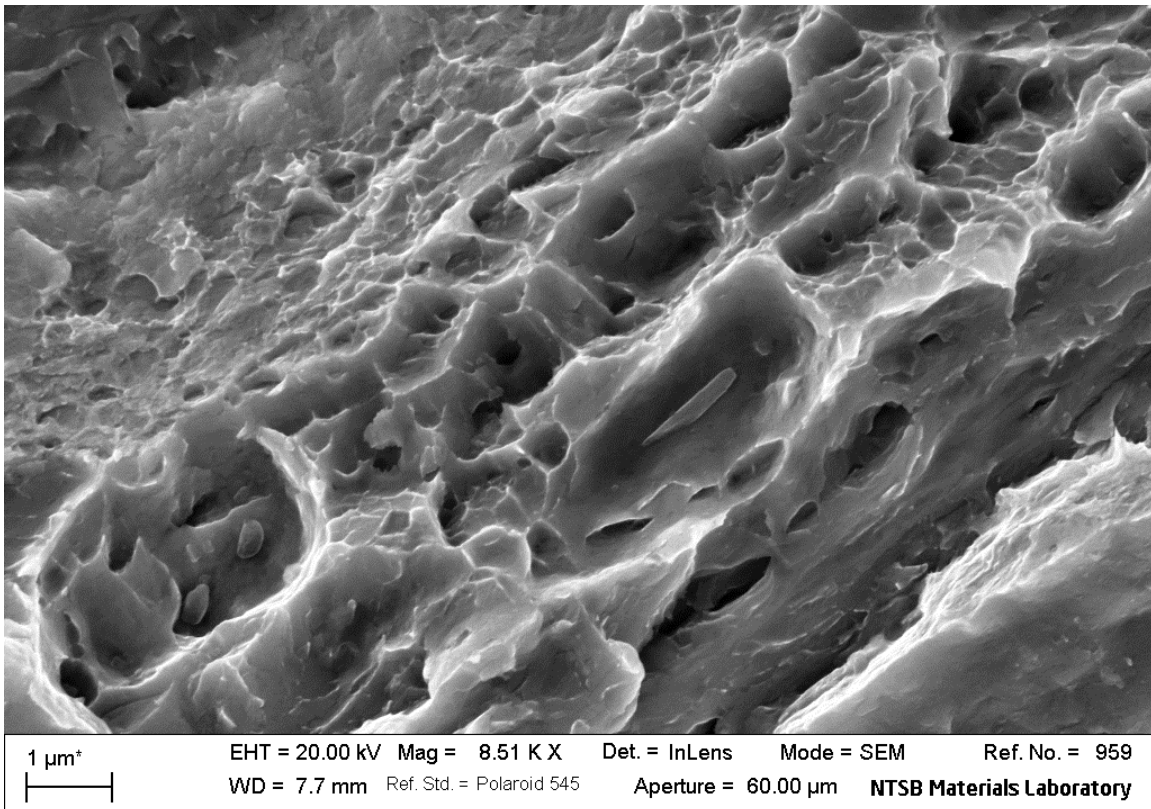
The fracture surfaces of both mating halves of the spring were examined in a scanning electron microscope (SEM). The portions of the fracture surface that were visually rougher and duller contained dimple rupture features consistent with tensile overstress (see Figure 7). These ruptured dimples were generally rounded and equiaxed in shape, indicative of little to no shear or torsional component.

Figure 7 – Secondary electron (SE) micrograph of an undamaged region of the longer segment fracture surface, showing dimple rupture indicative of tensile overstress.

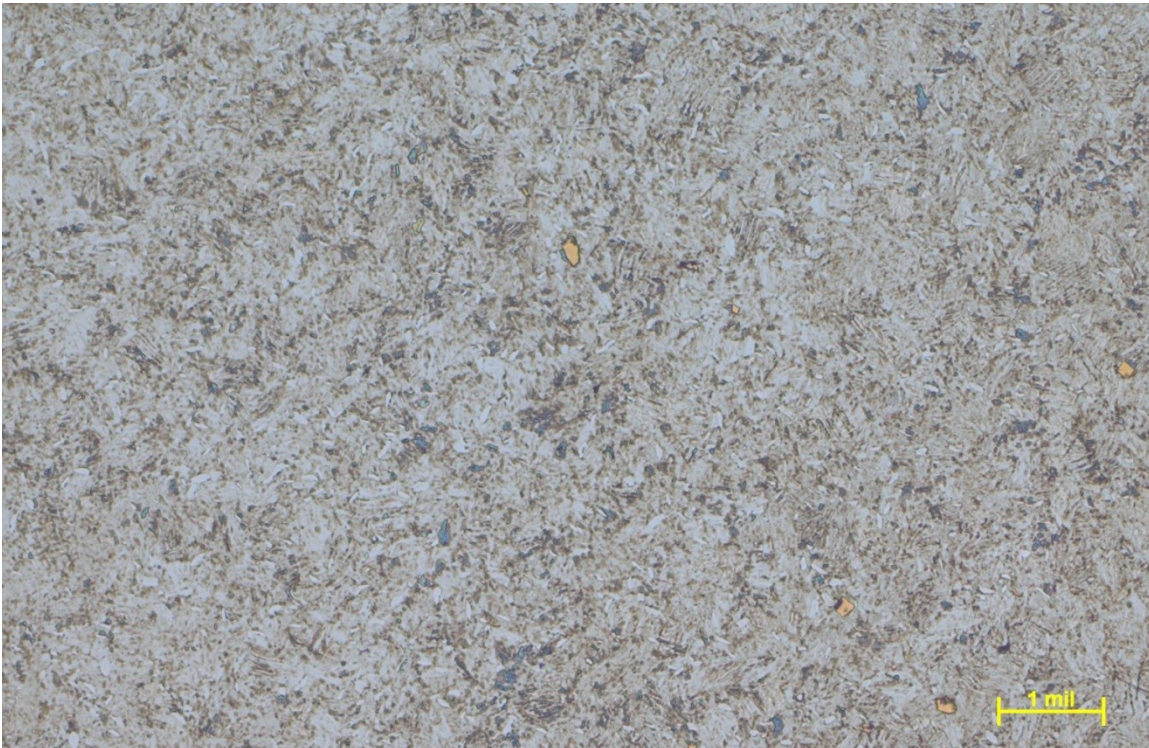
The larger spring fragment was sectioned adjacent to the fracture surface. This cross-sectioned portion was mounted in a direction normal to the running direction of the spring, and the sample was polished and etched. A representative portion of the spring microstructure is illustrated in Figure 8. This microstructure was consistent with tempered martensite, with isolated second-phase precipitates.

Figure 8 – Optical metallograph of the transverse microstructure of the spring near the fracture surface, consistent with tempered martensite (~500X, etched with Fry's Reagent).
