NATIONAL TRANSPORTATION SAFETY BOARD

MATERIALS LABORATORY FACTUAL REPORT

Report No. 17-076

Place : Charleston, WV
Date : May 5, 2017
Vehicle : Short Brothers SD3-30 (N334AC)
NTSB No. : DCA17FA109
Investigator : Adam Huray (AS-40)

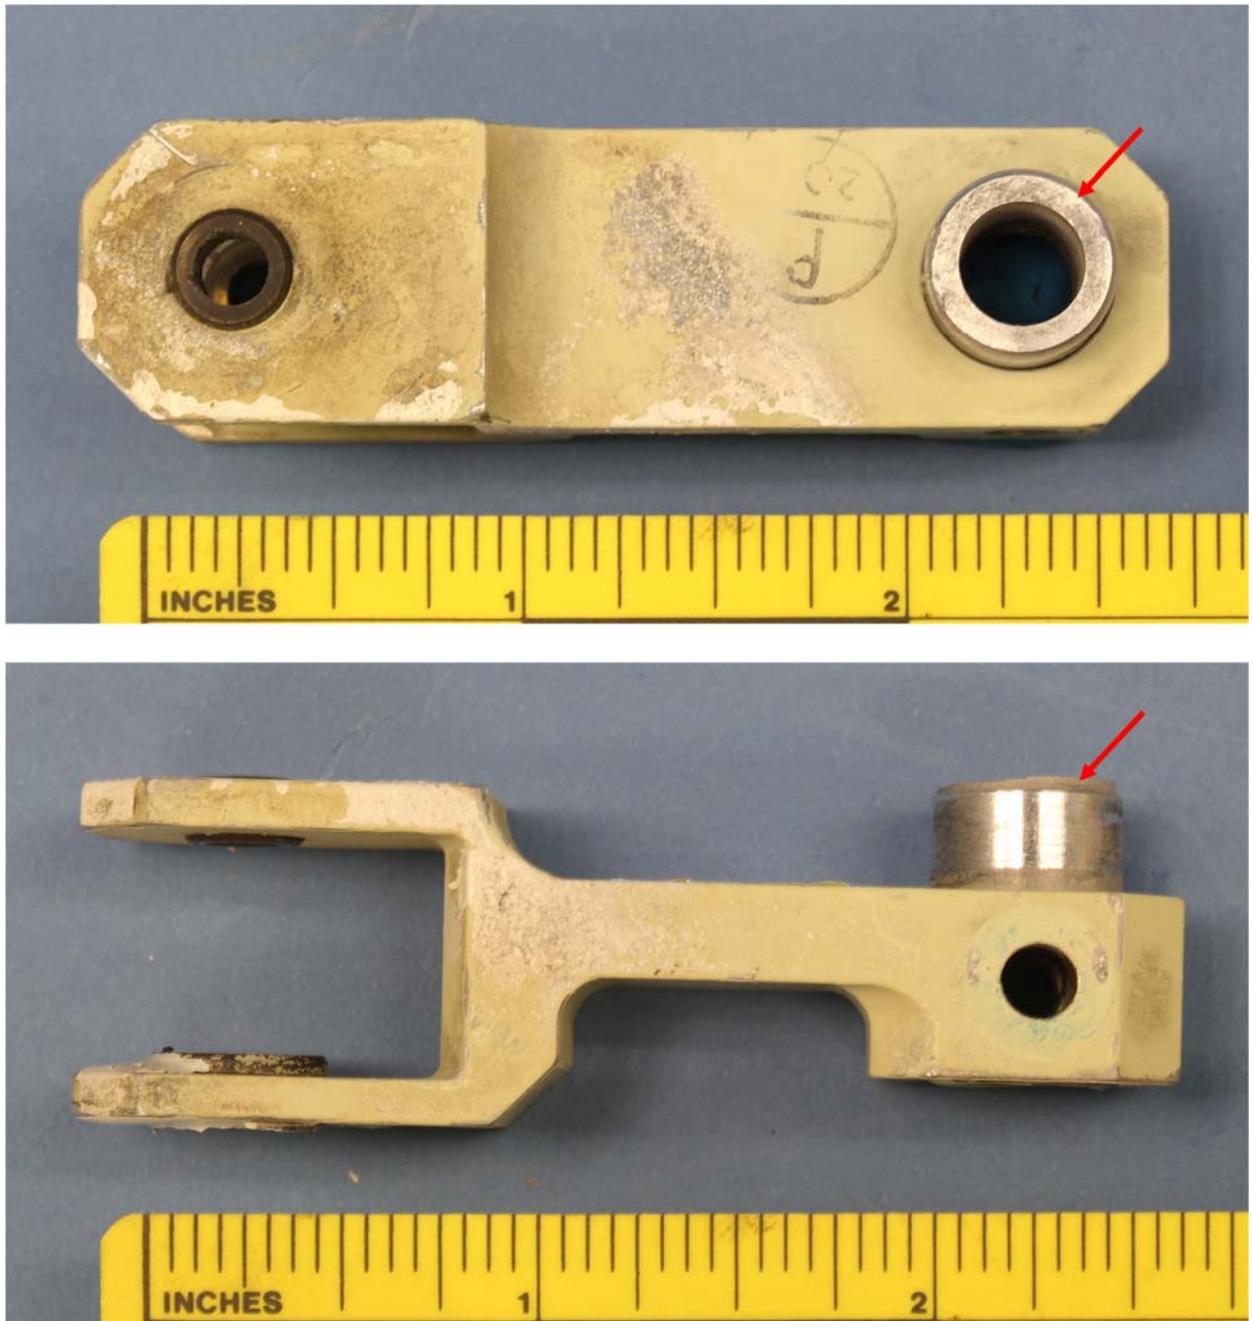
A portion of the flaps actuator was submitted with the input lever shaft fractured. The fractured shaft is indicated by the red arrows in Figure 1. The fracture surface on the shaft was flat, and was approximately perpendicular to the longitudinal axis of the shaft, as shown in Figure 2. The fracture occurred through a portion of the shaft with a reduced diameter. The reduced diameter was the result of a machined step visible on the shaft (white arrows, Figure 2), which was consistent with a shear section specified on the manufacturer drawing.

Figure 1: Overall photos showing the (top) fracture surface on the shaft and (bottom) profile of the shaft. The red arrows point to the fracture surface.

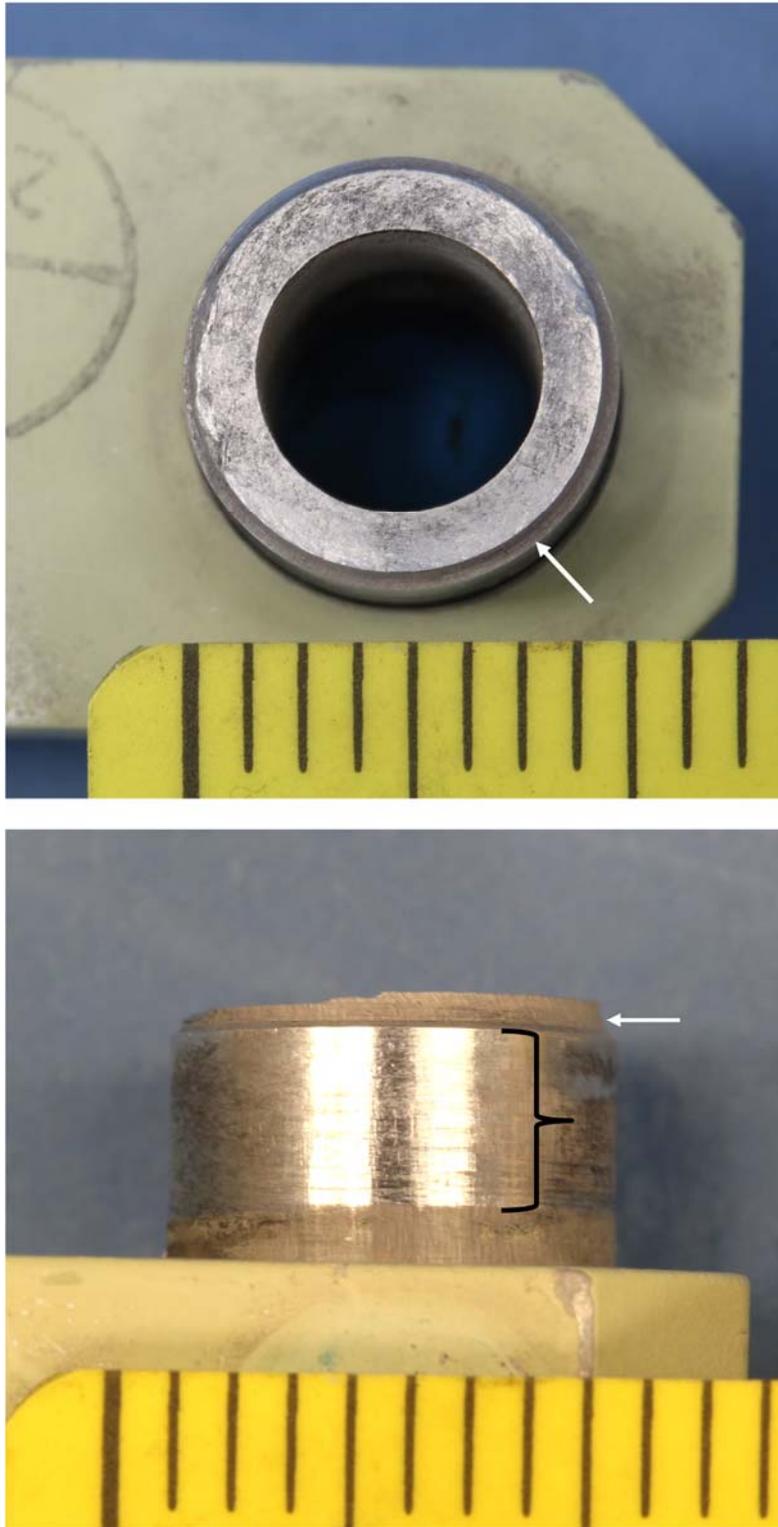
The black bracket in Figure 2 indicates a wear scar around the circumference of the shaft outer diameter (OD), just below the fracture surface. The band appeared shiny, which contrasted with the opaquer appearance of the original manufacturing finish of the shaft visible adjacent to the fracture surface and at the base where the shaft mated with the bracket.

Figure 2: Close-up photos showing the (top) fracture surface on the shaft and (bottom) profile of the shaft. The white arrows point to the machined step on the shaft. The black bracket in the bottom photo indicates the shiny wear scar on the shaft OD.

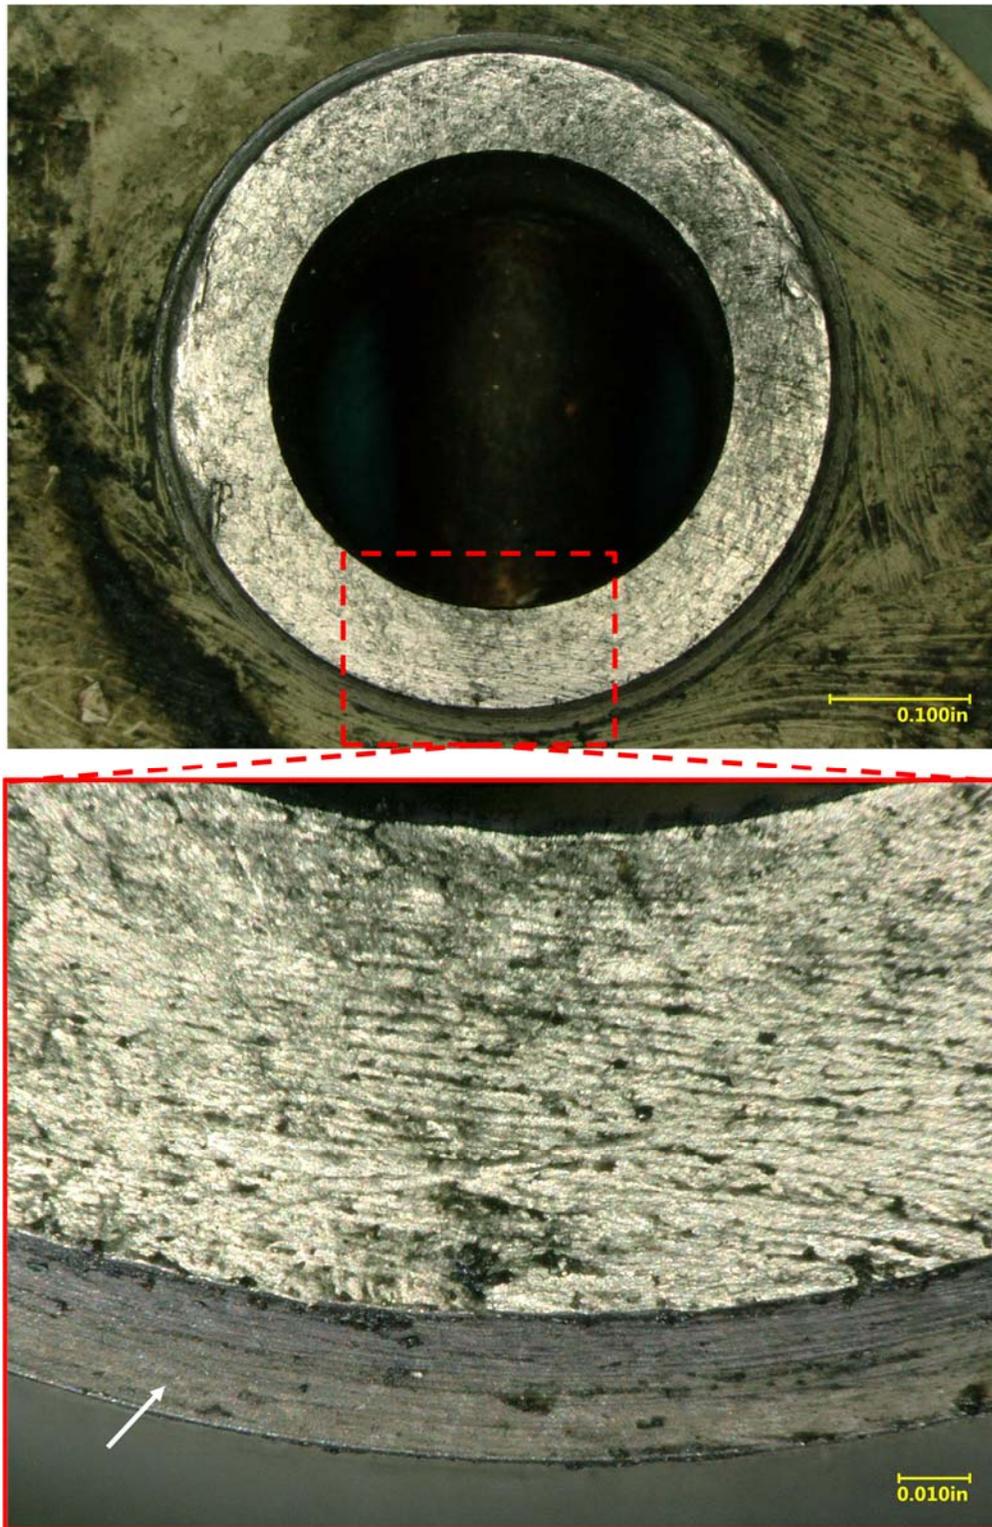
The fracture surface was examined using a 5x to 50x digital zoom microscope. The fracture surface was relatively flat, with smearing damage observed on large portions, as shown in Figure 3. The fracture surface was then examined using a Zeiss Auriga field emission (FE) scanning electron microscope (SEM), as shown in Figure 4. The smearing damage on the fracture surface obscured most of the finer features, but areas with microvoid coalescence were observed on undamaged portions of the fracture surface. The microvoids were elongated, which is consistent with shear overstress. The directionality of the microvoids, indicated by the black dashed line in Figure 4, followed the radial geometry of the shaft, which is consistent with shear overstress due to torsion.

Figure 3: Digital microscope images of the fracture surface on the shaft. The white arrow in the bottom image points to the machined step on the shaft.

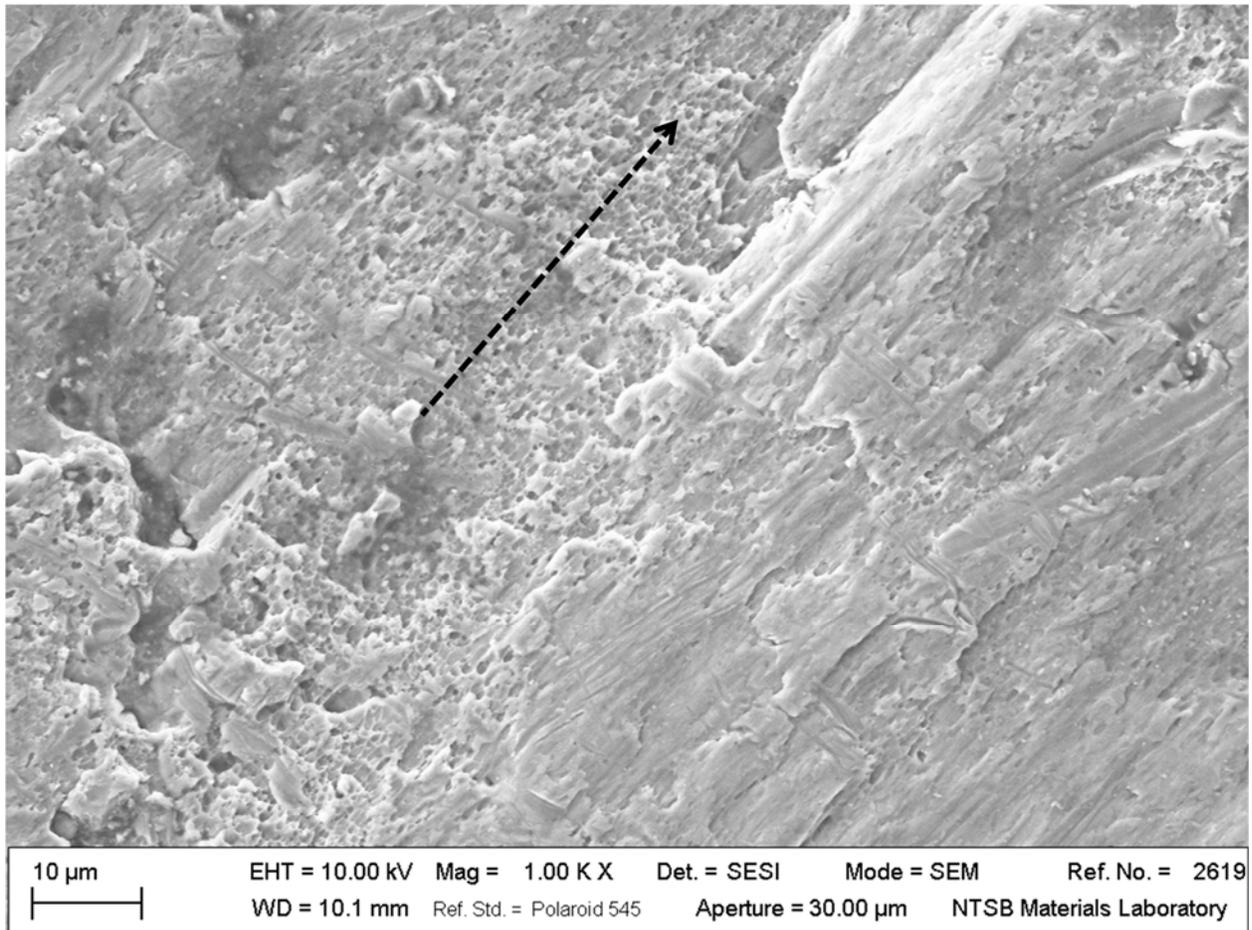
Figure 4: Secondary electron SEM image of the fracture surface on the shaft. The black dashed line indicates the directionality of the microvoids observed on an undamaged portion of the fracture surface.

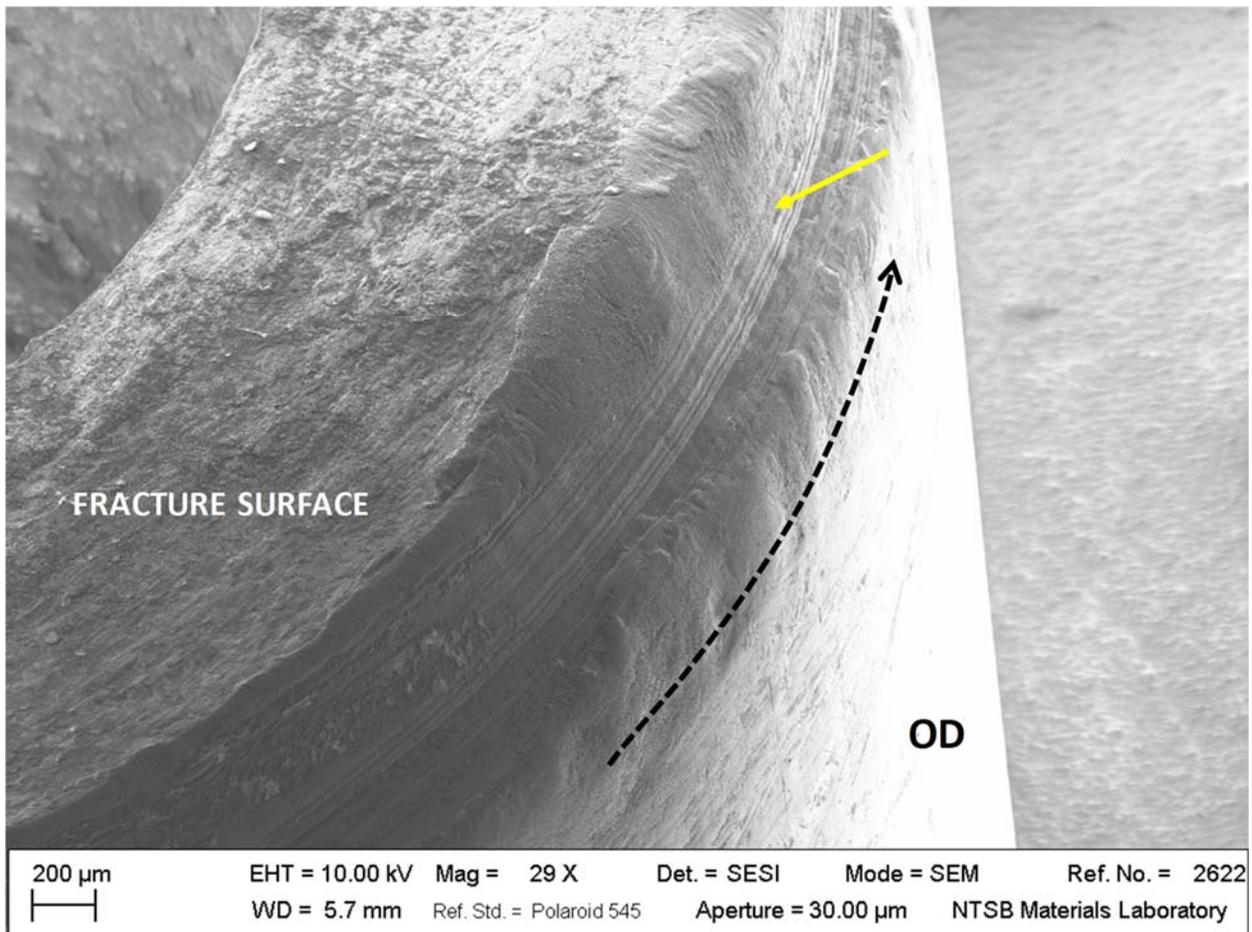
The wear scar was also examined in the SEM, as shown in Figure 5. Smearing damage was visible on the shaft OD adjacent to the machined step. The smearing damage had a circumferential pattern, indicated by the black dashed line in Figure 5, which is consistent with torsional movement of the shaft.

Figure 5: Secondary electron SEM image of the fracture surface on and the adjacent OD of the shaft. The yellow arrow points to the machined step on the shaft. The black dashed line indicates the circumferential directionality of the smearing damage on the shaft OD.

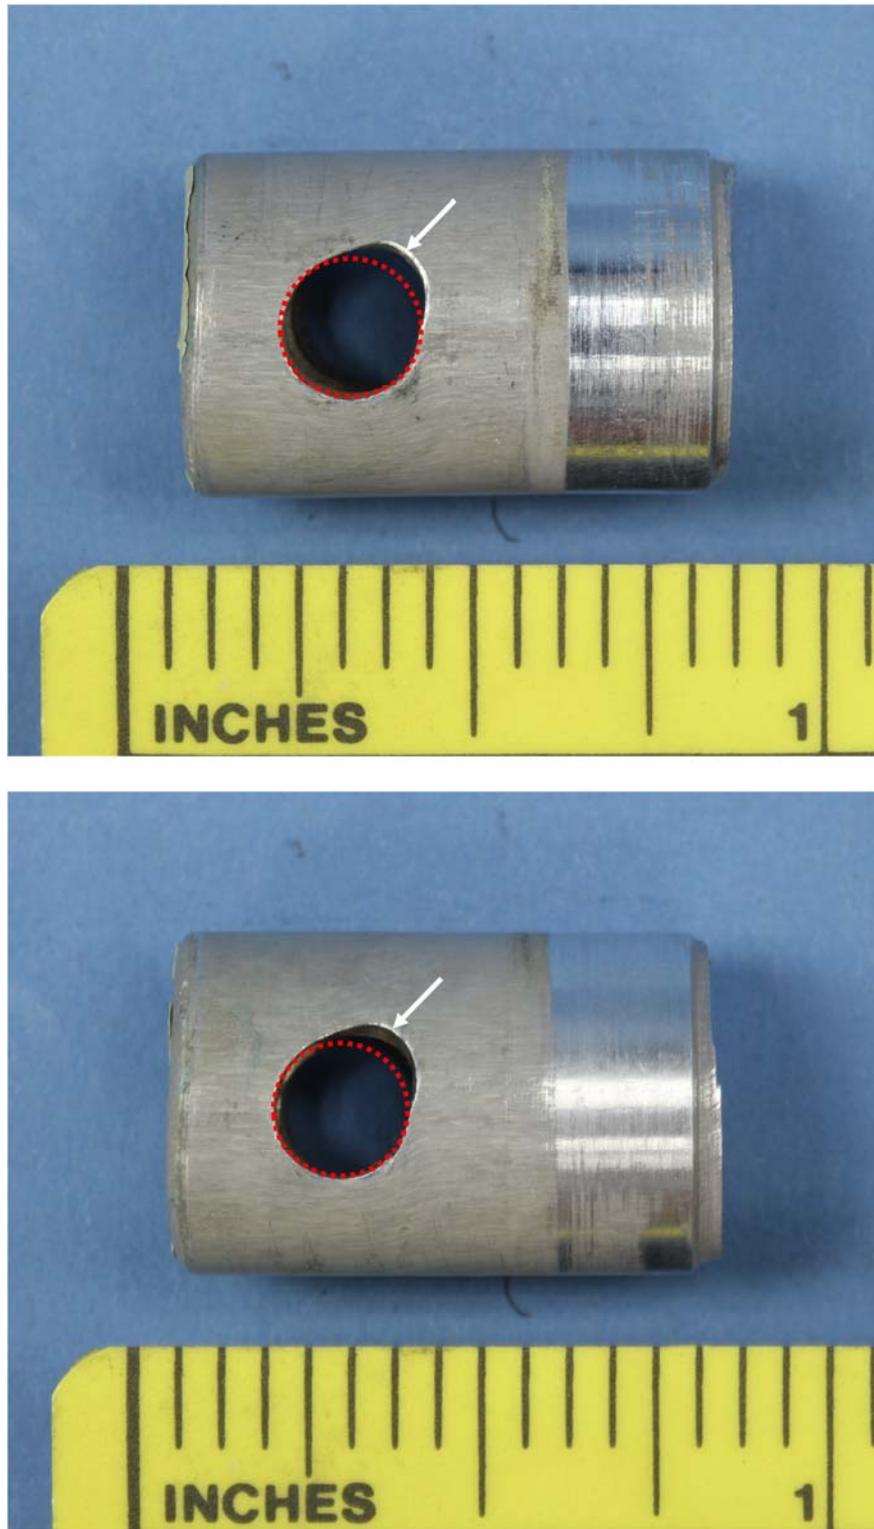
The shaft was removed from the mating bracket and is shown in Figure 6. Damage was observed on the through hole for the locking pin. The hole was elongated at a roughly 45-degree angle from the longitudinal axis of the shaft. The hole was elongated on both sides of the shaft (white arrows, Figure 6), and the elongation was on opposite sides of the hole, which is consistent with a torsional motion of the shaft.

Figure 6: Close-up photos showing opposite sides of the separated shaft. The red dotted lines illustrate a perfect circle, while the white arrows point out elongation of the through hole in the shaft.
