From: Eick Donald
Sent: Tuesday, June 25, 2019 7:46 AM
To: Bowling David
Cc: Helson David; Frantz Marvin
Subject: CEN19FA107 - Loveland, Colorado Weather Brief

Weather Conditions surrounding Loveland, CO, on March 23, 2019

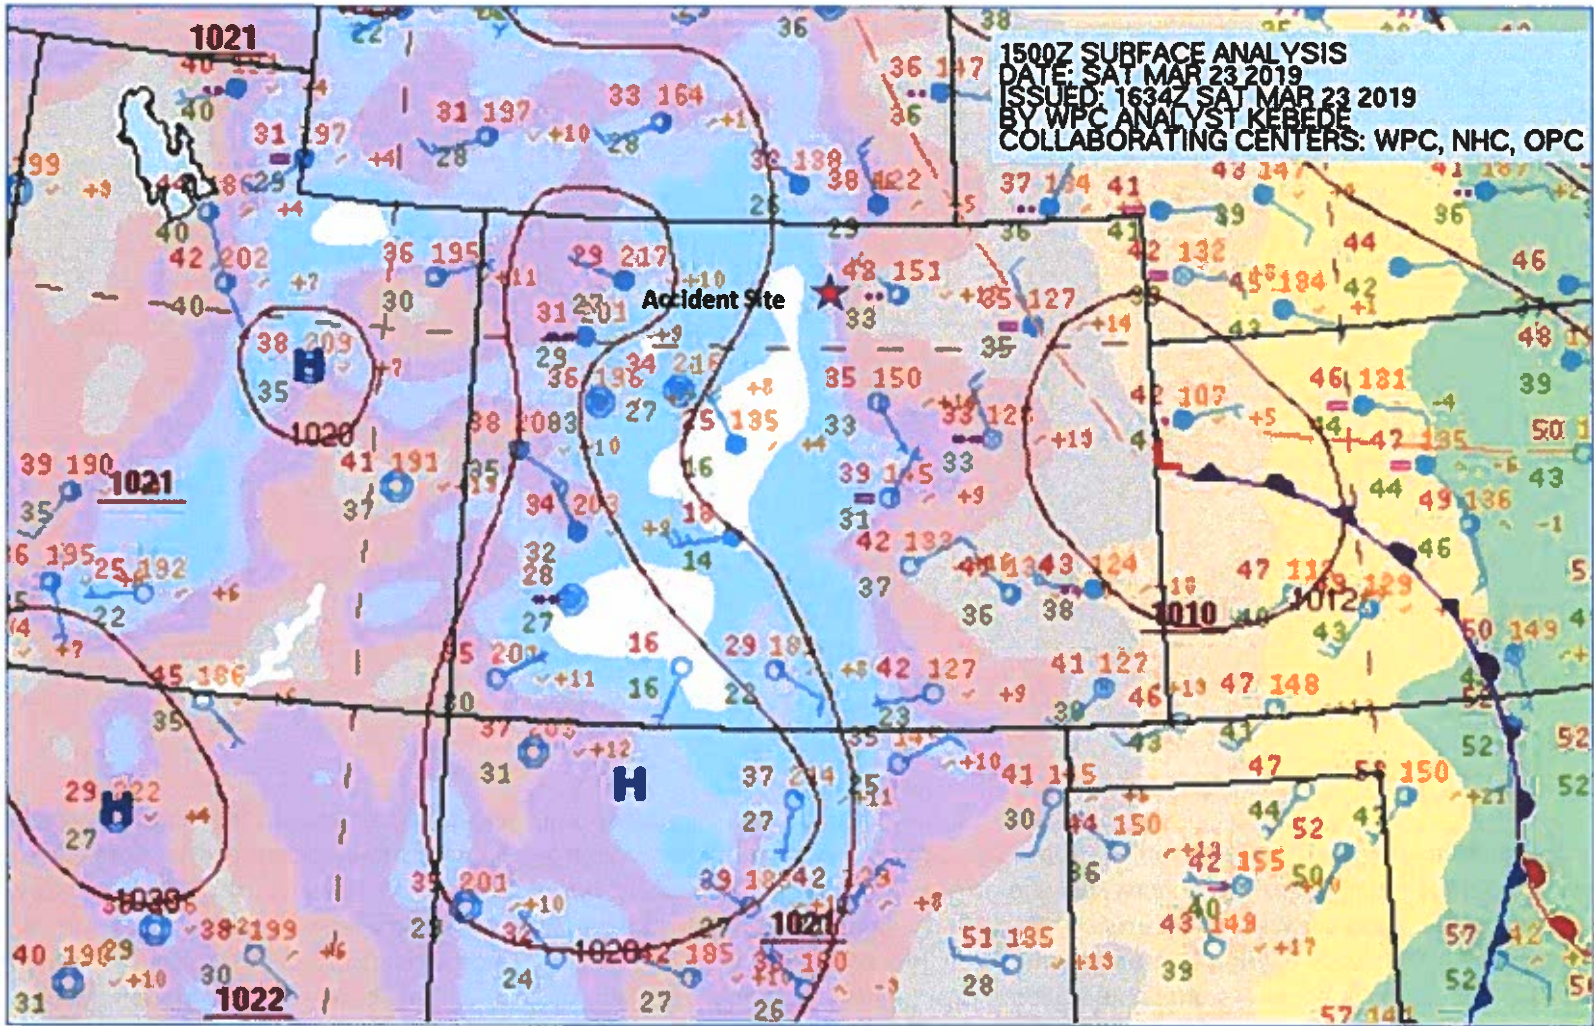
Synoptic conditions – The NWS Surface Analysis Chart for 0900 MDT (1500Z) with topography features is included below and depicted a low pressure system at 1010-hectopascals (hPa) over the Colorado and Kansas border associated with an occluded frontal system. A secondary trough of low pressure extended from the low to the northwest across northeast Colorado into eastern Wyoming. Several high pressure systems were noted at 1021-hPa over Utah and northern New Mexico. The accident site was located on the cold air side of the front in an area of relatively weak pressure gradient. The station model for Greeley, CO, immediately east of the accident site indicated northwest wind of 5 knots, light rain, broken clouds, temperature 42° Fahrenheit (F), dew point 33° F. Multiple stations surrounding the area reported fog, mist, or snow.

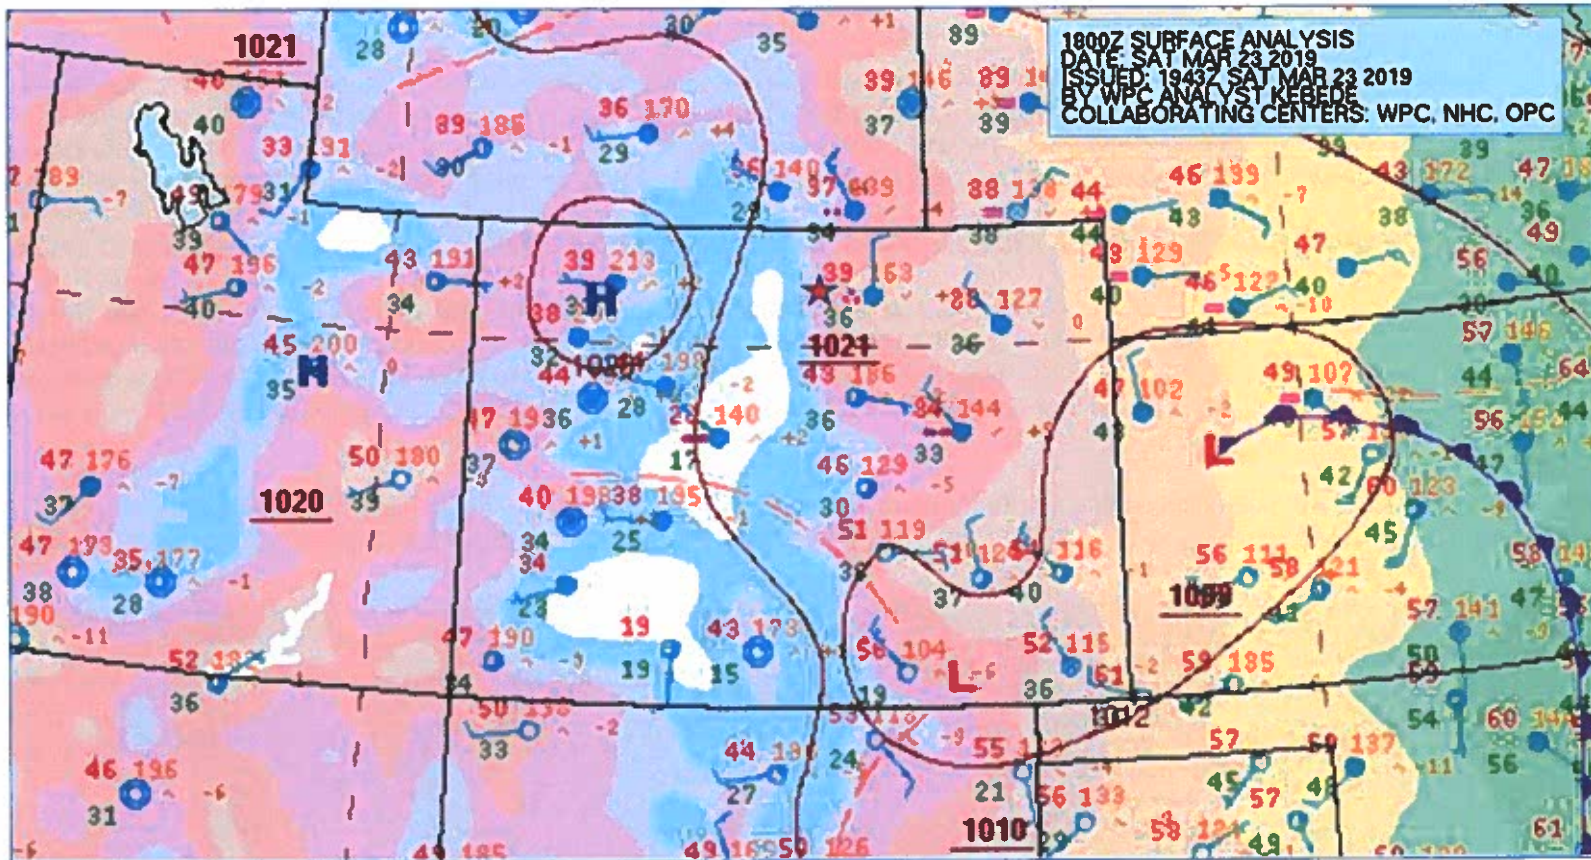
The next chart at 1200 MDT (1800Z) depicted the winds veering to the north at Greeley with moderate rain and to the east in the Denver area.

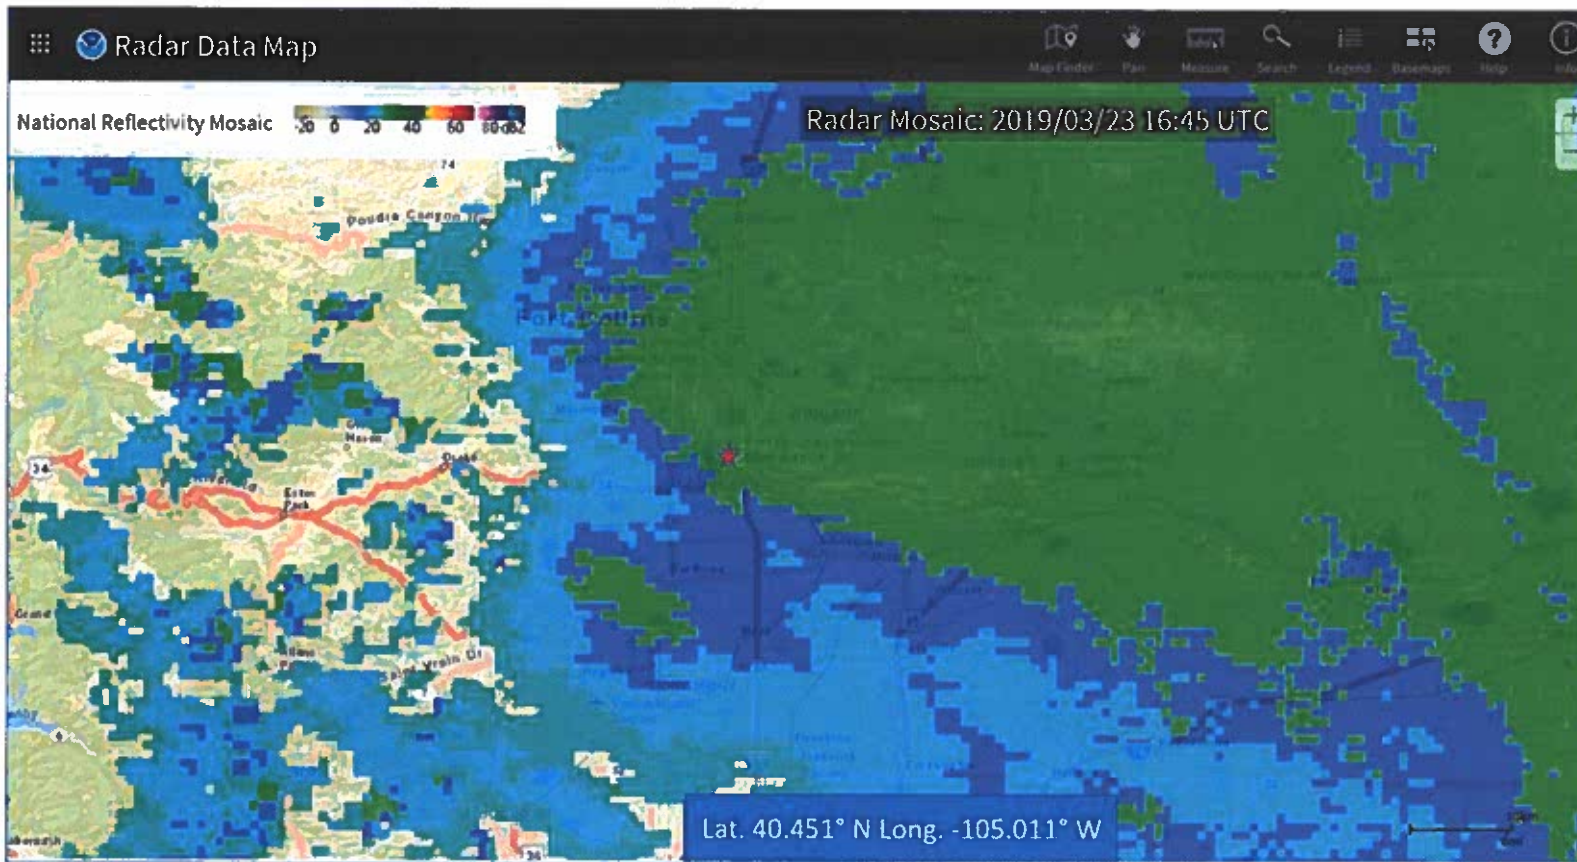
The NWS National Composite Radar Mosaic for 1045 MDT is included and depicted a large band of echoes near 30 dBZ associated with light rain over the area which extended eastward associated with the occluded front.

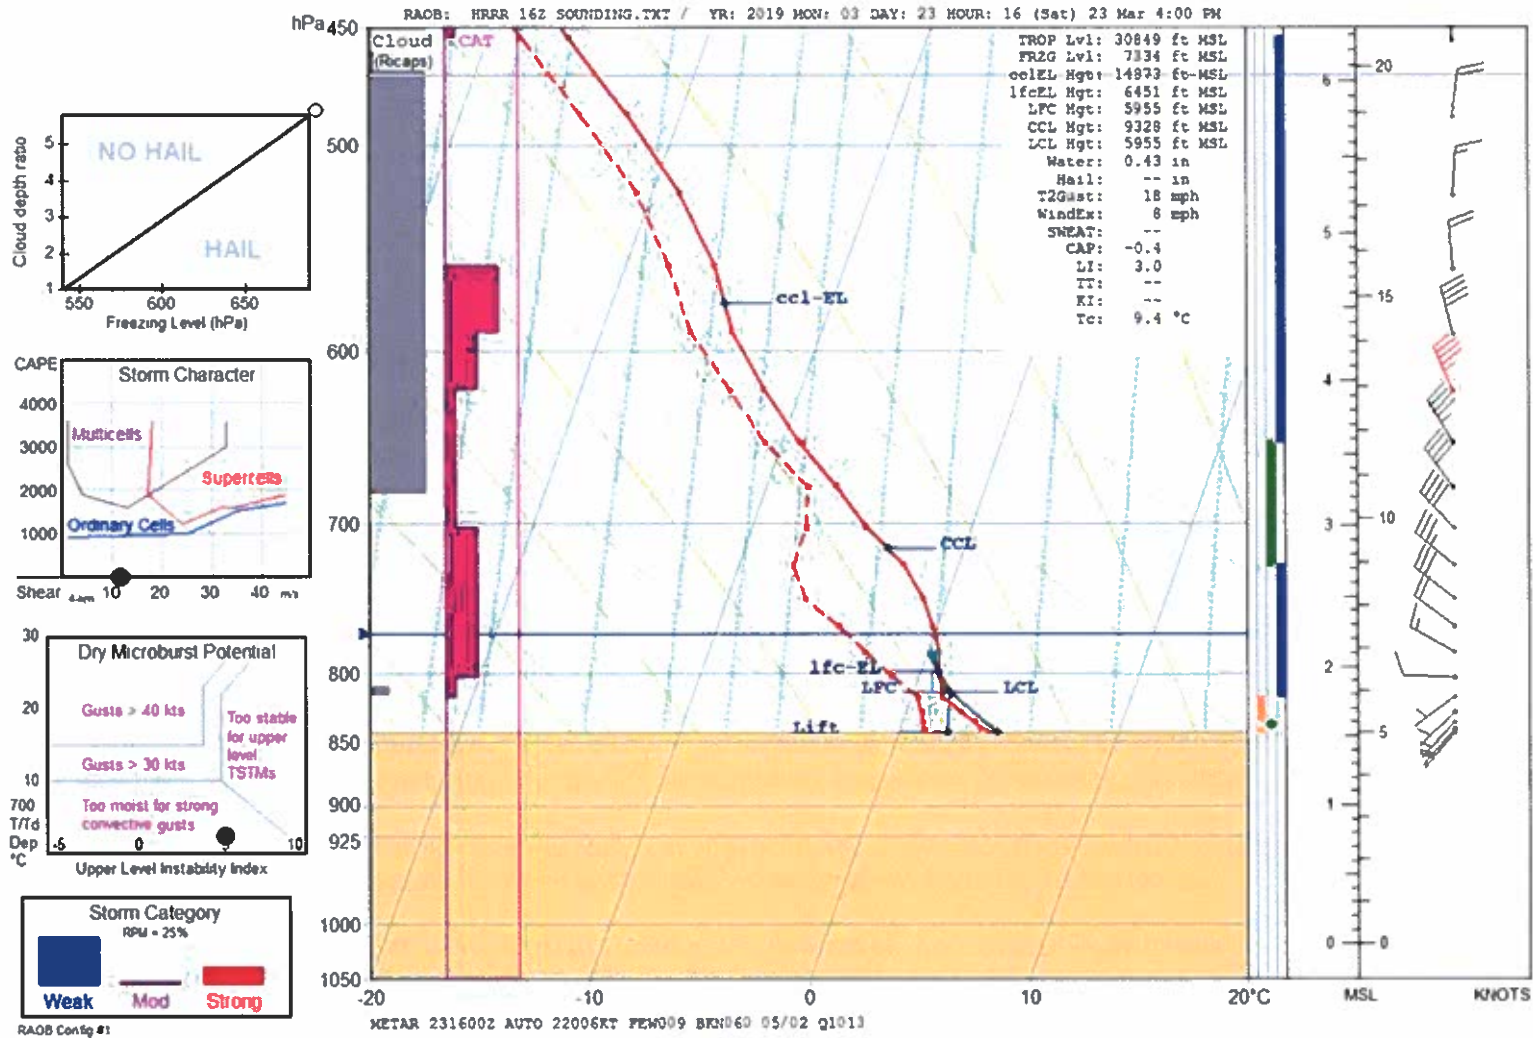
Sounding – a High Resolution Rapid Refresh (HRRR) numerical model sounding was obtained from archive data and plotted over the airport for 1000 MDT. The sounding indicated a conditional unstable atmosphere below 12,000 ft that supported weak convective activity. The sounding indicated a surface temperature of 4.5° C (40° F), a dew point of 2.2° C (36° F), with a relative humidity of 85%. The sounding did not support wet or dry microburst activity, and only weak convection. The wind profile indicated surface wind from the 220° at 6 knots with wind veering to the northwest and north through 15,000 ft with increasing wind speeds with height. The mean 0 to 6 kilometer or 18,000 ft wind was from 335° at 24 knots. The sounding did not depict any boundaries that would explain the easterly wind component reported after the accident. The sounding did support downdraft activity with the northwest to northerly flow above 8,000 ft over the mountains immediately west of the area.

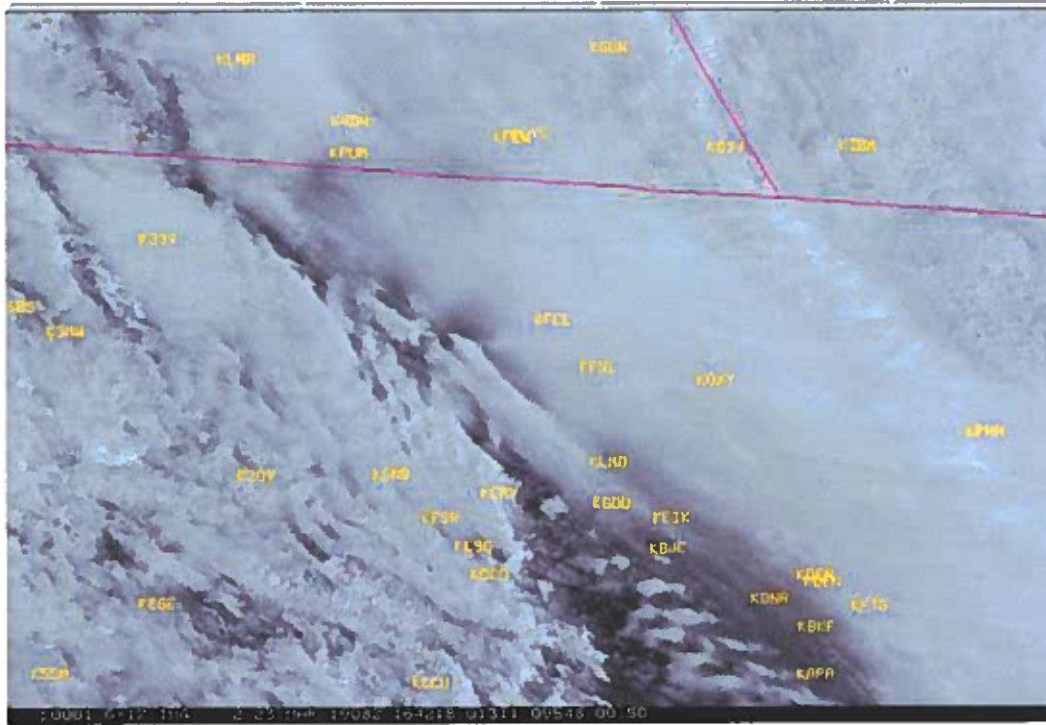
Satellite Imagery – the GOES-17 visible image for 1042 MDT is attached and depicted an extensive layer of clouds over the area. The smooth and laminar clouds suggest some topographical interaction and mountain wave conditions over the area during the period.

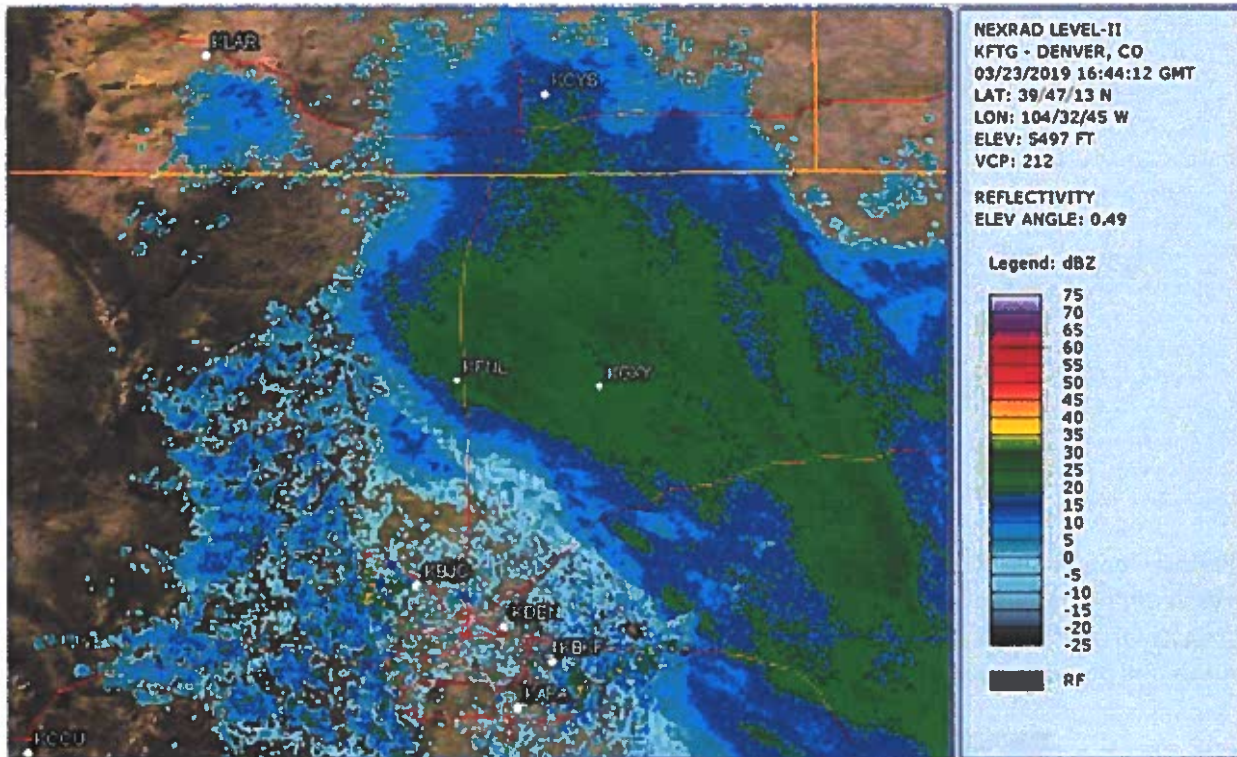
Radar Imagery – the NWS Denver (KFTG) WSR-88D base reflectivity imagery was downloaded and examined for any signs of wind shear over the area or any other strong convection typically associated with microburst activity. The image below is the lowest 0.5 base reflectivity image for 1044 MDT (1644Z) which depicted echoes of 30 dBZ over the accident site with no significant change in winds noted on the base velocity data. No divergent couplets or high reflectivity cores were observed over the area to verify any microburst activity, just stratified precipitation. The echoes were moving east-southeast with time.

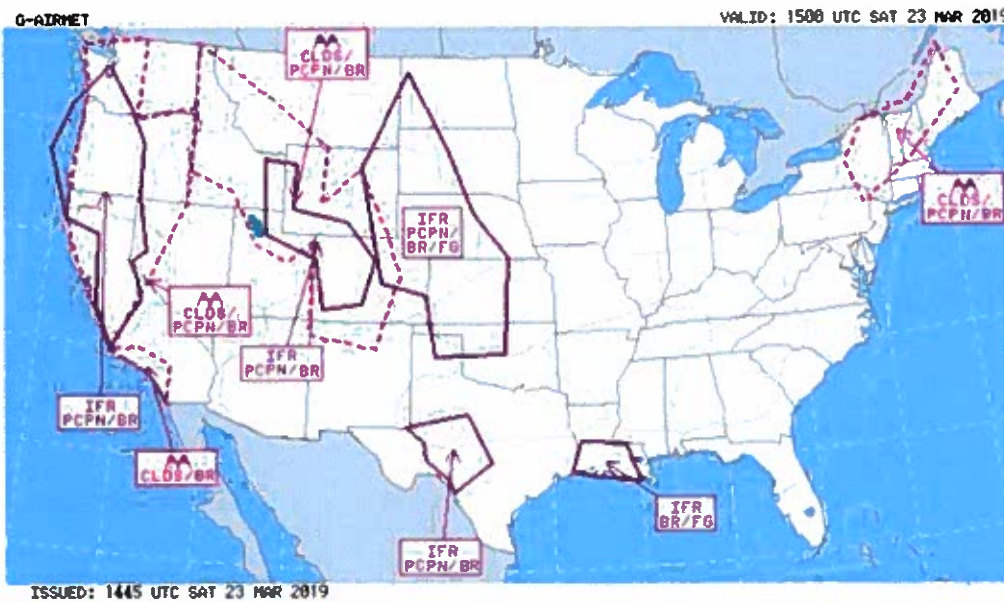
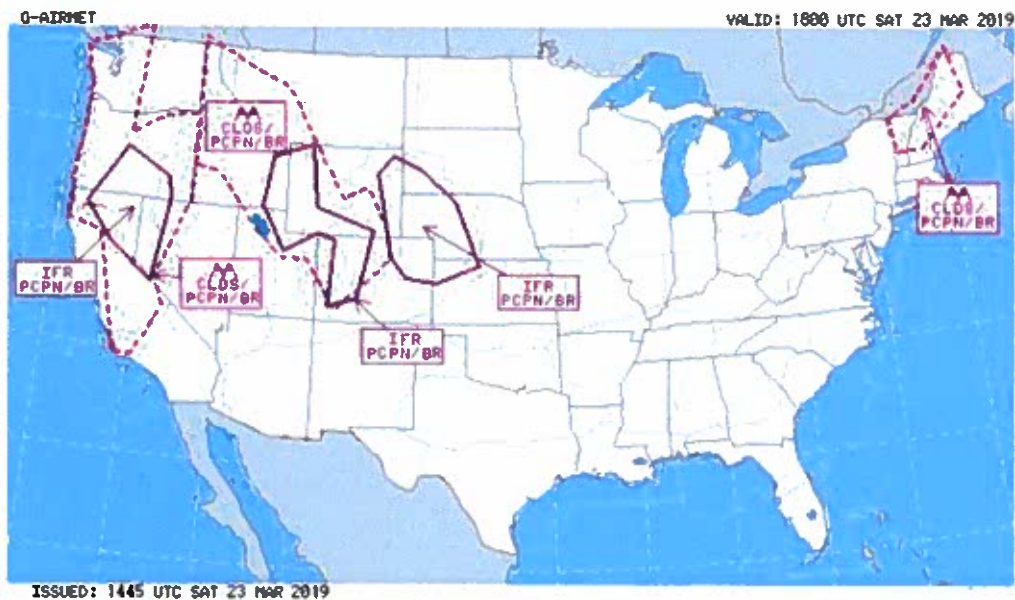
NWS Inflight Weather Advisories – The NWS had G-AIRMETs current for IFR conditions and mountain obscuration and moderate turbulence from the surface to 16,000 ft over a large portion of Colorado that extended over the accident site. Below are the graphic advisories for 0900 MDT (1500Z) and 1200 MDT (1800Z) respectively. No NWS SIGMETs, Convective SIGMETs, or Center Weather Advisories (CWA) were issued surrounding the period for Colorado.
