NATIONAL TRANSPORTATION SAFETY BOARD

NTSB ON SITE EXAMINATION NOTES

WPR16FA130

Location: Wikieup, AZ
Date: June 23, 2016
Aircraft: Robinson R66, Registration Number: N117TW, Serial #: 0042
NTSB IIC: Howard Plagens

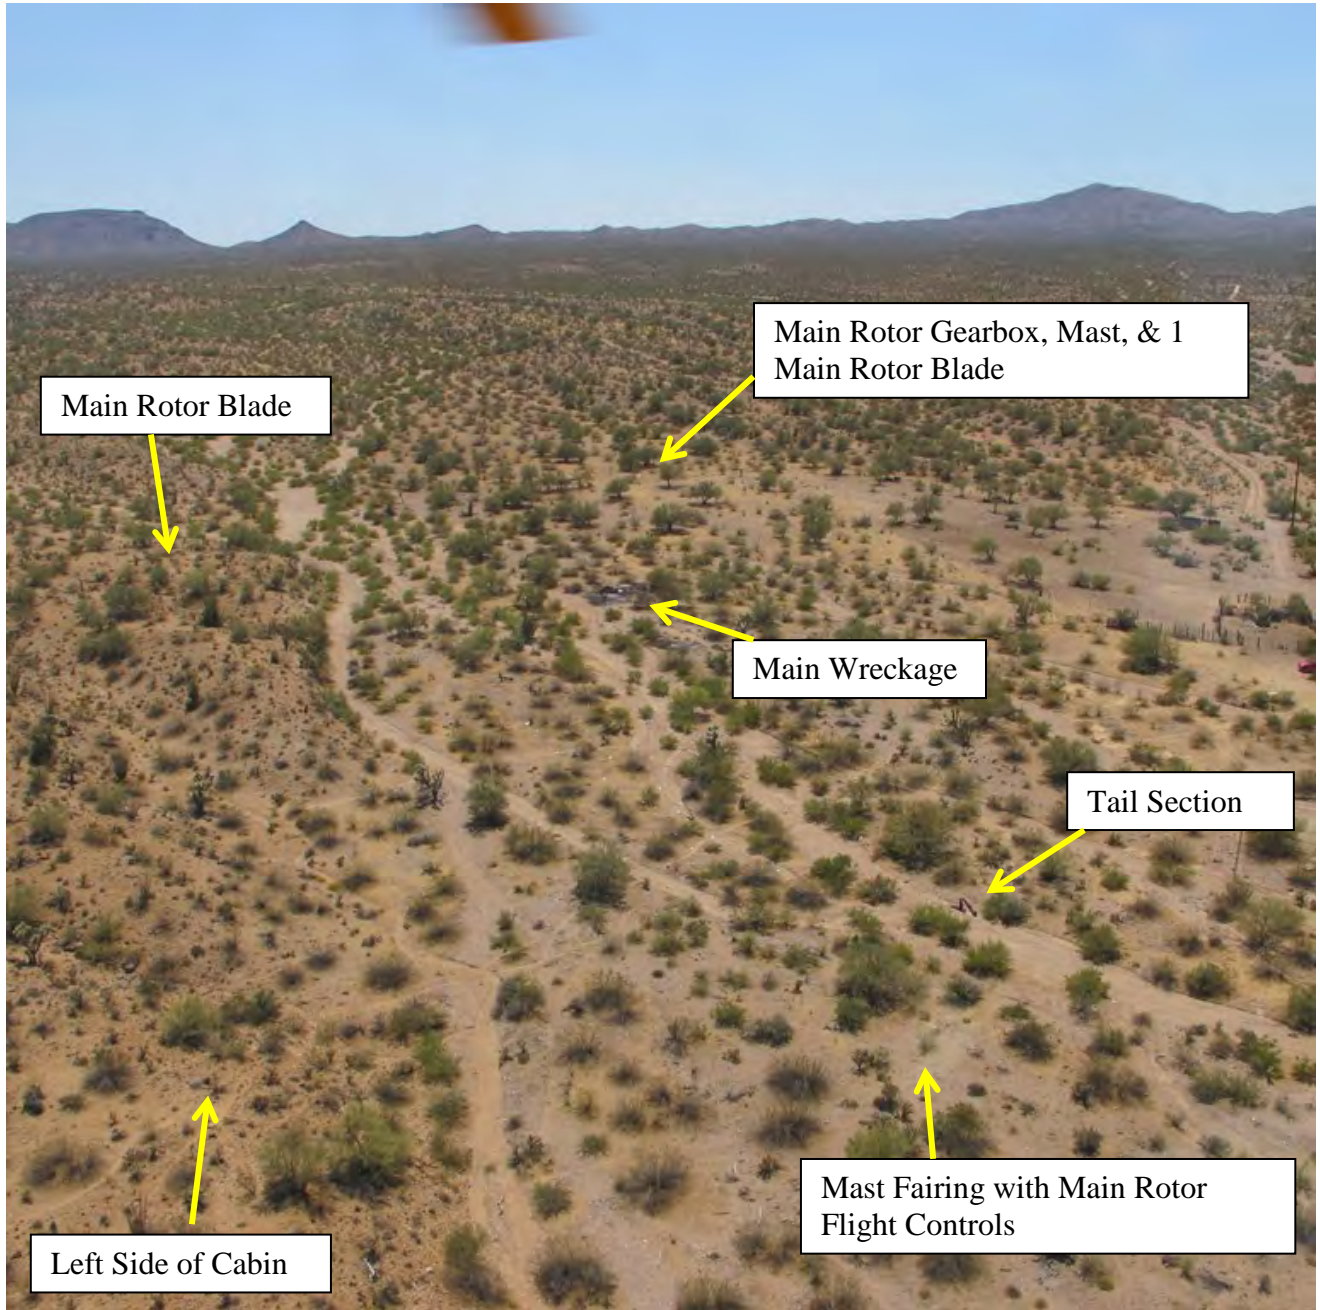
Photo 1 Robinson Aerial of Site Looking from Beginning of Debris Field

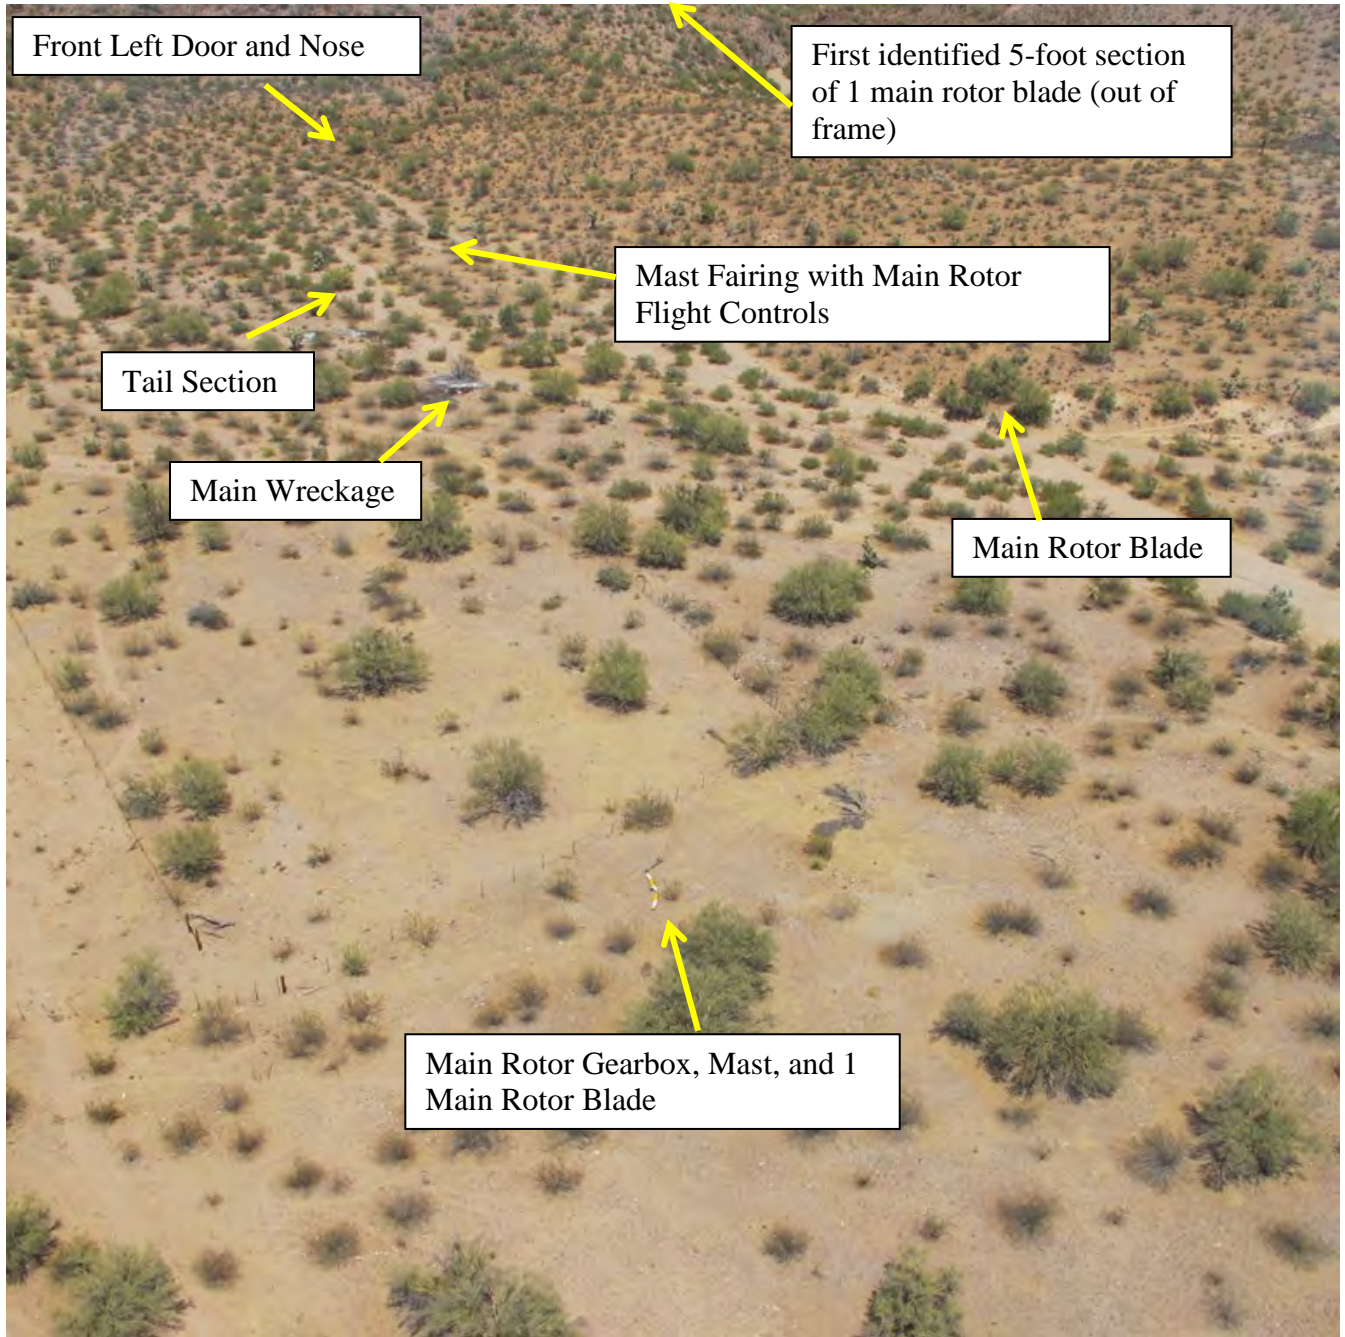
Photo 2 Robinson Aerial of Site Looking Back at Debris Field

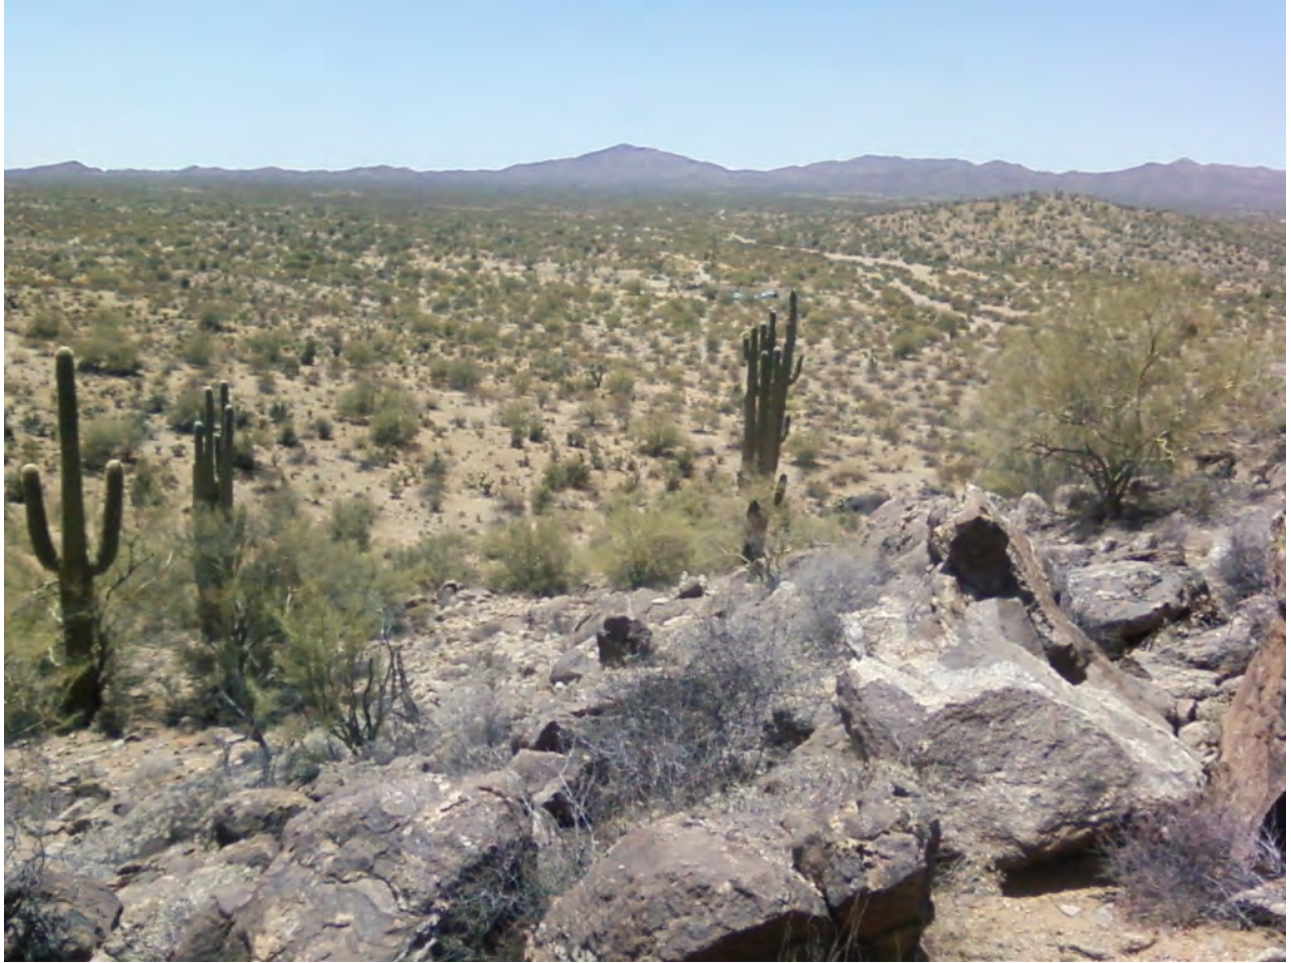
Photo 3 FAA Photo Looking from First Identified Debris

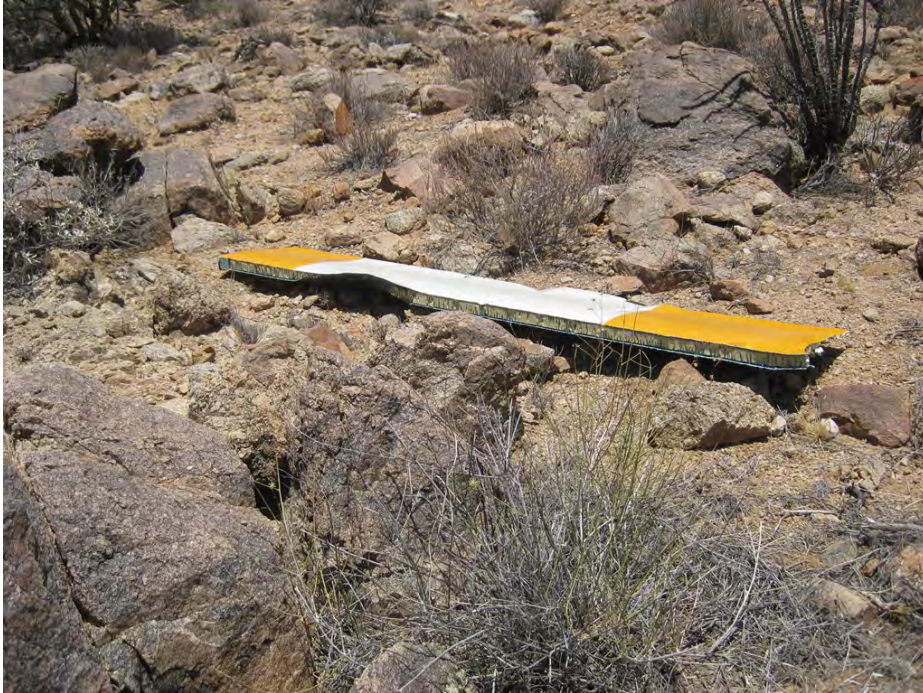
The helicopter came to rest in hilly desert terrain. The debris field was about 750 yards long and 150 yards wide. One of the first pieces identified was the outboard 5 feet of a main rotor blade afterbody that had separated from the leading edge spar. The left side of the helicopter was more fragmented than the right, and left side cabin pieces and instruments were distributed throughout the early part of the debris field. The tail boom was about midway into the debris field. The left side/nose cabin was in the same approximate part of the debris field with a straight separation line across one side. The cabin came to rest inverted about 600 yards into the debris field, and was destroyed by a postcrash fire. The engine remained attached to the cabin. The remaining

Photo 4 FAA Photo First Identified Debris - Outboard Piece of Main Rotor Blade Afterbody

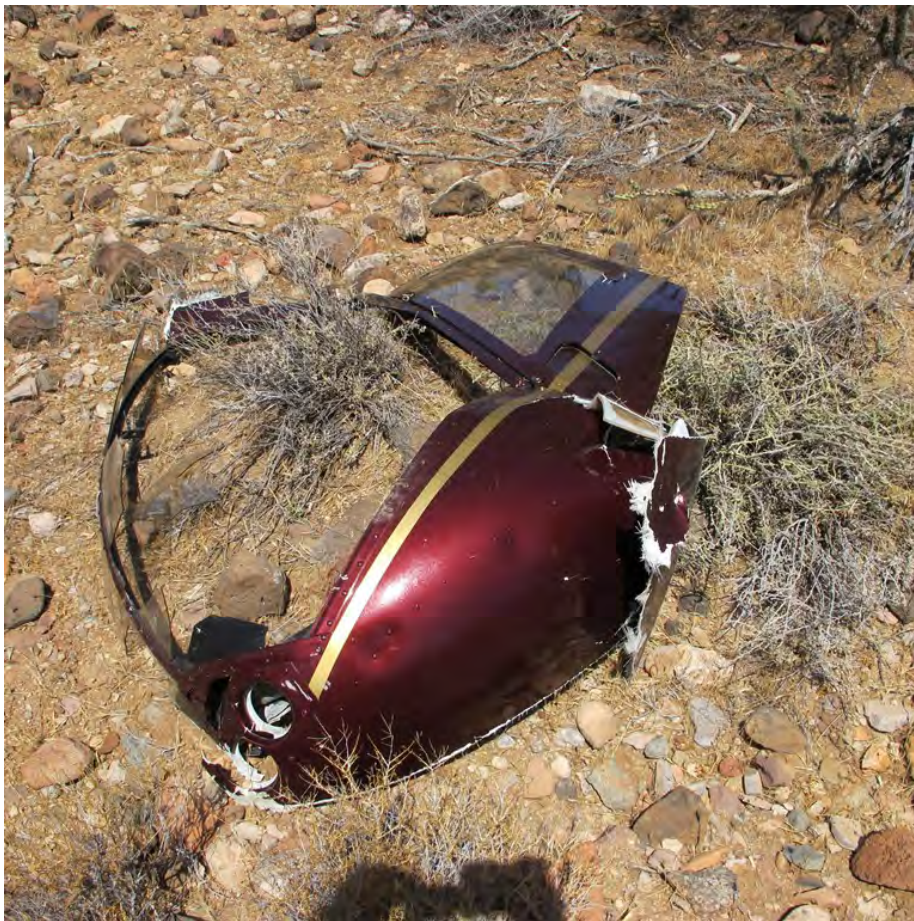
Photo 5 Robinson Photo Left Side of Cabin

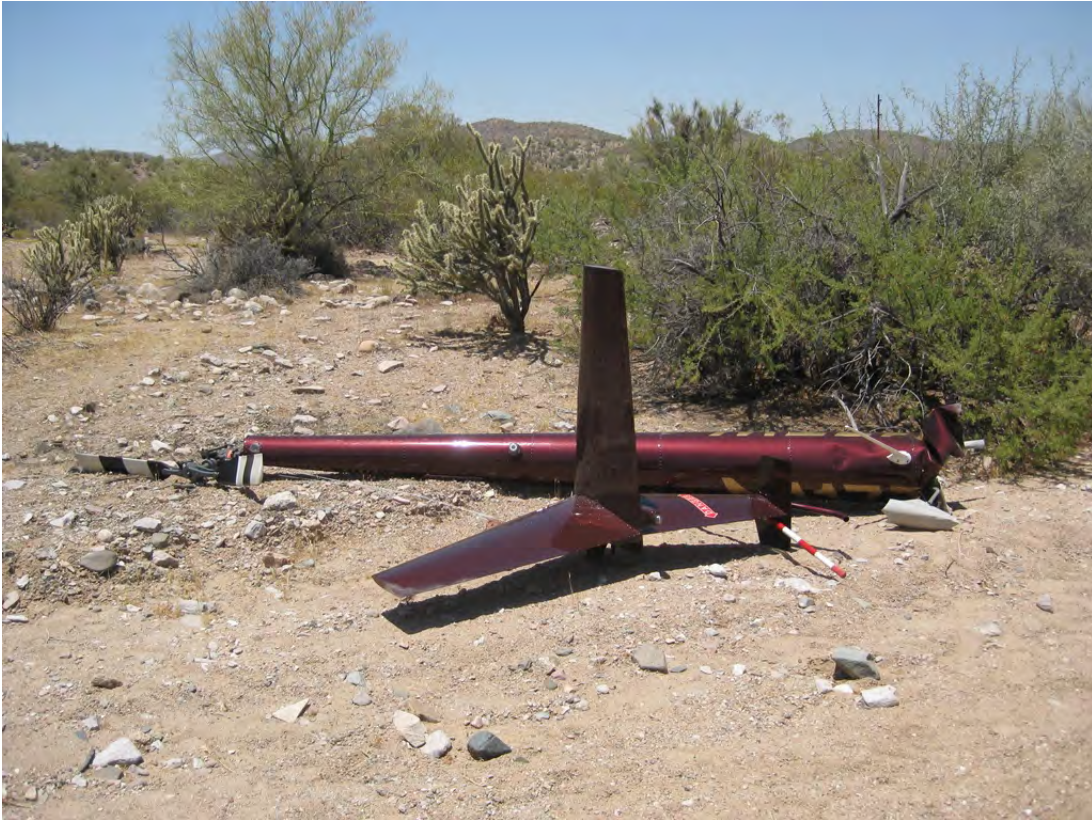
Photo 6 FAA Photo of Tail Section

The tail section was bent, and separated at the forward mount. There was no indication of contact from a main rotor blade.

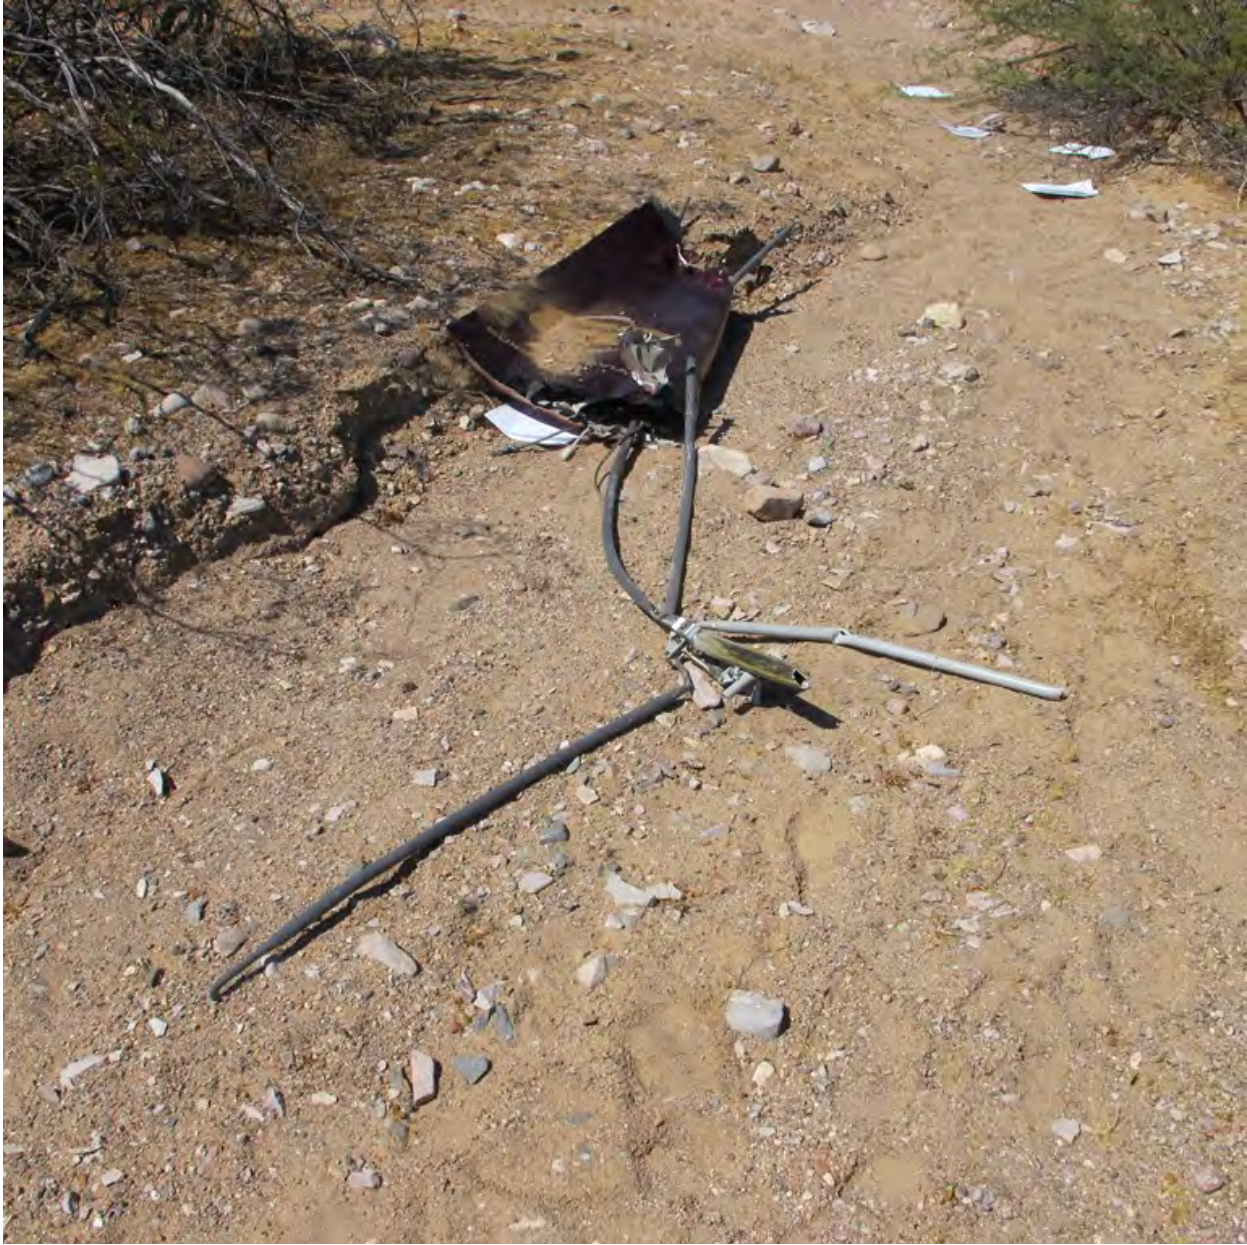
Photo 7 Robinson Photo of Mast Fairing with Main Rotor Flight Controls

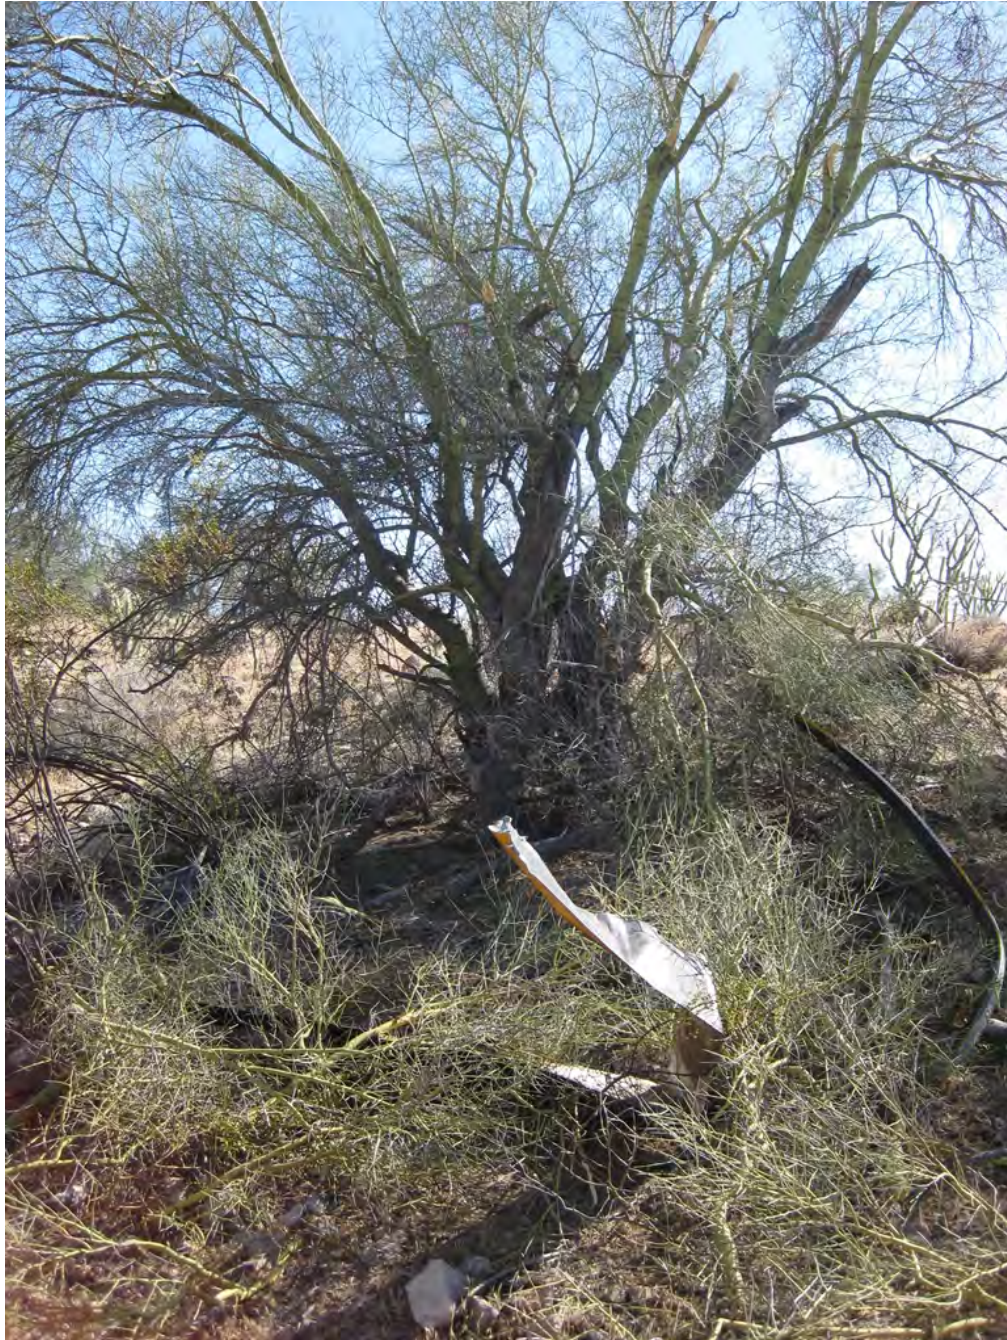
One main rotor blade separated at the spindle. The blade spar was bowed forward in the direction of flight and slightly upward about mid span.

Photo 8 FAA Photo Separated Main Rotor Blade

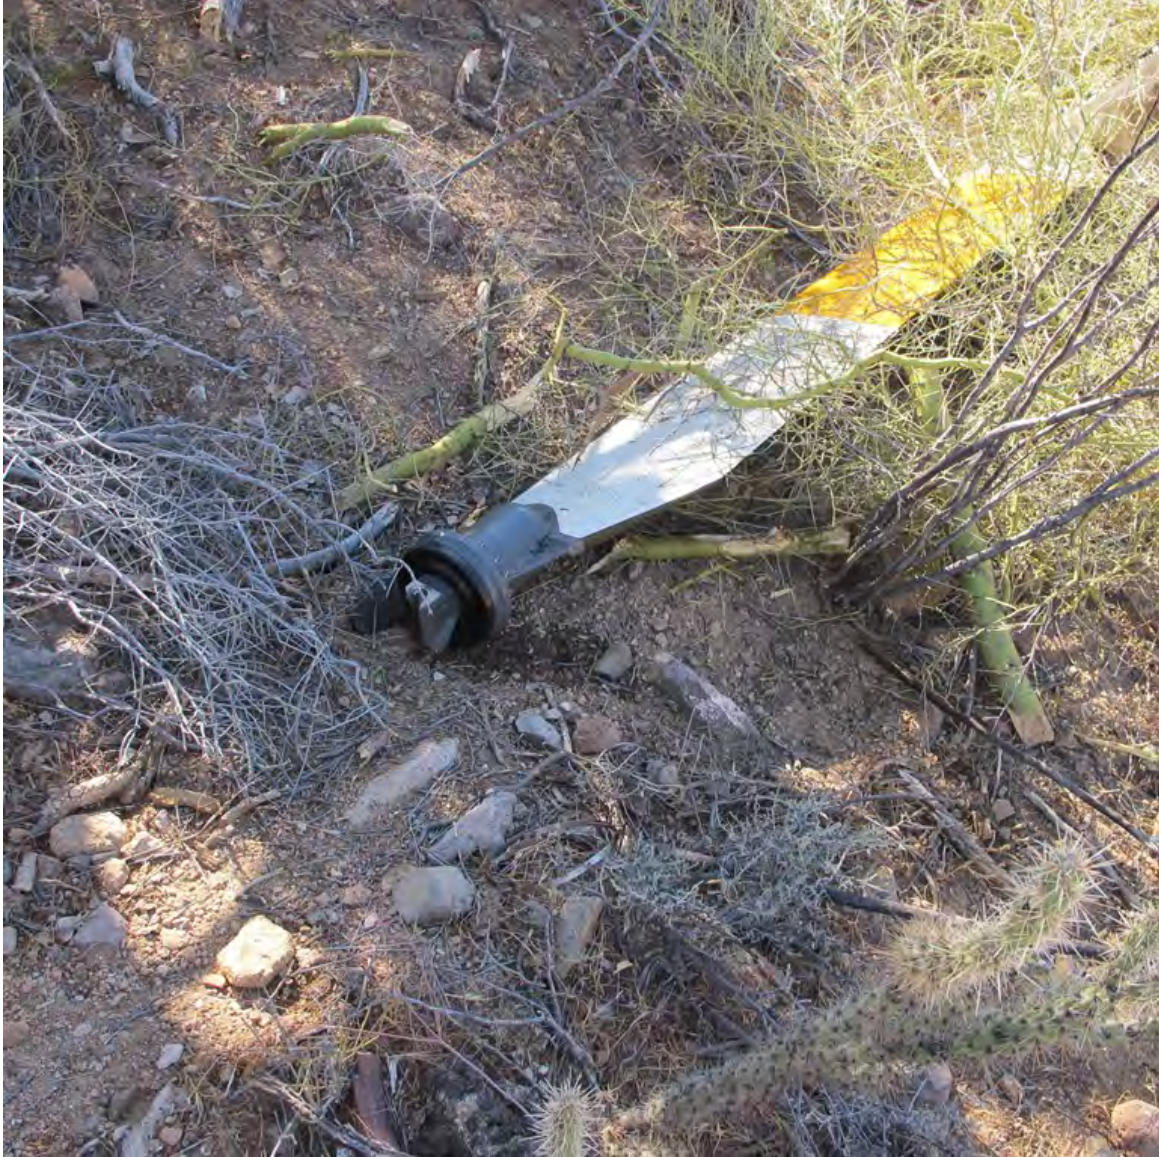
Photo 9 Robinson Photo of Separated Main Rotor Blade Hub End

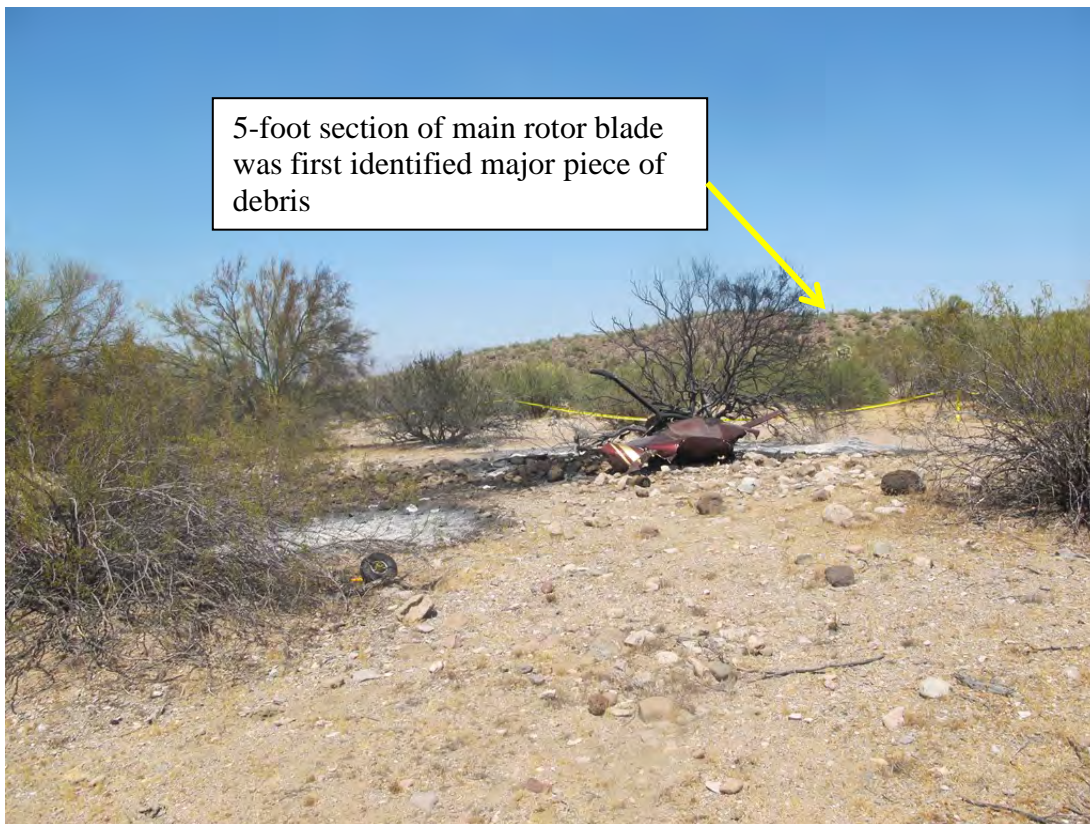
5-foot section of main rotor blade was first identified major piece of debris

Photo 10 Main Wreckage Looking Back Opposite Direction of Flight

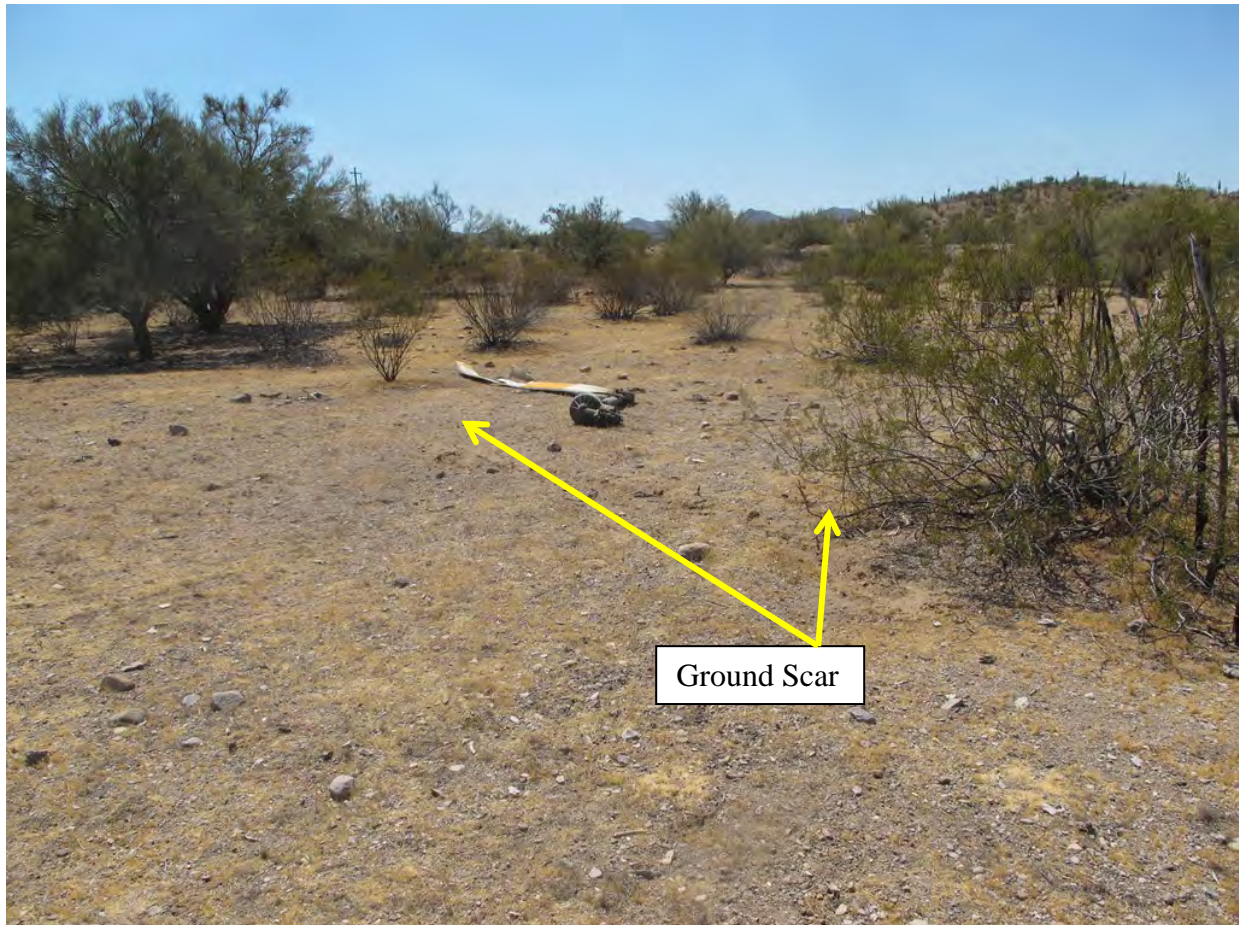
The furthest main piece of debris consisted of the main rotor gearbox, mast, and a main rotor blade. The main rotor blade was bent aft midspan. This piece was a feet past a ground scar that matched the shape of the piece. The main rotor driveshaft was bent approximately 15 degrees at the swashplate. The inboard section of the fractured spindle (w/droop tusk) was recovered near the hub.

Photo 11 Main Rotor Gearbox, Mast, and Main Rotor Blade

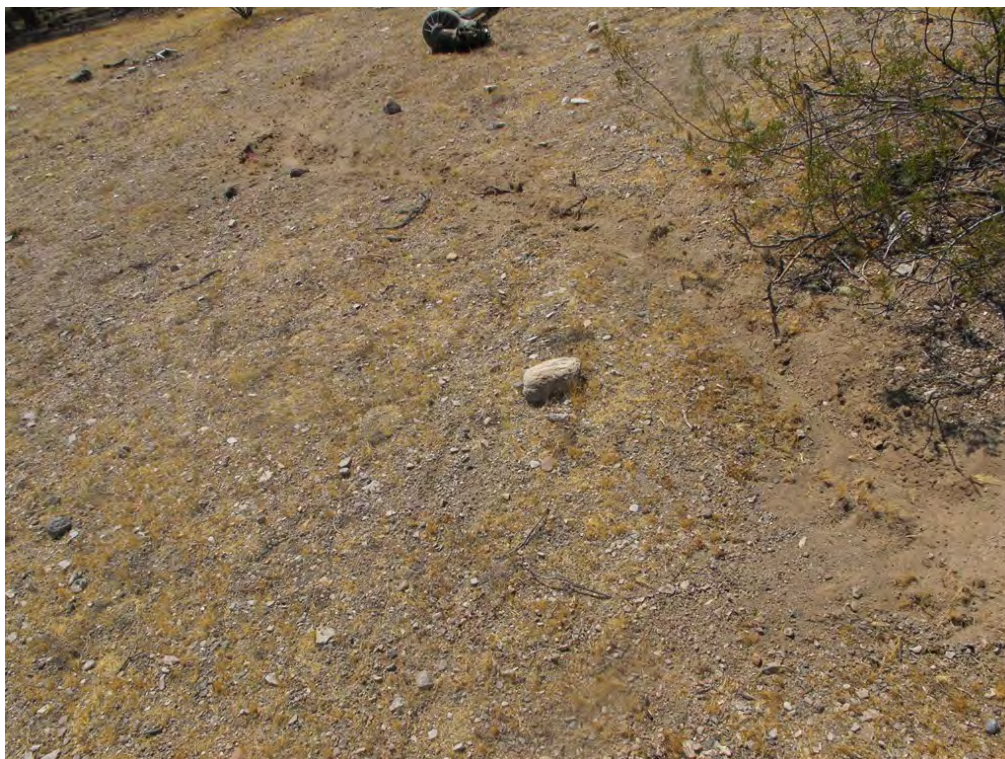
Photo 12 Ground Scar

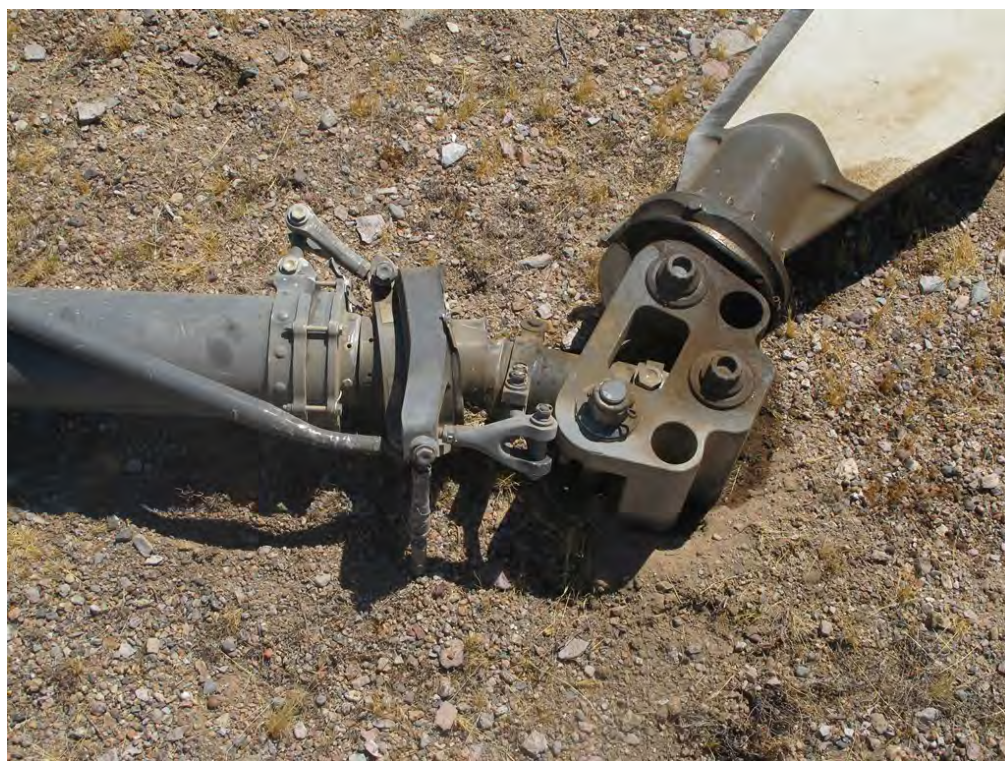
The main rotor driveshaft was bent approximately 15 degrees at the swashplate. The droop stop for the separated blade was damaged.

Photo 13 Bent Main Rotor Driveshaft

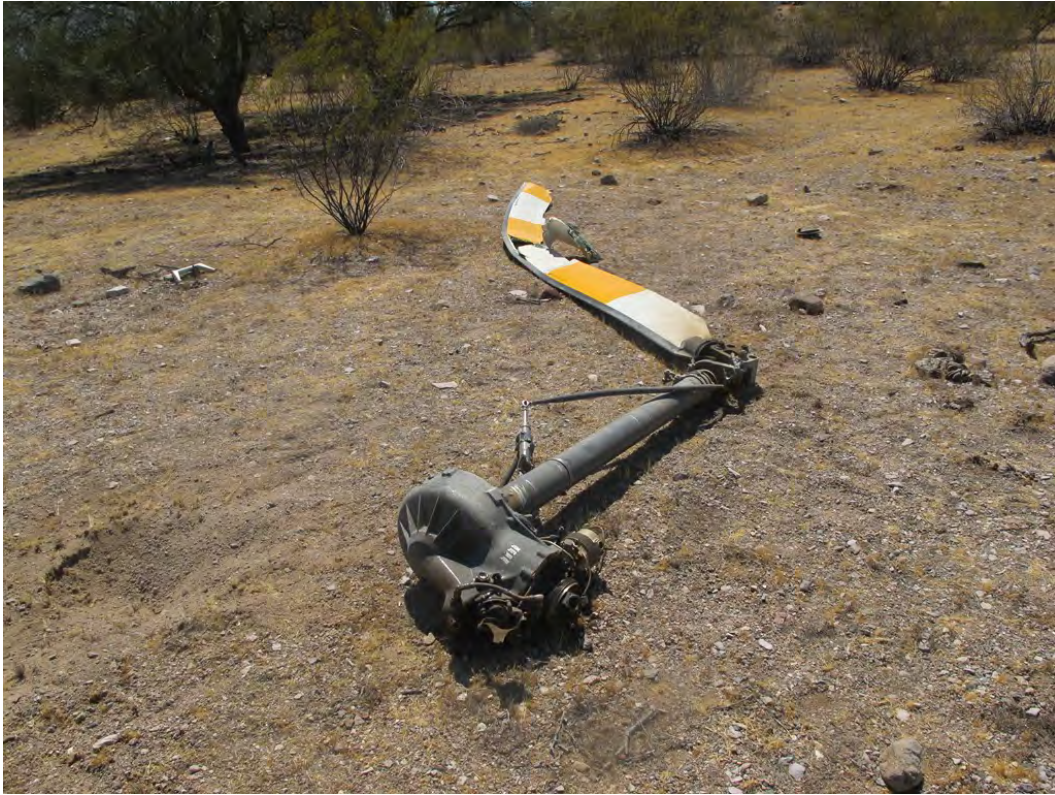
Photo 14 Main Rotor Gearbox, Mast, and Main Rotor Blade

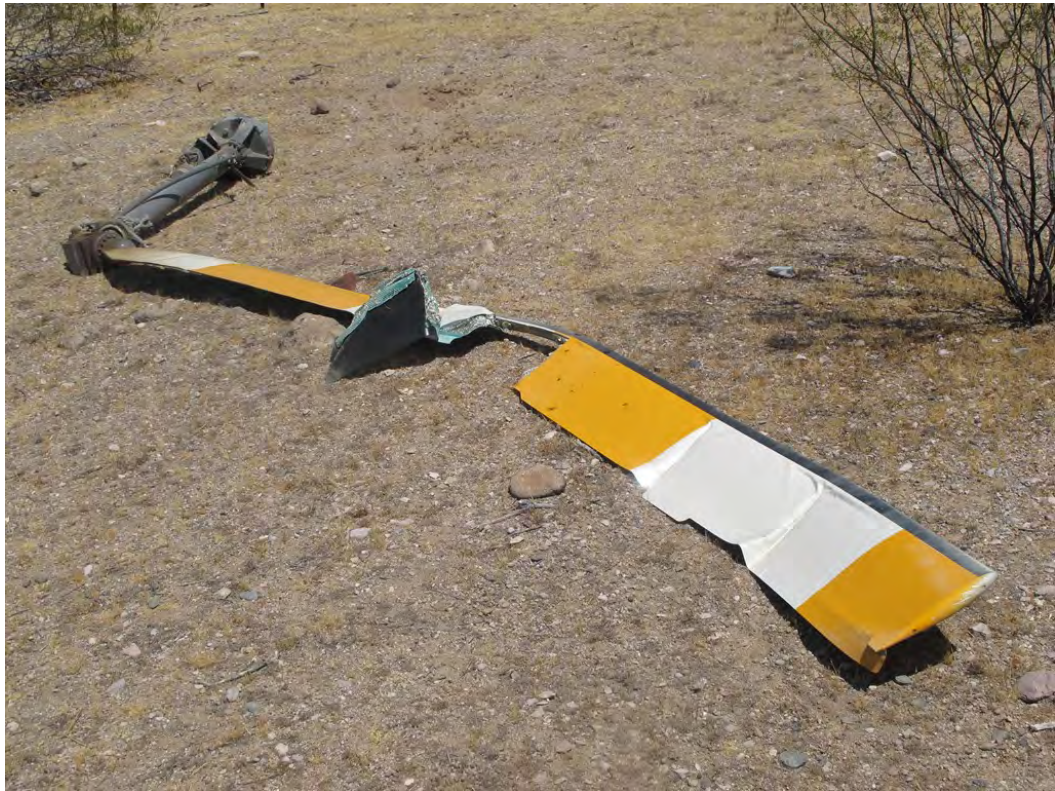
Photo 15 Main Rotor Blade

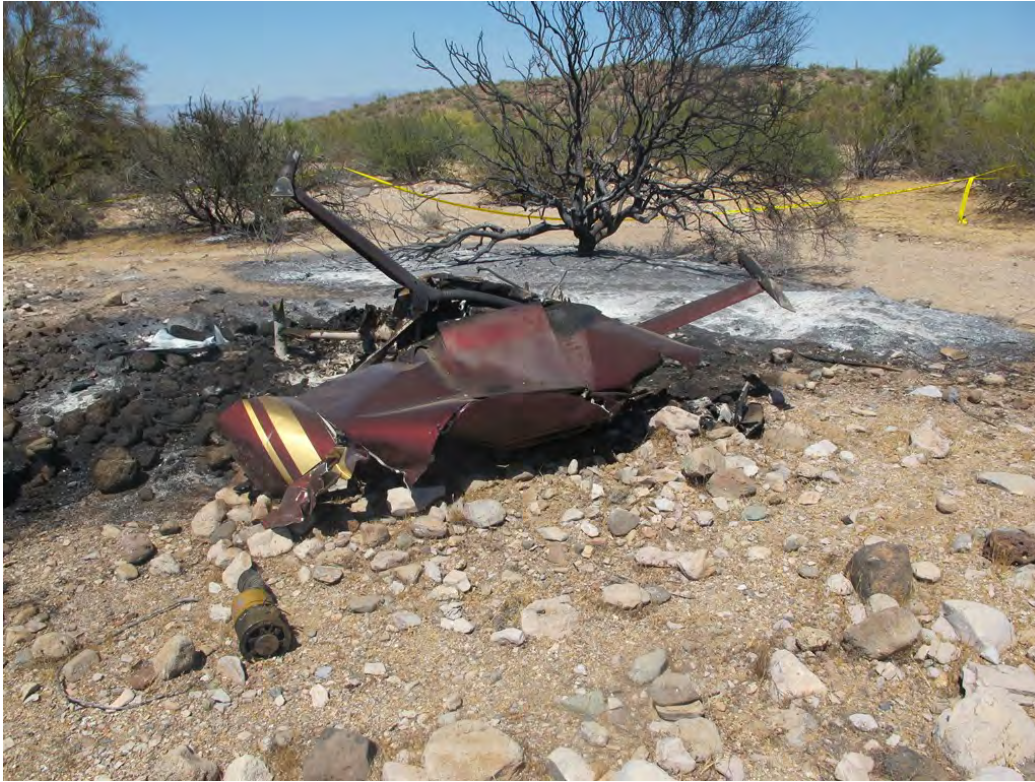
The main wreckage consisted of the inverted cabin area and landing gear skids. The cabin area was consumed by fire. The landing gear aft cross tube was bent near the right elbow, and the tip was bent up.

Photo 16 View of Inverted Main Wreckage (Aft Looking Forward)

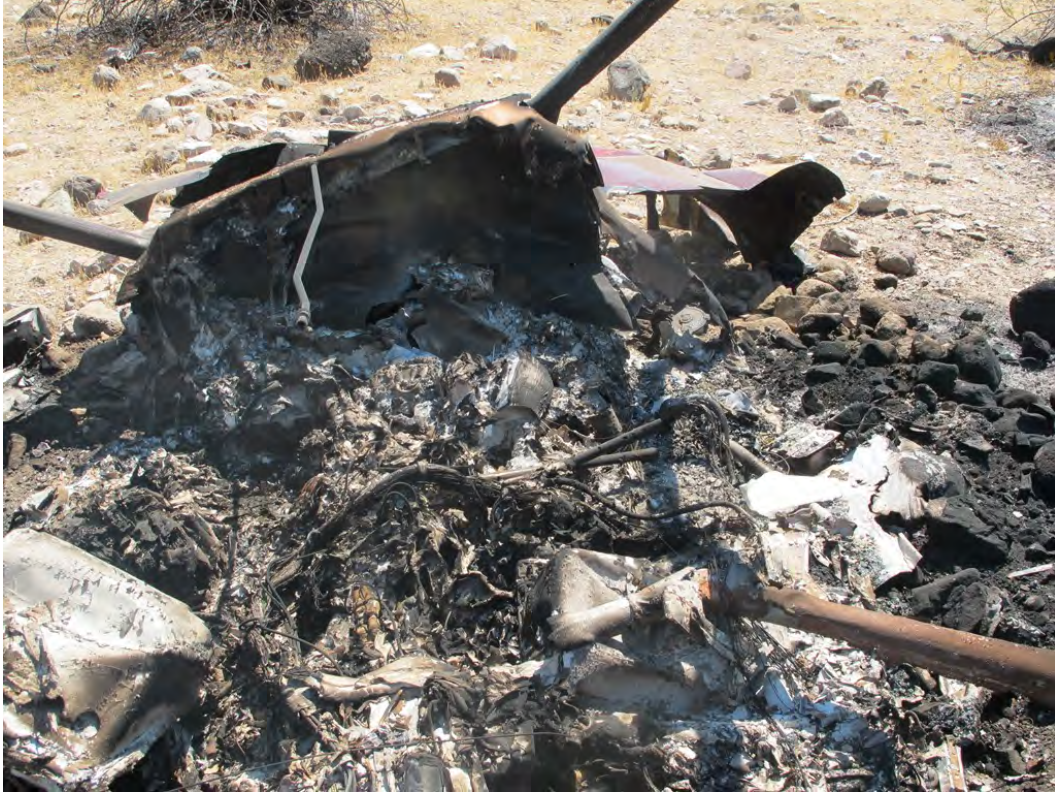
Photo 17 Front View of Inverted Main Wreckage

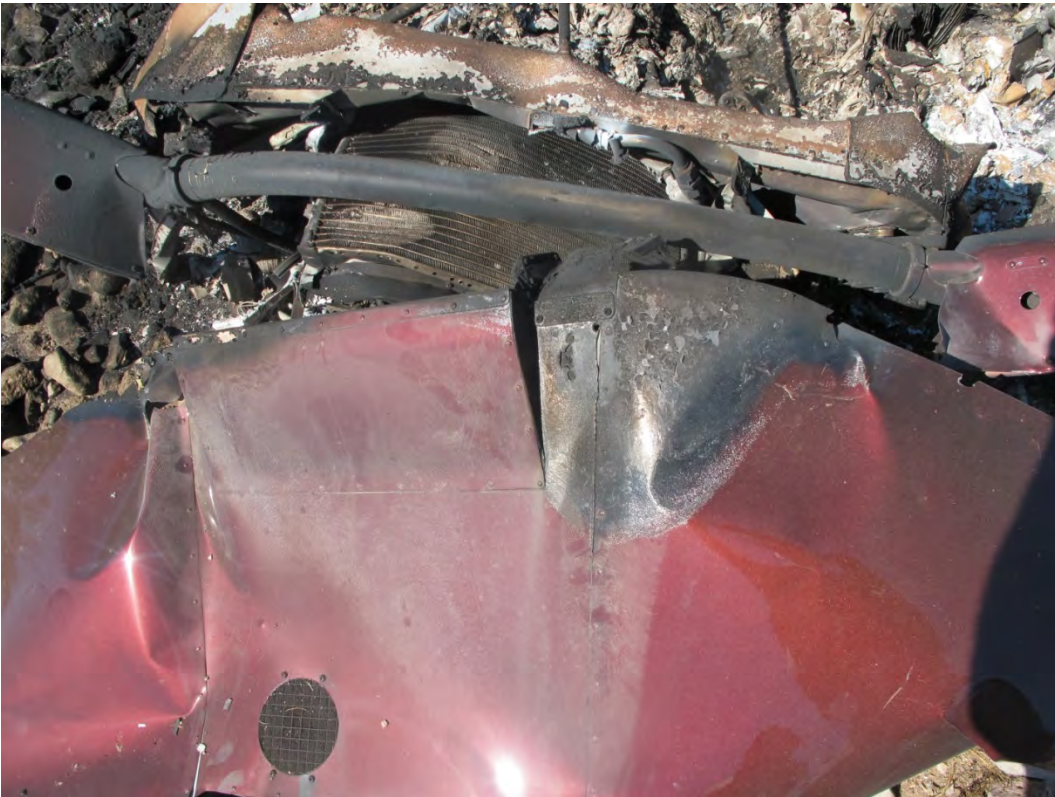
Photo 18 Landing Gear Cross Tube

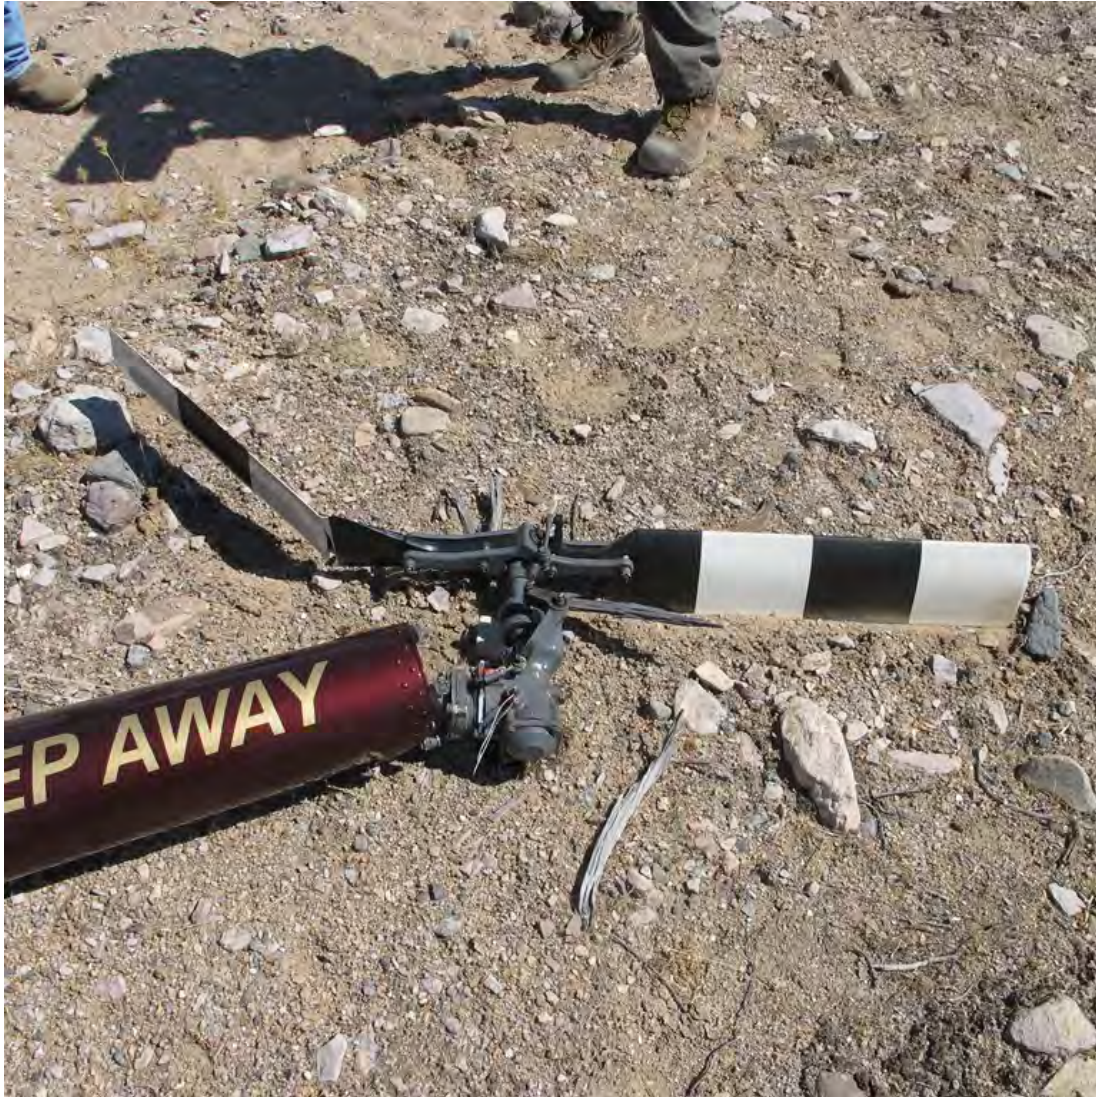
No rotational damage was observed to the tail rotor blades.

Photo 19 Robinson Photo of Tail Rotor Blades
