**NATIONAL TRANSPORTATION SAFETY BOARD
OFFICE OF AVIATION SAFETY**

OPERATIONS FACTUAL REPORT

WPR16FA040

Operator: Air Methods Corporation
Location: Superior, Arizona
Date: December 15, 2015
Time: 1723 mountain standard time
Aircraft: Airbus AS350B3 ASTAR

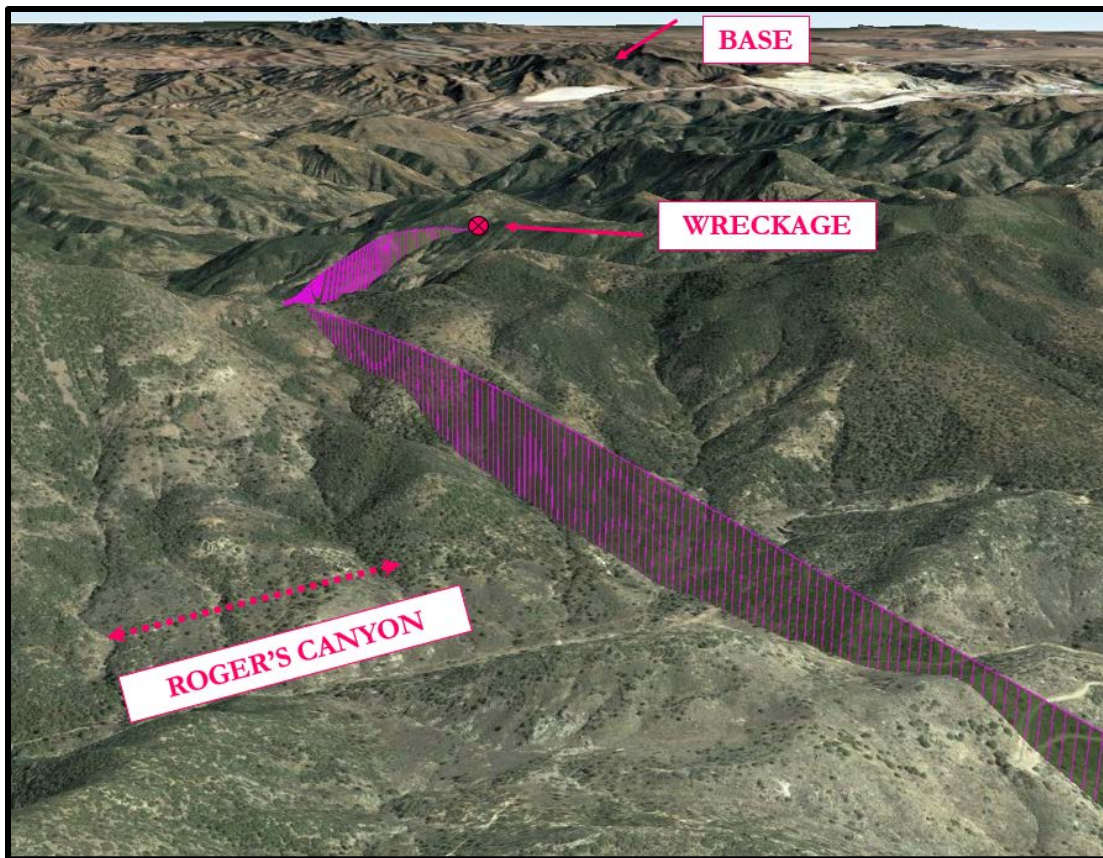
Figure 05: Last Seconds of Flight with Relation to Roger's Canyon

The helicopter flew nearly perpendicularly over the north-south oriented Rogers Canyon and at 1723:07 it continued through a saddle on the canyon's easterly wall, clearing the terrain by about 30 ft agl. As it passed over the eastern ridgeline, the helicopter banked to the right, changed from a ground track of about 43° to 76°, and reached a ground speed of about 120 kts.¹² According to the medic, the pilot was talking to the nurse about hunting and they discussed how there was a lot of game in the area they were flying over. The conversation then turned to the pilot reminiscing about his time in the Army and being overseas. The medic recalled the pilot was talking about having been deployed and the different helicopter attacks they would do during those times. The pilot reminisced about seeing the enemies on the ridgelines and telling them about firing on the enemy troops. He told them what it would feel like when the attack helicopter shot off rocket pods and how they would light up the skyline.¹³ Immediately before the accident, the pilot was talking about the different types of helicopters that they used while engaging with enemy forces and described using rockets and guns, while making machine gun noises to add effect to his story.

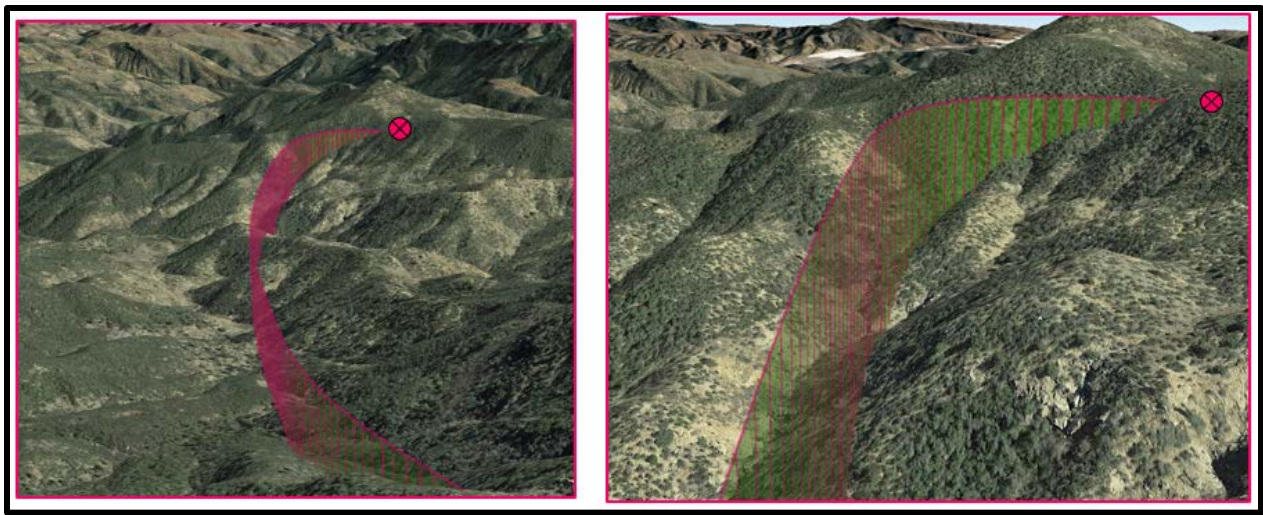
Figure 06: Flight Path During the Last Seconds of the Flight Relative to the Surrounding Terrain

The helicopter then started began a right roll toward a an approximately 970 ft.-wide saddle in a ridgeline to the right of its flight path. According to the medic, around this time¹⁵ the pilot said “Oh shit” in a panicked voice. The medic immediately looked up from the laptop and out the front windscreen. He saw a ridgeline immediately in their flight path and terrain filling up the view as they were approaching very close. The helicopter's nose tipped upward and he saw the sky.

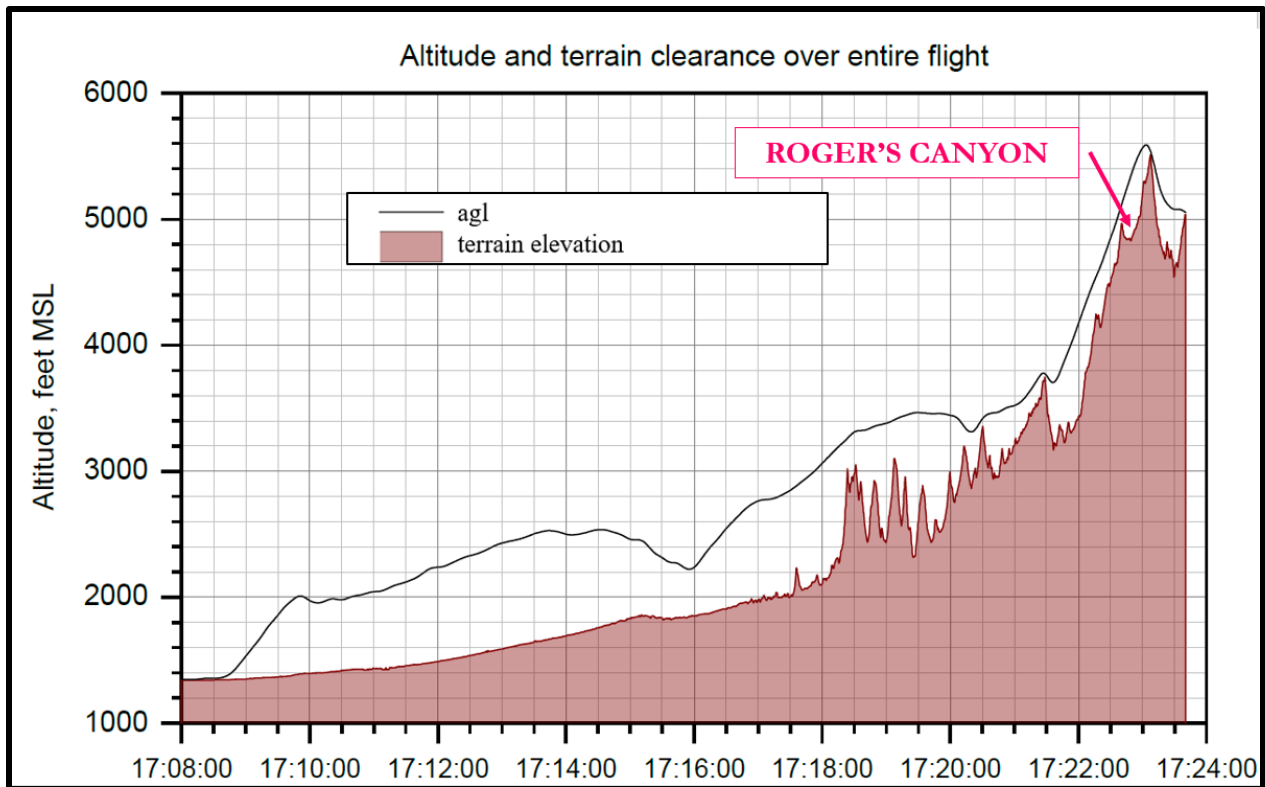
Figure 07: Terrain Elevation and Helicopter Altitude Plotted vs. Time

not see or hear anything out of the ordinary and the pilot did not say anything else but was making jerky fast hand movements. The medic described the feeling as if the pilot was performing an evasive maneuver and the helicopter did not have enough altitude and was too close for them to clear the terrain.

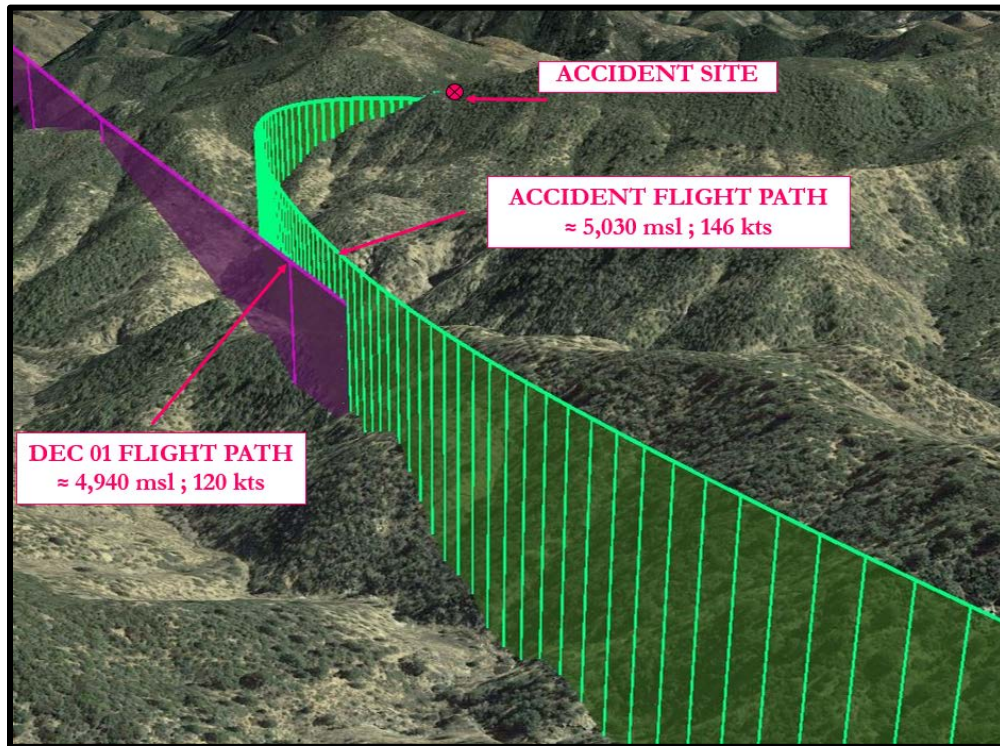
Figure 13: Comparison of Accident Pilot's December 01 Flight and Accident Flight

In December 2015 the pilot had flown the flight leg on four separate occasions all in the morning hours: December 01 (departed about 1050), December 06 (departed about 0420), and twice on December 11 (departed at 0120 and 0702). The December 01 flight was similar to the accident flight where the helicopter passed over the Roger's Canyon ridgeline and descended into the canyon, lower than the accident flight path. The nurse on that flight did not recall anything abnormal and did not think the pilot flew the leg lower than any of the other flights.

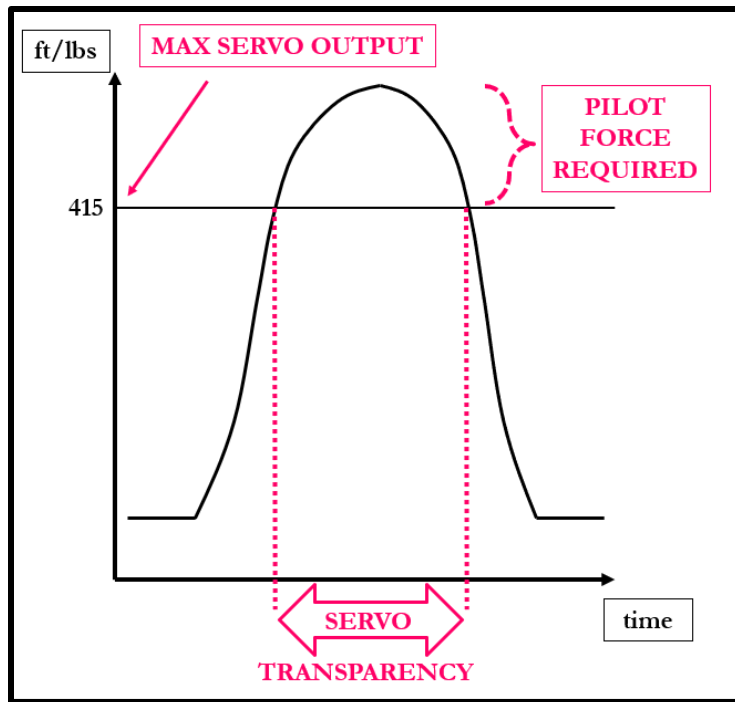
Figure 19: Visual Representation of the Servo Transparency Phenomena.

Servo Transparency begins when the aerodynamic forces acting to change the pitch of the rotor blades exceed the hydraulic servo actuators' capability to resist those forces and maintain the commanded blade pitch angles. The force deficit is then transmitted back to the pilot's cyclic and collective controls. On clockwise turning main rotor systems such as the AS350B3, the right servo receives the highest load when maneuvering (retreating blade), resulting in an uncommanded right and aft cyclic motion accompanied by down collective movement. The pilot's control force to counter this aerodynamically-induced phenomena are relatively high and according to Airbus "may give a pilot who is not aware of this phenomenon an impression that the controls are jammed." If the pilot does not reduce the maneuver, the aircraft will roll right and pitch-up. The amplitude of the induced control feedback loads is proportional to the severity of the maneuver, but the phenomenon normally lasts less than 2 seconds.

Based on the calculations described in the Performance memo, the helicopter likely experienced the servo transparency phenomena during the final 6 seconds of recorded data (from 1723:34 to the end of the GAU2000 data at 1723:40). After the helicopter passed over the eastern ridge of Roger's Canyon at 1723:07, the helicopter entered the valley and then maintained a shallow right roll angle. At 1723:32, the right roll angle and normal load factor suddenly started to increase. These changes in roll angle and load factor started below the servo transparency threshold, but crossed into conditions where servo transparency would be expected around 1723:34. The medic describes observing the pilot's hand motions just prior to the crash as seeming "fast, real fast, jerky fast," which is consistent with a struggle with the cyclic forces resulting from servo transparency. He additionally described an aggressive hard right turn which is consistent with the rapid onset of servo transparency.
