NATIONAL TRANSPORTATION SAFETY BOARD
Office of Aviation Safety
Washington, D.C. 20594

POWERPLANT GROUP CHAIRMAN'S FACTUAL REPORT

NTSB No: WPR16FA035

Location: Apple Valley, California
Date: December 6, 2015
Time: 1407 Pacific Standard Time
Aircraft: Aero Vodochody L-39C, Registration Number N39AY

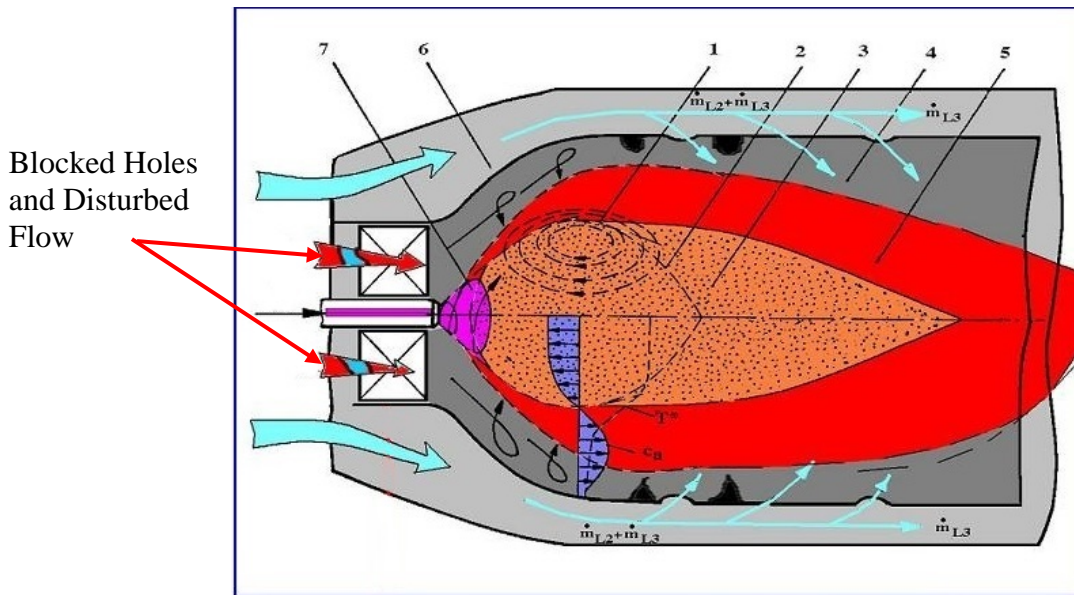
Figure 5 – Disturbed Combustion Shape with Interference from Soot & Blocked Holes

In contrast, the Figure 5 shows a delay of the complete combustion of sprayed fuel because of the restriction of the air from the anti-carbon-buildup holes, causing the flame to become longer and the maximum heat profile to shift aftwards. The maximum heat profile, which is normally confined in the combustion chamber and focused on the cooled 1st stage vane ring and turbine, now passes further aft, thermally affecting the 2nd and 3rd stage turbines and vane rings. The 2nd and 3rd vane and turbine stages are not internally cooled and are not designed for the higher temperature profile, causing thermal

degradation. The secondary affect is that this degradation causes a loss of engine performance, which the pilot may compensate for, by increasing the fuel flow, accelerating the thermal damage to the 2nd and 3rd turbine stages even more.

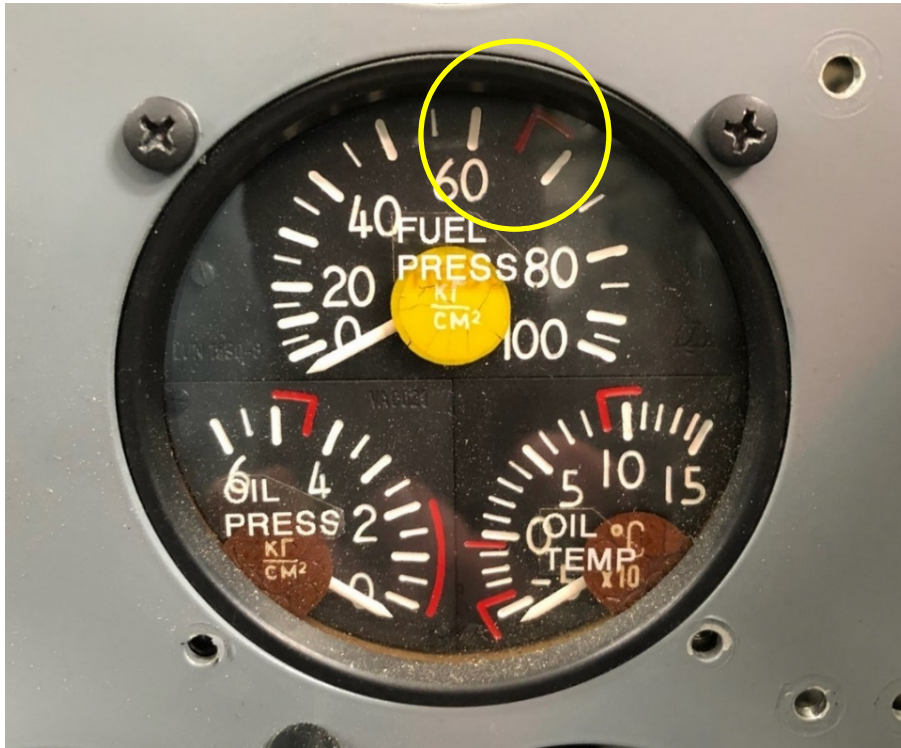
Figure 6 – Exemplar 3-in-1 Gauge in Cockpit – Note Fuel Pressure Redline of 65 Atmospheres

cause for further maintenance investigation. A gauge on the pilot's instrument panel displays the engine metered fuel delivery pressure (Figure 6) and clearly has a redline at 65 atm.

The maximum fuel delivery pressure measured for the event FCU was 85 atm. Screw number 28 had to be adjusted by several turns in the counterclockwise direction to bring the fuel delivery pressure back to 50 atm., indicating that there was no internal fault with the FCU but rather it had been purposely adjusted to 85 atm. fuel pressure.

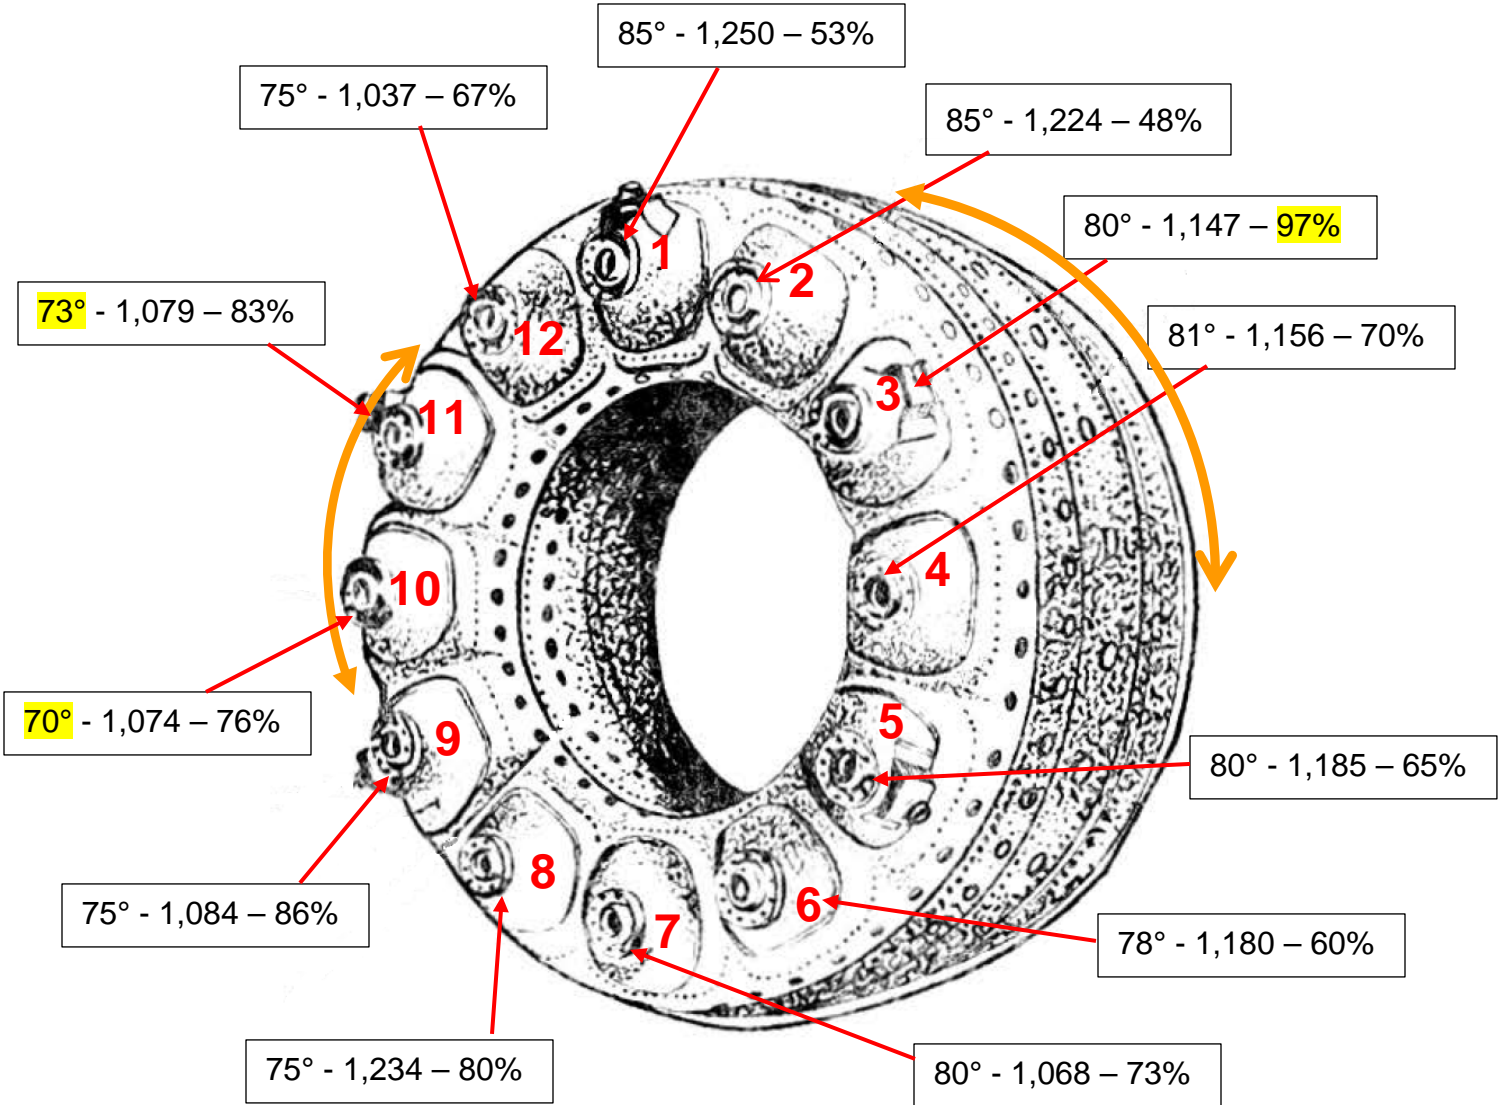
Figure 7 – Combustor with Fuel Nozzles Performance and Maximum Damage to 2nd Stage LP Nozzle Overlaid (Orange Arcs)

A record of the locations of the fuel nozzles was made during their removal at the Plain Parts facility in Pleasant Grove, California and their performance was overlaid on a sketch of the combustor in Figure 7.

It was noted that FN No. 3 had the highest spray pattern variance or streakiness (97%), matching the location of the thermal distress between 9:00 and 12:30 o'clock on the 2nd stage LP nozzle. Additionally, FNs No.10 & 11 had the narrowest spray cone angle (70° & 73° respectively), matching the location of the 2:00 and 4:00 o'clock on the 3rd stage (or 2nd stage LP) nozzle.

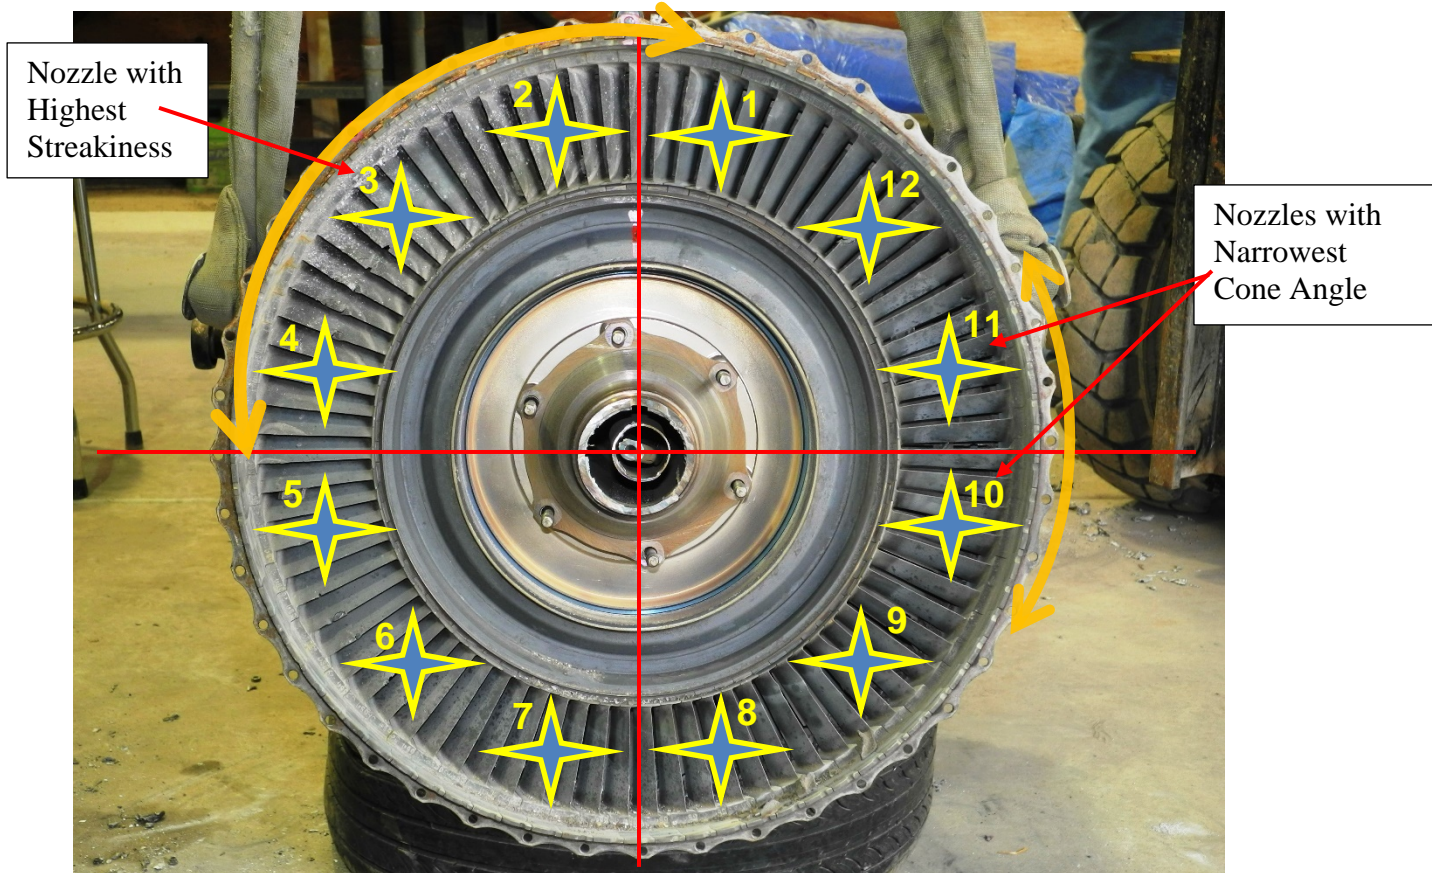
Figure 8 – Fuel Nozzle Locations Overlaid on Damaged 3rd stage (2nd Stage LP) Nozzle
(Note: ALF)

The upstream nozzle locations were overlaid on a photo of the 3rd stage (or 2nd stage LP) nozzle, (Ref. [Photo 33](#) taken during the engine examination at the Plain Parts facility in Pleasant Grove, California) which revealed a circumferentially varying heat distress damage pattern, highlighted on [Figure 8](#). Each star marking represents a fuel nozzle location and referenced FN number. The two orange arcs highlight the areas of greatest thermal distress on the 3rd Stage (or 2nd stage LP) nozzle vanes.

The damage noted on the 2nd and 3rd stage nozzles and turbines is consistent with overtemperature condition caused by a disturbed combustion process in the combustor due to poor fuel atomization by the fuel nozzles.

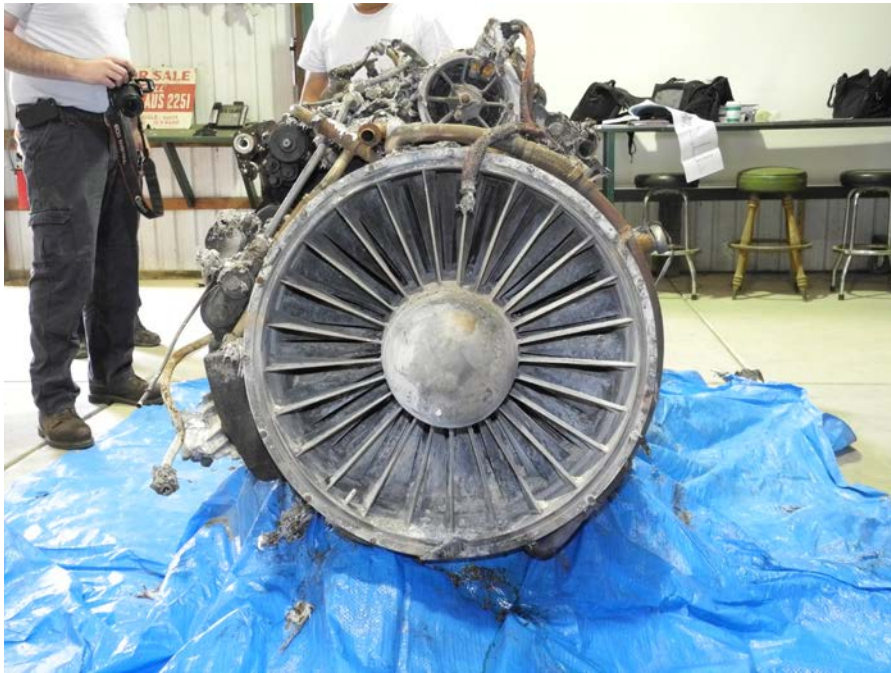
Photo 5

The LP compressor inlet guide vane assembly was intact (Photo 5), however, there were two small dents near the tip of the nose cone. The LP compressor assembly was externally intact. The bypass duct inlet housing and accessory gearbox drive and support was heat distressed. A segment of the bypass duct housing outer and inner ducts from the 10 to the 5 o'clock location was burned and missing, exposing the inner accessory gearbox bevel drive housing (Photo 6). The outer bypass duct aft of the bypass duct inlet housing was heat distressed and the segment from 9 to 6 o'clock⁴ was melted. The HP compressor housing, combustor housing, turbine housing and the exhaust pipe were externally intact (Photo 7).

Front View - LP Compressor Inlet Guide Vane Assembly

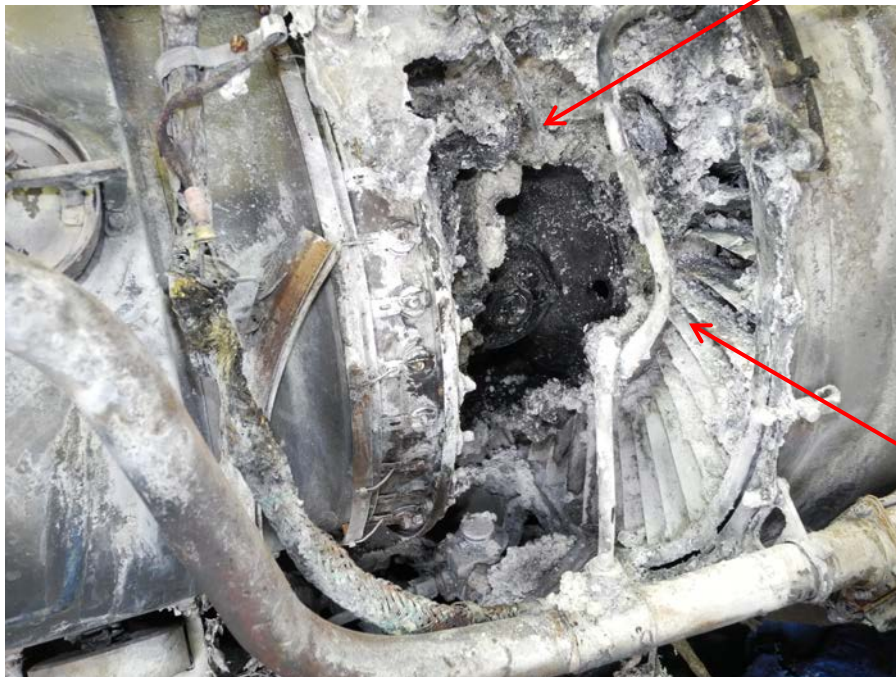
Photo 6

Because the outer bypass duct was melted through, the 3rd stage LP compressor could be observed without disassembling the engine case (Photo 6). All blades and stators

A segment of the bypass duct housing outer and inner ducts from the 10 to the 5 o'clock location was burned and missing, exposing the inner accessory gearbox bevel drive housing (Photo 6). The accessory gearbox lower access panel was removed, and the bevel gear drive shaft and its associated bearings were observed to be intact and free to rotate (Photo 41).

Bypass Duct Housing Outer and Inner Ducts

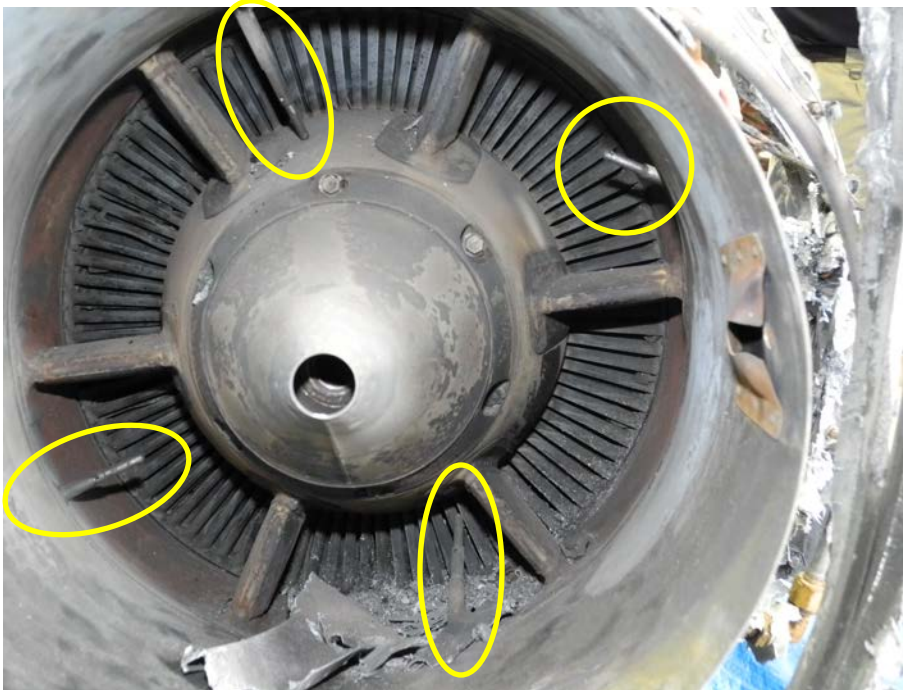
Photo 8

The 2nd stage LP turbine was intact, and all blades were present, however several blades were deformed (Photo 8). Approximately a handful of metallic debris was observed at the bottom of the duct on the plane of the 2nd stage turbine. Additionally, several fractured and overheated blade tip fragments (Photo 9), consistent with material from the 1st stage turbine were found lodged between the 2nd stage blade gaps. The four exhaust gas thermocouples were still present (Photo 8), however the 9 and 12 o'clock thermocouples were bent in the counterclockwise direction, while the one at 6 o'clock, although unbent, was radially translated inward and rested against the rear bearing housing inner duct. The 3 o'clock thermocouple appeared to be undamaged. (See paragraph D.4.5 Thermocouples (TC) for detailed thermocouple tests and examination results).

Aft View: 2nd Stage LP Turbine, Rear Bearing Housing

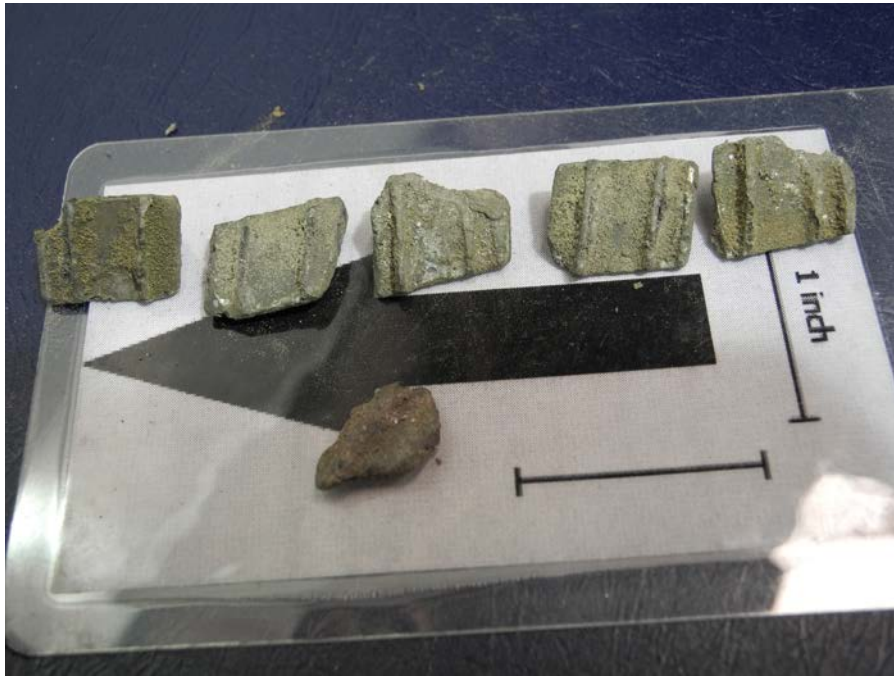
Photo 9

Fractured Blade Tip Segments Found in Exhaust Duct

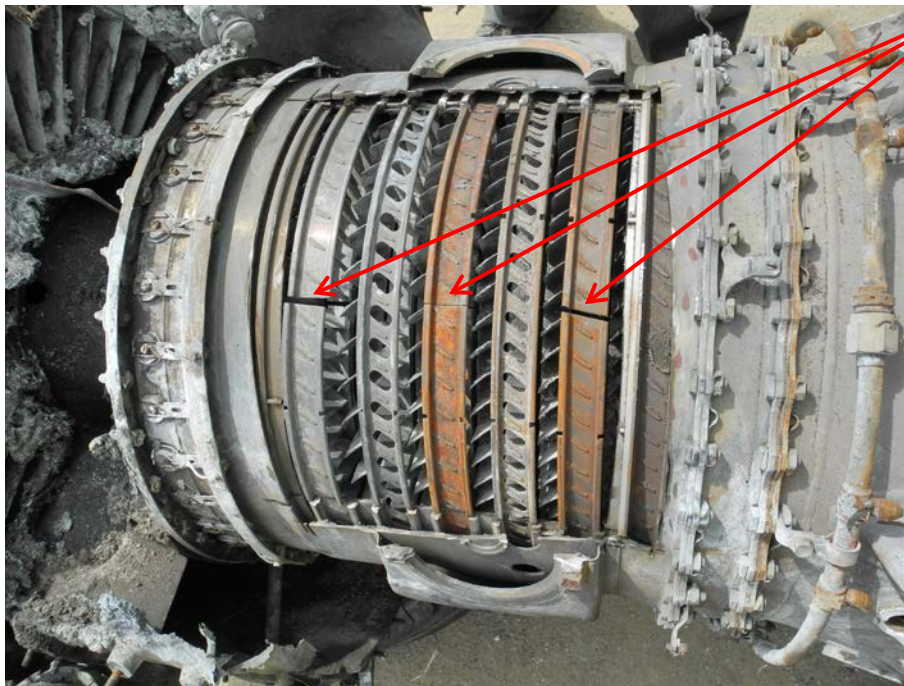
Photo 14

Because no factory tooling was available to correctly disassemble the HP compressor, a cutting wheel was used to remove a section of the HP compressor housing (Photo 14), revealing nine stages of blades and stators which were intact and undamaged. The leading edges of the blades and stators were examined for any nicks or other FOD damage and none was found. Additionally, a white powdery coating was observed throughout the HP compressor as well as some minor local surface corrosion.

HP Compressor (Housing and Plenum Cut)

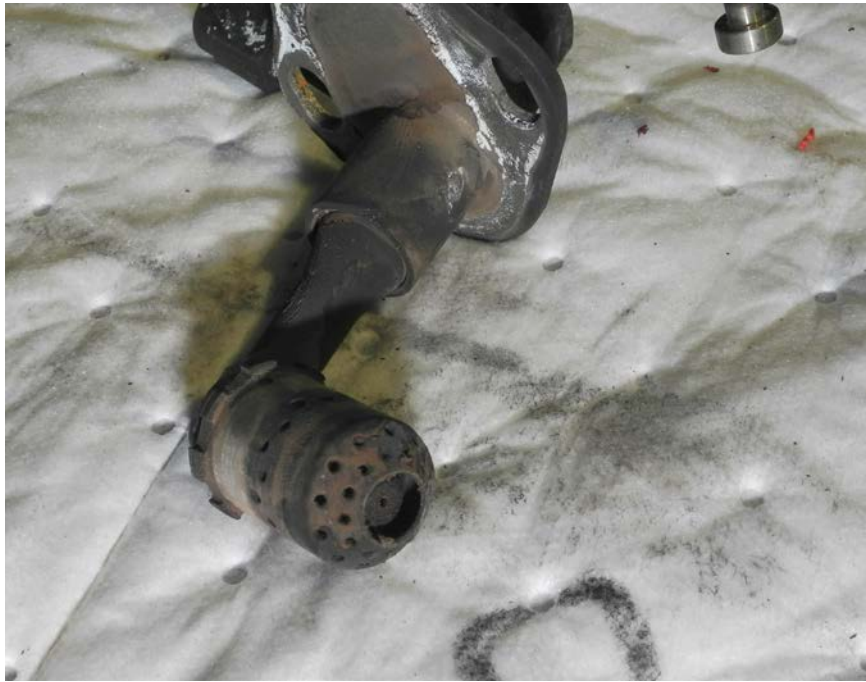
Photo 17

Fuel Nozzle – Carbon Deposits

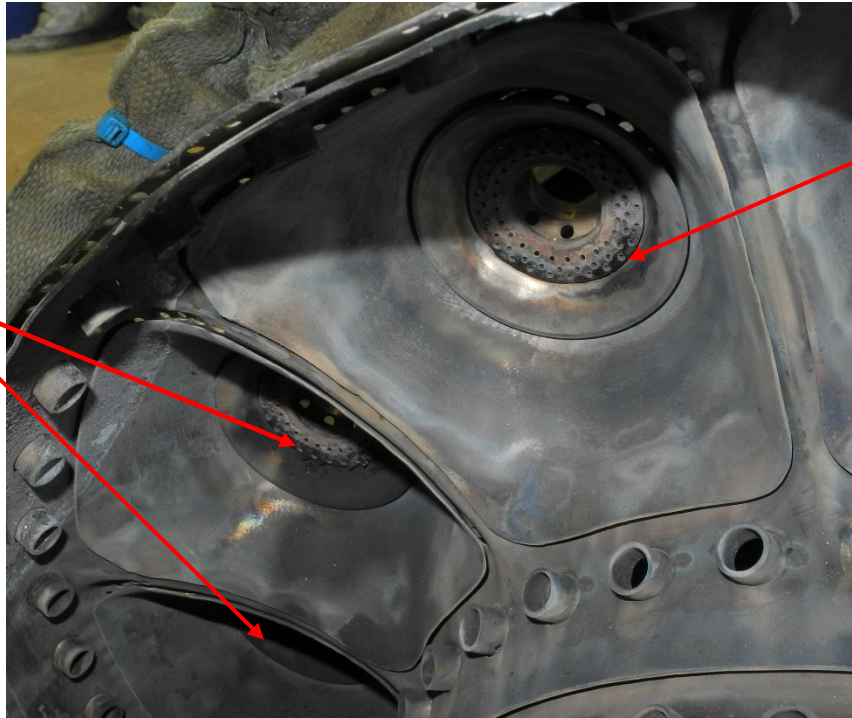
Photo 19

The damage observed on the 2nd and 3rd stage nozzles and turbines is consistent with overtemperature condition caused by a disturbed combustion process in the combustor consistent with restricted anti-carbon-buildup holes in the fuel nozzle head assembly.

Fuel Nozzle Head Assemblies – Carbon Deposits & Restricted Cooling Holes

Carbon Deposits and Restricted Cooling Holes

Carbon Deposits

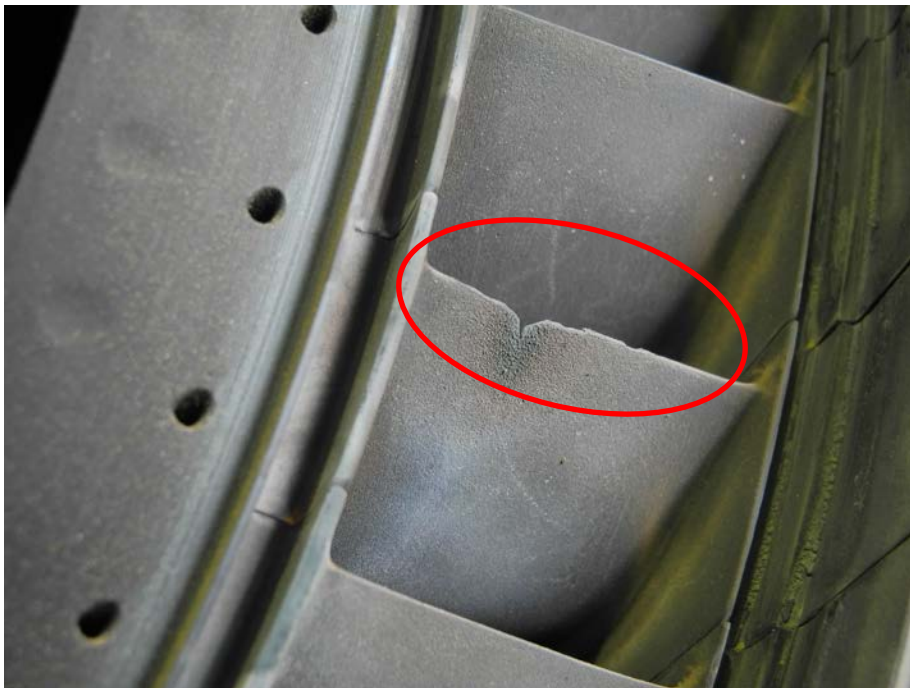
Photo 22

The HP turbine nozzle consists of an assembled set of individual vanes locked in place via inner and outer retaining flanges and clips. The vanes are hollow and during operation, compressor air is directed through their internal cooling passages for cooling purposes. All the vane segments were present, locked in their proper location and intact⁵ (Photo 20). The concave side of the vanes exhibited a slight lightened discoloration on the forward 1/3 span. Additionally, a mild streaking in the airflow direction was noted on approximately the forward 1/2 span (Photo 21). Only one vane segment at the 4 o'clock location exhibited heat induced erosion at the trailing edge (Photo 22).

Details of Eroded HP Turbine Nozzle Vane Trailing Edge

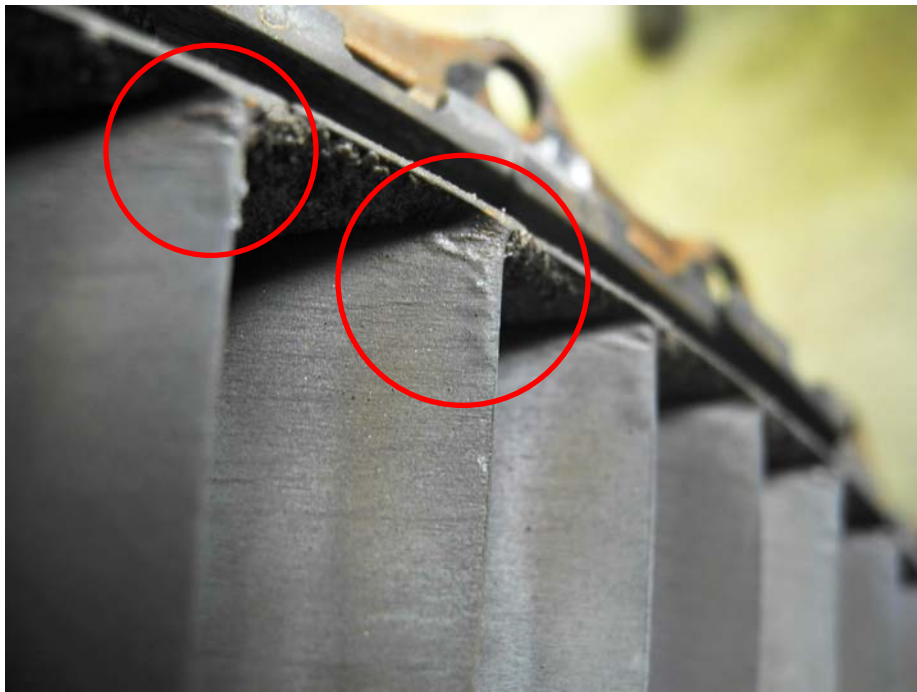
Photo 24

The HP turbine features a bladed hub design. The blades are hollow and during operation, compressor air is directed through their internal passages for cooling purposes. The hub was intact, and all the blades were present, locked in their proper location and intact (Photo 23). Light debris was noted, adhering to the inside surfaces of the blade tip platforms as well as the outer span of some of the blades. A rippling of the parent material near the outer span at the trailing edges of the blades was observed on many blades (Photo 24 & Photo 25), consistent with blade material becoming plastic during

HP Turbine Blades – Concave Side Trailing Edge Rippling

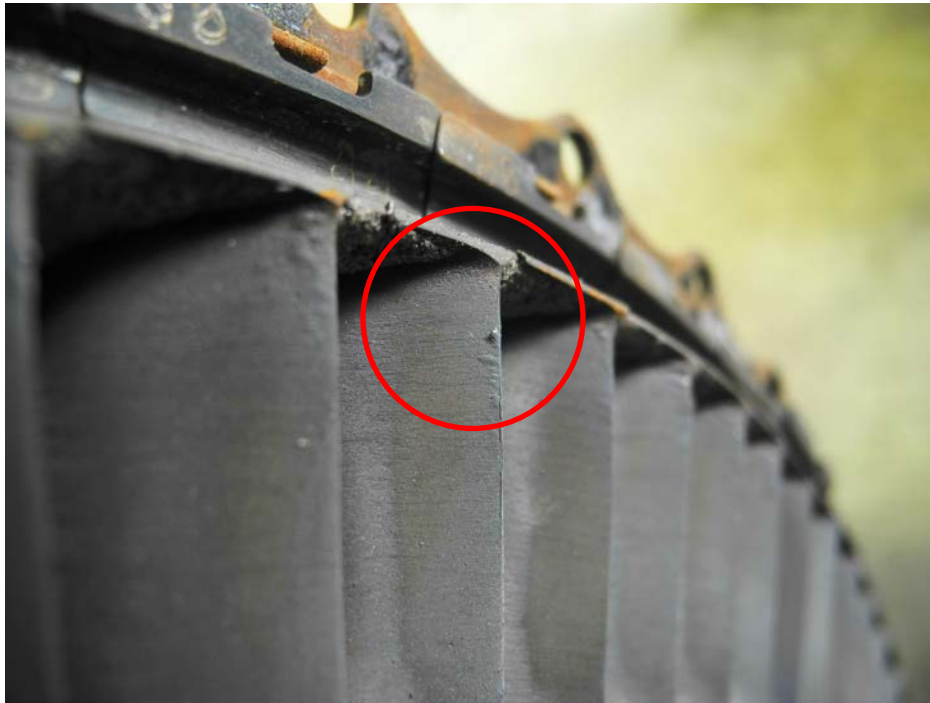
Photo 25

HP Turbine Blades - Concave Side Trailing Edge Rippling

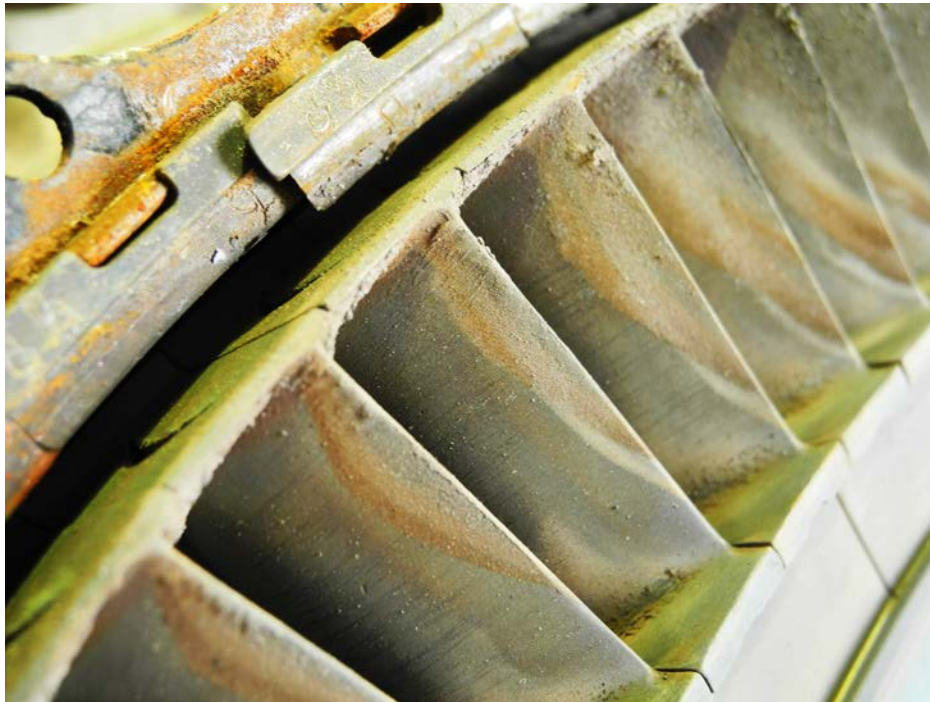
Photo 26

operation at elevated temperatures. Additionally, a streaking pattern in the airflow direction was noted on the entire convex surface of each blade ([Photo 26](#)).

HP Turbine - Details of Streaking Marks

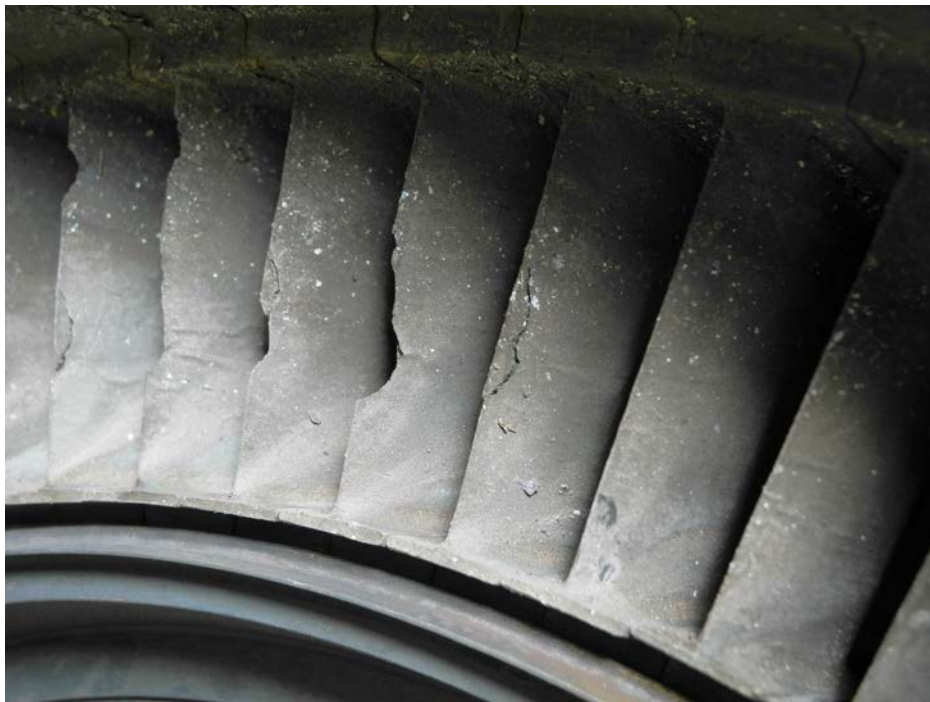
Photo 28

2nd Stage (1st Stage LP) Turbine Nozzle – Trailing Edge Fracture Details

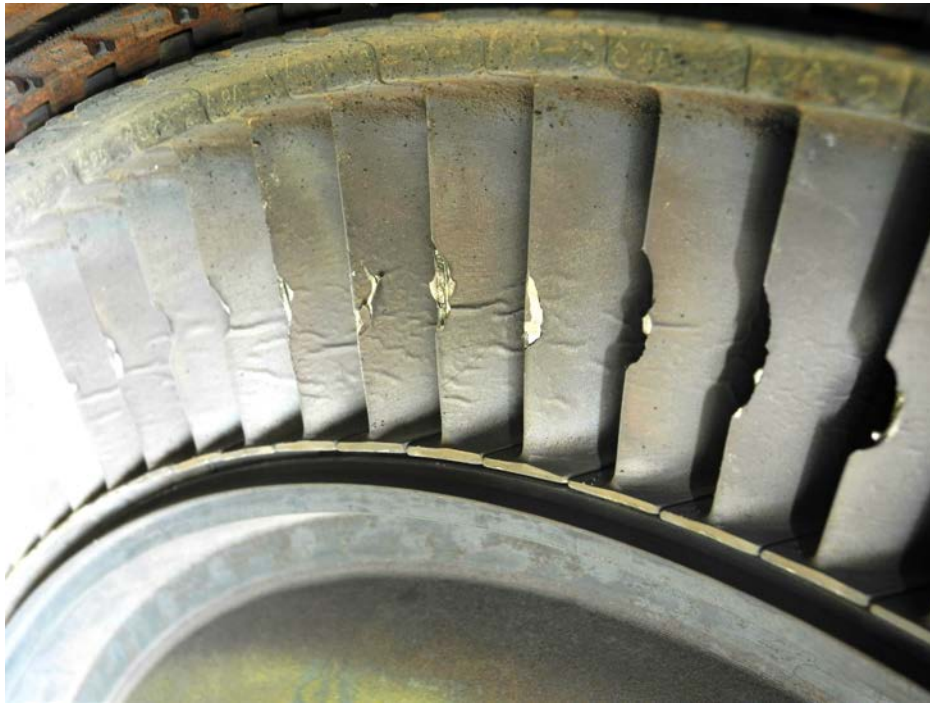
Photo 29

2nd stage (1st Stage LP) Turbine Nozzle – Surface Rippling Details

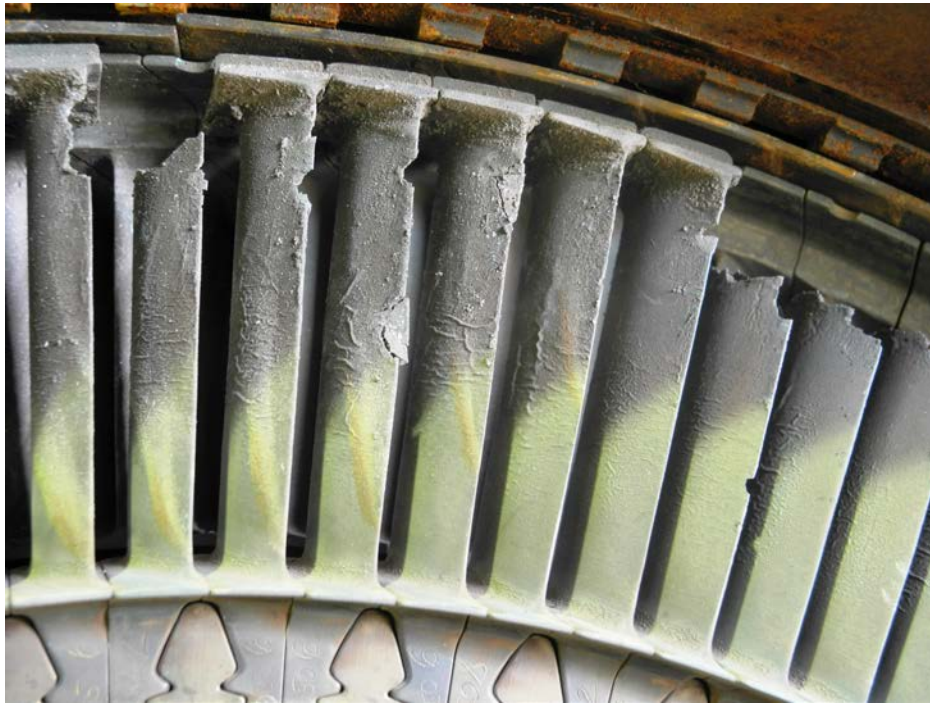
Photo 31

The 1st stage LP turbine features a bladed hub design, the blades being solid castings and uncooled. The hub was intact, and all the blades were present and locked in location, however approximately half of the blades were fractured in a sequential fashion near the tip shroud blend radius, while those with their tip shrouds still intact, had fractures near the trailing edges with fingernail-sized particles missing ([Photo 30](#)). A visual examination of all the fractures revealed only overload type failure. No evidence of fatigue was observed. All the blades exhibited a rippled pattern on the mid-span, consistent with a melted plastic flow ([Photo 31](#)). Several tip shrouds were found at the bottom of the turbine housing ([Photo 32](#)).

2nd Stage (1st Stage LP) Turbine – Rippled Pattern Near Mid-Span

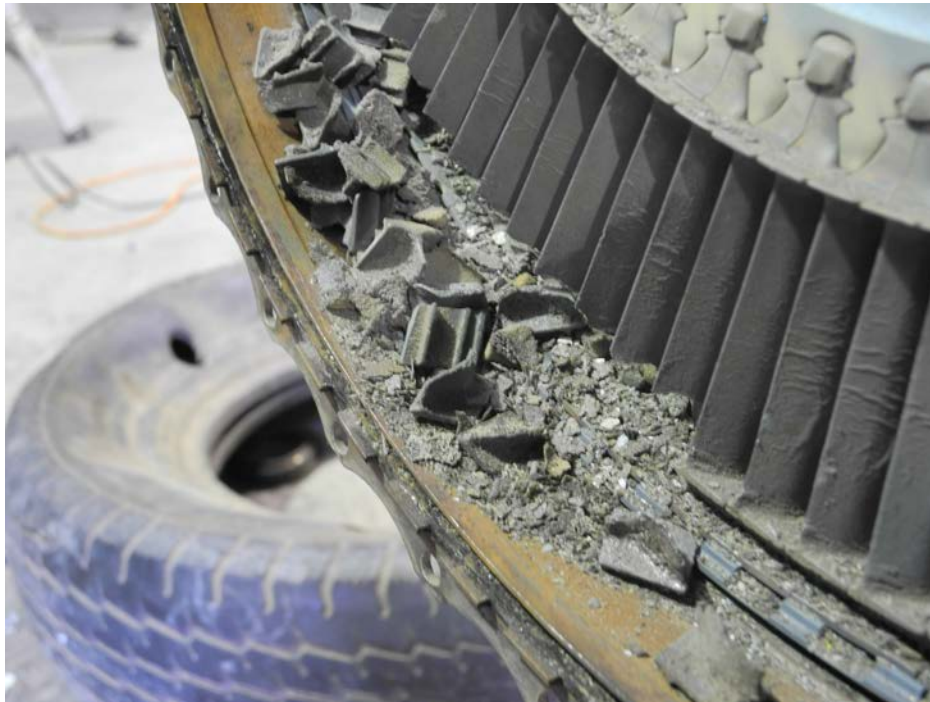
Photo 32

2nd Stage (1st Stage LP) Turbine - Fractured Tip Shroud Debris

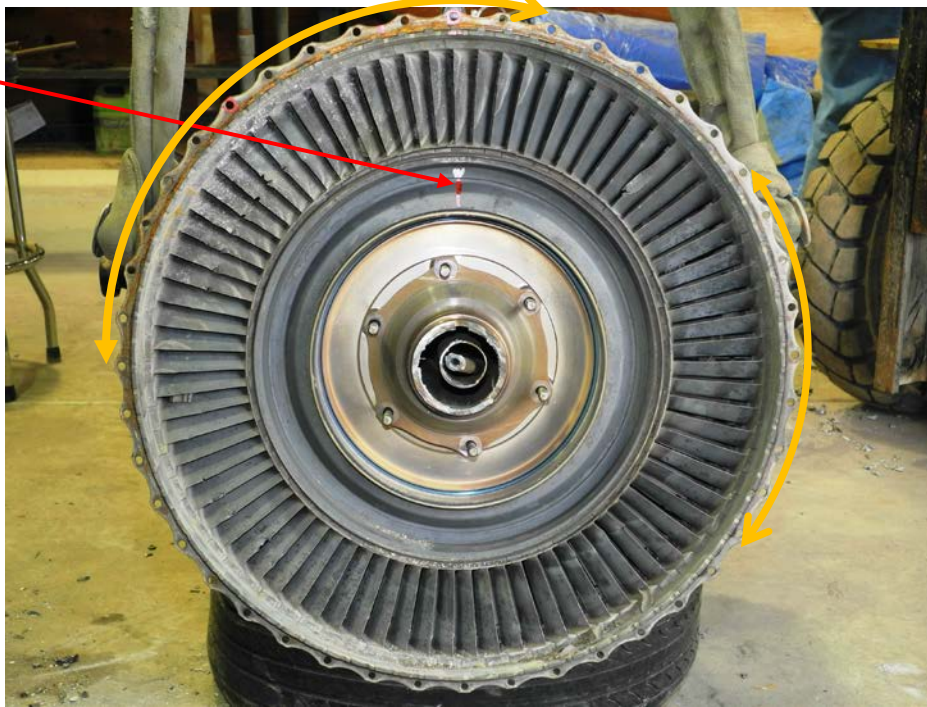
Photo 33

3rd Stage (2nd Stage LP) Turbine Nozzle – In Situ - Aft View

Note discolored pattern and greater heat distortion from 9:00 to 12:30 and 2:00 to 4:00 o'clock positions. Highlighted as Orange Arcs.

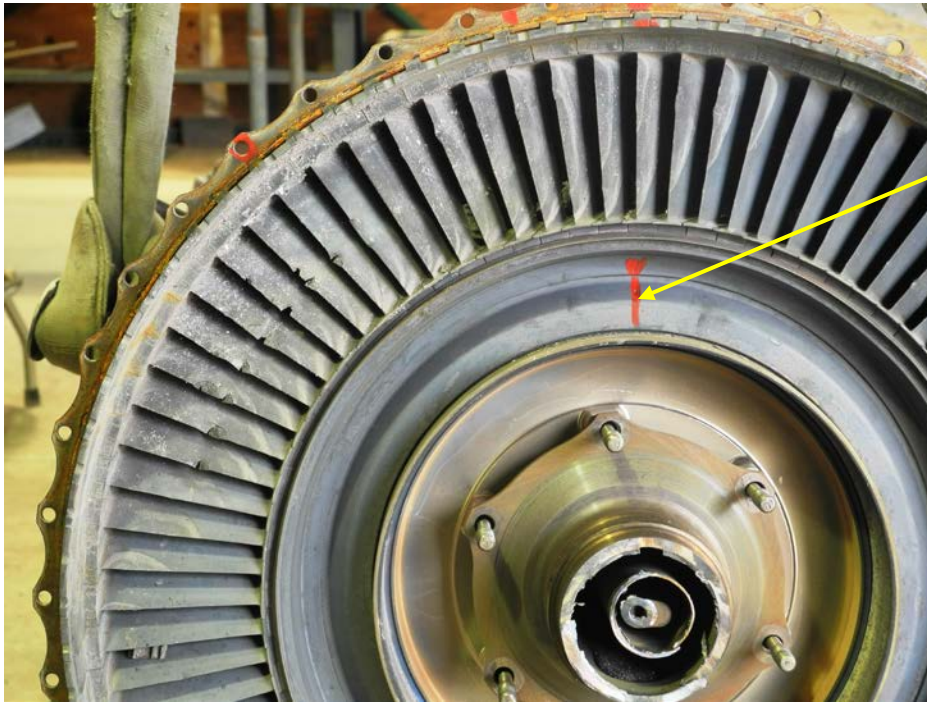
Photo 34

The 2nd stage LP turbine nozzle consists of an assembled set of individual vanes locked in place via inner and outer retaining flanges and clips. The vanes are solid and therefore uncooled. All the vane segments were present and locked in their proper location ([Photo 33](#)), however the vanes within the 2 segments between 9 and 12 o'clock as well as between 4 and 5 o'clock were deformed, distorted and fractured due to impact. The fractures displayed a soft, large radius deformation instead of the typical brittle fractures, damage which is consistent with impact while the material was in an elevated temperature, softened state ([Photo 34](#) & [Photo 35](#)).

3rd Stage (2nd Stage LP) Turbine Nozzle – 8:30 to 1:00 O'clock

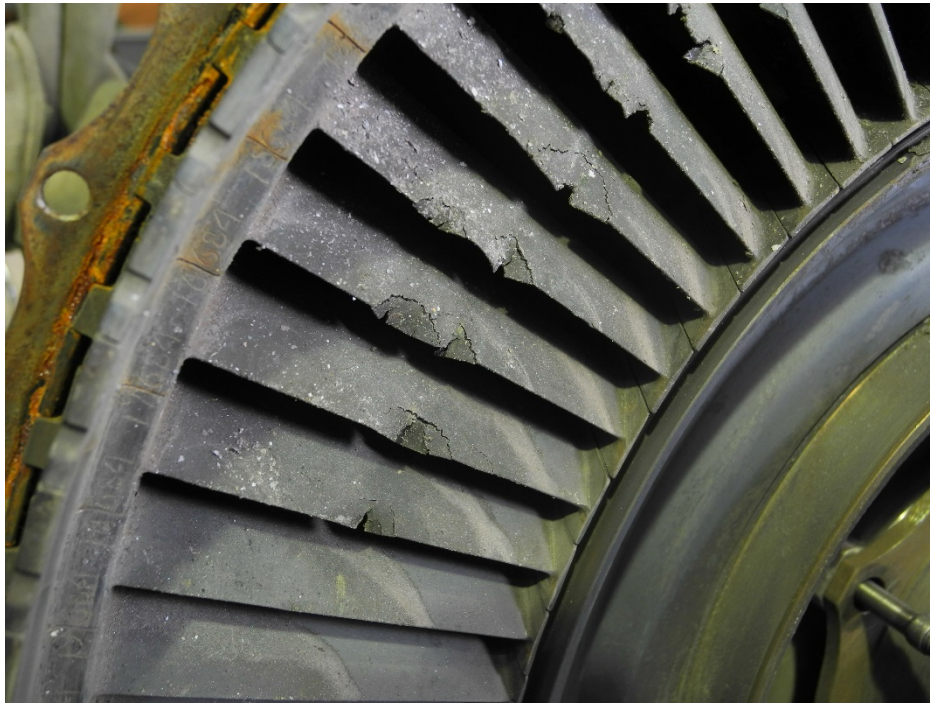
Photo 35

3rd Stage (2nd Stage LP) Turbine Nozzle – Fracture Details

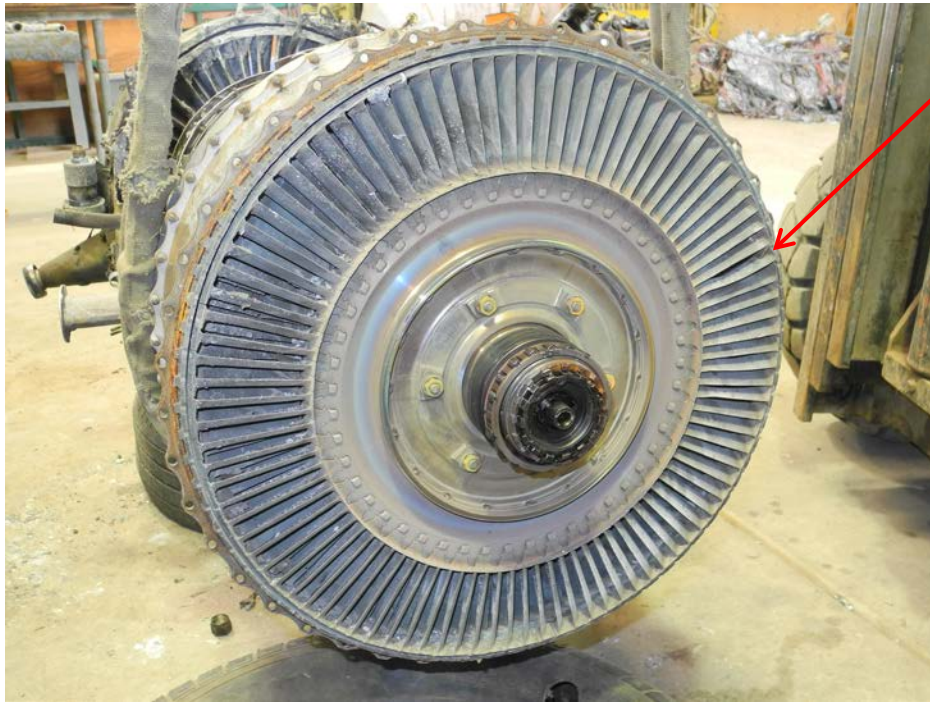
Photo 36

The 2nd stage LP turbine features a bladed hub design, the blades being solid castings and uncooled. The hub was intact, and all the blades were present, locked in their proper location, intact and undamaged (Photo 36). Two non-consecutive blades were bent. Blade tip shrouds from the 1st stage LP turbine as well as other metal debris was found between the blades and at the bottom of the housing.

3rd Stage (or 2nd Stage LP) Turbine – In Situ – Aft View

Deformed Blade

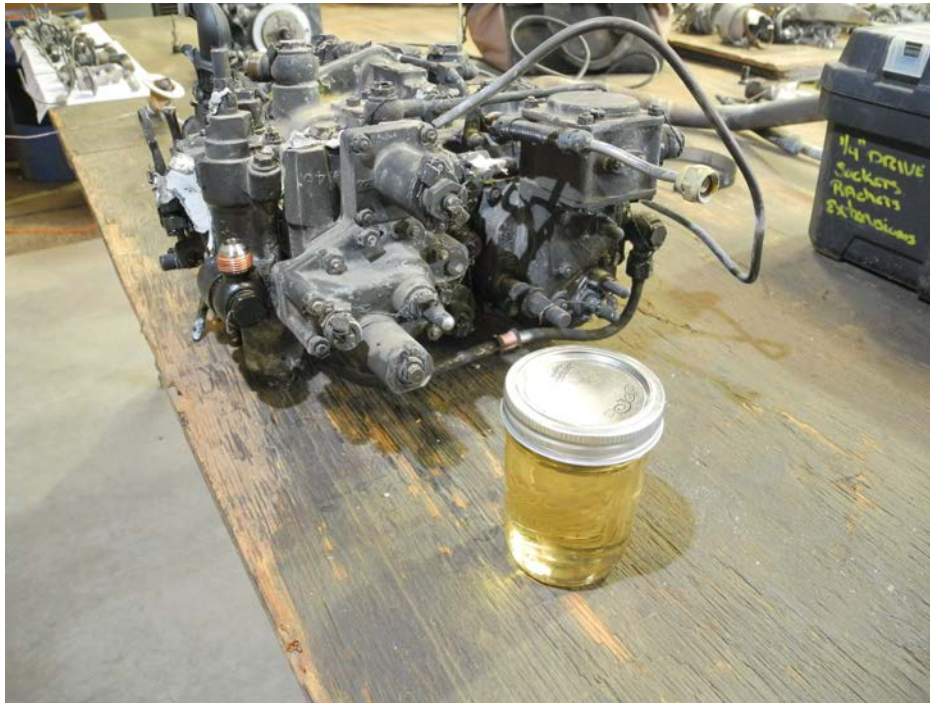
Photo 41

The FCU was intact, and externally undamaged. In the in-situ condition, the fuel control input lever was observed to be in the cutoff condition. Additionally, it was coated with drippings of solidified, previously molten aluminum as well as a light white powdery deposit. When removed from the AGB, the input and drive splines were observed to be intact and undamaged. When the fuel line connectors were removed from the FCU, clean fuel was seen to exit the unit ([Photo 41](#)). Approximately 1 ½ pints were recovered.

Fuel Control Unit with Recovered Fuel

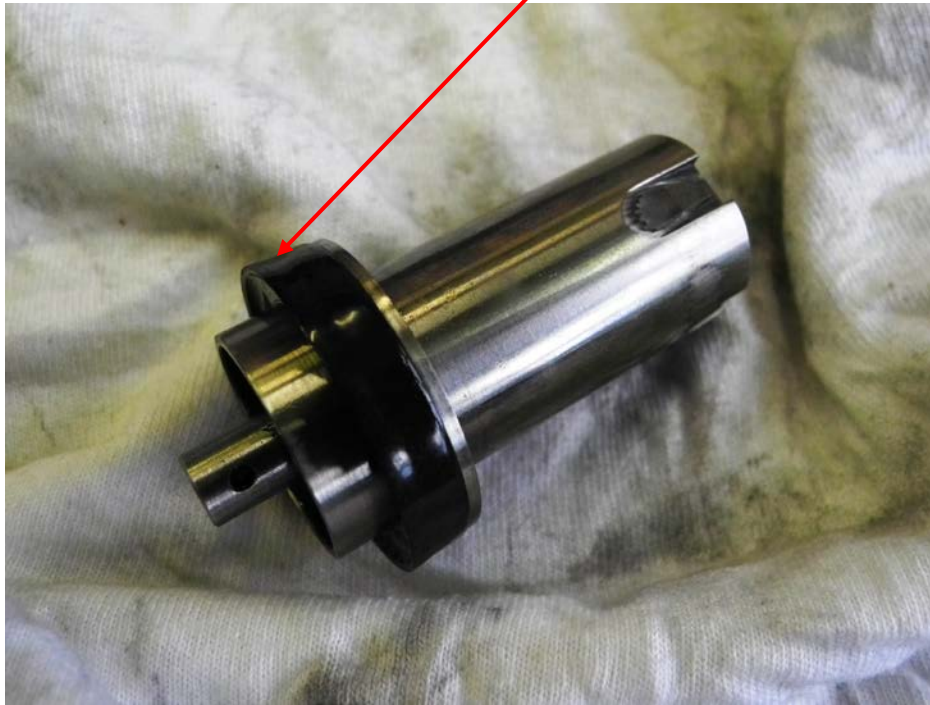
Photo 45

After the FCU tests were completed, the FCU was partially disassembled so that critical internal elastomeric membranes and seals could be inspected. The covers of two membranes and one fuel pressure shuttle valve were removed and the components inspected (Photo 43). The elastomeric membranes were all still flexible and had retained their original rubber-like softness. The part markings, which were still visible, indicated that they were manufactured in July 1990 and that they were likely the original parts (Photo 44). One membrane displayed two small half inch long crusty deposits of corrosion most likely from aluminum housing. The main shuttle valve elastomeric sliding seal lip was slightly worn, which is consistent with normal wear (Photo 45).

Shuttle Valve – Slightly Worn Sliding Seal

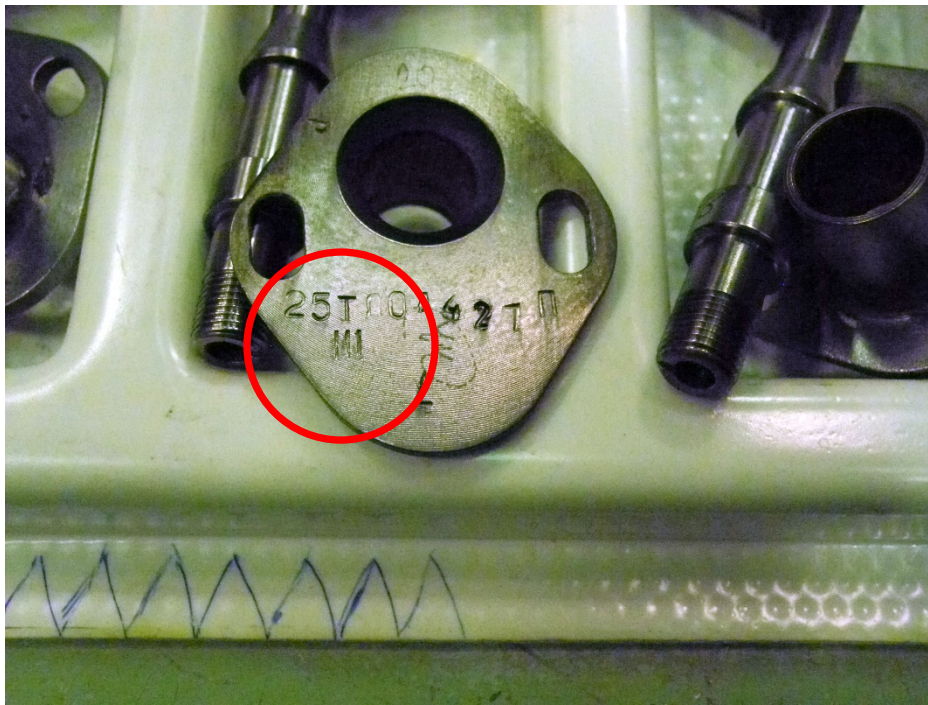
Photo 49

Nozzle class is not marked on the actual nozzle body, but rather on the mounting plate of each nozzle. These two parts must always be retained together. A conflict was noted with the Class rating marks on each tested FN. All the mounting plates of the tested nozzles were marked as Class III ([Photo 49](#)). LOM could not explain this discrepancy.

Fuel Nozzle Mounting Plate w3ith Class III Indications
