NATIONAL TRANSPORTATION SAFETY BOARD

Electronic Devices

Specialist's Factual Report

Location: Duluth, Minnesota
Date: June 7, 2014
Aircraft: Lancair IV
Registration: N86NW
Operator: Private
NTSB Number: CEN14FA278

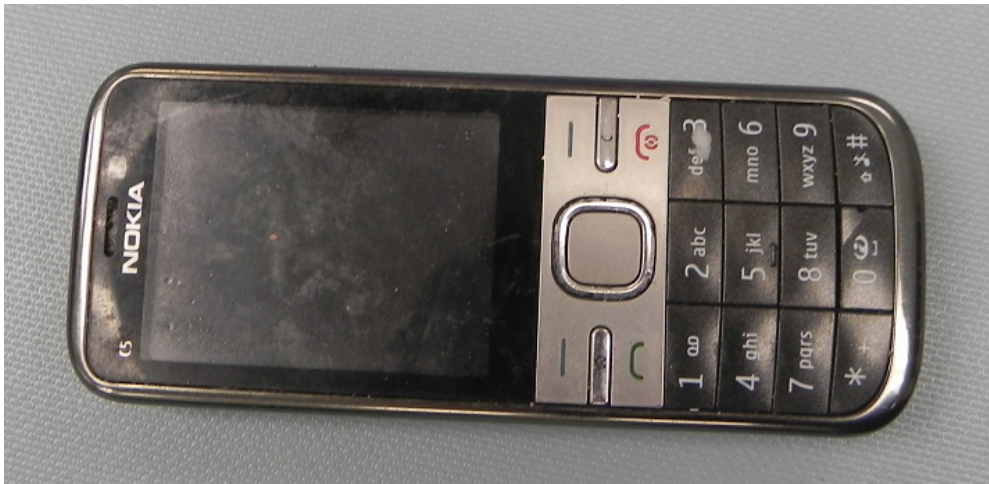
The Nokia C5 cell phone and Avidyne FlightMax Entegra are shown in figures 1 and 2, respectively. The Nokia cell phone turned on, but the screen was damaged. In agreement with the Investigator-in-Charge, no further recovery attempts were attempted.

Figure 1. Nokia C5 cell phone.

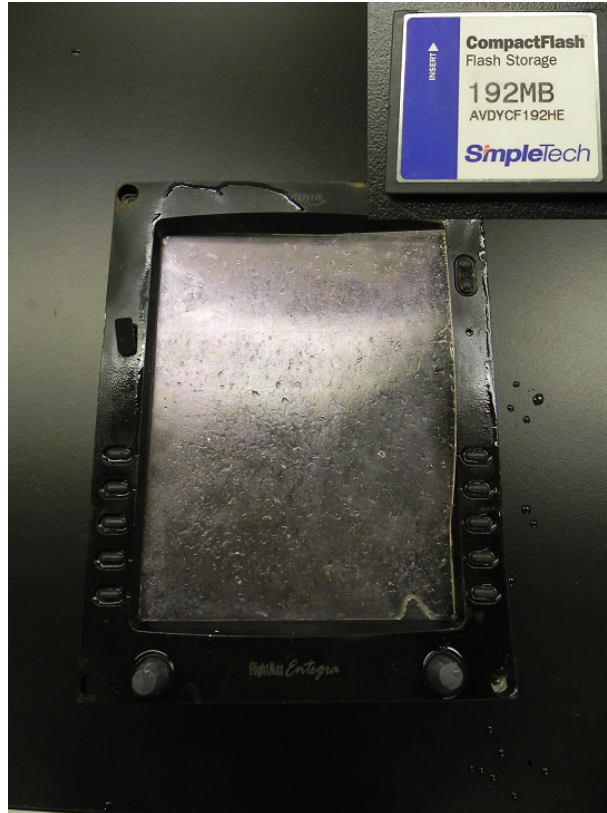
The Avidyne FlightMax Entegra is a multifunction display (MFD). Depending on the version and installation, the unit may record information to a removable compact flash (CF) card. While the CF card was successfully read, it did not contain any recorded information. Avidyne confirmed that the Entegra does not record any information when installed on an experimental, turbine aircraft.

Figure 2. Avidyne FlightMax Entegra with compact flash (CF) card.

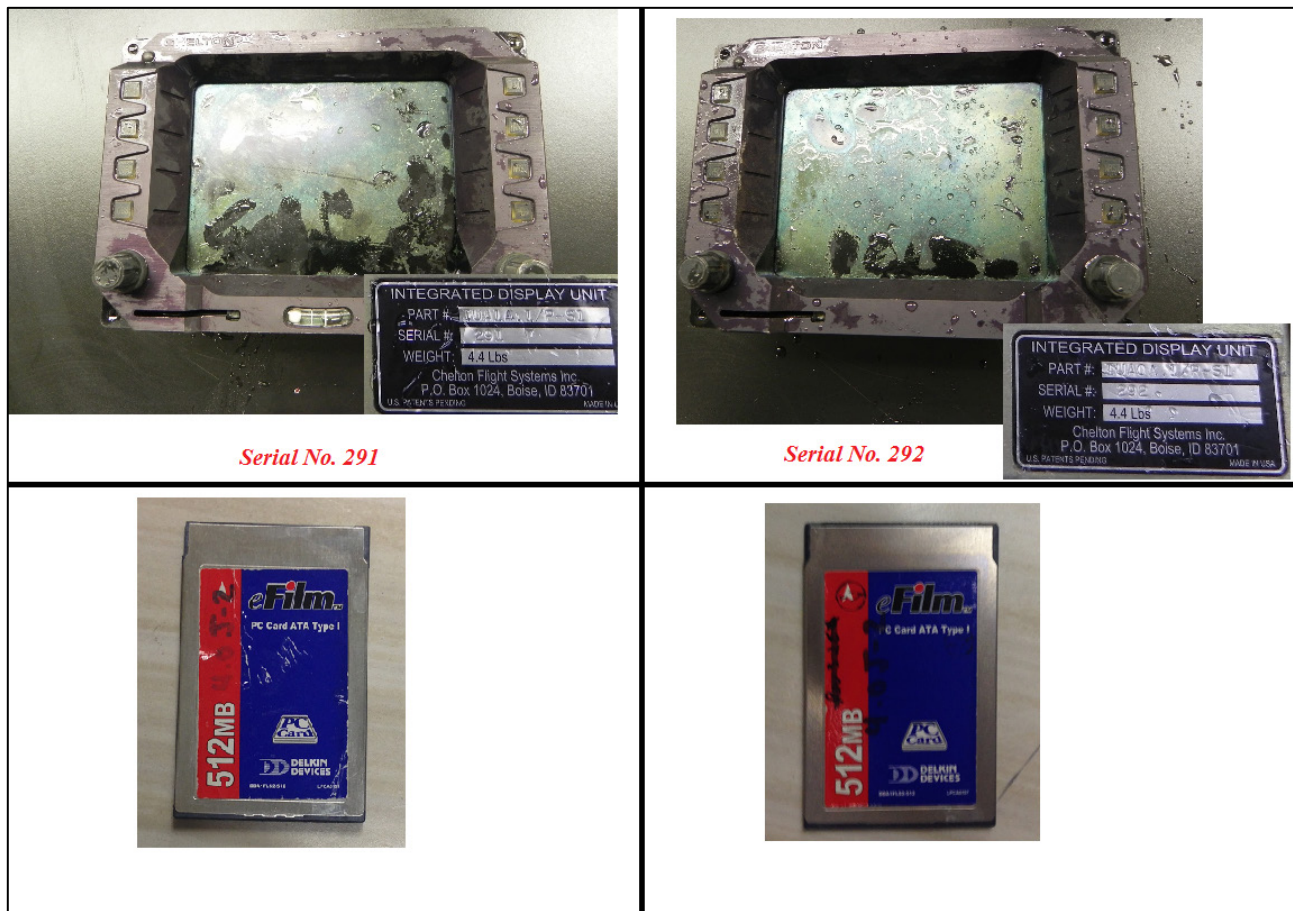
Two Chelton Flight Systems IDUs were recovered from the accident aircraft. The units sustained minor impact and water damage. Figure 3 shows the units with serial number 291 on the left and serial number 292 on the right. Figure 3 also shows the internal PCMCIA cards that were removed from each unit.

The cards were heated to 40° Celsius and a half atmosphere for 12 hours to dry; however, afterwards each card was opened and residual liquid was still observed. The cards were cleaned with deionized water and ethanol and then dried with compressed air. Each PCMCIA card was reassembled and read with a Windows-based computer and the data log and screen capture files were retrieved.

Figure 3. Damaged exterior of Chelton Flight Systems IDUs.

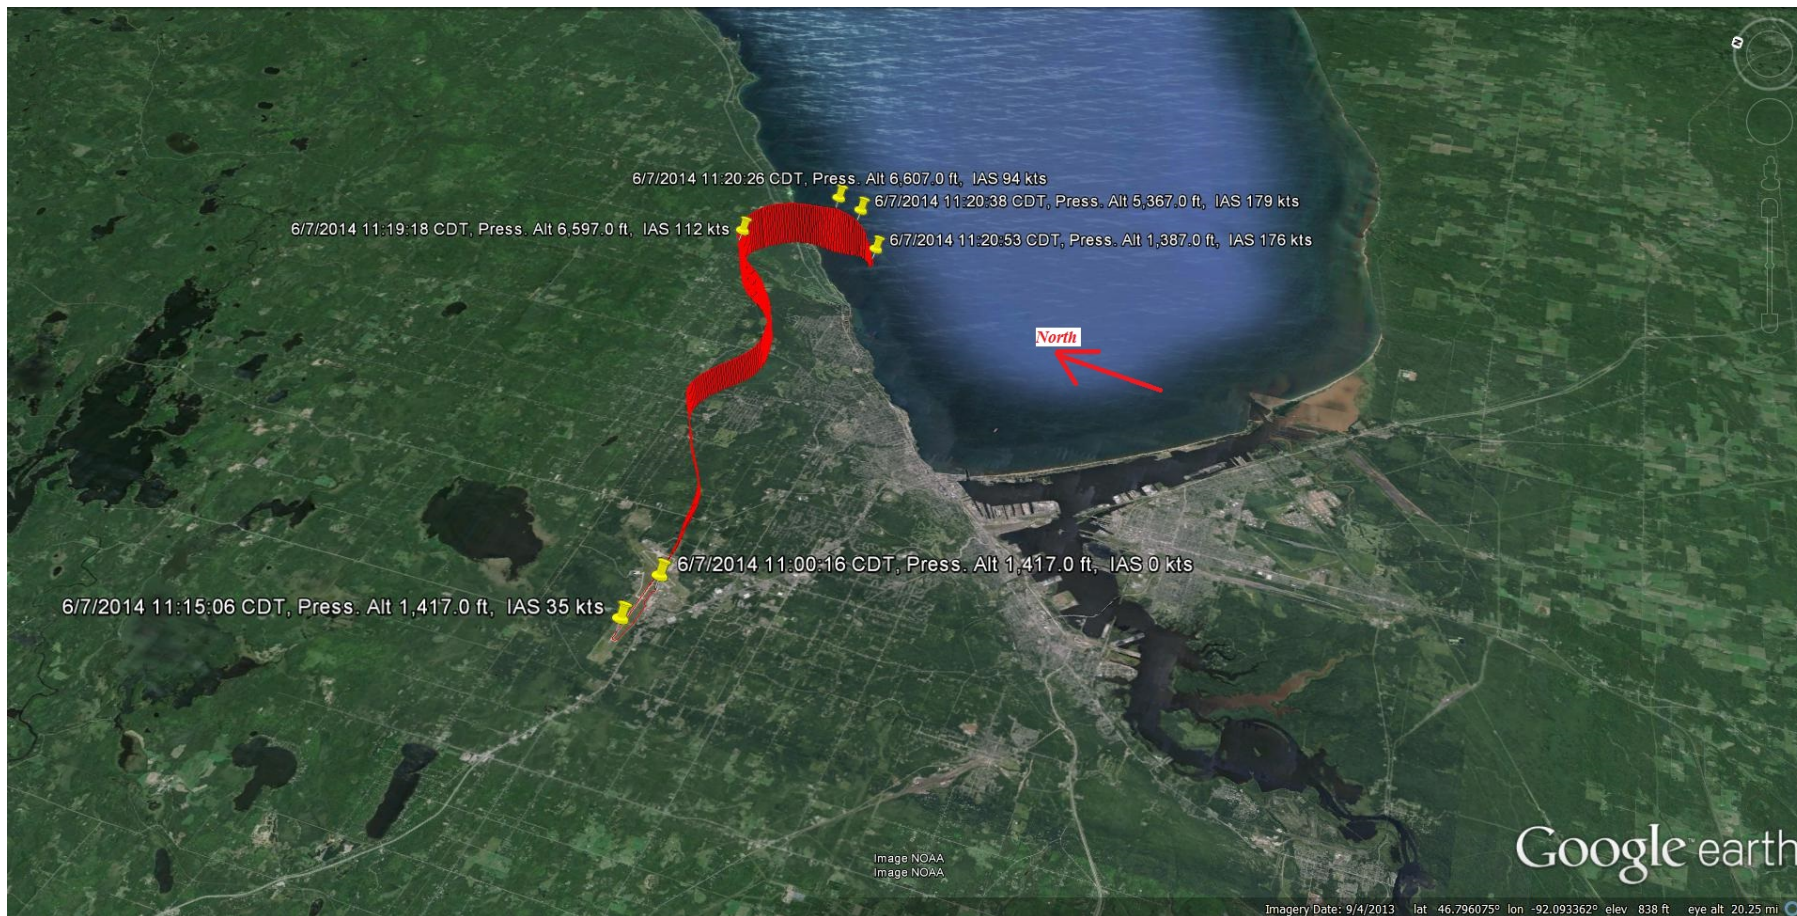
Figure 4. Google Earth overlay of accident recording.

The Google Earth overlays and plots in this report show the aircraft departed from KDLH, climbed towards Lake Superior with intermediate level offs, exhibited fluctuations in pitch, speed, and roll, and then descended rapidly and crashed into Lake Superior. The narrative that follows provides further details.

Figure 4 is a Google Earth overlay of the accident flight with select points annotated. The recording began at 11:00:16 CDT with the aircraft taking off at about 11:15:06 CDT. Figure 5 shows the start of the recording and ramp movements. At about 11:15:06 CDT, the aircraft climbed on an easterly track and achieved a maximum altitude of 6,607 ft at 11:20:26 CDT. Figure 6 focuses on the end of the recording. The minimum recorded indicated airspeed (IAS) after the initial departure climb was 94 kts at 11:20:26 CDT at the maximum altitude of 6,607 ft. Thereafter, the IAS increased and the aircraft descended, reaching a maximum recorded IAS of 262 kts about 6 seconds before the end of the recording.

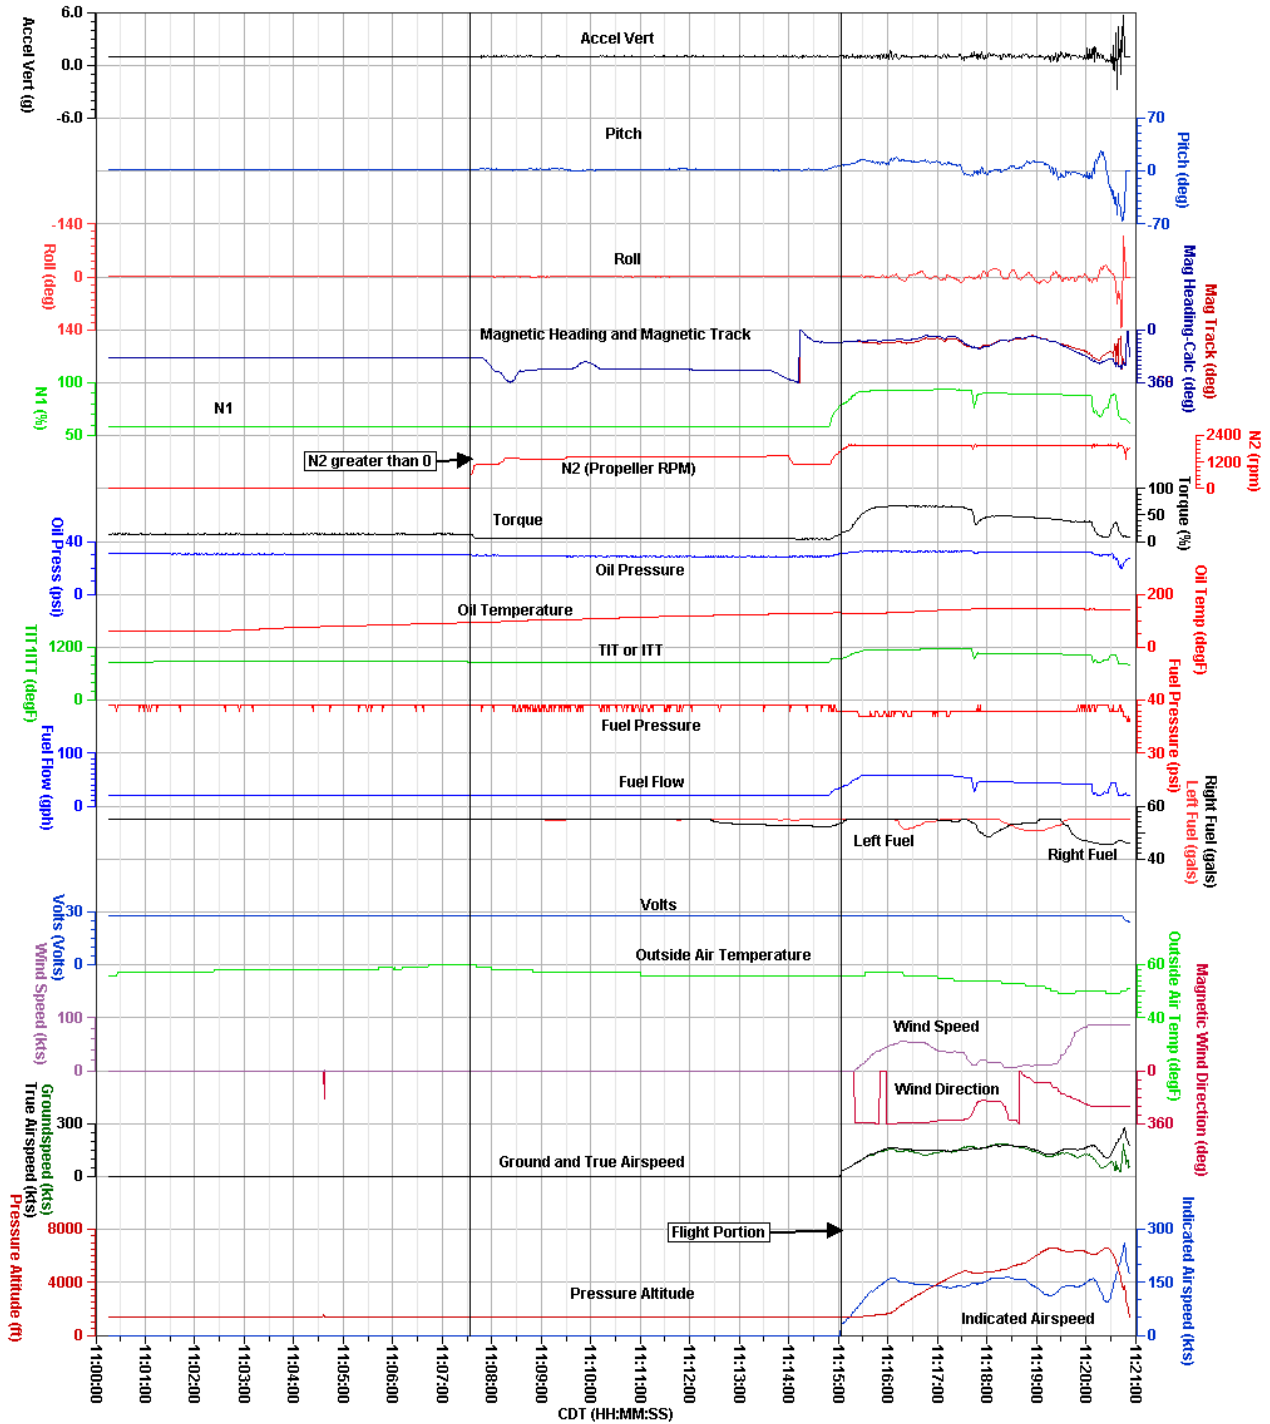
Figure 7. Plot of accident flight recording.

Figure 7 is a plot of the entire accident flight recording. The recording began at 11:00:16 CDT, and at 11:07:34 CDT, N2 values were greater than 0%. As shown in figure 5, by 11:08:16 CDT, the aircraft began to move on the ramp. By 11:15:06 CDT, the aircraft began its take-off from KDLH.

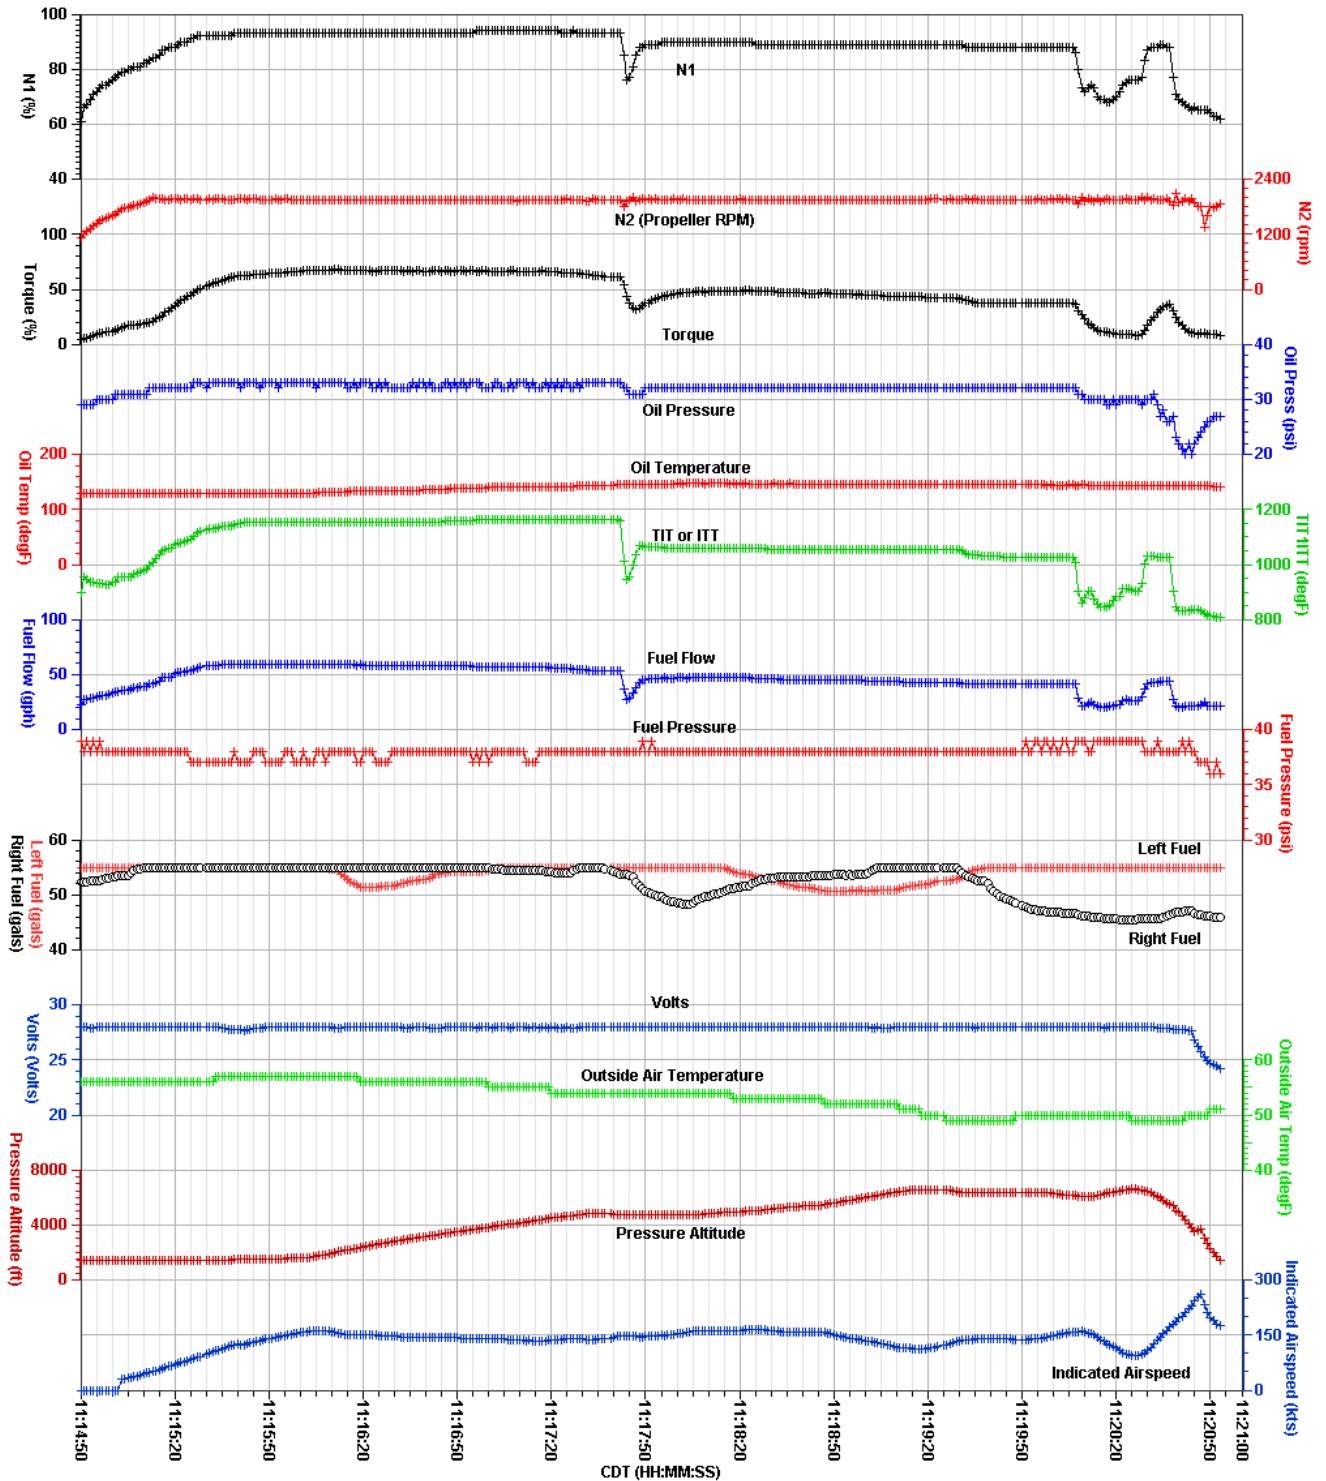
Figure 8. Plot of engine parameters during the flight portion of the accident recording.

Figure 8 is a plot of engine parameters during the flight portion of the accident recording. At about 11:17:33 CDT, the pressure altitude first levelled off since take-off, followed by an IAS increase until 11:17:43 CDT. At 11:17:44 CDT, N1 reduced from the climb value of about 93% to 77%, before increasing to a value of about 90% by 11:17:56 CDT. N1 decreased steadily to 88% by 11:19:32 CDT and remained so until 11:20:06 CDT.

At 11:19:52 CDT, the pressure altitude began to descend from 6,407 ft as the IAS increased. At 11:20:09 CDT, N1 decreased to 73% as the IAS peaked at 160 kts, and then began to decrease as the pressure altitude began to climb by 11:20:13 CDT. By 11:20:18 CDT, N1 reduced to 68%, IAS was decreasing and pressure altitude was descending. For about the next 7 seconds, N1 began to increase as IAS continued to decrease to a minimum value (after the initial take-off climb) of 94 kts as pressure altitude reached a maximum value of 6,607 ft. By 11:20:30 CDT, N1 increased to about 88% for about 6 seconds as pressure altitude decreased and IAS increased. By 11:20:38 CDT, N1 began to decrease through 77% as IAS increased through 179 kts.

Figure 8 also shows the left and right fuel tank measures decreased and then increased during the recording. After the IAS passed through about 55 kts during the take-off roll, N2 stabilized at about 1,960 rpm and remained so, with slight fluctuations, until the IAS passed through 243 kts at 11:20:45 CDT, when N2 reached a minimum value of 1,339 rpm and then increased at the end of the recording.

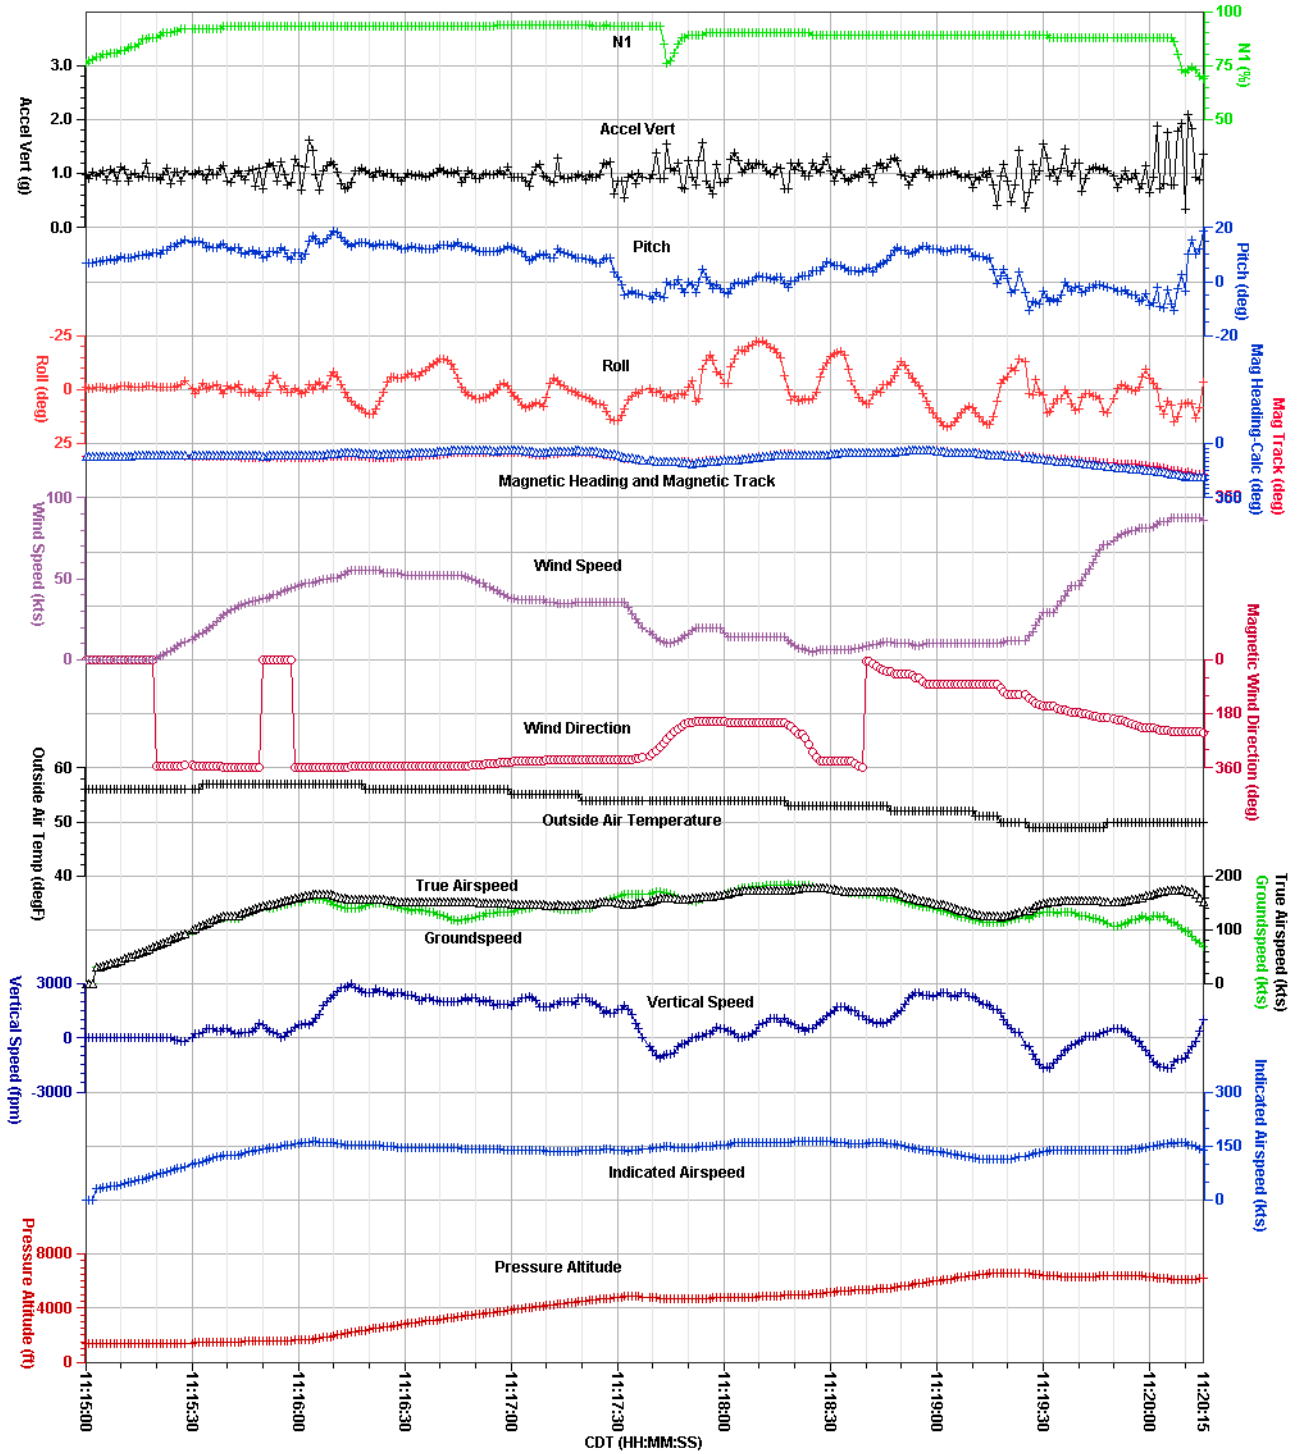
Figure 9. Plot of basic parameters during first part of accident flight.

Figure 9 is a plot of basic parameters during the first part of the accident flight, before the pitch attitude exceeded 20 degrees nose up towards the end of the recording. Between 11:15:03 CDT and 11:15:31 CDT, the aircraft accelerated from 0 kts IAS to 102 kts IAS as

the pressure altitude remained at about 1,427 ft. At 11:15:31 CDT, the pressure altitude began to climb as the IAS continued to increase. By about 11:16:03 CDT, the pressure altitude was climbing through about 1,700 ft as the IAS was about 160 kts. By about 11:17:31 CDT, the pressure altitude levelled off at about 4,800 ft and remained so until about 11:18:20 CDT. At about 11:18:20 CDT, the pressure altitude began to climb, reaching about 6,600 ft by 11:19:22 CDT. The pressure altitude descended to about 6,200 ft by 11:20:15 CDT.

After about 11:16:05 CDT, when the IAS first steadied at about 155 kts, the Chelton calculated wind speed varied between about 50 kts, then decreased to about 6 kts, then increased to about 90 kts by 11:20:15 CDT. The Chelton calculated wind direction also varied during this time period. The magnetic track and heading were generally consistent with each other during this same period.

Figure 9 also shows that recorded vertical acceleration varied during the first portion of the flight. Around the time of the N1 change at 11:17:44 CDT, vertical acceleration varied between +0.7 and +1.6 g. By 11:20:15 CDT, vertical acceleration varied between +0.3 and +2.1 g.

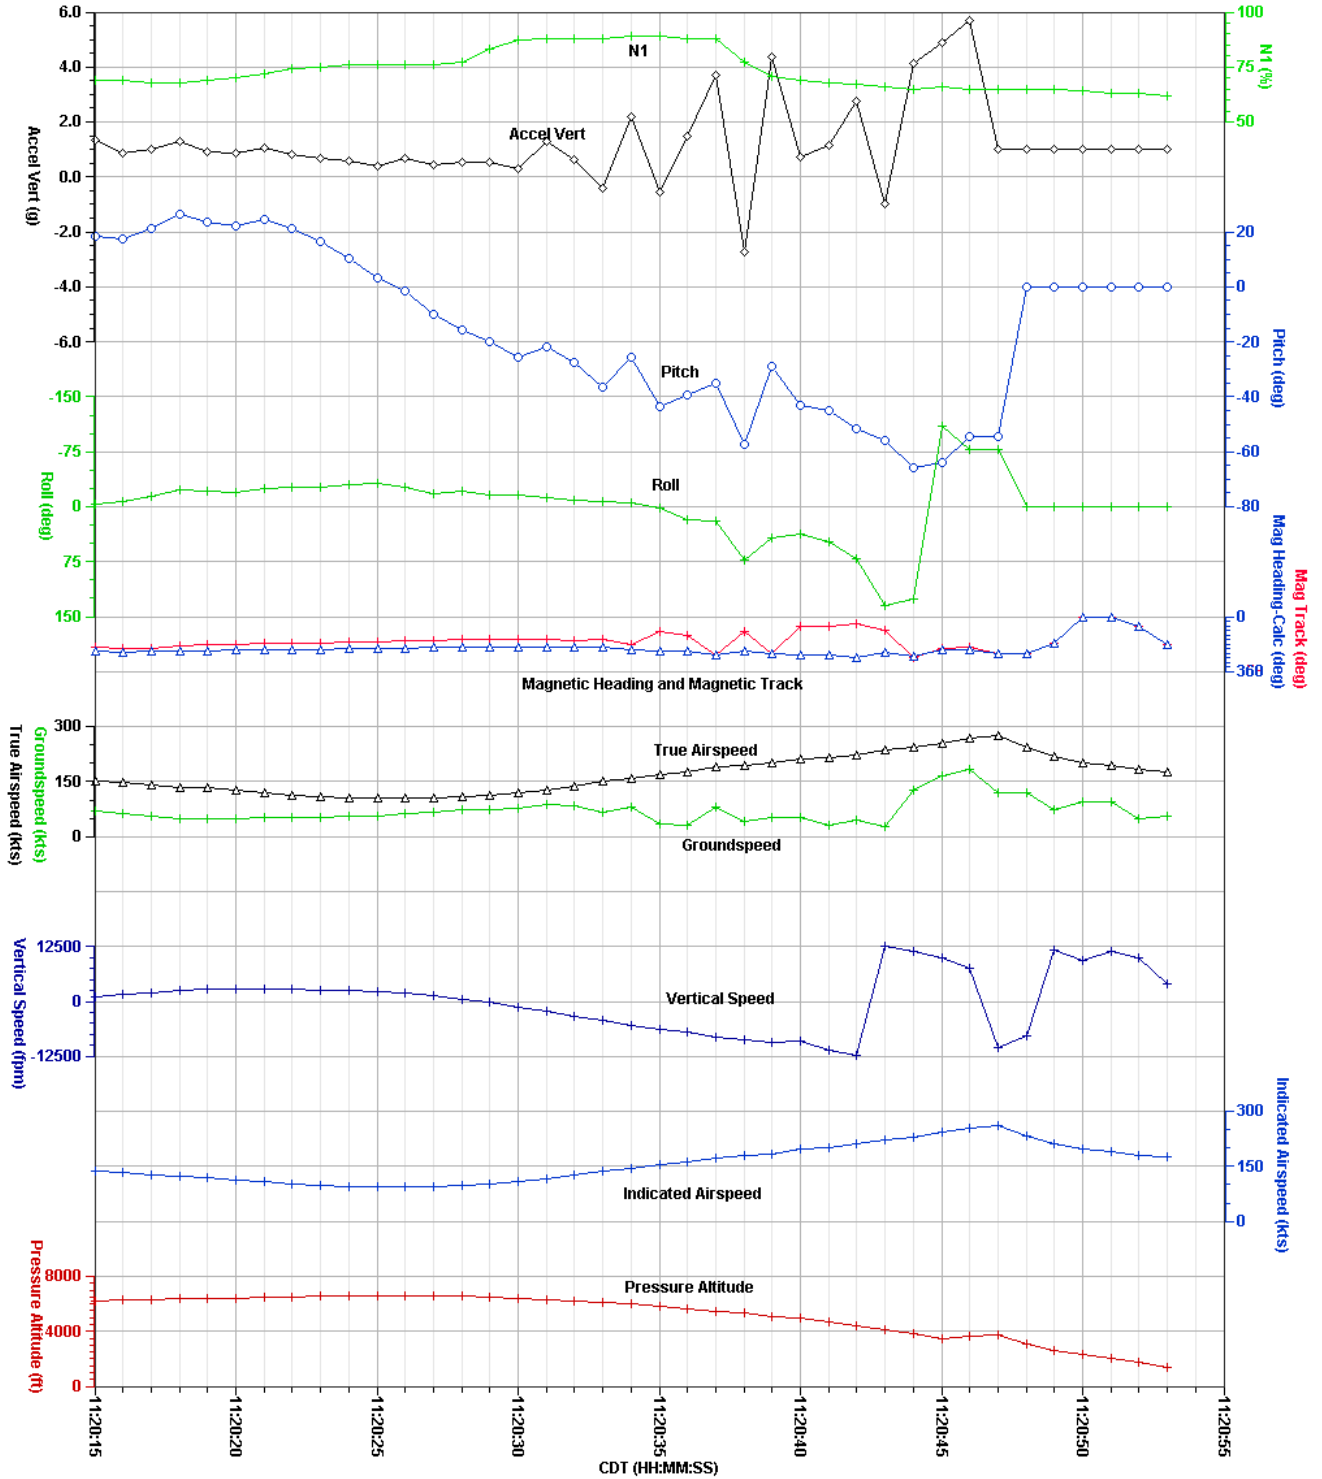
Figure 10. Plot of basic parameters during end of accident flight.

Figure 10 is a plot of the end of the accident flight. After 11:20:47 CDT, the validity of certain values become questionable (e.g., vertical acceleration steady at 1.0 g, pitch of 0 degrees, which are inconsistent with the accident sequence). At 11:20:21 CDT, the pitch attitude began to decrease from a maximum 24 degrees nose up when the airspeed was 108 kts. By 11:20:25 CDT, the pitch attitude decreased through 3 degrees nose up as the airspeed reached a minimum recorded value of 94 kts. From 11:20:33 CDT, the vertical acceleration began to fluctuate between -2.7 and 5.7 g, roll recorded extreme values (greater than +/- 60 degrees), and vertical speed recorded extreme values (greater than +/- 4,000 feet per minute).

Between 11:20:28 and 11:20:47 CDT, IAS increased from 97 kts to a maximum of 262 kts. The recording ended at 11:20:53 CDT with a pressure altitude of 1,387 ft.
