# **National Transportation Safety Board**

## **Radar Performance Study**

### **Specialist Report**

| NTSB Number: | CEN14FA110 |

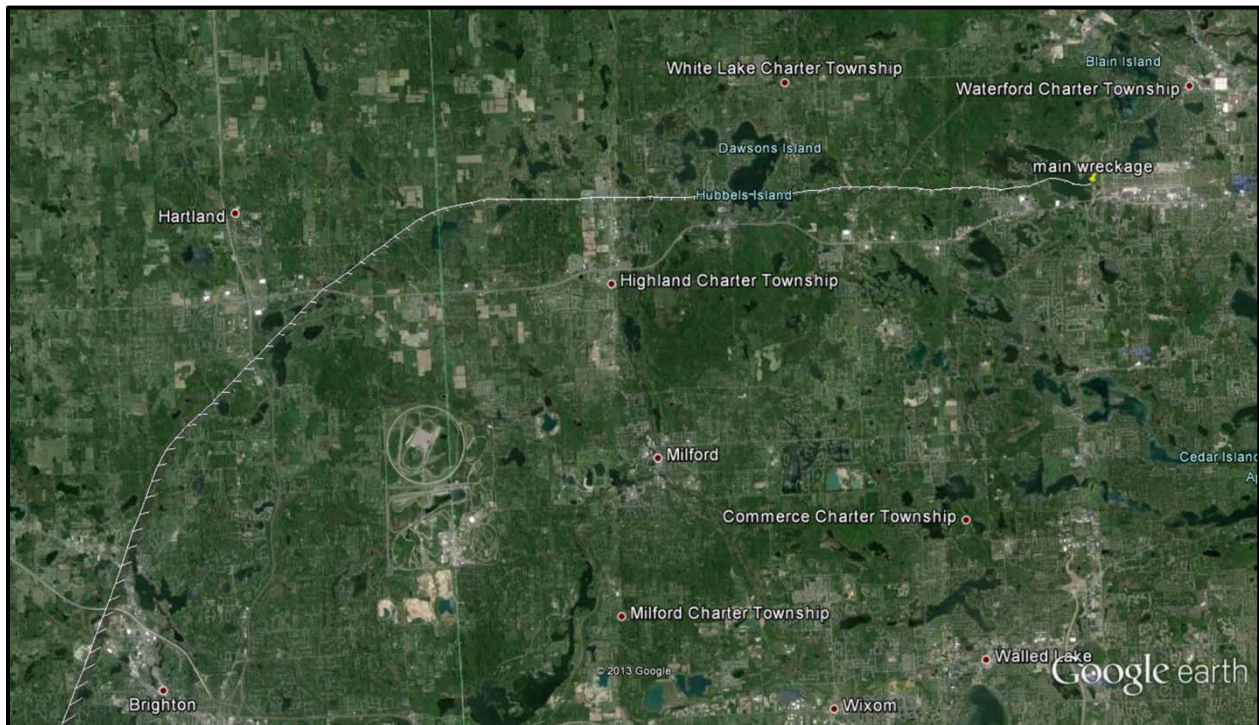
**Figure 2: Radar Ground Track From KPTK Radar**

Figures 2 and 3 show the radar ground track for N3829G's approach into KPTK. Figure 4 is the approach plate for Oakland County's ILS 9R.

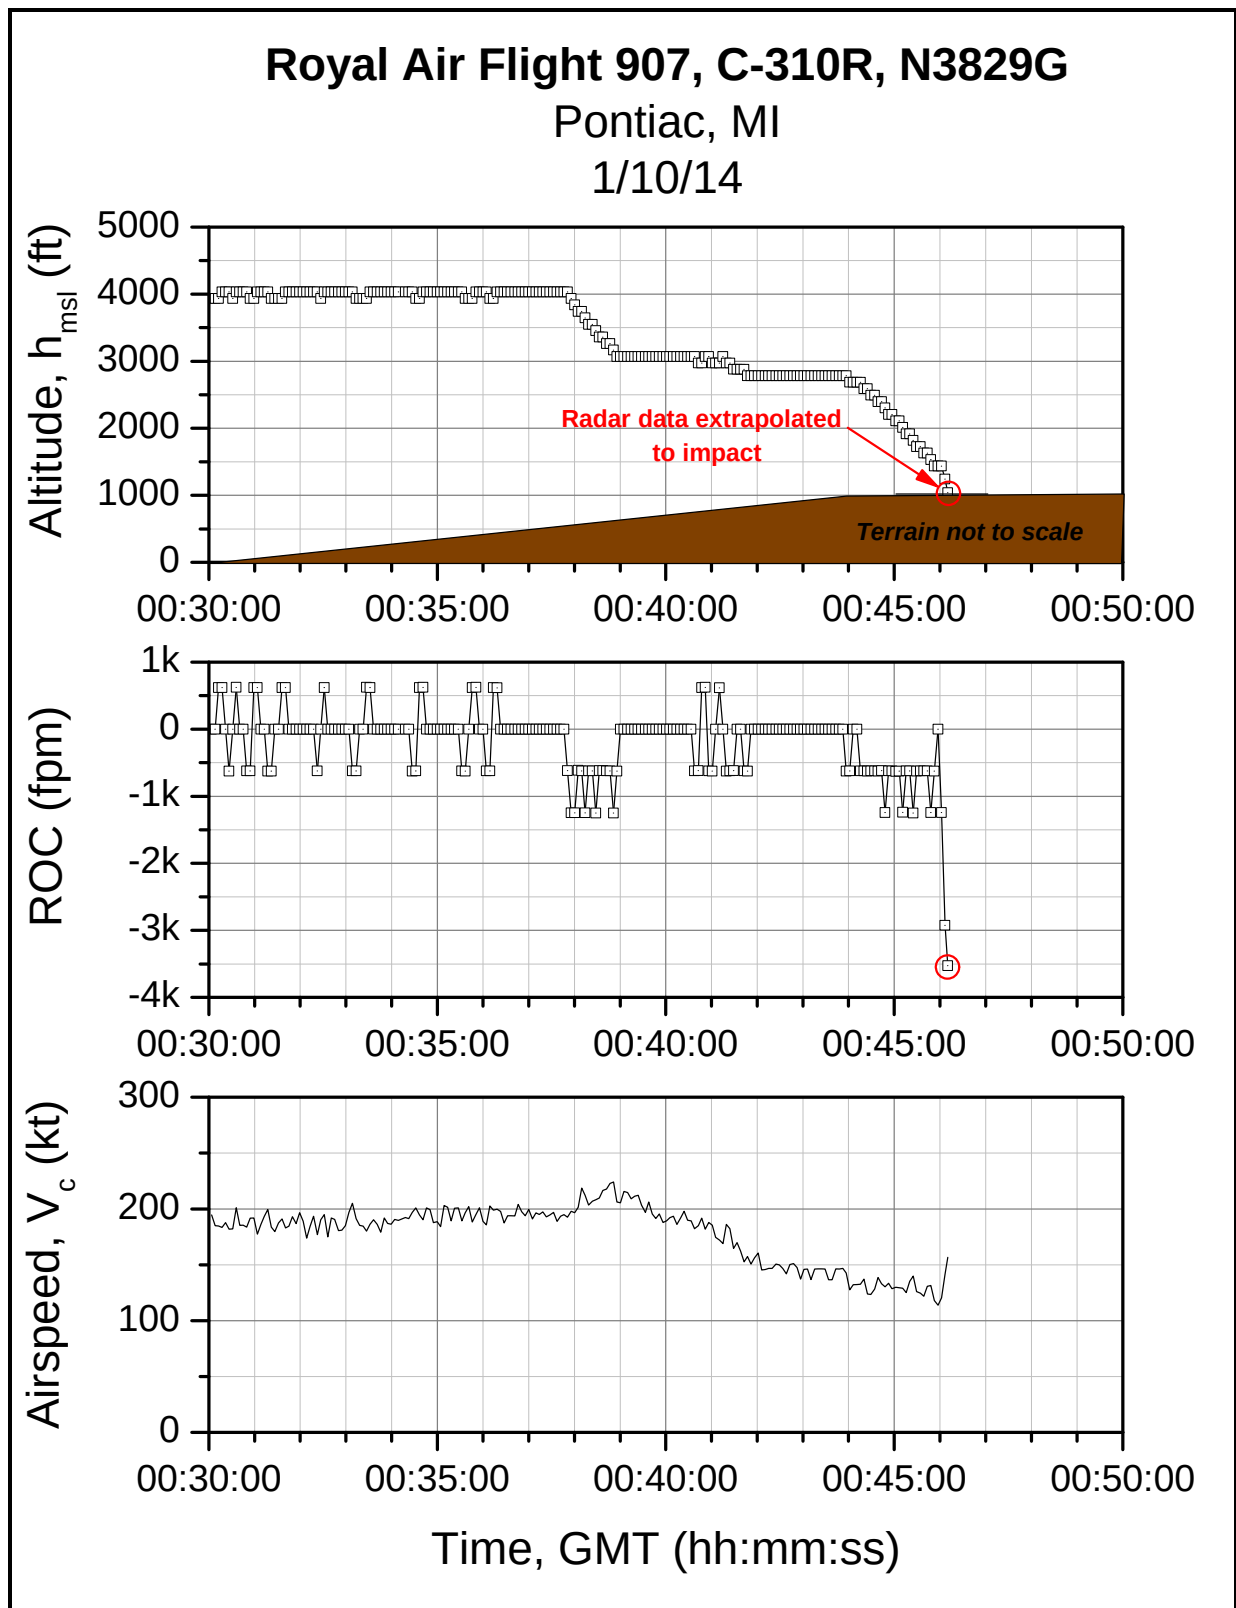
Figure 5: Altitude and Speed for Final Minutes of Flight

Figure 5 shows the altitude and airspeed estimated from radar data and the Meteorological Factual, while Figure 6 is an estimate of N3829G's pitch, roll, and heading angles during the final minutes of the flight.

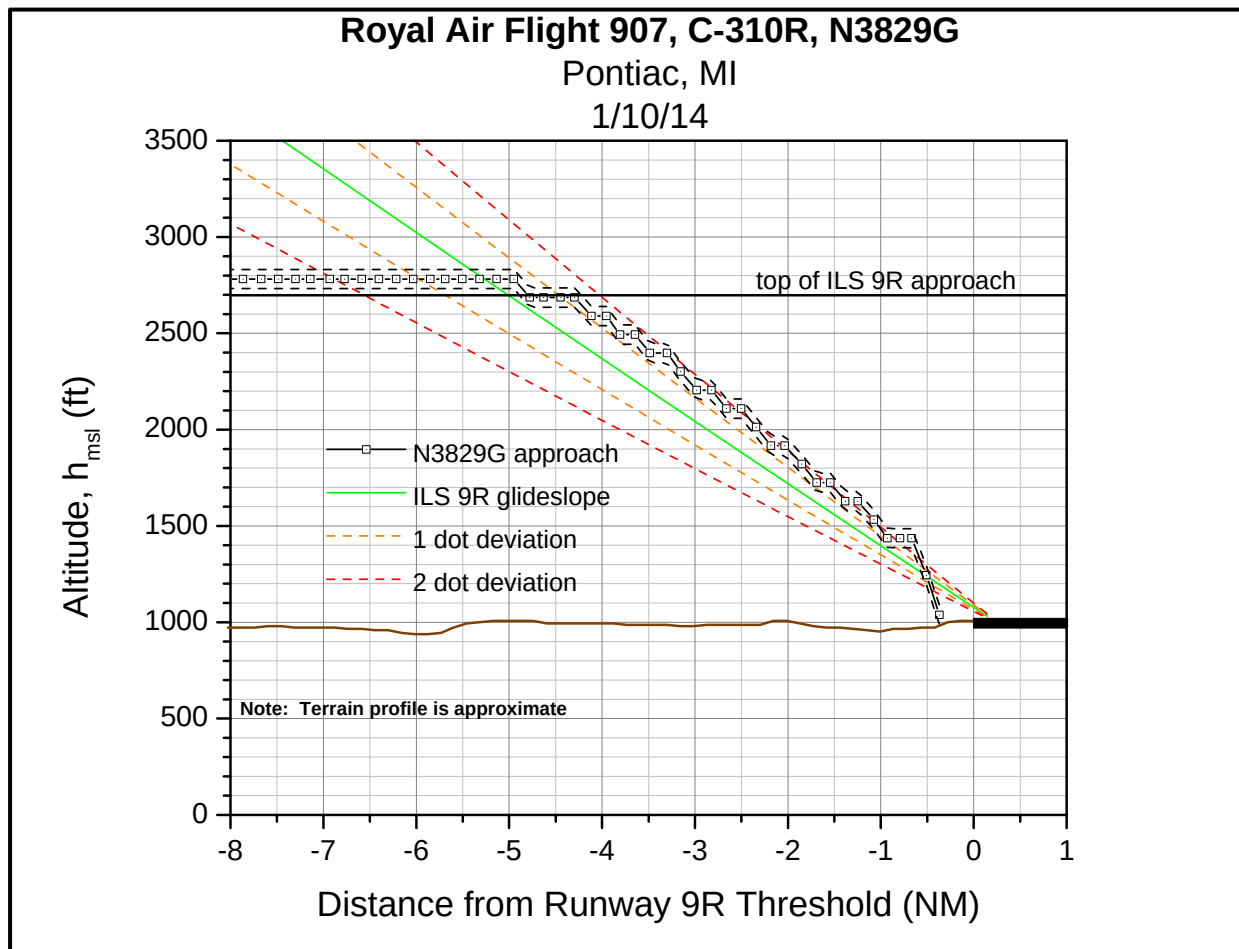
**Figure 7: Flight Path Relative to KPTK Runway 9R Glideslope**

Finally, Figures 7 and 8 provide an estimate of the accident flight path relative to the ILS 9R glideslope and localizer, respectively. The airplane begins the approach at an altitude of 2700 ft as called for in the procedure but right of the 092° final approach course. However, the airplane then remains above the glideslope until less than 0.5 NM from the runway threshold. This is shown in Figure 7. The airplane stays right of the localizer until 1.25 NM from the runway when it overshoots and turns back to recapture. This can be seen in Figure 8. The airplane overshoots the localizer once again before impacting trees and terrain.
