# **National Transportation Safety Board**

## **Radar Performance Study**

**Specialist Report**  
**Timothy Burtch**

Location:	Bellevue, TN
Date:	February 3, 2014
Time:	1655 CST
Airplane:	Gulfstream Commander 690C, Registration N840V
NTSB Number:	ERA14FA112

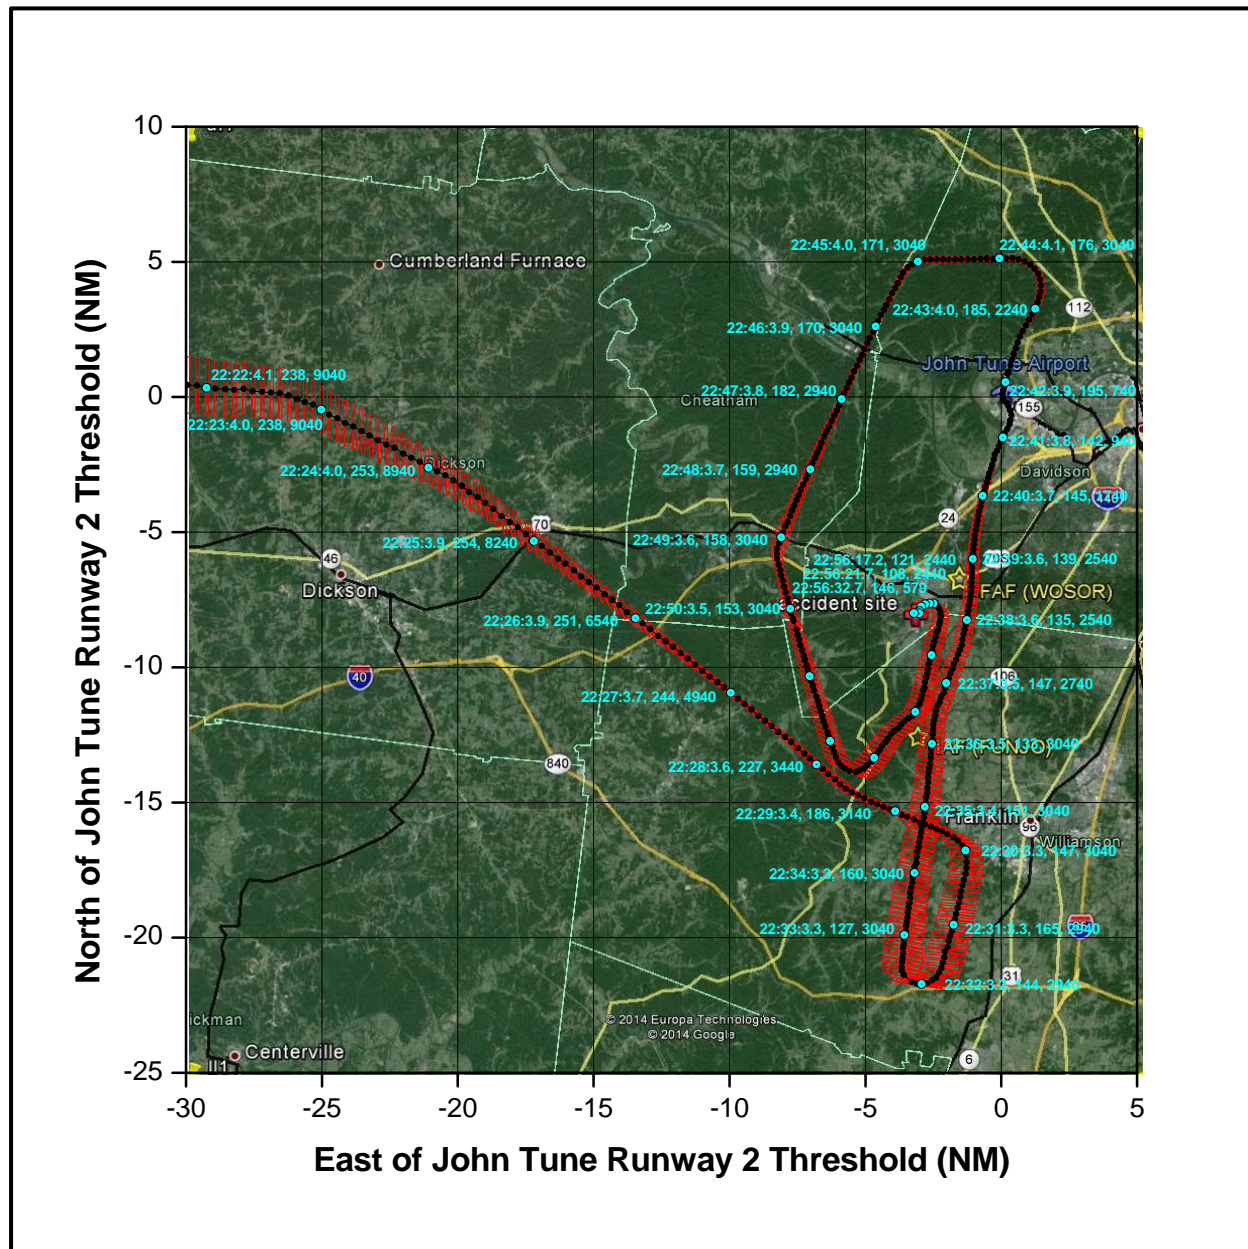
Figure 3: Radar Ground Track in Terminal Area  
hh:mm:ss (GMT) / Vc (kt) / hmsl (ft)

Figures 3 and 4 highlight the radar ground track for N840V as the airplane approached John Tune airport. Each radar point<sup>2</sup> in the figures has an associated GMT time, estimated calibrated airspeed in knots (kt), and altitude above mean sea level  $\pm$  50 feet (ft).

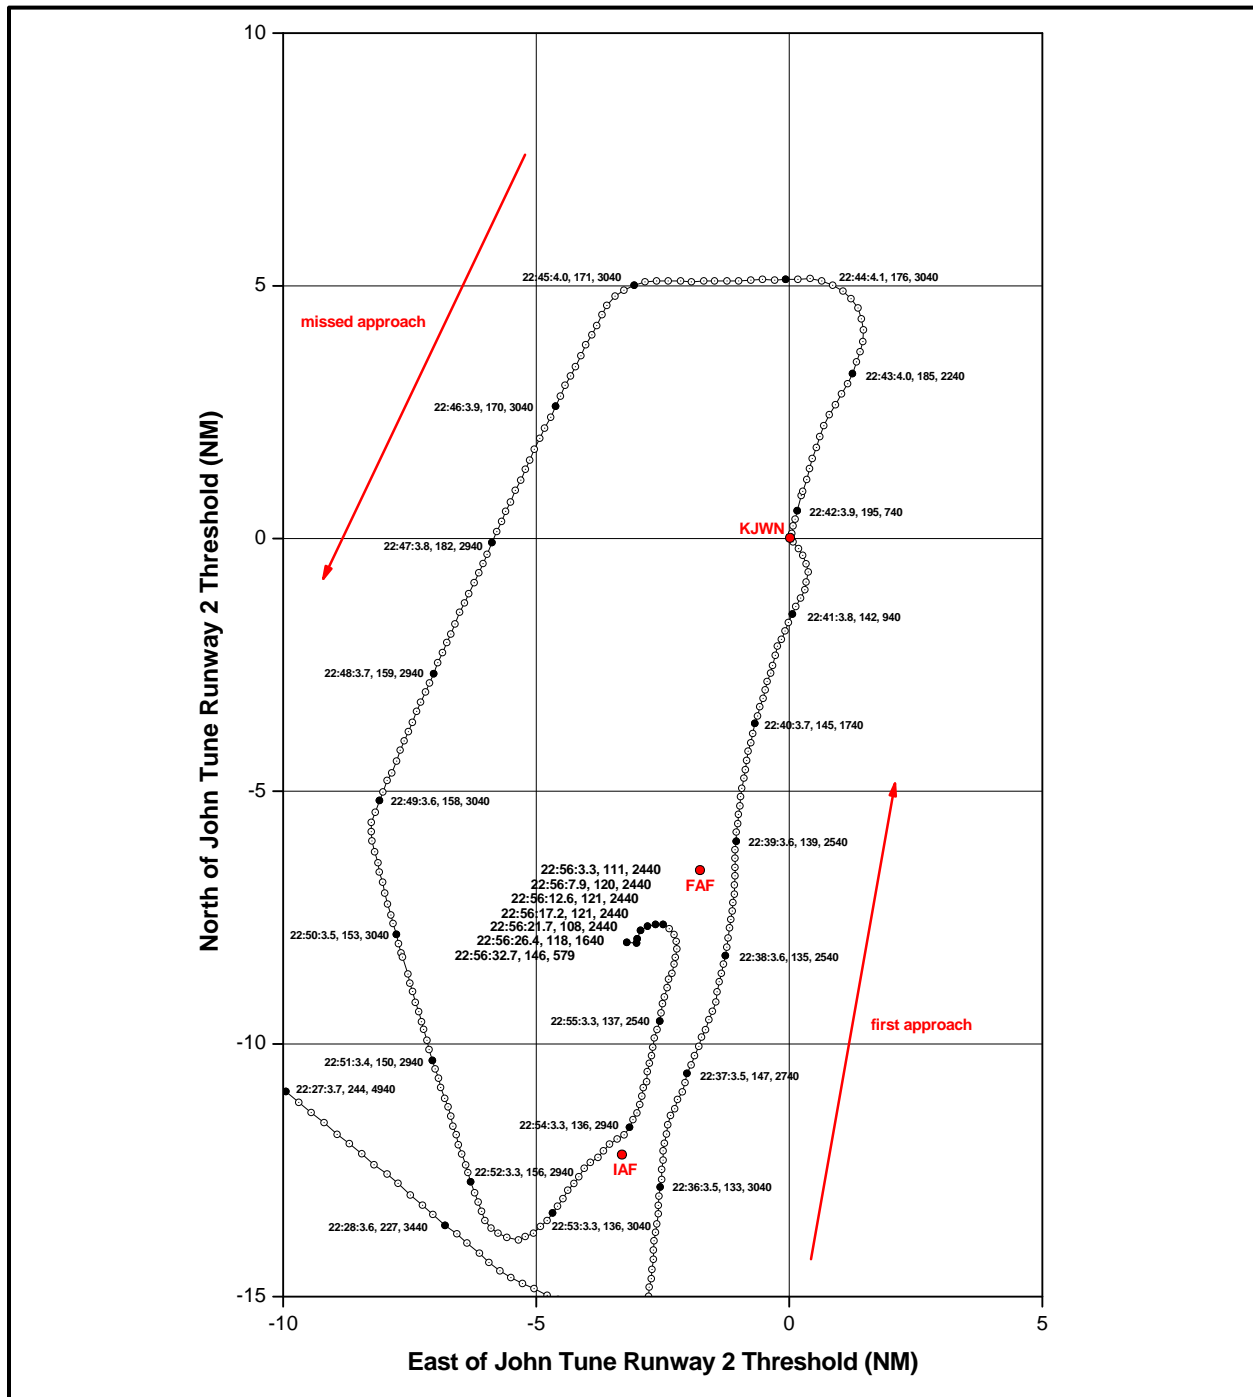
**Figure 4: Radar Ground Track With Respect to GPS Runway 2 Approach**  
**hh:mm:ss (GMT) / Vc (kt) / hmsl (ft)**

The estimated airspeed and altitude for the final 30 sec of flight are highlighted in Figure 4. From 22:56:3.3 until 22:56:21.7, the radar data indicate that the airplane was at the 2500 ft altitude prescribed for the RNAV (GPS) runway 2 approach procedure (as shown in Figure 7). However, the airplane was turning to the left. The airspeed decayed to approximately 108 kt<sup>3</sup> in the turn and, at 22:56:21.7, began increasing rapidly while the airplane descended at over 10,000 feet per minute. The airplane impacted the ground approximately 11 sec later.

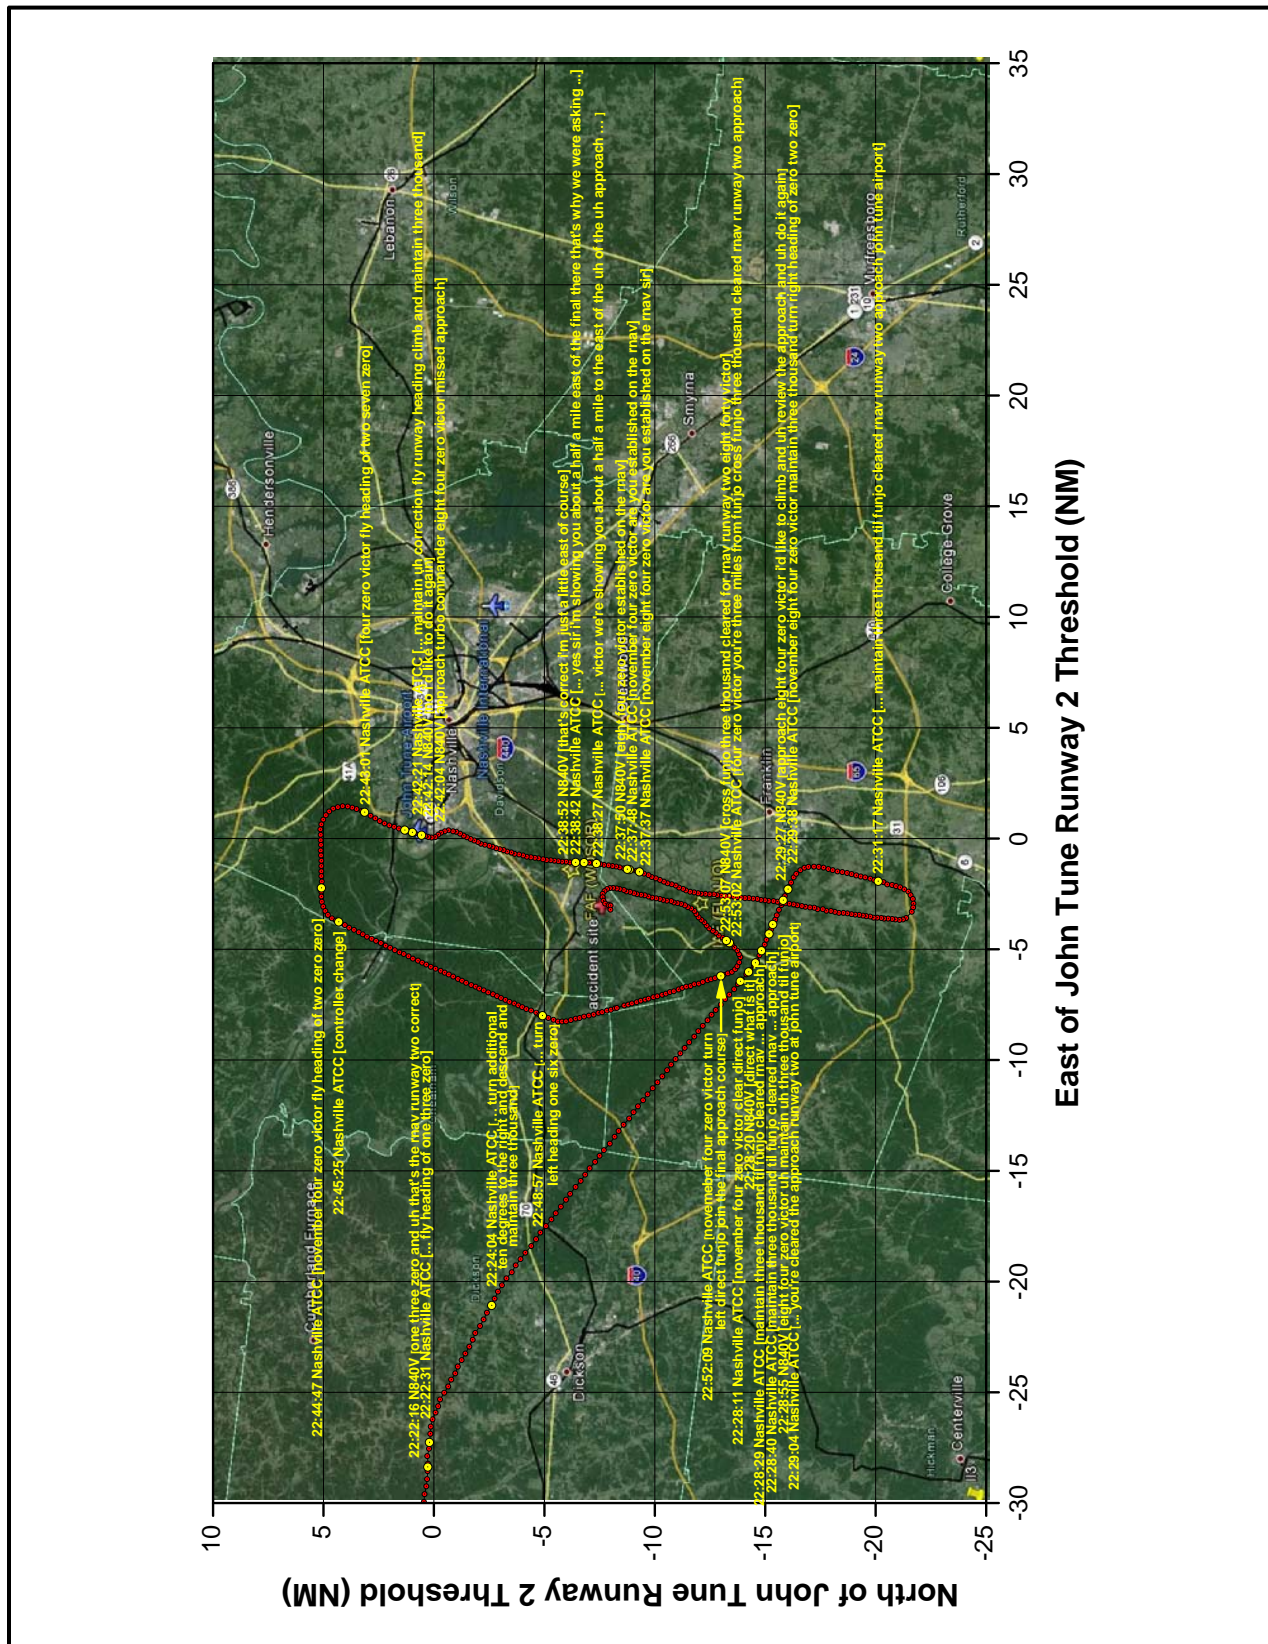
Figure 5: Radar Ground Track in Terminal Area with Select Radio Communications

Figure 5 shows select radio communications between N840V and Departure Radar West , Nashville Air Traffic Control Center (ATCC). Note that at no time was the possibility of ice in the vicinity of KJWN mentioned by either the pilot or ATC.

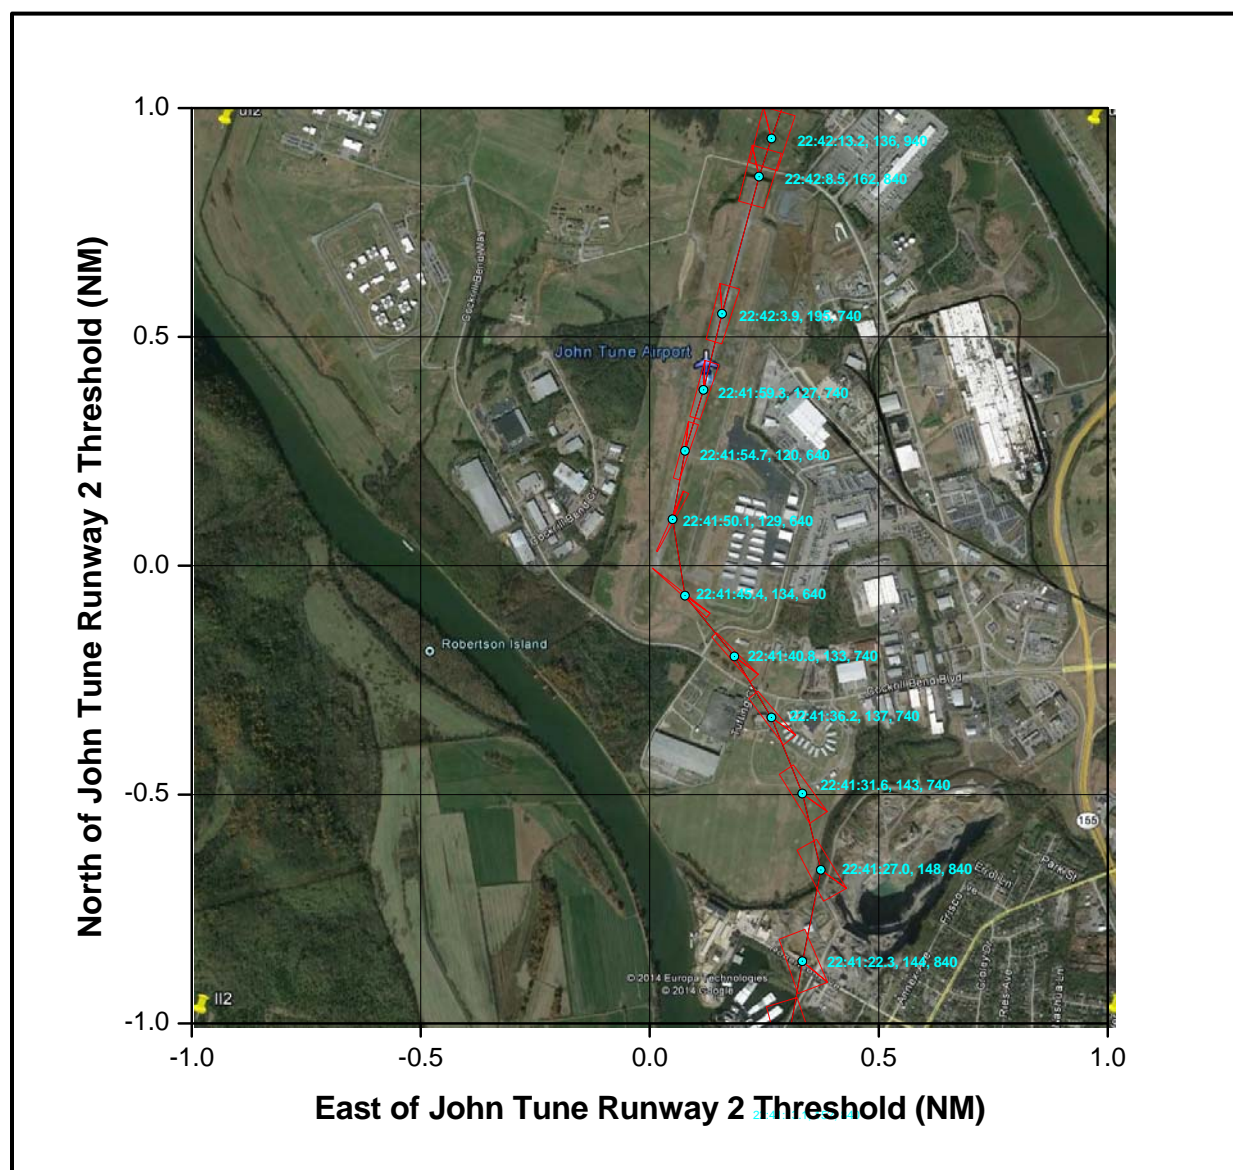
Figure 6 highlights the ground track during the first approach to the airport. Radar data indicate that the airplane descended to 640 ft msl  $\pm$  50 ft (145 ft  $\pm$  50 ft agl) over the threshold of runway 2 or approximately 655 ft below the reported 800 ft agl overcast ceiling. In addition, Figure 6 shows that the airplane was likely not aligned with runway 2 during the first approach until sometime after reaching the threshold. Both the weather and the runway alignment could explain the pilot's decision to abort the first landing attempt.

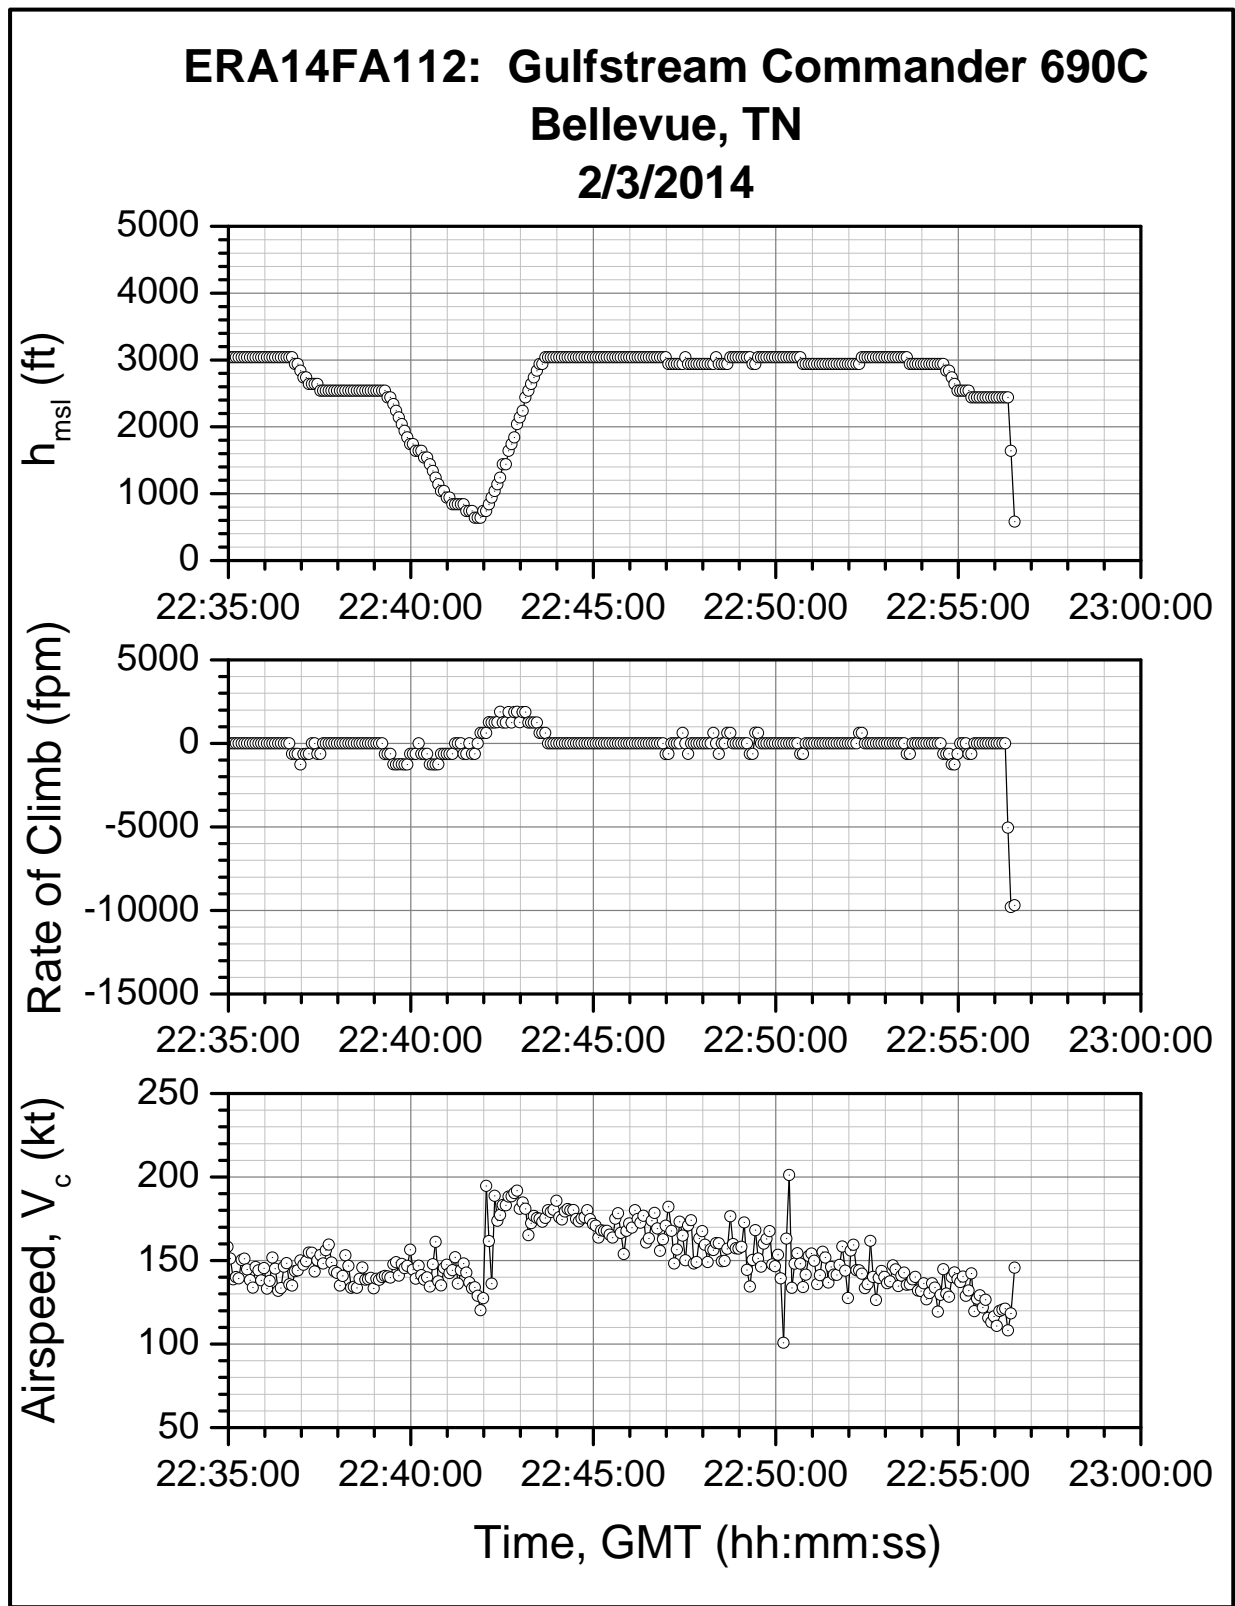
Figure 8: Altitude and Speed for Final Minutes of Flight

Figures 8 thru 11 highlight other radar data and flight parameters that were estimated from radar assuming that the airplane was in coordinated flight with little or no sideslip. The

airspeed was nominally 150 kt during the first approach and showed good acceleration after the pilot declared a missed approach. The altitude was approximately that called for in the approach until the final 11 sec. Finally, the estimated heading angles support the ground track data that show the airplane was not aligned with runway 2 during the first approach.

The pilot then made a second attempt to land. However, the airplane entered a 25° left bank turn after slowing to 111 kt and, 18 sec later, while still in the turn, the airplane slowed to 108 kt and descended at over 10,000 feet per minute until impacting the ground. While the published stall speed for the Gulfstream Commander 690C is 77 kt, both bank angle and ice accretion would increase this speed.
